CHURCH OF ST. LEONARD, FARLEIGH HUNGERFORD, SOMERSET

FOUR MONUMENTS IN CHANCEL

REPORT ON CONSERVATION WORK CARRIED OUT

January - May 2020

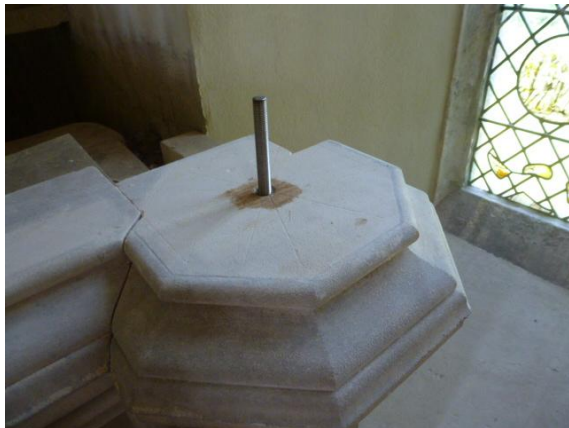
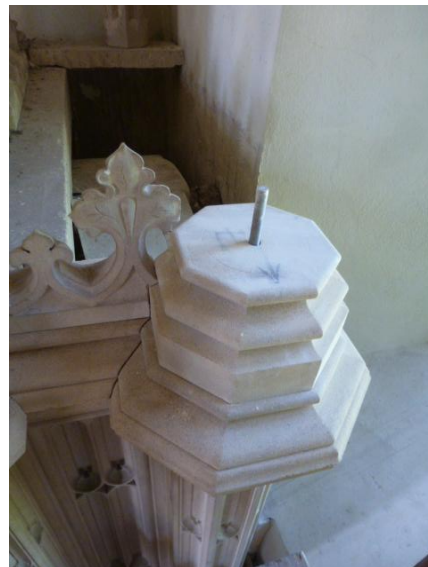
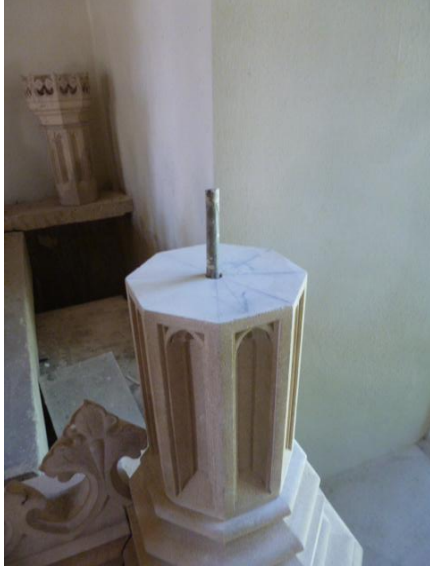
2.1 **Structural** : The lower areas of the monument are stable, although there is slight opening of the horizontal joint below the quatrefoil niches. The rest of the superstructure was stable, apart from the freestanding turrets on the northeast corner and its base, the whole section shifting towards the north, creating a large pressure flake on the section beneath. None of the turrets had any fixings.

As mentioned above, the monument is not tied back to the wall, relying on bridges of stone for its stability and in this case the system has worked well, with the exception of the back east upright, where there was some movement which looked to be caused by its being knocked, perhaps during redecoration. However, the lack of any fixings for the turrets had to be addressed, starting with the back east upright, which was dismantled and given a 12mm vertical dowel through all sections.

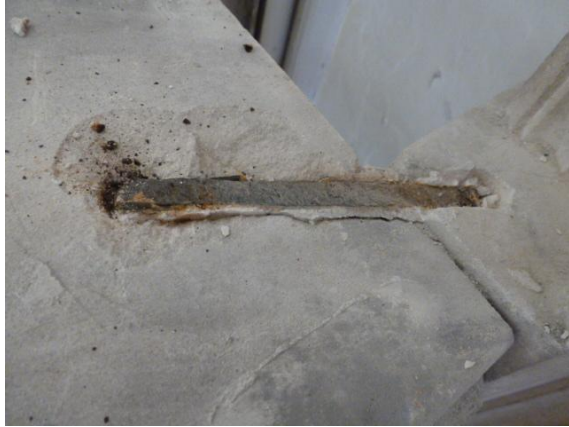
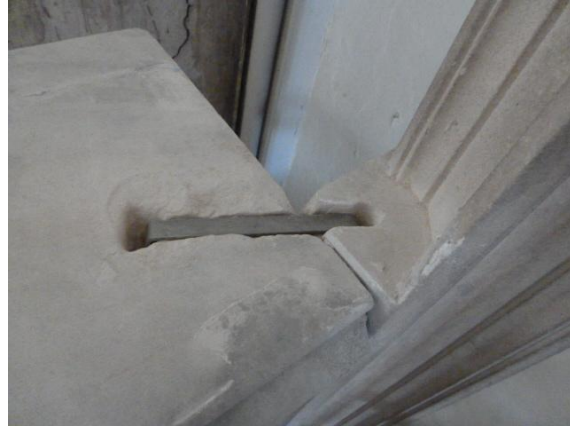
2.1 **Structural :** In spite of the construction method described above, the monument has remained largely stable, with no signs of movement away from the wall. The exception is the area of the two panelled columns at the east end, which have signs of movement (see photo above). The top of the inner column is broken off and is not anywhere behind the monument.

At the east end, the top sections were lifted off to give access to the parapet. An iron fixing tying the pilaster to the centre was removed and replaced in stainless steel (Grade S316 marine).

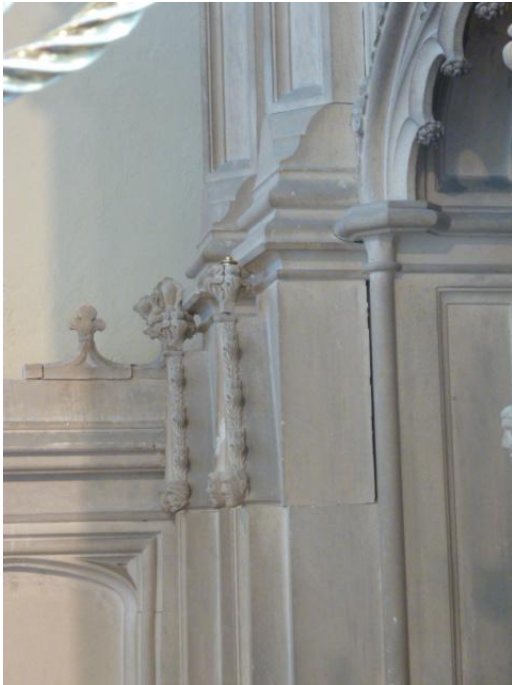
Movement at east end

At the east end a similar thing was happening, but on a less dramatic scale.

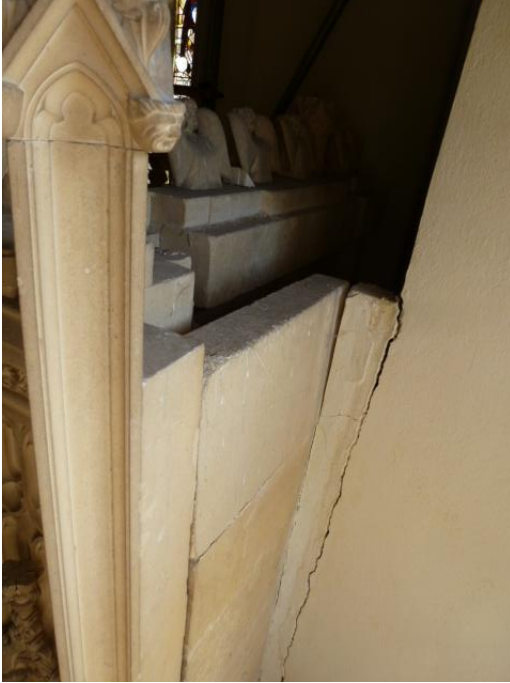
View from behind - movement out from wall, unfixed sections

Once movement had started, the design was failing, as corner pilasters began to pull out, particularly on the west end, which was unsupported.

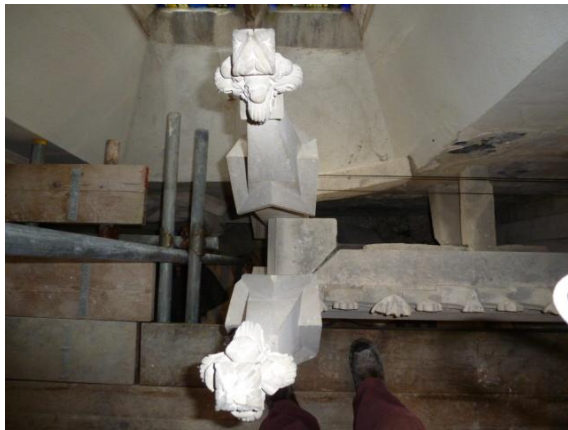
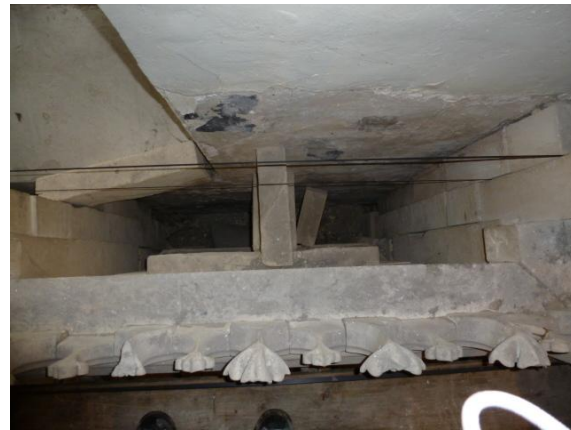
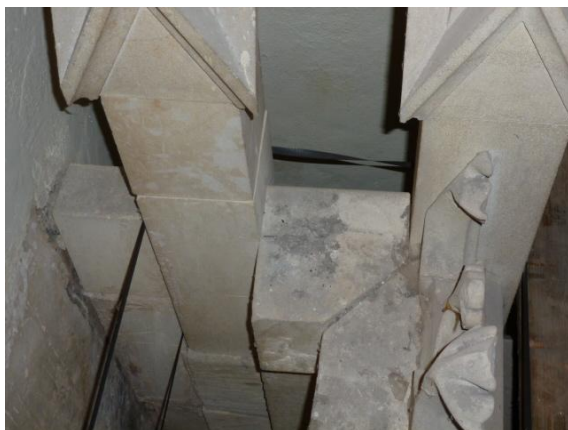
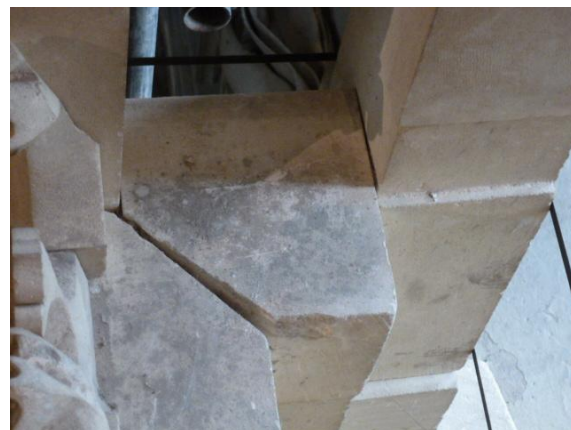
The top sections, from about 2 metres upwards, were all shifting about in a random manner and had been strapped together on the architect's advice.

2.3 **Assessment of risk** : Whilst the shifted stonework does not present an obvious danger, it is nevertheless loose and should be given fixings.

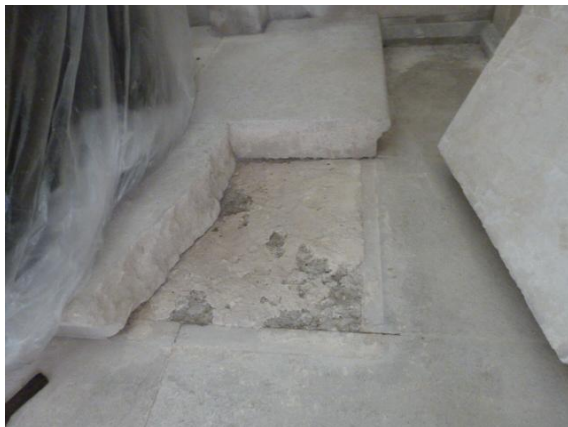
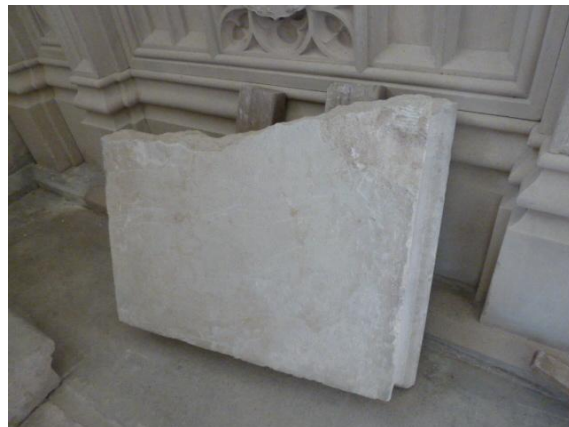
A section of the south end of the top altar step had been broken away and pushed upwards by the corrosion and expansion of the iron fixing for the carpet rail.

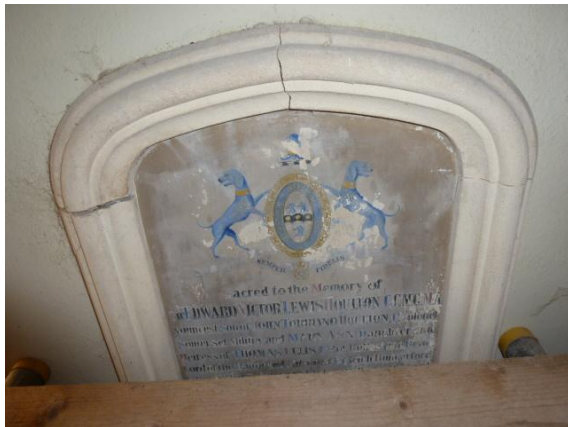
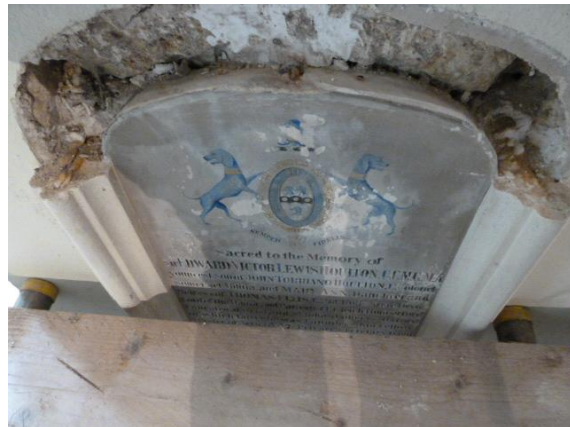
This monument had damage caused by the corrosion and expansion of three iron retaining cramps beneath the top arch.

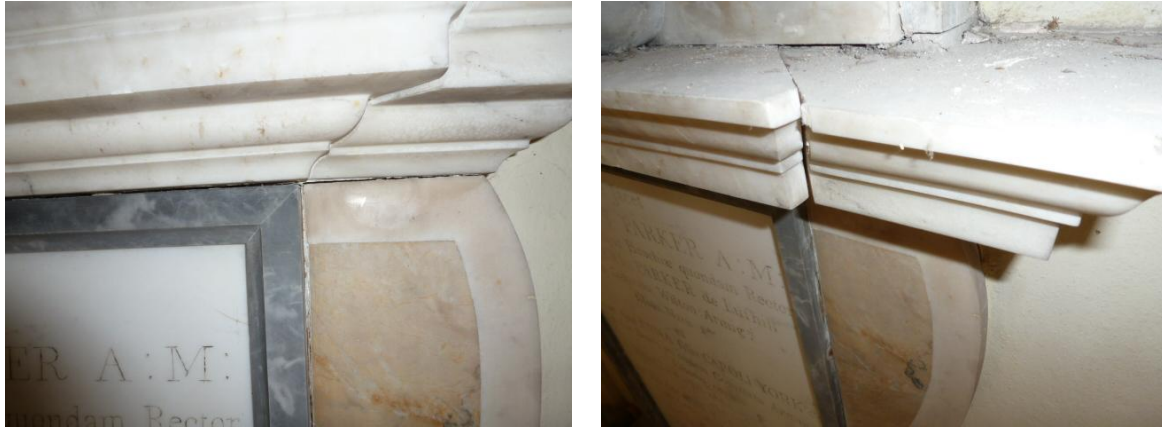
This monument has a similar situation to the one above, with the corroding iron fixings into the top of the inscription tablet causing the sections above to lift.

In this situation, accessing the fixings would mean removing the ornate top sections of the monument and the problem was not considered severe enough to justify this. Instead, the open joints were filled with a non-hydraulic lime mortar which would make any further movement obvious and it should be kept under observation.

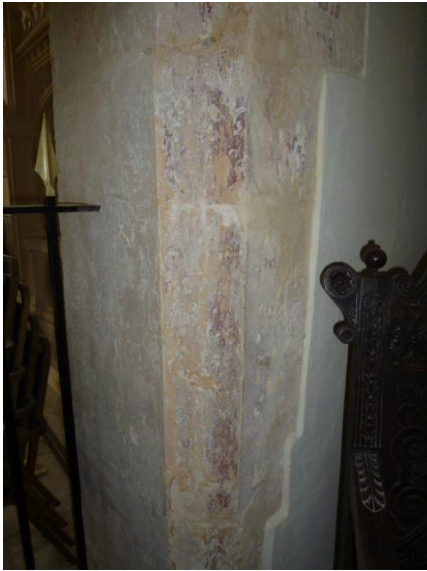
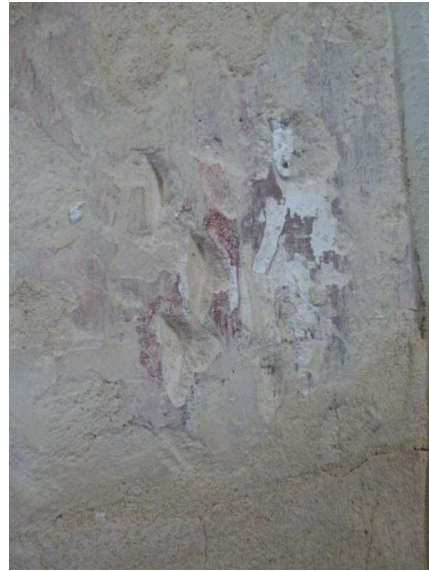
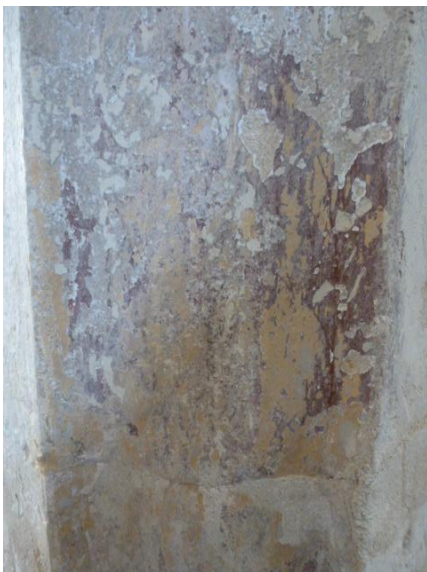
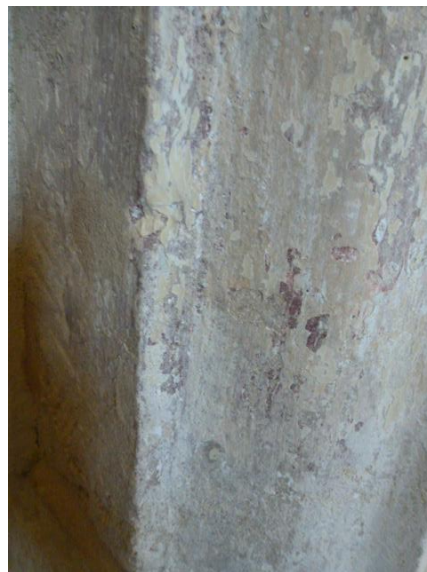
The polychromy, which extends to both sides of the chancel arch, consists of a fine white layer, over which is a thick layer of red oxide paint, which also is covered patchily by a later layer of yellow ochre. This seems to have run over the whole outer order of the chancel arch, with more surviving on the south side.

The earlier layers have been roughly hacked back to key in later limewash and/or plaster and the stone itself has been keyed for plaster.

All the polychromy appears in sound condition.
