St. Mary's church, Antingham, Norfolk

Report on the conservation works on the font, March 2021

This report forms the final conservation record of the works carried out to the font in St. Mary's church, Antingham, Norfolk. The works were carried out by Emma Teale, Theo Gayer-Anderson and Russel Bell under the overall supervision of Dr David Carrington ACR FSA, all of Skillington Workshop during March 2021.

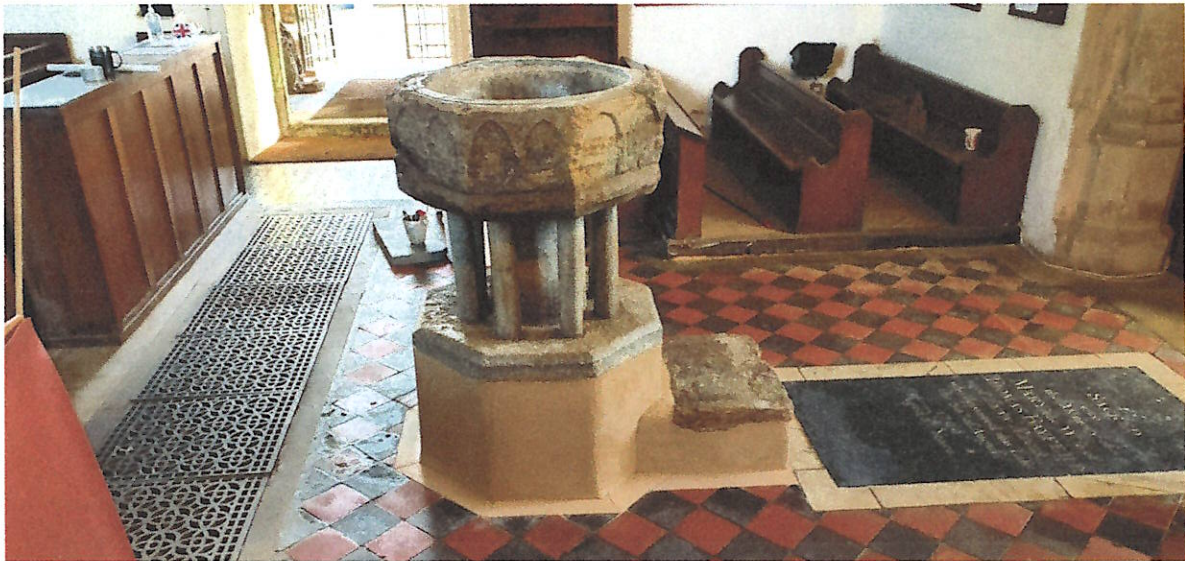
Plate 1: Finished font looking towards south porch

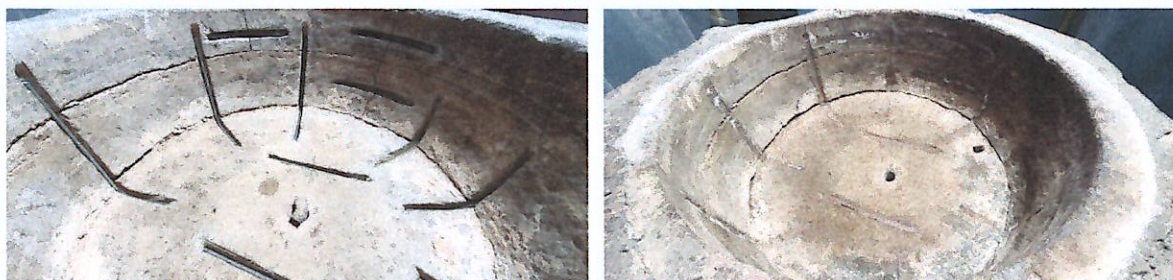
Plates 2 and 3: Dowels before and after being fixed with Hilti HY

The fractures running around the sides of the bowl along the bottom were then stitched on the inner face of the bowl with 14 nr 8mm threaded 316 grade stainless steel dowels set in Hilti HY resin (using about 3 meters of threaded dowel).

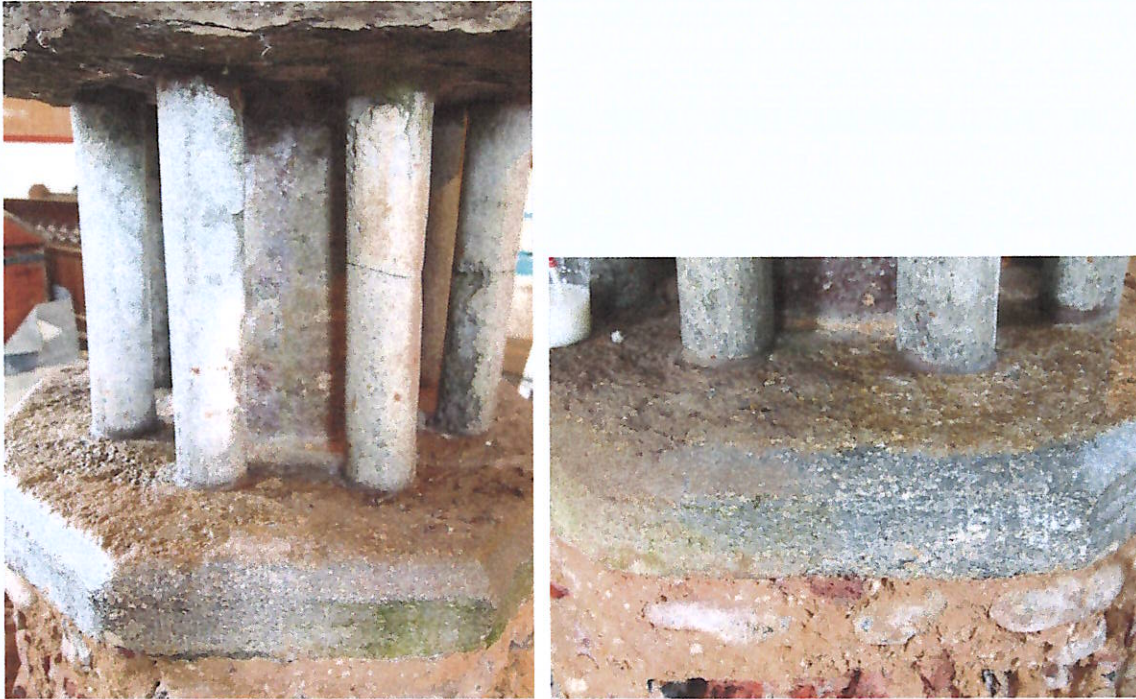
Plates 4 and 5: Cleaning trials of Purbeck marble

The cement on the outer face of the bowl and west step was then carefully removed using hand tools. After the cement was removed cleaning trials took place to find the most suitable cleaning method making sure not to damage the friable surface. After hoovering the surface it was found that cleaning with a V&A solution using a toothbrush and cotton wool was the best method for the majority of the Purbeck with localised cleaning with a Derotor steam cleaner for stubborn biological growth on more stable surfaces, which also served to remove superficial surface salts.

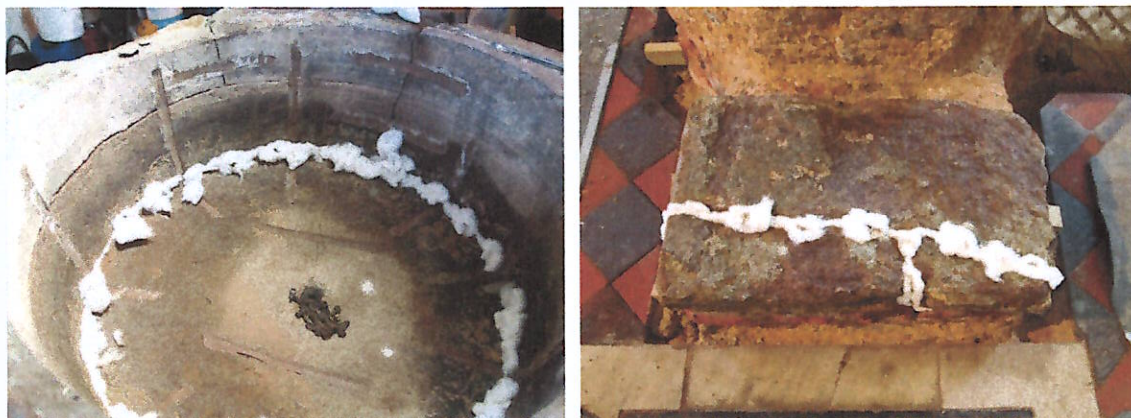
Plates 6 and 7: During grouting of bowl and west step

The fractures were grouted using a lime putty and Trass liquid grout (50:50) injected into the cracks this was then left to dry before any consolidation of the surface took place. The grouting was successful as the grout ran both along the cracks and through from the inner to outer face of the bowl. It was noted that the grout took a long time to dry out and could be another indication of how wet the font is.

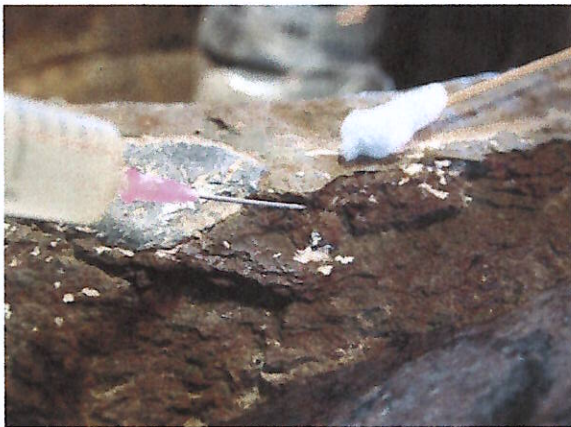
Plate 8: Consolidation with Paraloid B72

Delaminating areas of the surface of the Purbeck marble were then consolidated using a 10% Paraloid B72 acrylic resin in Acetone, this was injected making sure not to leave any surface darkening, this was mostly concentrated on the upper surface of the bowl. Two small fragments that came loose after removing the cement repair were reattached using *General* polyester resin. The old iron fixing for the plug chain that had caused a vertical crack was removed carefully before being filled with lime putty mortar.

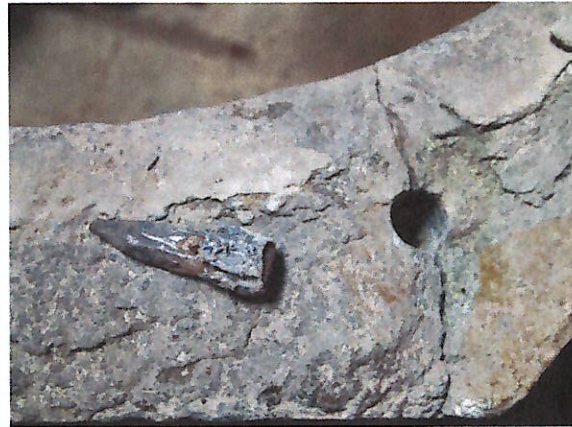
Plate 9: Removal of old iron fixing

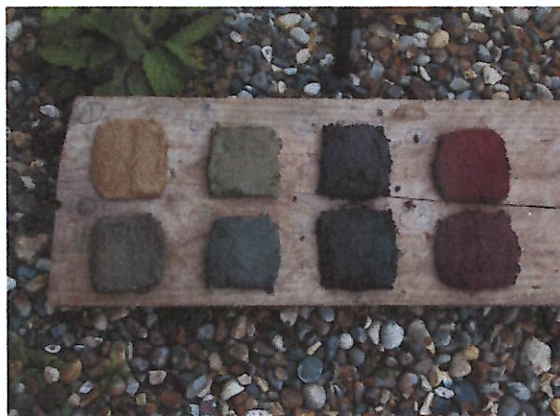
Plate 10: Mortar trials

Colour matched lime putty mortar repair trials were carried out to find the best colour and texture for a repair mix, see below for mix. This was then used to fill the fractures and to stabilize exposed edges of delaminating flakes all over the Purbeck marble of the font.

Lime putty colour matched mortar repair mix (number 2)

- 60ml Singleton Birch Lime putty
- 60ml Sieved Baston plastering sand
- 60ml Bird grit
- 15ml German fawn pigment
- 1.2ml Black pigment

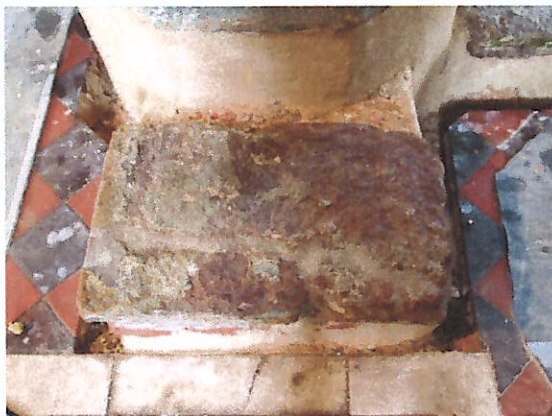
Plate 11: Mortar repair of west step

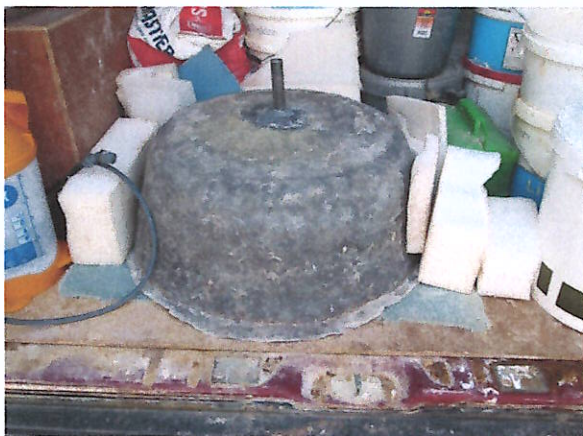
Plate 12: Lead liner with new spigot

Once the conservation works had finished on the bowl the lead bowl liner was bought back to site to be re-installed. A spigot of 100mm x 24mm had been lead welded to the bottom this spigot was then to be fitted to a PEX plastic pipe that would carry the water down through the font and to get past a couple of historic iron cramps a 370mm length of 28mm PEX plastic pipe was attached using a waterproof silicone sealant , to a 22mm PEX plastic pipe, 1277mm in total. The bottom of the pipe had holes drilled to try and prevent clogging with dirt, this was then pushed into the font before spigot of the lead liner was attached to the plastic pipe using waterproof silicone sealant.

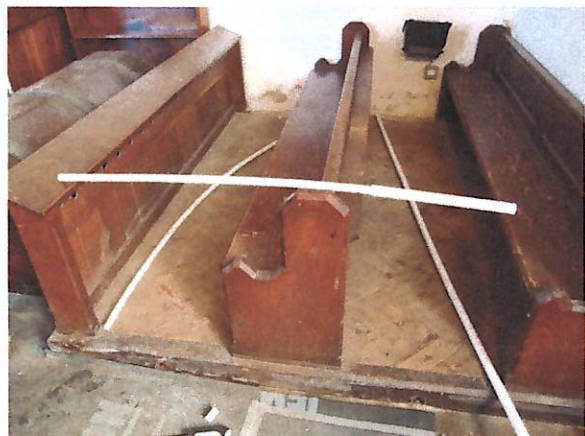
Plate 13: Internal plastic pipe

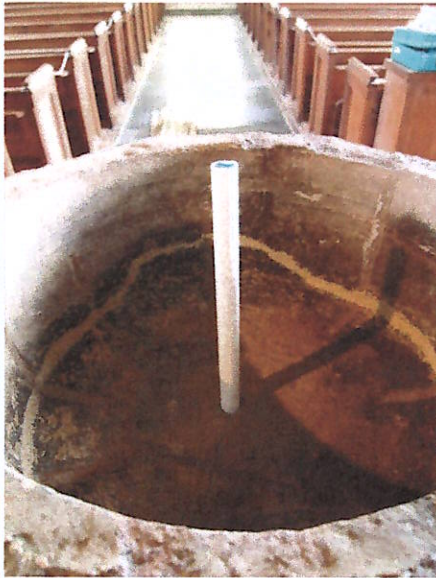
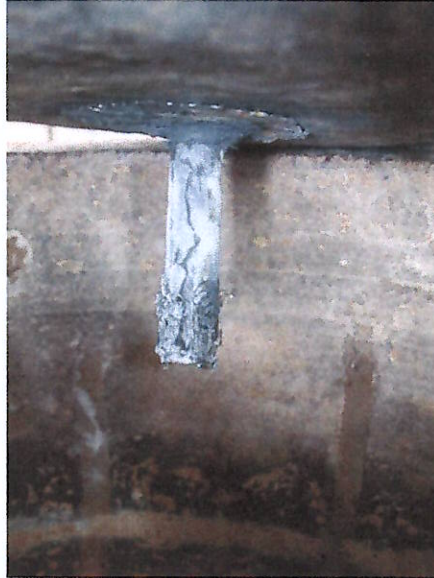
Plate 14: Internal plastic pipe Plate 15: Spigot with silicone sealant

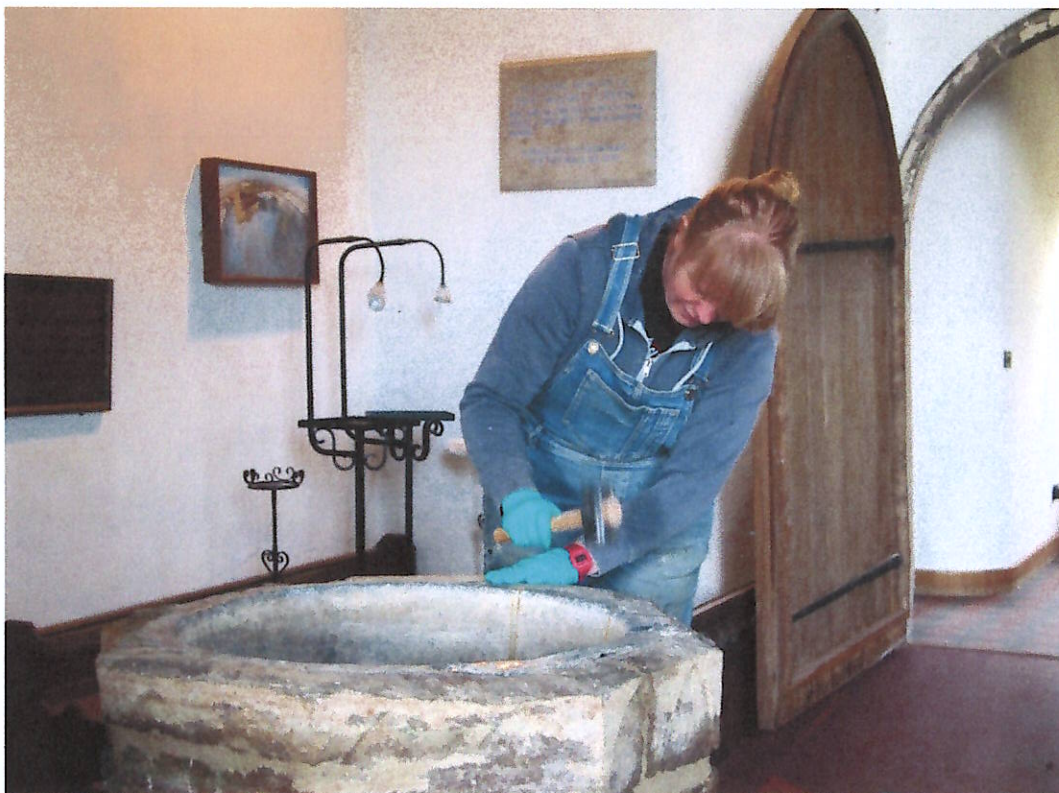
Plate 16: Top of the lead liner being manipulated back into shape

The edge of the lead liner was then gently knocked back with a small rubber mallet to lie flat against the top of the bowl.

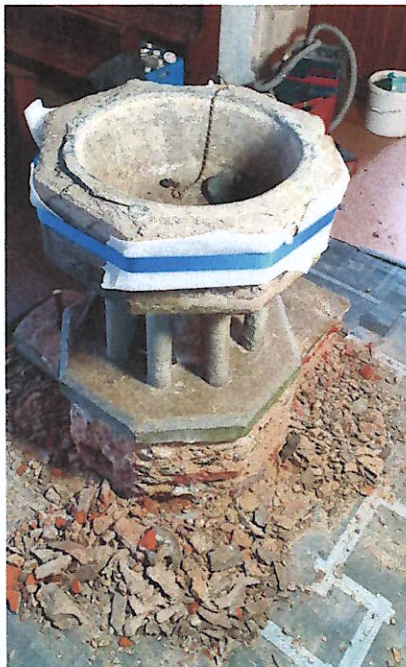
Plate 17: Cement render removal

All of the cement render was carefully removed from the font plinth using hand tools. After the render was removed the south step was found to be loose and the Purbeck stone step was removed to be re-bedded later. A border of 90mm from the plinth was cut into the tiles so to fit the new Ancaster weatherbed stone slips,

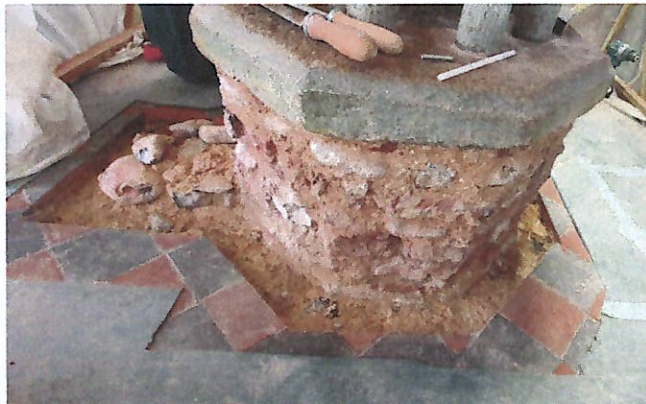
Plate 18: Removal of tiles surrounding plinth

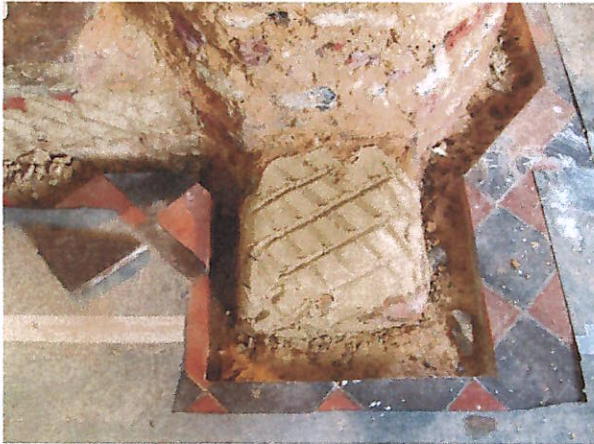
Plate 19: Rebuilding underneath south step

The base of the south stone step was rebuilt with flint as before and the stone step was re-bedded in a 3:1 sand and lime putty mortar - see plates 19 and 20. Any loose tiles around the edge of the cut were re bedded in a 3:1 sand and lime putty mortar, see plates 21 and 22. Ancaster stone slips of 90mm width x 40mm height were then cut and bedded to fill the gap between the plinth and tiled floor in the same mortar to create the breathing zone, see plate 23.

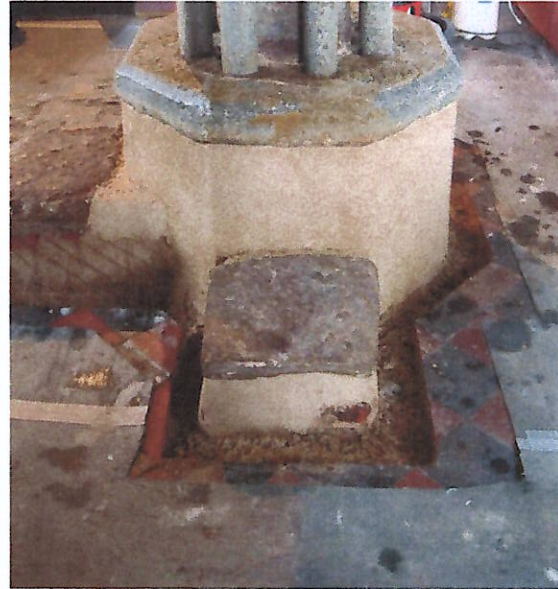
Plate 20: South step refixed

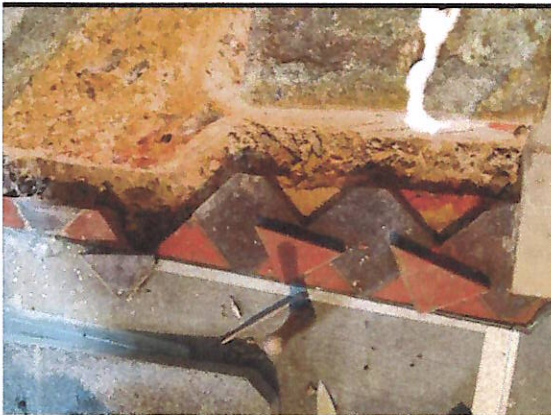
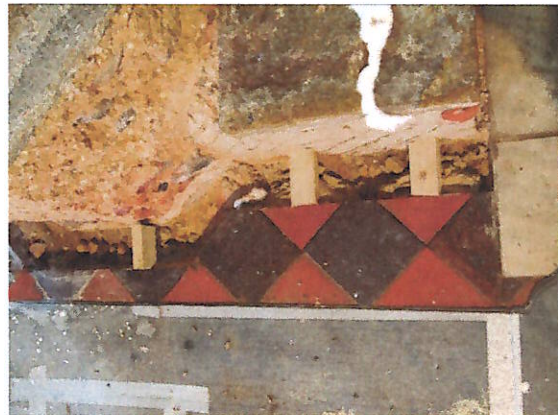
Plates 21 and 22: Re-fixing loose tiles around cut edge

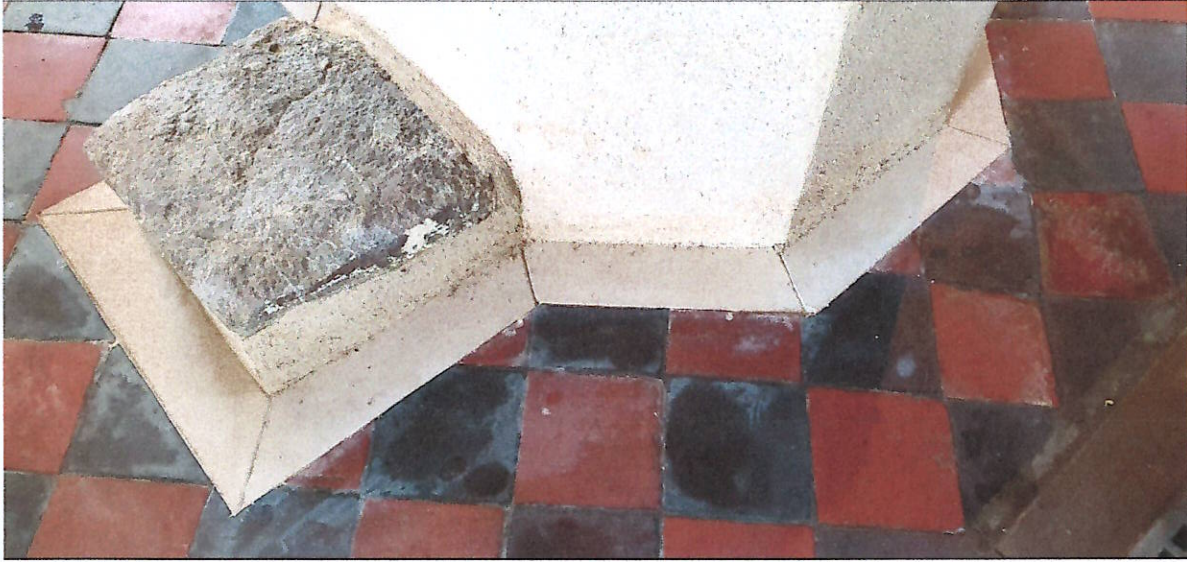
Plate 23: New stone slips installed

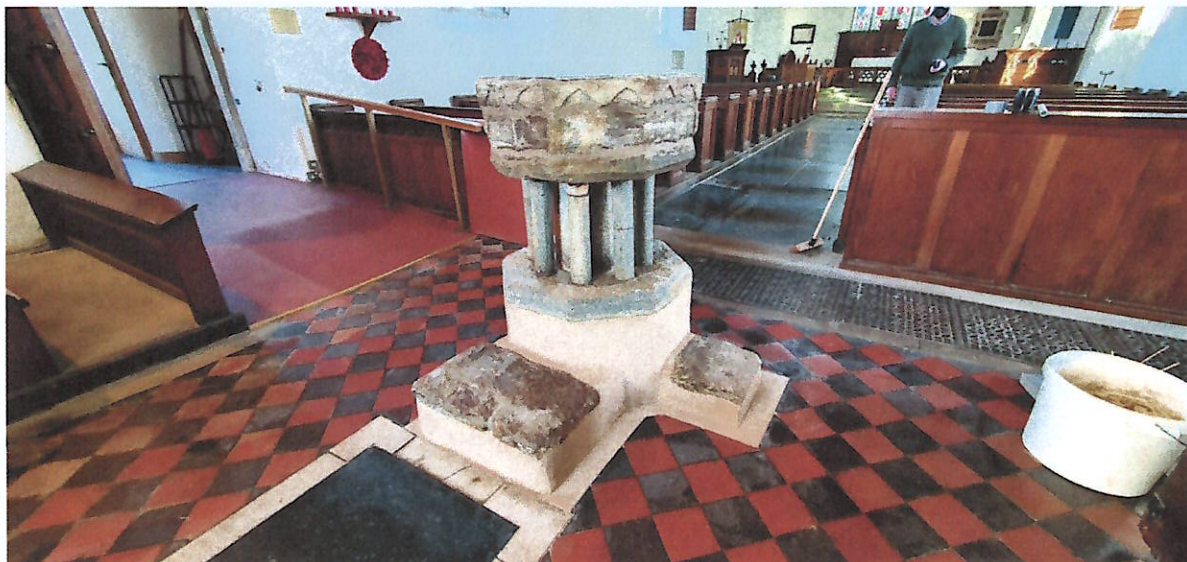
Plate 24: Finished lime putty render

The Plinth was then re rendered in two coat lime putty render, see mix below

Lime plaster render

0.5 part Singleton Birch mature Lime putty

0.5 part St. Aster NHL 2

3 parts Baston plastering sand
