NAVE ROOF ~ CARVED ELEMENTS
ABBAY CHURCH OF ST MARY & ST MELOR
AMESBURY

CONDITION ASSESSMENT
AND
CONSERVATION RECOMMENDATIONS

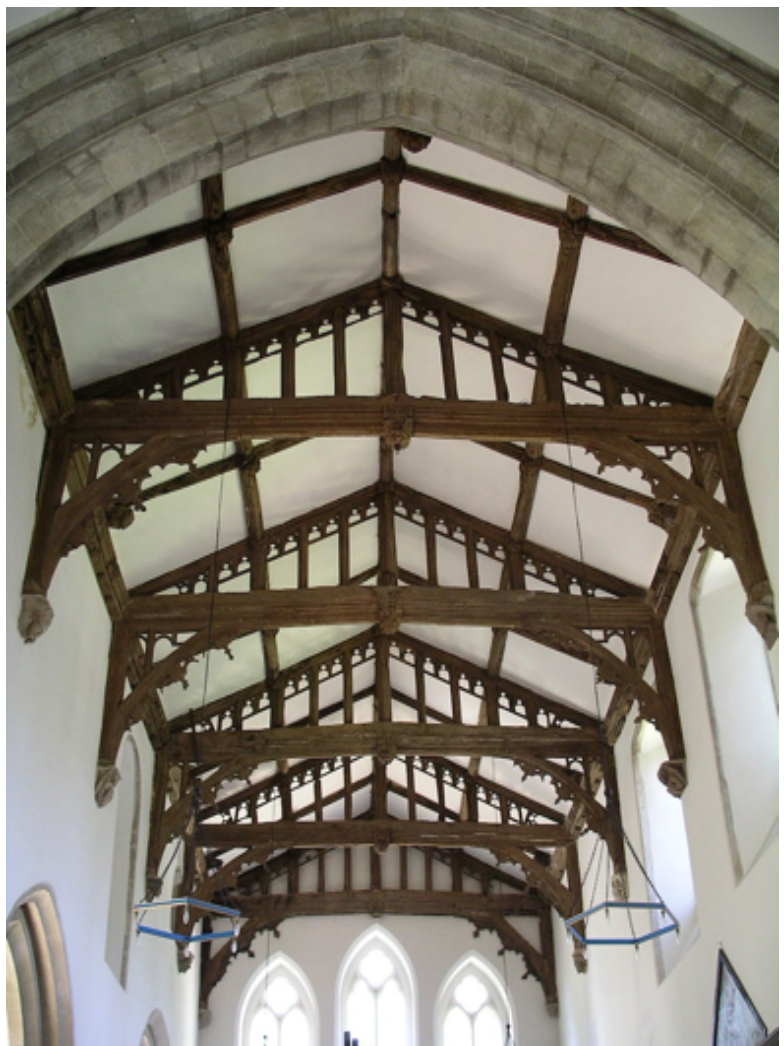
Figure 2 ~ View of nave roof September 2004. (Photo copyright of D & M Ball ~ oodwooc.co.uk)

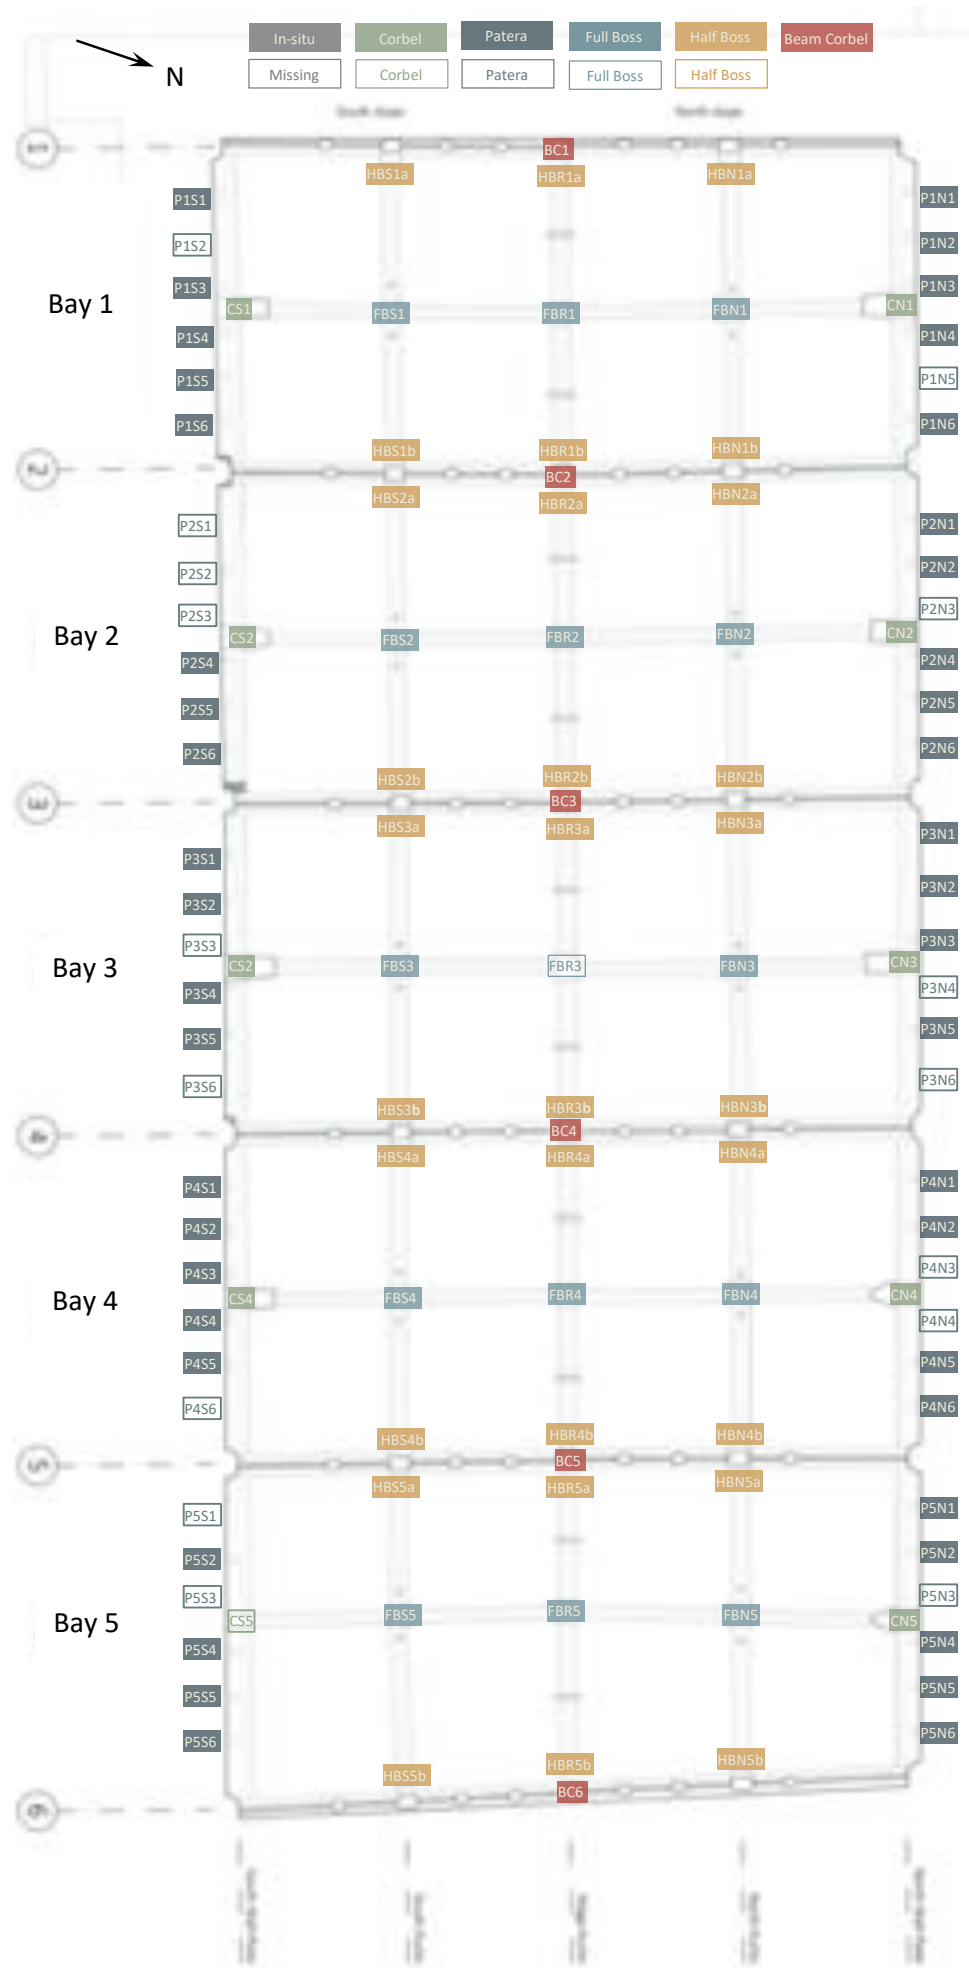
Figure 3 ~ Reflected ceiling plan with references for the decorative carved timber elements. Original plan supplied by Emma Mullen Architect, St Ann's Gate Architects.

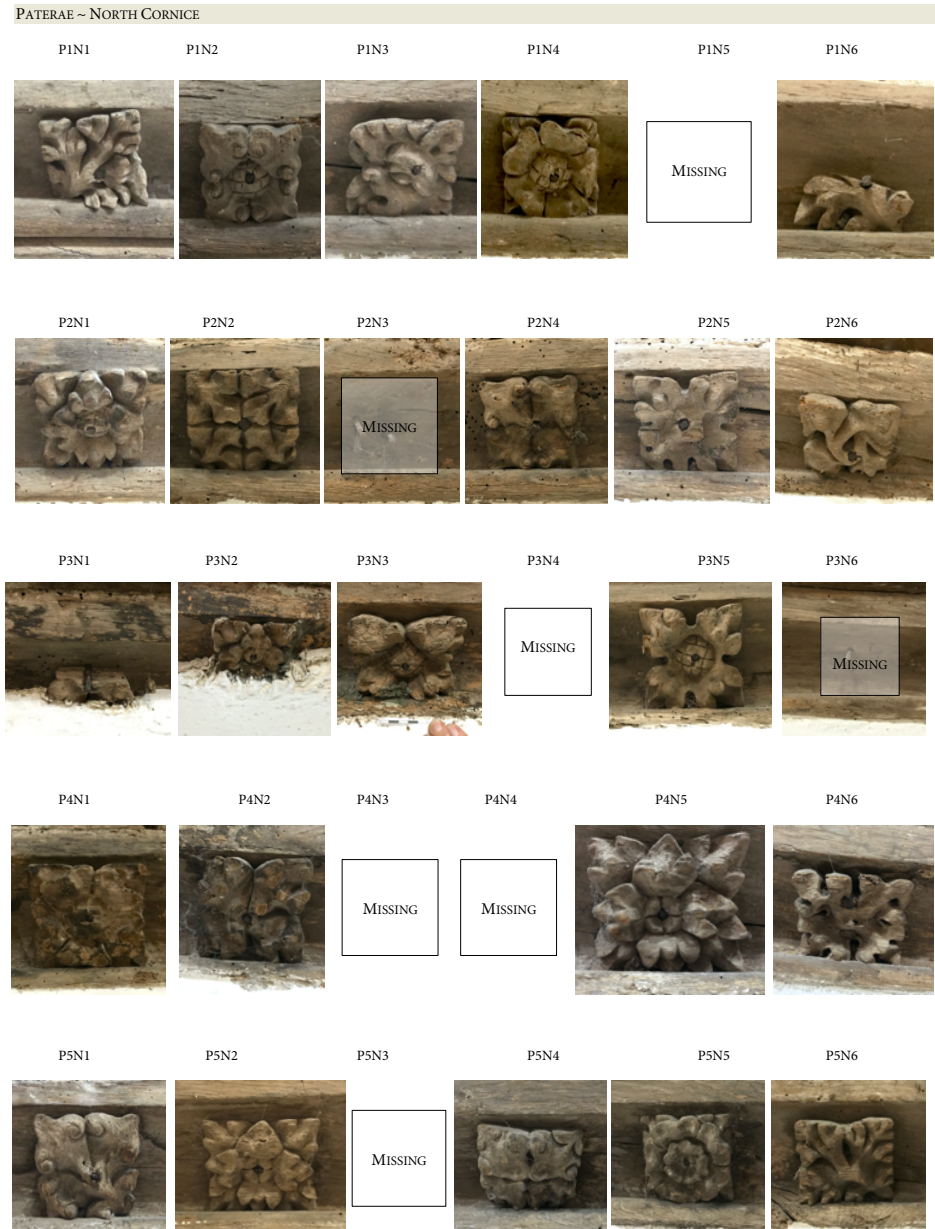
Figure 5 ~ Paterae on the north elevation timber cornice.

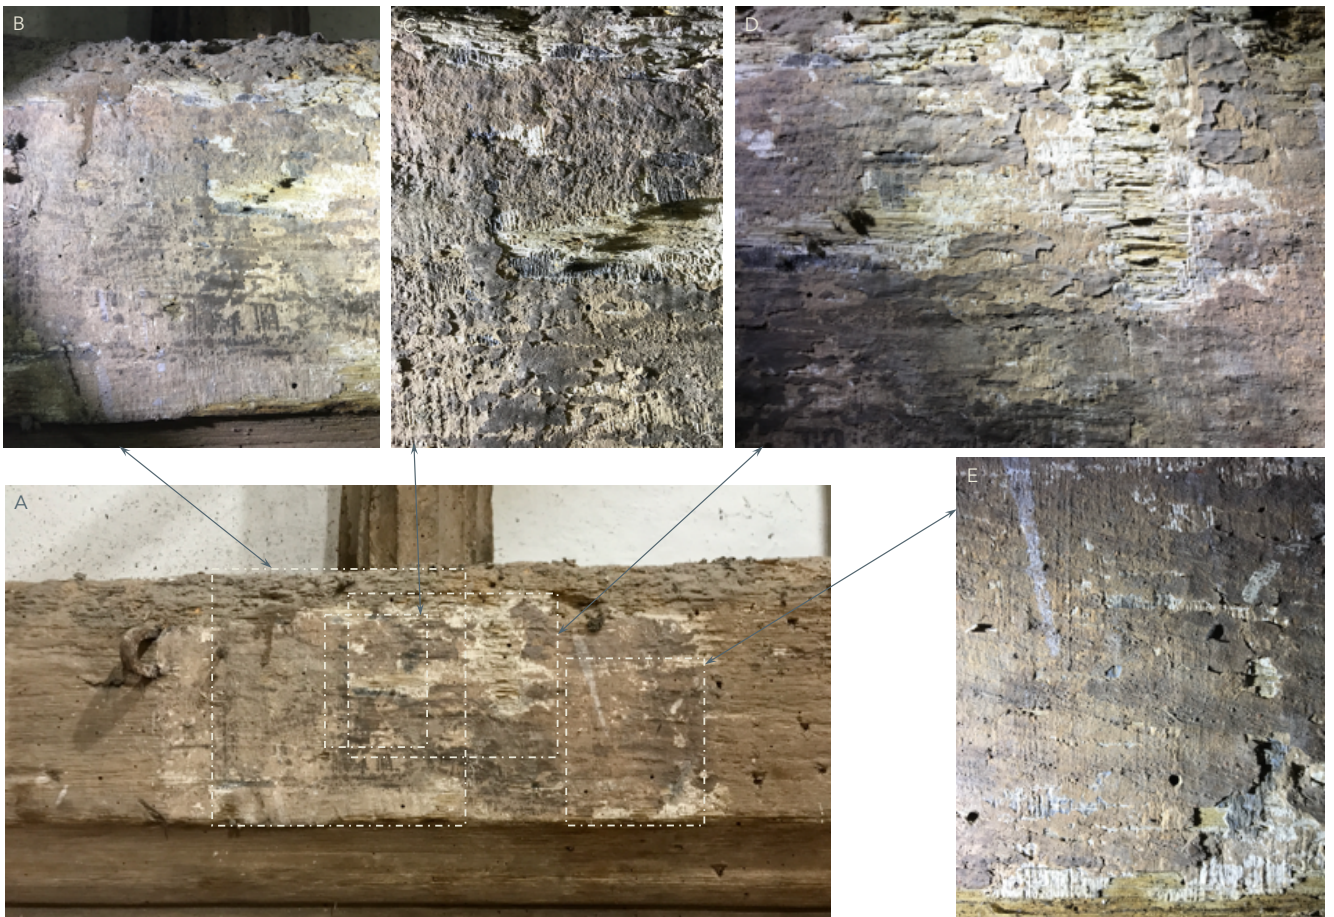
Figure 9 ~ Painted patch on Truss 6. Image A shows the area of the applied paint. Images B, C, D and E were taken in raking light to illustrate the application of the paint and highlight the different layers.

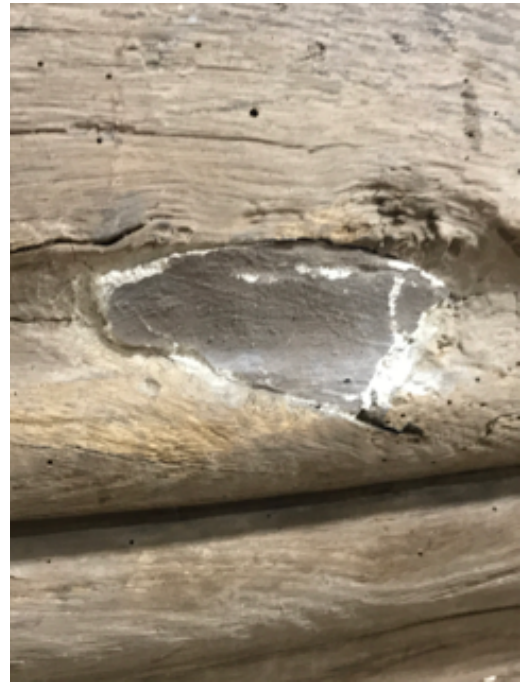
5 CONDITION ASSESSMENT

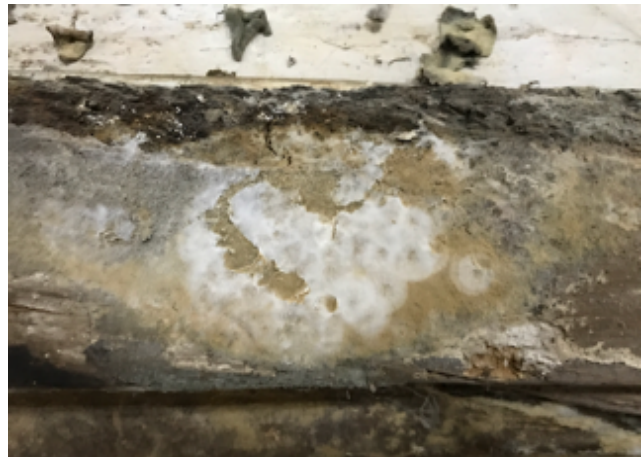
Figure 12 ~ Area of mould over a lime plaster fill on the wallplate. Note the brown paint to the right over the plaster.

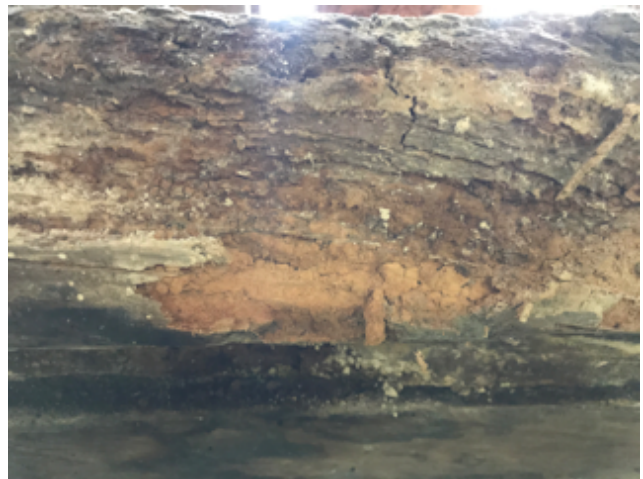
Figure 13 ~ Area of decay caused by prolonged damp. Attempts at past repair are evident, however the damp was on-going. The orange indicates more recent surface loss.

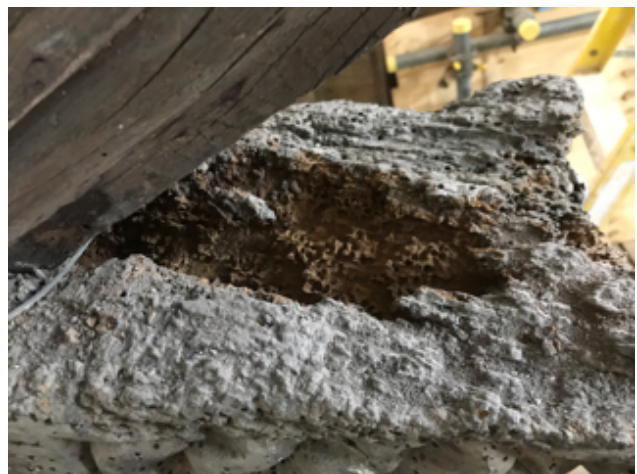
Figure 14 ~ View from above of a corbel illustrating the insect damage of the internal timber.

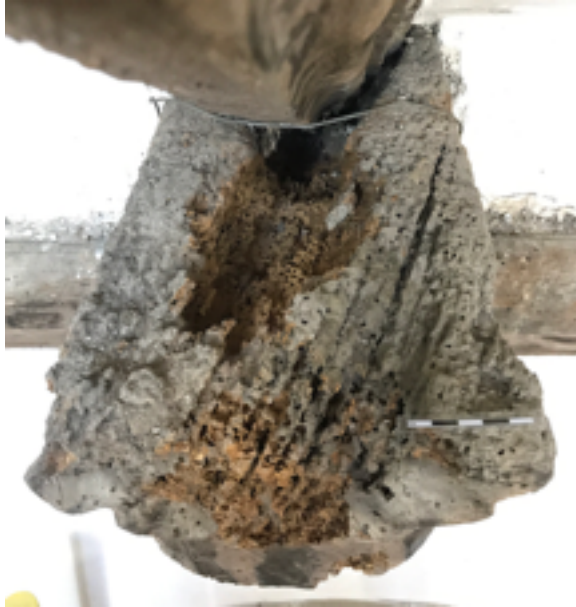
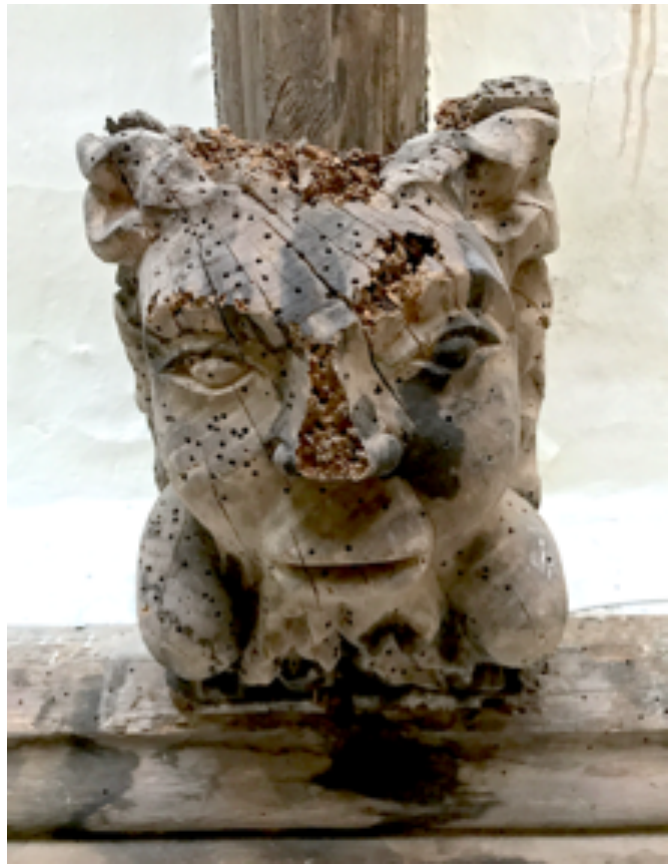
Figure 15 ~ Decay and surface loss to Beam corbel on Truss 1. Note iron fixing securing the base of the corbel to the beam.

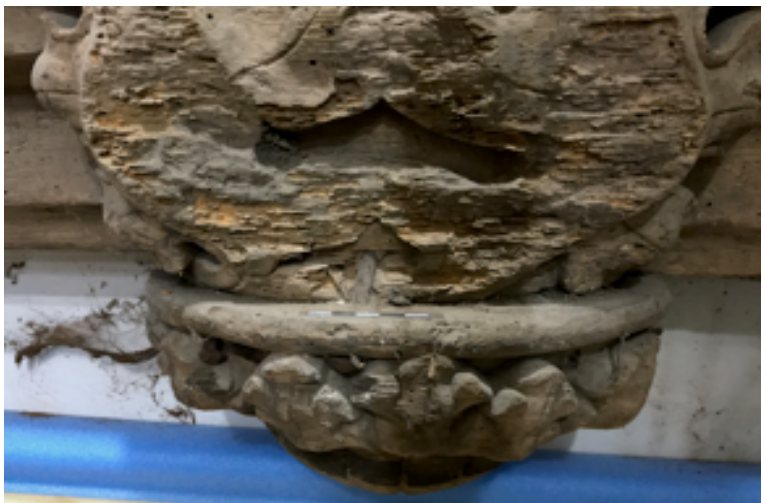
Figure 17 ~ Recent loss of decayed area to corbel CN5 (exposed orange).

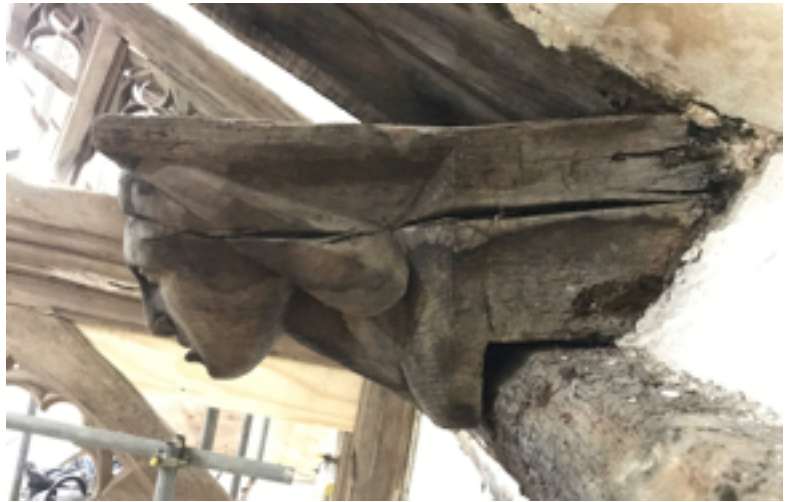
Figure 18 ~ Corbel CS1 illustrating historic shake extending from the rear to the front face. The corbel has suffered from damp and is disfigured with dark water stains but is not deemed unstable

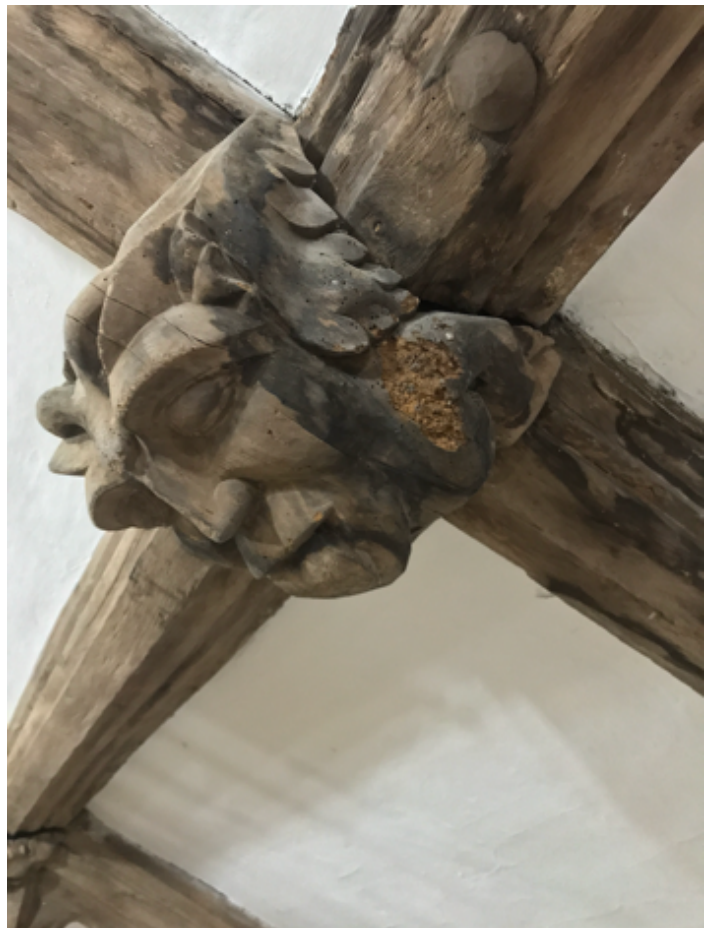
Figure 19 ~ Boss FBS4 illustrating unstable and friable side. Damage caused by a combination of water ingress and insect infestation.

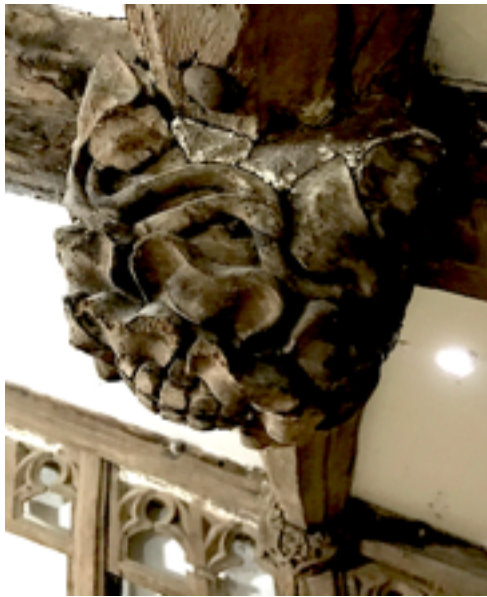
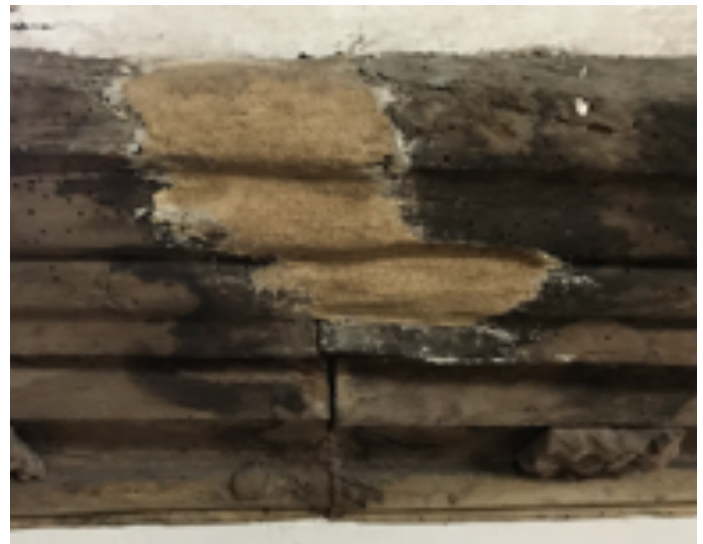
Figure 21 ~ Boss FBN1 with soft plaster fill applied to void between boss and purlin. The fill is cracked and loose.

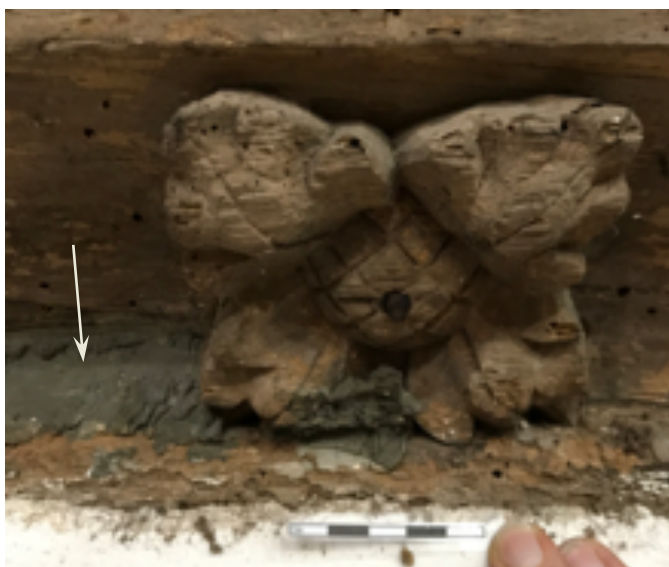
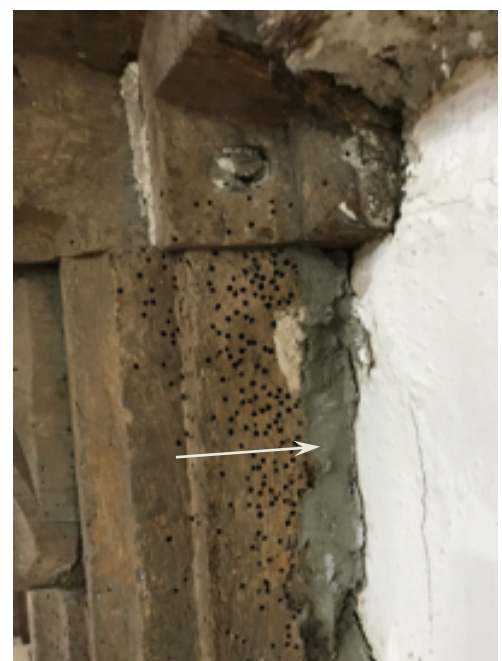
Figure 22 ~ Cementitious fills adjacent to the wallpost and paterae in Bay 3.

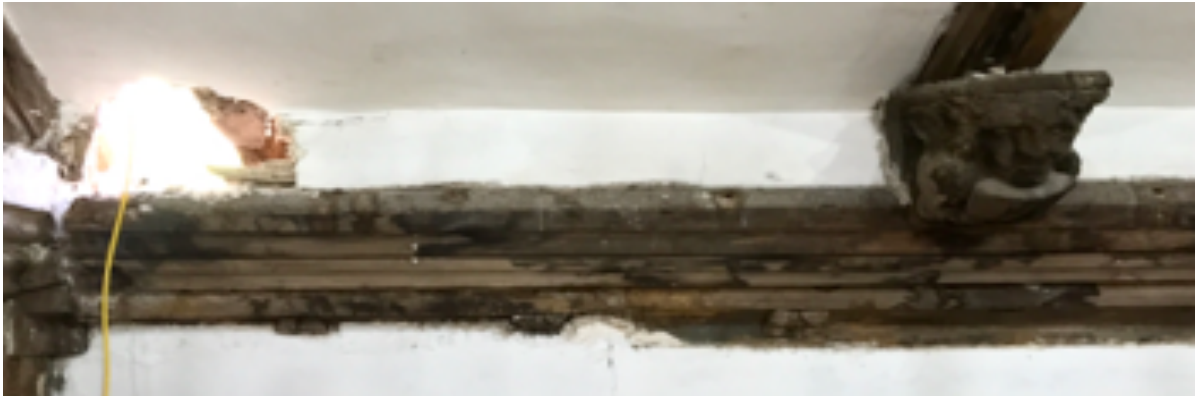
Figure 23 ~ Area of Bay 3 on the north elevation. Image illustrates the crude plaster and putty repair over the lower edge of the timber cornice, breaking up the original line of the moulding and partially concealing the paterae. It is likely that some of the timber has decayed and is missing, however much is evident beneath the repair.

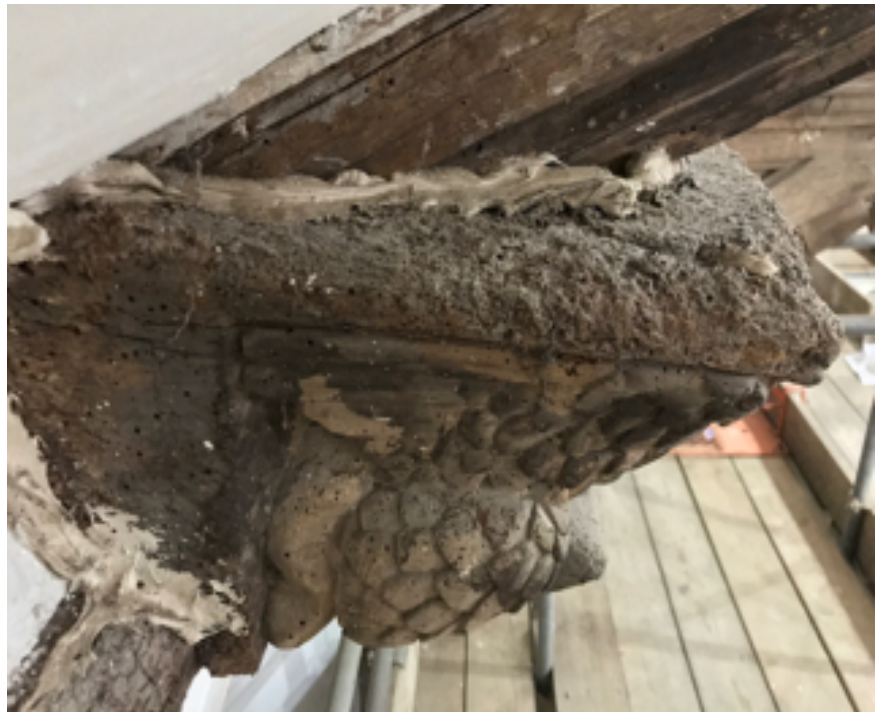
Figure 24 ~ Corbel CN3 with extensive and crudely applied filler around the perimeter of the decayed timber.

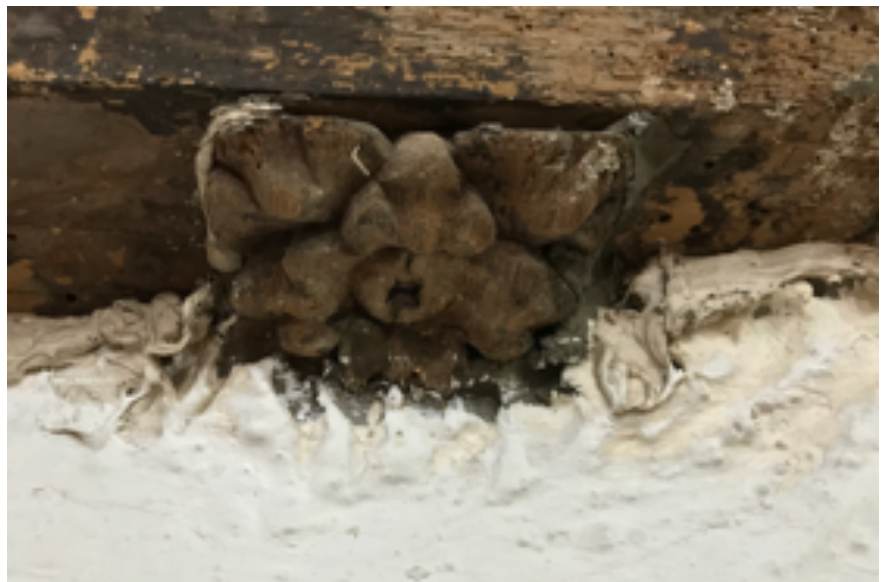
Figure 25 ~ Detail of patera P3N2 which is partially concealed by poorly applied repair.

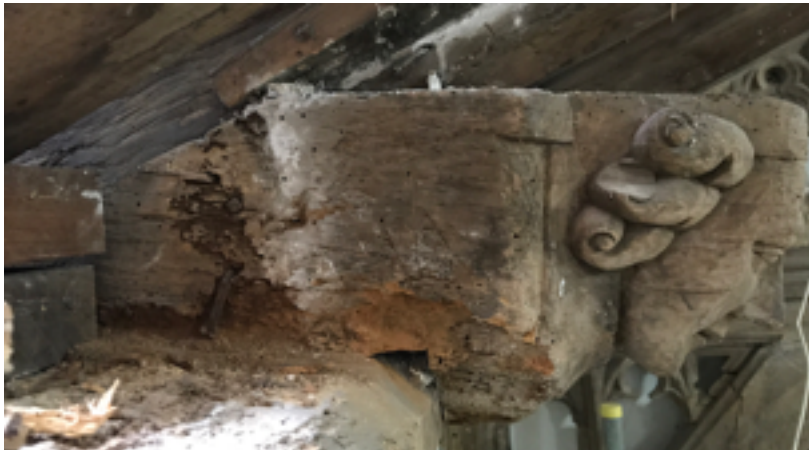
Figure 26 ~ Corbel CN5 illustrating timber decay and loss to rear. Note corroding iron fixing into wallplate.

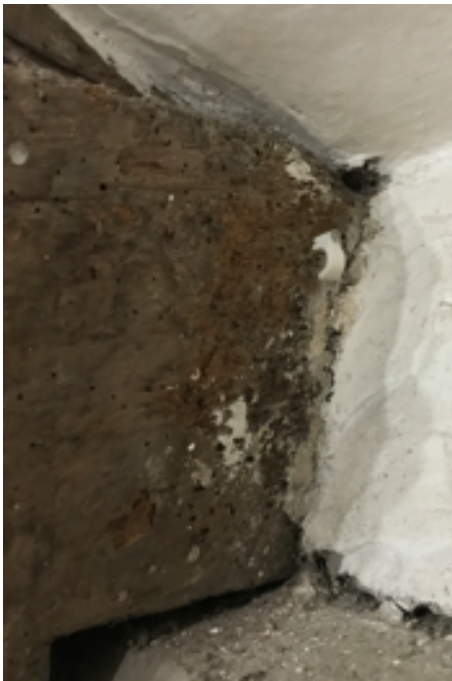
Figure 29 ~ Modern fixing in rear of corbel CN5.

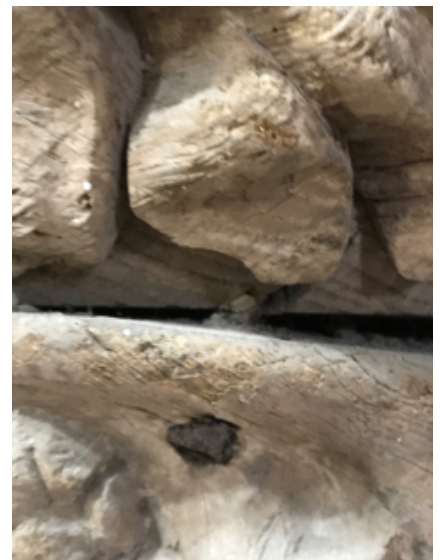
5.6 SOILING & STAINING

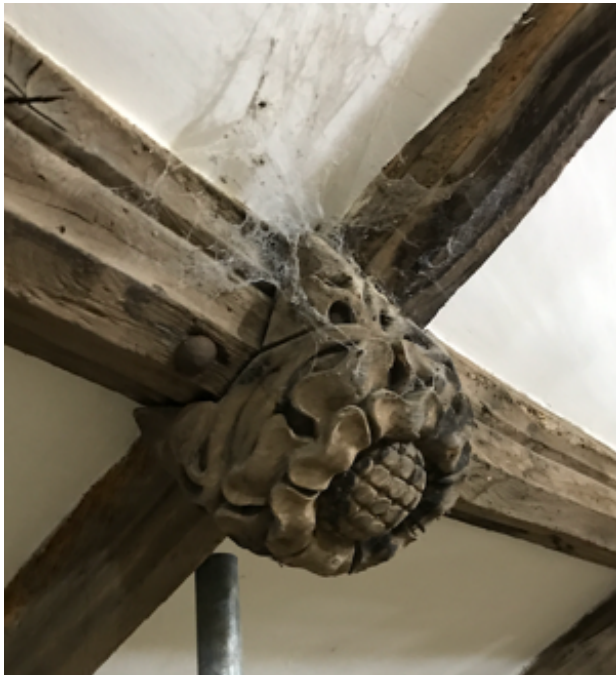
Figure 30 ~ Boss with dust and cobwebs.

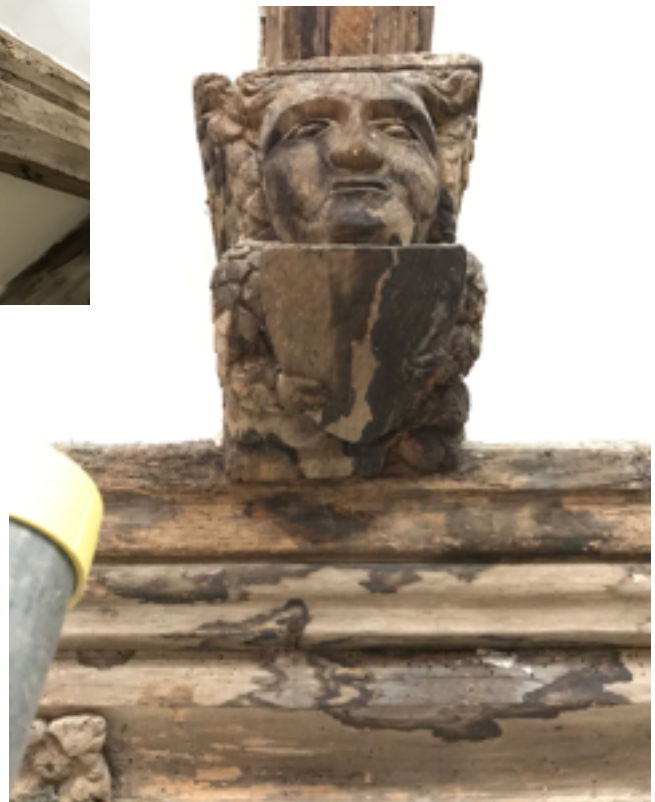
Figure 31 ~ Dark water staining to corbel CN3 and surrounding timbers.

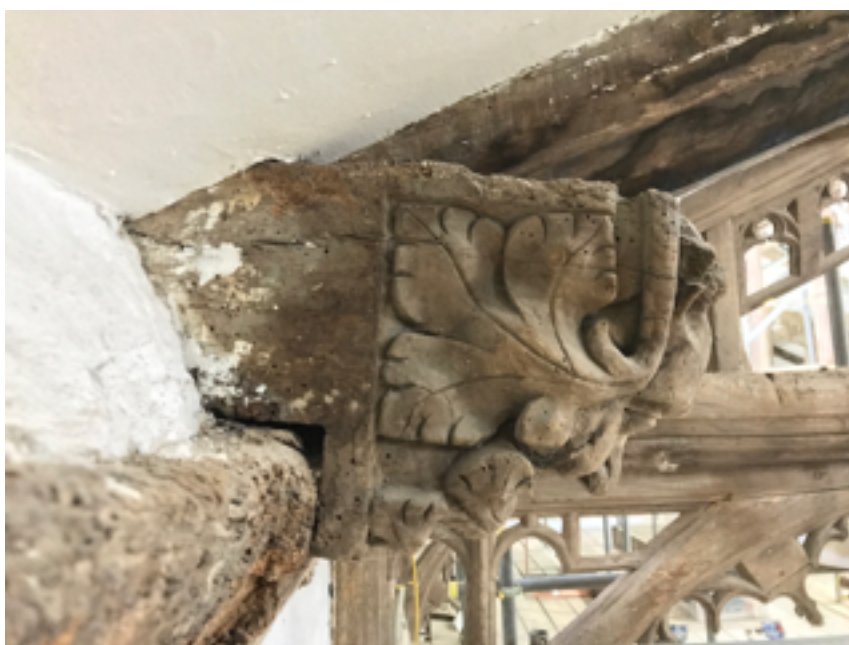
Splashes of white paint spills from later wall and ceiling decoration are apparent on the corbels in particular.

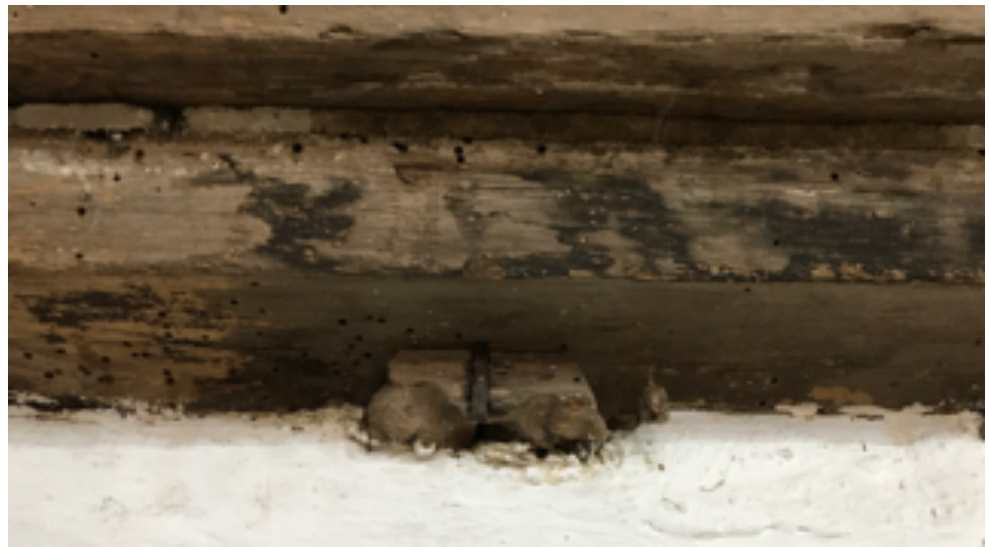
Figure 33 ~ Detail of Bay 3 north elevation and paterae P3N1 which is half missing.

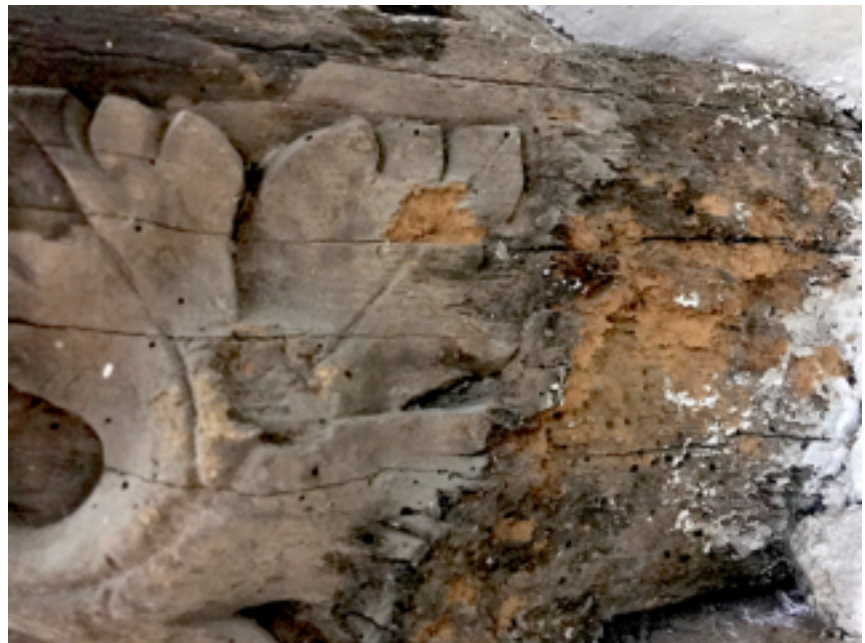
Figure 34 ~ Detail of corbel CN2 illustrating localised surface loss and ongoing decay. The edges of the losses are extremely vulnerable.

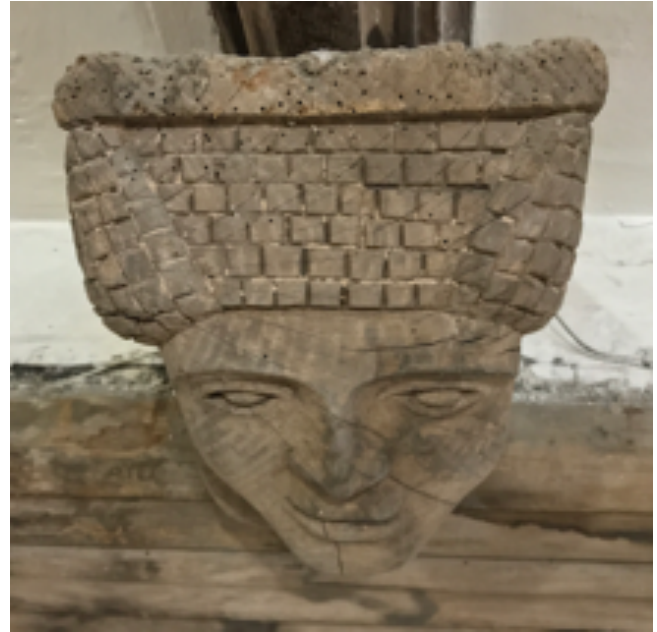
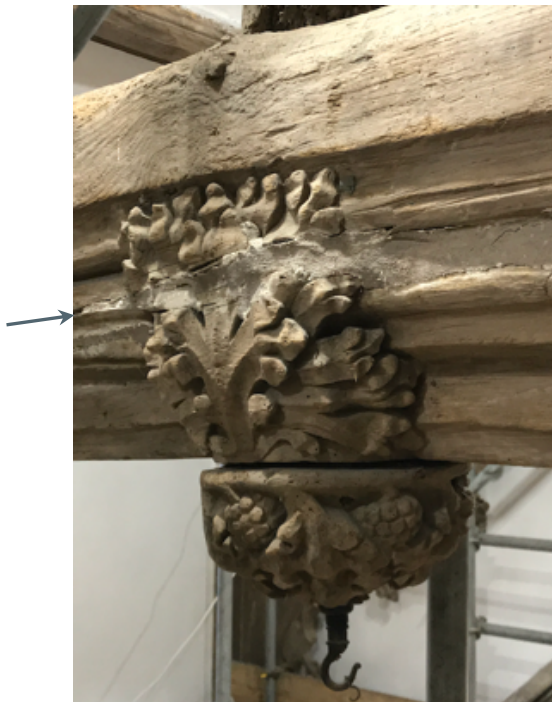
Figure 36 ~ Tie-beam corbel (BC5) with large plaster fill within shake as indicated. The fill is overpainted with a similar brown paint as seen across many of the trusses, repairs and the painted 'panel' discussed in section 4.6.

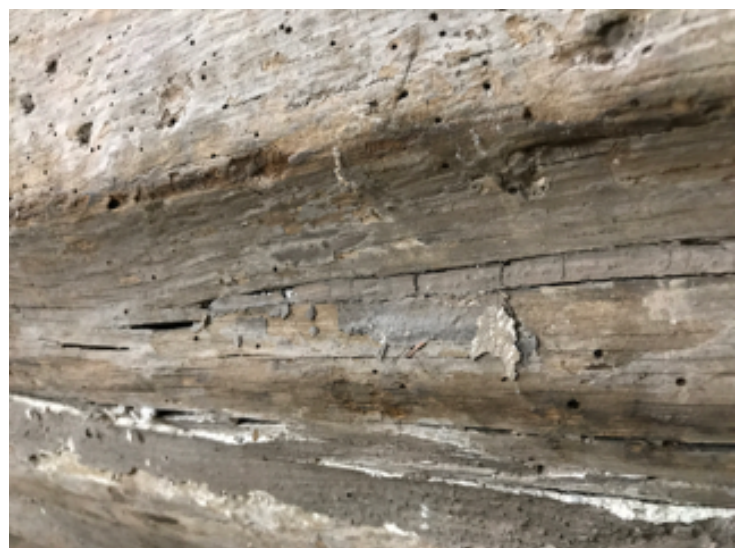
Figure 37 ~ Brown paint over truss and plaster repair within the shakes of the truss.
