THE CHURCH OF ST JOHN THE BAPTIST, ROYSTON

CONSERVATION TREATMENT OF THE WALL PAINTINGS

JULY 2021

Report No: RTJB01.2 **Date:** 20th July 2021

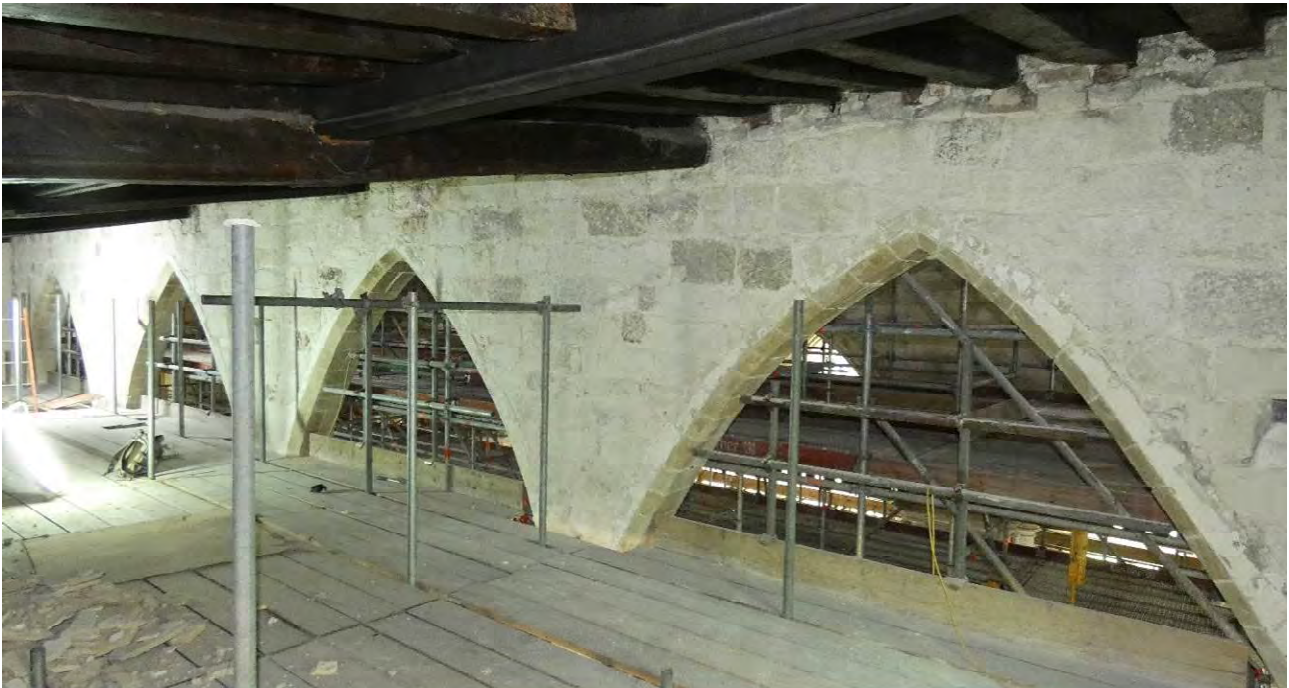
Figure 6. View facing east along the upper part of the wall showing the exposed stonework of the arcade with the render removed.

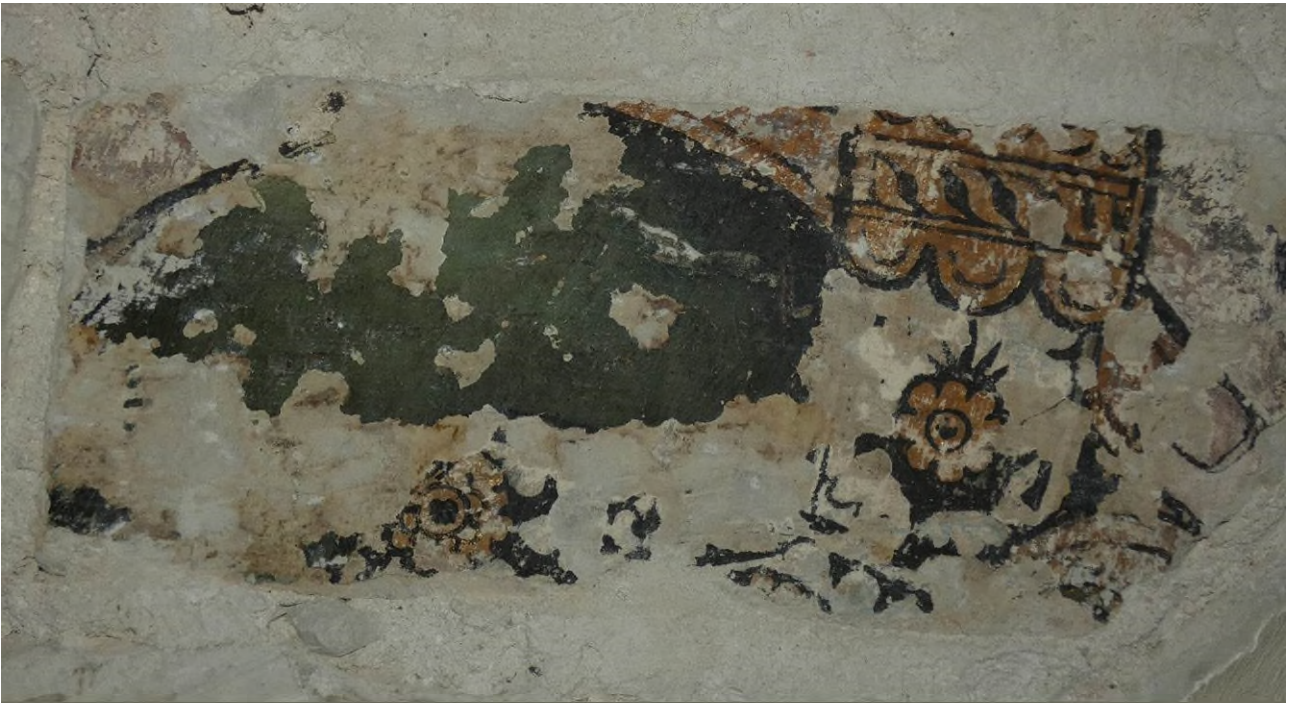
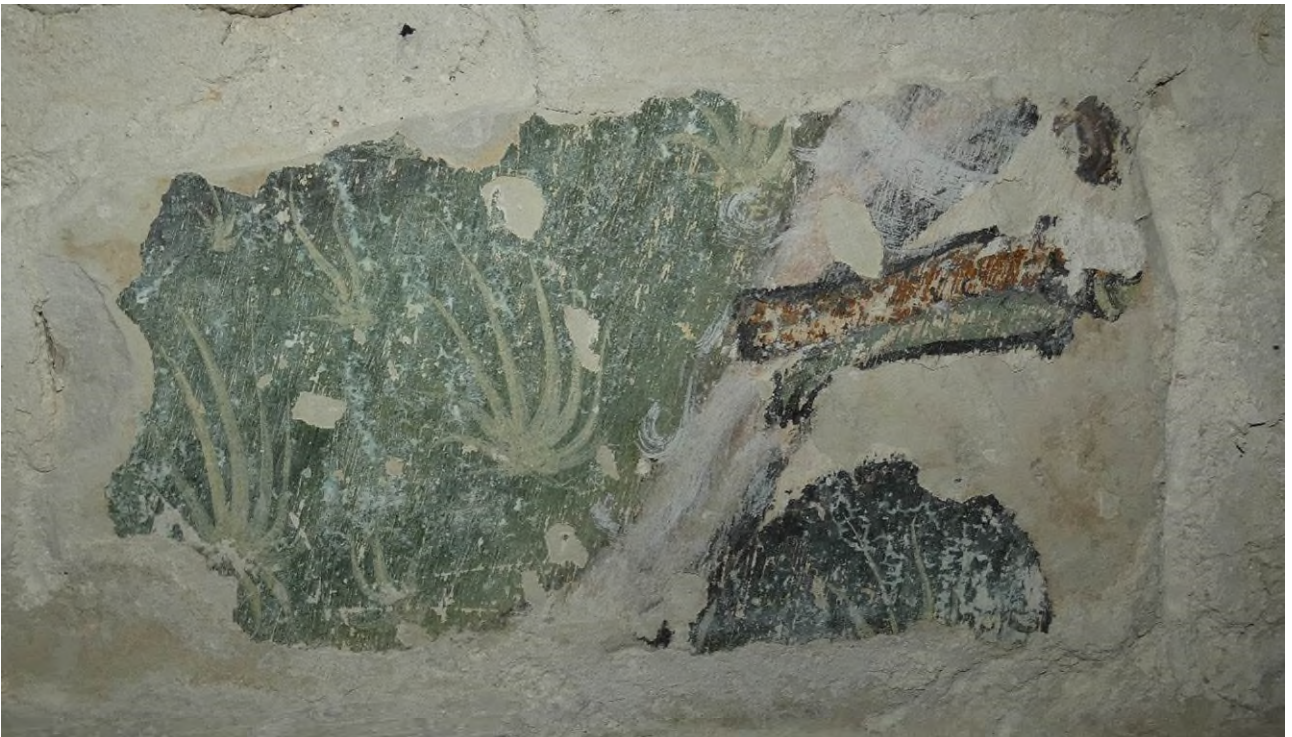
Figures 7 & 8. Details of two of the sections of painting between arcades 2 and 3 showing the foliate background and the elaborate decoration, which is thought to be part of either architectural or fabric detail from a larger painting.

The painting is clearly limited to specific blocks of clunch, indicating that these had been reused from an area once covered by a large scale scheme of decoration. In general, the cohesion of the clunch is relatively sound, with most damage associated with historic and recent impact. The paint layer is medium rich and also retains a good level of cohesion. However, there is considerable delamination between the painted ground and substrate, resulting in delamination and flaking. Some of this appears to be old (i.e. before the render was removed), while some is more recent and is likely to have taken place during the recent uncovering. Some detail of the painting is obscured by limewash residues remaining on the surface of the paint layer.

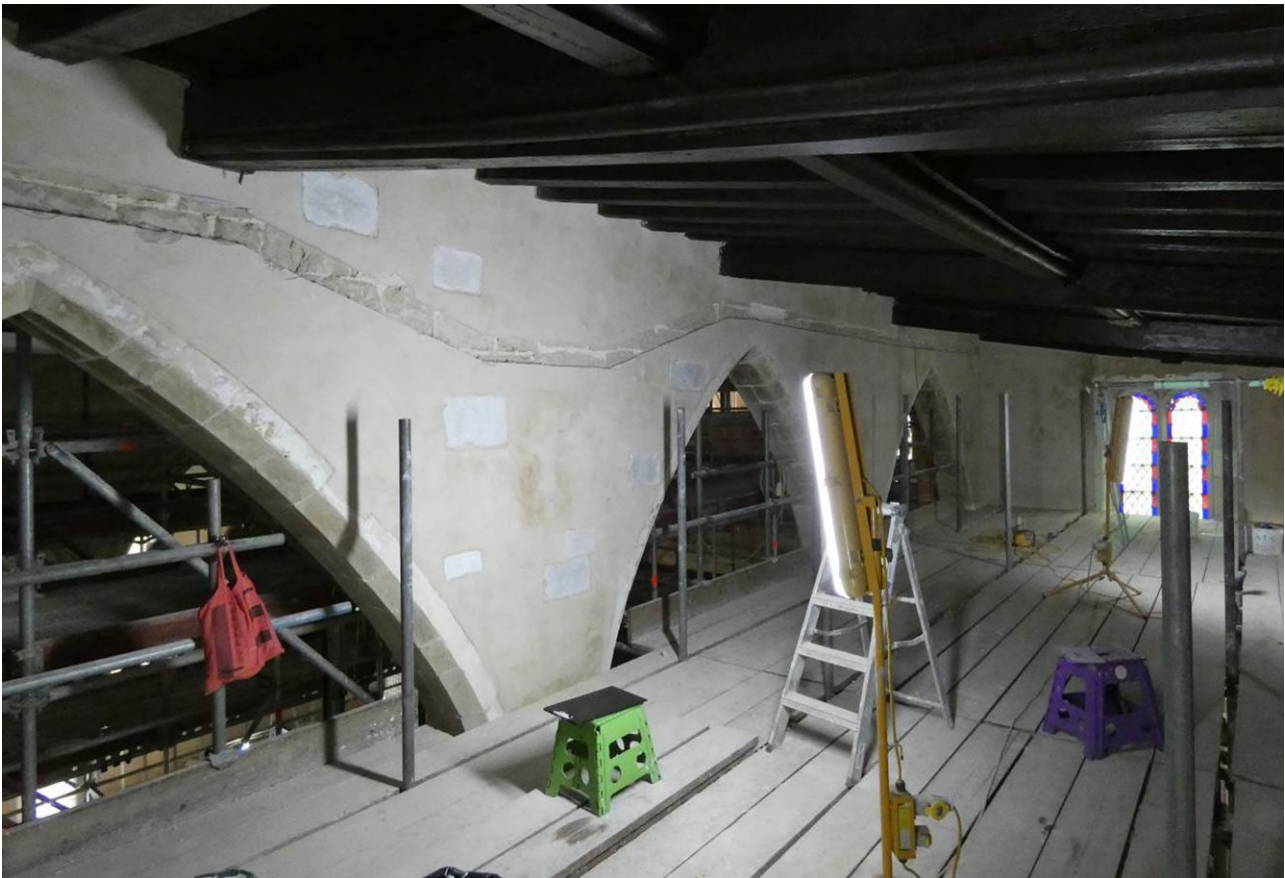
Figure 9. View of the south wall towards west side, with the painted fragments following treatment, ready for the final plaster layer.

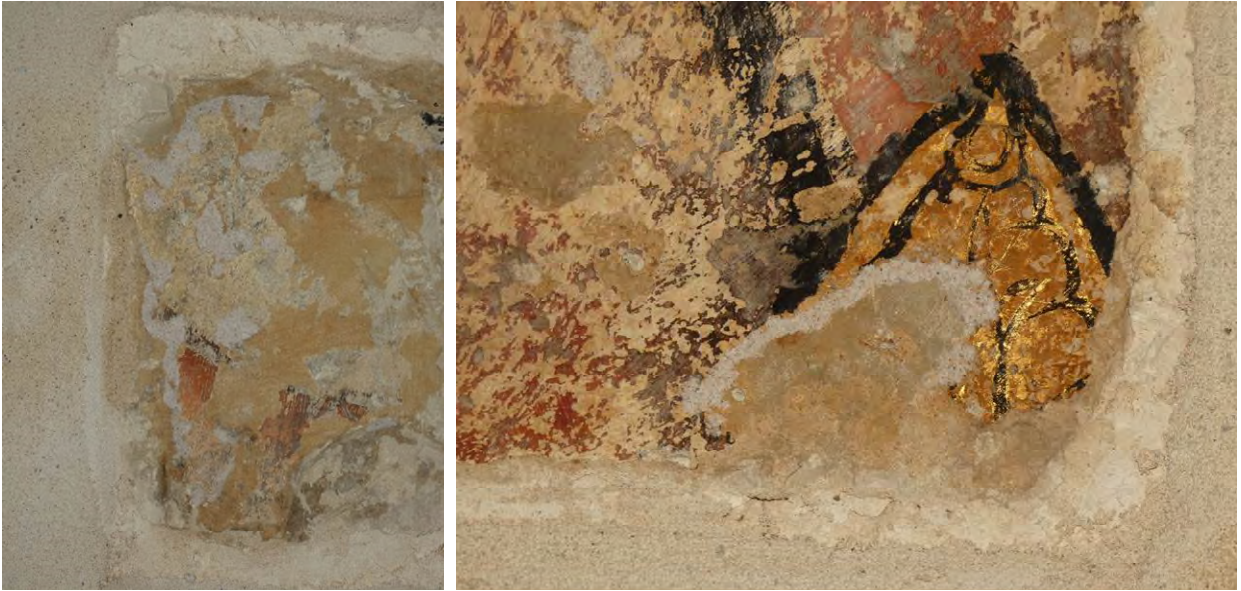
Figures 10 & 11. Details of two of the painting fragments which have been consolidated with Plextol B500 and had edge repairs securing the vulnerable edges.

The readhesion of the paint layer was carried out with the conservation adhesive Plextol B500² in a concentration of 10%, after pre-wetting with IMS and water to reduce surface tension.

Areas where the thick limewash ground was found to form vulnerable edges and edge repairs for the stabilisation of the support were undertaken with fine lime plaster comprised of 1:3 lime putty and fine silver sand.

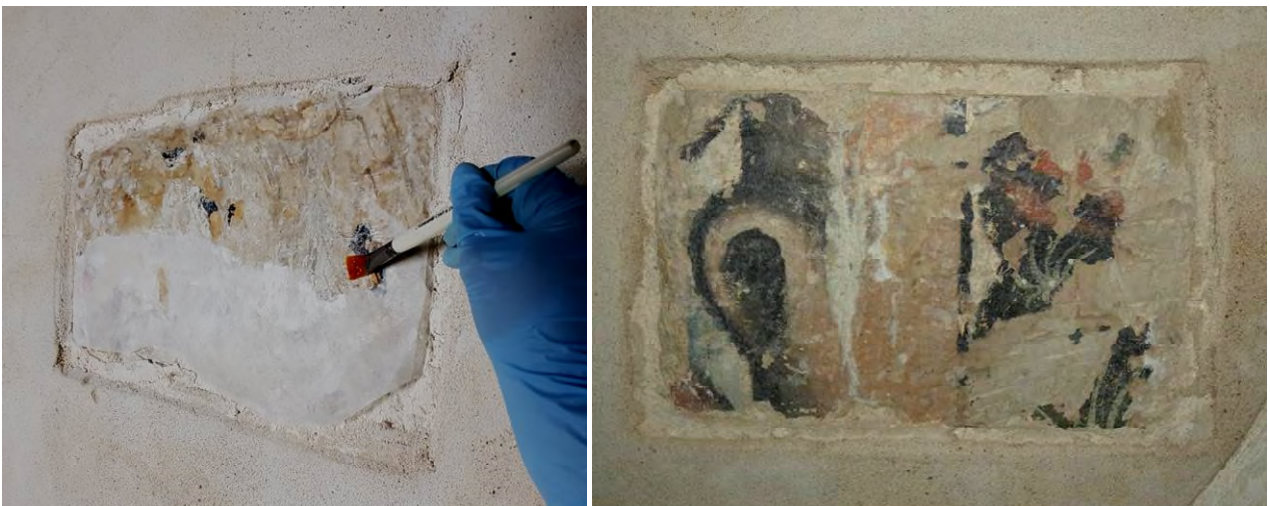
Figures 12 & 13. Details of two of the painting fragments during and after the application of lens tissue.

A protective layer of Japanese tissue was applied with an adhesive of 5% Tylose. The tissue was cut in order to conform as closely as possible to the topography and limits of the clunch blocks. Areas of rougher surface texture resulting from the residual plaster layer required an additional application of a weak solution of the acrylic resin Paraloid B72.

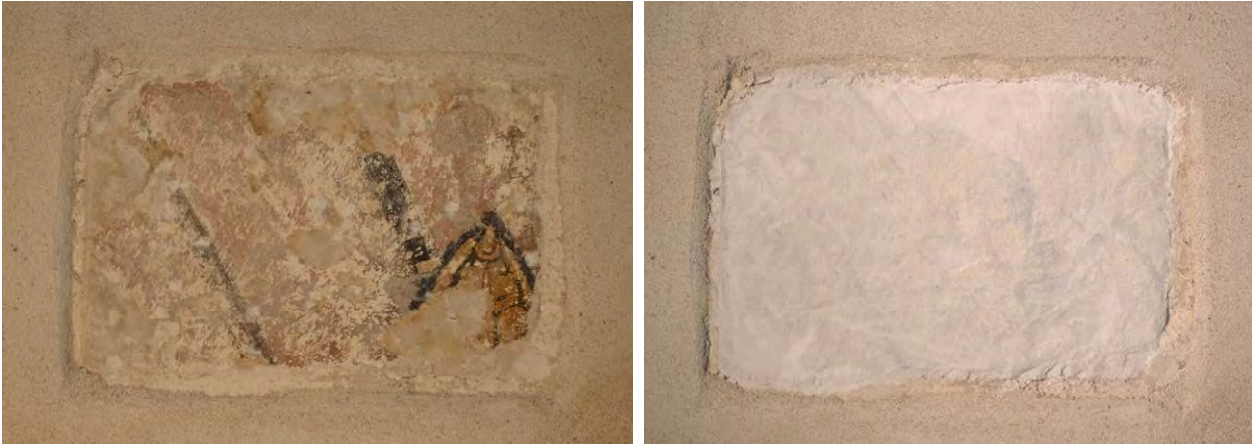
Figures 14 & 15. Painting fragment before and after application of limewash over lens tissue.

Finally, a layer of limewash composed of 1:6 lime putty and Fordacal 40 (marble dust) was applied to prepare the surface for the final plaster layer, which is to be undertaken by the main contractor.
