Final Conservation Report
for the Yale Monument

St Oswald's Church – Oswestry - Shropshire

Church of St Oswald King & Martyr - Oswestry – The Diocese of Lichfield

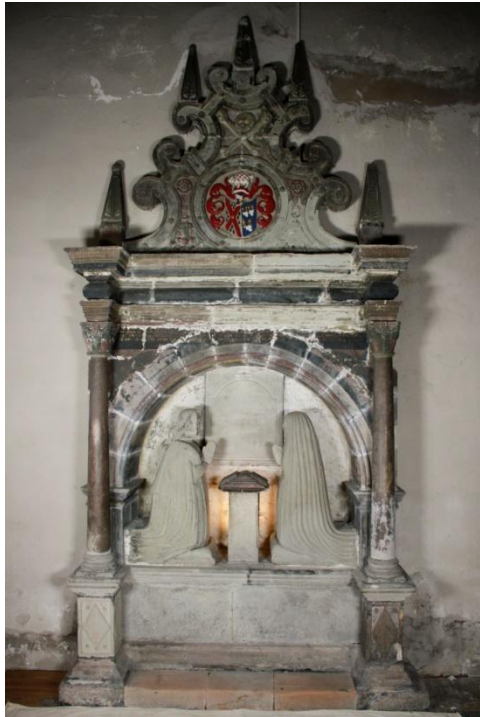
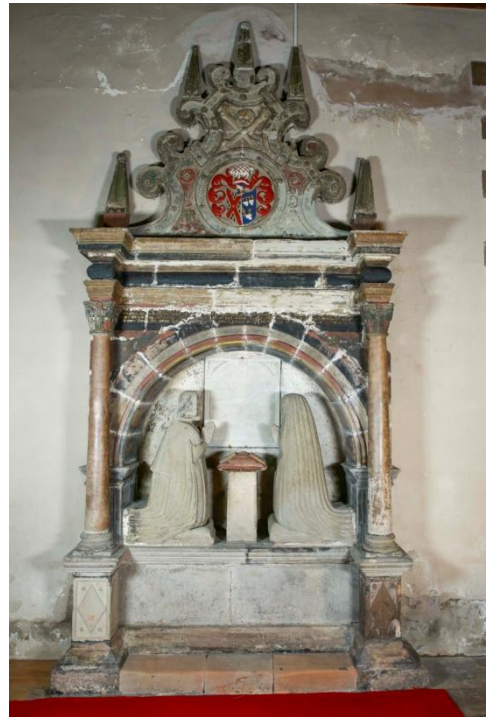
The Yale monument before and after all treatments (on the right). Note how the original intention of the designer is more apparent after cleaning, with the different warm colours more visible again, from ground-level. The images were taken with studio lights using daylight simulation tubes. All images have been colour-balanced to white.

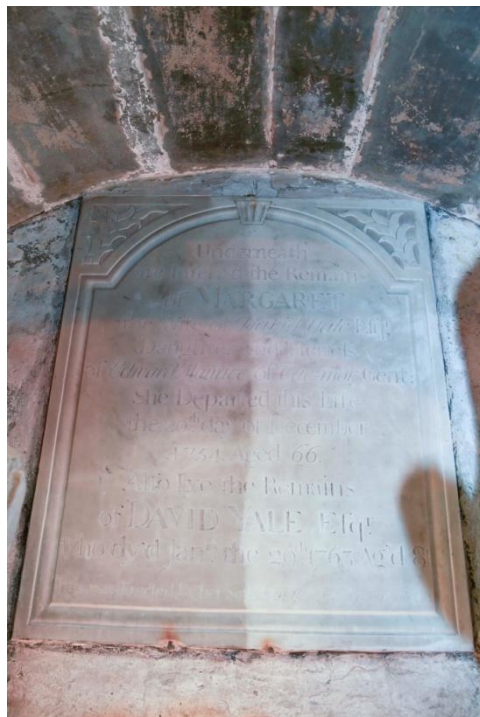
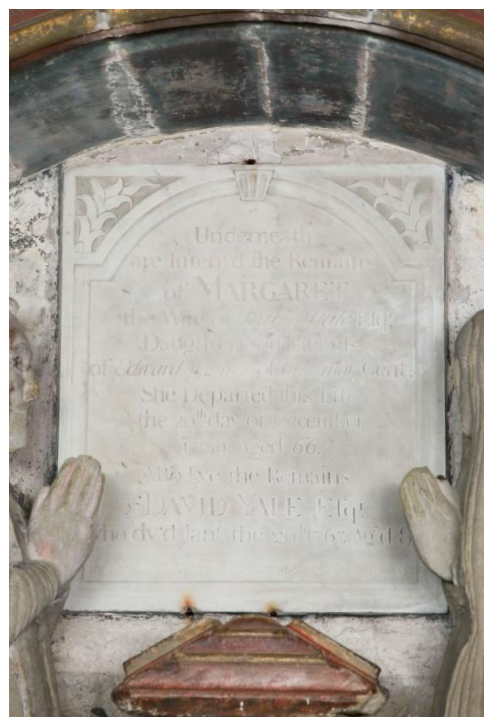
- 4.8 The later white marble inscription panel in the rear of the recess was found to be in a sound condition, with fragmentary remains of both black paint and preparation layers for gilding within the lightly incised lettering. There was no thought of re-applying these materials, knowing the inscription would be far more legible even after light-cleaning. The marble which was in a sound condition albeit having suffered chromatic alteration, that is loss of original surface polish, which there would have been at time of manufacture. Chromatic alteration in a sheltered location such as the recess indicates the applied finish (polish) has been compromised by prolonged condensation acting on the surface, which was/is being exacerbated by the warm heat source (bare bulb) providing daily heating and cooling cycles. The extent of alteration did not warrant application of a modern, protective conservation-grade wax (which still requires removal and re-application on a periodic basis) which is safe to use on a sound, crystalline surface such as marble. In chronically damp conditions vertical run-marks from condensation can be seen etched into the surface of previously flat, polished marble.

The later, lightly-incised, marble dedication panel in the recess, during and after cleaning. The marble responded well to a solvent mixture. It could have been taken much further and re-polished, but that approach is inappropriate, choosing instead a light-general clean. Note the top of the lectern between the two kneeling figures is completely cleaned in this image, revealing the crude marbling to the painted, carved sandstone.

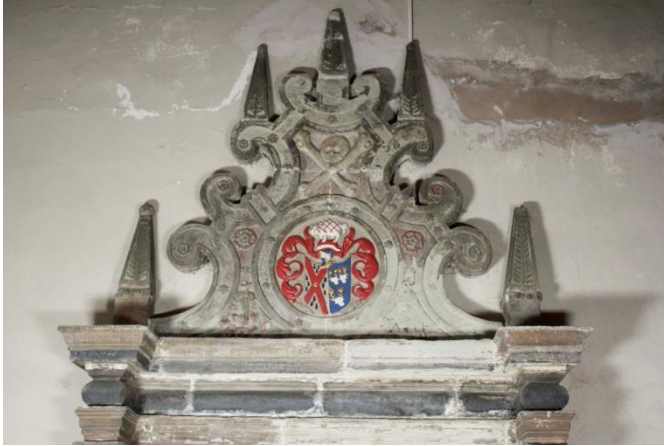
The florid embellishments surrounding the coat of arms, appear uniformly dirty before conservation, with no sign of the delicate painting to the floral and foliate detailing, which is all but lost visually.

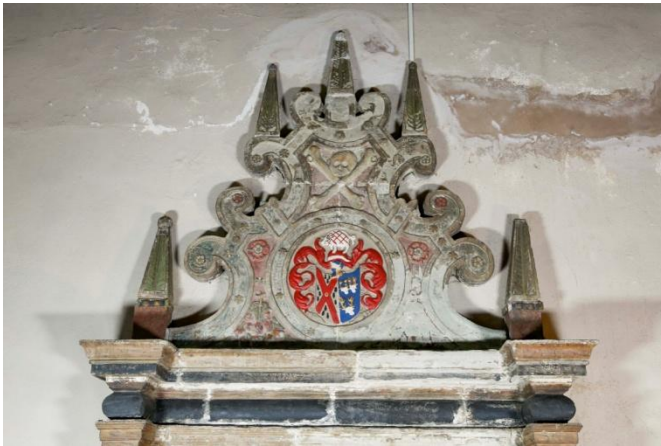
After conservation, the vertical four pinnacles display their green decoration, with supposedly red marble bases. Presumably the painters had seen red marble –which would have been prohibitively expensive, even for such an elaborate monument.

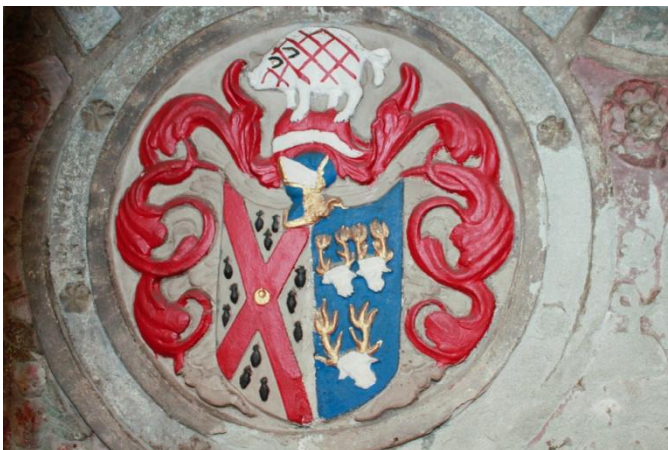
The now crudely, oil-painted heraldry, at odds with the delicate decoration visible over the remainder of the monument.

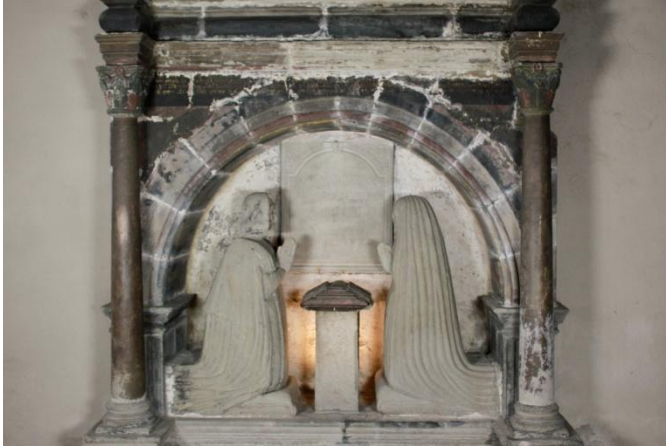
The arched recess, depicting the kneeling couple. Note the warm filament-bulb will be raising the temperature within the recess enough to likely contribute to the loss of surface-polish to the marble from repeated heating/cooling cycles. Strong consideration should be given to replacing it with cold-source lighting, during the planned re-display / interpretation of the monument.

- 5.2.3 The rather crude, bare bulb lighting in the recess should be changed for a cold-source light (LED) and would hope new lighting proposals would come up with a more imaginative scheme. The warm bulb will elevate the temperature within the recess during winter months, if the church continues to be left open for the public and that light is turned on (by others) as it was daily for the duration of involvement with the monument. The impact of which will be determined during the winter, when we return to re-take all of the previous data.

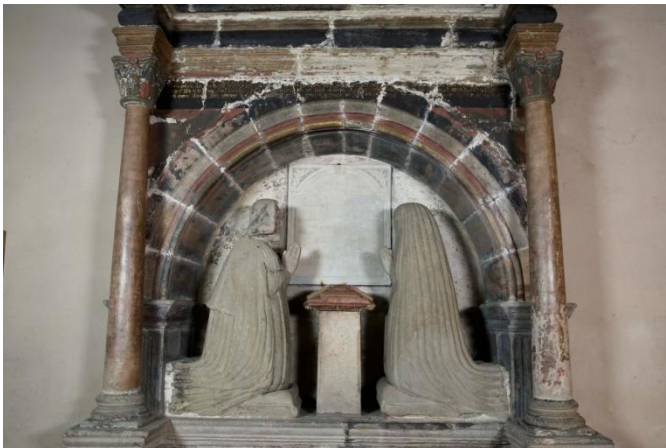
The arch elements and overlying moulded cornice after all treatments. It might also be a good idea to incorporate an information panel nearby, detailing whom the monument commemorates. Note the colours on the supposedly marble lectern top, between the figures.

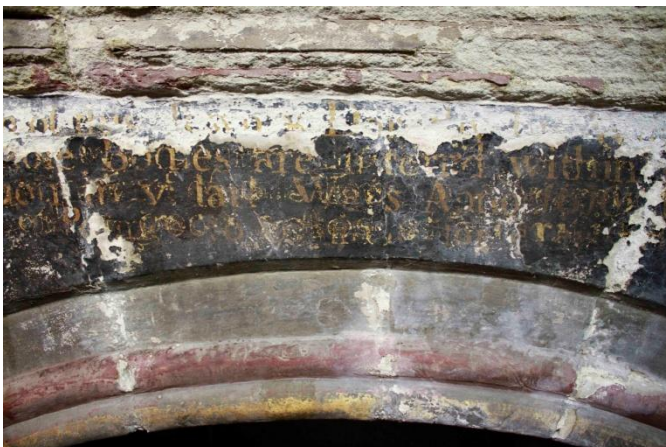
A detail of the concentrated damage caused by efflorescence (soluble-salt activity). Liquid consolidant was injected along the paint edges, which is drawn down behind and along the flakes by capillary action, ensuring the paint is secured back to the substrate when the solvent carrier has evaporated. The arch is yet to be cleaned but the flatwork is painted to give the appearance of green marble, with red and gilded mouldings beneath.

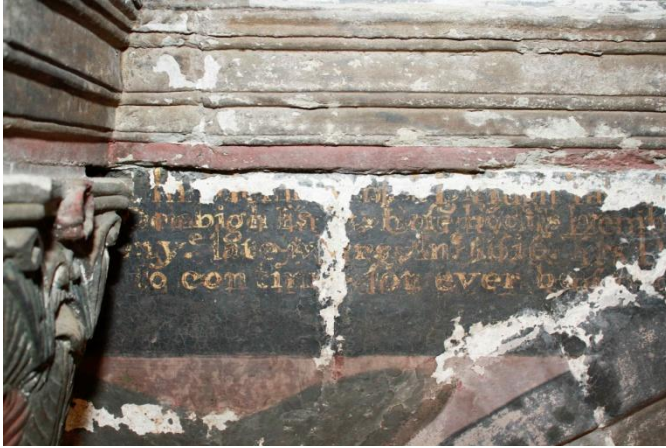
- 4.7 The uppermost section of the inscription had been applied over the horizontal joint, which is obviously more permeable than the stone, offering moisture and with it soluble-salts the path of least resistance with the resulting loss of material. No thought was given to re-painting areas of paint loss and neither should it be, being restoration and NOT conservation.

The moulded horizontal entablature and spandrel beneath complete with oil-gilded dedication. The white areas of loss are where the mortar joints (the path of least resistance) have been disrupted historically, by efflorescence.

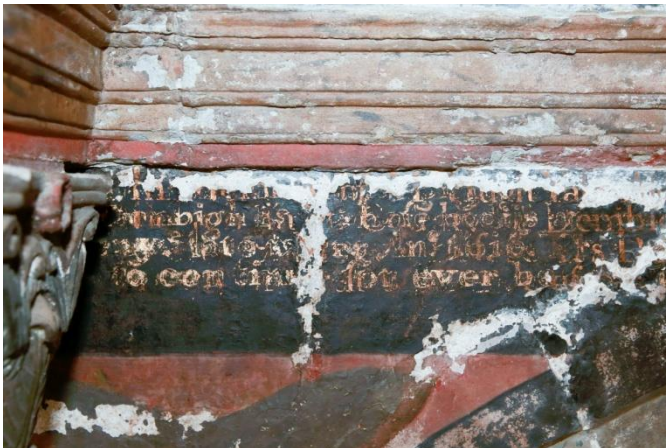
The same area after detailed cleaning - using separate materials on the painted marbling and the drying oil beneath the gilding. With all paint edges having been consolidated to ensure their physical integrity once again, now the external factors leading to chronic efflorescence have been addressed.

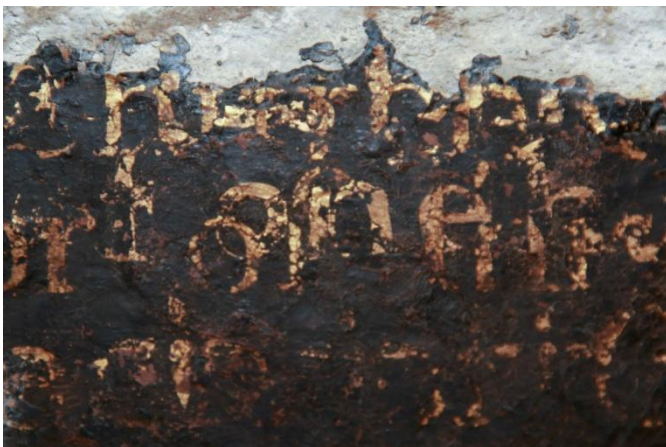
- 4.6 The horizontal gilded inscription at capital level was applied onto a black paint with a drying oil binder which has degraded to a characteristic craquelure (the appearance of crocodile-skin even under low magnification). There are two different phases of gilding, one overlaying the other, being slightly off-set, making it difficult to read once cleaned. There was no thought of removing the upper-most dedication, even if it had been feasible, as it is part of the history of the monument.

A detail of the two separate layers of oil-gilding over a black pigment in a drying-oil binder. The dedications are off-set and it is not clear why, making the dedication extremely difficult to read in places.

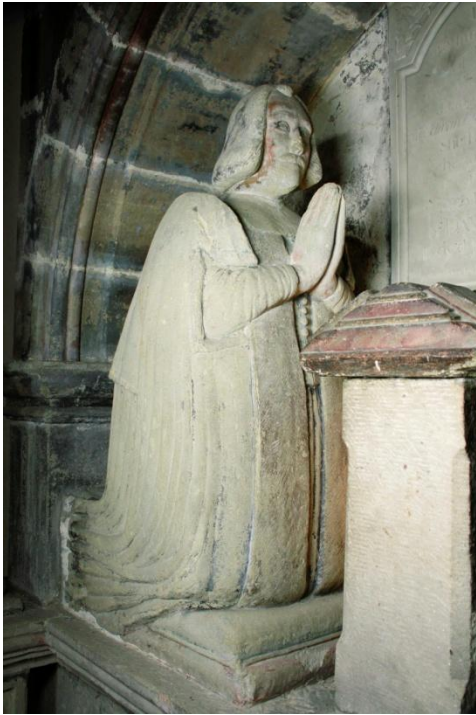
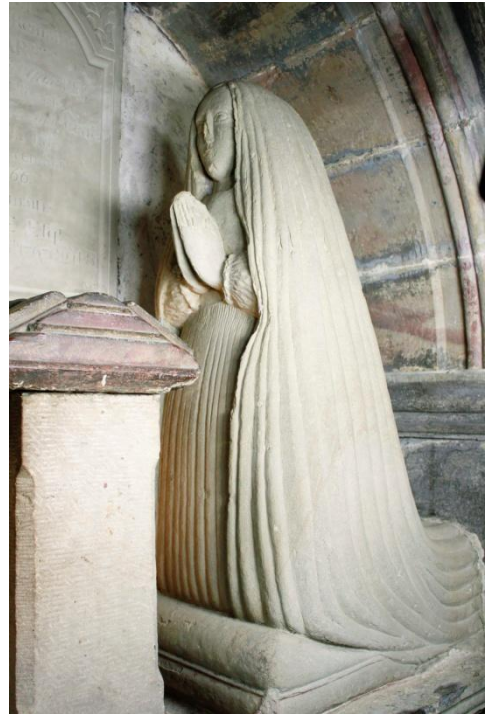
The male kneeler thought to be Mr Hugh Yale opposite the female, thought to be his wife, Dorothy Yale. Between them is a crudely tooled lectern-base and marble top, all carved from sandstone, with the upper element decorated to give the appearance of marble, complete with a book on each sloping side facing the kneelers.

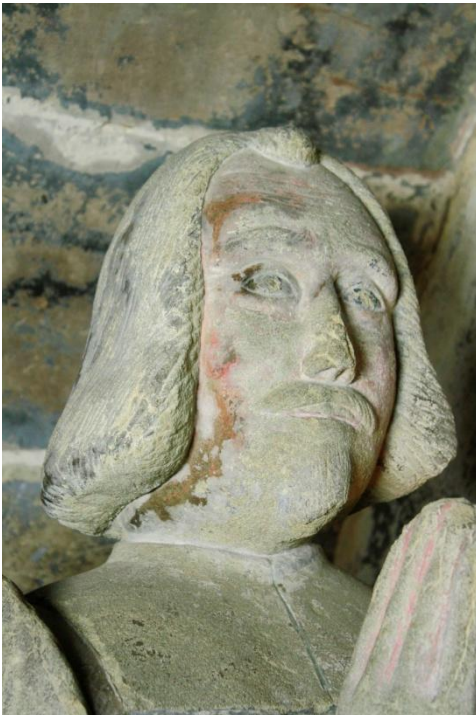
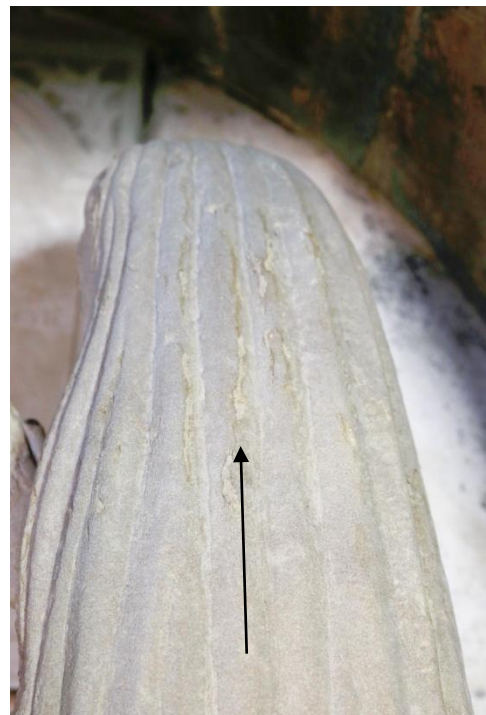
Painted flesh-tones can still be seen on the face and chin of Hugh Yale, in what would appear to be a concerted effort to remove all traces of applied decoration, with such decoration not deteriorating so uniformly. The striations in the vertical drapery folds of Dorothy Yale were at the stage prior to serious delamination and had liquid consolidant applied by pipette until a consolidative affect was achieved. Any excess consolidant on surfaces were then swabbed with Acetone to remove residual darkening.

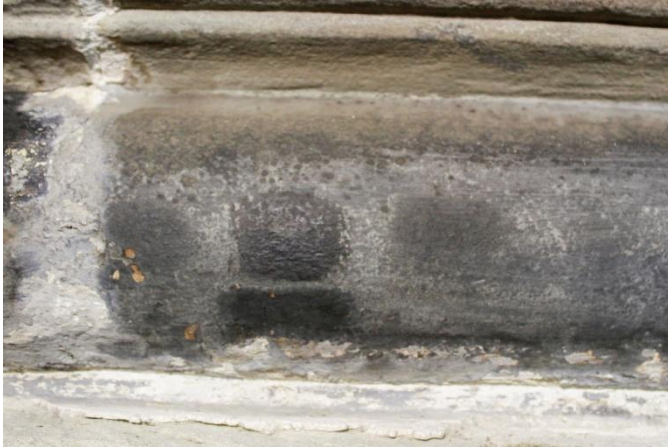
Solubility and cleaning trials to the oxidised black paint above the moulded entablature. Airborne dirt becomes almost fused onto surfaces by a number of factors such as : elevated humidity in that area of the building; photo-degradation from direct sunlight and the heating/cooling from the warm-source within the recess, albeit it at lower level.

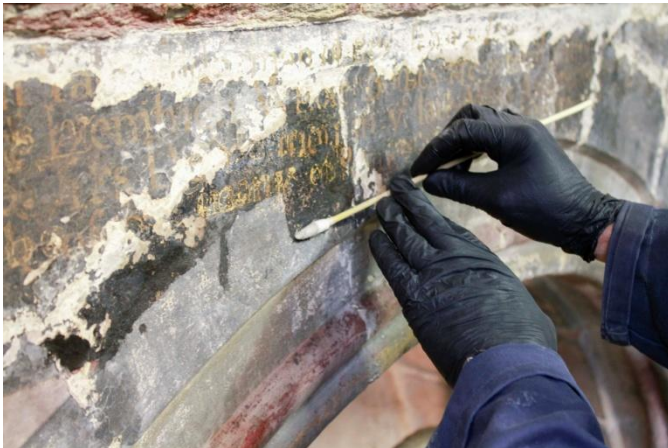
The safest and most suitable solvent (determined after trials) rolled over the surface in the majority of areas with cotton-wool swabs, as the decorated surfaces were not up-to circular rubbing with cotton-wool, such was the fragility of the aged paints.

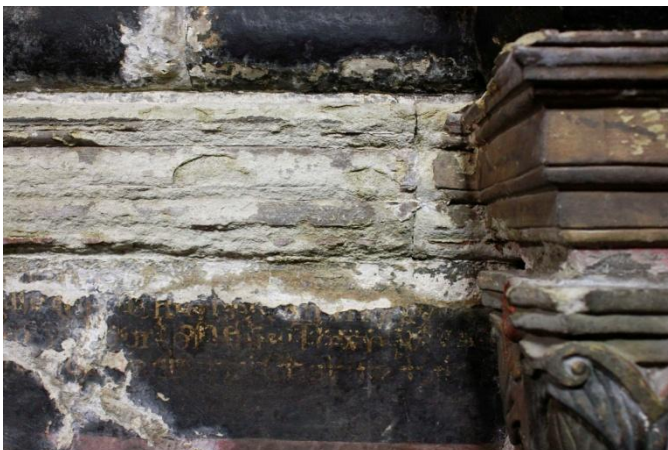
- 2.6.3 The majority of historic deterioration from efflorescence or rather the repeated crystallisation of soluble-salts has occurred between 3 and 4 metres above finished floor level. Levels for the three salt types in this zone are now consistent with tap-water and of little concern. Levels of salts closer to ground-level indicate rising moisture was a more significant problem compared to falling moisture, with salt levels negligible in the upper reaches, as one might expect. It being a source of excess moisture being more of a problem, which has been addressed.

Efflorescence was concentrated in a horizontal zone 3 – 4 metres above finished-floor level. It is most likely attributed to horizontally penetrating, excess moisture in the external pointing at that level, but it should not be forgotten that sandstone is a natural material and individual blocks could have been contaminated prior to quarrying, carving and fixing/building the monument.

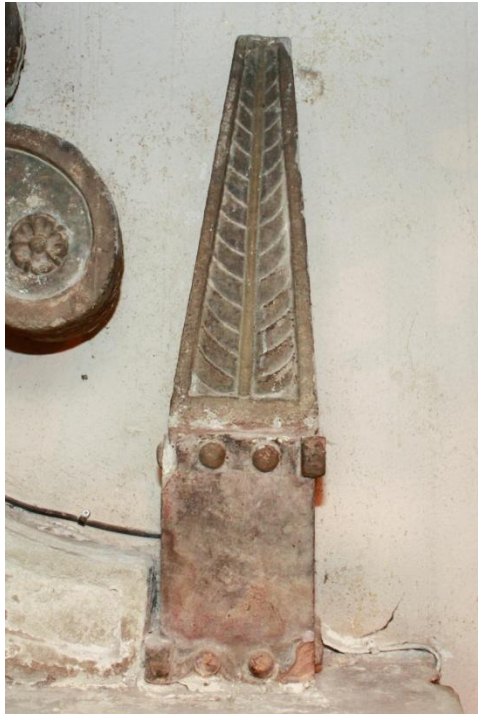
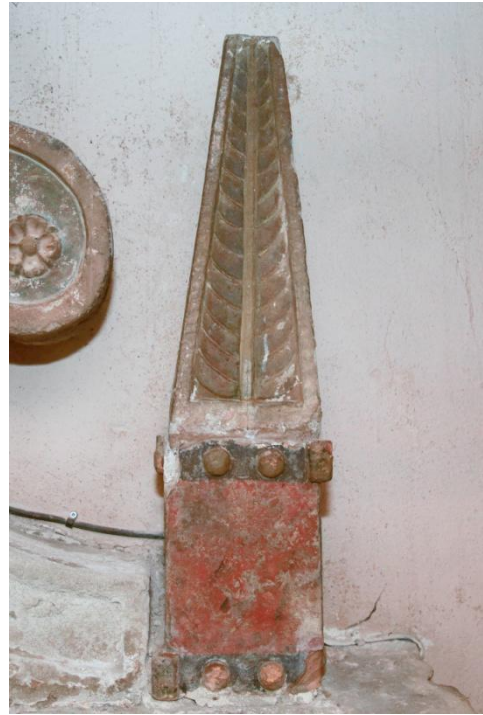
The viewer's right-hand pinnacle at entablature level, before and after cleaning. Note the delicately applied, green decoration is not apparent before conservation and will be difficult to establish from floor-level, with the current ambient lighting. Note also the black horizontal banding complete with gilded spherical domes above and below the red marbling, complete with black veining.

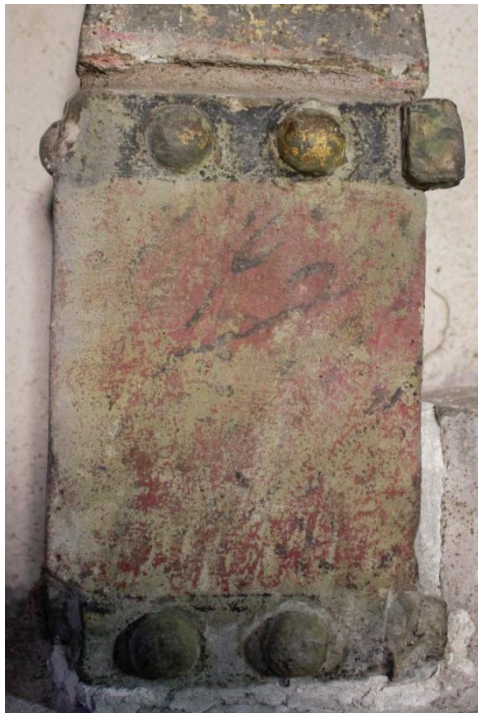
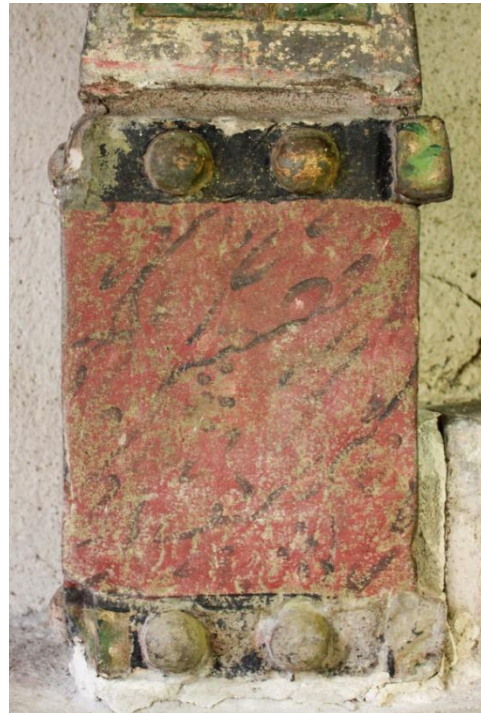
The marbling with black veining (as in real marble) is more apparent after cleaning, as is the oil-gilding, which highlights the extent of care and cost lavished on an otherwise more humble sandstone monument.

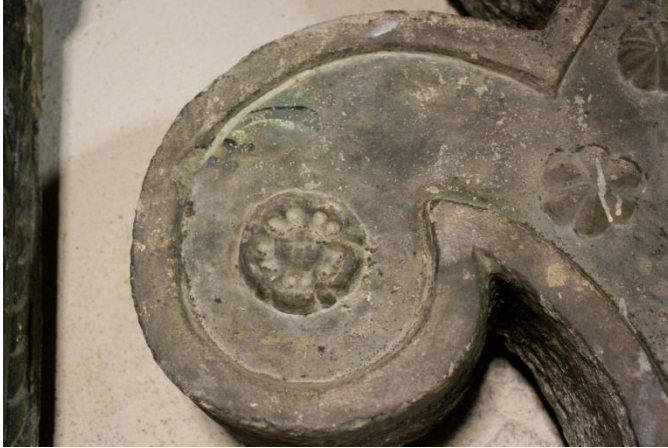
One of the proper left-hand curlicues or embellishments, surrounding the coat of arms - with a supposedly green marble panel (Connemara is the only geologically true marble in the UK) representing its characteristic, inherent black and white veining.

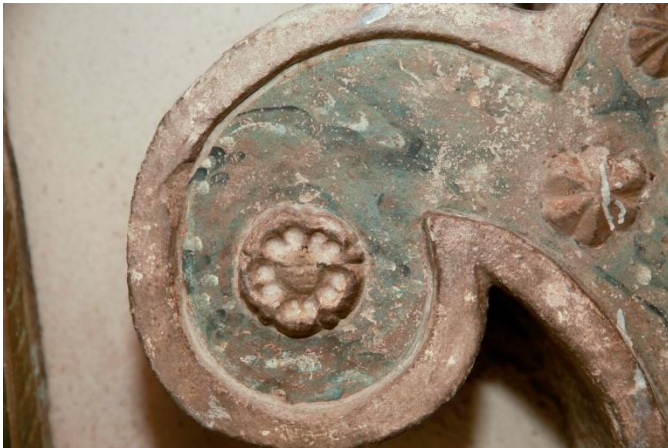
The delicate, fragmentary remains of largely green painted marbling. The high-relief, white rosette is more pronounced after detailed cleaning with cotton-wool swabs. There was no point applying the best consolidant currently available, over all painted remains, largely because ambient conditions within the building are much more favourable and everything (even stable consolidants) degrade.

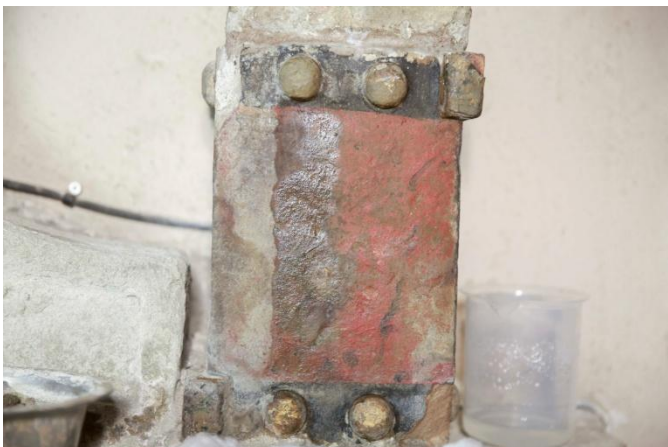
- 1.4 There are several anomalies, most notably the upper right-hand obelisk located on the cornice, which has been fixed incorrectly – that is three of the sides are decorated (painted and gilded). The undecorated rear is facing east (into the nave) and not against the wall as it should be. The lower right-hand pedestal is bedded significantly out of plumb (with a visible lean) when viewed from the east. Fortunately this is obscured by the replaced pew and is not nearly as apparent when viewed from the west. None of the bed or perpendicular joints on this block display any signs of movement or jacking and must be down to poor workmanship.

Cleaning in progress to one elevation of the overlying pinnacle base. There is an error in building this pinnacle, in that only three of the four elevations are decorated (presumably to save money). The undecorated side should be facing into the wall and so unseen, but instead faces out into the nave and as such, is part of the history/development of the object.

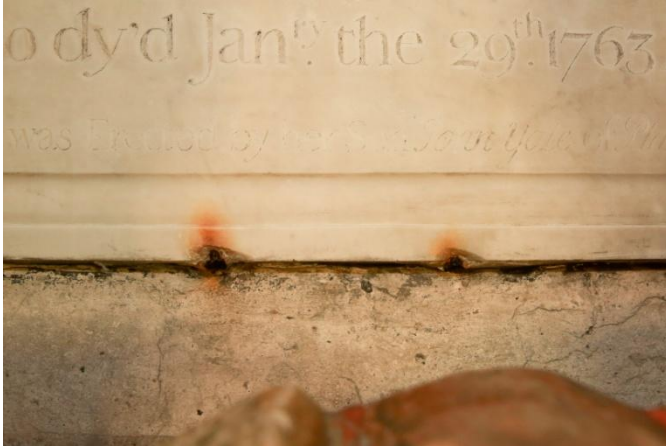
- 4.10 The two load-bearing fixings on the bottom-bed had expanded historically forcing off the front edge of the stone, which was not within the recess. There were no signs of progressive corrosion on the exposed iron surfaces and their removal and replacement with stainless-steel fixings was deemed inappropriate, due to causing avoidable damage to adjacent stonework, plaster and marble no matter how carefully executed. Instead they were treated insitu by being abraded with a metal polishing-mop to remove any loose corrosion. They then had two brush applications of Jenolite (a corrosion inhibitor containing Orthophosphoric acid) which were allowed to dry, prior to a single 10% w/v application of Paraloid B72 dissolved in Acetone : I.M.S. to provide additional protection to the corrosion inhibitor.

The pair of load-bearing fixings in the bottom bed of the later marble dedication panel, have corroded (due to excess moisture) causing spalling of the marble arriss, as the iron corroded. The exposed iron was abraded with a polishing-mop, treated with two applications of corrosion inhibitor, followed by a single protective coat of acrylic resin. Removing and replacing the fixings with stainless-steel would have caused avoidable damage to the surrounding plaster fillet and the likely integrity of the panel.

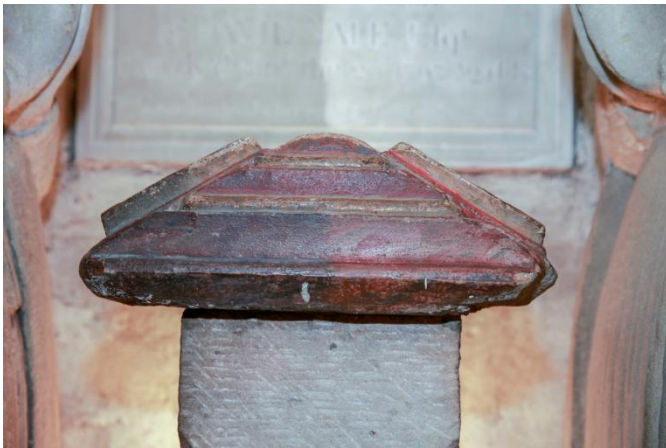
Cleaning in progress to the marble dedication panel in the background and the right-hand side of the marbled lectern top, in the foreground.

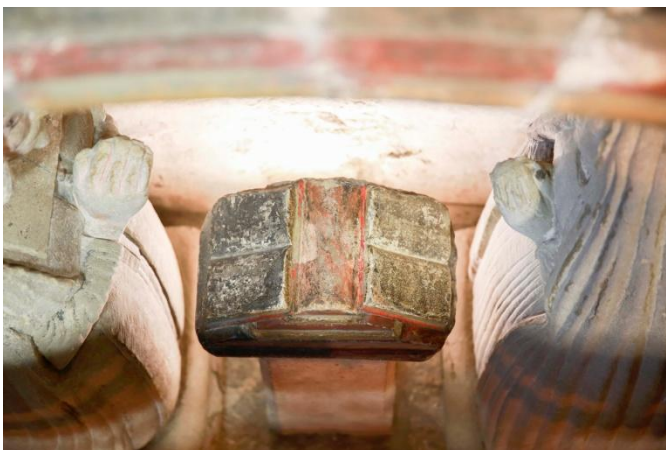
Cleaning in progress to the top of the lectern (right-hand side) complete with the painted books either side of the centre. The decorators even applied marbling to the top of the lectern, which will never be seen.

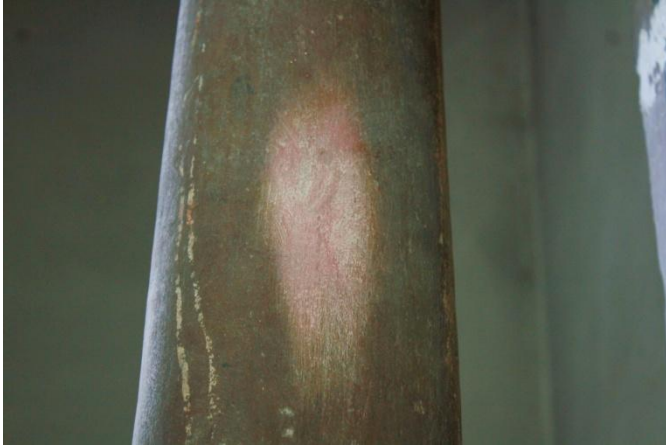
A previous, crude attempt at cleaning, that has scratched or removed the surface of the paint when viewed under magnification. It does however, highlight the delicate nature of the applied decoration.

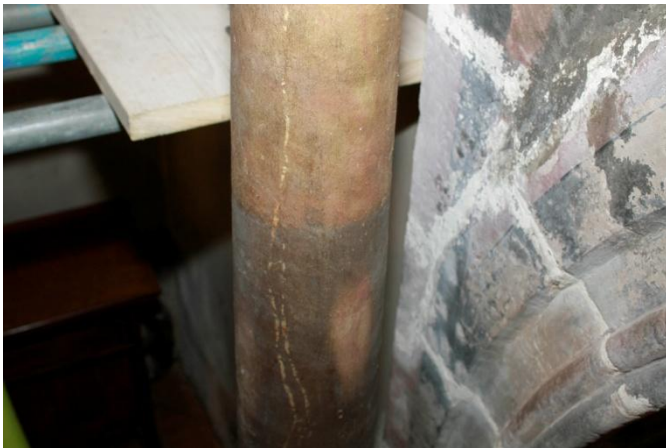
Cleaning in progress to the left-hand column. This was carried out using a weak liquid-soap solution, applied with small blocks of close-cell foam. Once cleaned you can appreciate more fully the intention of the designer and skill of the painter(s).

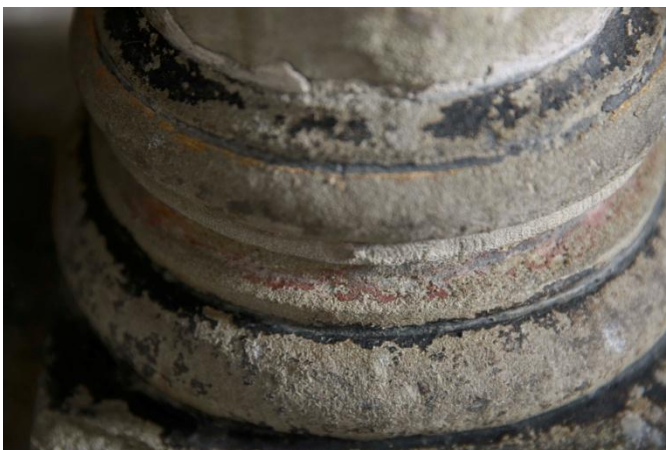
The well-adhered, fragmentary remains of applied decoration to one of the column bases, hinting at the exuberant, original : black; gilded; red and black decoration from top to bottom. The exposed sandstone is in a sound condition, indicating the decoration appears to have been removed intentionally.

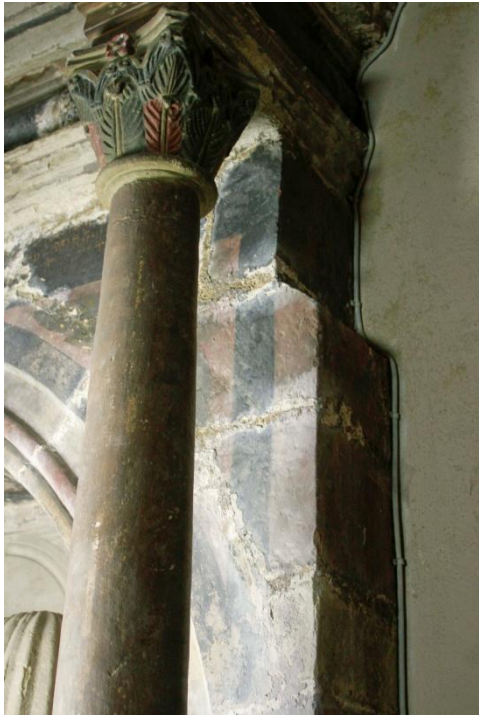
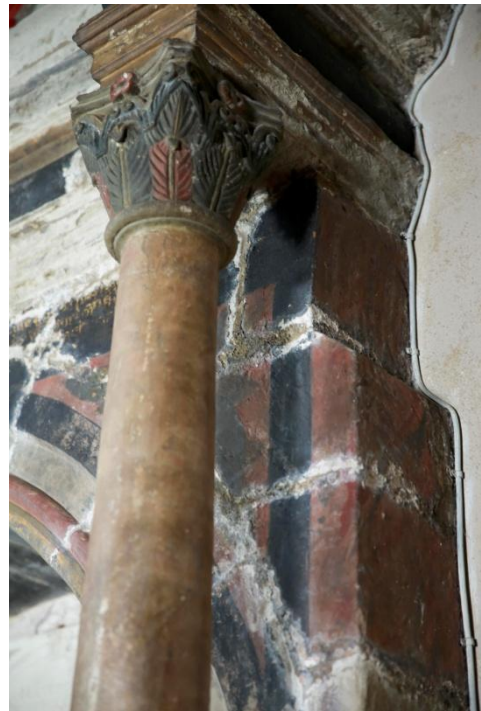
The right-hand column and spandrel (behind) before and after cleaning. Note the thick, vertical black-line looks like a shadow, but has been painted intentionally. The marbling to the column would have looked realistic when first applied (before deterioration) and only looks obvious now, due to the loss of paint at the bottom, exposing the sandstone beneath.

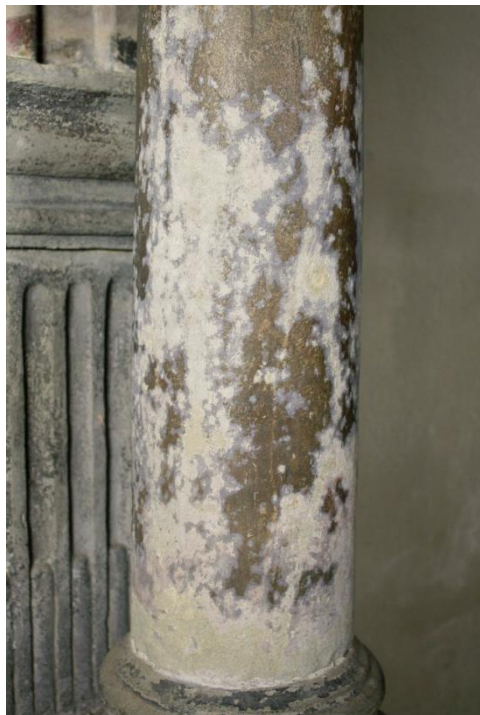
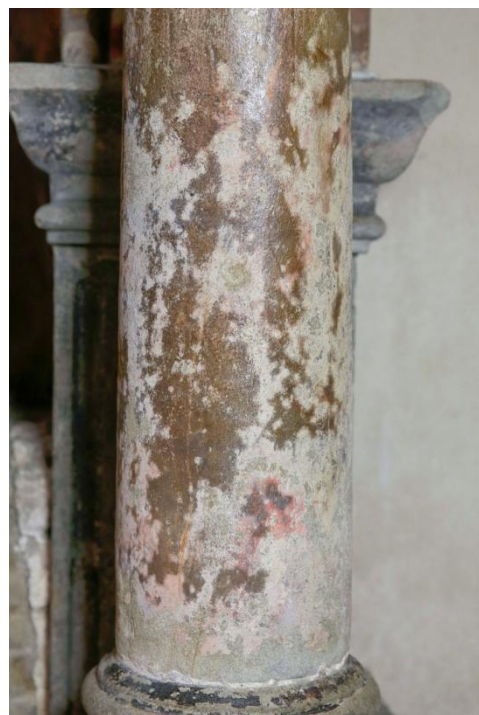
The extent of deterioration to the bottom of the right-hand column. Loss has been caused by physical wear being at low-level, likely - intentional over-cleaning, and the effects of efflorescence. Note how the cleaning process has imparted a degree of lustre, back to the degraded, aged paint.

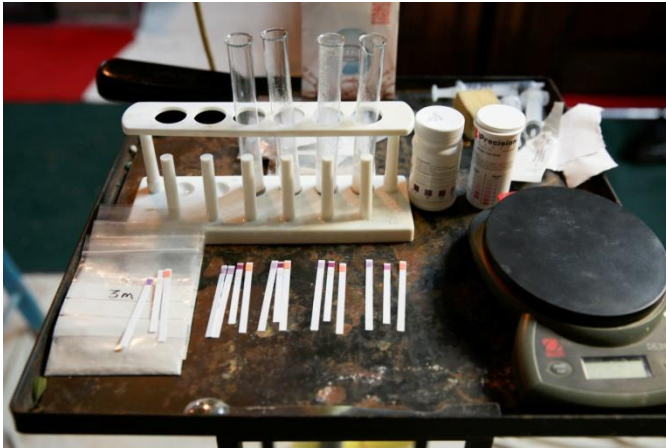
Salt analyses of adjacent wall-plaster - testing for different salt-types and their concentrations. This was undertaken to each of the drilling locations from floor to ceiling. Sampling was consistent, with each sample - with the same weight, dissolved in the same volume of de-ionised water for the same time period - to give consistent, repeatable results.

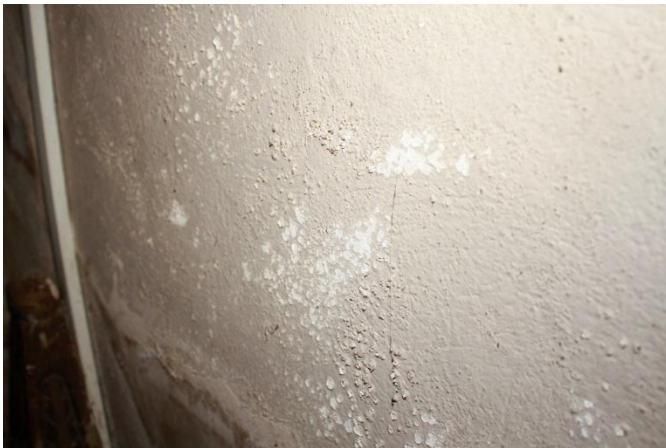
Efflorescence in the form of salt pustules just below wall-plate level and above the monument. These localised growths of soluble-salts are capable of forcing off non-permeable paint, as salts crystallise at the intersection between the permeable bare plaster and impermeable overlying paint layer(s).

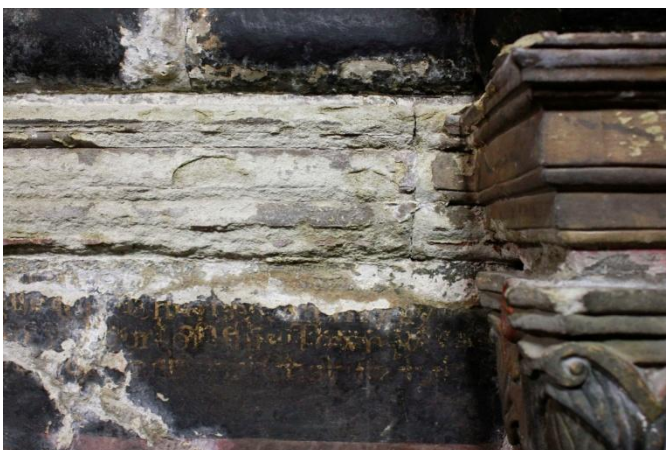
Soluble salts exert significant forces on a microscopic level and can cause even the hardest sedimentary stones to disaggregate (lose physical cohesion) particularly arrisses/edges - areas of greatest evaporation, such as in this image. The source of salts on this monument is inconclusive but the chronic deterioration is concentrated over a relatively small area.

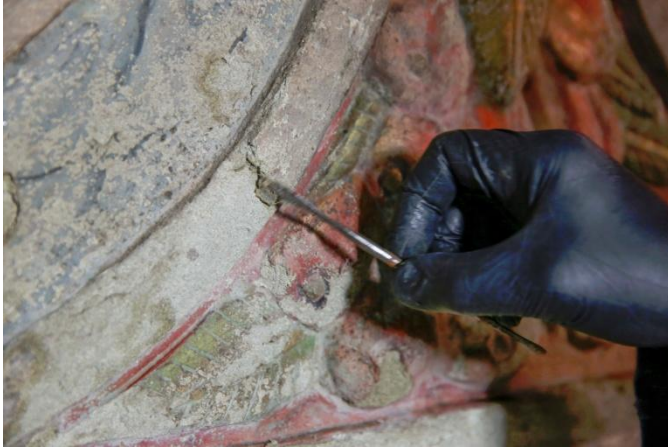
Support fillings made of crushed/sieved sandstone dust and/or sand - mixed with a 10% solution of acrylic-resin being inserted into and behind vulnerable edges. These areas had been surface consolidated beforehand, with two cycles of a weaker solution of Paraloid B72. The areas were allowed to give-off the solvent-carrier, before support fillings were introduced.

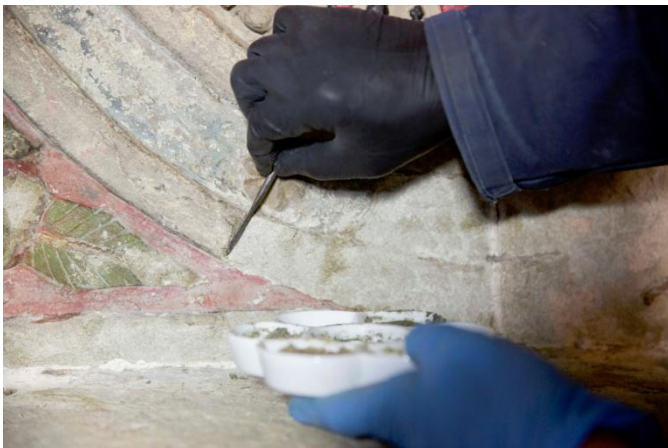
The majority of support fillings were applied to the decoration beneath the coat of arms and a zone of the right-hand cornice and entablature, as well as other isolated areas. Stone is a natural material of course and can deteriorate in a random manner, next to an area of completely healthy adjacent stone.

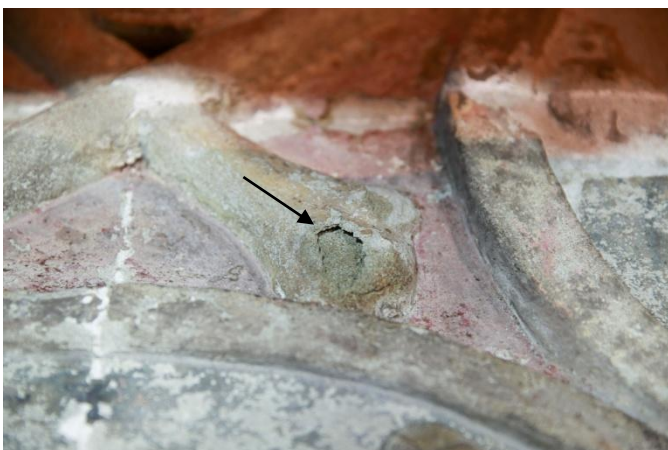
Vulnerable areas such as this, where there is a real risk of losing carved upper-surface were consolidated and then packed with the filling-medium, coloured to blend-in with adjacent, sound stone. No attempt was made to replicate or suggest missing carved detail. The fillings are easily reversible in Acetone, unlike lime mortars which would be harder than the weakened stone under repair and as such have no place on this type of stone or delicate carving.

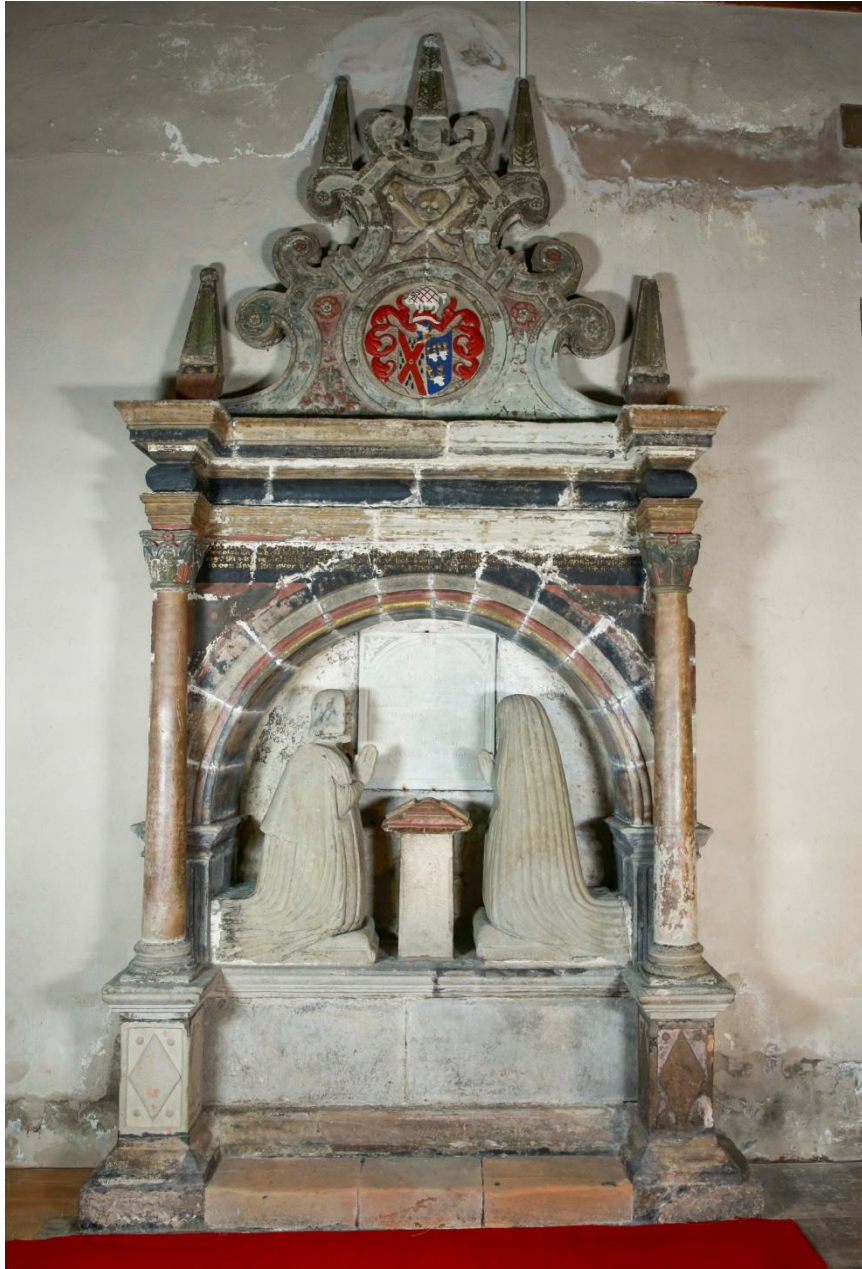
The Yale monument after all treatments, with the original palette of colours more obvious once again, despite the intervening 400 plus years. Note the historic damp/deterioration zones above the monument, due largely to the historic faulty/ineffective rainwater removal from the overlying parapet and other rainwater goods, which have been addressed relatively recently. This image is captured with strong studio-lights, incorporating daylight simulation tubes. The current, ambient lighting arrangements are known not to illuminate this culturally important object effectively. It would certainly benefit significantly from the planned, sensitive lighting scheme, taking into account the amount of surviving polychromy. The adjacent tracery window to the south would provide additional light levels (free of charge) in this area of the church, just from being vacuumed carefully, whilst being mindful of enhanced Lux (light) levels as outlined in the report.

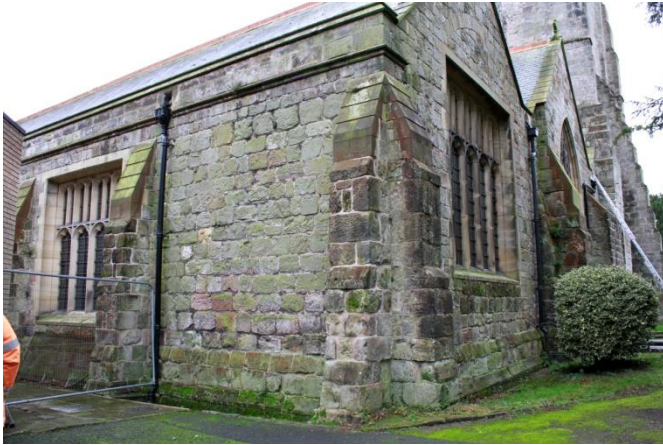
- 1.9 It is clear from the historic morphology/patterns of deterioration to the monument and adjacent wall-plaster, that defective : overlying parapet/joints; rainwater collection/hopper; external wall-pointing, concrete apron; drainage as well as poor architectural detailing of the string-course shedding rainwater onto the flared plinth beneath (and into the building fabric) have all contributed to the decay mechanisms witnessed.

The external location of the monument, which is situated between both buttresses – extending just beyond the viewer's left-hand buttress. The faulty (presumably lead-detailed covering) parapet which overlies the monument inside, was rectified several years ago. The legacy of it being defective can still be seen over the internal plaster at high level, as outlined in the report.

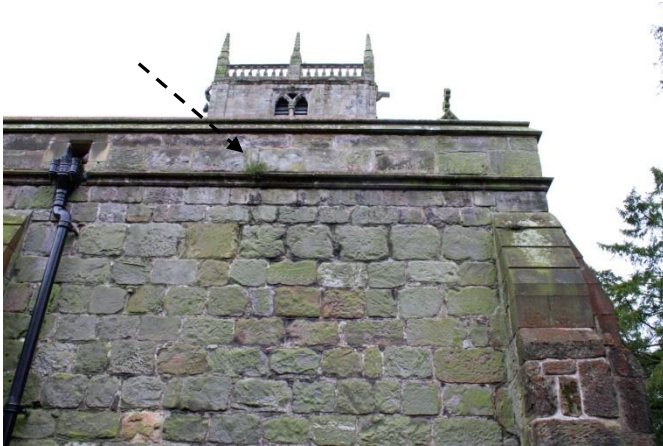
- 1.5 Higher plant forms were observed by us to be issuing from joints to the overlying parapet externally, during our initial assessment in the winter of 2020. These were removed and resultant access points for water filled with mortar by others, in a recent phase of exterior remedial treatment.

Plants were seen issuing from joints (indicated) above the horizontal string course and the overlying coping stone, during our initial survey. These were removed recently (by others) and pointed to stop the ingress of moisture into those entry points. The pointing to the walling immediately behind the monument appears to be in relatively good order, but should be monitored to ensure its integrity. .

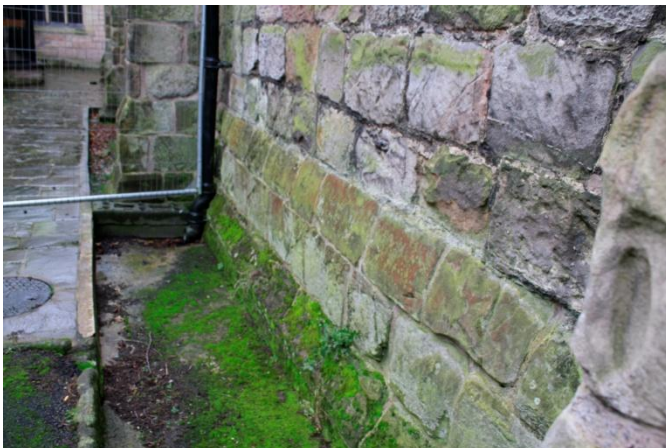
Well-established moss on the lower flared plinth (shed onto it by the string-course above) and the concrete gulley, both indicate a prolonged problem of excess moisture, which moss retains on the surface of stone, enabling it to migrate horizontally into the fabric. This should be removed on an annual basis, if only to prevent the drain in the background, at the foot of the down-pipe from blocking with biological material. Sediment is visible in the new concrete gulley indicating this is already an issue that needs addressing.
