Object Treatment Record

INVENTORY NUMBER	N/A
OTHER NUMBER	
LOCATION	St Mary the Virgin church, Shrawardine, Shropshire
OBJECT TYPE	Maiden's Garland
MATERIALS	Wrought iron, paint, copper alloy, gilding, (wood), paper
DIMENSIONS LxHxD of entire object	300mm x 250mm

Very thin sheet of wrought iron sheet cut into the shape of a heart and originally painted gloss black with the remains of gold lettering. The Heart was originally fitted to a polished oak panel secured with 6 no. gilded copper alloy nails in the form of a small cross. There were a number of additional small iron nails fixing the edges. Dedicated to Dolly Newcombe.

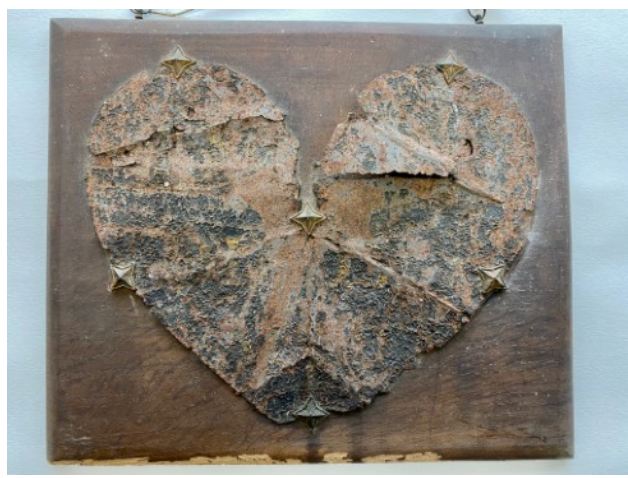
The Maidens Garland heart was in a poor condition. It was dusty and dirty. Over 50% of the original painted finish was missing. The paint had heavily degraded, flaking and lifting from the iron surface exposing the metal beneath. There was a layer of rust to the exposed iron surfaces. The gilded copper alloy nails had some dirt and patches of green copper corrosion products present to their surfaces. The oak board had some old wood worm damage along its lower edge. The iron sheet had previously been folded and unfolded which had left creases and cracks to the thin iron.

The Maiden's Garland before conservation.

TREATMENT		
<p>TREATMENT REPORT:</p> <p>The iron heart was first very gently dry cleaned with very soft paint brush to remove loose dust and dirt. Areas of loose corrosion (rust) were carefully removed using a sharp scalpel and soft brush under magnification. The remaining paint layers were very friable so was consolidated using 2 coats of Paraloid B67 in white spirit applied with a fine paint brush laid onto the surface. After drying a second coat was applied in the same manner.</p> <p>After thorough consolidation, the heart was gently removed from its oak board by lifting out the 6 no. gilded, cruciform nails. To remove the remaining small iron nails each head had to be carefully drilled away using a fine drill bit under magnification. This freed the heart from the oak board and it was gently lifted clear and sat on a piece of acid-free tissue paper. The gilded copper alloy nails were gently cleaned using 2% non-ionic detergent in deionised water using a very fine Scotchbrite pad (white). The cleaned surface was protected with a coating of microcrystalline wax.</p> <p>The heart was turned over carefully and laid onto a padded acid-free tissue. The back of the garland was gently dry cleaned using a soft paint brush to remove dust and dirt. The back was then consolidated with 2 no. coats of 5% Paraloid B67 in white spirit applied by gently laying a paint brush on the surface.</p> <p>The oak board was dry cleaned using a soft brush and vacuum cleaner before being further cleaned using 2% non-ionic detergent in deionised water applied on swabs. Once dried the wooden surface was protected with a coating of beeswax polish. The remaining nail stems were gently dressed down into the surface of the wood to remove their sharpness.</p> <p>Once conserved, the Maiden's Garland was mounted in a 10mm thick clear perspex panel. The original gilded copper alloy nails were re-fitted into pre-drilled holes in their 'original' positions. They were held into the holes using a small amount of clear epoxy resin adhesive. Two extra copper nails with large heads, were fitted to the inner edges of the heart lobes in order to hold the lifted iron down onto the surface of the perspex. These were set into pre-drilled holes with the epoxy resin adhesive. The head of each nail where painted with a gold paint.</p>

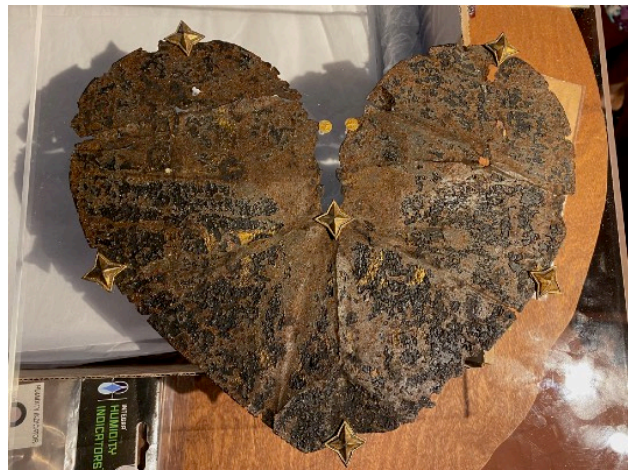
The Maiden's Garland after conservation.

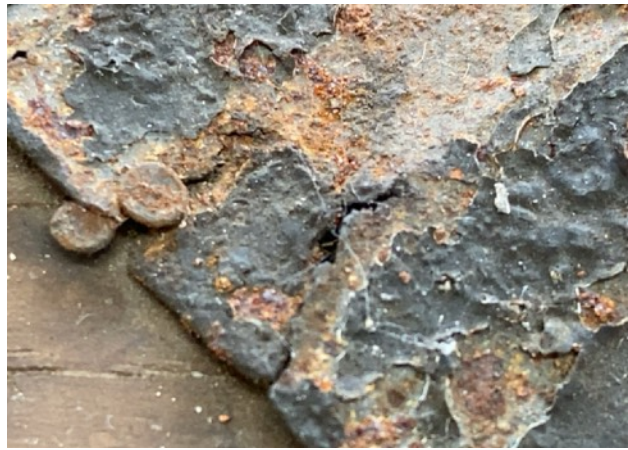
Detail of the surface of the heart showing the lifting paint, rust spots and small iron nails.

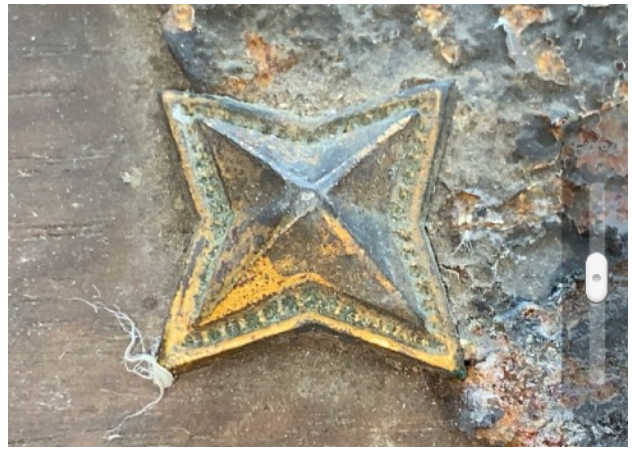
The gilded copper alloy cruciform nail before cleaning.

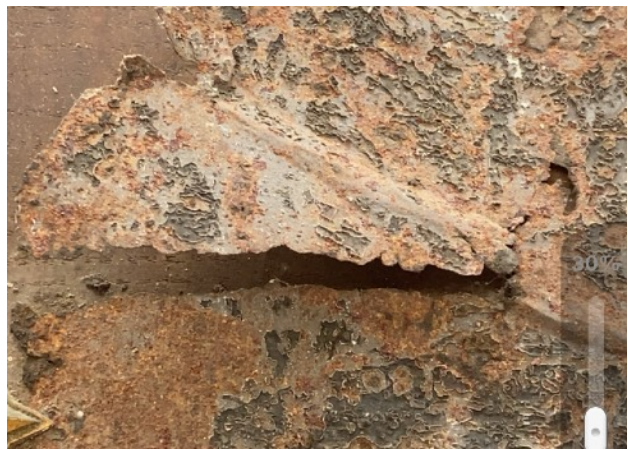
A detail of the cracked and lifted lobe section before treatment.

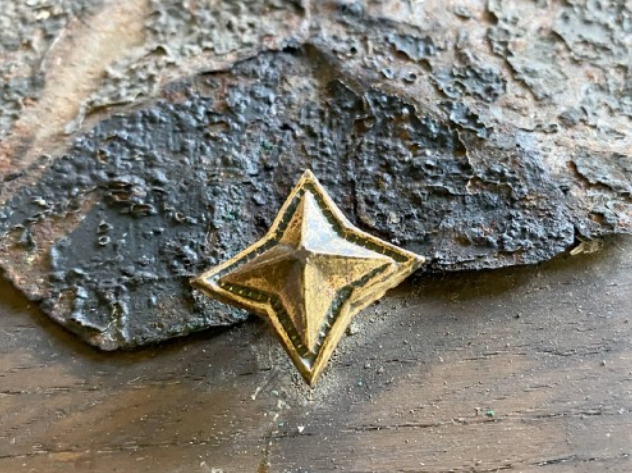
Lower gilded cruciform nail after removal and cleaning. Note the consolidate paint layer underneath.

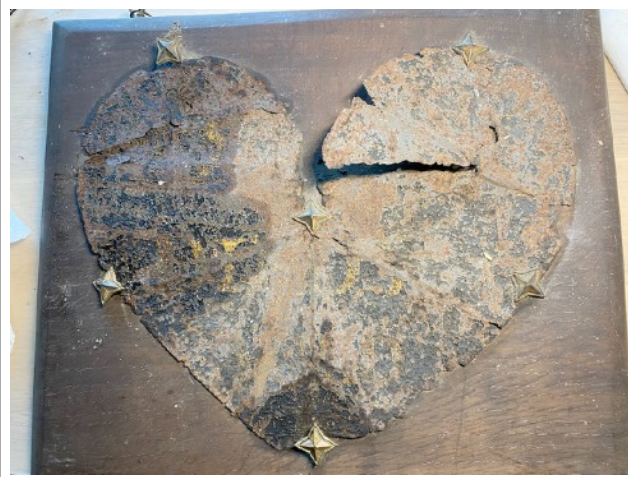
The iron heart after cleaning and during the process of consolidation with the Paranoid B67.

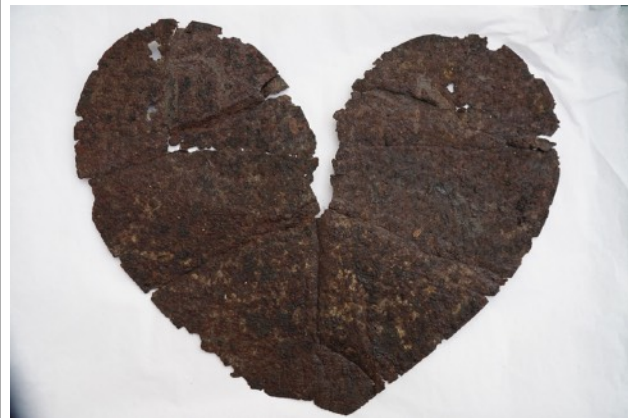
<p>FURTHER TREATMENT PROPOSAL AND NOTE (IF RELEVANT)</p> <p>No further treatment is required. The outline of a capital 'D' and 'N' were seen on the back of the heart on each heart lobe.</p>		
<p>REQUIREMENTS NOTE (environmental and monitoring, preventative conservation or housekeeping notes)</p> <p>It is recommended that the Maiden's Garland is stored in an air tight polythene box with dried silica gel in order to keep the relative humidity (RH%) below 30% so that the iron does not continue to corrode.</p>

The back of the heart after cleaning and consolidation showing the outline of the letters 'D' and 'N'.

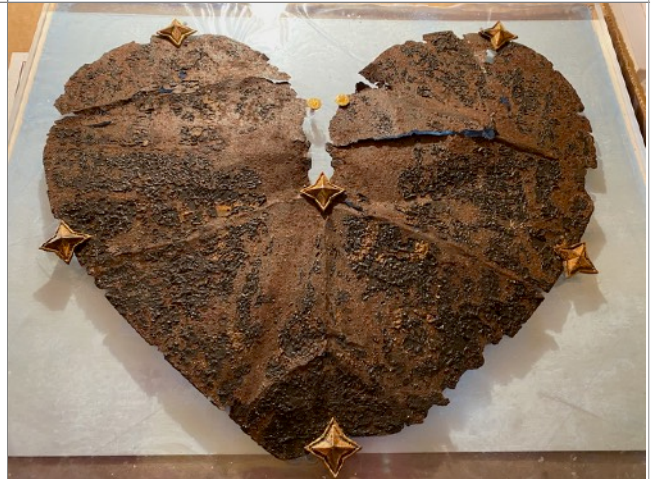
The Maiden's Garland after conservation treatment and mounting on the perspex panel.
