## ANGLO-SAXON PREACHING CROSS FRAGMENT : CONDITION REPORT

For the PCC of the Church of Saint Mary the Virgin, Gillingham

August 2021

Job No. 2293

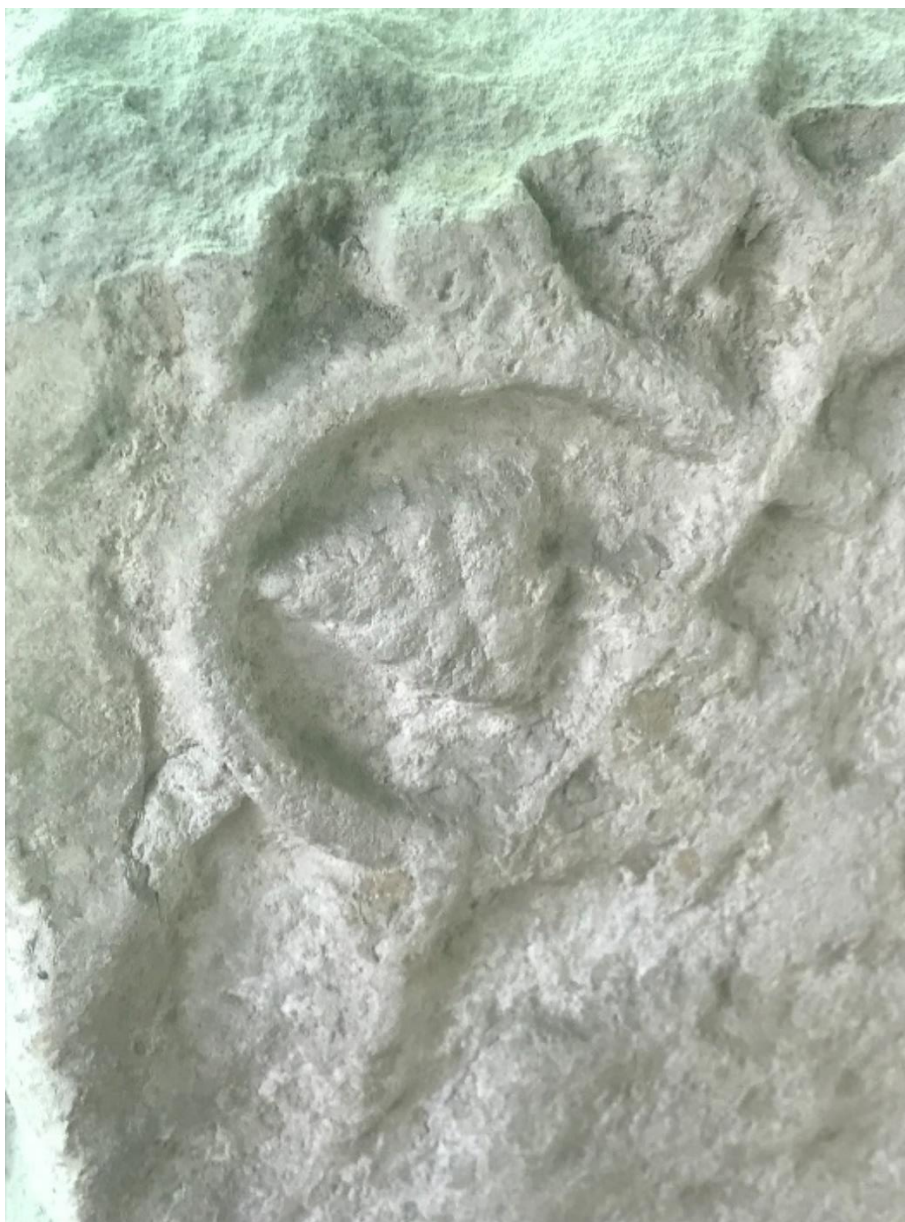
- South face, in the top dexter corner is a stylised depiction of a cluster of grapes within an intertwined vine. Leaf stems can be seen springing off the vine, the leaves however fade into obscurity as does what remains of the rest of the carving. The decoration on the lower half has been flattened and corresponds to the mass dial.
- The west face has the largest section of the Anglo-Saxon double strand carving on the fragment. Sadly the lower half is again missing.
- The east face also has the double strap work present. More weathered than the west but still very present, upper half only.
- North face all decoration has been lost.

Figure 11 Detail of the vine and grape carving in the upper dexter quarter of the south face (the grapes are approximately 60mm x 35mm)

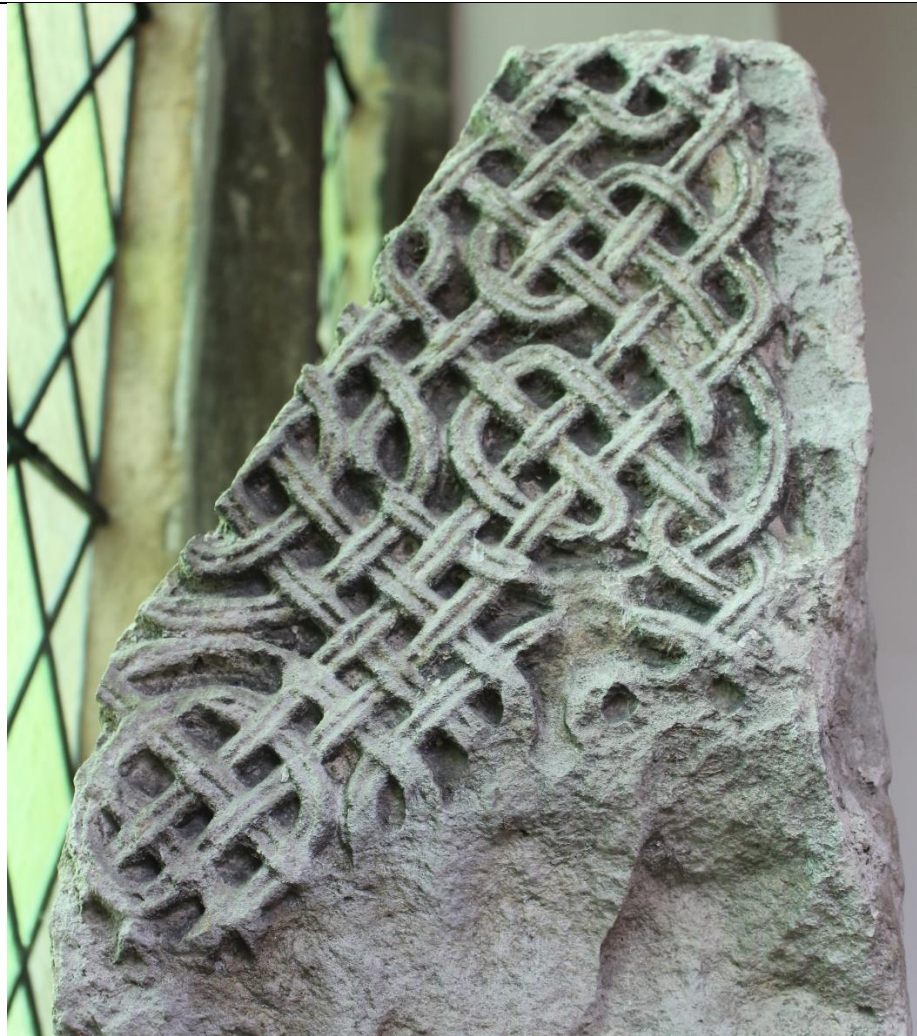
*Figure 12 Detail of the double strap work low relief carving of the west face*

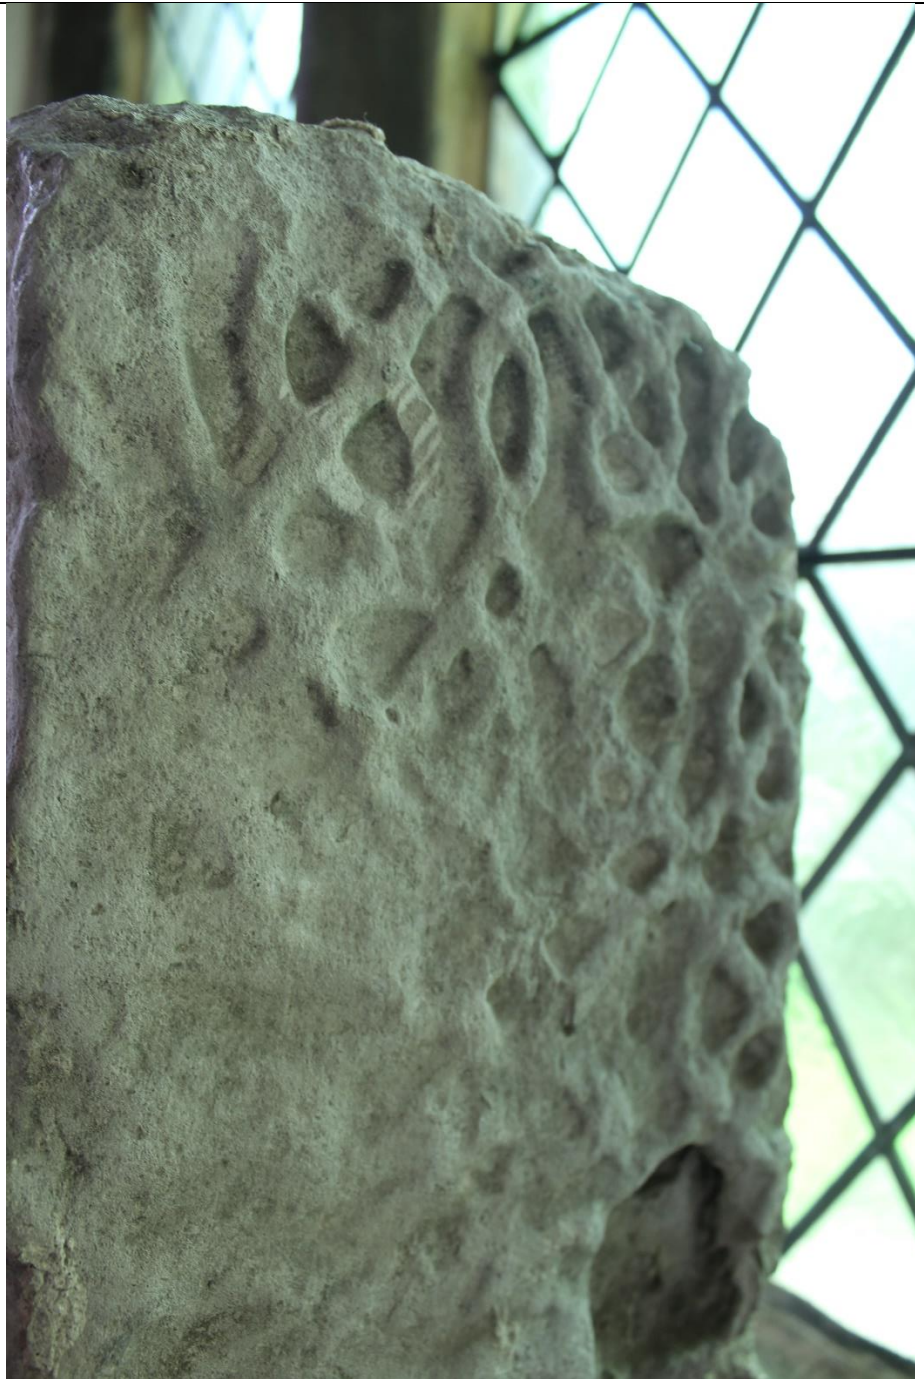
*Figure 13 Detail of the weathered double strap low relief carving of the east face.*

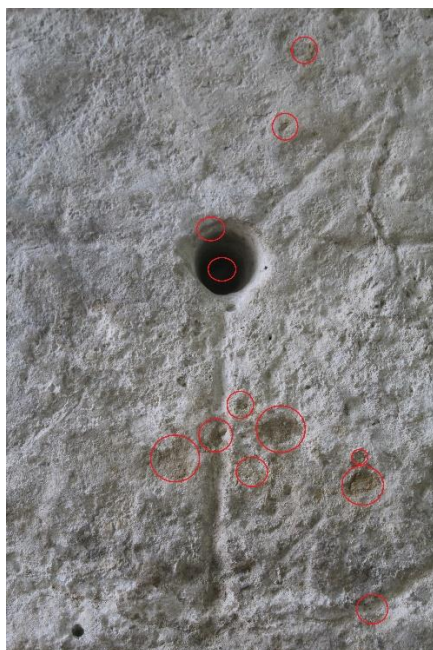
There are three mortars present on the surface of the fragment, the white and brown mortars are lime, the grey mortar needs further investigation (*possible weak cementitious mortar*). The white mortar contains black flecks of charcoal and has minimum fine sand (see figures 16 and 17 below for some of the locations of white mortar) and can be found on all four sides. The brown lime mortar is more coarse and contains clay. The brown mortar can be found in the gnomon holes of both south and north. It can also be found in small patches on the west and south faces (see figure 23 of the north gnomon hole, see figures 14 and 15 for general patches). The grey mortar is only found in the inner walls of the socket (see figures 21 and 22). The three different mortars indicate that this stone has been used more than once as a building material. When looking at this stone under the changing light, inside the socket can be seen an almost translucent white veil of lime. This thin veil is what remains of the original mortar which held the cross in the socket. There is a second thin lime veil on the lower half of the south, this lines up to the band of later carving on the east.

Figure 14 Locations of brown mortar on the south face

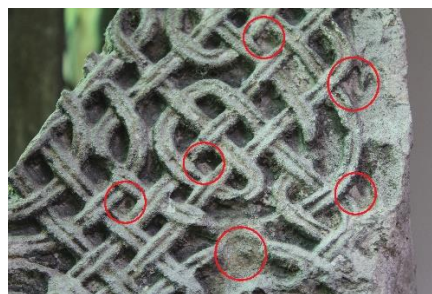
Figure 15 Locations of brown mortar on the west face

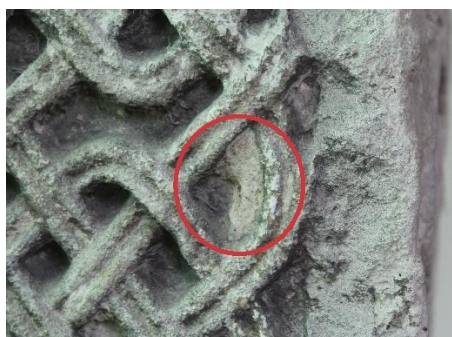
Figure 16 Detail of the location of white mortar on the upper decoration of the west face

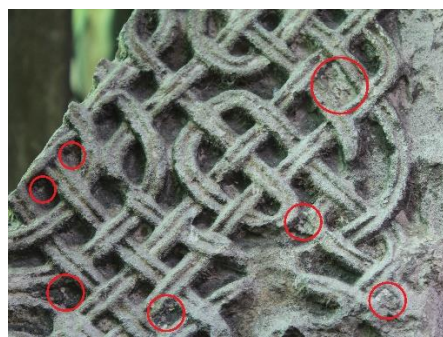
Figure 17 Location of white mortar on the west face

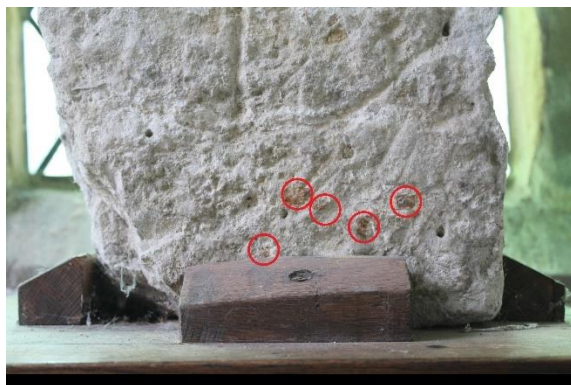
On the south face about 60mm or so from the bottom of the fragment, visible and detected by the cover meter are the remains of iron rusting which has fused itself to the surface. These are not causing any harm. They are the remains of some ferrous metal object once in contact with the fragment (*see figure 18 below*).

*Figure 18 Location of bonded iron rust on the south face*

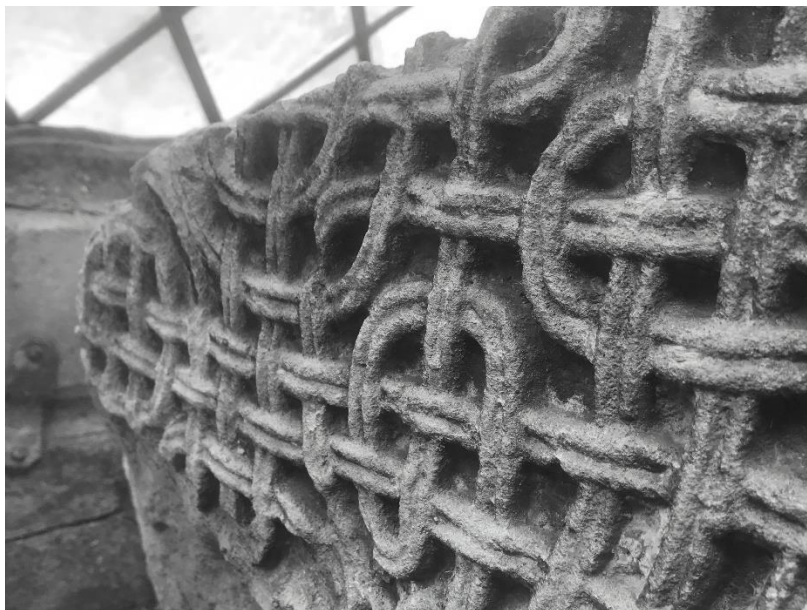
Weathering has affected all sides at some point, the west side is the only one to have collected carbon. Which points to this being the side on show in the vicarage wall. Fine white lime mortar remnants are also contained in the decoration of the west side, possible render which would explain why the carving on that side is still quite crisp. Brownish staining can be found on all sides of the lower half of the fragment.

*Figure 19 Carbon deposits on the west face*

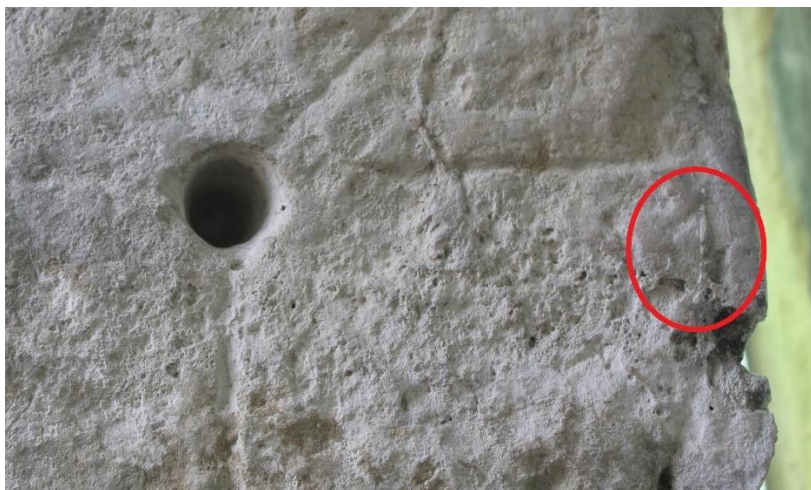
*Figure 20 Modern paint drip from the redecoration of the church*

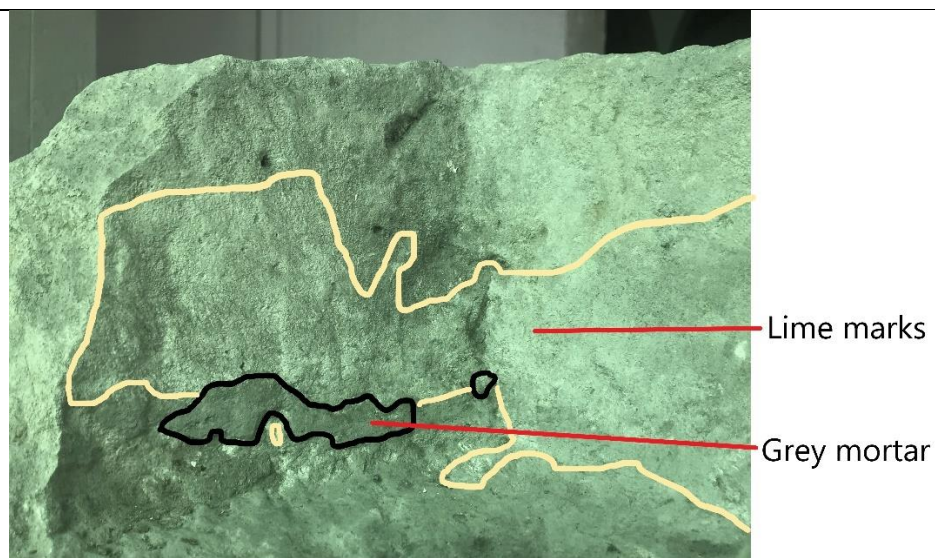
Figure 21 Lime stain and patches of grey mortar, socket inner walls east and south sides

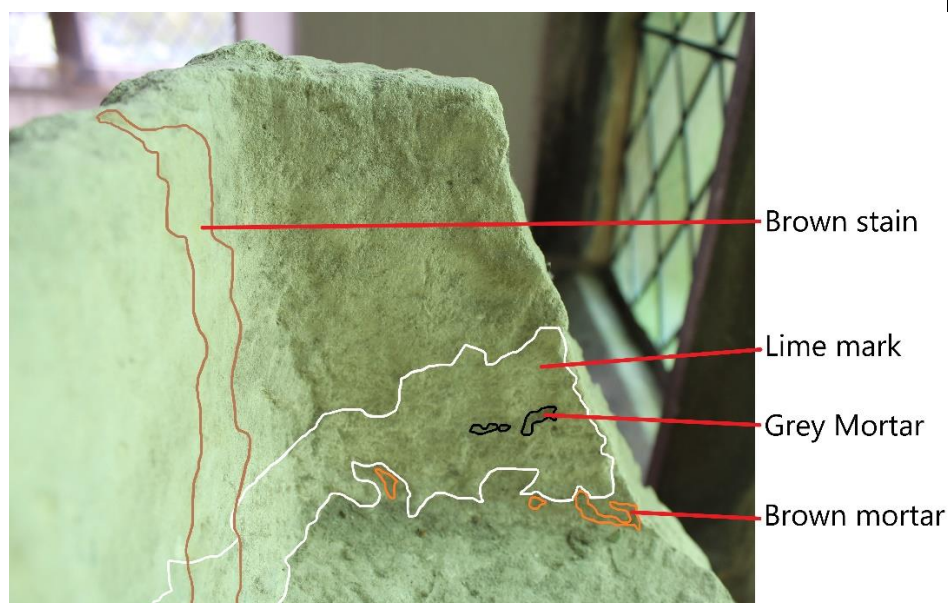
Figure 22 Grey mortar fragments with lime and unknown brown stain within the inner walls of the socket, south and west sides

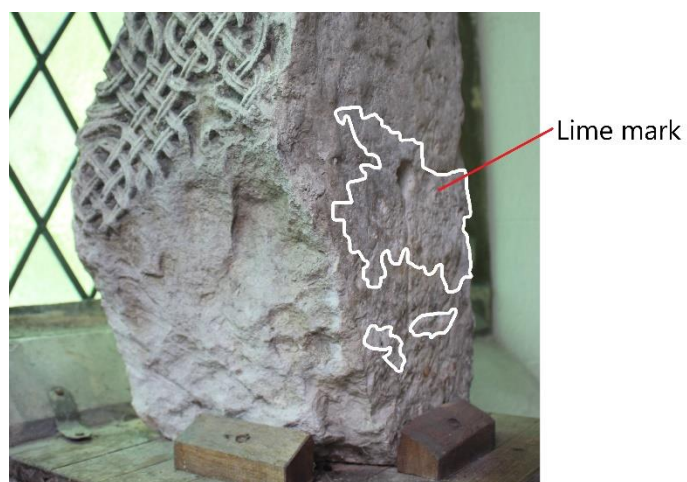
Figure 23 Lime stain on the south face

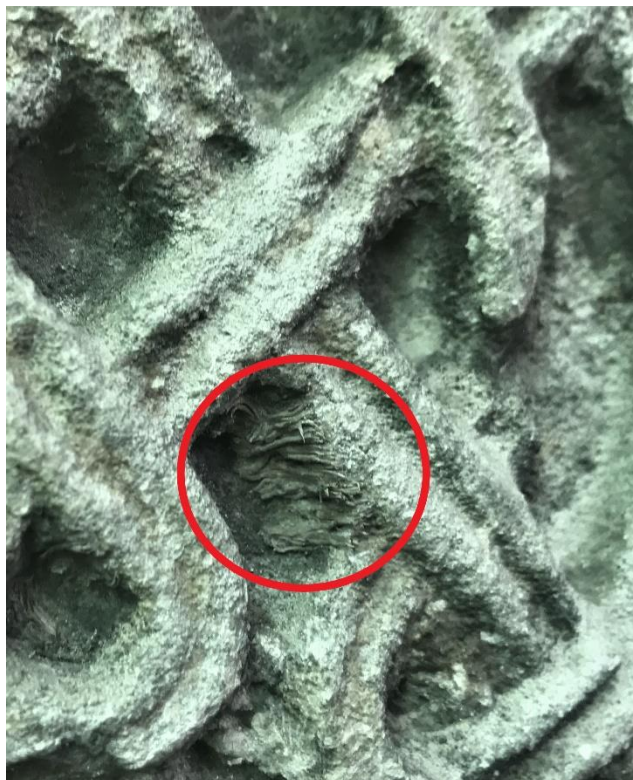
The current remnants of biological growth i.e. the ivy roots are not active. No other evidence of biological growth is present. Moving the fragment to another location may however trigger dormant algae etc to start growing if the conditions are right.

Figure 24 Detail of the root system still present from when the cross was covered with ivy

The west side looks like it was nature that was responsible for this section cracking no tool make are evident. Ivy roots (see figure 24) are still present and could have helped split a weakness in the stone alongside ice, but it is also possible the removal from one of its many locations caused the loss of this section of stone.

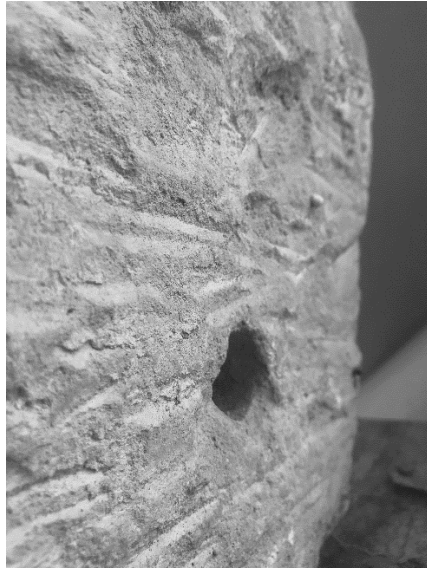
Figure 25 The unknown hole on the northside

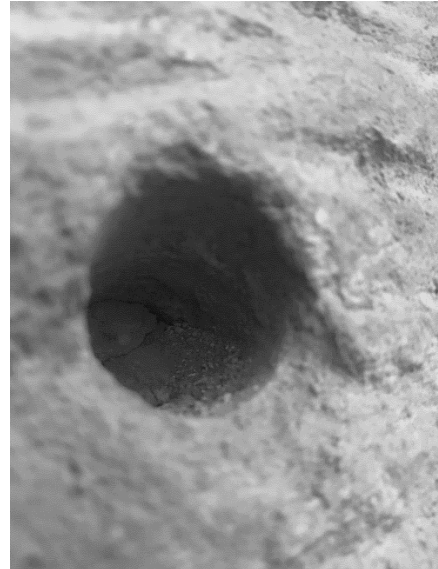
Figure 26 Detail of the northside hole, showing brown lime mortar remains within the hole

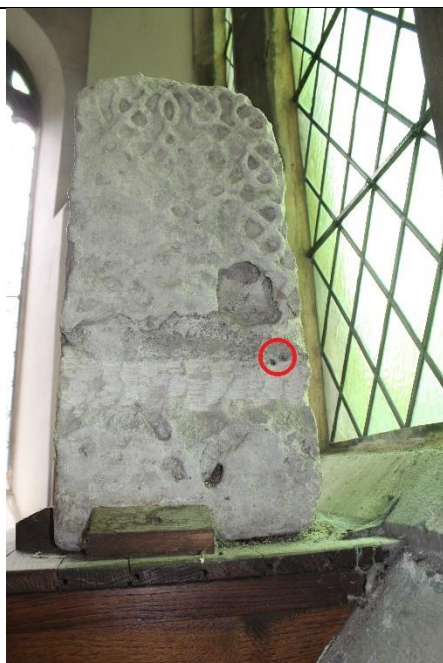
Figure 28 Locations of drill holes on the east face

Evidence of small drill holes exist on the south and east sides (see figures 28 and 29). The reason for these little holes is unclear. The set of two holes on the east side are the only holes that seem to have a common link with each other and are more likely to be made when the fragment was used as a building block. They do seem very small for standard building wooden plugs for use with screws; as do the four holes on the front face (south) unless they were for pins to secure light cables such as telephone wire? All the holes have a diameter of 5mm, all the holes but the lower sinister one on the south face are at a ninety-degree angle to the surface. The lower sinister drill hole is set at a forty-five-degree angle down into the block.

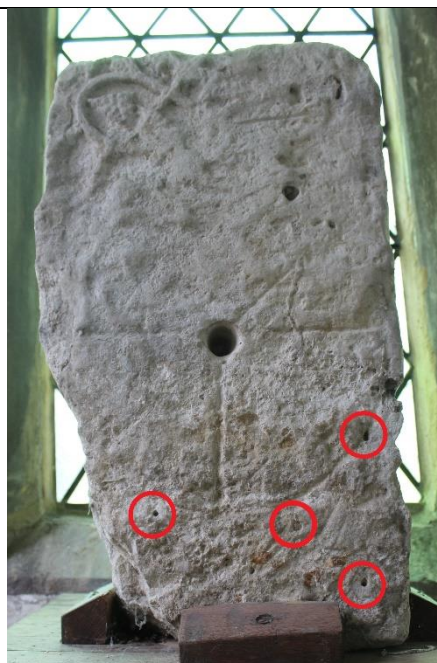
Figure 29 Locations of drill holes on the south face

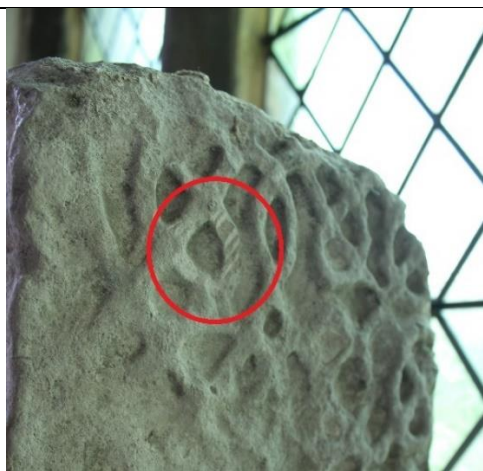
On the east side, upper dexter quarter, there has been some chiselling applied to the decoration (see figure 30). The marks are close to the same fresh strikes lower on the same face.

Figure 30 Location of modern chisel marks on the east face

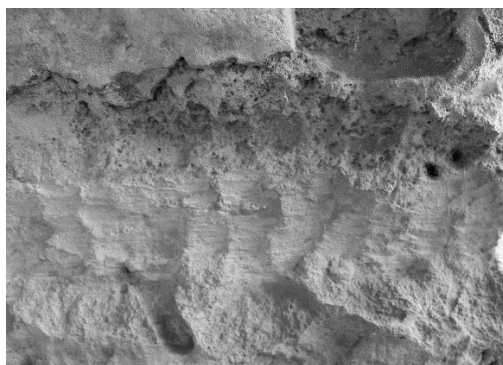
The lower east face has been worked twice, once with just being roughly chased out, then a second time which was more thoughtful with a small chisel and mallet. The two phases may be a considerably long time apart, the chasing out has lost all marks, but the later chiselling still has its white strike marks etched onto the stone.

Figure 31 Two types of cutting into the east lower faces. The larger chasing out with crude cutting and the more considered cutting.

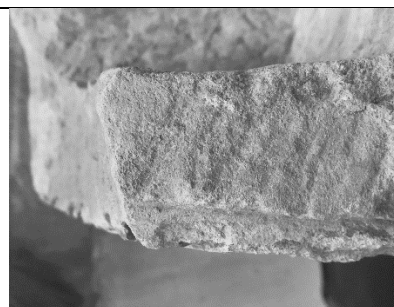
Figure 32 The top of the socket on the west side, tool marks levelling off the stone

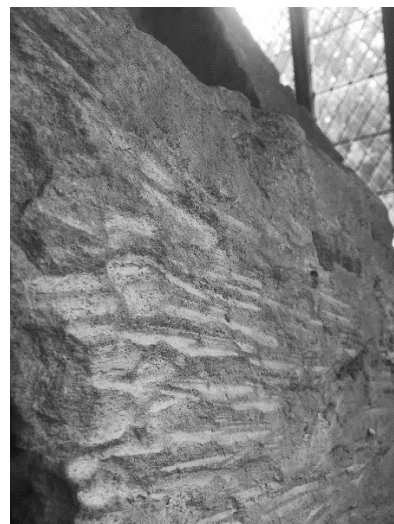
Reshaping for use as a building block, the north face has had the whole side reduced very carefully and precisely. The chisel marks are still present and show they were struck with a small bolster (see figure 22).

Figure 33 Cut marks made by a bolster along north side. All the decoration on this side has been lost.

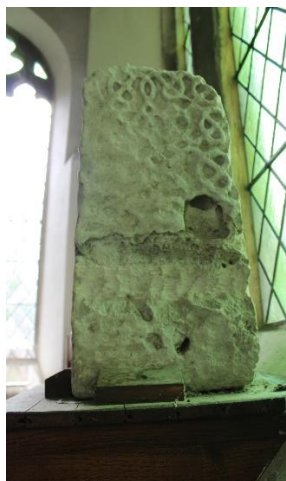
The glass within the window have differing shades of the colour green; set as diamonds in lead cames. This coloured glass does cast a displeasing hue onto the stone (see figures 37 and 38 for comparison).

Figure 37 East side, photograph taken without flash with the green hue cast

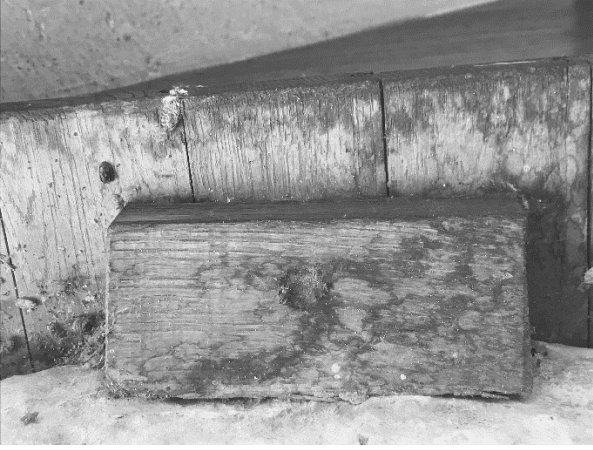
<p>Figure 39 Water damage, recorded in the block and top of the wooden box sinister side of cross</p>

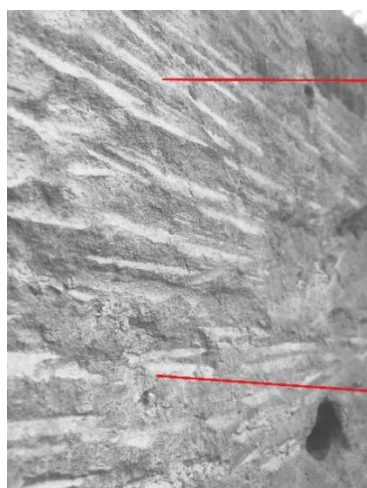
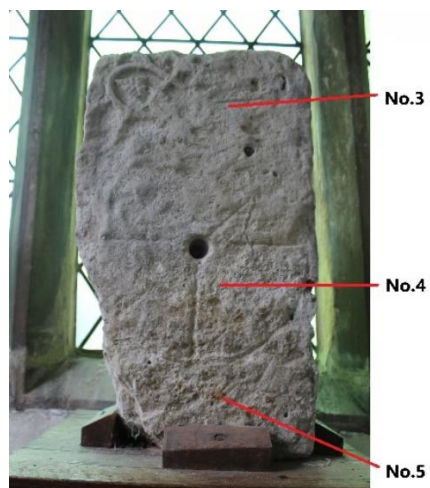
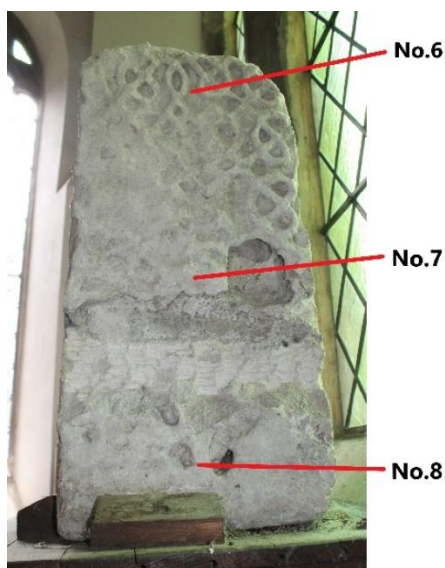
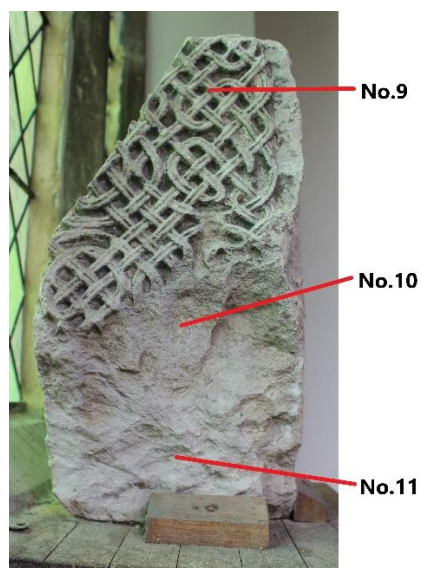
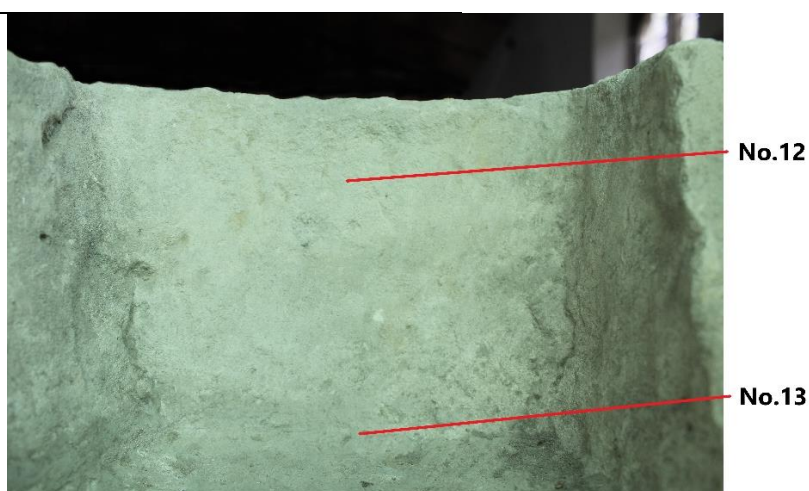
### 23.1 Moisture Readings Locations

No.1- 11.6 Dry	No.5 – 12.3 Dry	No.9 – 15.1 Dry	No.13 – 10.9 Dry
No.2 – 15.1 Dry	No.6 - 15.5 Dry	No.10 – 9.8 Dry	
No.3 – 22.7 Wet	No.7 – 10.1 Dry	No.11 – 9.8 Dry	
No.4 – 19 Risk	No.8 – 9.5 Dry	No.12 - 21.8 Wet

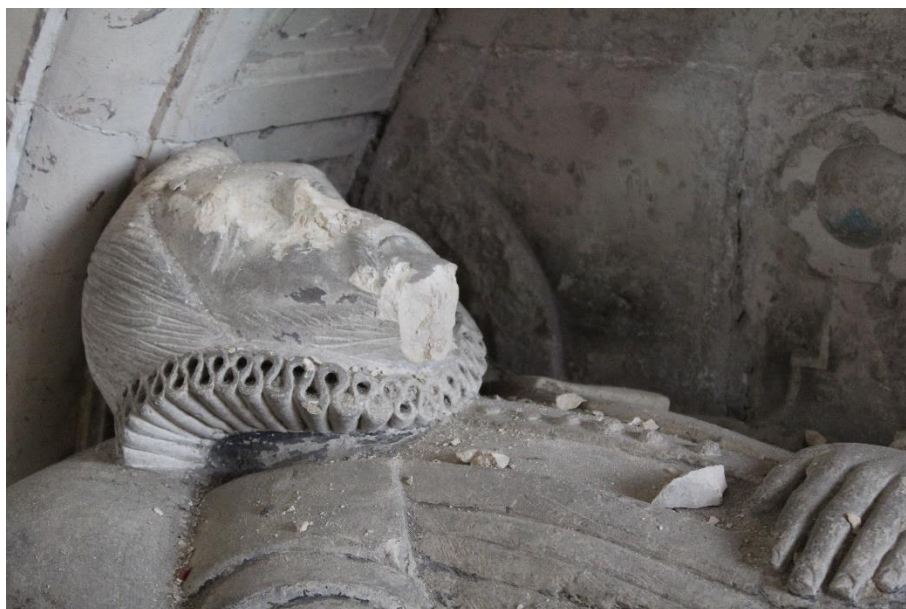
Another fixed monument within the church (*Jesop Brothers*) has had more damage from persons unknown cast upon it very recently (see figure 40, below)

Figure 40 Recent damage to one of the Jesop Brothers tomb (1626) which is situated hidden behind the organ just off the chancel to the left.
