ST PETER'S CHURCH, HEVER

REPORT ON THE CLEANING AND CONSERVATION
OF THE 17TH CENTURY WALL PAINTING

JUNE 2021

St. Peter's Church, Hever, Kent

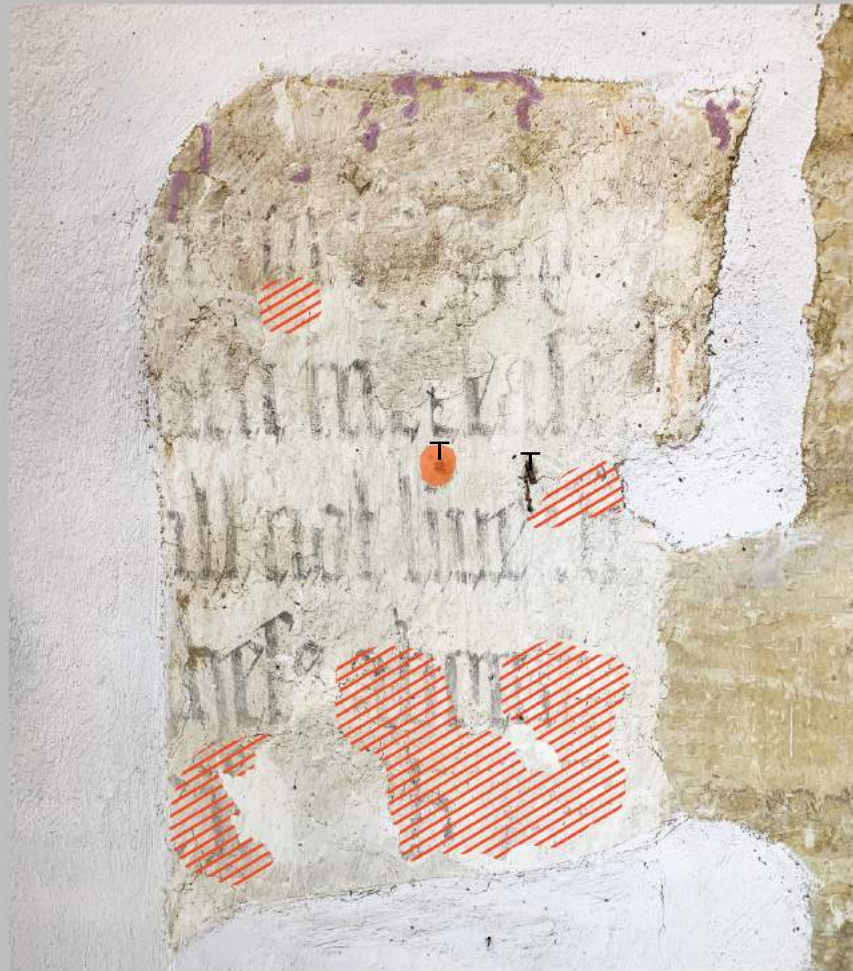
CONDITION SURVEY				
St Peter's Church, Hever, Kent North wall mural - 8 June 2021 Survey carried out by Tom Organ & Rita Radovanovich T 01795 538750 M 07770 722201 E thomasorgan@me.com				
Foreign material on surface Drip marks (water) Micro-biological growth Iron fixings - nails, etc Area of detached limewash	 	Flaking paint Powdering paint Hollow but stable plaster Areas of plaster requiring grouting Loss of original plaster layer	 Recent paint losses Old lime plaster repairs Old cementitious plaster repairs Cracks requiring plaster repairs Surface accretions (plaster smears)	
Arte CONSERVATION

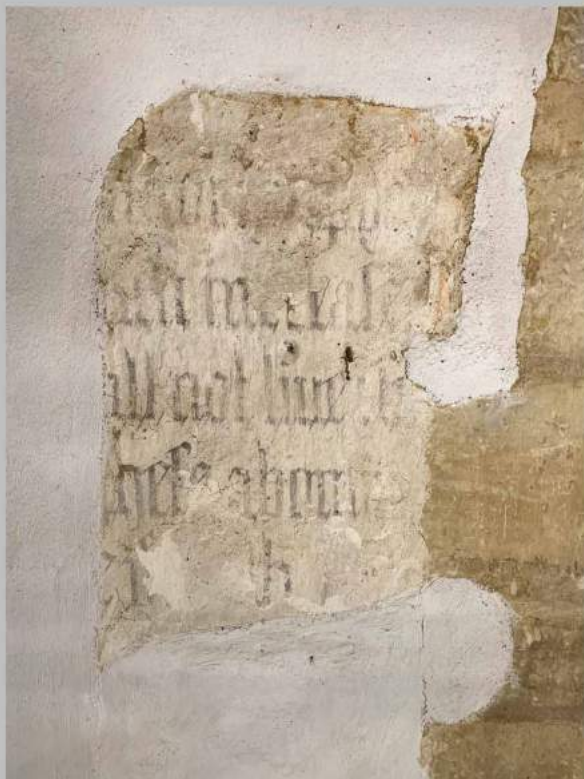
The condition of the mural prior to treatment

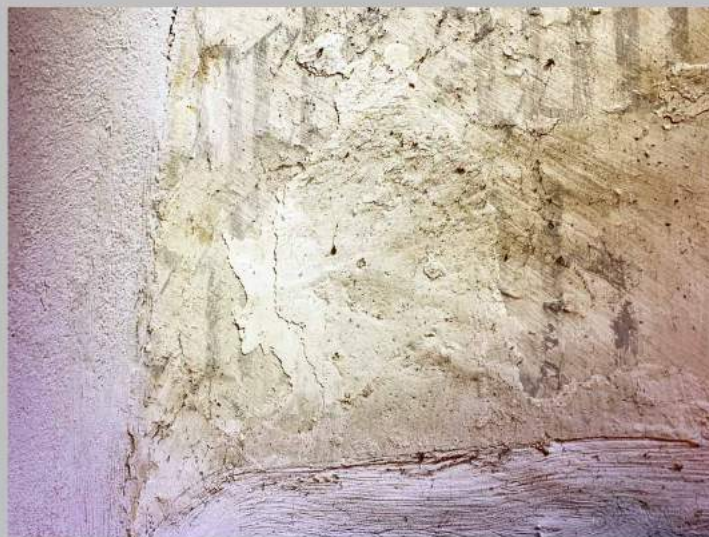
The surviving fragment of wall painting appeared to be in a relatively stable condition in most areas but there were a few areas of concern, most notably within the lower third, particularly on the lower left where it was evident that there had been some recent loss both of the limewash layer and the text – see *Condition Record on page 7*. The text was covered by accumulated dust and dirt and there were localised areas of plaster on the surface of the lettering. This is probably residual lime plaster from the 19th century restoration and extensive replastering of the interior. The black paint layer appeared to be only weakly bound and was rather powdery in places. The causes of the localised flaking and recent losses were not immediately apparent – i.e. there was no simple identifiable cause such as water infiltration – but were rather more likely to be the result of long-term issues. There is no evidence of any previous restoration work to the mural and it may be that the limewash layers have been in a weakened condition since the time that they were discovered behind the Jacobean pulpit in 1894.

Recent losses to the lower left side

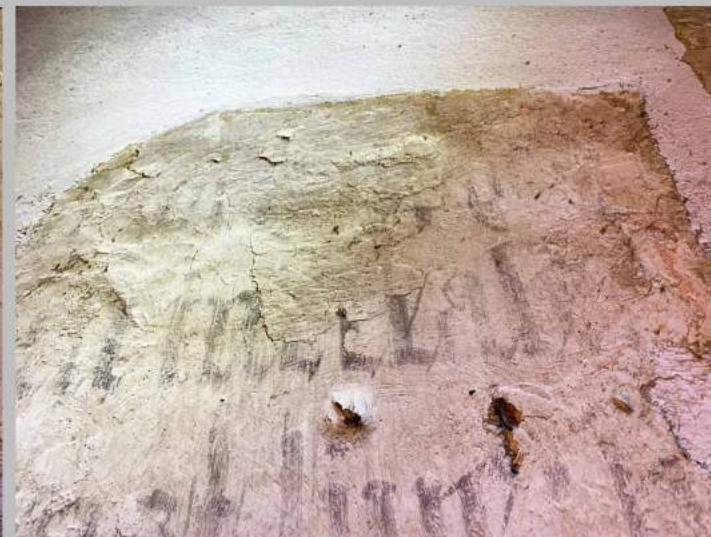
A heavy accumulation of dust and dirt on the upper parts
and an old nail

- 5.2 Surface cleaning Superficial cleaning of the painted surfaces was carried out in order to remove the accumulation of dust, dirt, salty debris and cobwebs using very fine haired soft brushes to carefully and gently lift dirt, etc. towards a Museum Vac® adjustable vacuum cleaner. Some additional cleaning was achieved during the process of stabilising the paint and the subsequent clearing of residues with deionised water. After stabilisation of weak areas further cleaning was achieved using a dilute ammonium bicarbonate⁴ solution (5% in deionised water) to remove ingrained dirt.

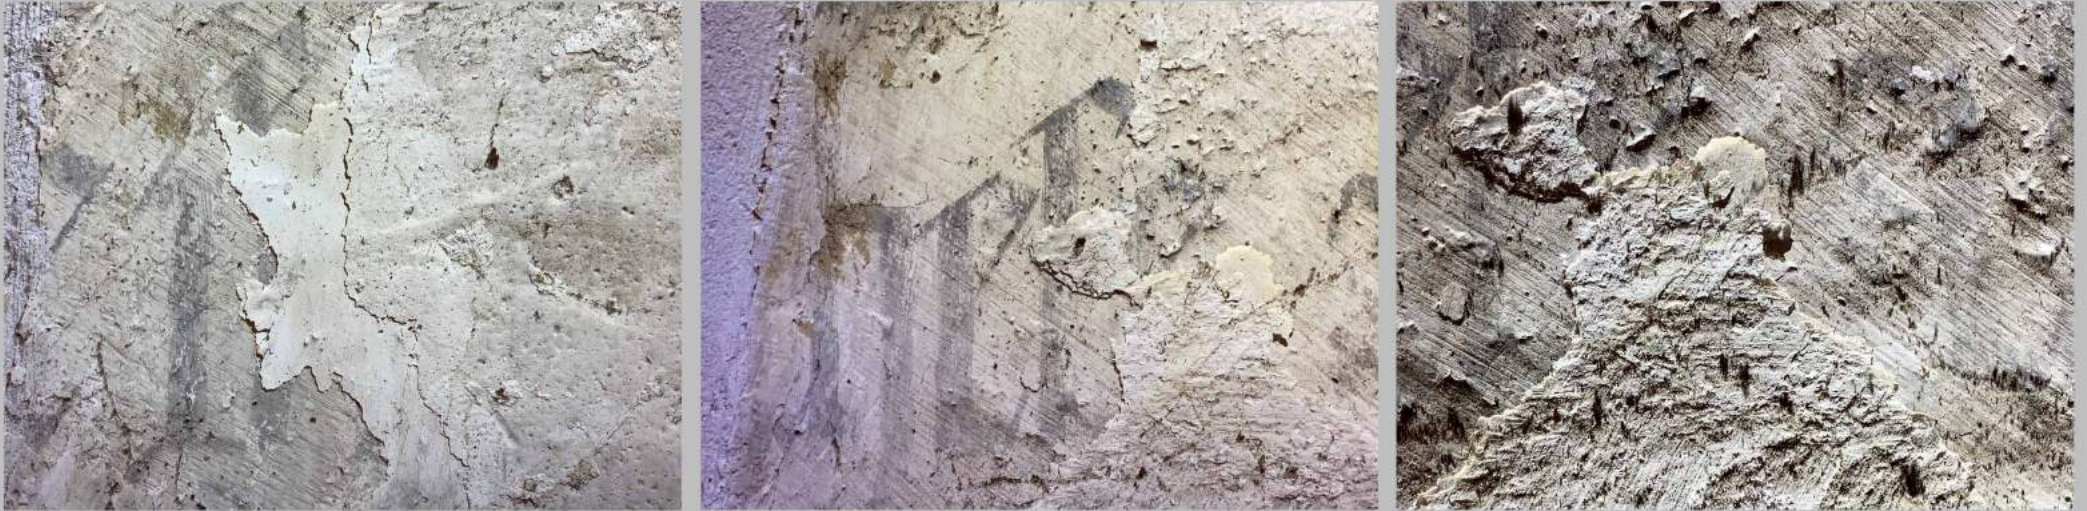
Plates 4-6 - 17th century Biblical Text (*from left to right*)

Detail showing the recent limewash loss on the lower left side

Areas of 19th century plaster smeared on the text

The heavy accumulation of dust, dirt and cobwebs

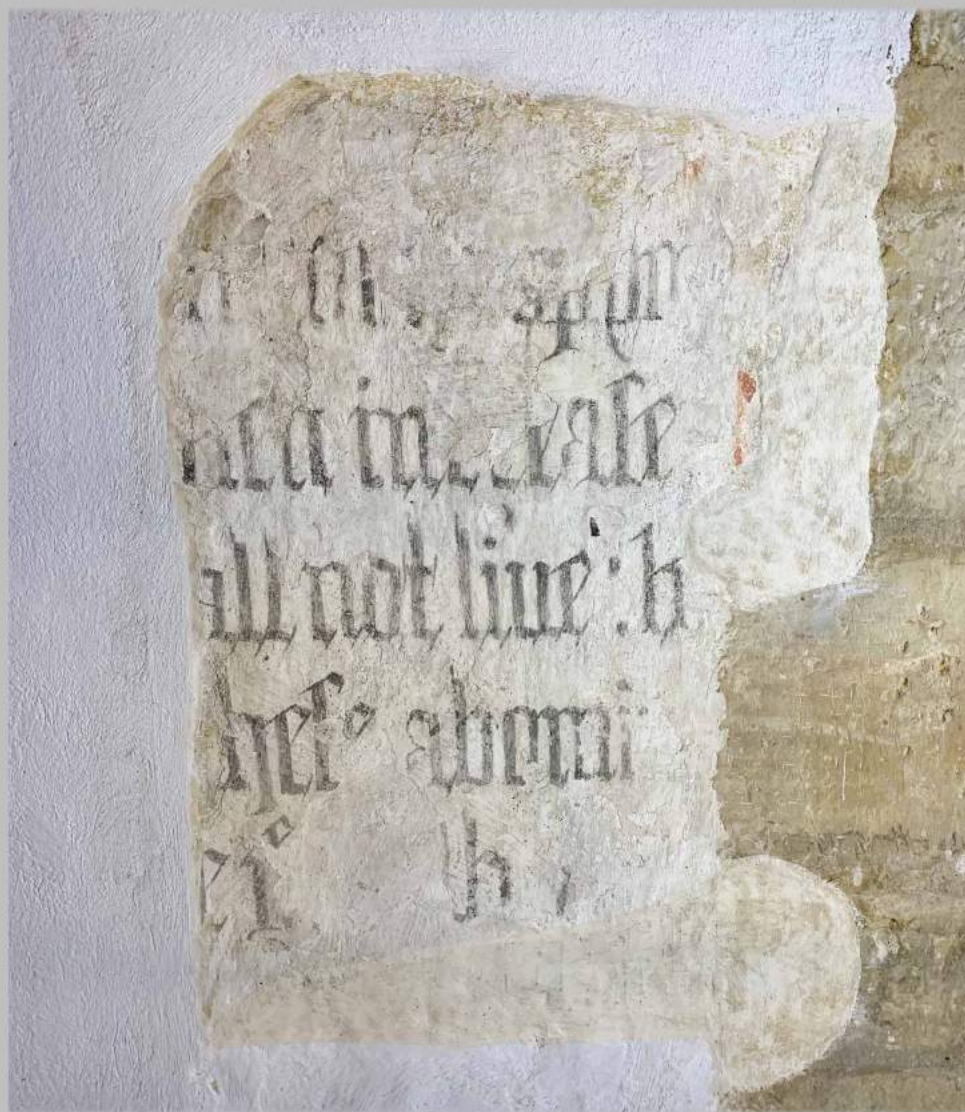
Plate 7 - 17th century Biblical Text from Ezekiel 18:13

The mural fragment after cleaning and conservattin
