RE: ST MARTIN'S CHURCH, CONEY STREET, YORK- JOHN KENDALL MONUMENT

We carried out an initial investigation into the condition of the John Kendall Monument in St Martin's Church on January 22, 2019. The findings from this initial investigation are detailed in our Report, dated February 5th, 2019.

Based on this evidence, we were then invited to carry out the dismantling of the monument and careful transportation of the elements back to our workshop, which led to a more detailed investigation of its condition. The process of dismantling the monument and subsequent recommendations for repair were detailed in our second Report, dated July 26th, 2019.

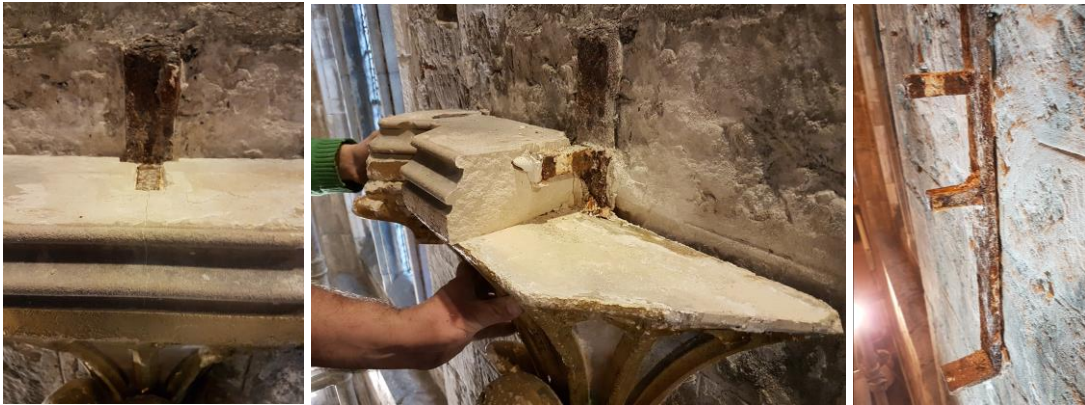
1. We removed all of the iron cramps by gently micro-drilling around them. When excavated, it became apparent that the wrought-iron armatures were completely over-sized, and for this reason some components of the monument were made quite weak when it was originally made.

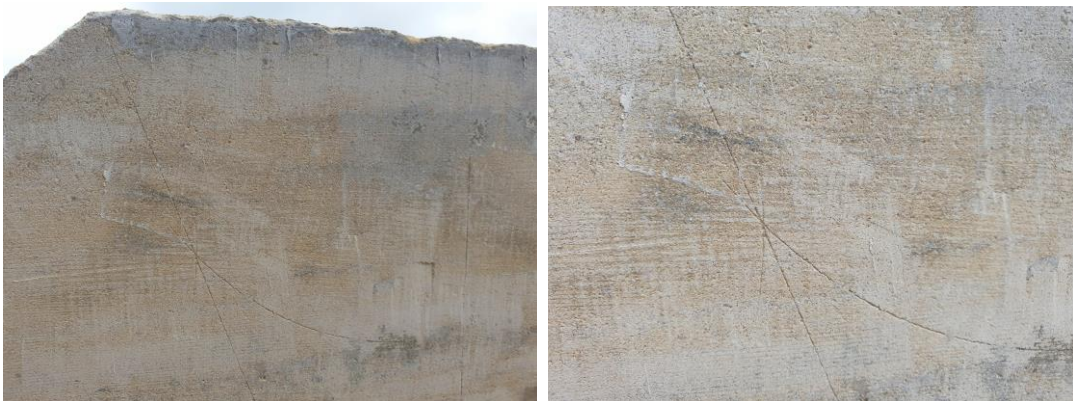
2. We are quite confident that all of the fixings are original and that the monument was placed in its current position when it was first made. Some of the fixings in the wall of the church were poured with lead. All other fixings on the monument were lime-mortared with a high gypsum content. Further, the plaster remaining on the back, behind the monument, appears to be in line with the date on the plaque.
3. We cleaned the mortar off of every stone and fragment, and we found old setting-out lines from when it was made, which was very interesting.

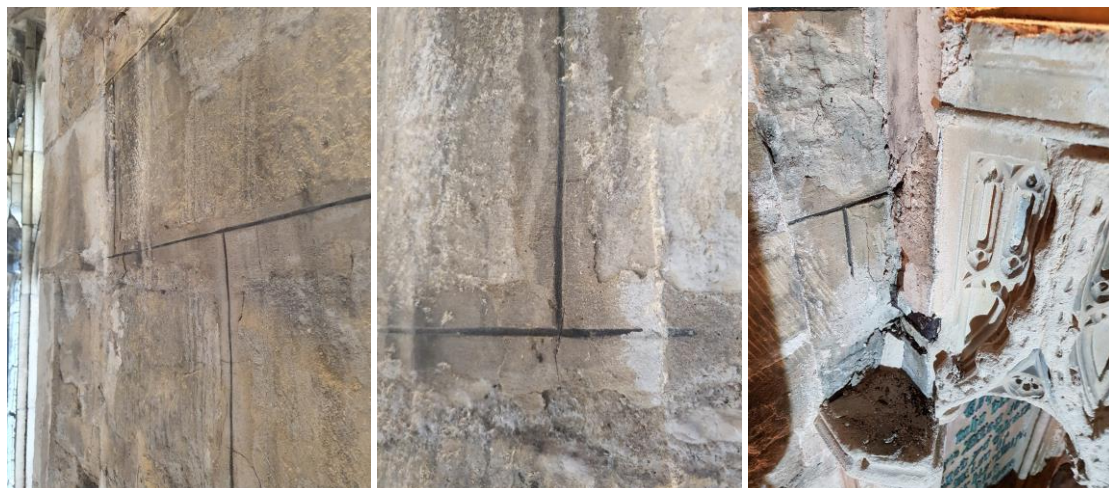
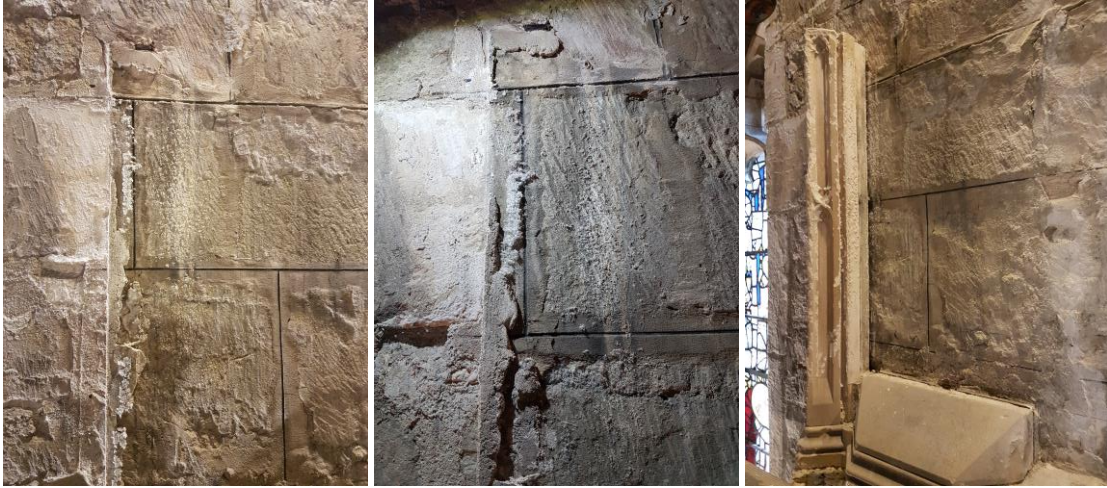
4. As the monument was mortared directly to the church wall, and the church wall appeared to be very wet for extended periods in previous years, the monument most likely absorbed a lot of the embedded salts in the wall, as clearly seen on the original scored and painted joint lines.

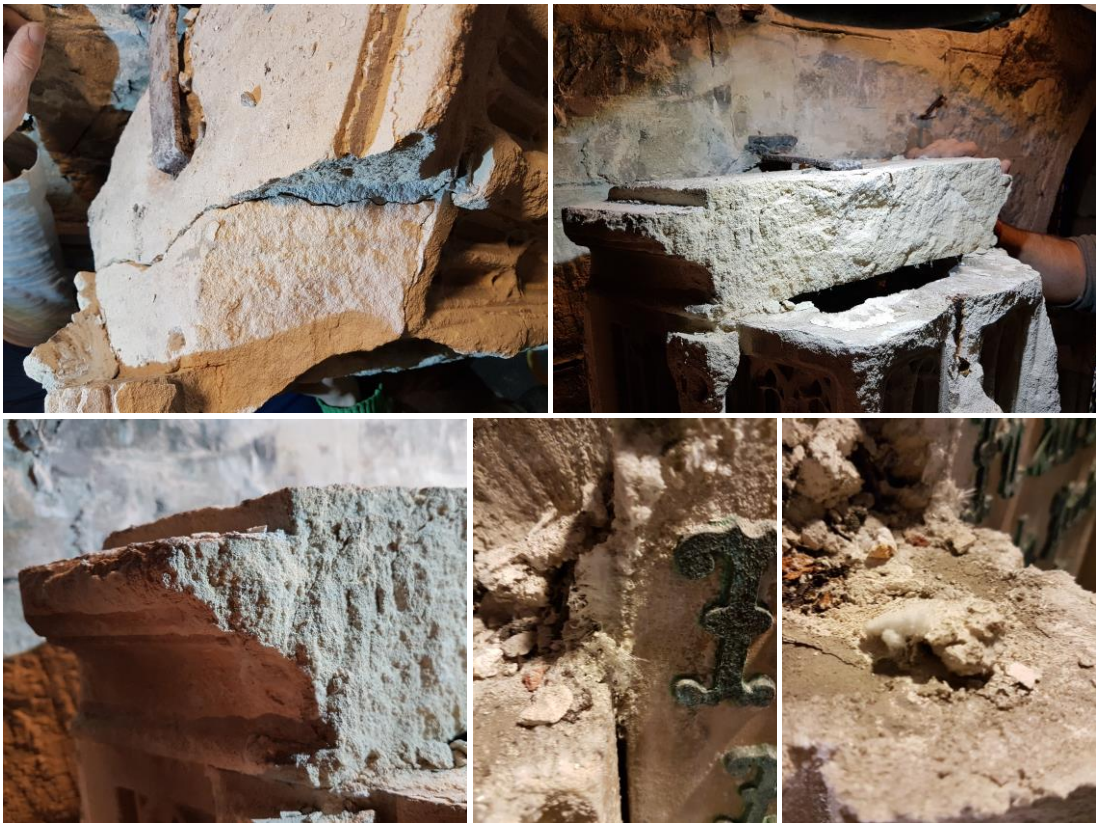
5. In short, the monument was loaded throughout with salt- which also resulted in heavy surface erosion. But some of the salt, when dried out within the cracks caused by rust jacking of the wrought-iron, grew and further accelerated the monument's decay. This indicated to us that this cracking and salt ingress has occurred over a long period of time.

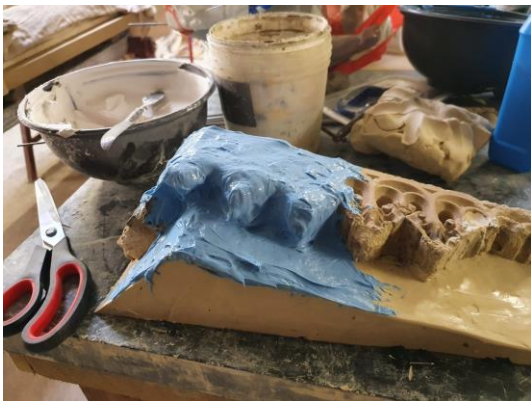
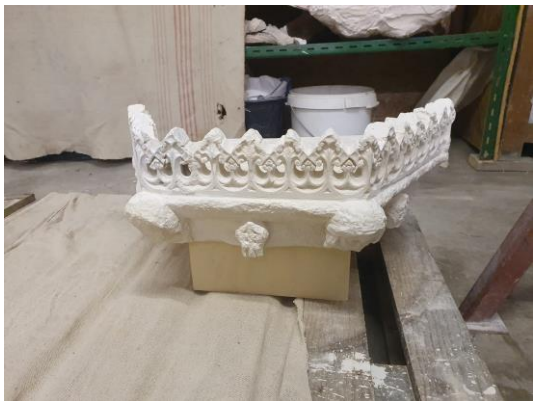
10. The corona had approximately 40% of original material missing. We casted areas of the existing, cleaned elements to reproduce the missing parts in Herculite plaster. These pieces were then shaped to match the existing, broken, remaining items. No original material was removed.

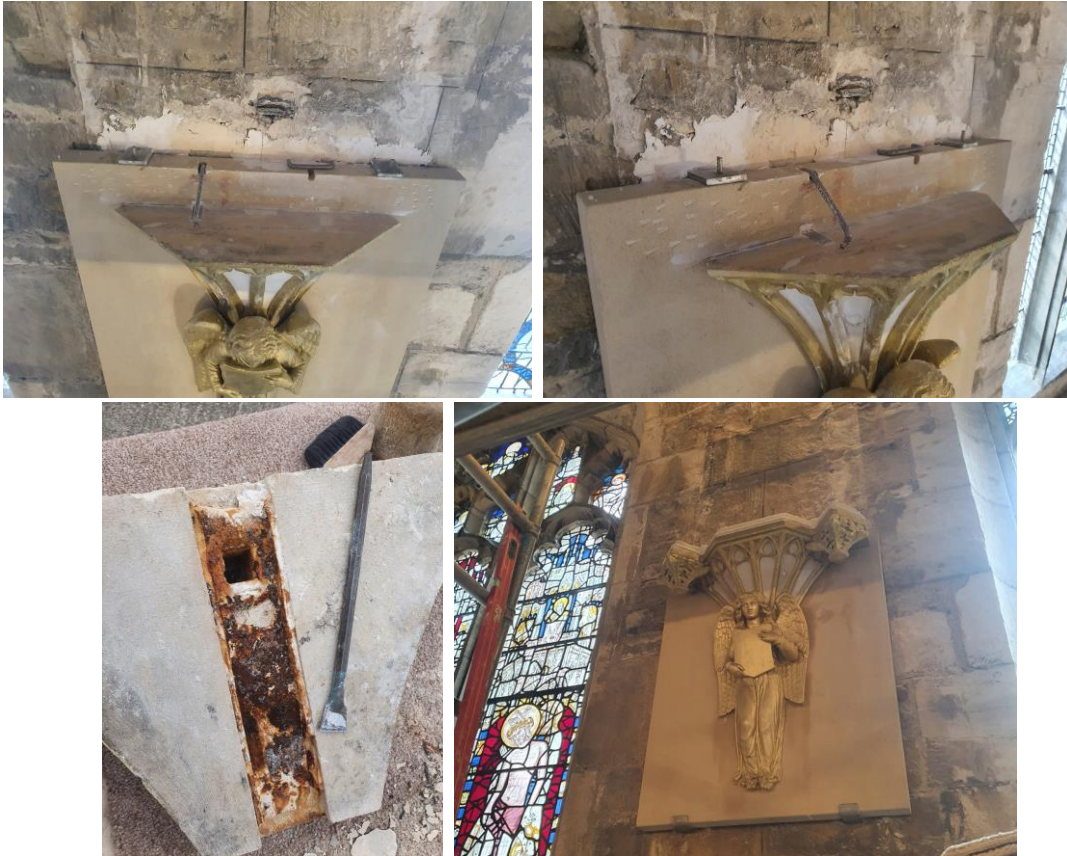
12. The bracket above the angel has two large stainless-steel flat bars embedded at the top and fixed into the back plate as well as two downward facing pins in the centre of the bracket. This is the most structurally important piece as the rest of the monument would have sat on it, but unfortunately, as the previous fitting was grossly over-sized, the entire stone bracket was hollowed out on the back in order to receive this original fitting. We filled all of these holes using plaster in order to regain some stability within this piece.

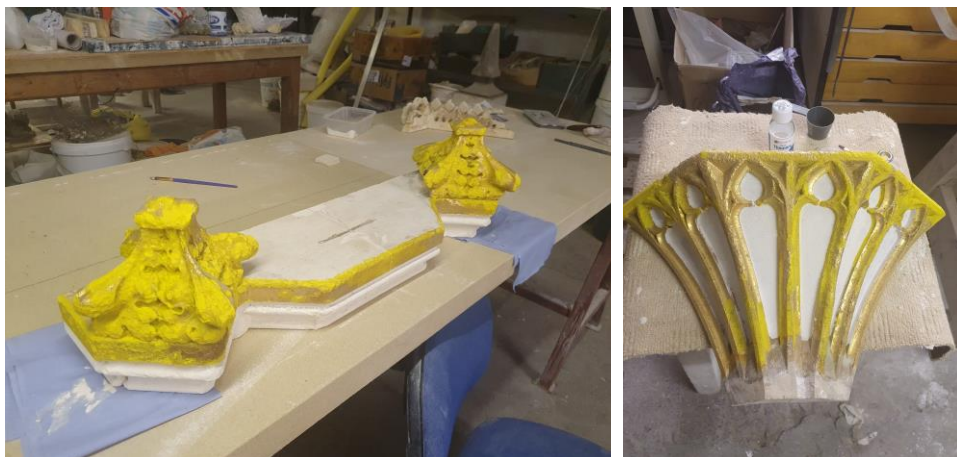
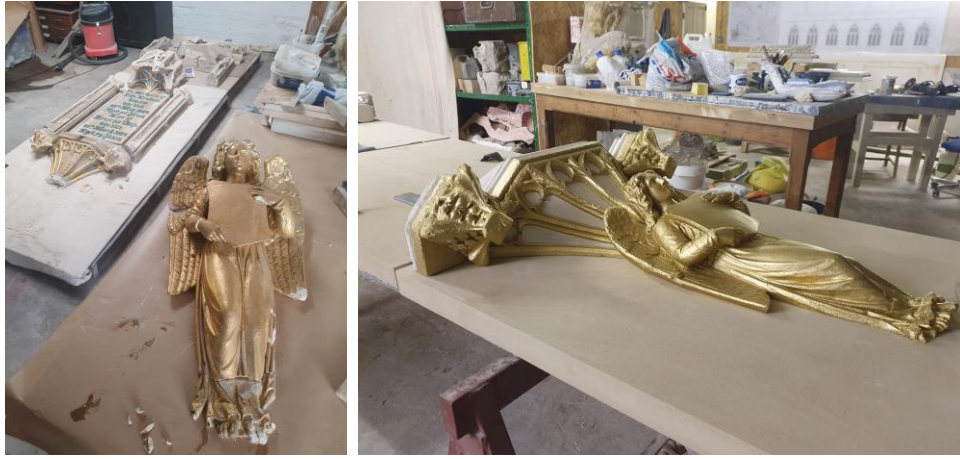
13. Above this, the shelf with two hanging corbels- which was cracked in the middle- was fitted together with two stainless steel cramps. The two hanging corbels had embedded steelwork which we removed and replaced with stainless steel. All of the carvings on this piece were heavily eroded due to salt ingress as described. All of the loose pieces were removed, cleaned and repainted with a yellow foundation paint above which was painted gold-leaf- to match the existing.

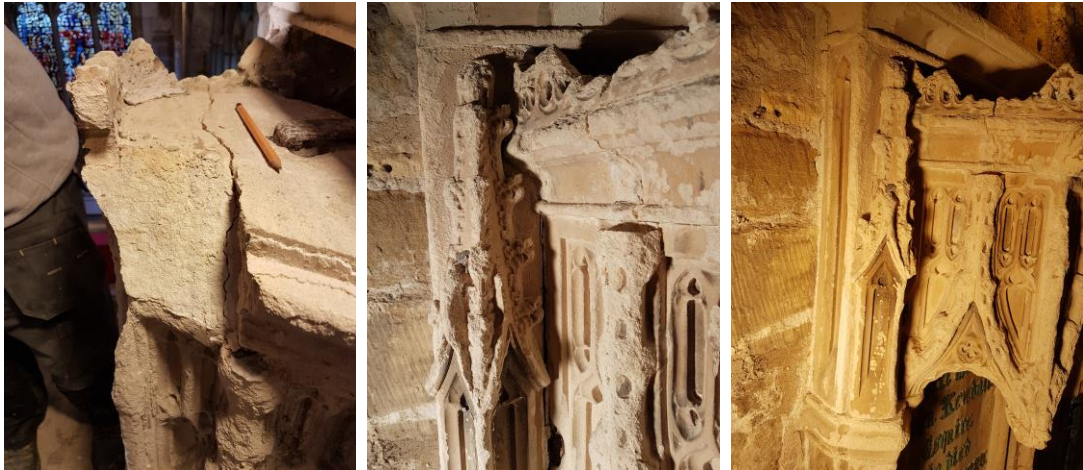
15. The corona itself was in a very bad condition and, again, the bracket below was heavily pierced with over-sized steelwork in order to stop it from toppling over as this stone has only 4 points of contact to the base stones. We repaired the entire corona, which was broken into 8 pieces, with stainless steel pins and using modern resins, plaster and lime mortar. We casted the fine fretwork on the upper left-hand side using the right-hand as a mould. These cast pieces were then shaped to fit perfectly around all existing stonework. In order to unify and bring the colours together, a very light limewash was applied to the corona top. The corona itself was fitted with five anchors, hooked into the back plate. All of these receiving holes were prepared in our workshop. Some of the stainless-steel hooks work by gravity alone. These fittings are far less intrusive, and much more sustainable, for the future of the monument.

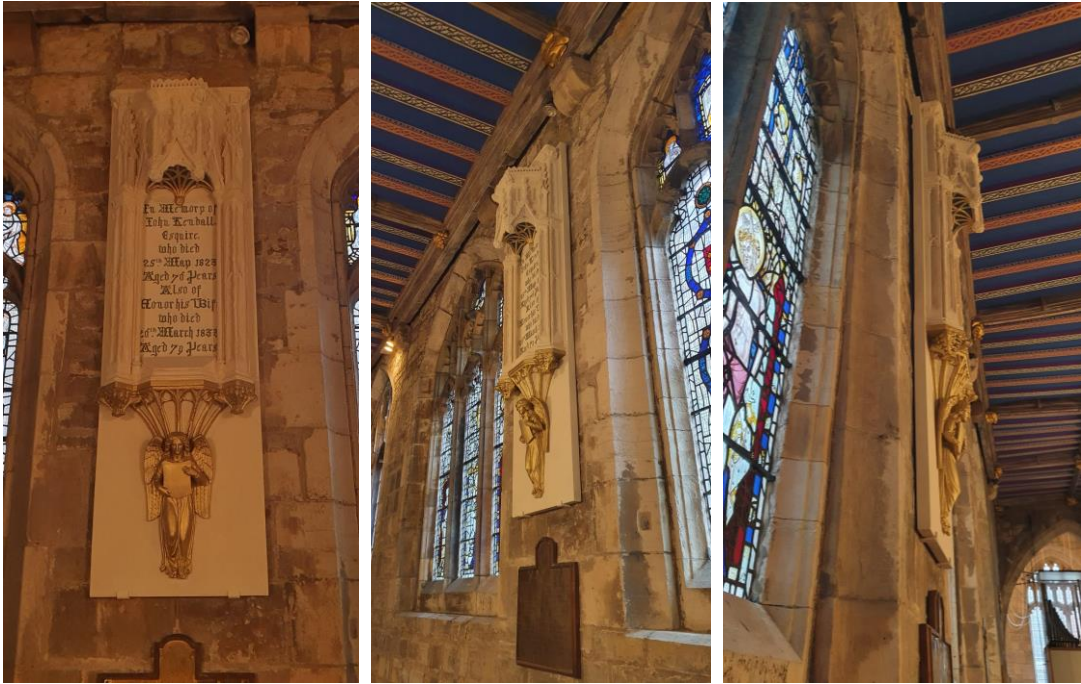
17. The monument itself is slightly leaning back in order to follow the slight tilt of the wall, but we made the monument quite flush at the base and slightly proud at the top so that all of our mechanical stainless steel fitting could be fitted through the sandstone plates and so that, most importantly, the existing wall plaster with the coloured in joint work is preserved. This fixing also now allows the monument to fully dry out on the reverse and therefore not receive any more moisture from the wall as air can flow freely between the wall and backplate.
