**A Level 2 Historic Building Recording and  
Archaeological Attendance and Recording (watching brief) at  
St. Andrew's Church, Main Street,  
Carlton,  
Leicestershire  
NGR: SK 39650 04980**

**ULAS Report No 2021-109  
©2021**

**Site Name:** St. Andrew's Church, 30 Main Street, Carlton, Leicestershire.

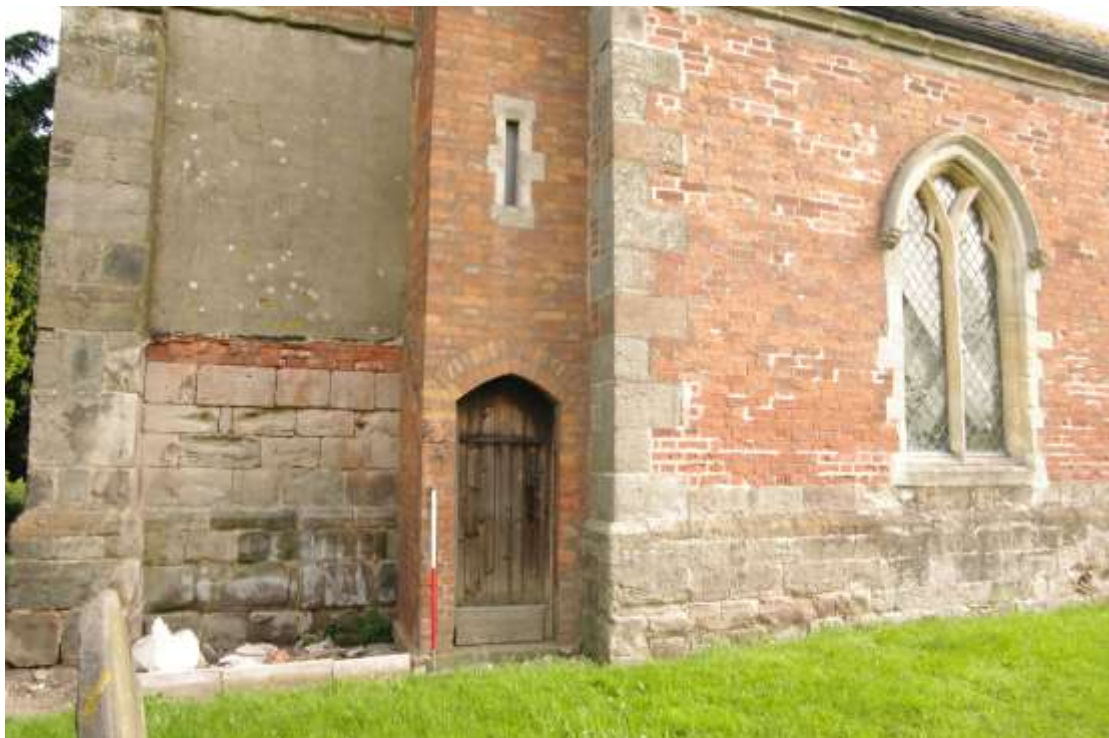
Figure 12 Location of proposed extension  
Looking north-east. 1m scale. Note the marks left by the demolished lean-to shed which had a roofline following the three courses of brick between the render and the stonework on the tower wall. The lean-to extended out as far as the brick-built clock and belfry access tower

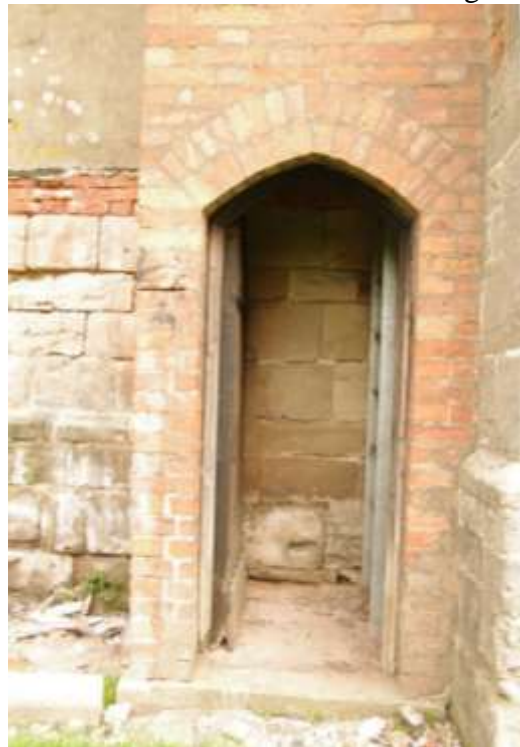
Figure 14 Open door of clock chamber and belfry access tower  
Looking north. The visible stonework within the doorway forms parts of a buttress which projects approximately 0.2m beyond the main wall of the tower

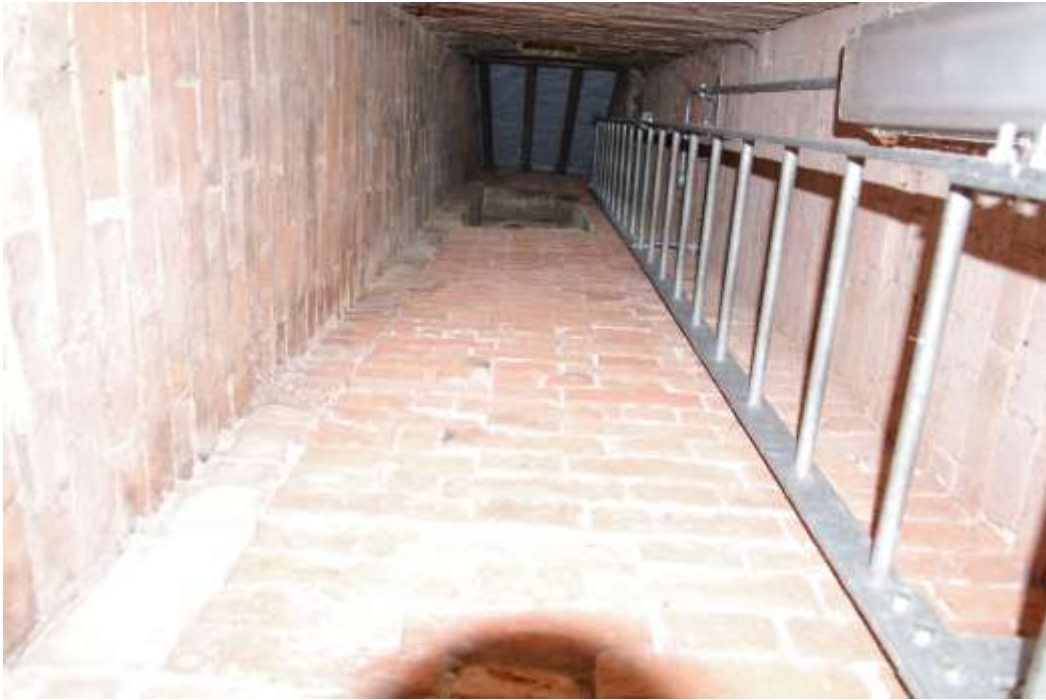
Figure 15 View up to the clock chamber and belfry access tower  
Looking north. The brickwork in the centre of the picture is part of the tower buttress.  
Note the infill of brick and later added wall on left. This indicates that the original tower access was within the main body of the tower – see Nichols illustration Fig. 3 and Fig. 16 below. This later access is probably from the 1867 remodelling

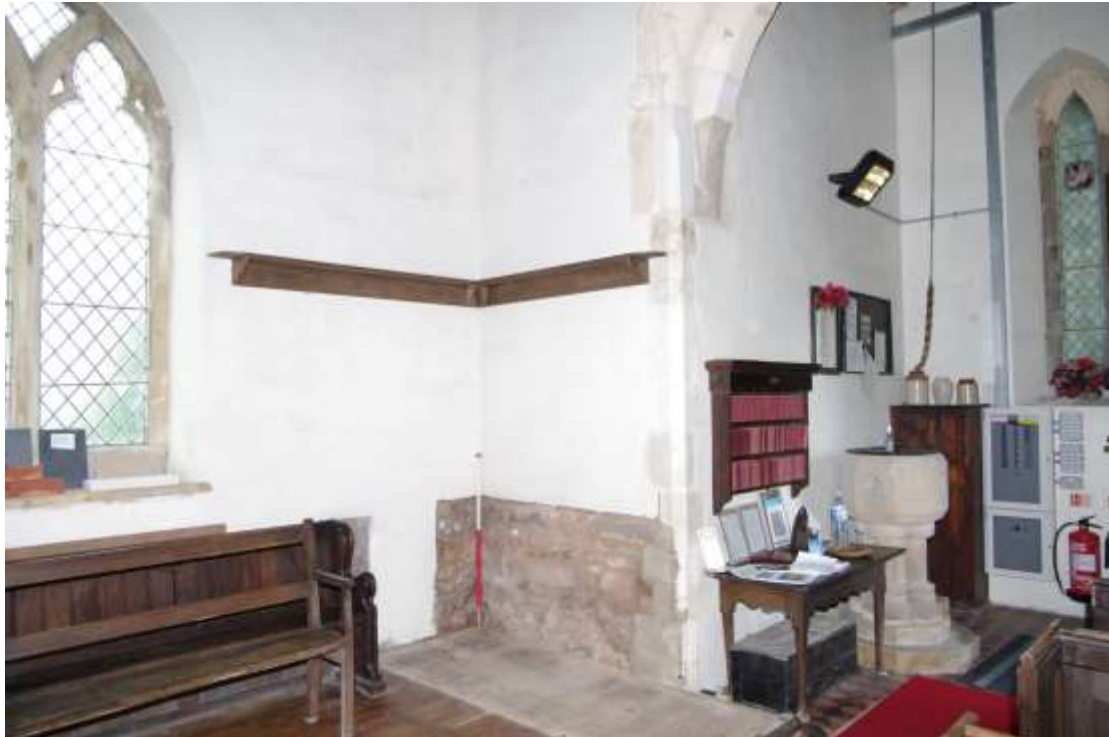
Figure 19 South-west corner of nave

The pews on this side of the nave have been removed showing the wall plaster to be relatively late and laid around the edges of the pews rather than behind them. Note font on the right which will be moved. There is no sign of burning on the stone which may have been present if the stonework was part of the earlier burnt-down church

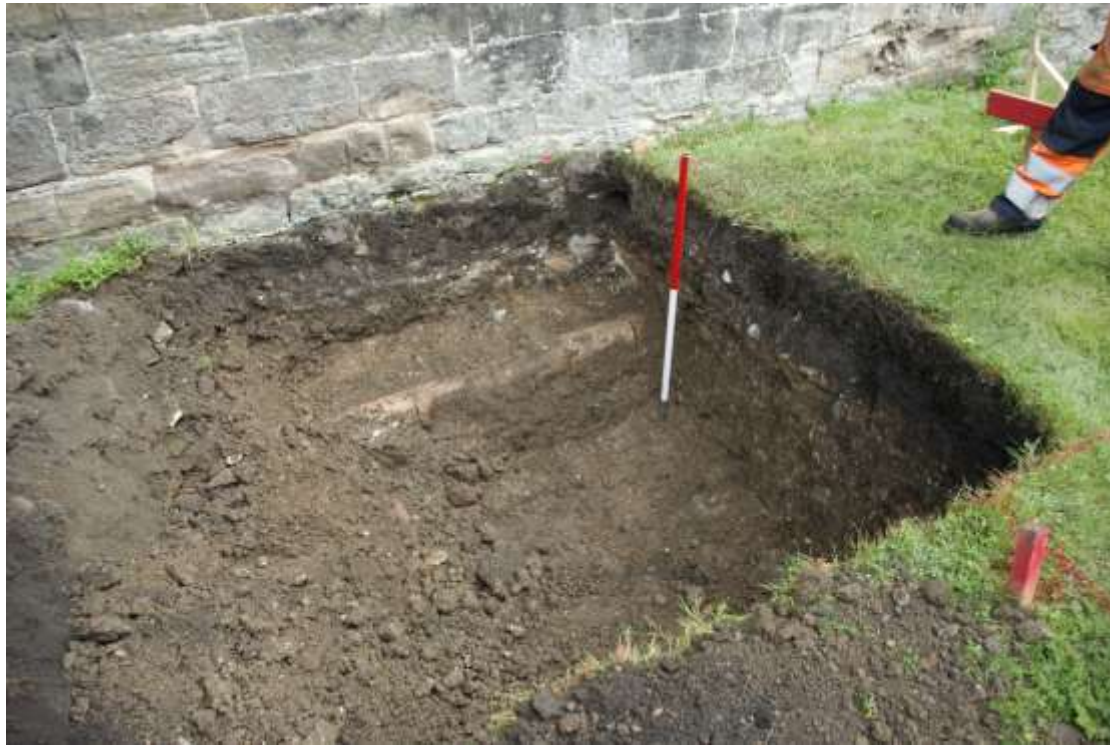
the wall and towards a ceramic land drain running parallel to the church (Fig. 26). The drain ran westwards as far as the corner of the nave before diving down beneath the base of the trench. The slates and circular-section pipes were removed during the work but will be replaced if necessary (Fig. 27). The drain pipes are likely to be of very late 19th century or early 20th century date.

Figure 26 Drain alongside the church being exposed  
Looking north-east. 1m scale

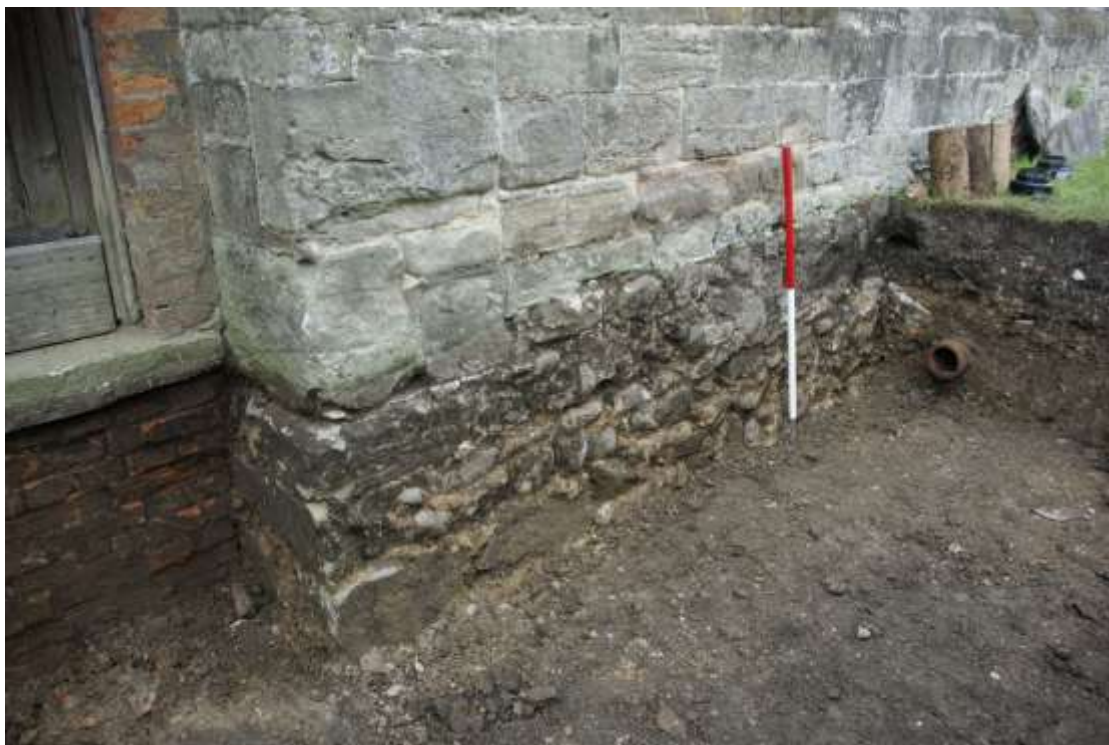
Removal of the drain exposed the uncoursed rubble church wall with faced ashlar stone only being present at ground level (Fig. 28). The stone continued below the maximum depth of excavation. Whilst it cannot be stated with absolute certainty that this exposed base was only built as part of the 1764 church, the use of the same stone in both the ashlar wall and the below ground quoin stones (see Fig. 28) suggests that this wall is all of one phase and not part of the earlier church.

Figure 28 Exposed base of nave wall  
Looking north-east. 1m scale. Tower on left

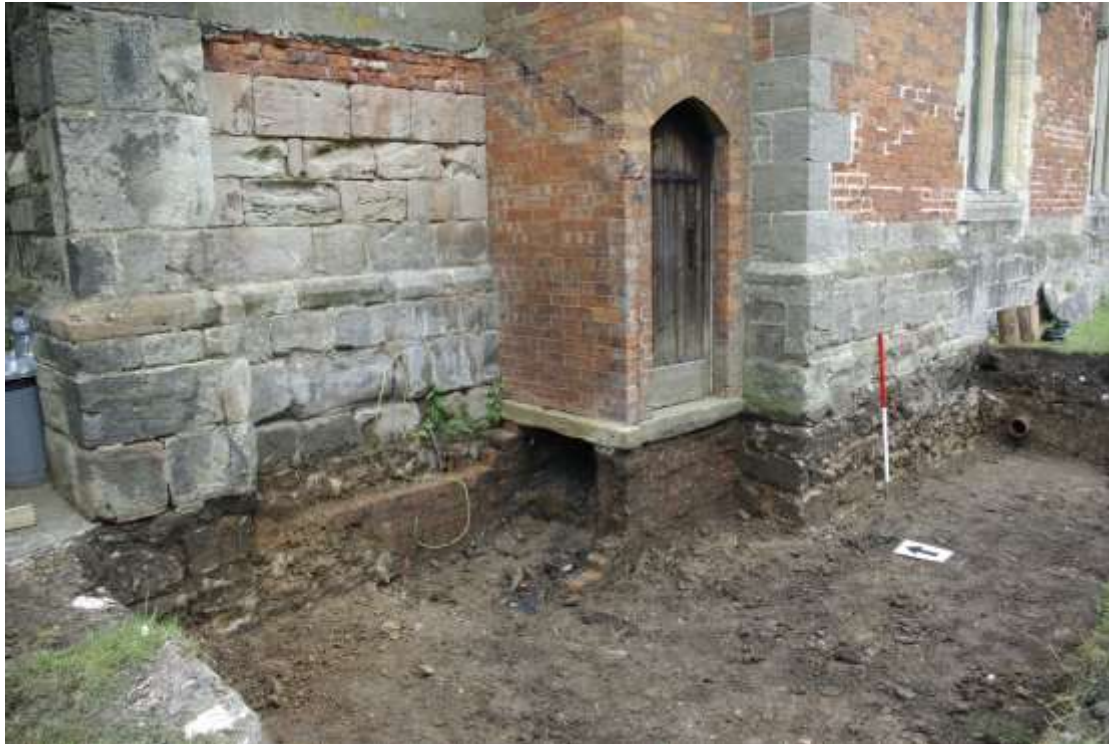
As the excavation progressed westwards towards the tower the base of the later belfry access tower was exposed. This base consisted of a pair of brick walls bridged with a stone plinth across a void (Fig. 29). The brick wall closest to the main body of the tower continued across to the western tower buttress joining with part of a wider stone base (Fig. 30). Because the supporting walls continued beyond the maximum depth of excavation it is not known how deep these walls are. The area immediately around the belfry tower contained a lot of clean pale yellowish brown clay mixed with the mid-orange brown mixed sandy clay seen elsewhere in the excavated area which was probably part of the backfill from the construction of the belfry access tower.

Figure 29 Exposed base of belfry access tower  
Looking north-east. 1m scale

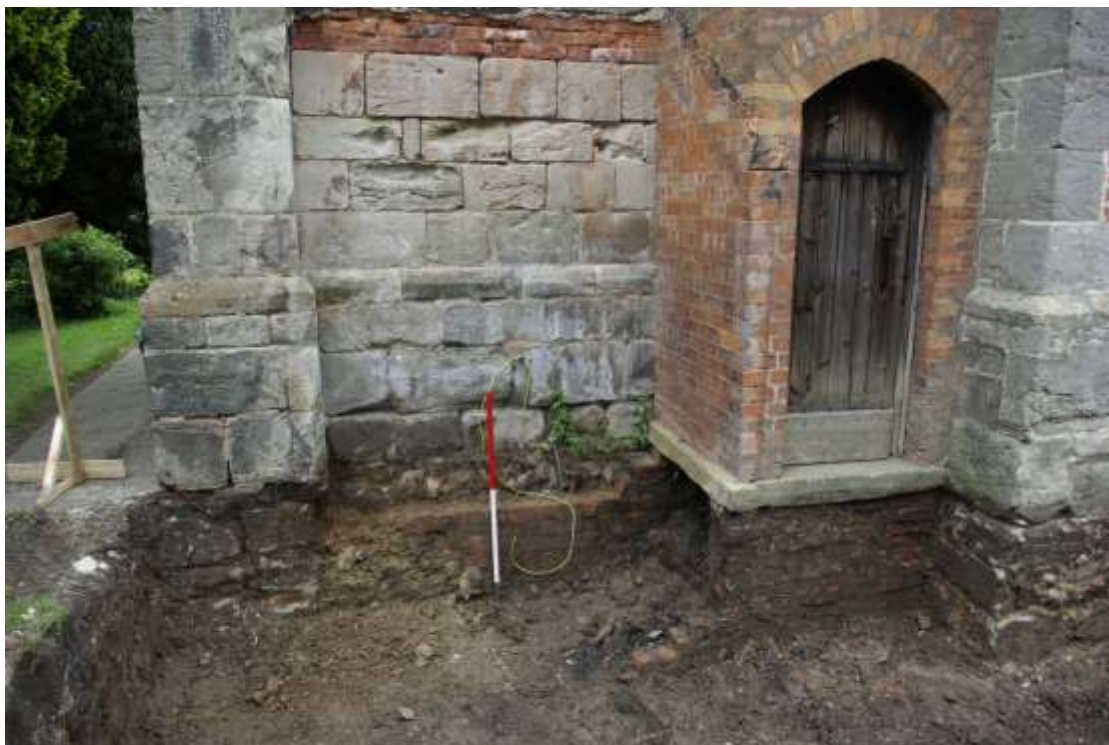
The tower base, as with all other walls seen in this excavation, continued below the maximum trench depth with no visible evidence of any earlier phases of buildings. The exposed structure of the tower consisted of stone rubble with areas of brick of the same size as used elsewhere in the tower walls. The coursed ashlar stone corner buttress of the tower was seen, and recorded, down to the same depth during the test pitting exercise.

Figure 30 Exposed tower base  
Looking north. 1m scale

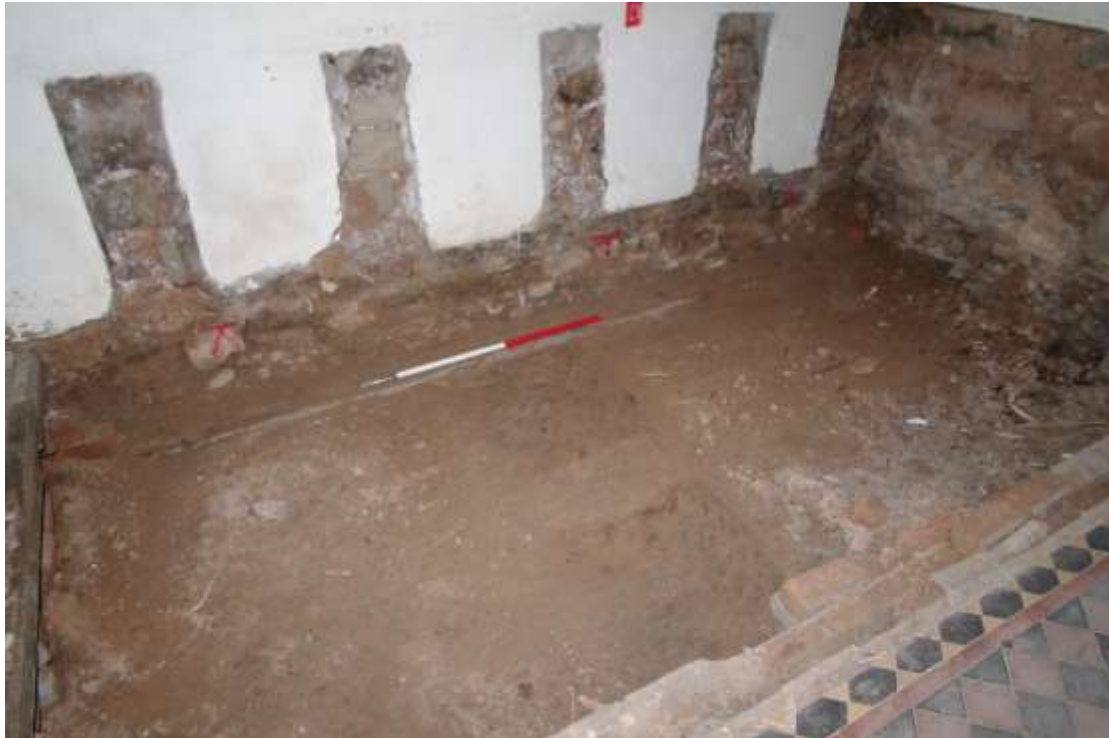
Figure 35 South-west corner of nave showing plaster outline around the pews  
Looking south-west. 1m scale

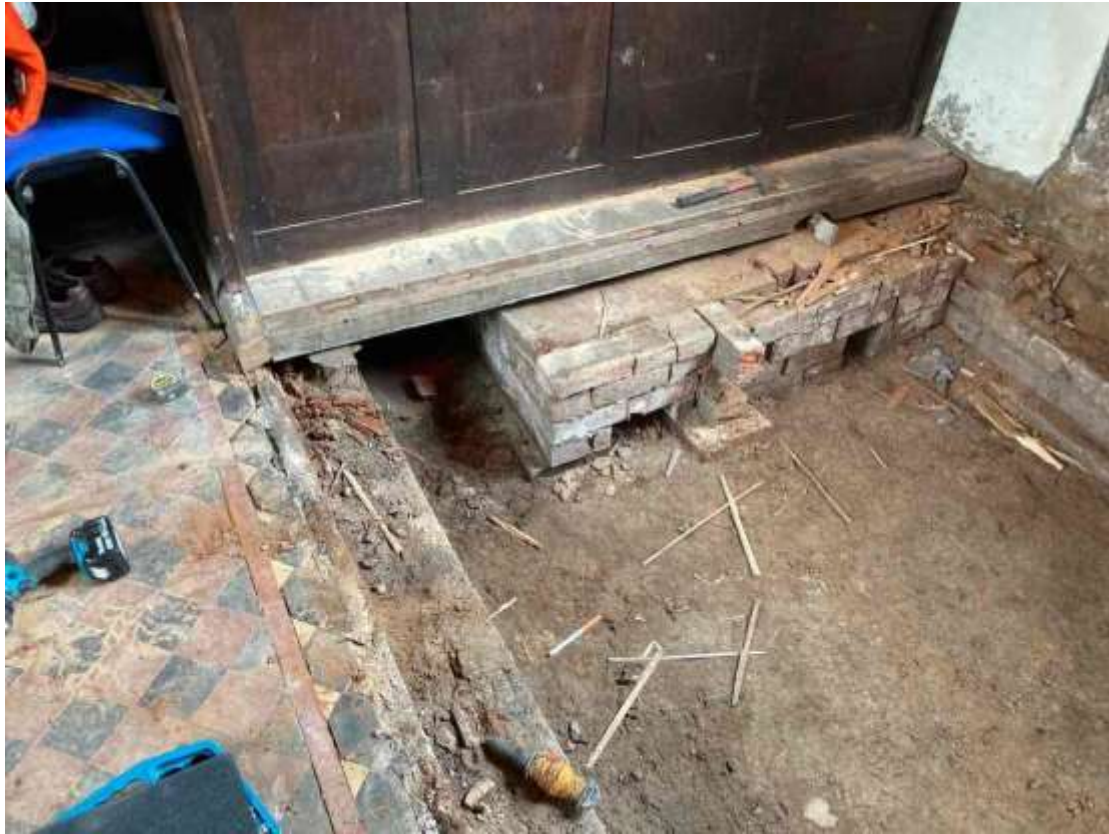
Figure 37 Exposed base for stove against south wall seen beneath pews  
Most of this plinth was left in-situ. Picture taken by Ackroyds

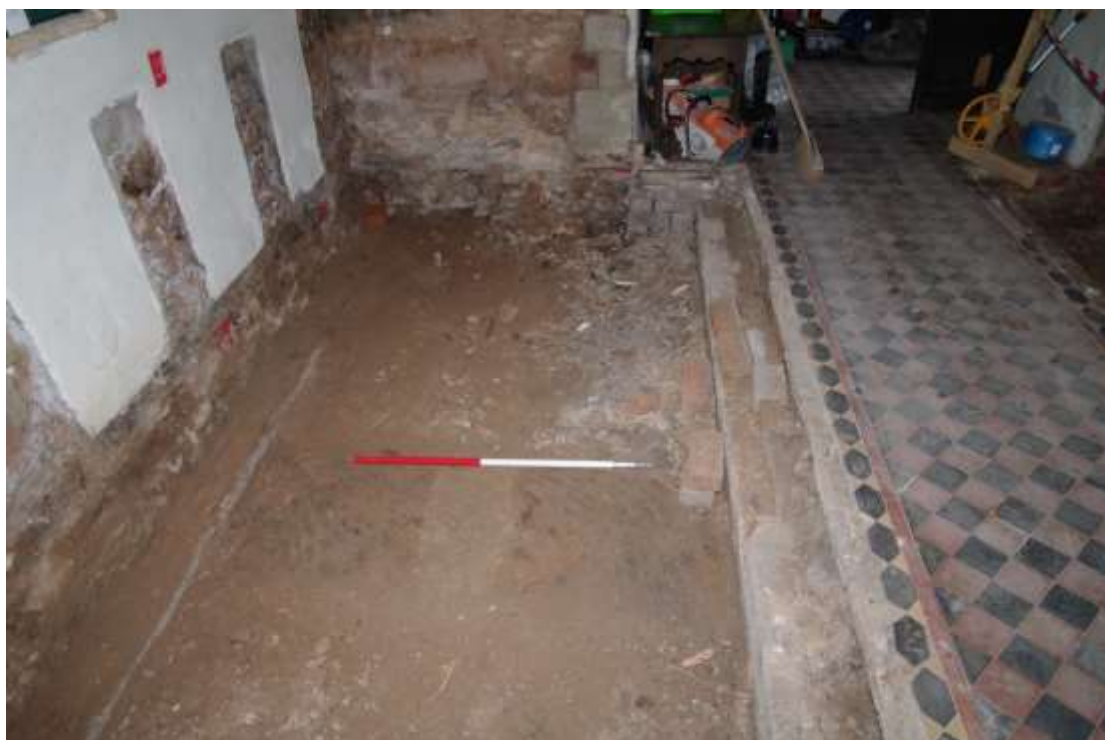
Figure 40 Compact layer beneath platforms  
Looking west on south side of aisle. The supporting bricks have been reduced in height down to the compact layer. 1m scale

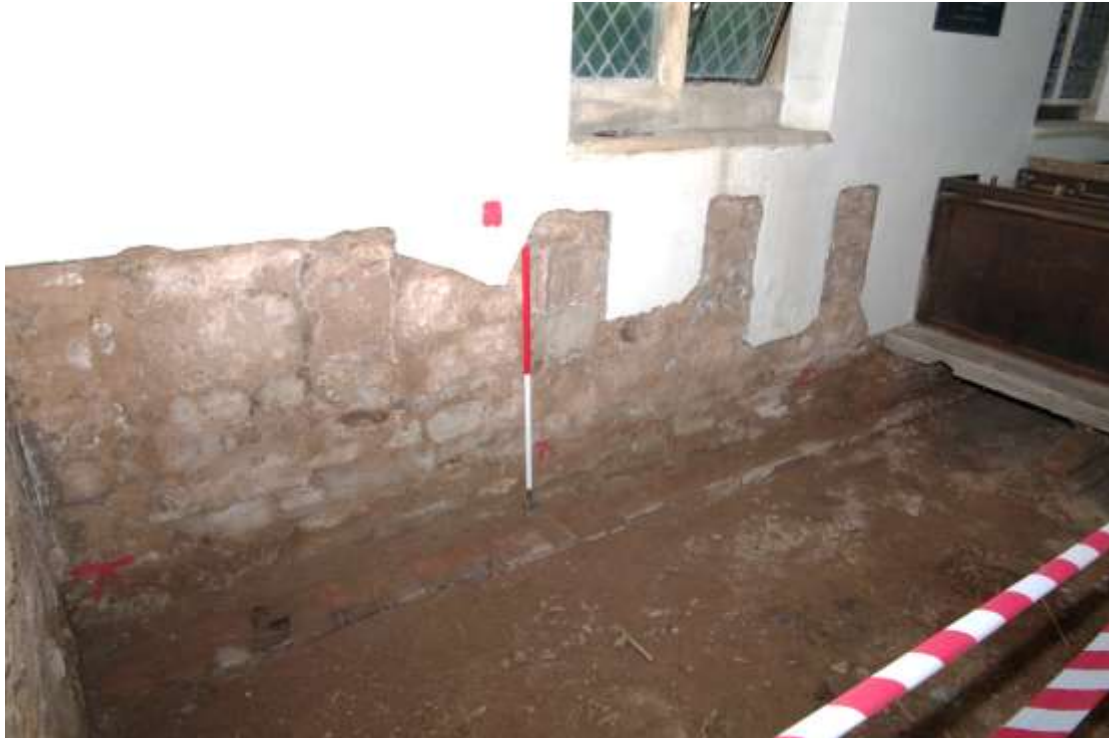
Examination of the exposed stonework of the side walls indicated that they are of a single phase as seen on the exterior walls (Figs 40 and 41). Some of the edges of the soft stone appear to have been damaged by the earlier removal of plasterwork and are still covered in unpointed mortar. The decorative quoin stones around the gothic arch into the tower stop at current floor level (Figs 42 and 43). This suggests that the creation of the arch and the present floor level are likely to be of a similar date.

Figure 41 Exposed stonework on north wall  
Looking north-east. 1m scale

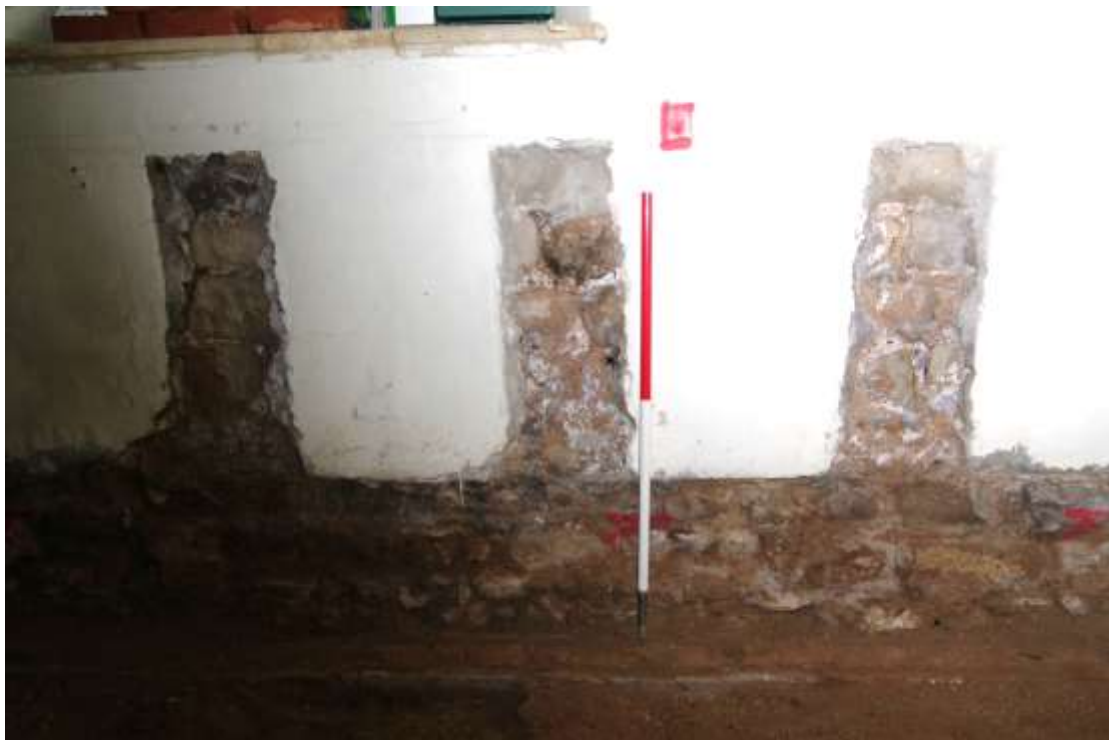
Figure 42 Exposed stonework on south wall  
Looking south. 1m scale

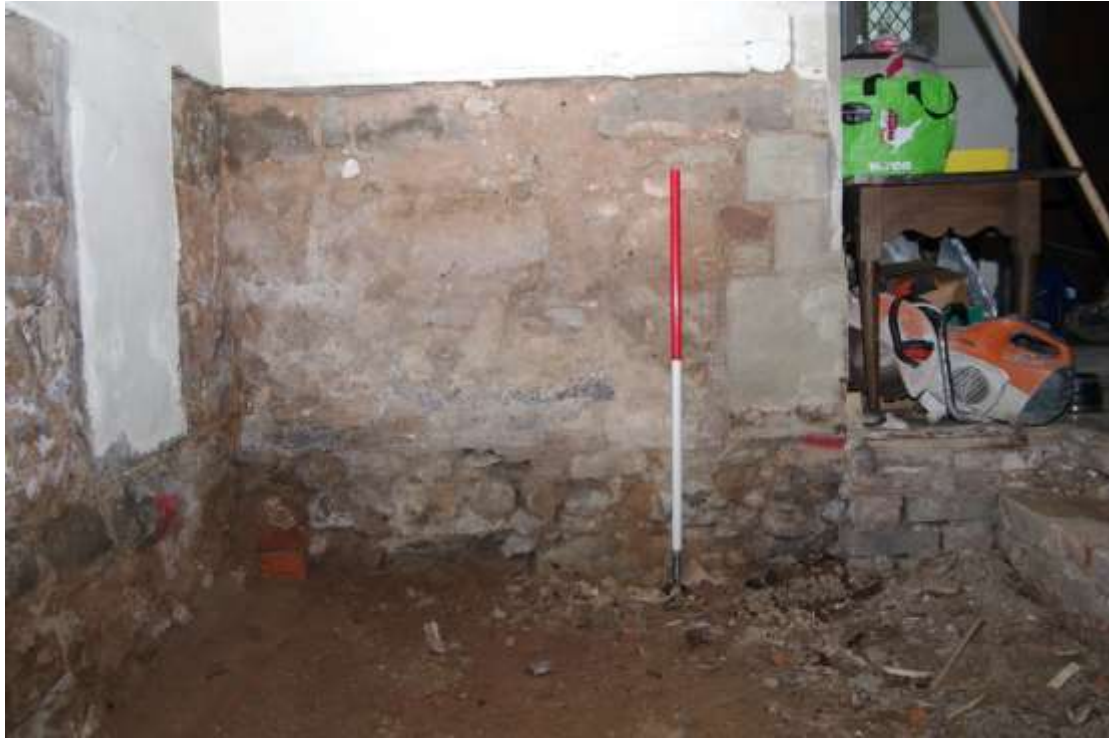
Figure 43 Tower wall on south side of aisle  
Looking west. Note how quoin stones stop at floor height. 1m scale

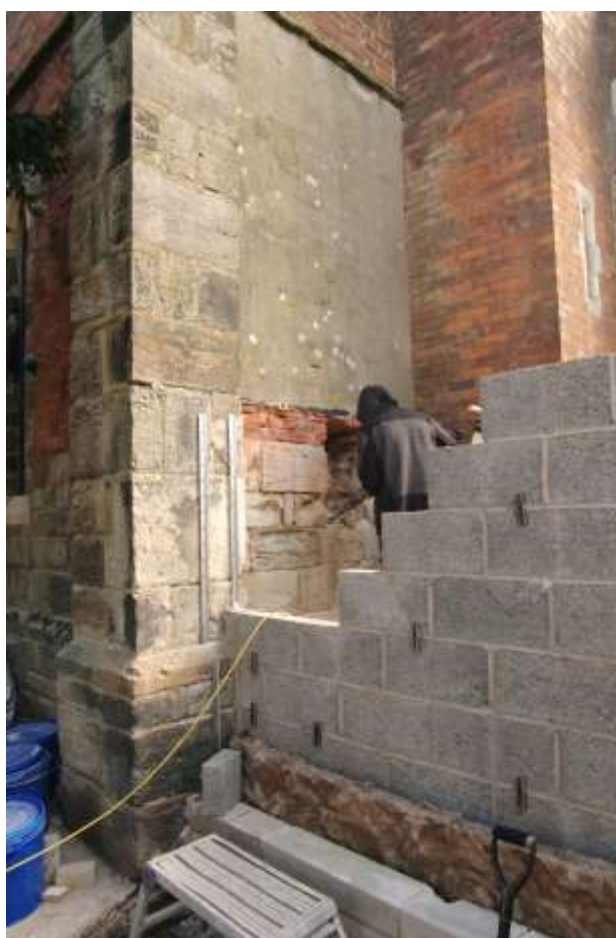
Following on from the removal of the pews and platforms the next stage involved the monitoring of the breaking through of a new doorway on the south side of the tower. Initially, the lower courses of the new extension were built in order to make the site secure before the new doorway was created. To start with, a small exploratory slot was made cutting into the wall from the outside (Fig. 44). The full height of the hole was then cut from the church floor level up to the top of the stone height and for two courses of brick on top of that (Fig. 45).

Figure 45 Initial hole being made in the south wall of the tower  
Looking north-east. Note the presence of the new extension by this stage

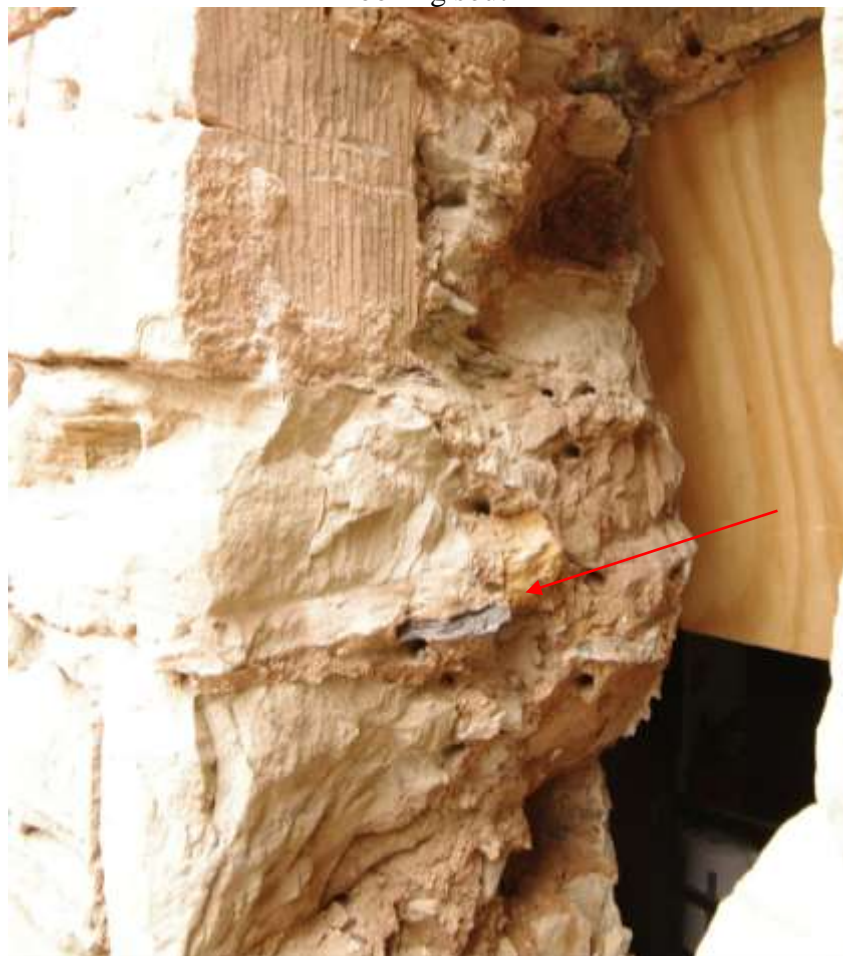
Figure 51 Piece of slate used as levelling material  
The red arrow points towards the slate

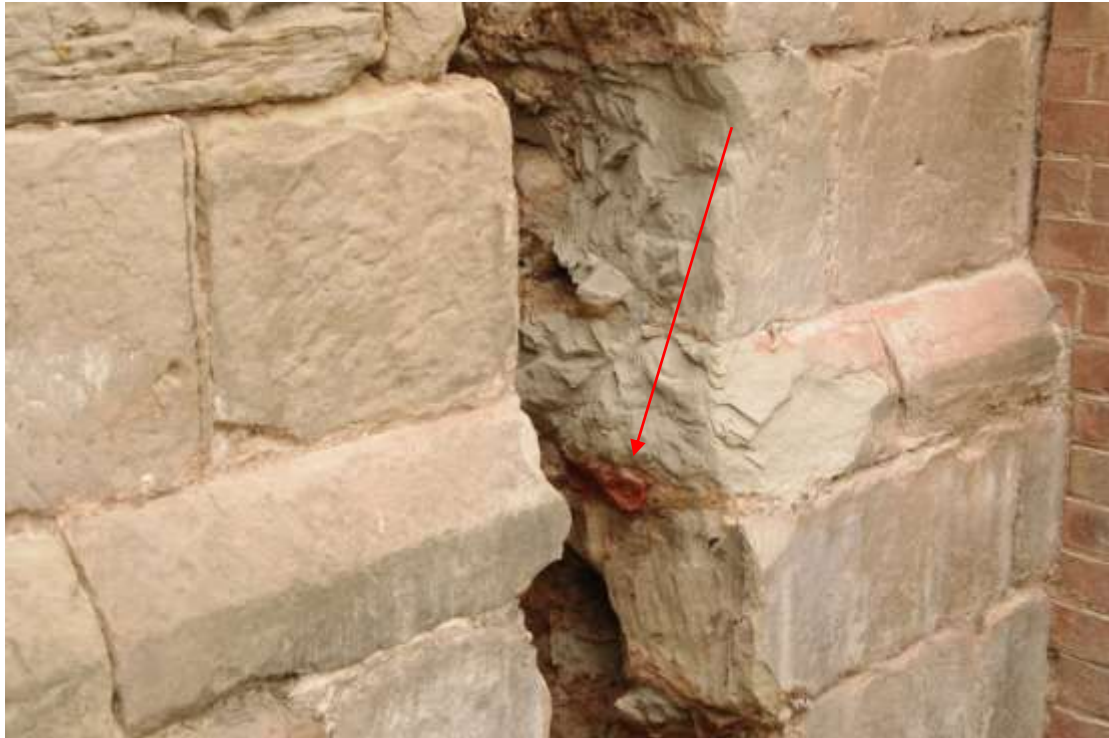
Breaking through the stonework showed that the approximately 0.6m thick tower wall consisted of a skin of faced stone on the outer face with a heavily mortared rubble core behind it (Figs 46 and 47). On the inner face the wall had a thick layer of plaster laid directly onto the rubble core which had no dressed stone on this side. The plaster had been scored to represent painted ashlar stone courses (Figs 48 and 49). Within the fabric of the wall small pieces of slate could be seen which appeared have been added to act as levelling aids to the dressed stone face (Fig. 50). More importantly, to aid in the dating of the wall, was a fragment of brick which was seen embedded within the fabric of the wall (Fig. 51). Although the brick could not be accurately measured it appeared to be the same colour and soft-fired texture as the bricks used elsewhere in the tower. Such a piece of brick deep within the fabric of the stonework suggests that the tower is all of one phase which matches the church.

Figure 52 Fragment of brick within the stone matrix of the tower wall  
The red arrow points towards the brick fragment
