Archaeological Recording of the  
Roof over the Willoughby Chapel  
at the Church of St Mary & All Saints  
Willoughby-on-the-Wolds, Nottinghamshire

Report Number: R-0125

January 2022

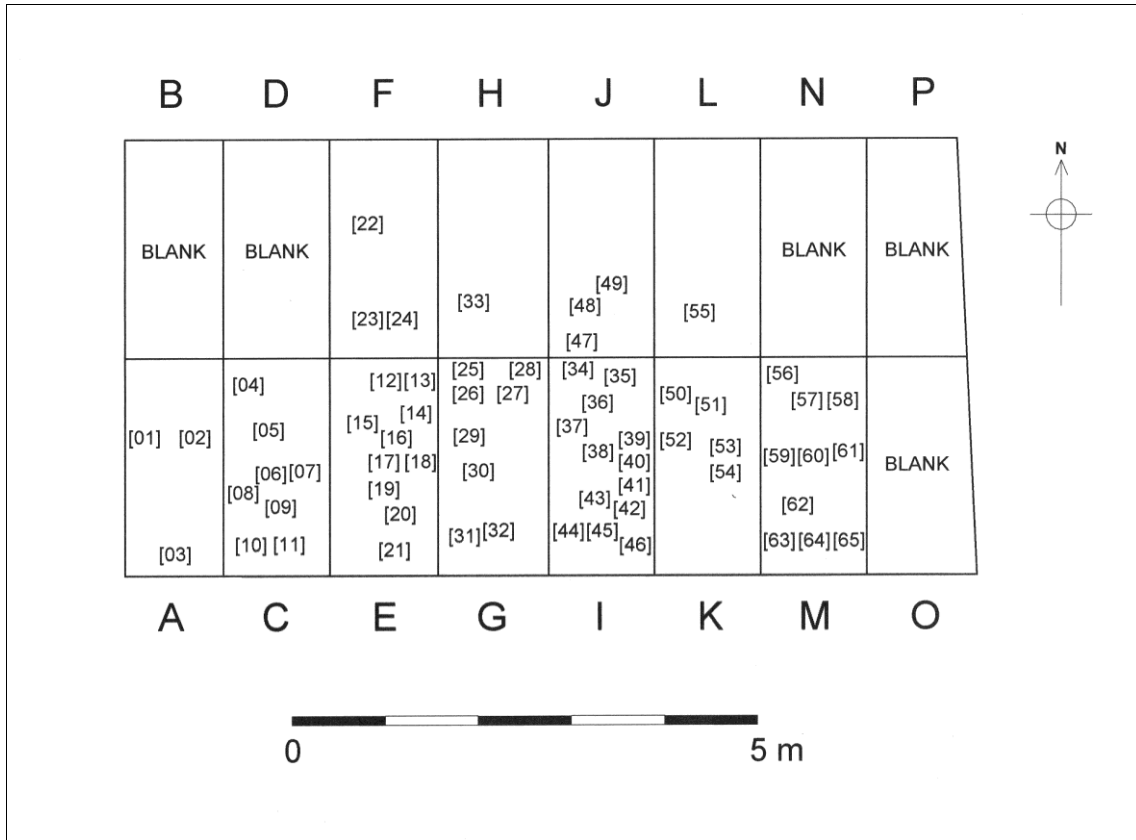
Figure 5. Plan of Willoughby Chapel roof showing locations of plumber' marks [01] to [65].

7.1 65 plumbers' marks were recorded on the upper surface of the lead roof covering of the Willoughby Chapel (Figure 5). 51 of the marks (78.5%) were the traced outlines of footwear (either boots or shoes). Eight of the marks (12.3%) were tracings of hands (6 complete and 2 incomplete examples). The remaining 6 marks were miscellaneous inscriptions and drawings.

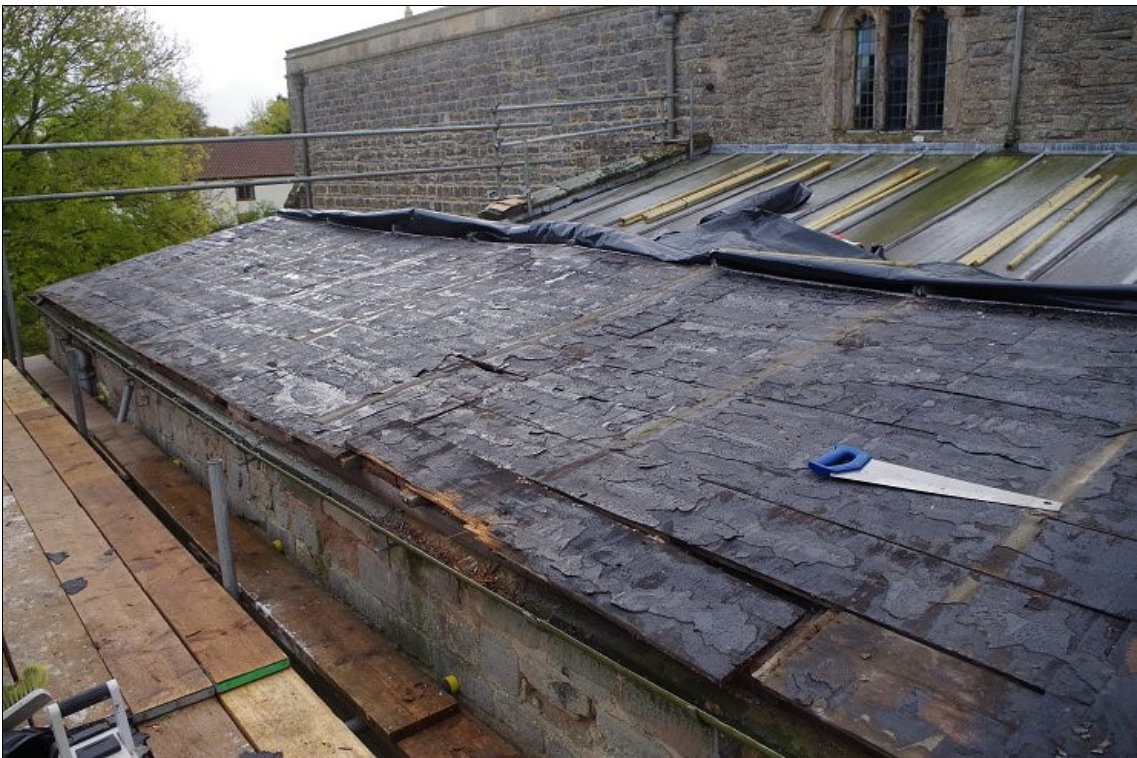
6.3 Following removal of the lead covering the roof boards were found to be in reasonably sound condition; these were left *in situ* and overlain with new diagonal boarding to which the new roof covering was fixed (Photos 6-7).

Photo 6. North slope of the Willoughby Chapel roof following removal of the lead, looking SE.

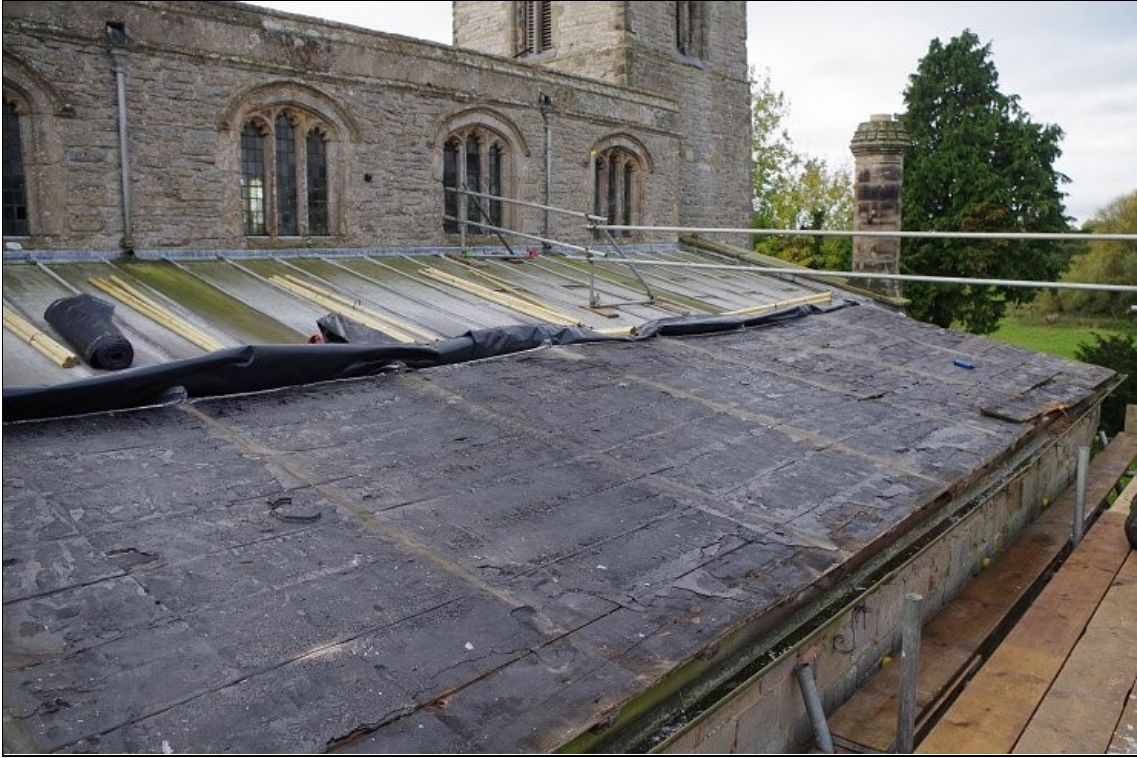
Photo 7. North slope of the Willoughby Chapel roof following removal of the lead, looking SW

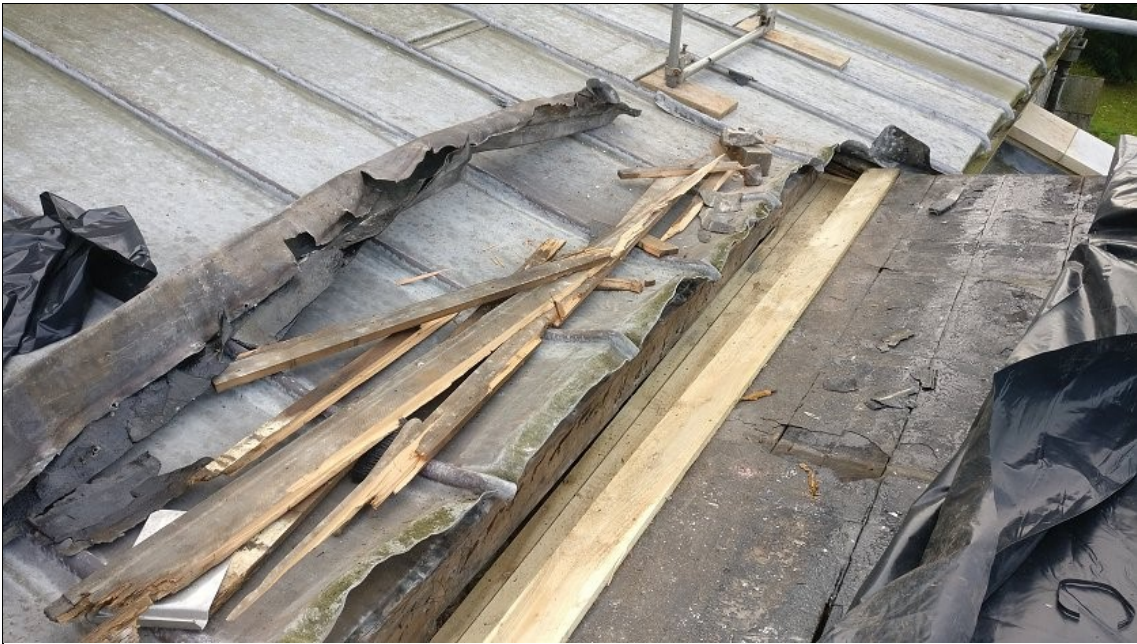
6.4 The only timbers that were replaced were modern softwood boards forming the valley gutter between the Willoughby Chapel and the north aisle (Photos 8-9). The base board of the valley gutter was seated on concrete and evidently formed part of a 20<sup>th</sup> century repair. No earlier roof timbers were affected.

Photo 8. Repair to valley gutter between north aisle (left) and Willoughby Chapel, looking W.

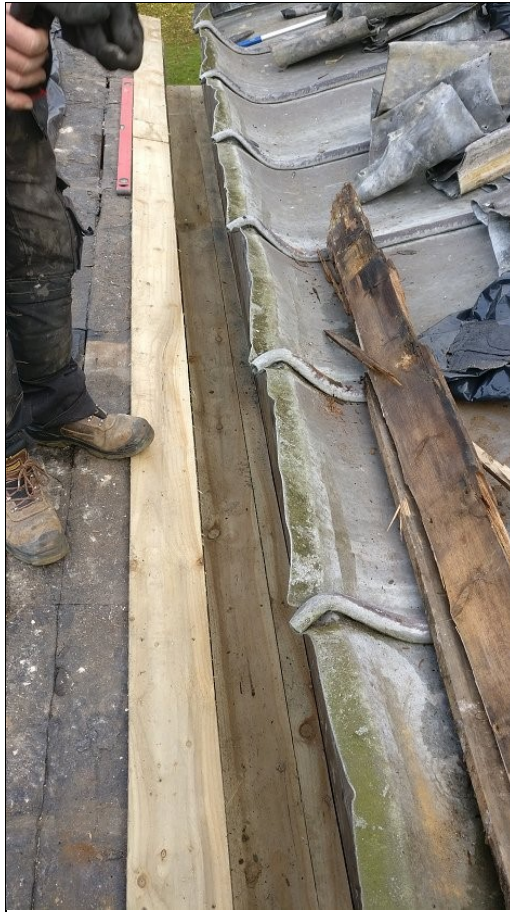
Photo 9. Repair to valley gutter between north aisle (right) and Willoughby Chapel, looking E.

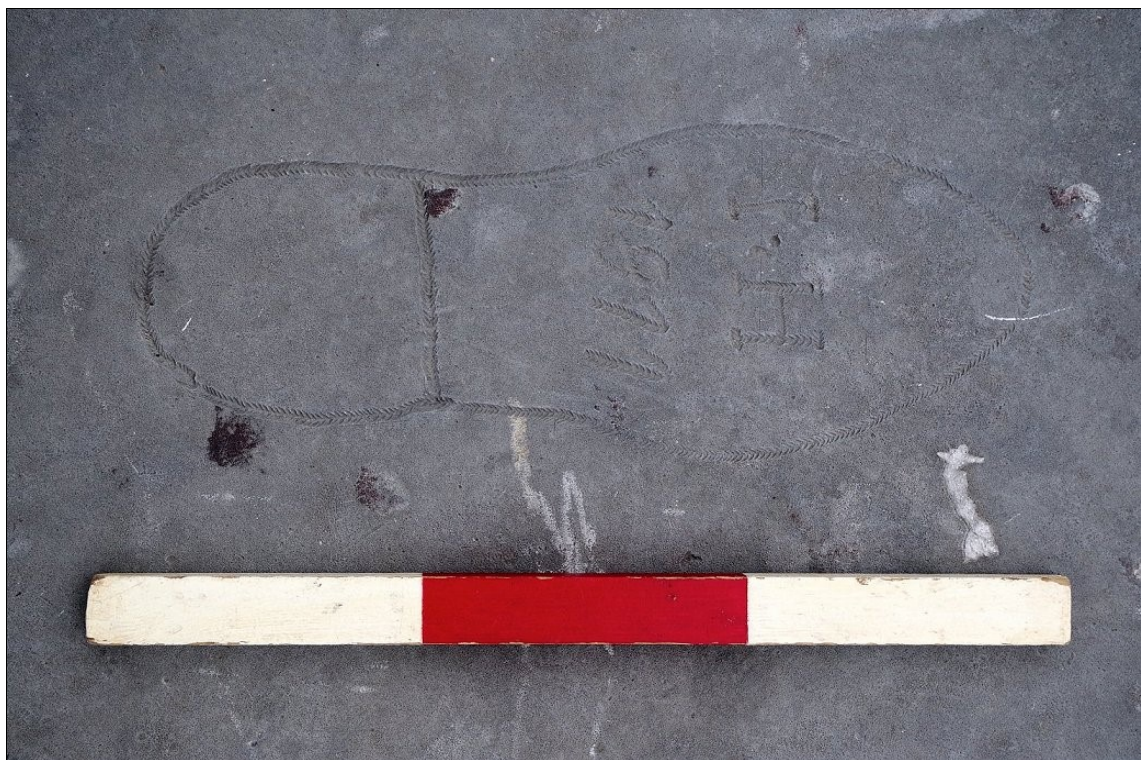
[33]. Tooled footwear outline. Rounded point toe. Heel. Initials and date: *I.H. 1811*. 277 x 105mm.

Photo 10. Example of tooled footwear outline, cat. [33].

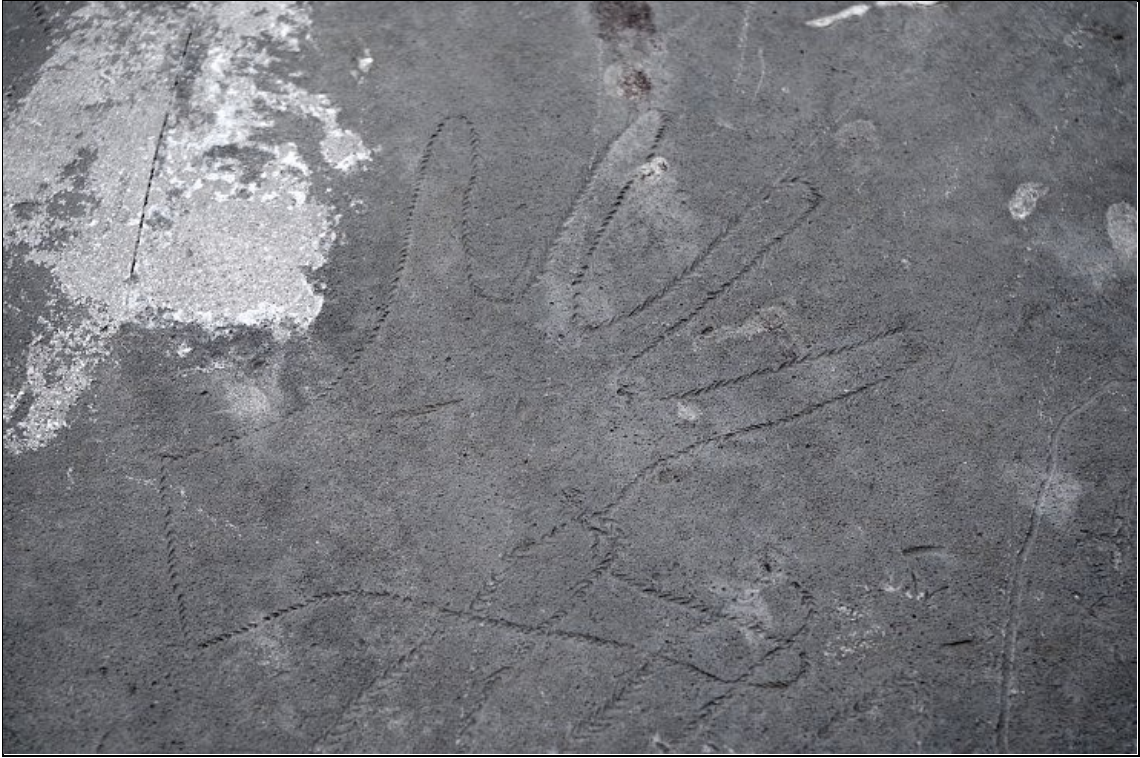
[39]. Tooled outline of left hand. No initials/date. Partially overlaps [40].

Photo 11. Example of tooled outline of hand, cat. [39].

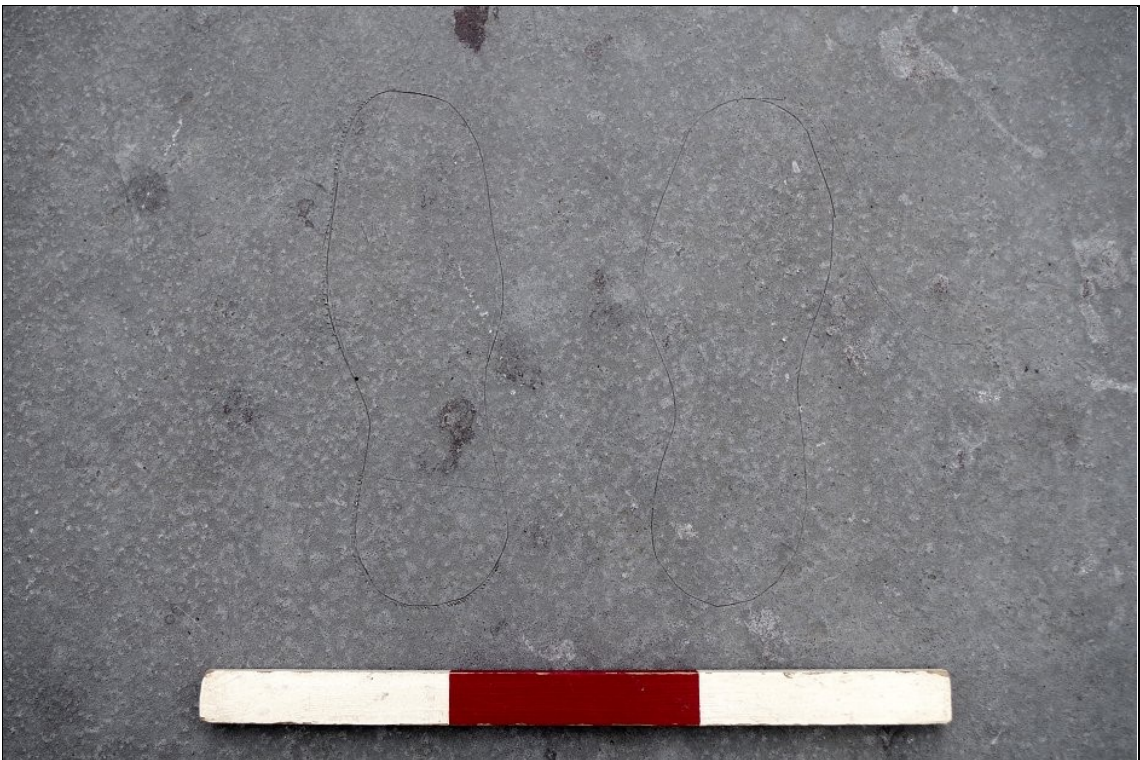
[06]. Footwear outline, partly scribed and partly tooled. Rounded toe. Crude heel. Faint scribed initials, possibly *WS.* 235 x 80mm. Appears to be associated with [07].

[07]. Scribed footwear outline. Rounded toe. No initials/date. 231 x 81mm. Appears to be associated with [06].

Photo 12. Example of scribed footwear outlines (that on left partly tooled), cat. [06] & [07].

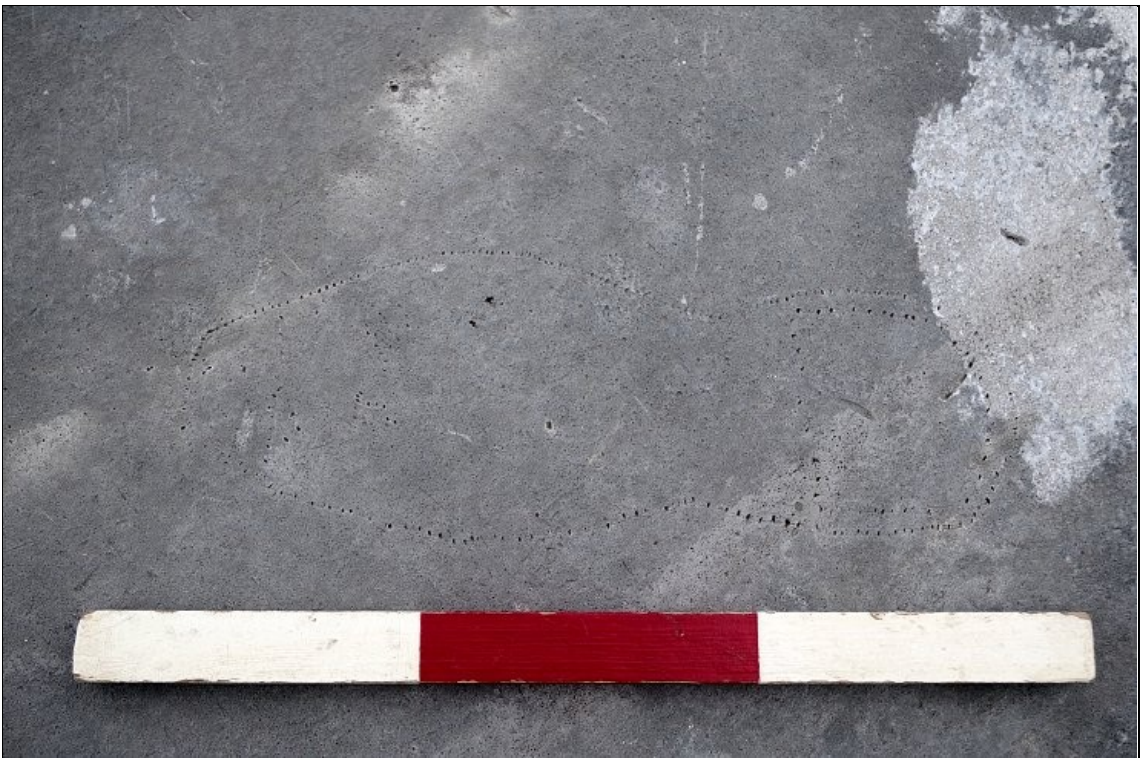
[21]. Pricked footwear outline over scribed lines. Square toe. Heel and heel detail. Illegible pricked ?initials. 262 x 92mm.

- 8.21 As noted above, scribed marks were probably made with a knife blade or other sharp implement. The single example of a pricked mark [21] may have been made with a nail, punch or other pointed tool (Photo 14). The series of concentric circles [37] must have been made with a pair of compasses (Photo 22), as was the hexafoil within [49] (Photos 23-24). What type of implement (or implements) was used to make the tooled marks is less clear.

Photo 14. Example of pricked footwear outline, cat. [21].

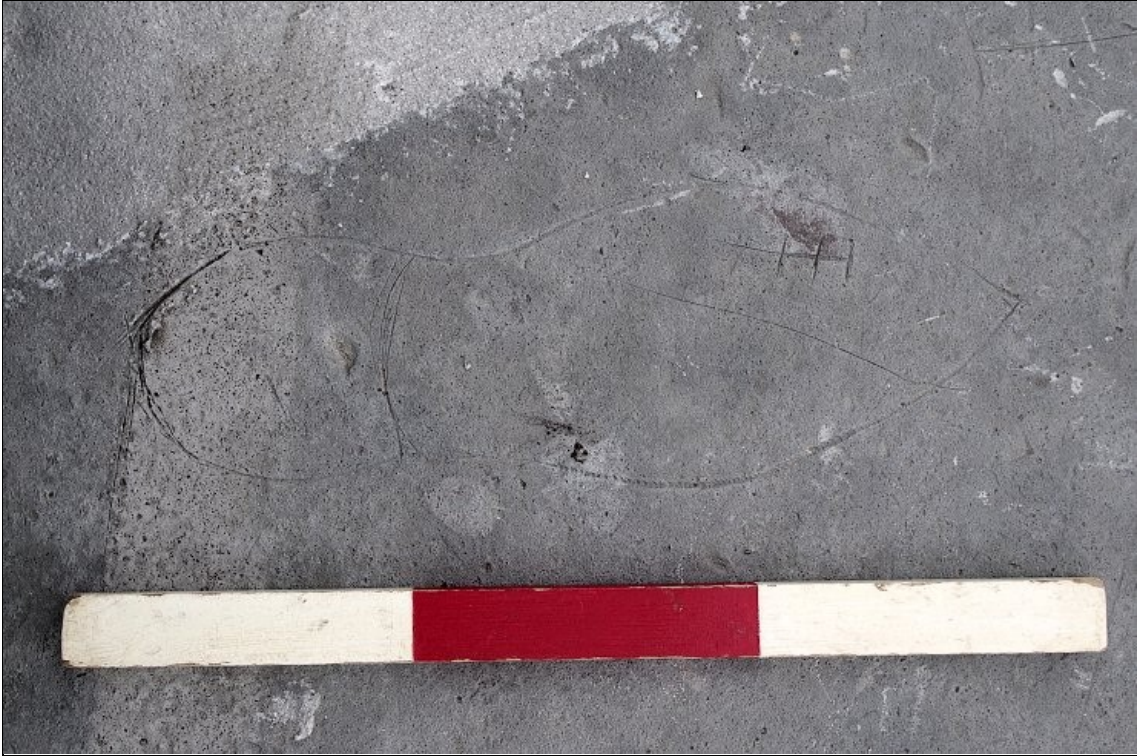
[31]. Scribed and partly tooled footwear outline. Pointed toe. Heel. Scribed mark inside toe, possibly an *I*. 264 x 90mm.

Photo 15. Example of partly scribed and partly tooled footwear outline, cat. [31].

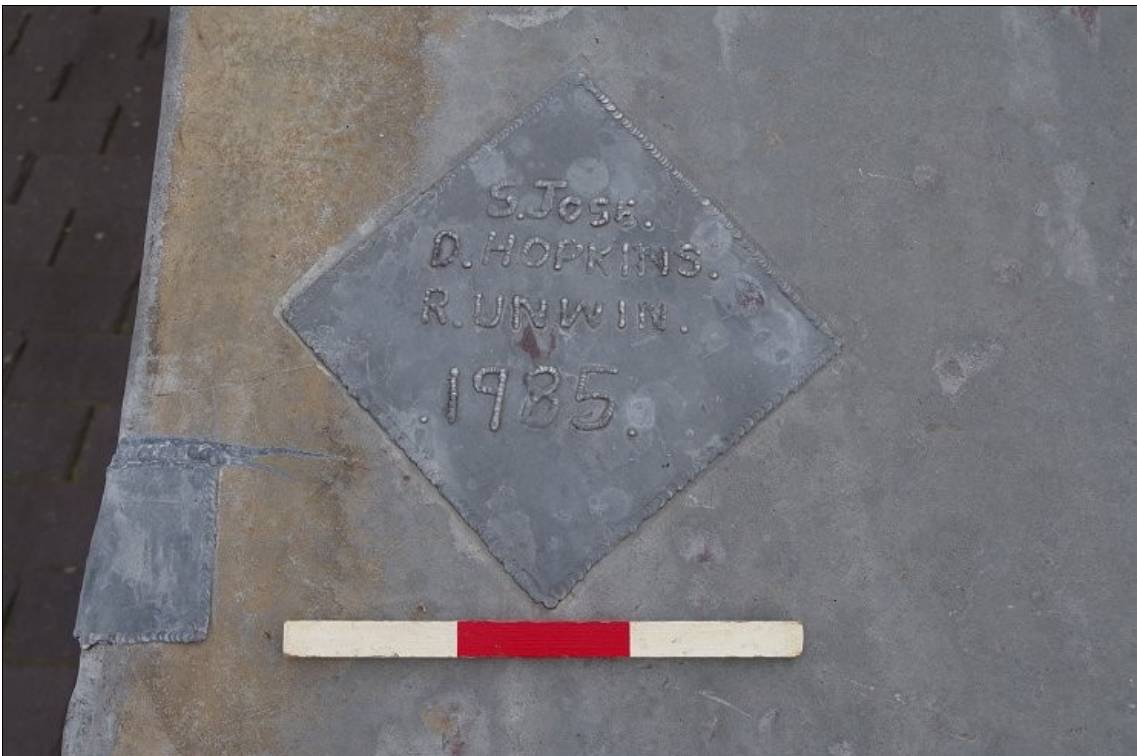
[01]. Diamond-shaped applied lead panel, 250mm square, with lead-welded inscription: *S. Jose. D. Hopkins. R. Unwin. 1985.*

- 8.13 At Willoughby-on-the-Wolds it seems probable that *S. Jose*, *D. Hopkins*, and *R. Unwin*, whose names occur together on an applied welded lead plaque, along with the date 1985 [01], were plumbers employed to repair the chapel roof (Photo 16).

Photo 16. Lead-welded plaque commemorating roof repairs in 1985, cat. [01].

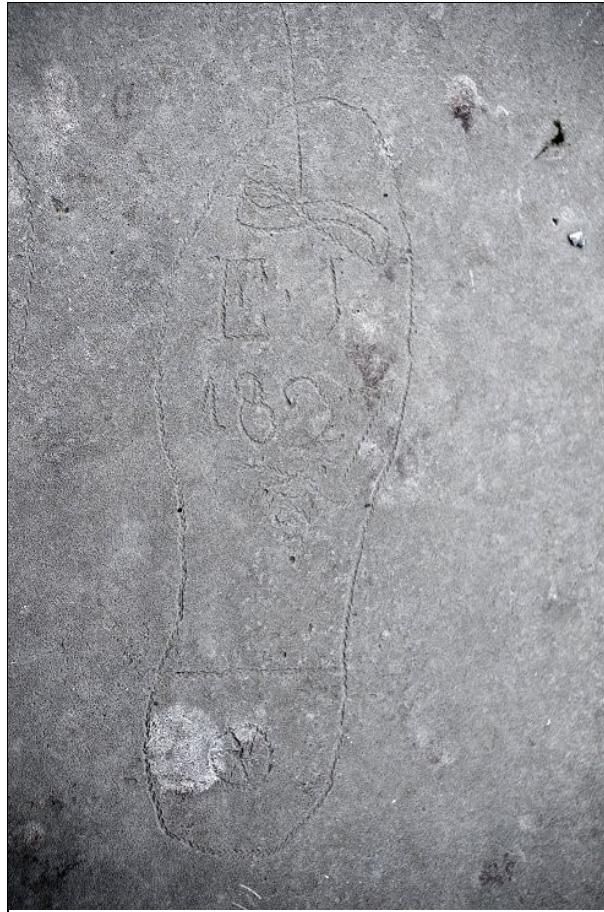
[24]. Tooled footwear outline. Rounded point toe. Heel. Star in circle detail to heel. Initials and date: *E.J. 1827*. 230 x 78mm. Appears to be associated with [23].

Photo 17. Example of tooled footwear outline with initials and date: *E.J. 1827*, cat. [24].

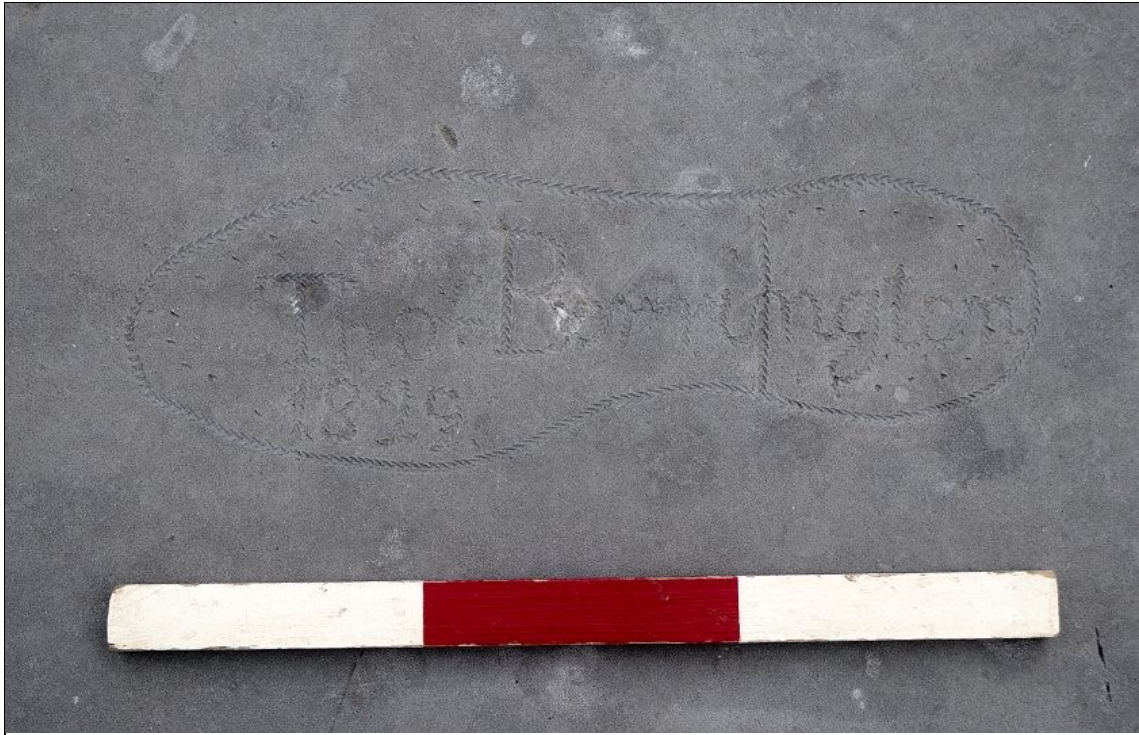
7.6 In a single instance a full name was included along with a date: *Thos. Borrington 1829* (Photo 19).

[22]. Tooled footwear outline. Rounded point toe. Heel and heel detail. Name and date: *Thos. Borrington 1829*.

Photo 19. Tooled footwear outline with full name: *Thos. Borrington 1829*, cat. [22].

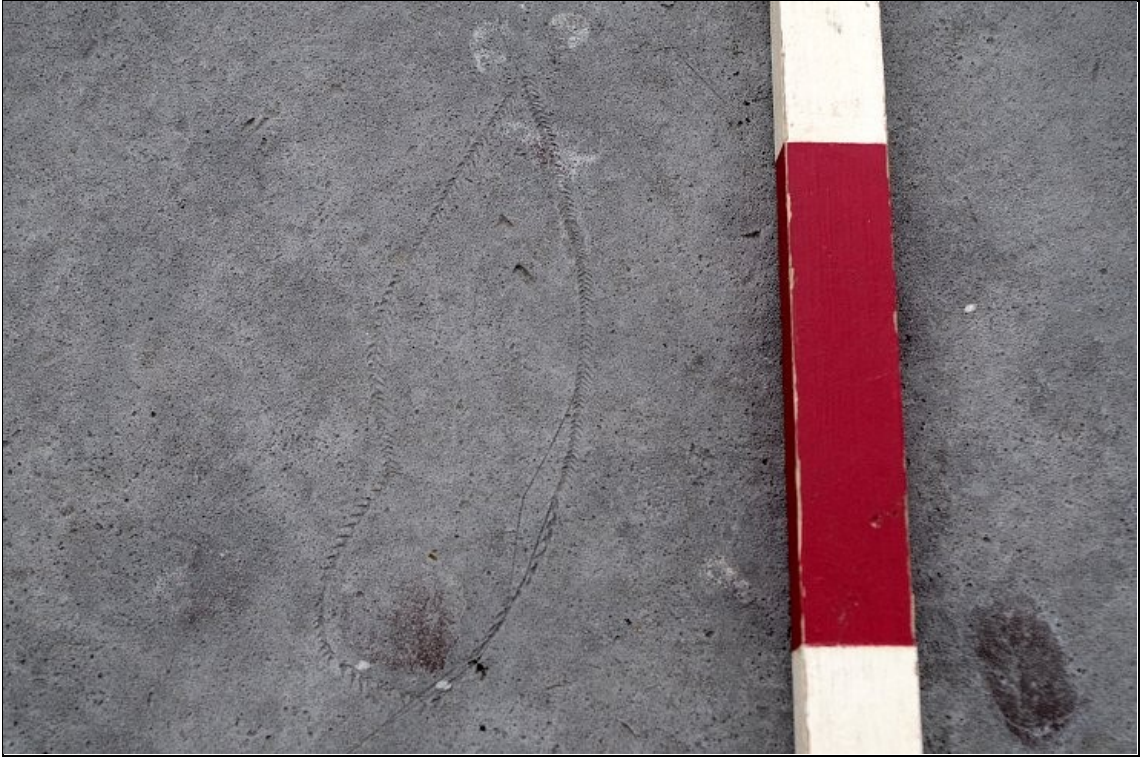
[02]. Footwear outline, mainly tooled but partly scribed. Pointed toe. Very small, 130 x 45mm. Apparently a tracing of a child's shoe.

Photo 21. Child size footwear outline, tooled over scribed line, cat. [02].

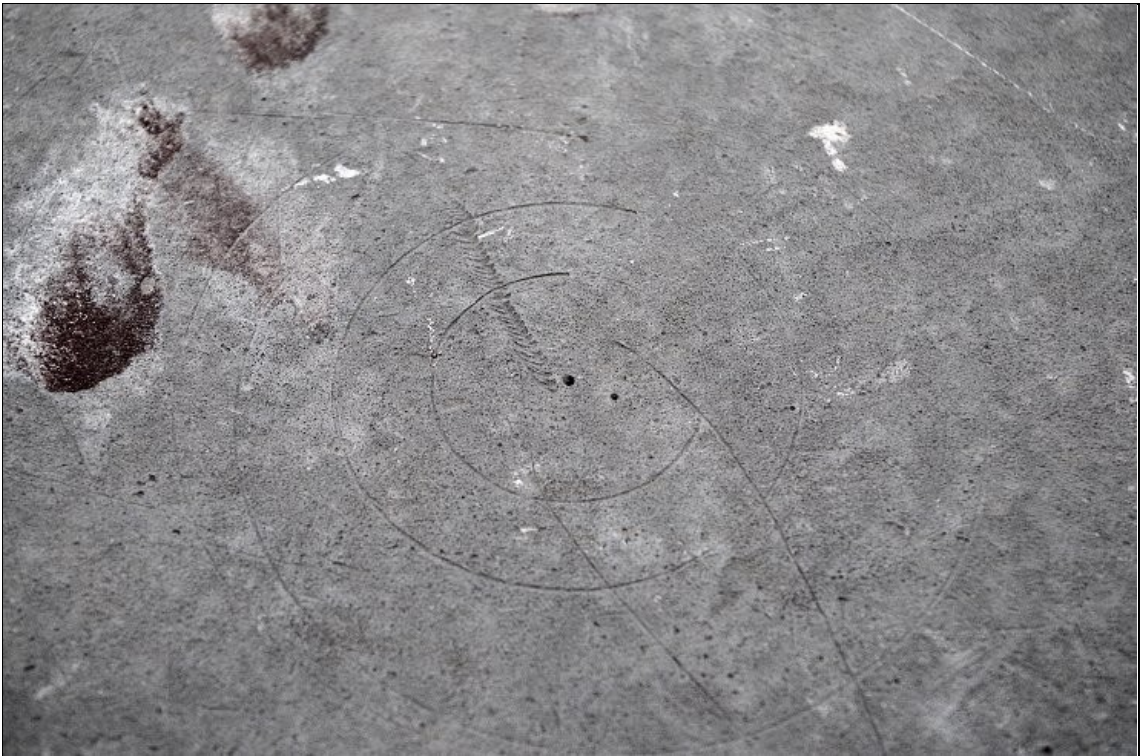
[37]. A series of 5 scribed concentric circles, the largest 320mm in diameter and the smallest 43mm in diameter. Evidently made with a pair of compasses. Outermost circle very faint.

Photo 22. Concentric circles scribed with a pair of compasses, cat. [37].

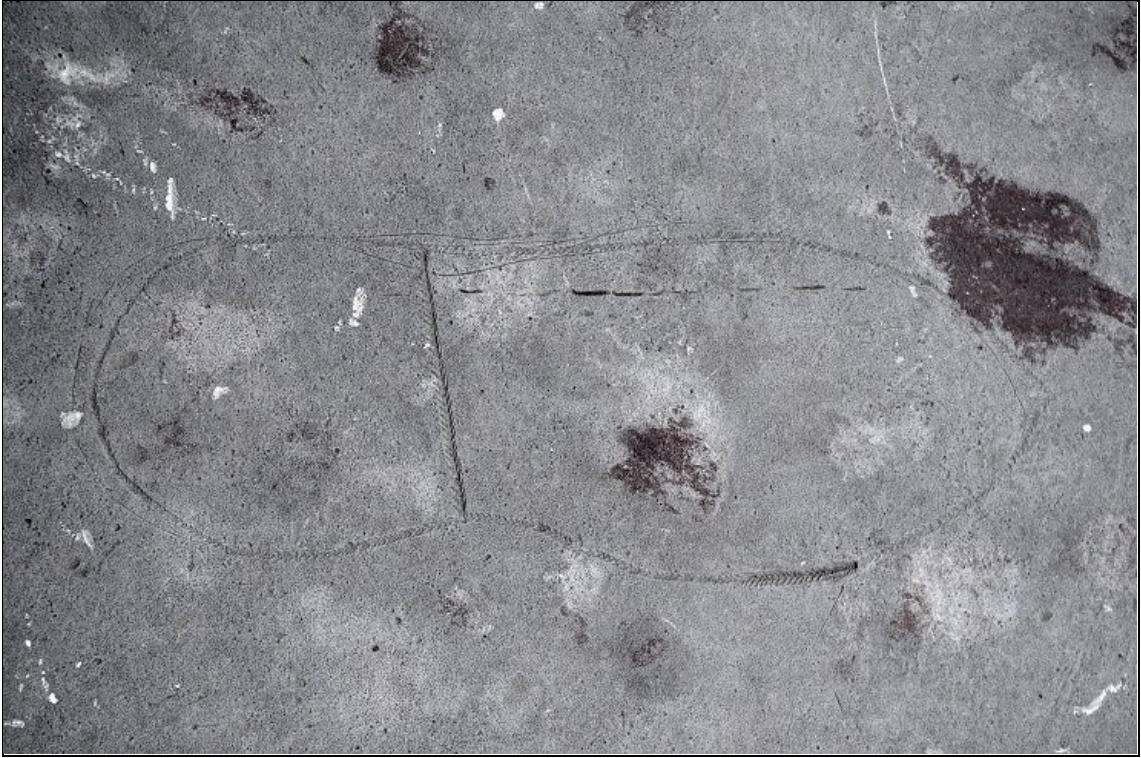
[26]. Tooled footwear outline over scribed line. Rounded point toe. Heel. No initials/date. 230 x 84mm.

Photo 25. Tooled footwear outline deviating from earlier scribed line at toe, cat. [26].
