**Report on the Repairs
to the
Gillett and Bland Turret Clock
at
St Mary's Church
Woodchester Gloucestershire**

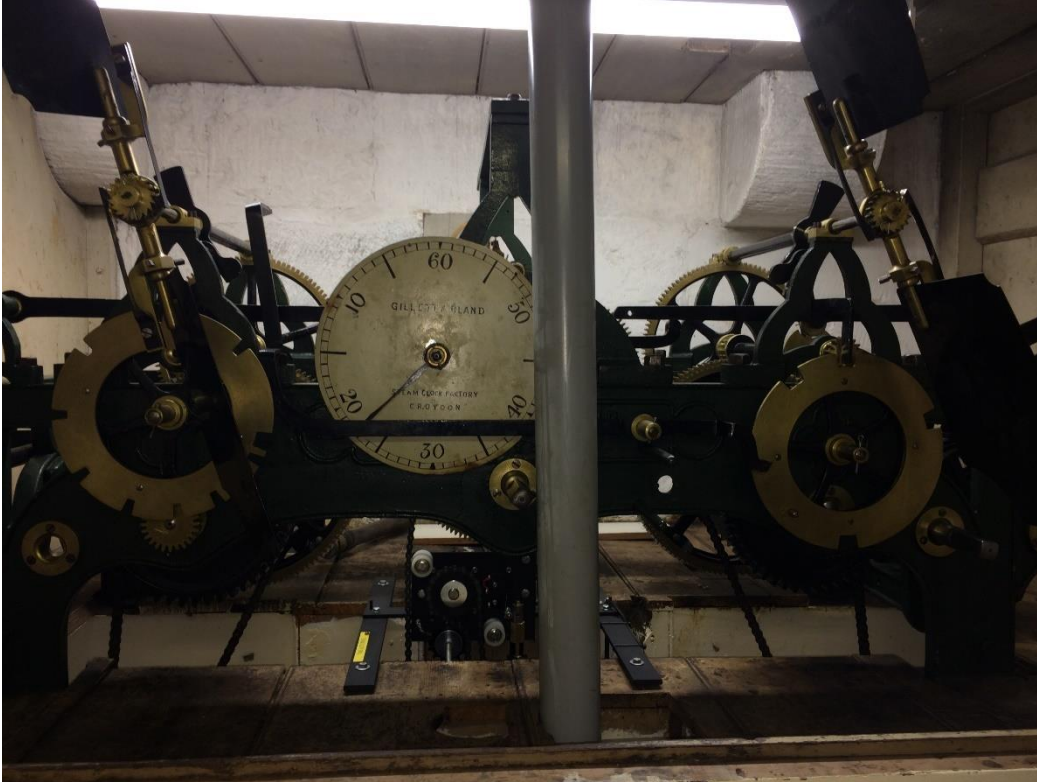
Figure 1 – The clock following maintenance

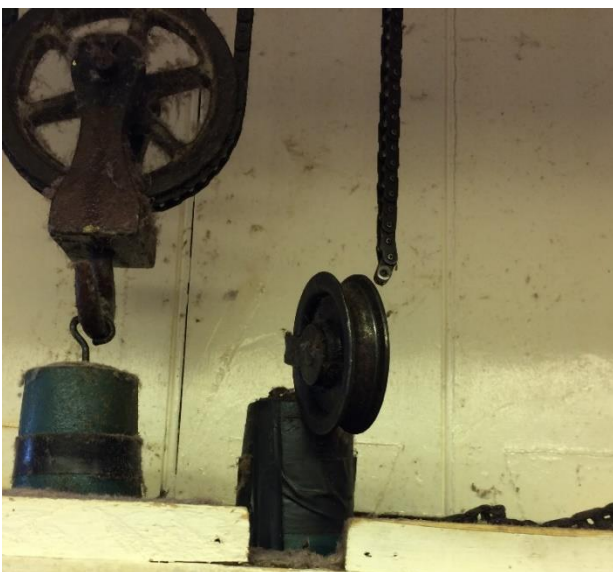
Figure 2

During a ringing session in early 2019, a link in the quarter chiming automatic winding drive chain snapped, **Figure 2**, and the 17 kg driving weight fell to the floor, **Figure 3**, narrowly missing one of the ringers on its way to the floor and on health and safety grounds, the clock was stopped.

A decision was made to overhaul the clock, the bell cranks and replace the automatic winding system in order to move the striking and chiming weights to the corners of the ringing chamber. This move would put the weights safely out of the way of the ringers and allow the weights to be enclosed in panelled safety cages.

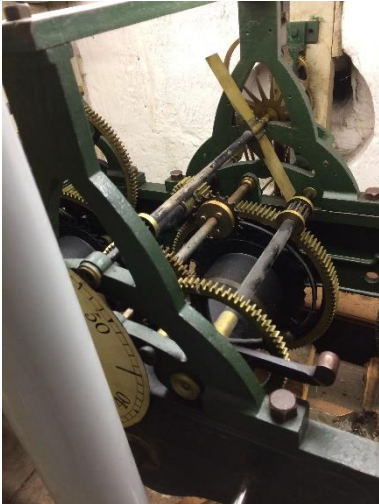
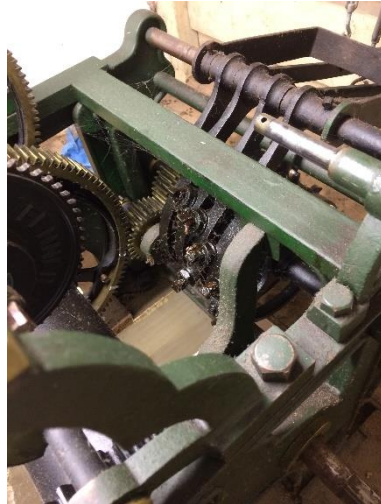
The three trains of going (time), hourly striking and Westminster chimes are in good mechanical condition but have become clogged up with dust and congealed oil, and some of the bearings are running dry of oil.

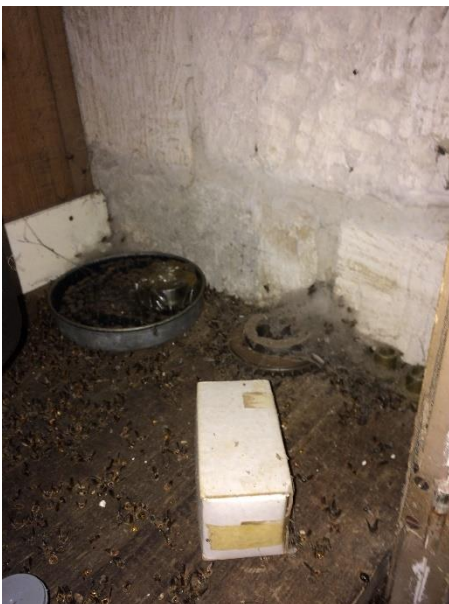
Figure 6

The clock cabinet is somewhat dirty with dead insects and debris scattered about it, **Figure 6**. With dust and old spider webs generally taking over, **Figure 7**. The whole clock cabinet and surrounding area was given a clean before the clock repair work commenced, and the years of dust and dead insects were vacuumed away.

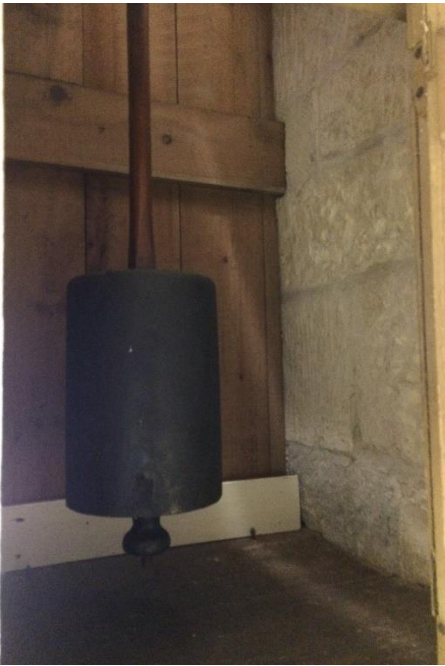
Figure 20

The pendulum was in good order, the wooden rod straight and neither cracked nor distorted. The bob being fixed to the rod by traditional means of a rating nut. The suspension spring had light surface rust present and was found to be in sound mechanical condition.

The suspension spring assembly was cleaned with Liberon Ultrafine 0000 grade wire wood and mineral sprit. A thin layer of petroleum jelly was applied to the assembly to prevent rust from forming in the future.

The pendulum rod was waxed using Lochinvar Olde English Furniture Cream².

The bob was brushed to remove dust and dirty and then given a coat of Curator Slate Blackening Compound³.

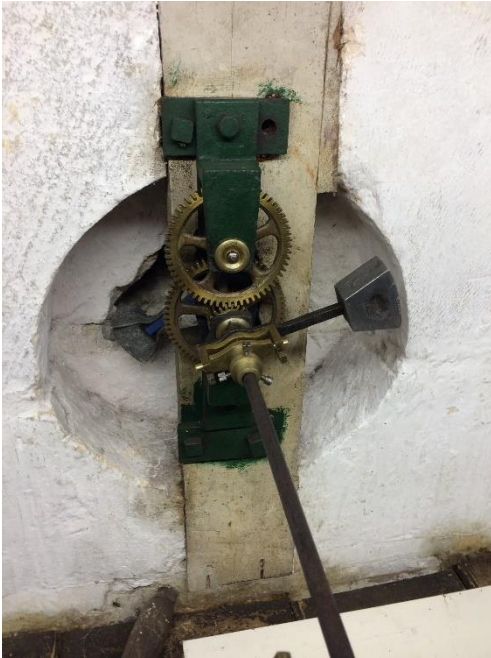
Figure 21

The motion work, **Figure 21**, the 12:1 ratio gearing to turn the hour hand from the minute hand, takes its drive from the rear of clock to turn the hands on the dial, **Figure 22**.

The motion work was found to be in good mechanical order. Build of dust and debris was present and the wheels were cleaned in-situ using cloth charged with pure turpentine to remove this minor debris from between the teeth and pinion leaves.

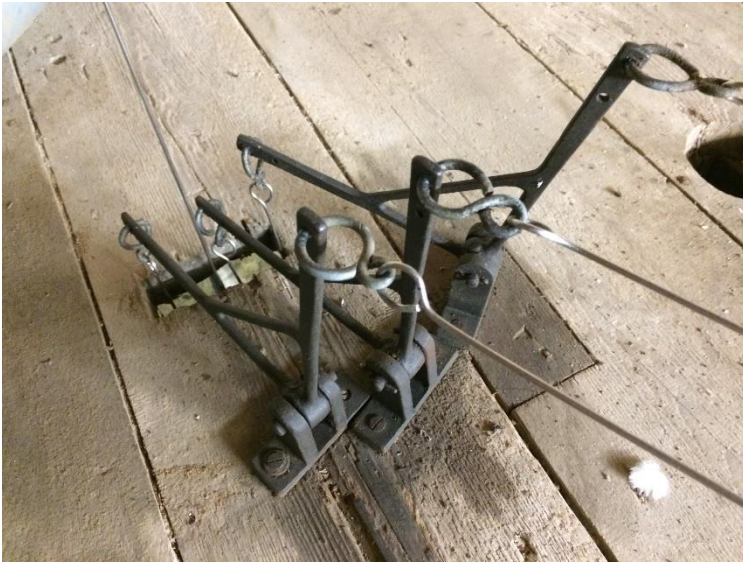
Figure 23

The chime hammers were checked and their adjustment nuts and securing mounts checked for tightness. The No.3 bell hammer was bent, and this was straightened out. The 'S' hooks were all in good condition and were reused.

Servicing of the cranks was carried out with them remaining in-situ in the deadening chamber. The bearing was cleaned on each crank with cotton cloths charged with pure turpentine to remove the dirt. The whole area was then vacuumed, and debris removed. New 3mm stainless steel rods were cut to length and eyes carefully formed at each end and connected to the cranks by their original 'S' hooks.

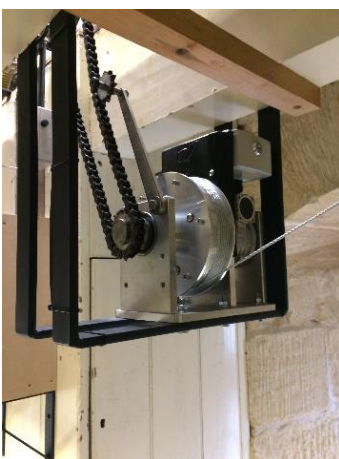
Figure 26

The old automatic winding system was driving each of the three trains of the clock from their 3rd wheels and not their main barrels. **Figure 26** illustrates the drive sprocket and chain mounted on to the 3rd wheel of the quarter chiming train.

The current guidance requires that the drive to the clock must be to the great wheel or barrel assembly (referred to as main barrel automatic winding). In other words, as the clock would have been originally driven if the weights were still being wound by hand. This is because gearing in clocks is designed for a large wheel to drive a smaller pinion. Driving a large wheel from a smaller pinion can result in abnormal wear on pinion leaves and wheel teeth, or if a jam occurs, the possibility of broken leaves and teeth.
