MSH/JH.1195A

28th January 2022

ALL SAINTS, MONKOKEHAMPTON - LYCHGATE REPAIR COMPLETION

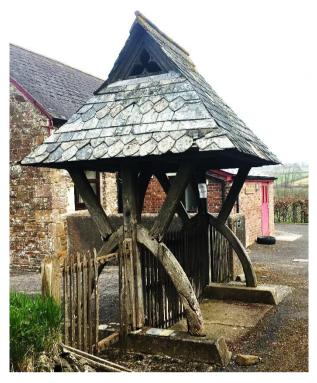
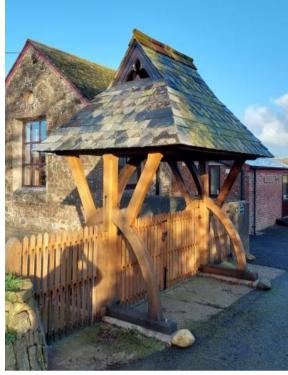
South Elevation

It was also good to see the lychgate useable again and not in a dangerous condition for users and visitors passing under to access the church and churchyard.

The work carried out is to a high-quality of workmanship and joinery replacement replicates details from the original structure.

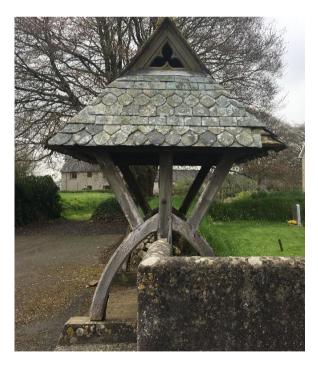
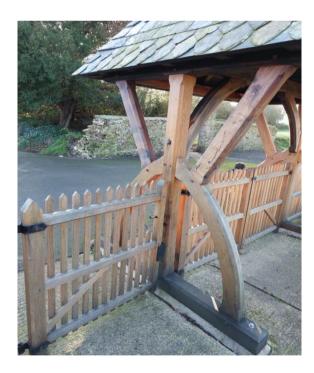
North Elevation

Removal of the former concrete plinths and exposing the original/earlier granite bases and new oak bearers above is a significant improvement both visually and technically.
