SITE REPORT FORM No.1

CHURCH: St Mary Magdalene, Madingley, Cambridgeshire

PROJECT: 20-46 Chancel Floor

ISSUE ARISING: Investigation into the make-up of the existing floor

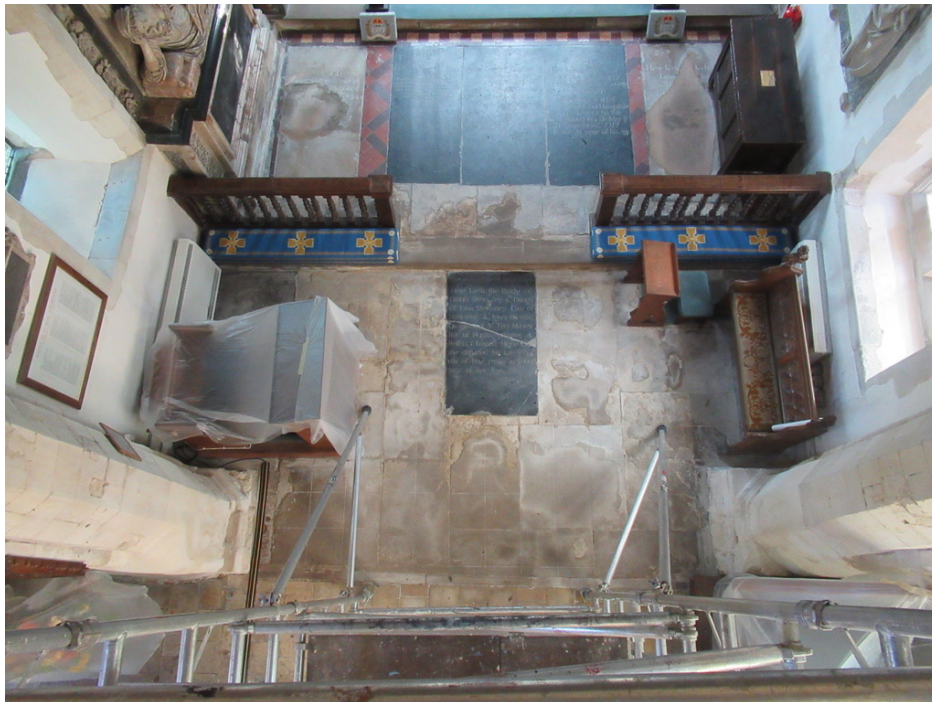
The condition of the chancel floor has become very poor, and is posing a trip hazard to the congregation when taking communion (see figs.1 and 2).

Fig.1, a high level view of the chancel floor in question

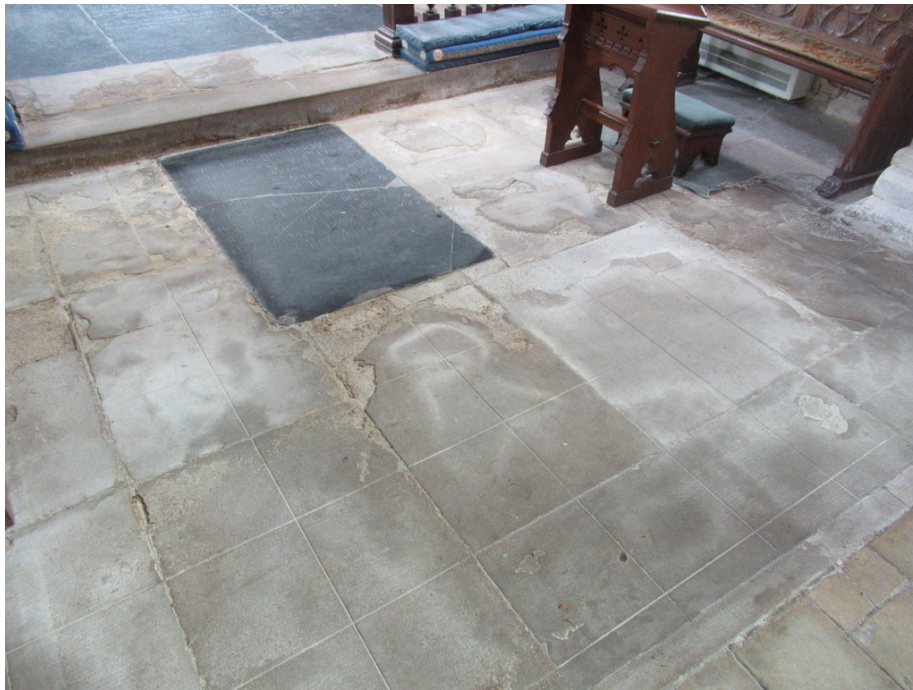
Fig.2, condition of the York stone floor, with a trip hazard against the ledger stone, normally covered by a carpet

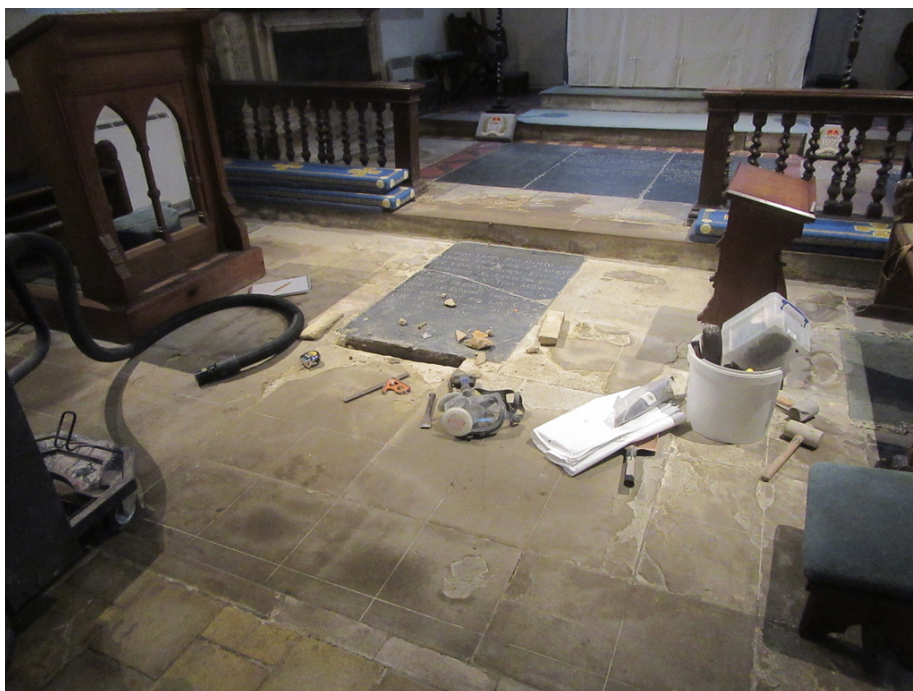
Fig.3, showing the two small stones removed against the ledger stone.

The substrate underneath was dry and not very firm and altogether rather soft. The York stone itself is 50mm thick as originally conceived, and the underside is clearly pecked to provide a key. Underneath there appears to be a bed of very weak lime mortar that is some 50-75mm thick before being laid on a hardcore mix of broken stone, flint and field stone, down to fines; altogether it is quite soft and a chisel can easily be pushed further in. The ledger stone is some 125mm thick and it would appear this has been laid on the tamped hardcore and shimmed. The mortar appears to be lime based, and has to a great extent perished. A rusty nail and even small small fragments of timber were found, as well as a small piece of stone that had a “polished” surface and may once have been part of the floor or a ledger stone.

There was no concrete slab or any evidence of the use of cement in the substrate.

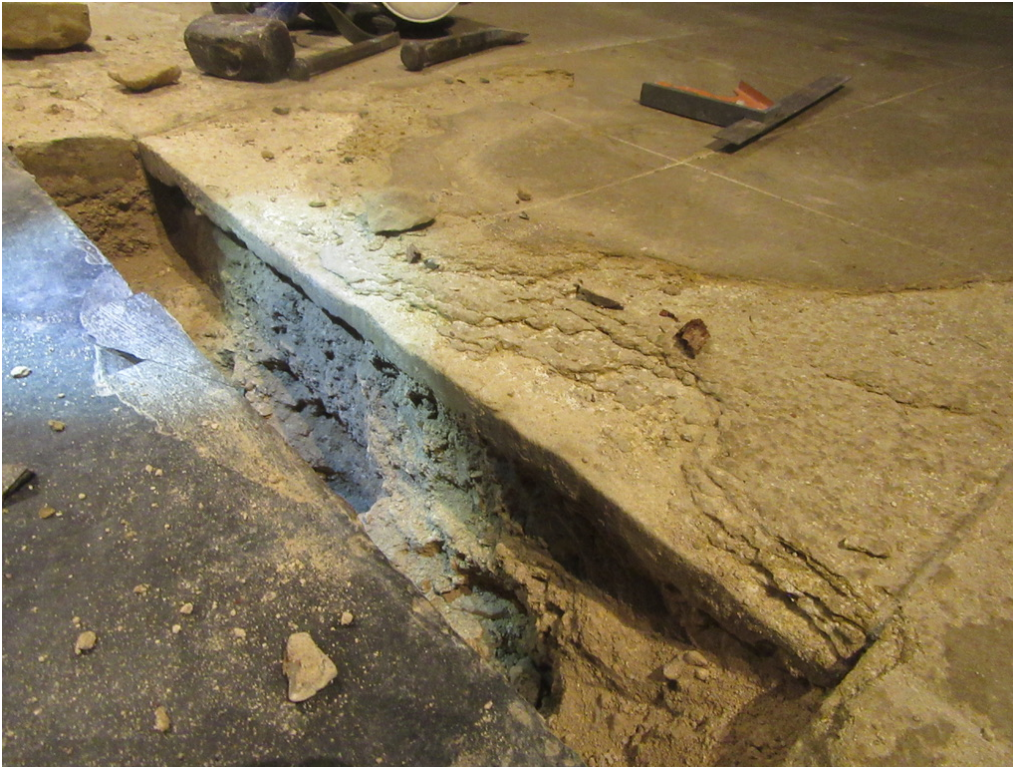
Fig.4, detail view of the investigation.

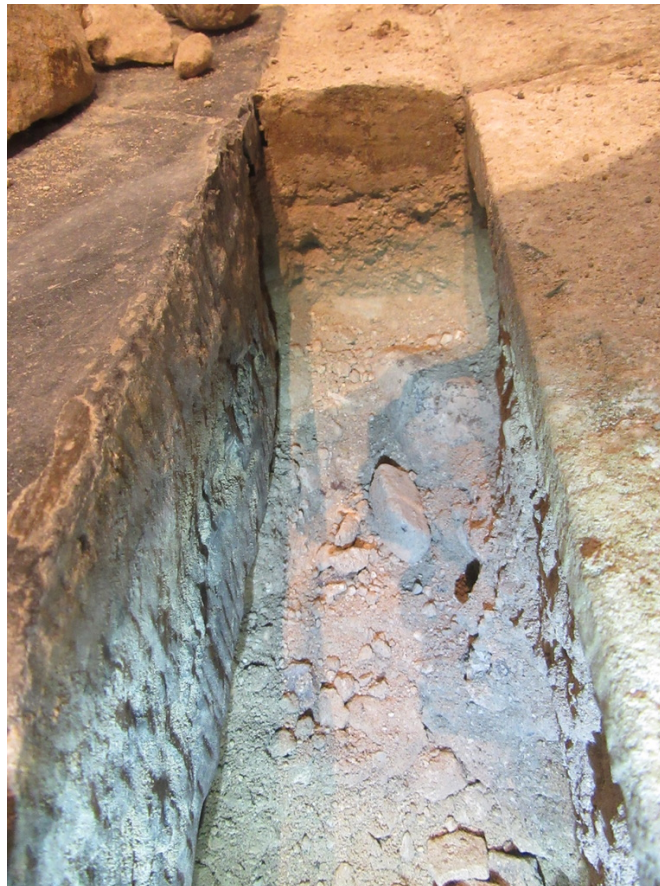
Fig.5, detail view of the investigation showing the ledger stone on the left.
