## **St Mary's, Nettlecombe, Somerset (Diocese of Bath and Wells)**

**Effigies attributed to Sir Simon, Sir John and Maud Raleigh**

### **Conservation and Relocation Report**

**February 2022**

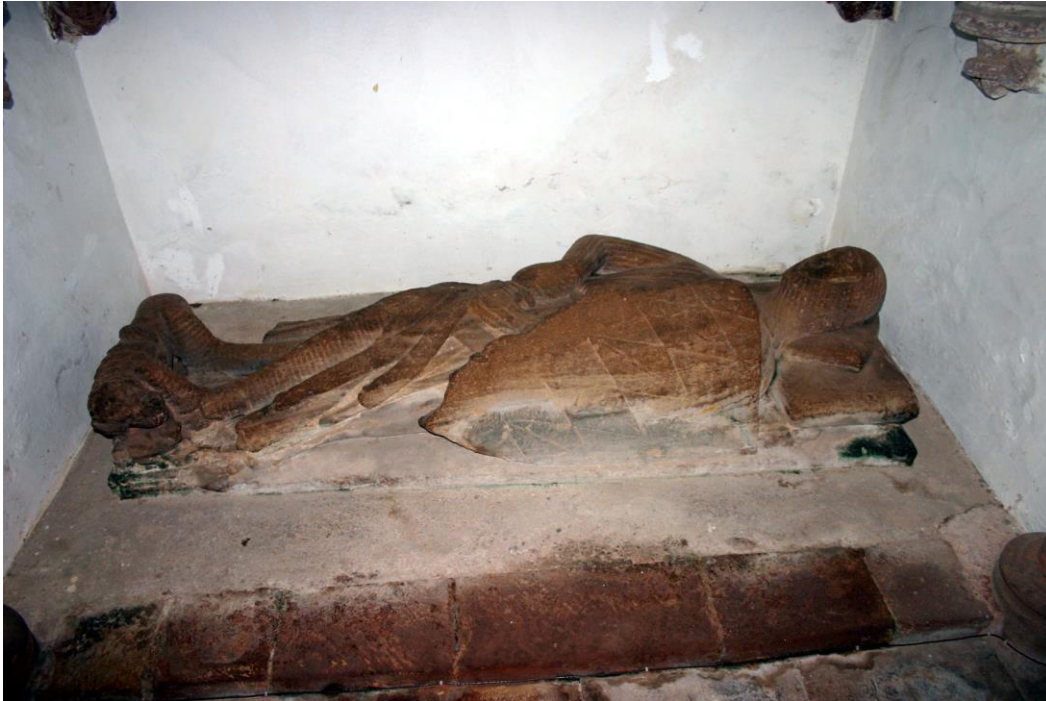
Plate 1 Effigy of Sir Simon Raleigh before work

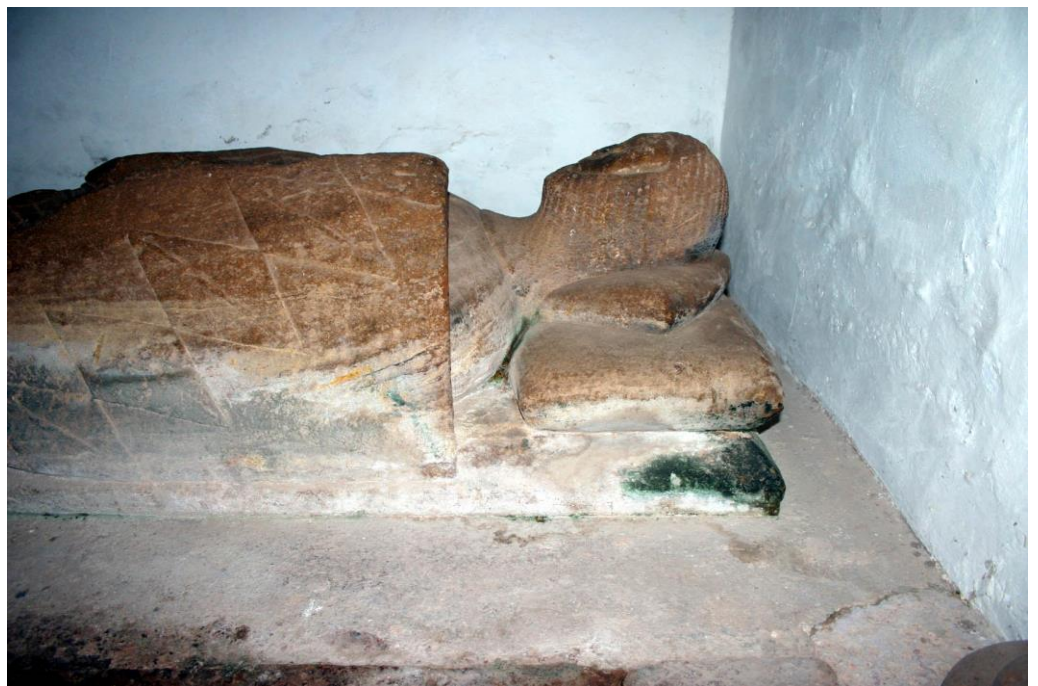
The effigy of Sir Simon was found in 2012 in very damp condition, with widespread green algae growth and some salt efflorescence on the stone surface. Specific local areas of stone deterioration had begun to appear on the edges of the draperies and on the sword. The entire effigy had a dark damp appearance, it was partially buried in a very damp soil-based rubble capped with a cement skim, and the walls and floor of the effigy retained high levels of dampness. Plaster was blowing off the walls. In addition, the supporting animal had been detached at some point in the past and reattached with curious clay-based mortar. Despite this, the detail of the effigy and even considerable remnants of its polychrome decoration survived in good condition. The presentation and situation of the figure, however, left a great deal to be desired in both technical and aesthetic terms.

Plate 2 The head end of the effigy, showing damp and organic growth

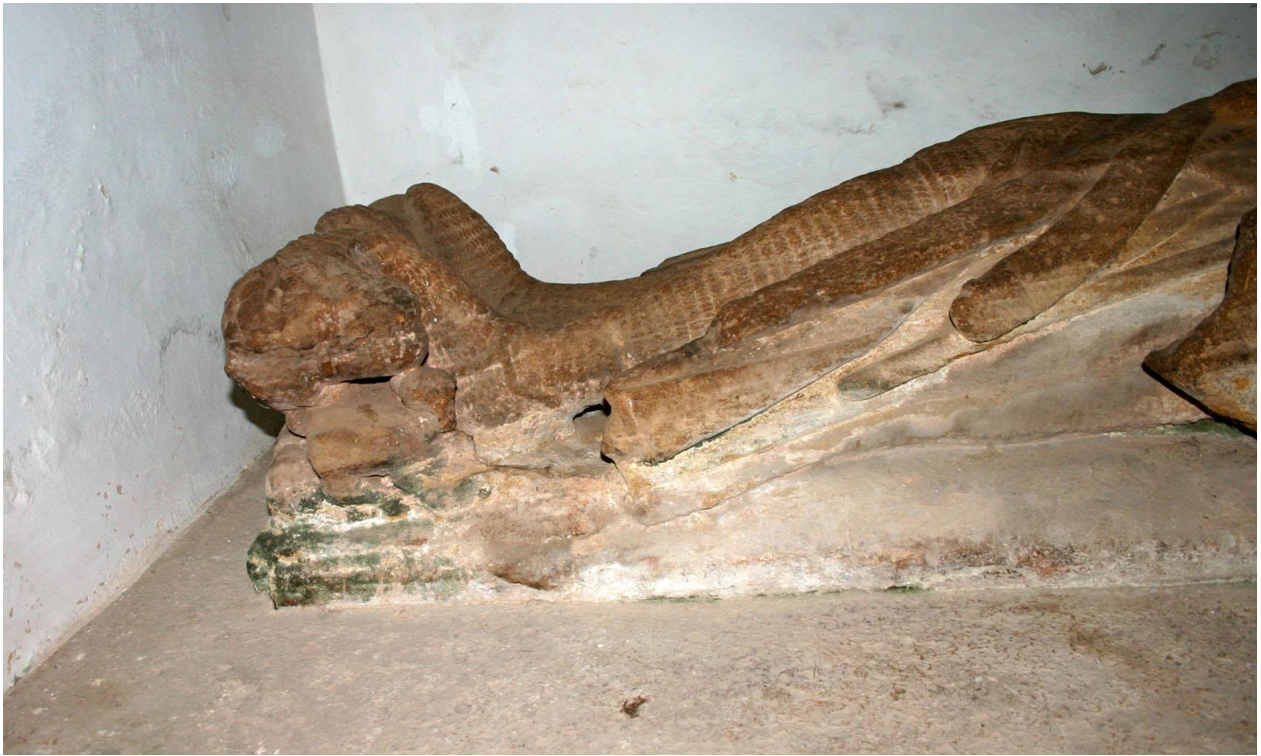
Plate 3 the foot end of the effigy before work, showing damp and growth

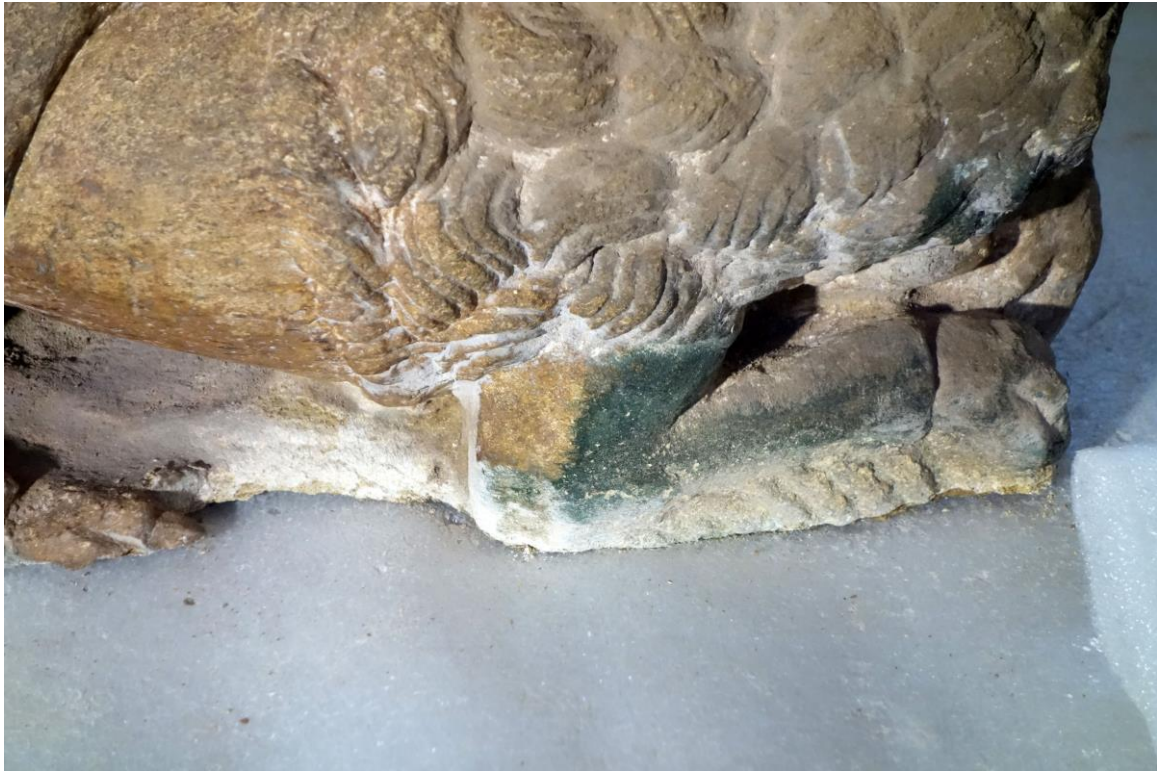
Plate 10: the supporting lion, cleaning in progress

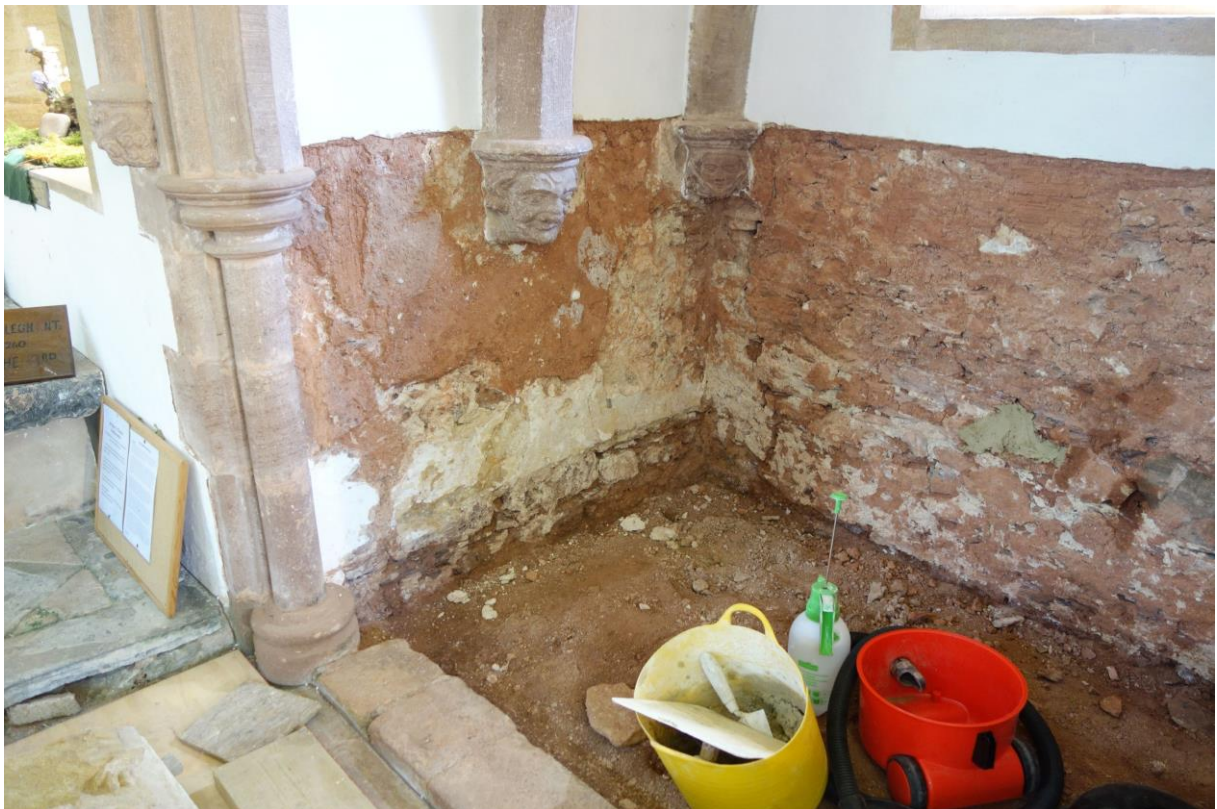
The lower part of the walls of the recess had plaster in poor condition, much of it blown and some repaired with gypsum plaster. This plaster was removed and the wall allowed to dry out for a few months before re-plastering with lime plaster finished with three coats of limewash.

Plate 11 The lower walls of the niche, plaster removed

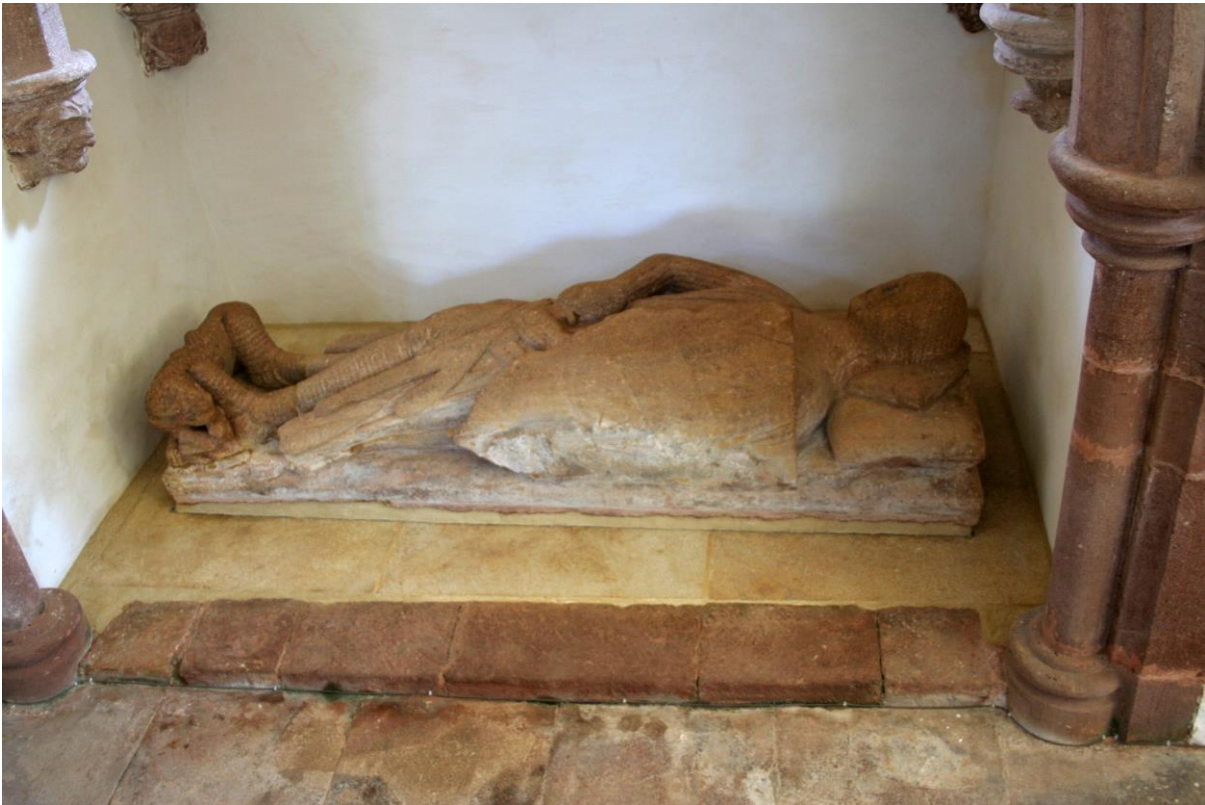
Plate12: walls re-plastered, floor laid and figure returned to the niche on lead and bearers

A new floor was laid in the recess. Ham Hill stone was selected since the effigy itself was of this stone type. The floor slabs were laid into fine sand and pointed with lime mortar with an open texture to allow moisture from the sub-floor to escape.

The effigy was then reinstated. It was laid onto a membrane of Code 6 lead and carried on stone bearers clad in lead to additionally permit air to pass underneath the figure. The detached supporting animal was refixed and the fracture filled with a mortar repair matched to the surrounding stone. The visible front joint as then repointed in open textured lime mortar.

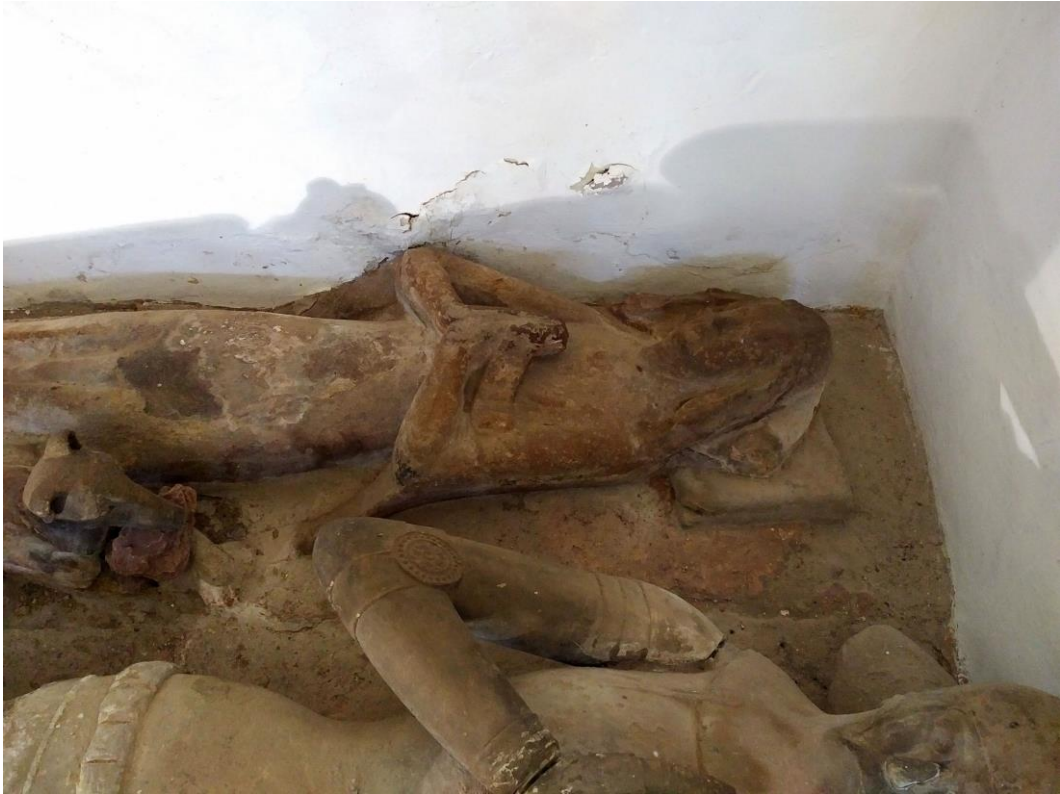
The effigy of Maud was in the most fragile condition of the three Raleigh effigies. The Ham Hill stone had laminated in various places, failing along the weak, clay-rich beds. A major fracture across the centre of the figure had produced two large fragments. This fracture had been superficially filled and repaired in the past, and it seems certain that Maud was placed in this recess in two sections and filled as necessary afterwards. The fracture ran up at an oblique angle through the slab, through the side hound's paws and along the side of Maud's gown, passing across the figure at about knee level and then back up to her elbow on her dexter side.

Plate 21: Maud before work: the head end, showing dirty and stained surfaces,

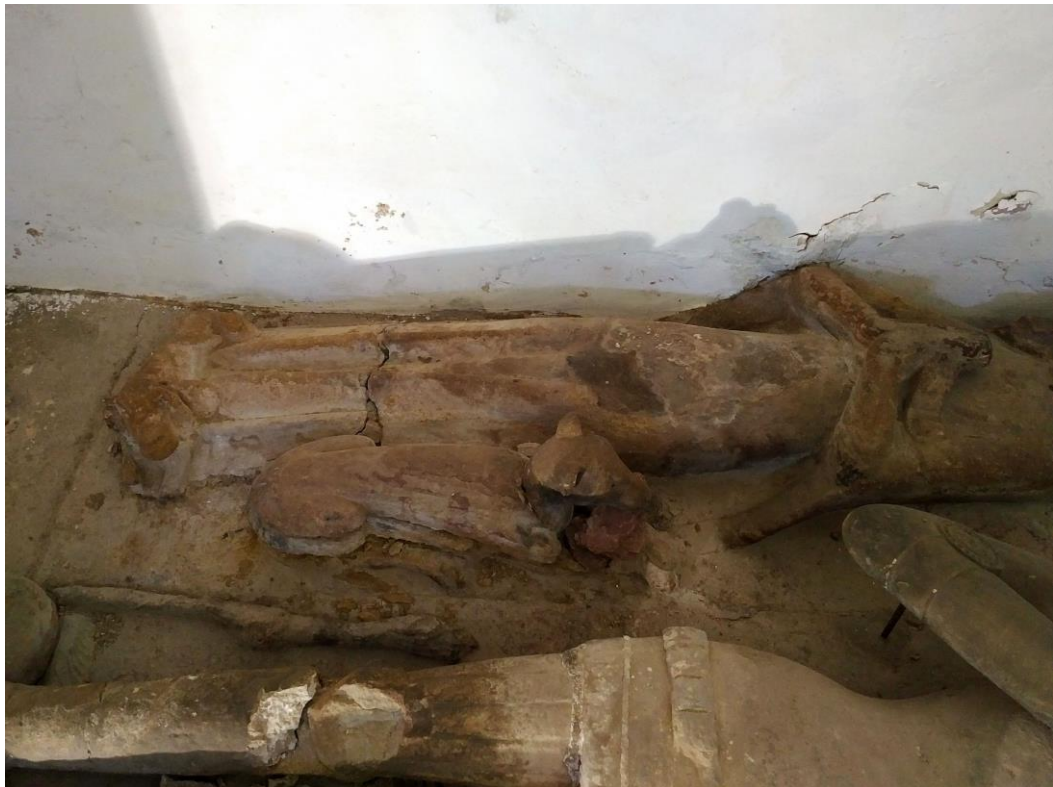
Plate 22: Maud before work: the foot end; cracks, soiling and bloom

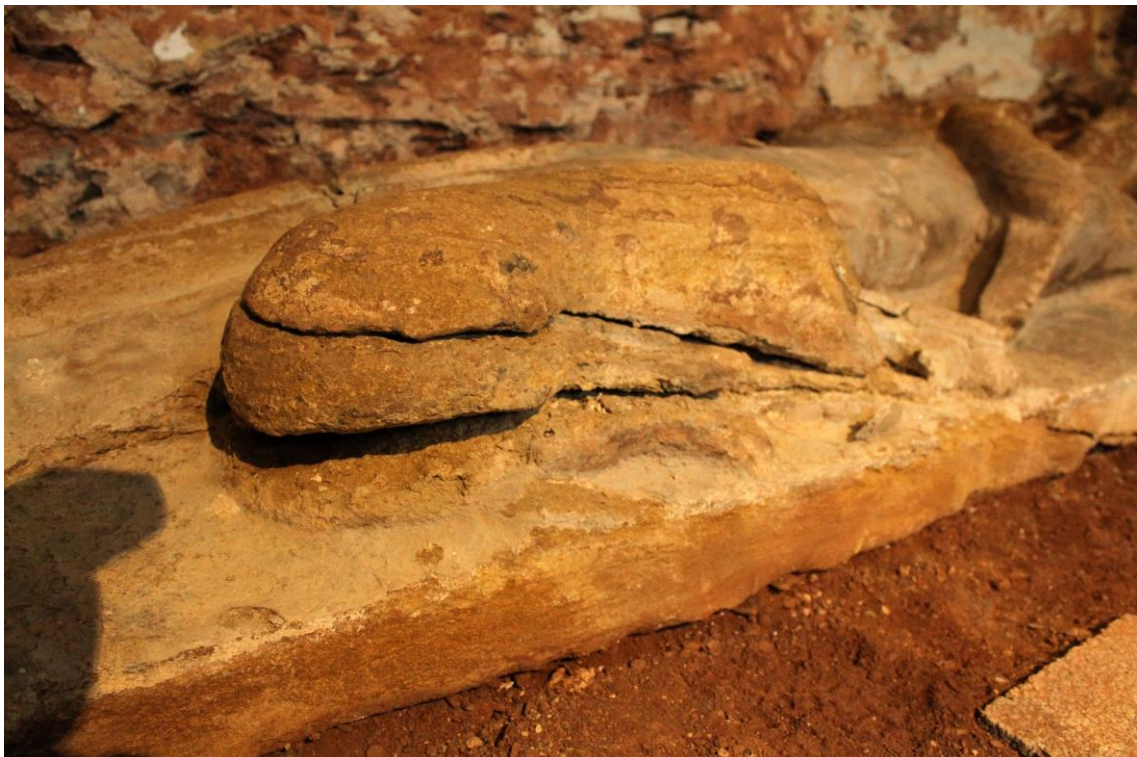
In addition, there were further fractures at the lady's neck, along her forearms, extending along her upper arms and along the base of the figure where it joined the slab. This last fracture continued around the lower cushion. The hound at her side was laminated into three main sections, the lowest

Plate 24: the companion hound, fractured into several large fragments

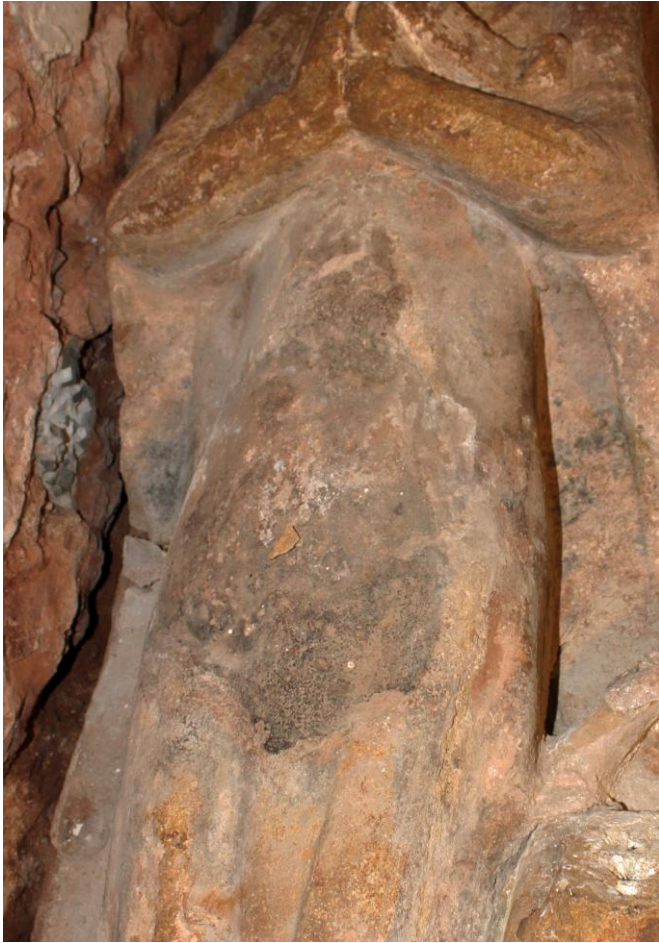
A large dark grey cement repair had been applied to the lady's gown over her stomach, and some salting could be seen around the edges of this hard inappropriate repair work. A number of other areas had also been repaired, but generally with softer mortars apparently bound in lime. Areas of stone surface were weak and crumbly, and there were numerous losses to surface details. Surfaces were soiled, covered in heavy accretions of dirt and debris, and in many places some kind of cement wash appeared to have been applied, perhaps to unify the surface appearance following the large cement repair mentioned above.

Plate 25 left: large grey cement repair on the lady's gown

Stone surfaces were cleaned with cotton swabs and pH neutralized deionized water; areas of significant weakness were consolidated with Calosil E25 nanolime, applied in a number of phases as the situation demanded. The large grey cement repair on the lady's kirtle was removed and, after consideration, it was decided not to replace this with lime mortar, since it was a shallow repair and its removal had not damaged her appearance.

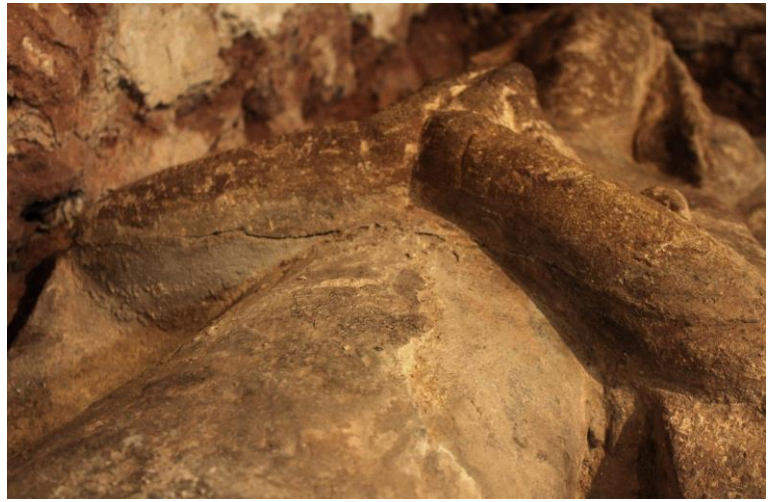
Plate 26 below: fracture along the arms

Grouting of fissures and fractures was undertaken with caloxil injection mortar- a material based on ethanol rather than water and therefore suitable for moisture sensitive situations. Surface filling of these fractures was then undertaken with lime mortars matched to the surrounding stone. Some surface distressing of these repairs was undertaken with water colours and limewashes.

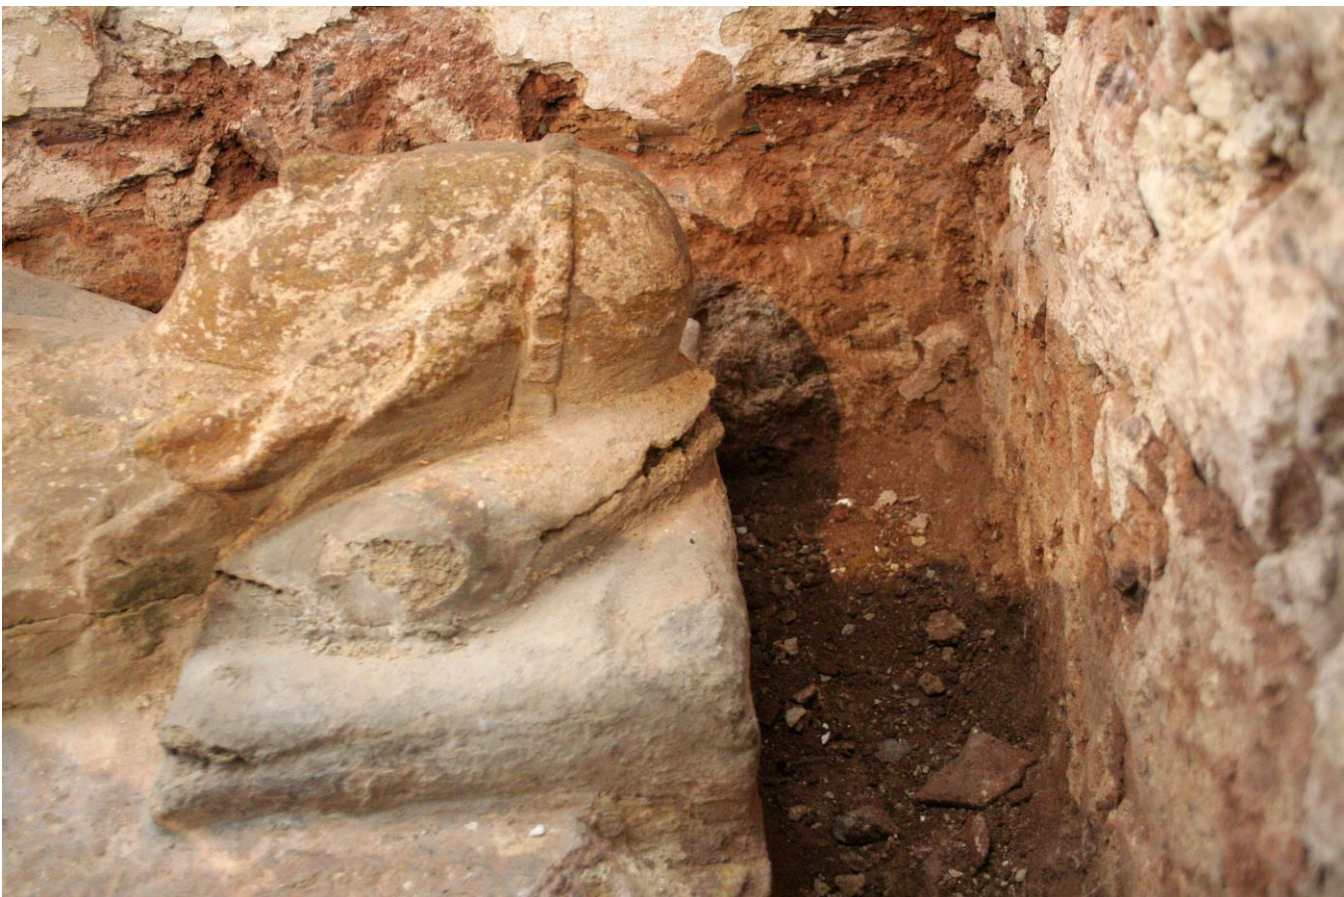
Plate 27 bottom: fractures through the cushion and head

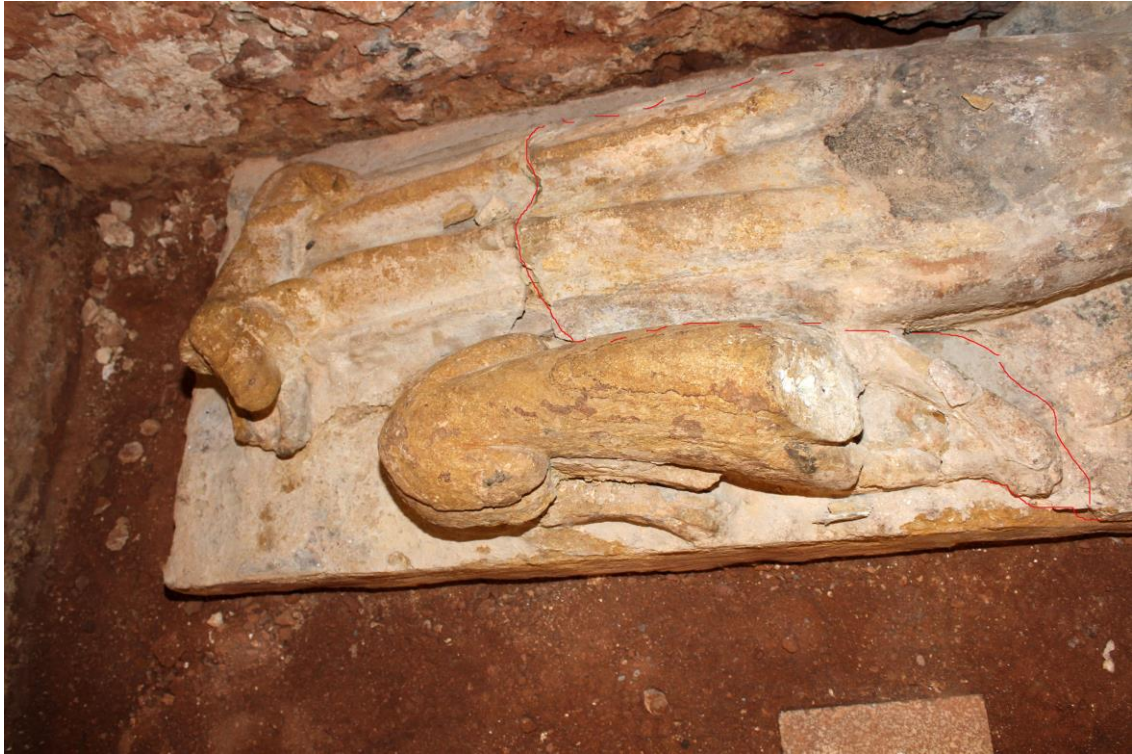
Plate 28: graphic, showing the fracture through the effigy (red line)

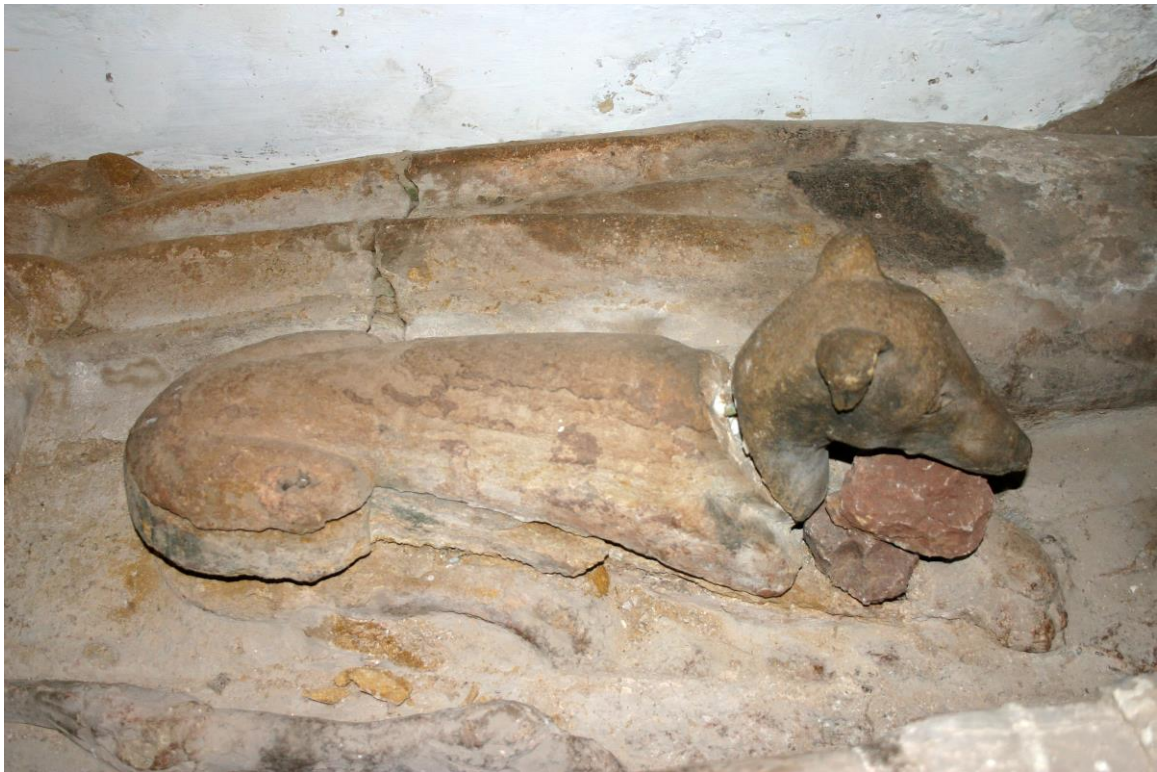
A discussion was held with the parish as to whether to retain the modern head of the hound at the lady's side. It was agreed that the head, though in style and condition somewhat different from the original, should be retained because it was well made in itself and its addition allowed the entire ensemble to read much more fully. A headless, somewhat decayed hound would have been difficult to interpret, not to mention macabre. The head was therefore re-fixed using the pre-existing dowel holes with a small amount of resin and plaster. This fixing will allow this head to be removed if at some future point it is deemed unsuitable, by creating a firm but reversible bond.

Plate 30: the companion hound, showing jumbled, unfixed arrangement with modern head

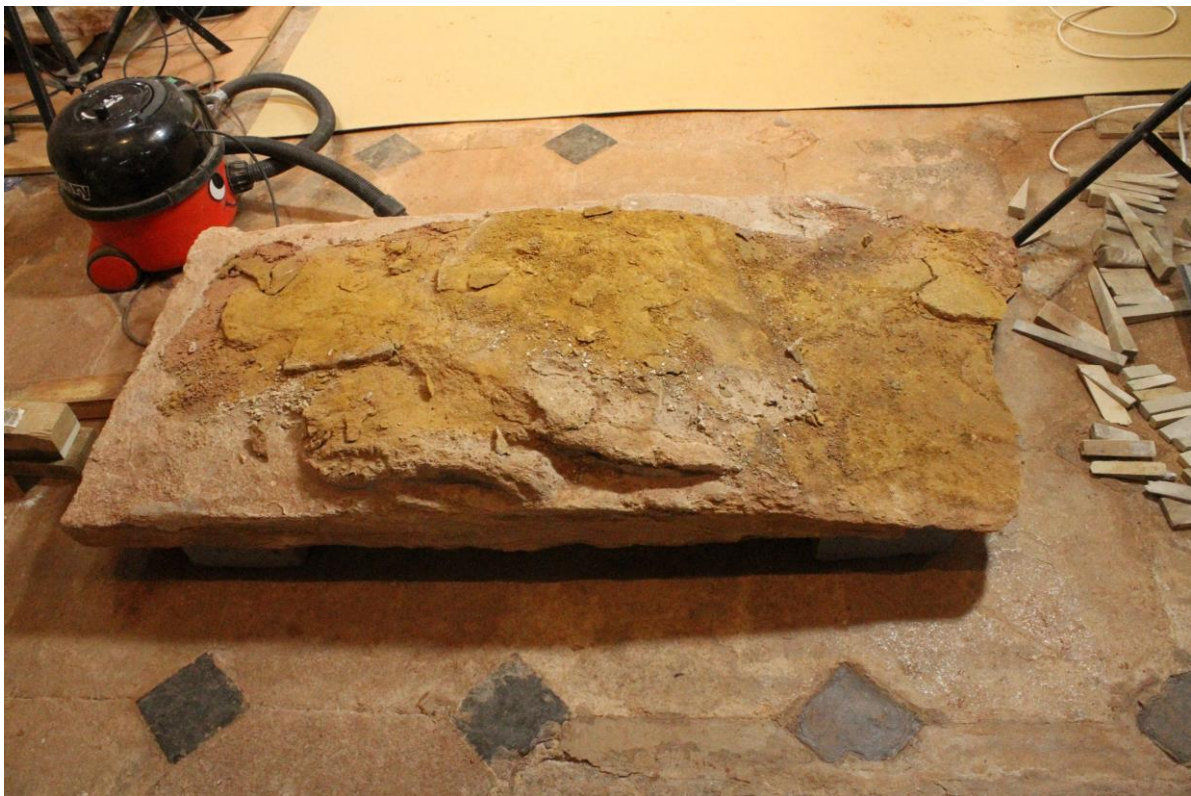
Plate 33: lower fragment, showing poor condition and stone weakness

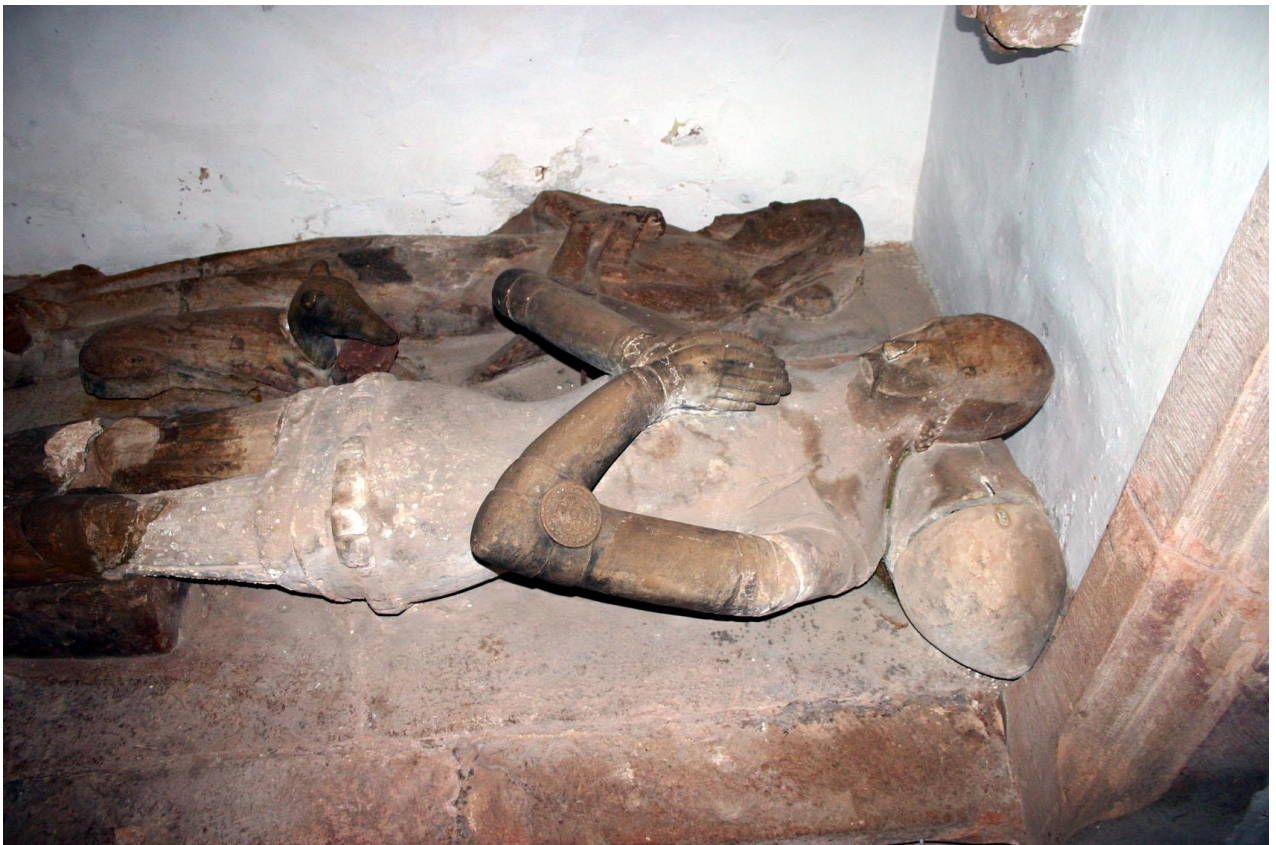
disrupted and blisters had broken open in some areas, whilst in others, fine cracks had formed in the surface. The base was buried into the floor, laid on very damp soil-based rubble and surrounded by a hard cement screed; staining and patchiness disfigured the carving, the animal's head had been detached and reattached crudely with gypsum plaster. Both effigies in this recess were tightly jammed into a space clearly too small to accommodate them.

Plate 46: Effigies of Sir John and Maud before work, squeezed into the recess, stained, damaged ,badly repaired

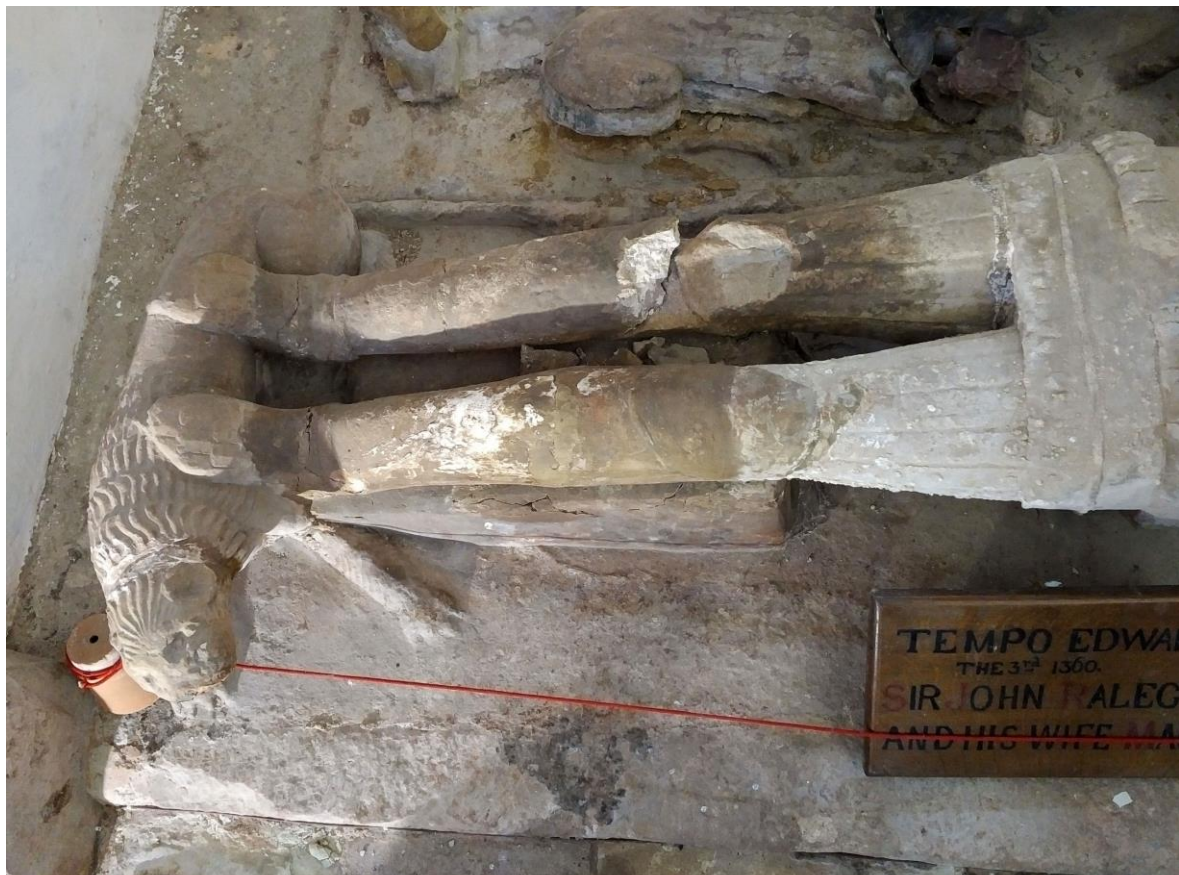
Analysis established that the disfiguring leg repair work had been carried out at least partially in gypsum-based plaster, and that similar material had been used to fix the hands and the detached dexter thigh. The surface was extensively covered with cement slurry, the inaccurate arms and hands had been fixed with ferrous rods that were now corroding and causing damage to the surrounding stone, and the dexter thigh had been fixed into the torso with a very large iron square-section bar. This had caused fine cracks to appear in the torso. Further ironwork was to be found in both repairs to the lower legs, and had caused shattering of the original stonework of the poleyns (knee protectors).

Plate 47: Poorly conceived and executed leg repairs, with large support block

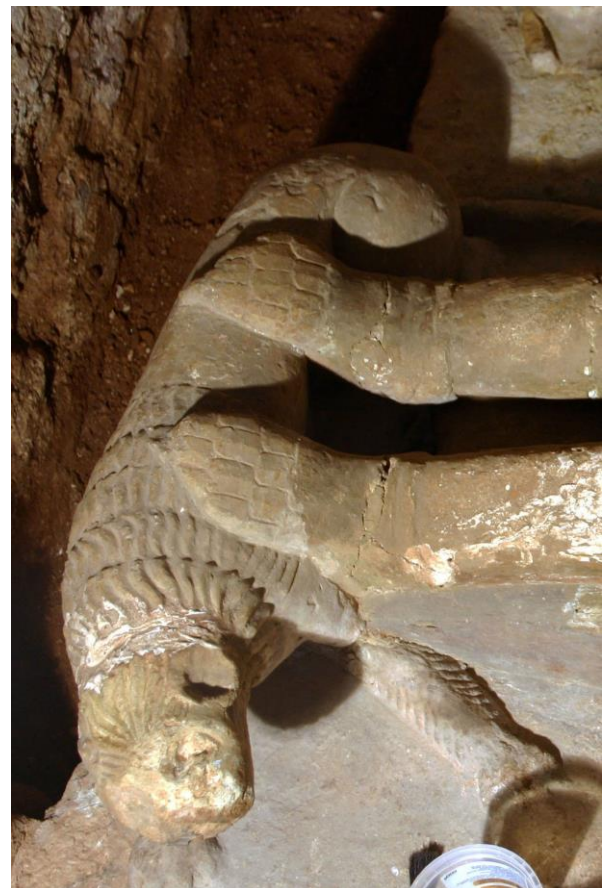
Plate 48, right: gypsum repair to the animals neck

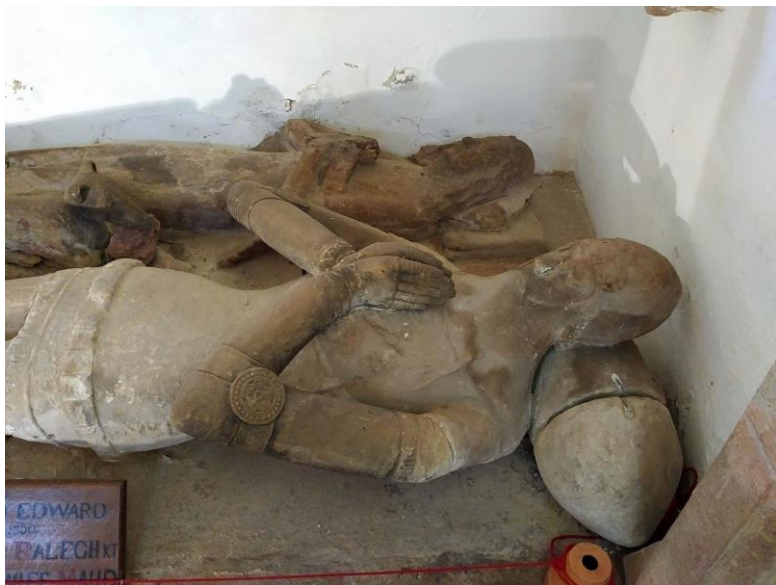
Plate 49: detail of inaccurate arm and helm repairs

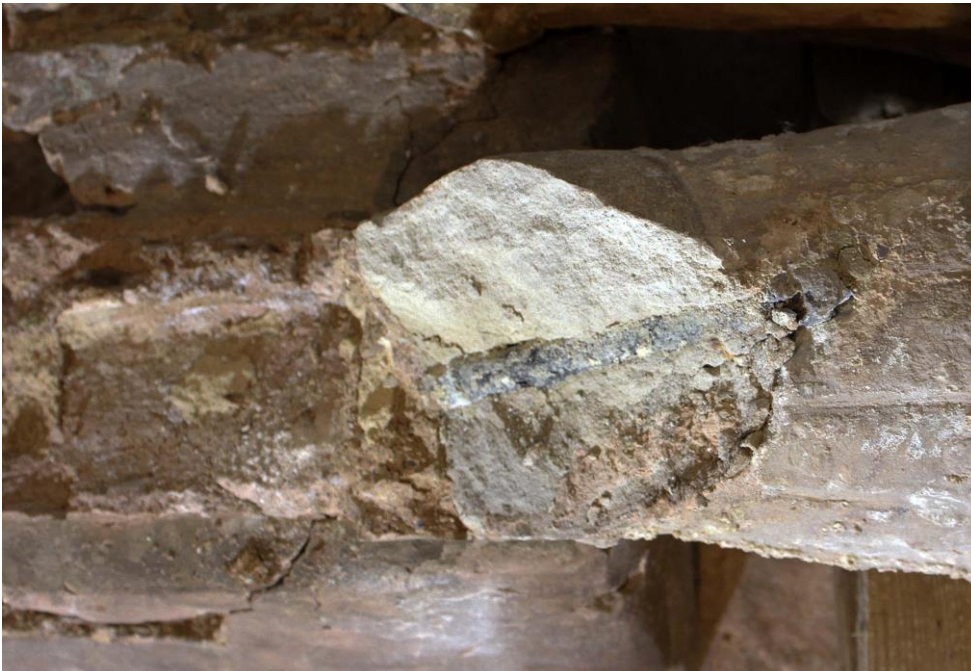
Plate 51: the large iron rod in the sinister leg

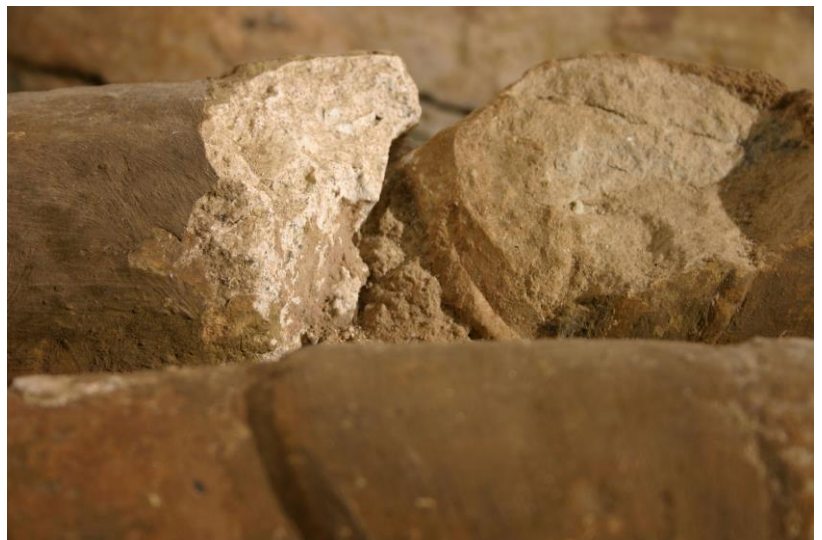
Plate 53: broken state of leg repairs before removal

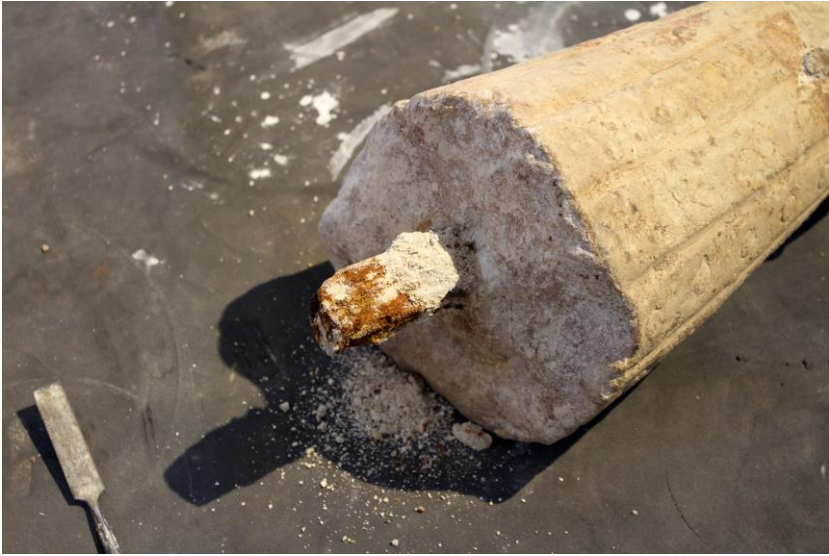
The dexter thigh, which was a separate block from the knight's torso, had been attached with a large iron bar, as mentioned above. This was gently eased out of its socket, but it was found to have fractured with dexter side of the torso in several places. These fine but deep fractures were accordingly stitched with skew pins of 4mm threaded stainless steel rod (316L) set in resin, to ensure

Plate 54: Dexter upper leg removed, with massive iron bar

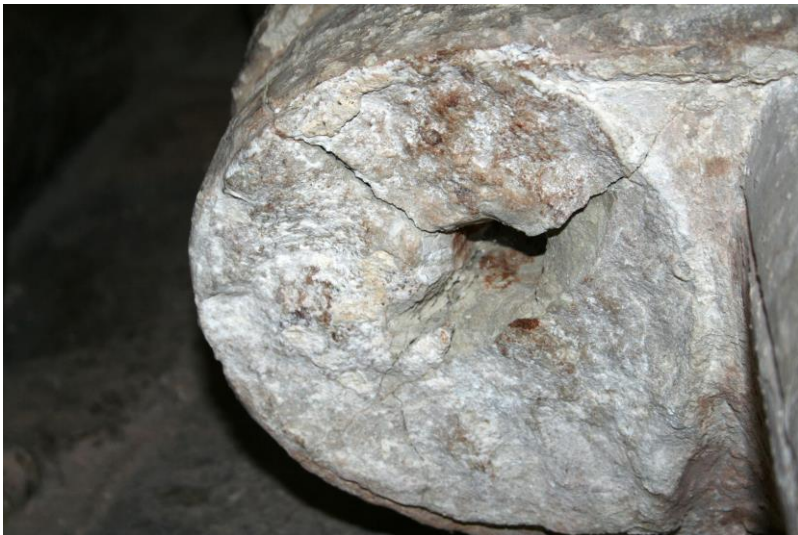
Plate 55: Damage caused to the torso by this bar

a firm repair. The cracks were then filled with matched lime mortars. Areas of damage and shattered stone around the knees of the figure were repaired, using Mastice 2000 polyester resin where necessary for reattaching shattered fragments, and air lime mortars for repairs. Areas of fine cracking were consolidated with dispersed lime or Calosil E25 nano-lime, applied through syringe. The large block at the dexter shoulder of the figure that had been inserted with Portland cement to support the new dexter arm was removed and the large holes that had been cut in this site of the figure were filled with lime mortar to match the surrounding original stone.

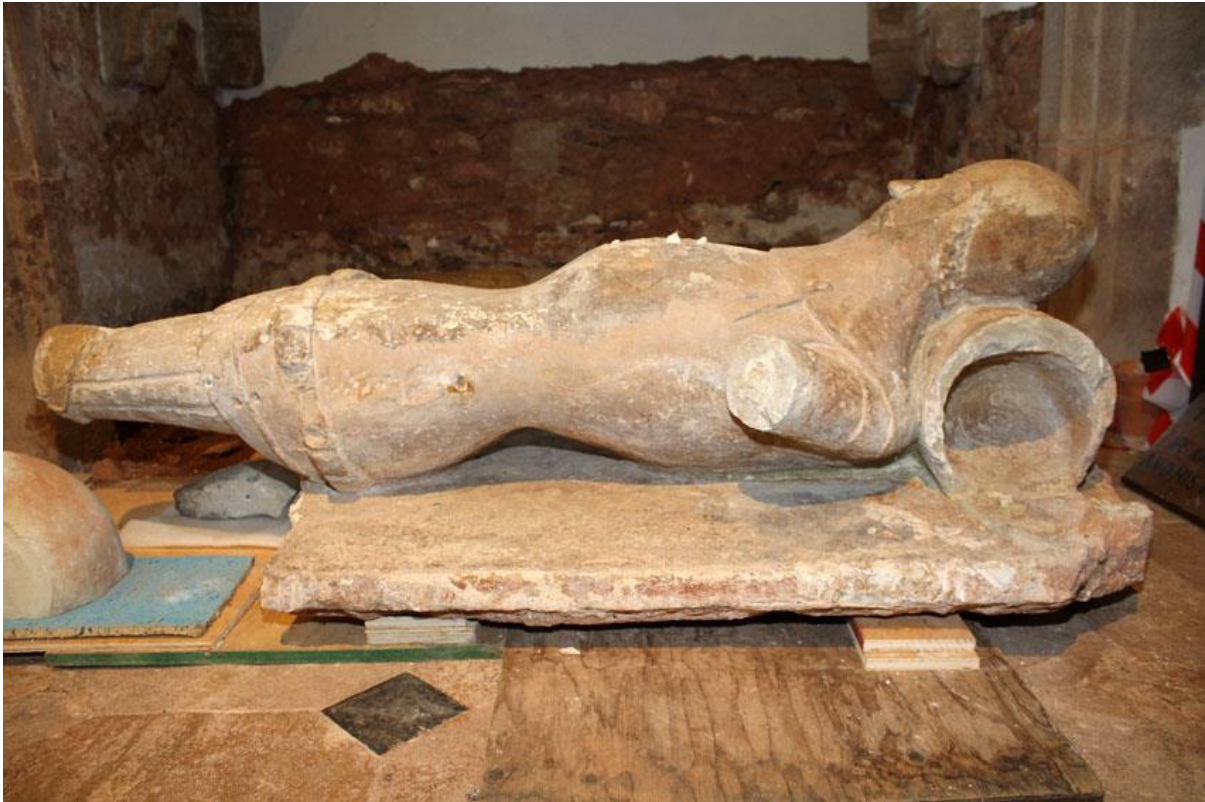
Plate 58: holes cut to take previous arm repairs, and cemented block to support those arms

Plate 59: removing the cement and block
