**WATCHING BRIEF:
ST MARY'S CHURCH
DRAYTON BEAUCHAMP
BUCKINGHAMSHIRE**

NGR: SP 9015 1188

November 2021

Project ref: 1883/DBC/02

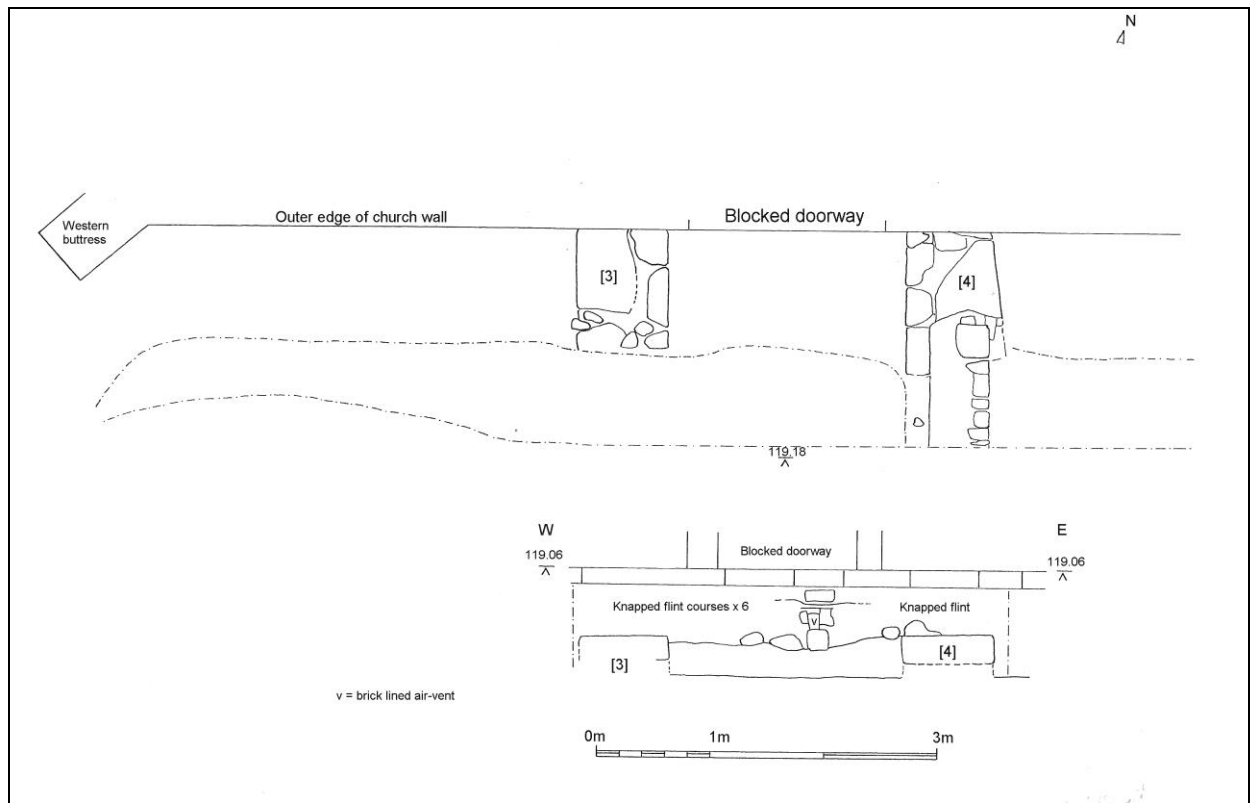
Figure 4: Plan and section through the blocked southern porch (*Scale as shown*)

Below the topsoil, approximately halfway along the south wall of the nave two, parallel, masonry built walls were uncovered. These were located either side of an existing blocked doorway (Plate 1). The western N-S wall (3) was 800mm thick and was situated 3.8m east of the western buttress. The eastern N-S wall (4) was 820mm wide and located 5.18m west of the eastern buttress (below, section 4.4.3).

Two courses of stonework were observed (Fig. 4; Plates 5-7). Overlying the lower course was a secondary course, c.500mm wide which was exposed for a length of 1.15m. The lower course composed roughly hewn limestone blocks of limestone (between 600 x 500 x 200mm and 200 x 400mm x 200mm) and Totternhoe Clunch (c.200 x 400 x 0200mm).

The internal width of the blocked porch was 2.05m but its length was not established as it extended beyond the area of the works. However, it was

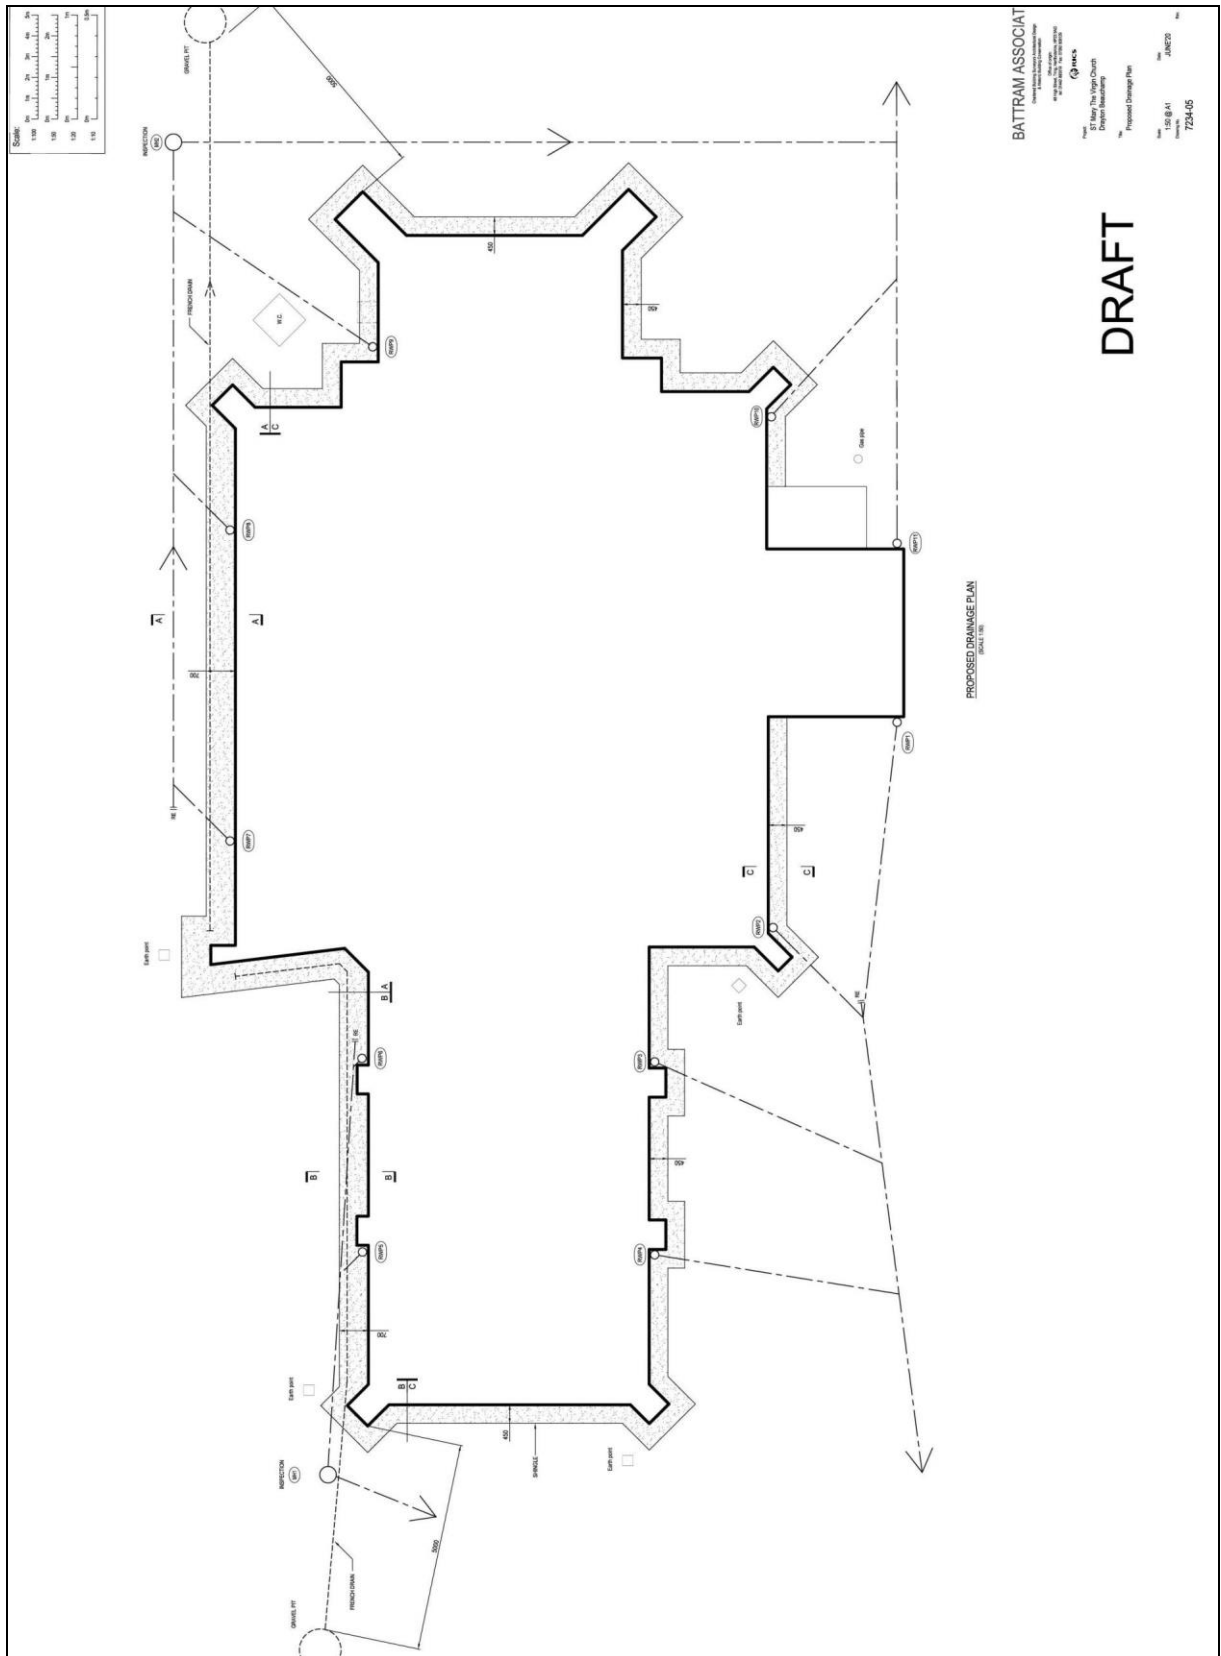
Figure 6: Plan of the drainage runs (Scales as shown)

4.5.1 The excavation of drainage runs around the entire circuit of the church (Fig. 3) was observed. The trenches were generally c.200mm wide and c.900 although their dimensions varied at intervals around the circuit.

4.5.2 The mixed burial ground soil was present throughout and comprised turf and topsoil, up to c.400mm thick over greyish brown subsoil which, in places contained chips of marl. Fragments of disarticulated human bone were present and, at the request of the parish priest, these were collected and will remain within the burial ground/church and will be reburied.

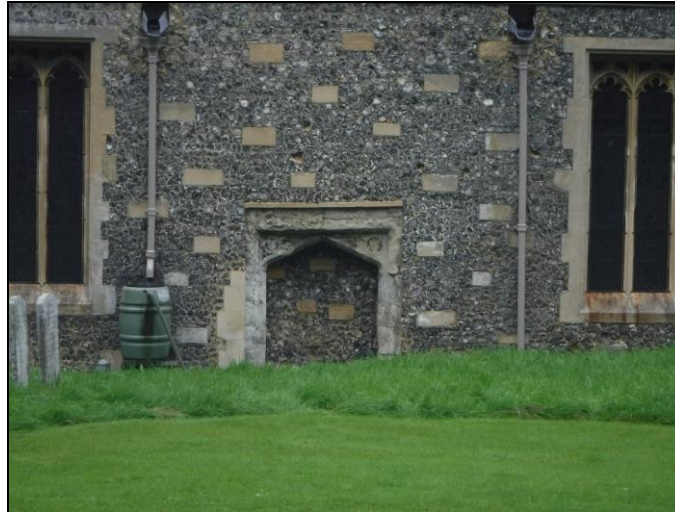
Plate 1: Detail of blocked doorway of former porch

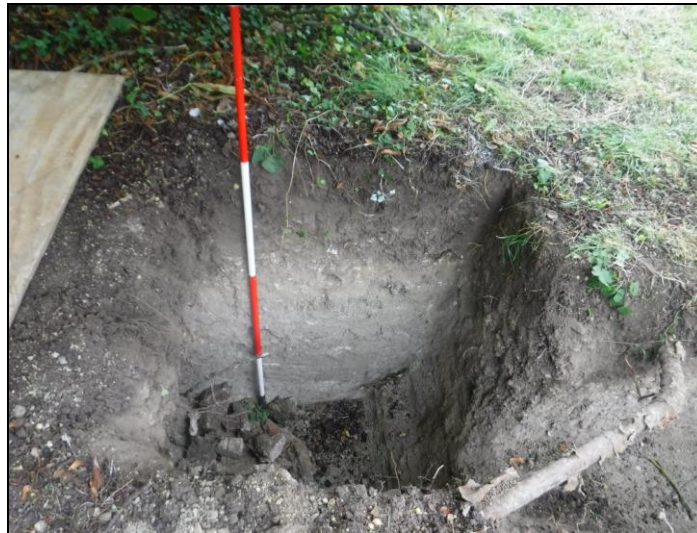
Plate 2: Detail of soakaway on SW side of church view N

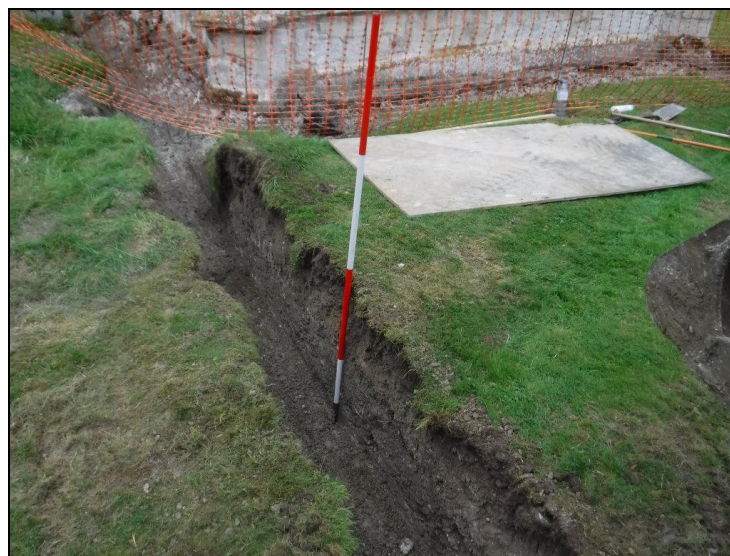
Plate 3: Character of make-up of the ground looking WNW

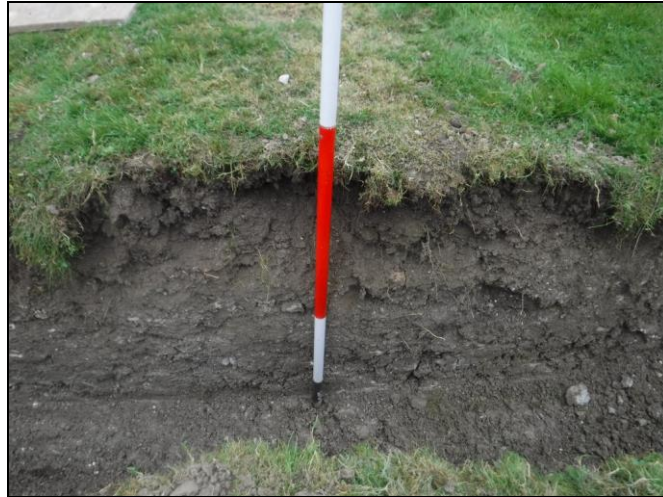
Plate 4: Detail of the above (Plate 3)

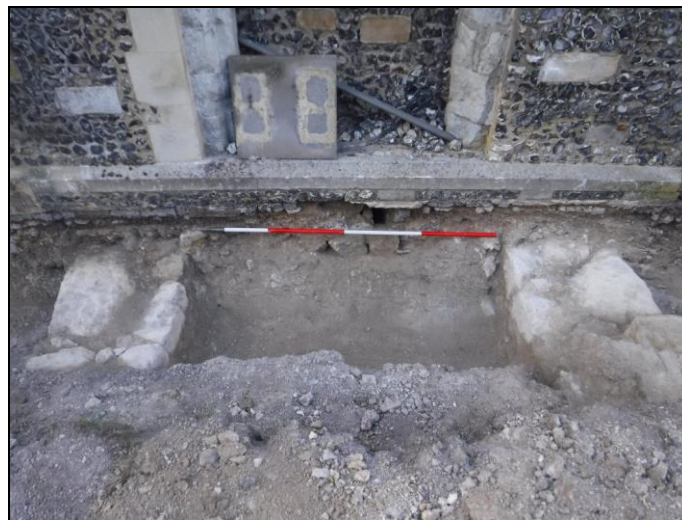
Plate 5: Exposed foundations of the former porch (*Scale = 2m*)

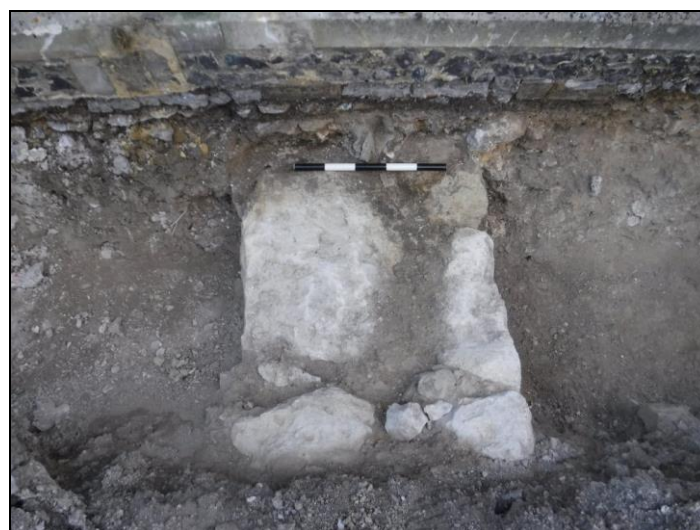
Plate 6: West side of N-S foundation of porch [3] (*Scale = 500mm*)

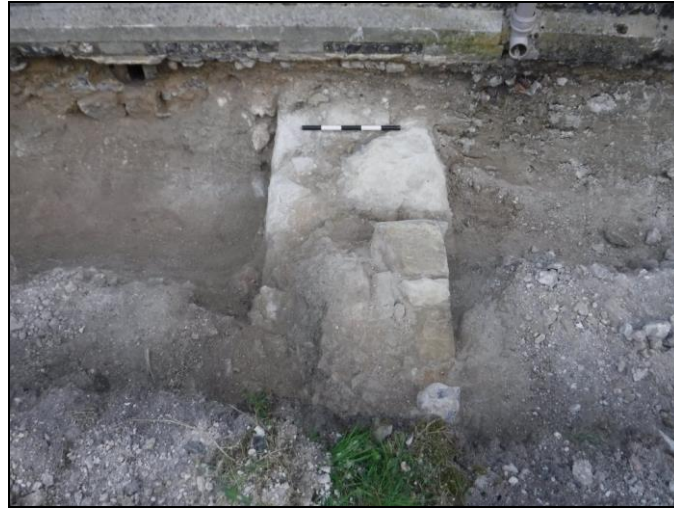
Plate 7: East side of N-S foundation of porch [4] (*Scale = 500mm*)

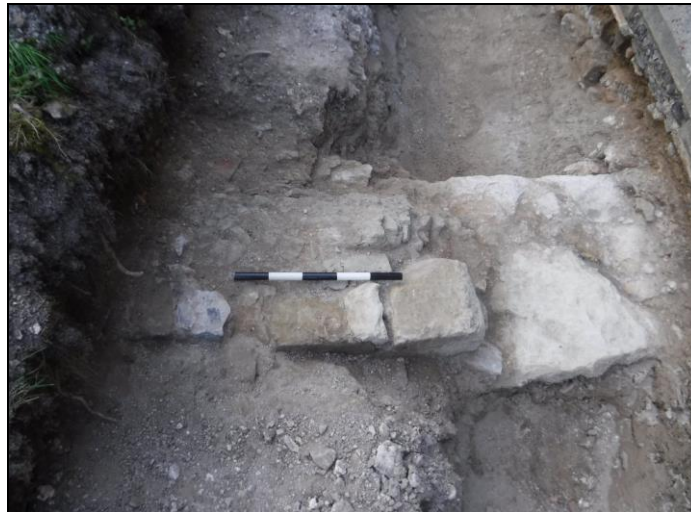
Plate 8: East N-S foundation [4] looking west (*Scale = 500mm*)

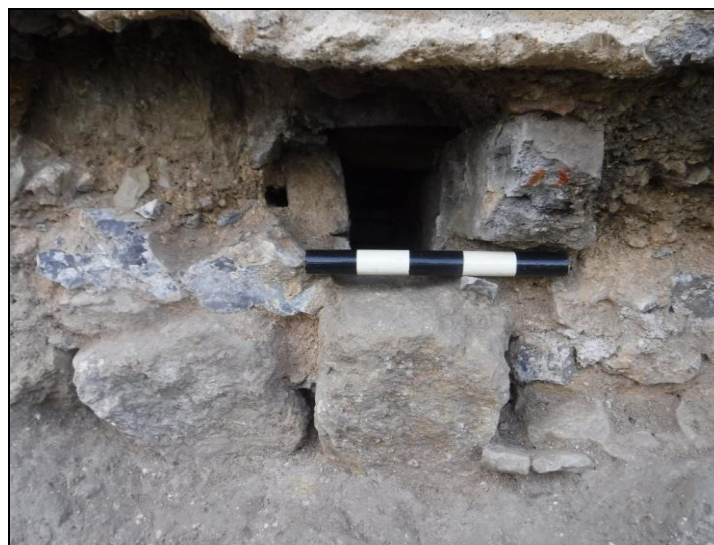
Plate 9: Air vent below blocked doorway (*Scale = 250mm*)

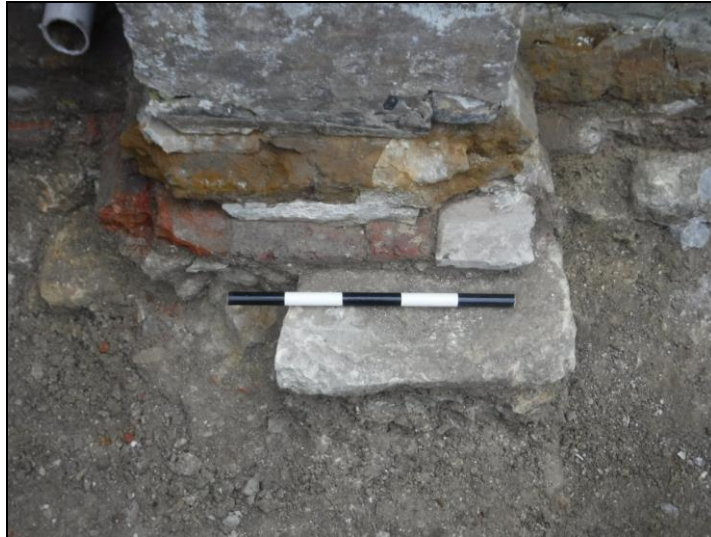
4.2.1 The bases of both the north and south walls of the chancel were exposed during the works (Plates 10 and 11). The wall on the south side of the chancel continues 0.5m down (below ground level) where it rests on an offset (0.14m wide) composed of a mix of Totternhoe Clunch blocks (c.0.4 x 0.2 x 0.15m and 0.3 x 0.2 x 0.12m) and limestone blocks (0.5m x 0.16m thick with width unknown) (Plates 10 & 11). This offset lies in turn on a second offset which is 0.4m wide and topped with chamfered brick 220mm long. The stones used in the upper chamfered stone course are 0.5 x 0.23 x 0.14m in diameter.

Plate 10: Detail of chancel buttress on its south side view N (*Scale = 500mm*)

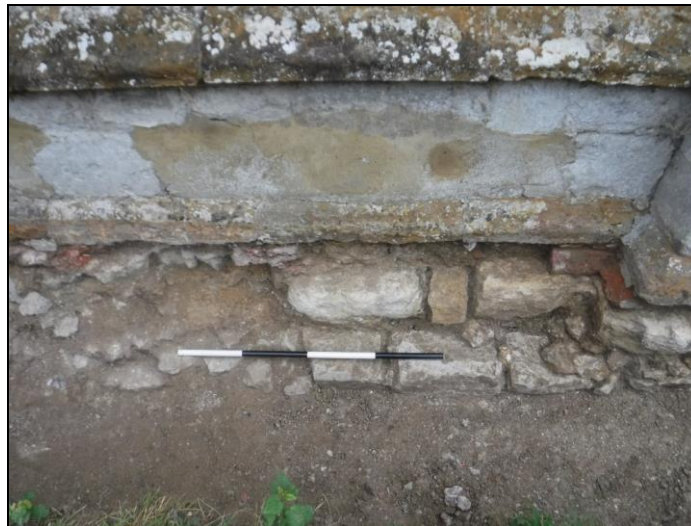
Plate 11: Footings of chancel on its south side (*Scale = 1m*)

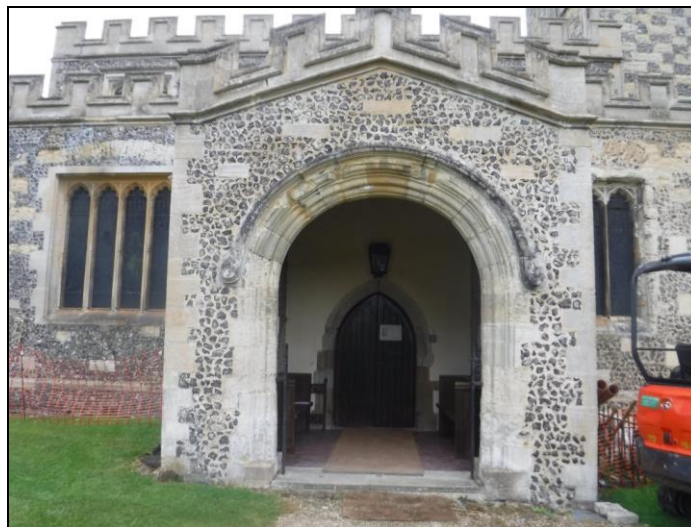
Plate 12: Entrance to existing porch on N side of church looking south

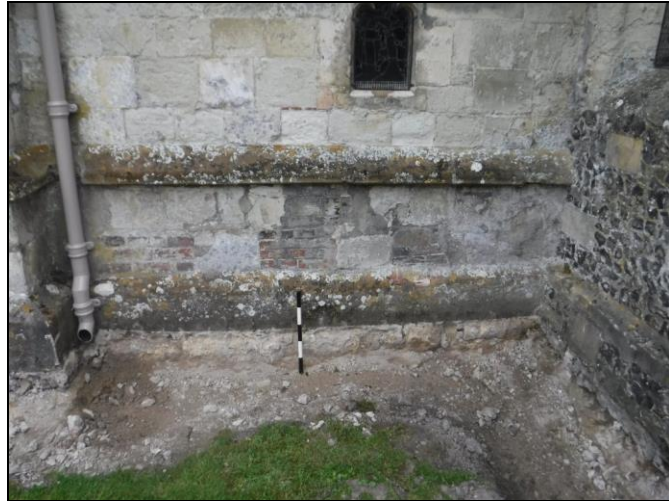
4.2.2 The north wall of the chancel appears to be composed of the same foundation material but is only 0.3m below the offset (Plate 13). This consists of limestone blocks overlain with Victorian brickwork.

Plate 13: Detail of wall and footings at NW end of chancel.

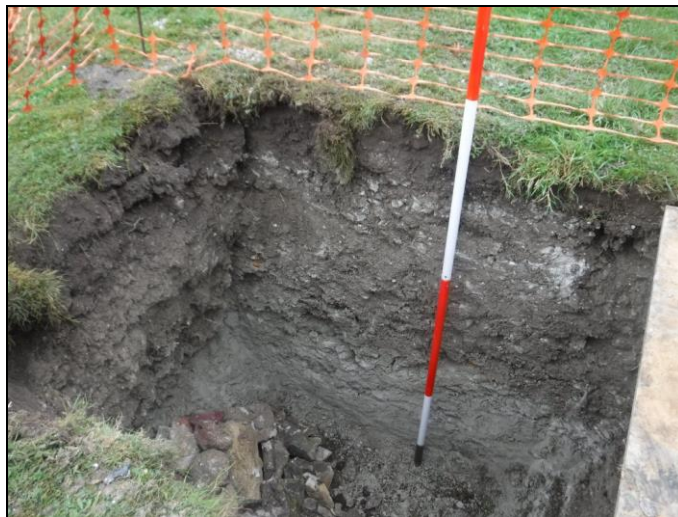
Plate 14: Detail of soakaway at the SE corner of the church view ESE

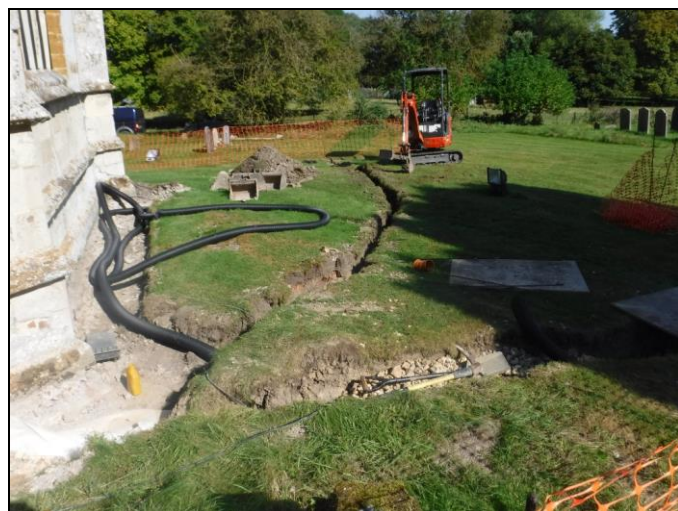
Plate 15: Drainage run on the east end of the church view west

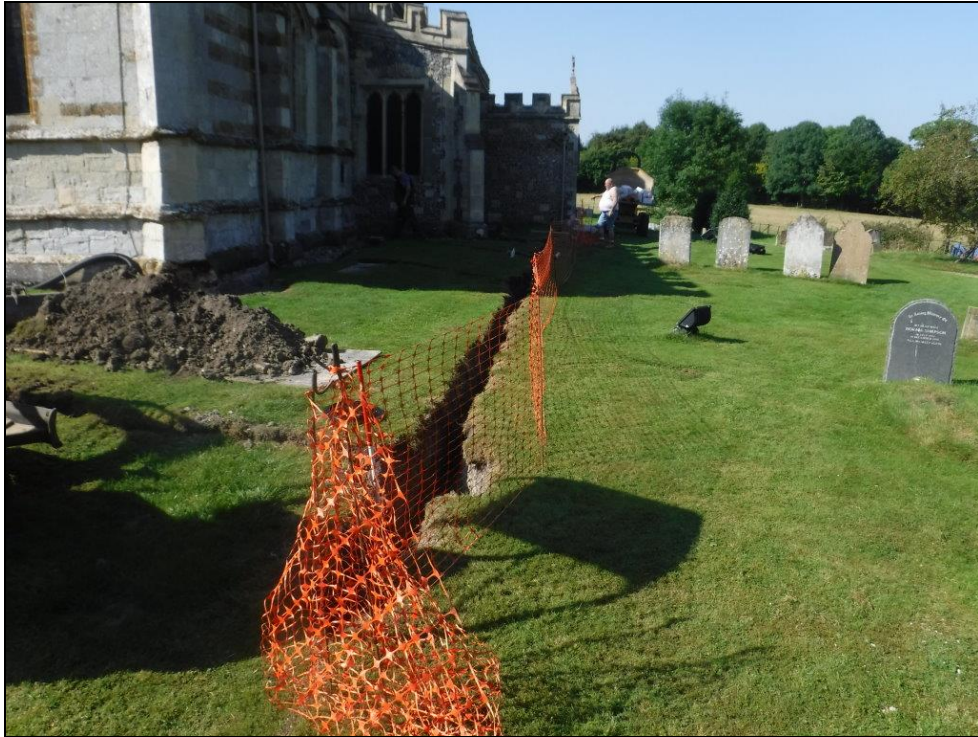
Plate 16: E-W drainage run looking west on north side of the church
