ST MARYS CHURCH, DRAYTON BEAUCHAMP

Excavation inspection around church Sept`21

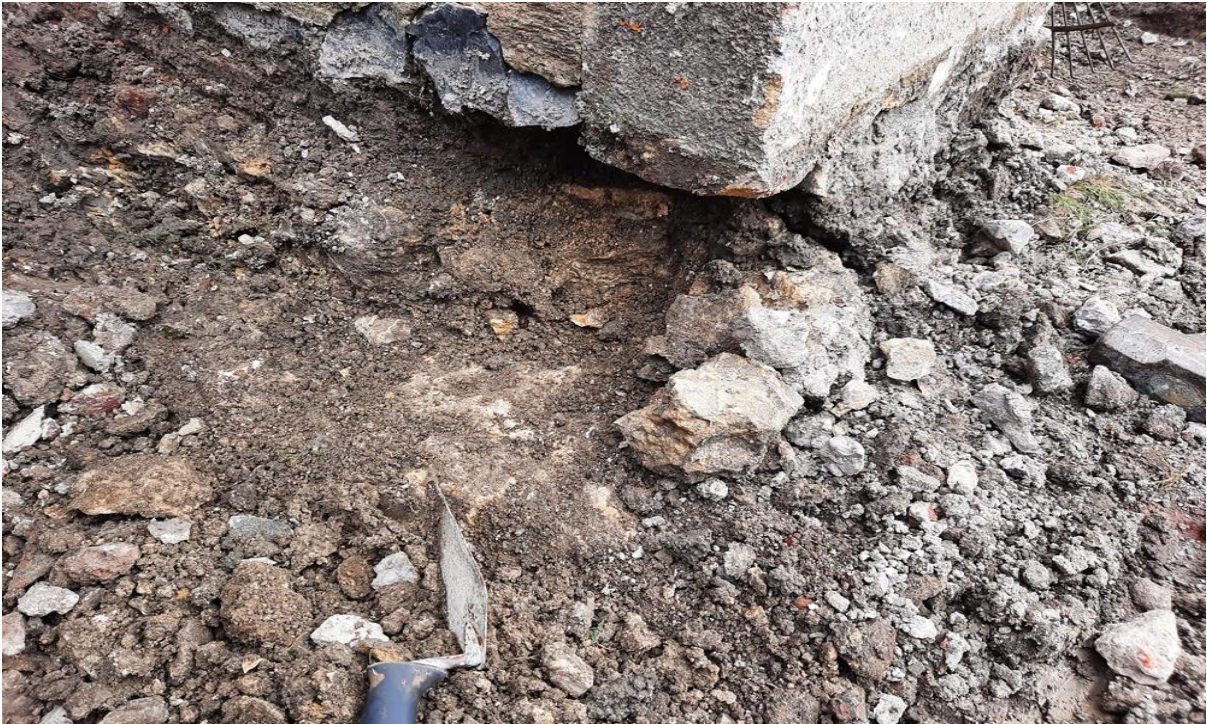
- 1) For positions of all photos see the addendum plan annotated. Photo (1) shows on NE aisle corner a collapse of underlying rubble – as part of the drainage works inset FFL resistant bricks below ground level to stabilise outer stone corner:

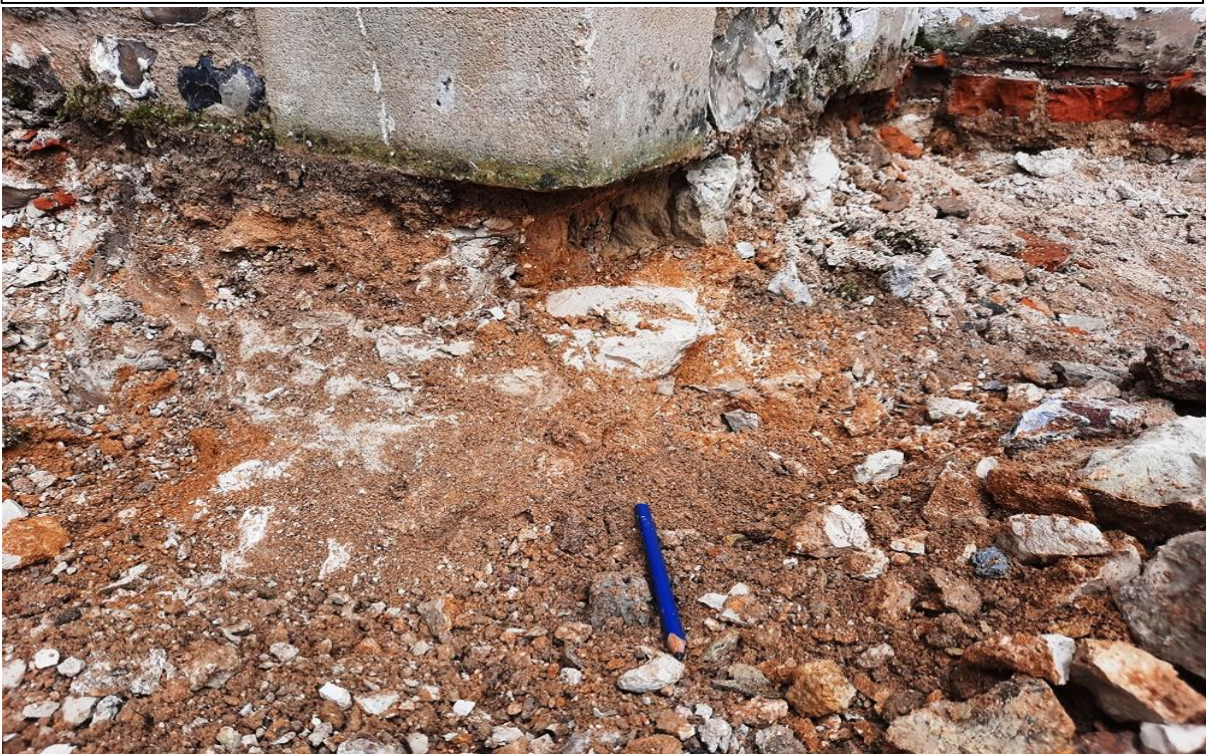
- 2) The photos and descriptions continue around the church in an anti-clockwork direction. This photo is as above with Victorian bricks underlying the stone corner dressing stone have crumbled away and new FFL bricks need to be set to protect the exposed outer edge of the buttress:

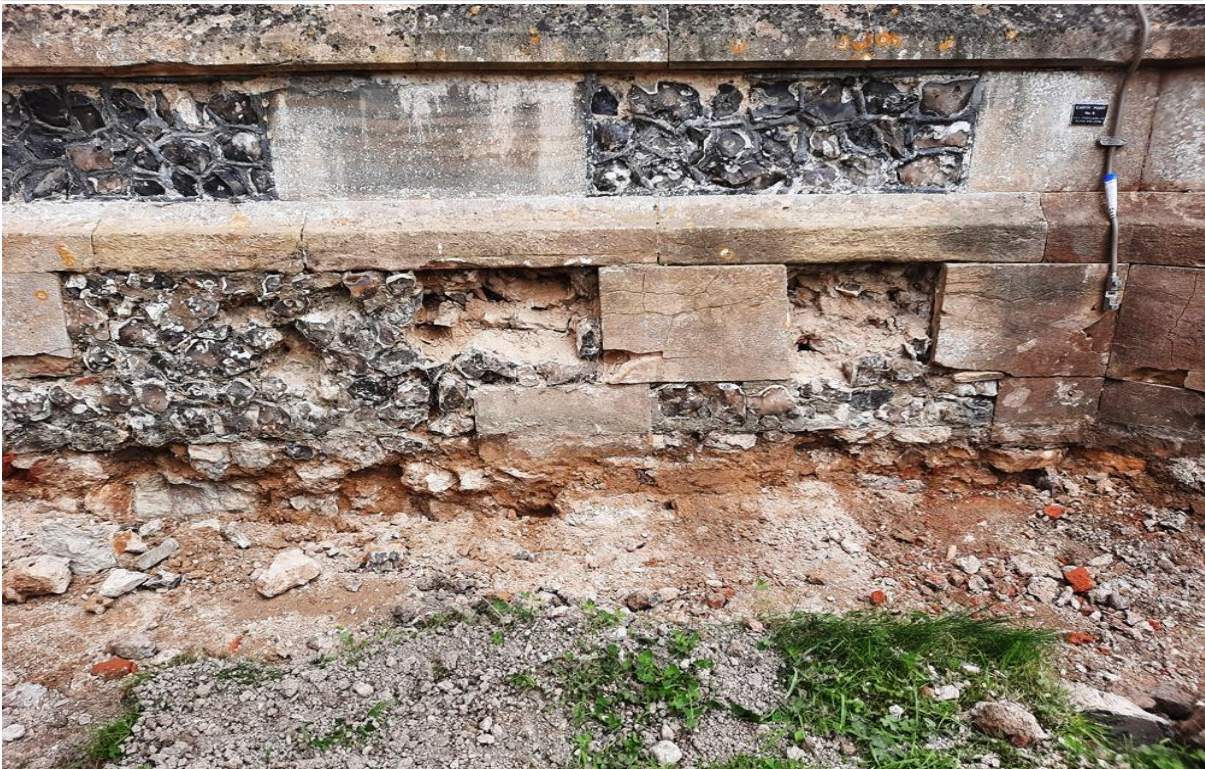
3) On North tower wall when the modern concrete apron was chiselled away it was noted that the Victorian applied flint base that was already crumbling started to fall away. The stone blocks that were spalled and fractured were very thin and need replacing, and flint panels reset:

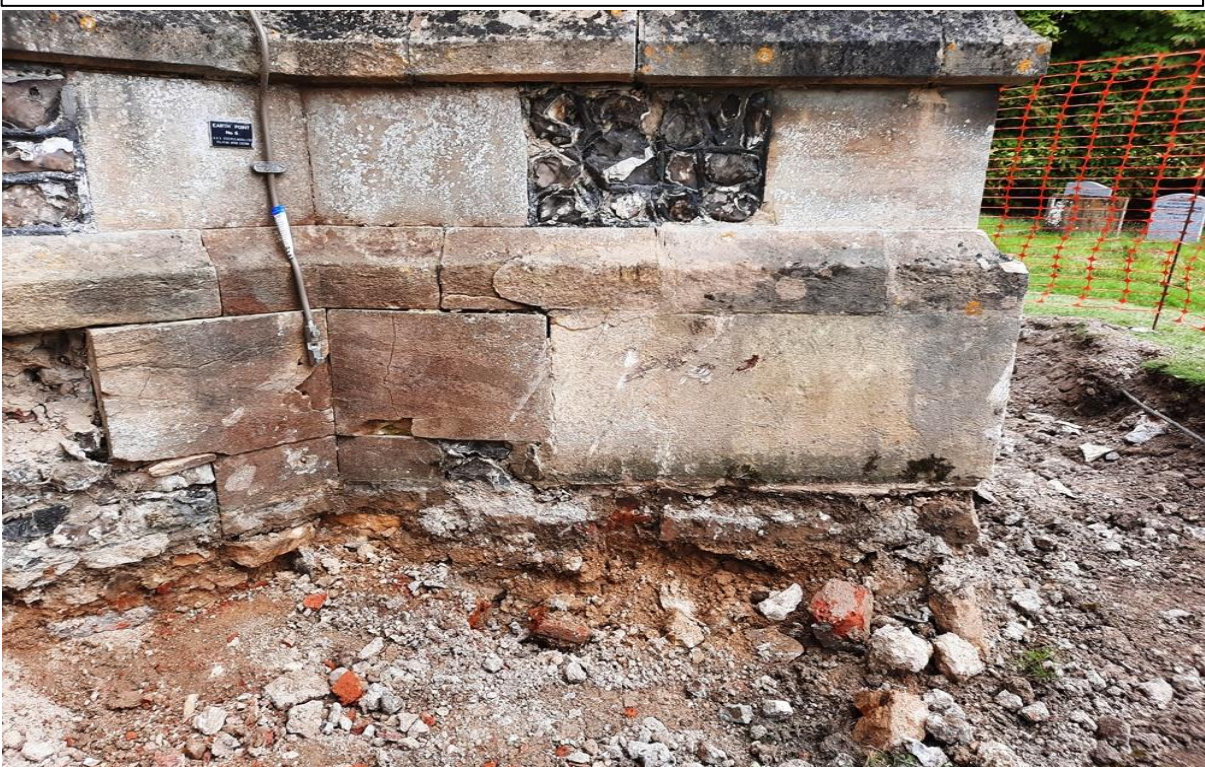
4) ditto last, the low level stones need repair, and part replacement:

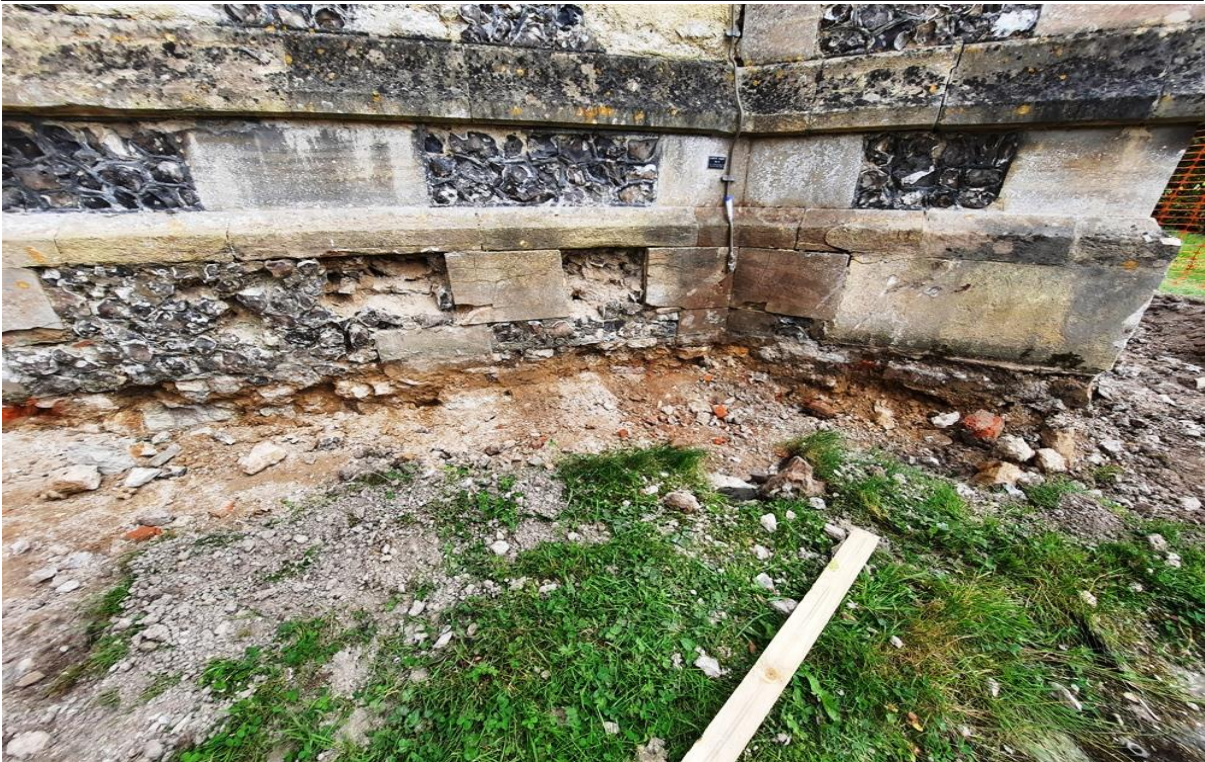
5) ditto last photo, the low level stones need repair, and part replacement – general view:

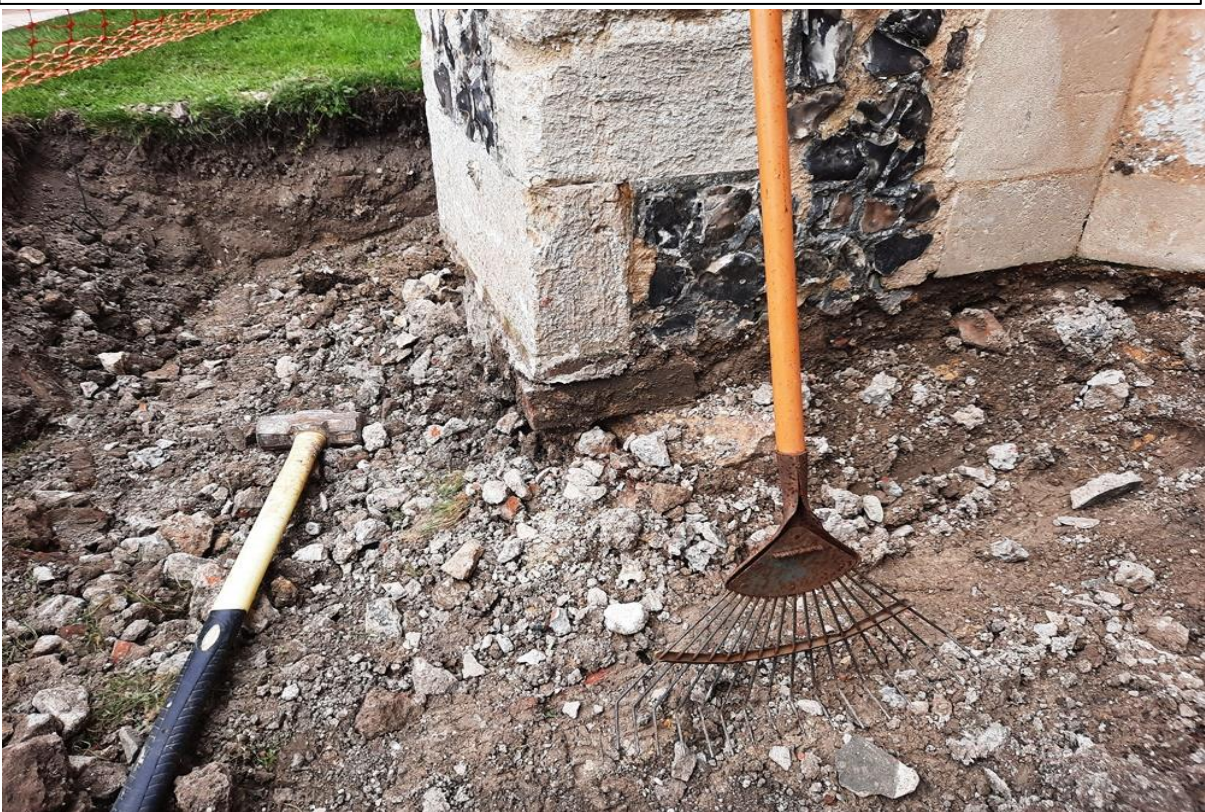
6) Another view of the NE buttress photographed in photo (1) where victorian bricks still intact:

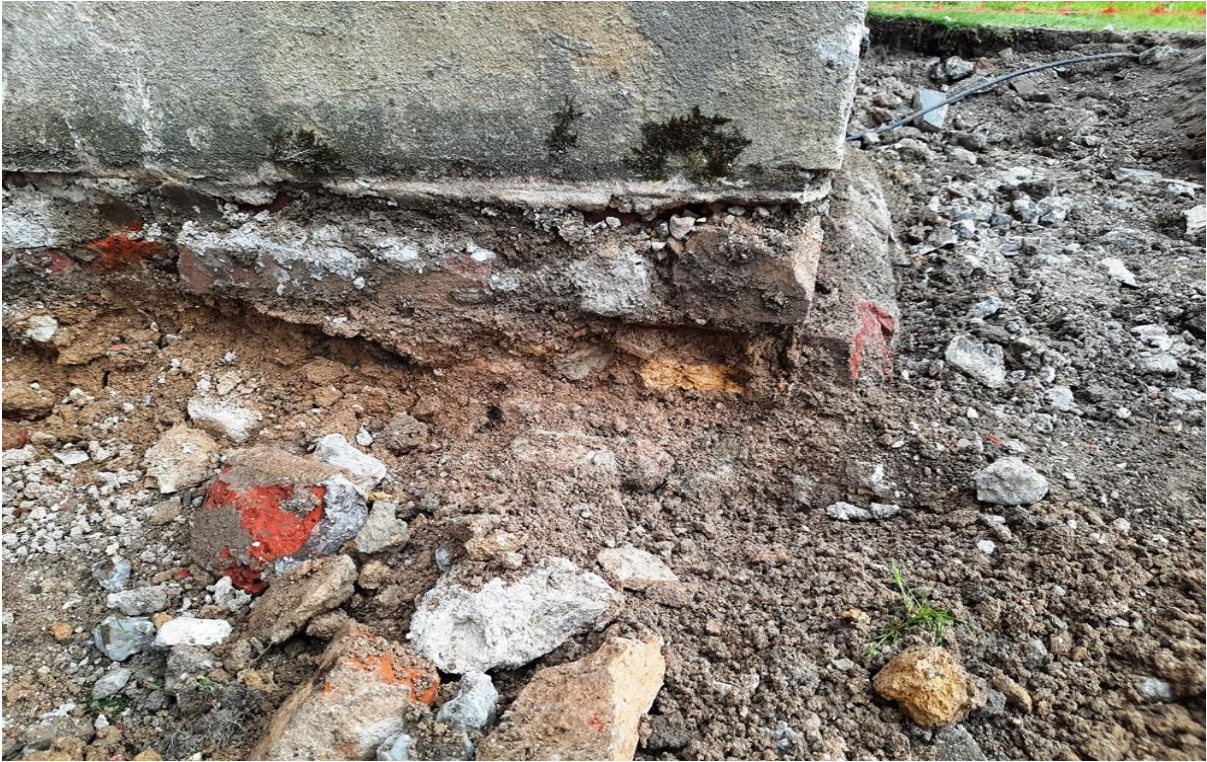
7) NE tower corner buttress noted to be set on compacted Marl rubble stones, which has settled. Chip away carefully the loose Victorian infill and set in FFL resistant bricks:

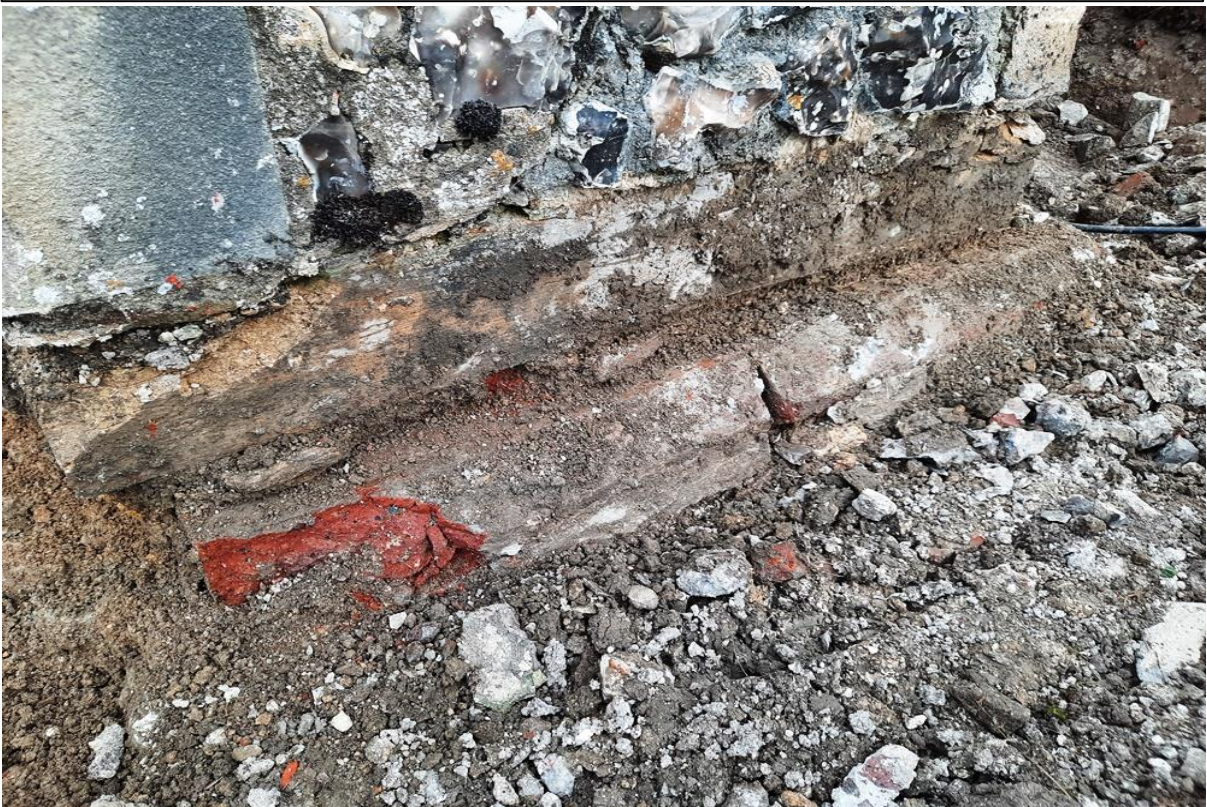
8) As above, viewed at front

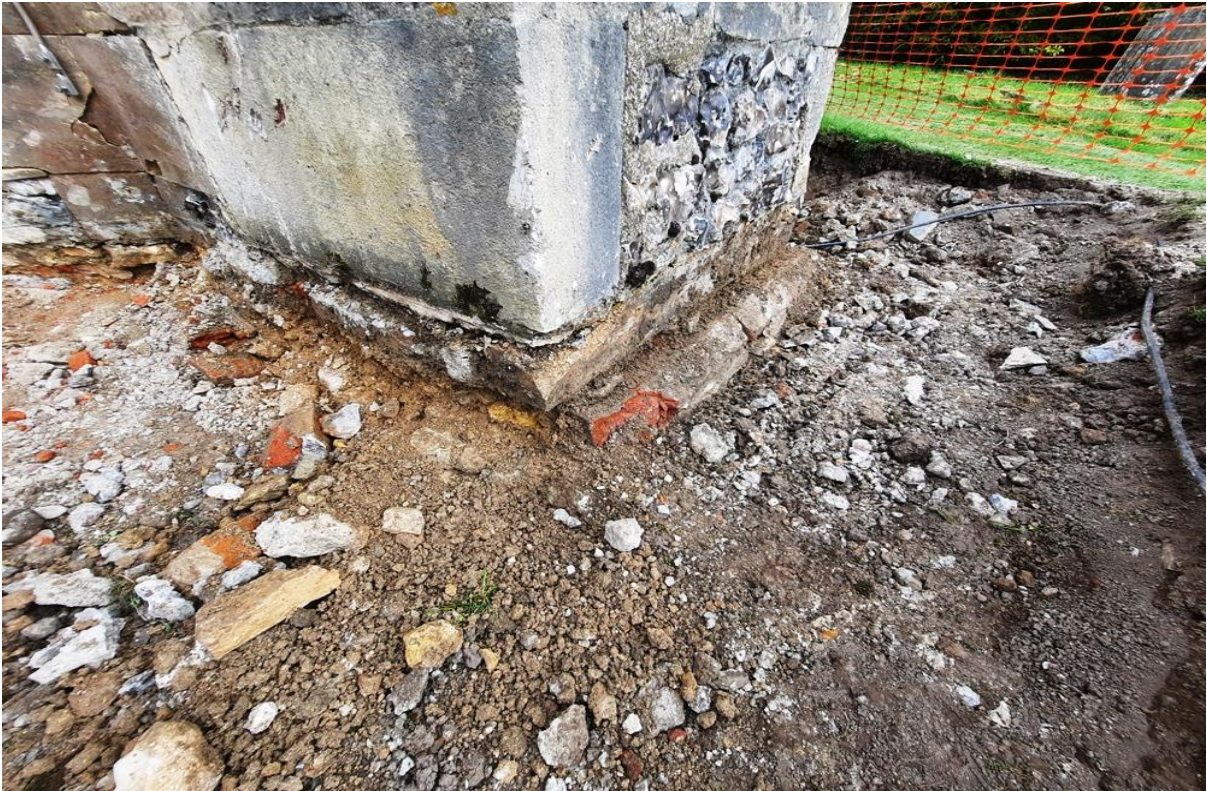
9) As above, viewed at front corner:

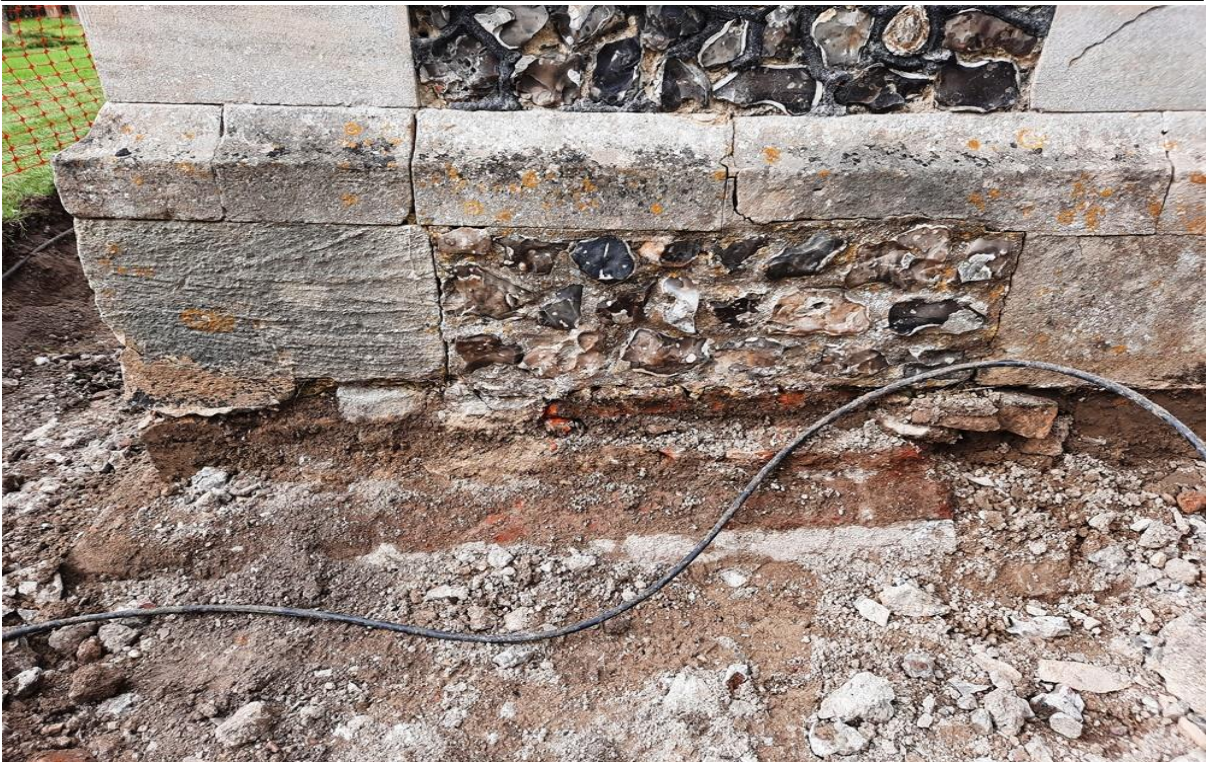
10) As above viewed on side of buttress

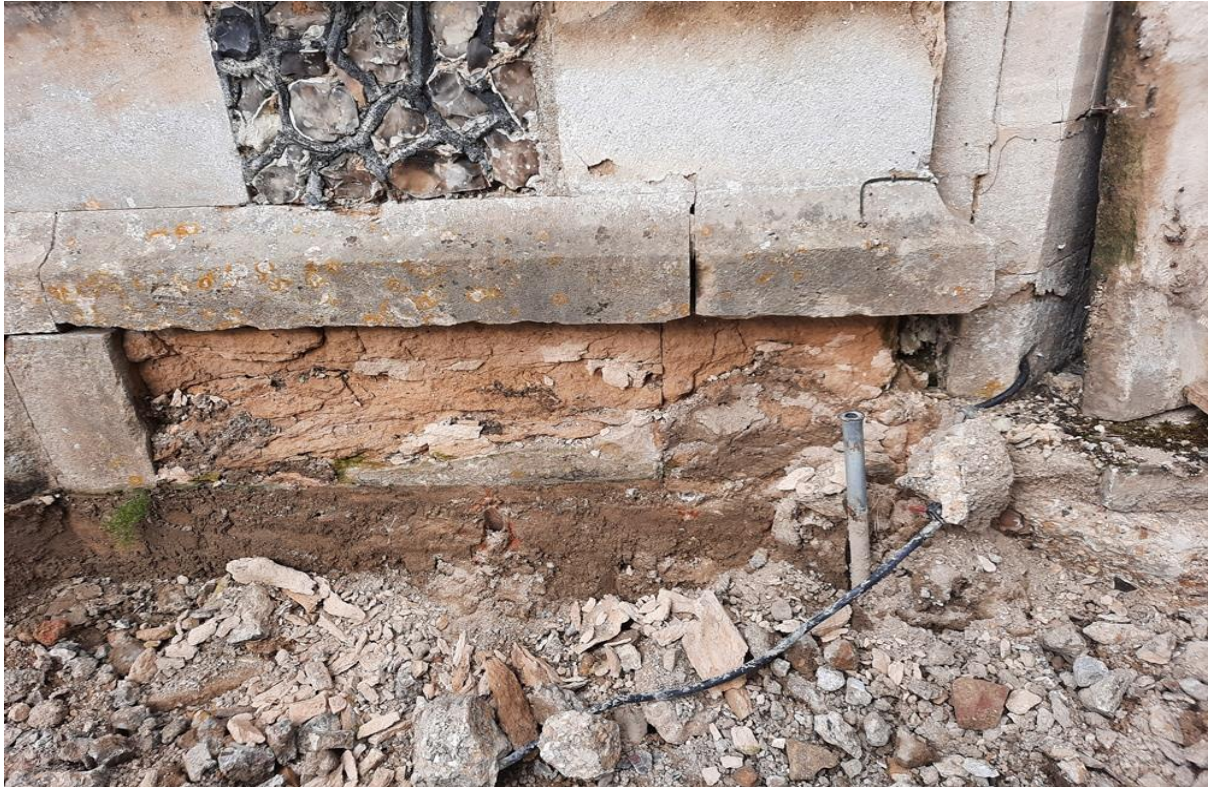
11) Along the tower East wall the thin ashlar stone facing along the plinth has collapsed – it was already in poor condition as noted in this years Quinquennial. Will needs specialist repair.

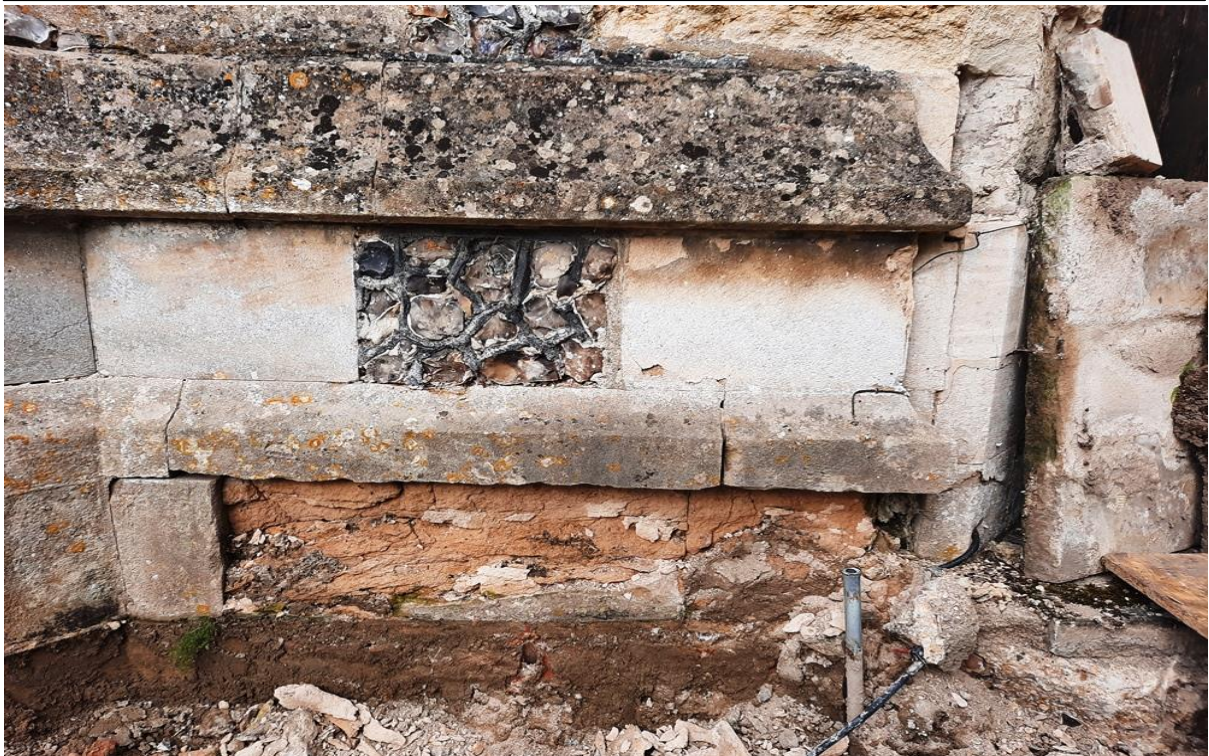
12) There is no proper foundation to take the edge of the stone – and the new stones will need cramping back into the Victorian brickwork background.

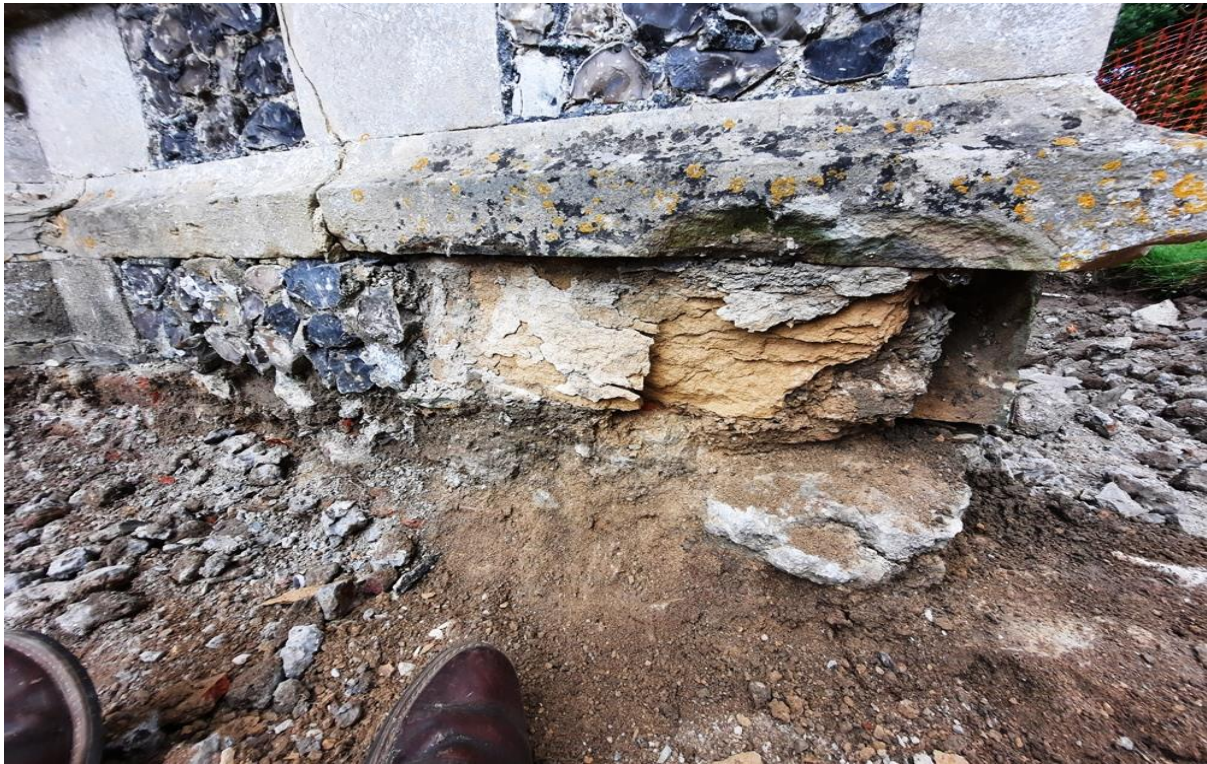
13) The SE tower buttress base is in poor condition, and again based on Marl stone fragments – specialist will be needed to cut new stone block, and make good the adjacent flint panel:

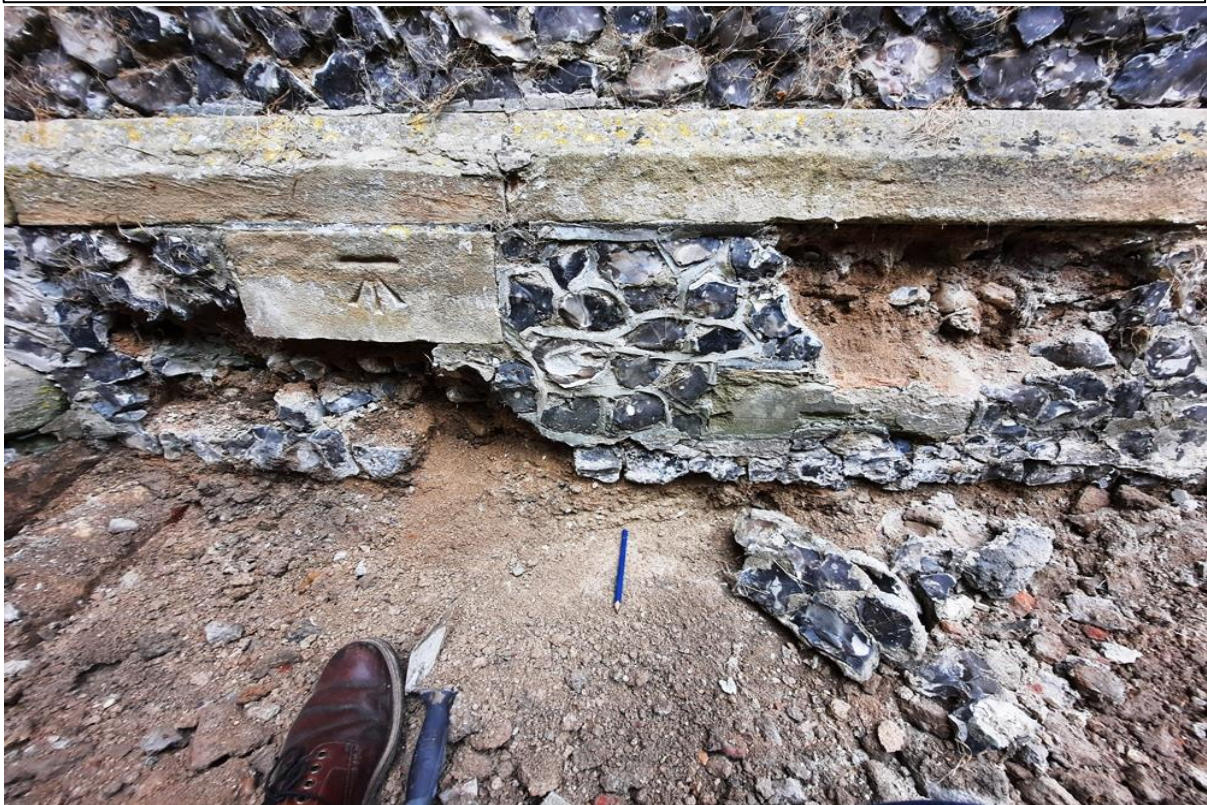
14) Along the south aisle the excavation again shows compacted stone fragments as a foundation and the Victorian flint addition seems to have just been built off the ground, and has collapsed, needing specialist repair:

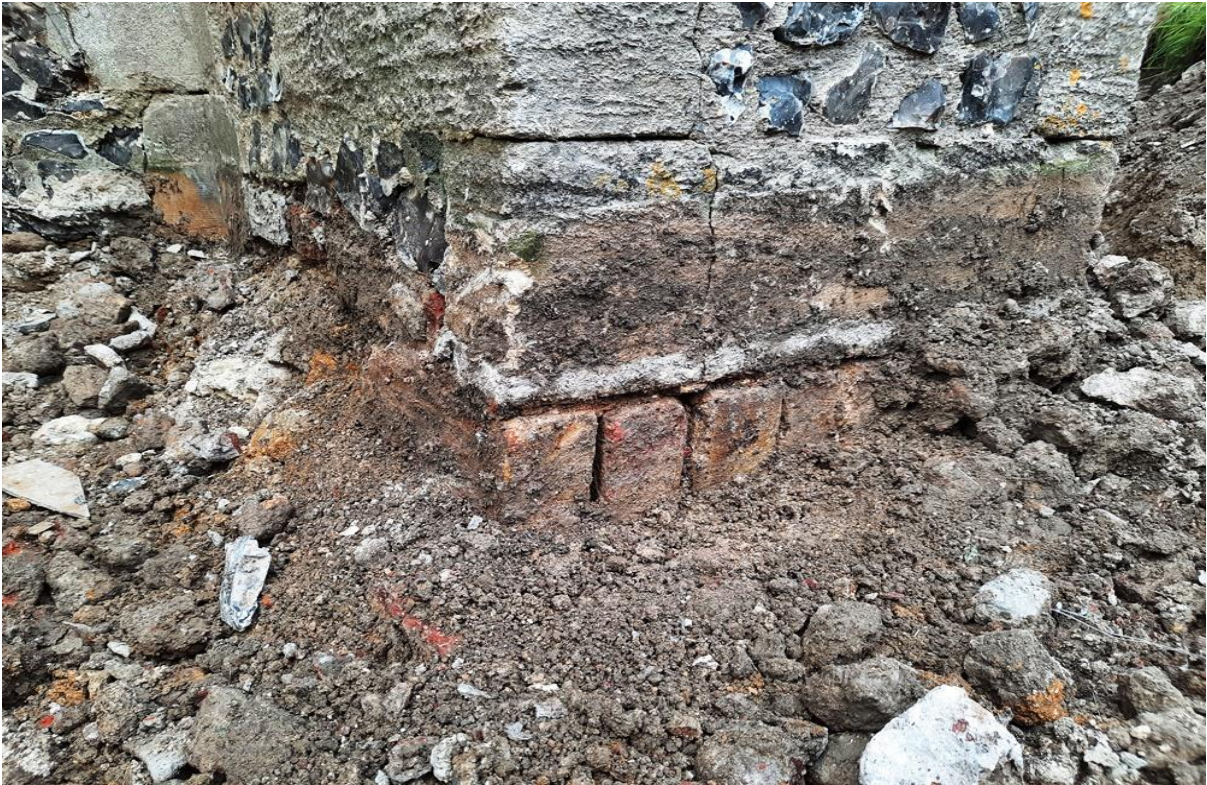
15) Evidence of Victorian brick underpinning in bricks down onto consolidated Marl rubble:

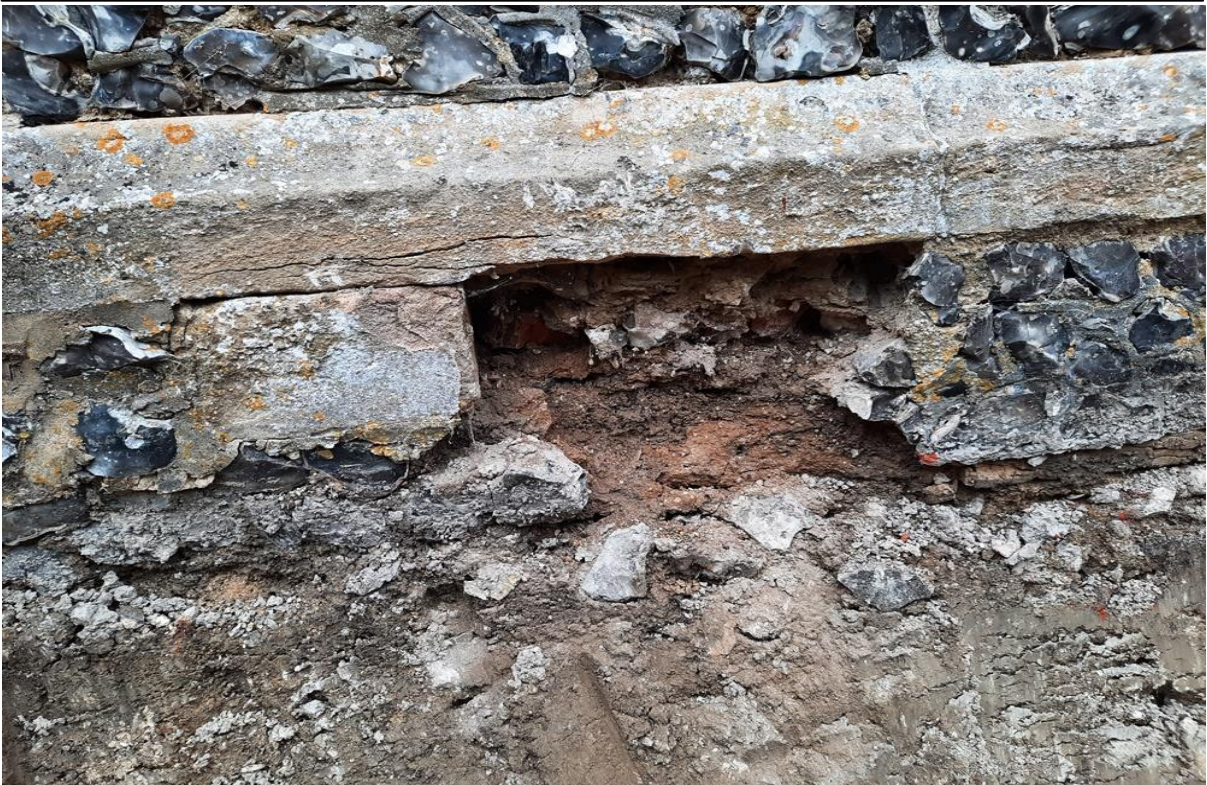
16) Small flint panel collapse, again due to no "foundation toe"

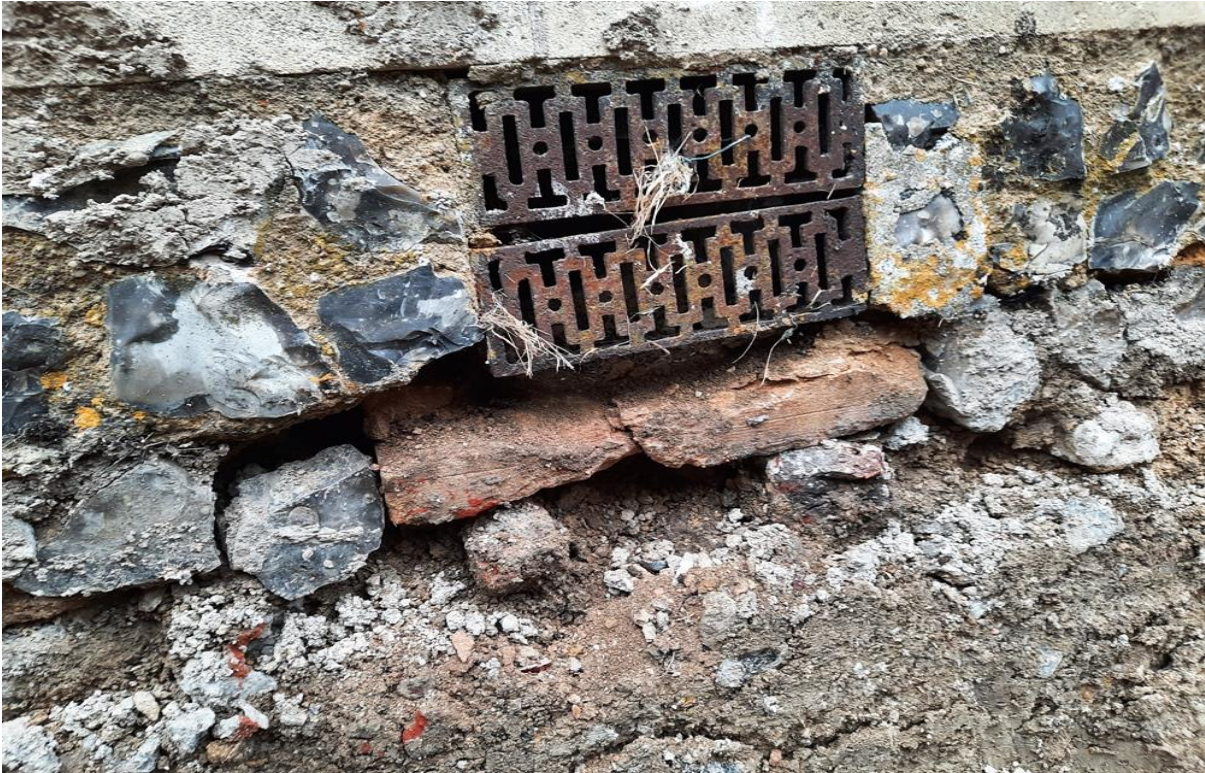
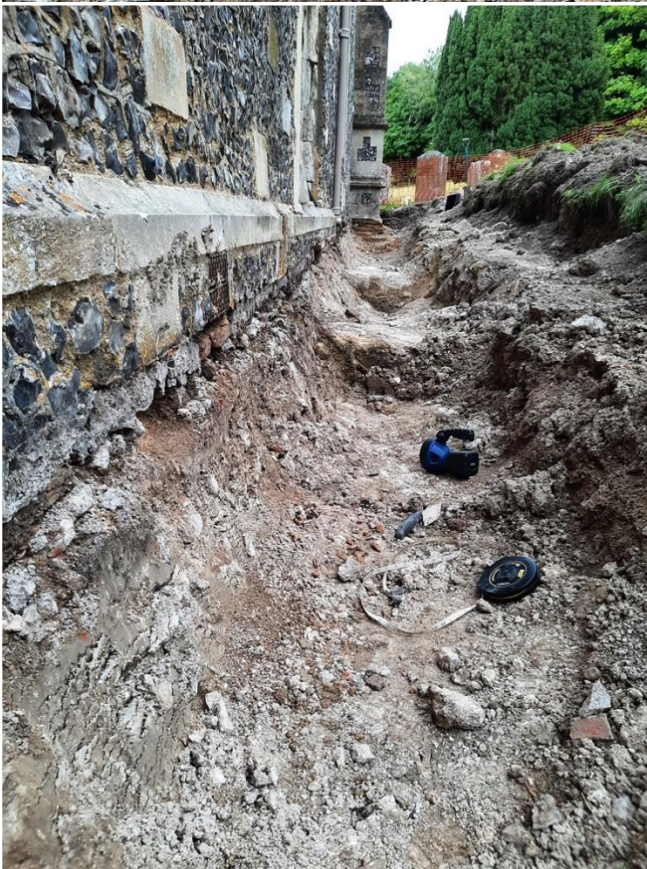
17) No foundation toe, and flint and masonry ashlar added to plinth has worked loose as concrete apron was removed.

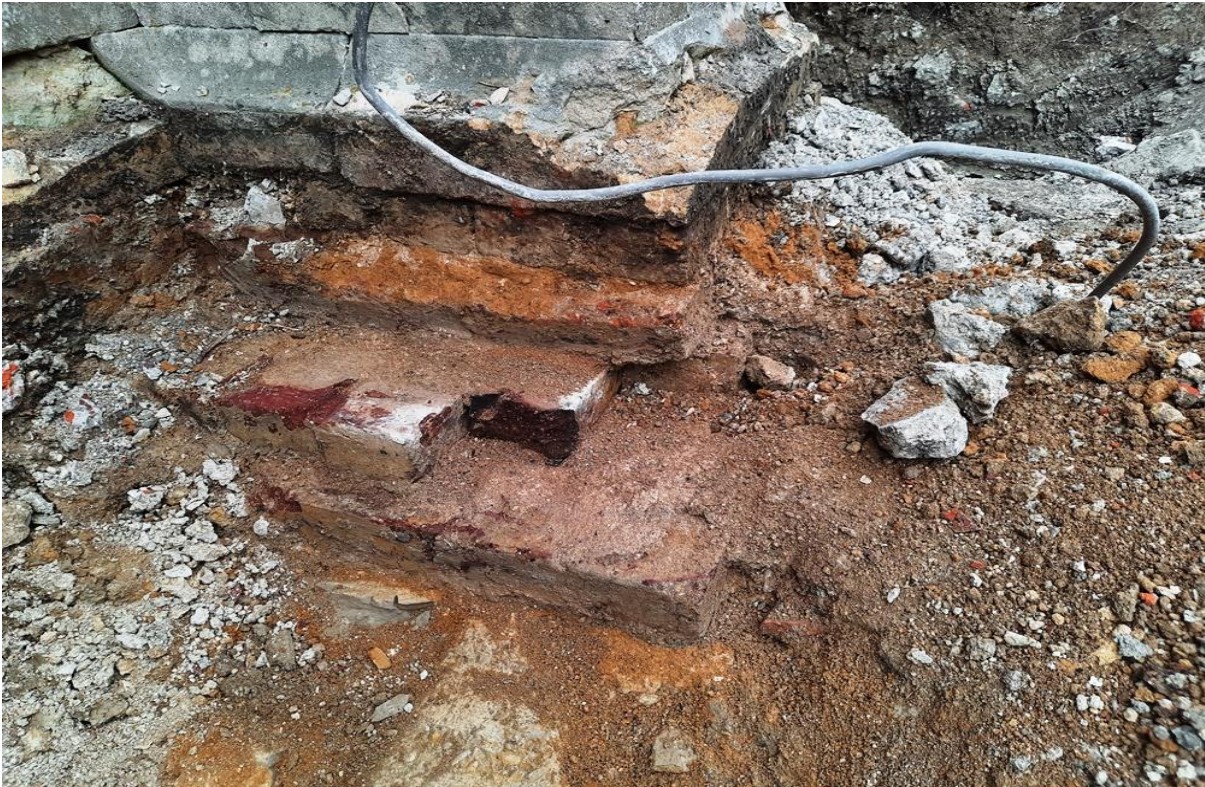
30) A brick in the diagonal shaft has a recessed "frog" indicative of C20th bricks used

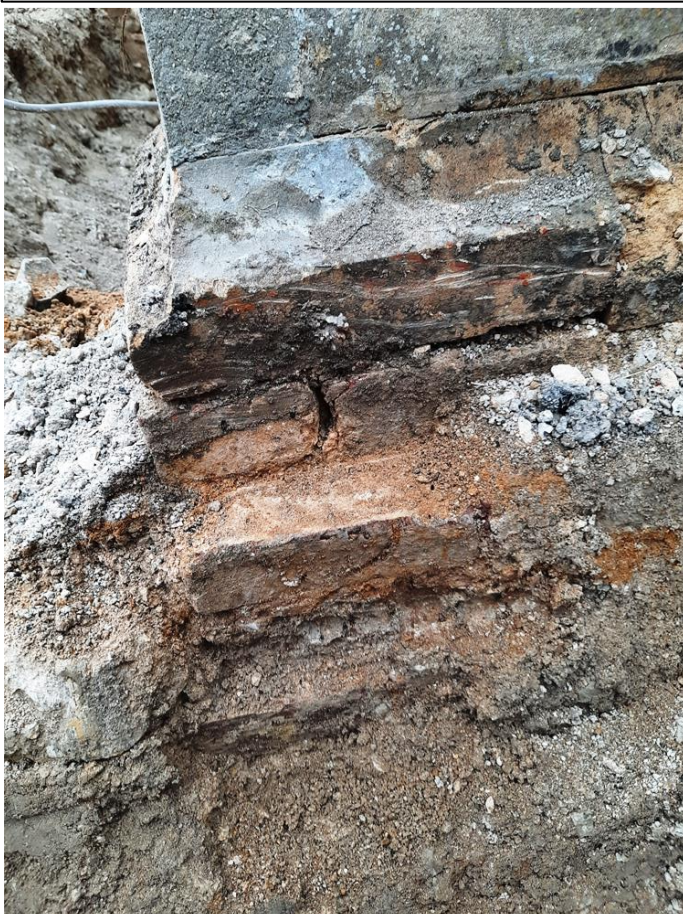
31) Under South Aisle SW buttress has had a number of bricks underpinning it. A brick size noted as wider than 4" and dating of the underpinning could be anything from the late C17th to late C18th

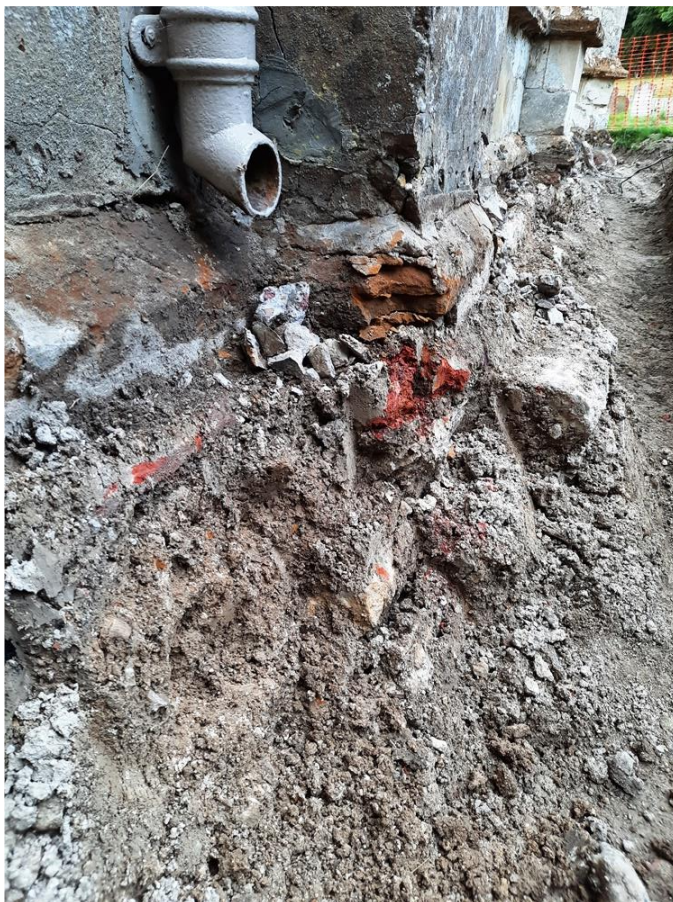
33) Small flint fall. Random foundation stones and bricks along this East end of the South Aisle

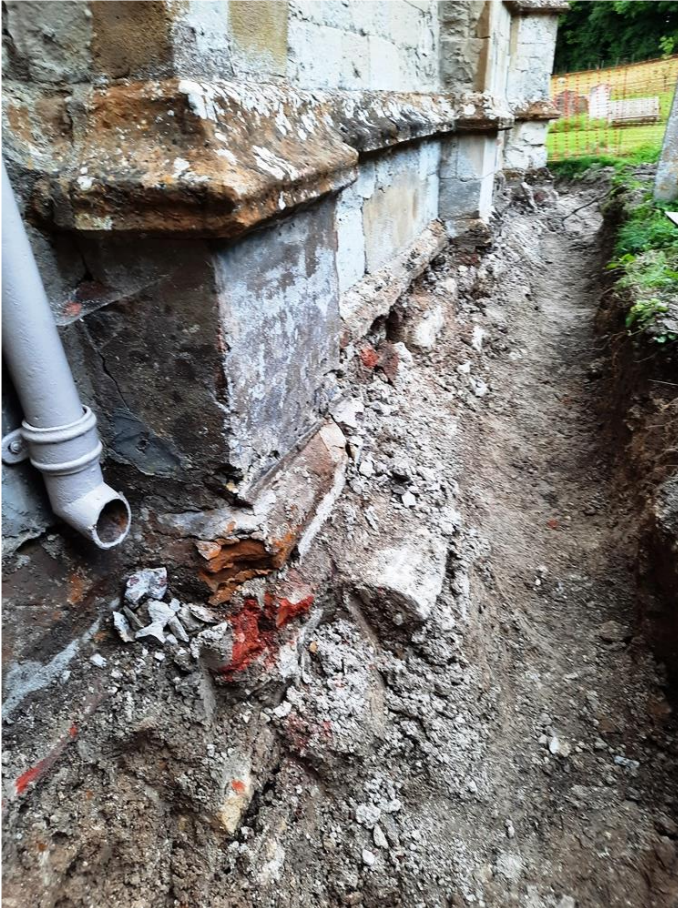
34) The South wall of the Chancel was divided into three, by way of two buttresses. This photo shows very little foundation base under this section of wall.

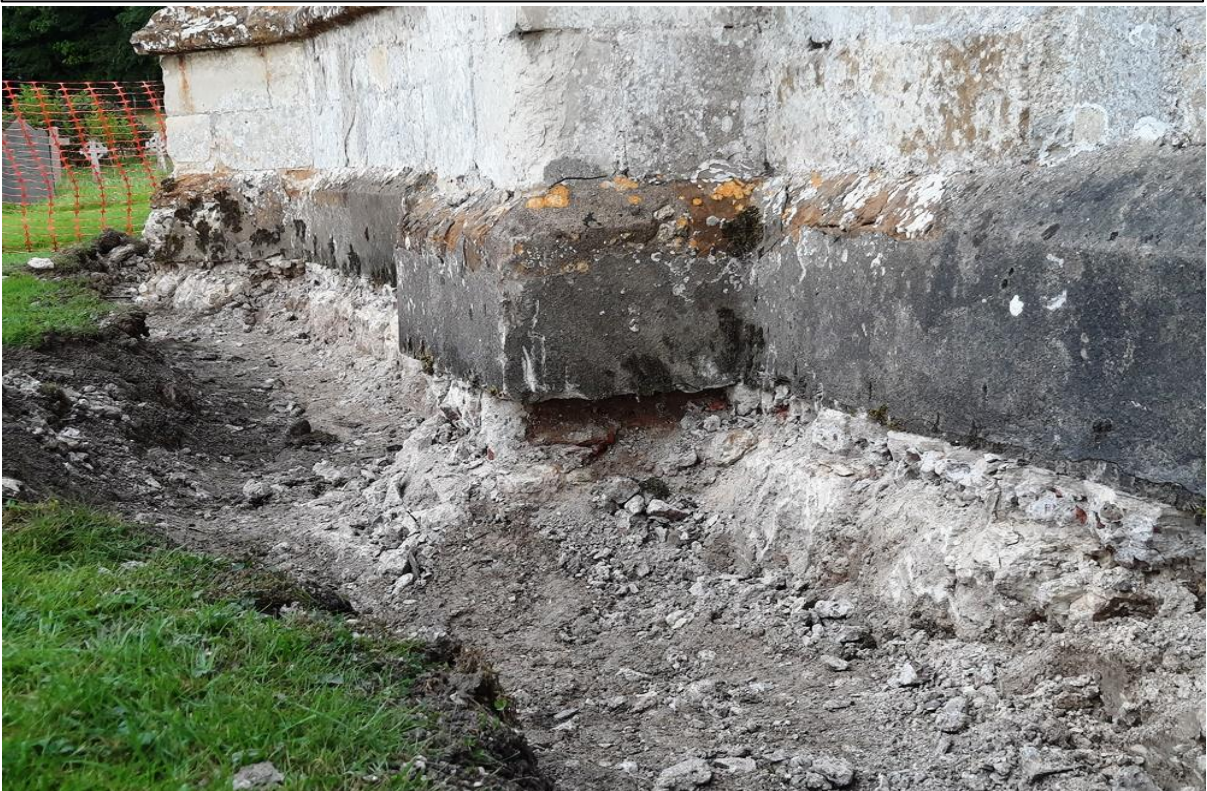
38) A buttress on the North side of the chancel had crumbled stone foundation – ideally needs FFL grade bricks underpinned

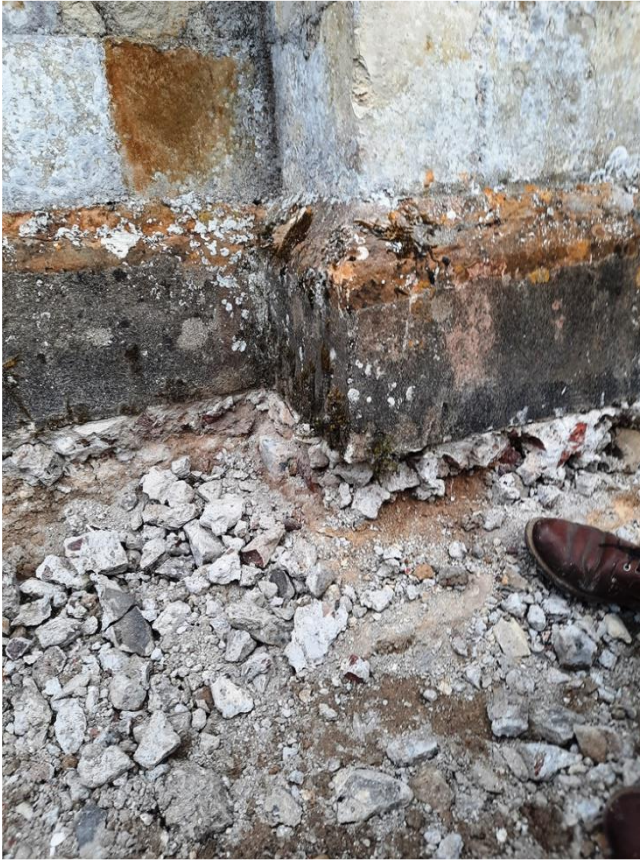
39) The second buttress on the North side also requires the foundation pinned under one corner

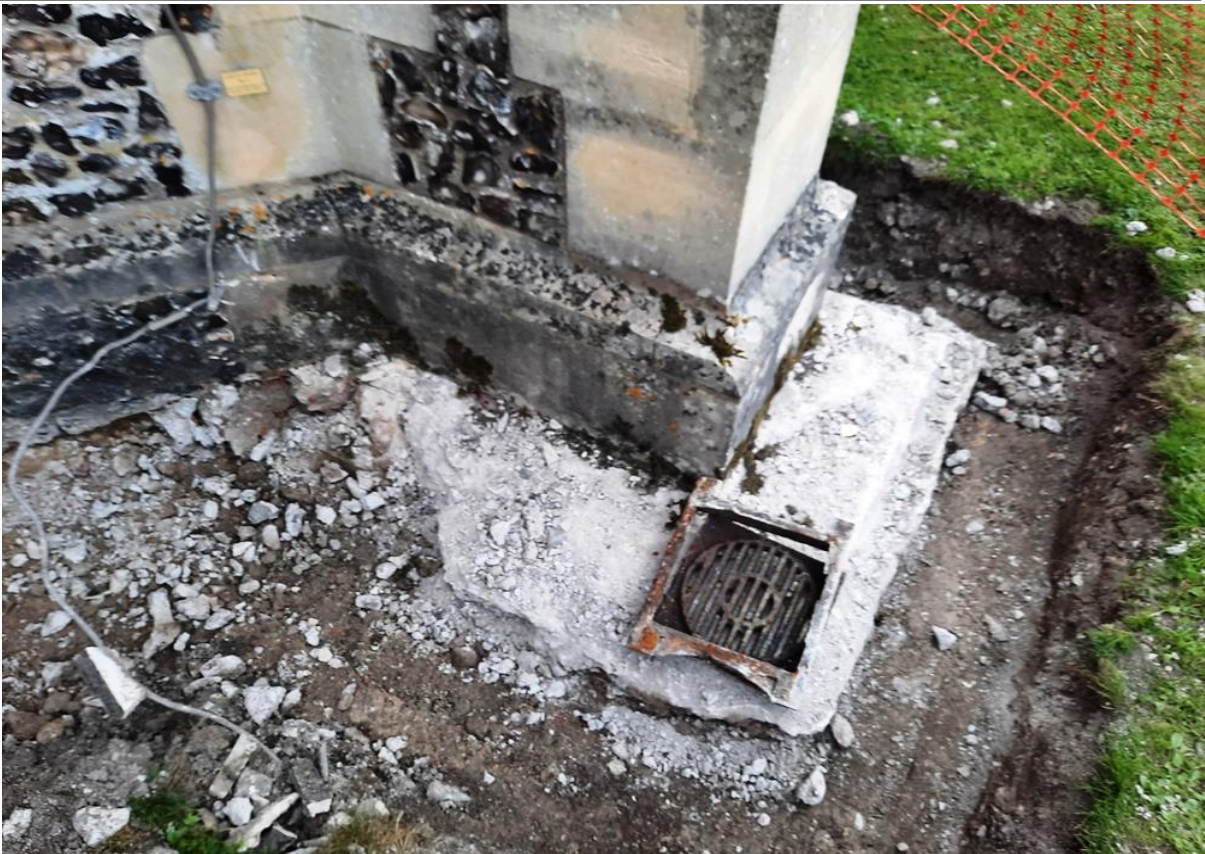
40) The foundation below the NE corner of the North aisle was again underpinned – this time in reinforced concrete

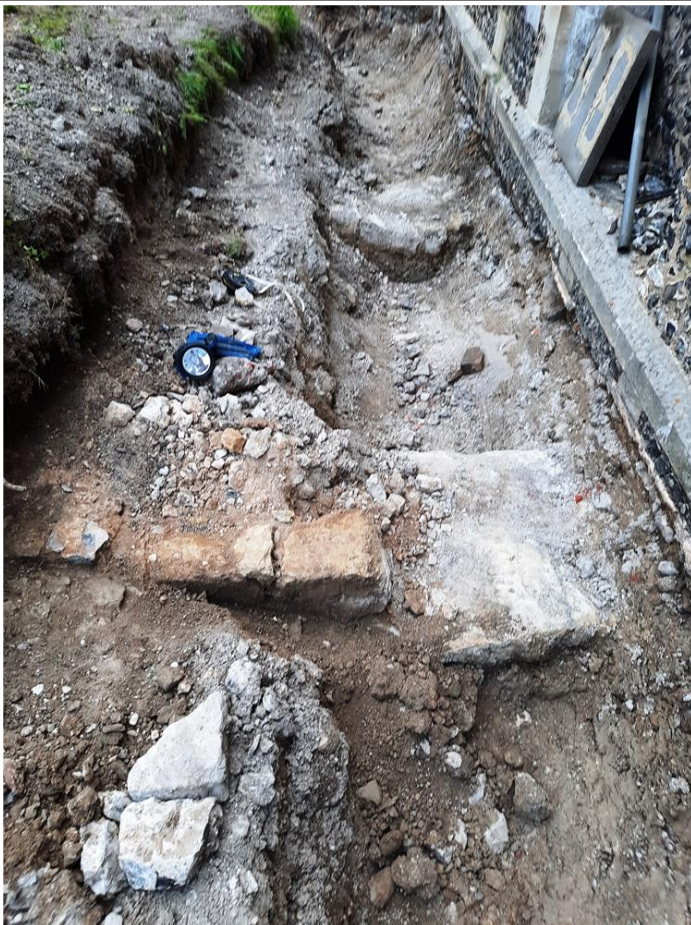
41) North wall had little supporting foundation of the applied flintwork –some has fallen away
