**Report on the Repairs
to the
Thwaites and Reed Turret Clock
at
St Mary Magdalene
Rodborough Gloucestershire**

**Simon Gilchrist MBHI
Crackstone Clocks Limited**

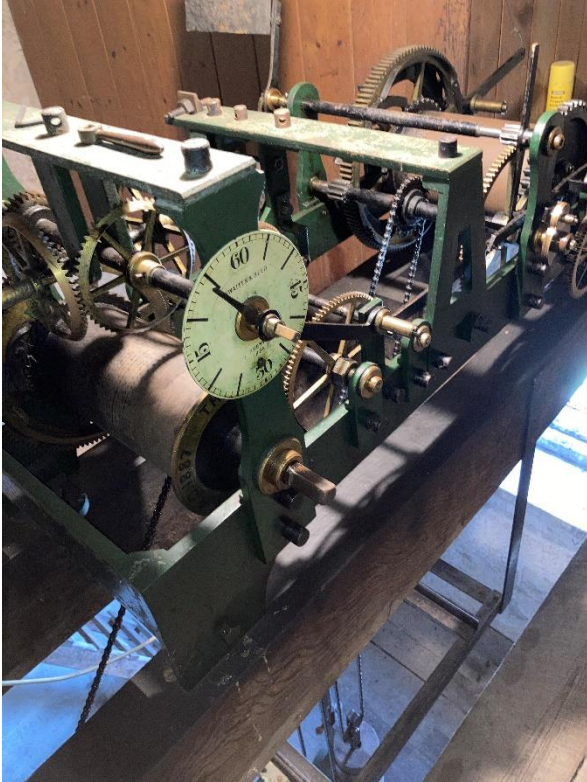
Figure 1

The two trains of time on the left-hand side and count wheel striking on the right, are in fair mechanical condition but have been neglected and are getting clogged up with dust and congealed oil.

The gravity escapement bearings are worn and require attention.

The motion and lead off work, the 12 to 1 gearing behind each dial that drives the hour hand from the minute hand, are in good order. There is a little bit of debris around them, but they are otherwise serviceable. The North face hour hand has worked loose and is pointing to 6 o'clock.

The hourly striking fly ratchet is worn out and requires replacing.

The clock has been converted to Smith of Derby automatic winding and these units are working fine, their bearings are running well, but their weight pulley/sprocket bearings are very stiff to turn, and an overhaul will return them to good order.

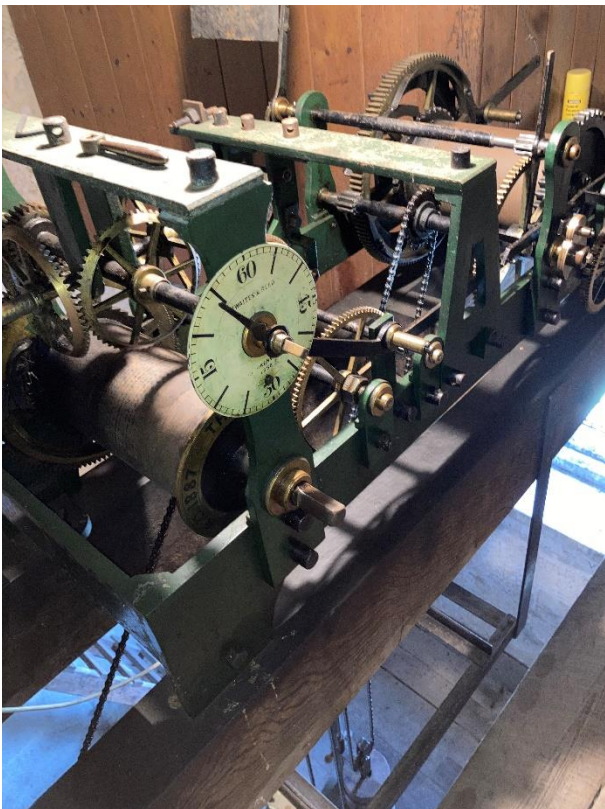
Figure 2

The general condition of the clock frame, **Figure 2**, is in good order. Some rust is present on the steel frame and the nuts, and light rust has formed on the pendulum suspension spring, **Figure 3**.

The frame work was given a wipe over with clean rags charged with pure turpentine as the work progressed.

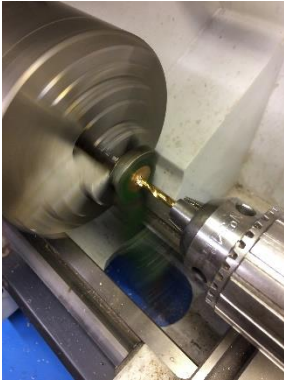
Figure 4

The 6 legged gravity escape wheel bearings were found to be worn. At some point in the past a weight has been added to the gravity impulse arm to make the clock go, in other words to overcome the loss in gravity as the arm impulses the pendulum due to increases in pivot wear.

The bronze bearings were cleaned with Liberon Ultrafine 0000 grade wire wool, bottle brushed and then washed with white spirit to remove traces of the old oil, dirt and grease. The front escape wheel bearing with its bracket was centred in the lathe and the old hole enlarged to 6mm in diameter, **Figure 4**.

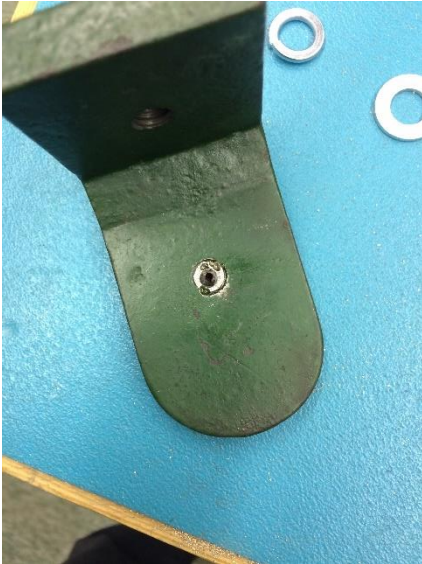
Figure 10

The gravity escapement arms run in 'V' shaped pivot holes and these holes had been "punched-up" to remove wear and close up the hole, **Figure 10**. This method of repair is not ideal, as instead of making the pivot hole round, it can create a burred edge and this scores the pivot face and increases wear, **Figure 11**.

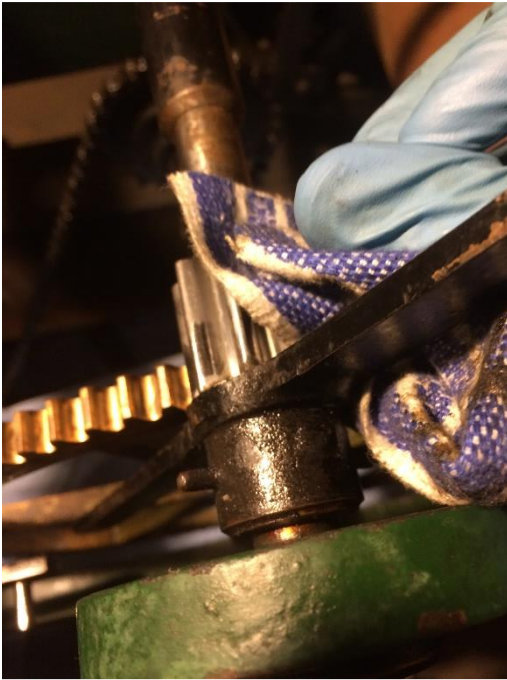
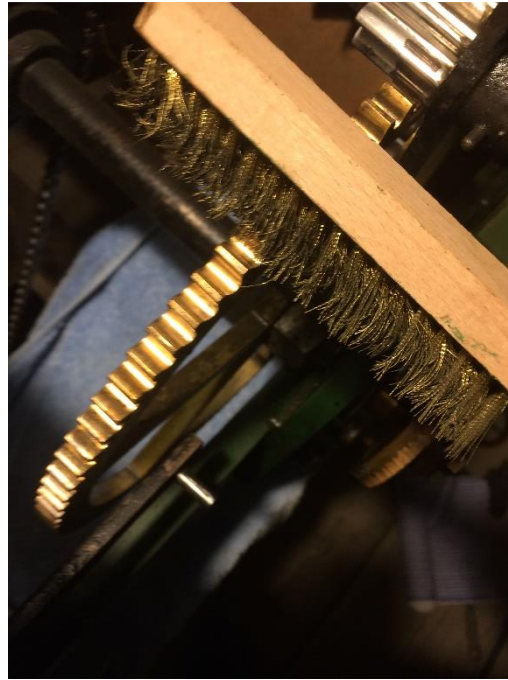
The wheels and pinions although dirty and suffering from some dried or congealed oil deposits between their teeth and pinion leaves, were in good mechanical condition.

Larger wheels were cleaned in-situ using a wooden stick and cloths charged with pure turpentine to remove the dirt and debris from between the teeth and pinions, **Figure 16**. The wheels were then washed in pure turpentine, dried and the teeth polished with a brass bristled brush, **Figure 17**.

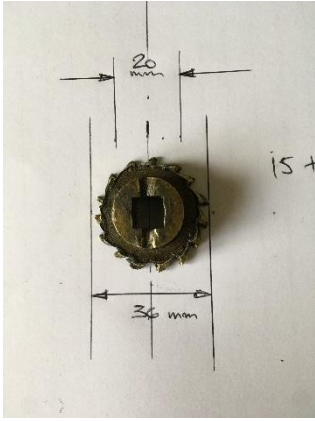
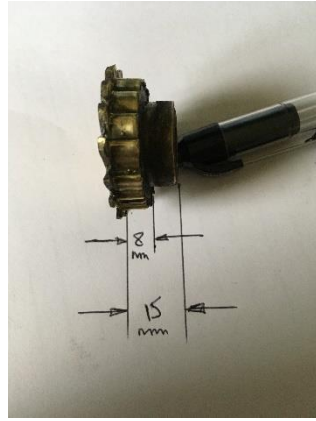
The fly is a two-bladed fan that is used to control the speed of the wheel train when striking the hours. The fly ratchet is a small wheel with pointed teeth that prevents the fly from turning backwards while in operation. These teeth on the ratchet were worn out, **Figures 20** and **21**.

A new ratchet was machined in CZ115 brass to match the original, **Figures 22** and **23**, and then hand finished, squared and fitted to the fly, **Figure 24**.

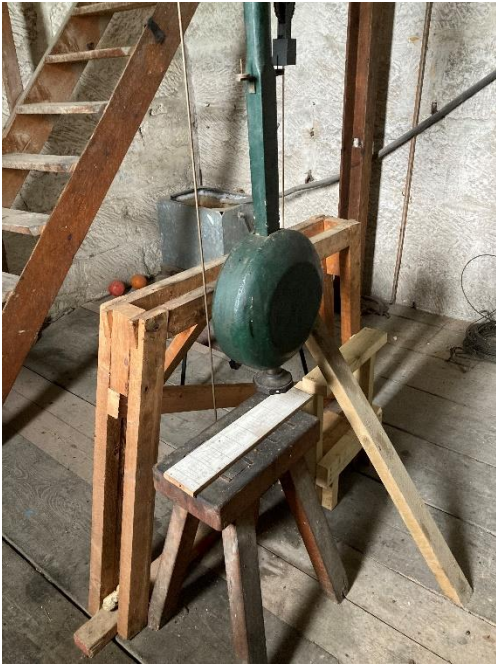
Figure 25

The pendulum was in good order, the wooden rod straight and neither cracked nor distorted. The bob being fixed to the rod by traditional means of a rating nut.

The suspension spring was found to be in sound mechanical condition and was cleaned with Liberon Ultrafine 0000 grade wire wood and mineral sprit. A thin layer of petroleum jelly was applied to prevent rust from forming in the future.

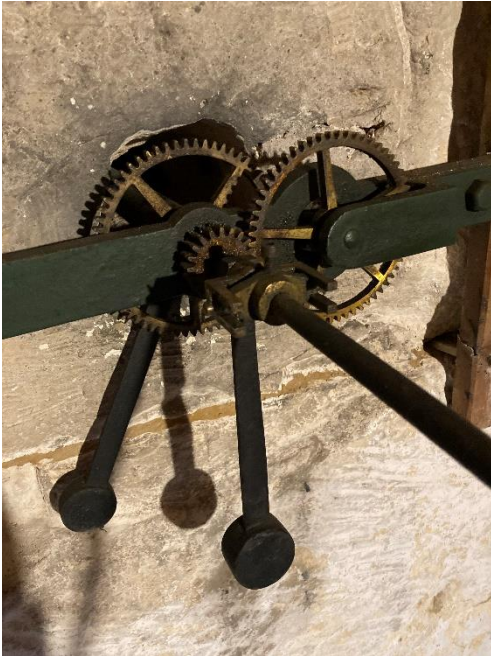
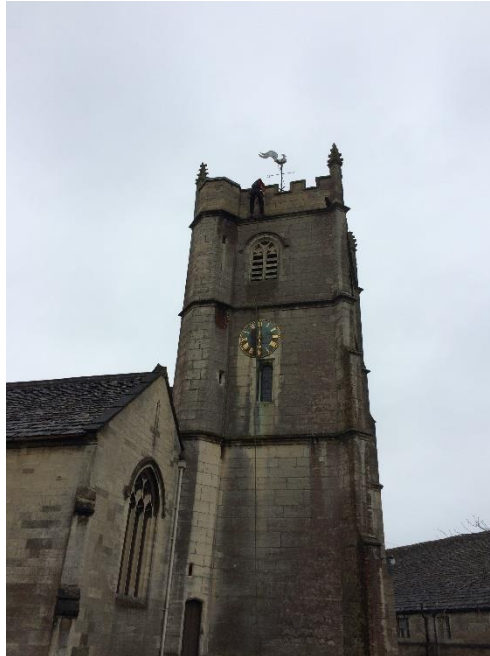
The motion work, **Figure 26**, the 12:1 ratio gearing to turn the hour hand from the minute hand, takes its drive from the clock to turn the hands on the dial, **Figure 27**.

The motion work was found to be in good mechanical order. Build-up of dust and debris was present, and the wheels were cleaned in-situ using cloth charged with pure turpentine to remove this minor debris from between the teeth and pinion leaves.

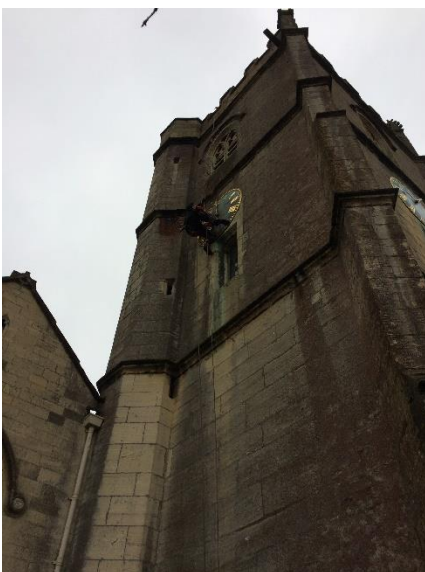
Figure 28

A rope access team removed the hands from the dials so that the motion work could be cleaned. The hour hand on the North dial was loose on its collet. The collet was cleaned and soldered back in to position. This work being carried out by the rope access team, **Figure 28**.

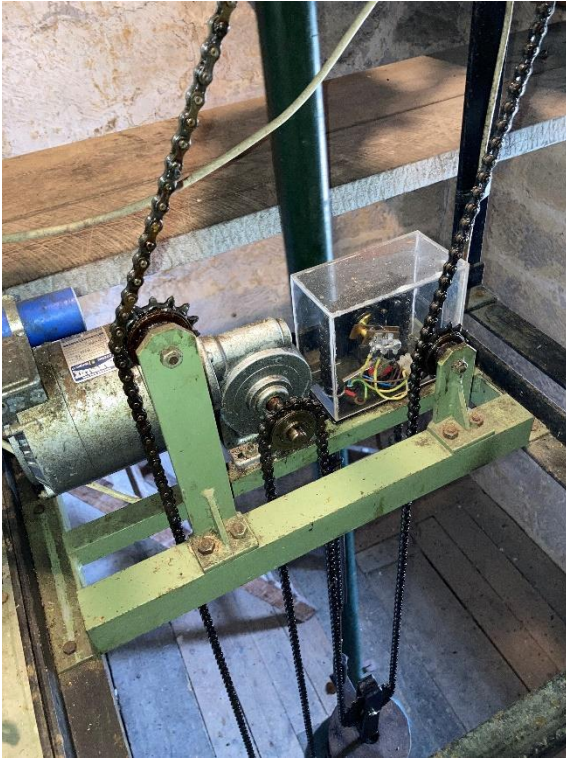
Figure 29

The automatic winding units driving each of the two trains of the clock were found to be working fine but the weight pulley/sprocket bearings were very stiff to turn. The motors were running nicely and remained cold. The gravity switches turning the motors on and off without issues.

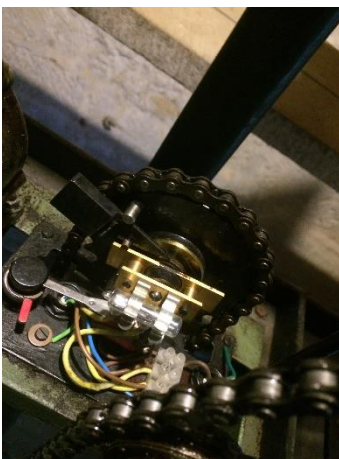
Figure 30

With the mercury switches being in good order with no sign of cracks or deterioration, the switching units were given a light clean to remove debris, **Figure 30**.

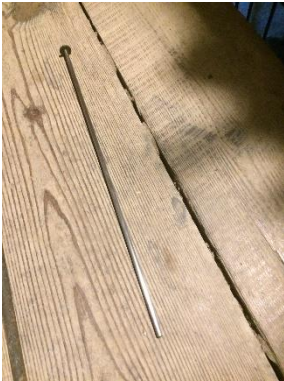
Figure 31

The over wind safety cut-out rods, although covered in light surface rust, would still operate in the event of the weight being wound to far. The rods were extracted while the clock was apart and treated to a clean and polish with Liberon Ultrafine 0000 grade wire wool, **Figure 31**.

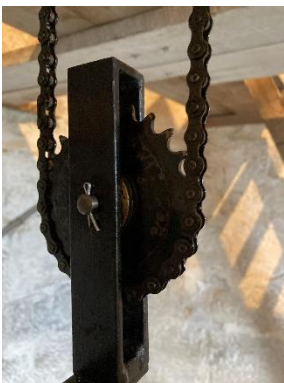
Figure 32

The two weight carrying sprockets were very stiff to turn and were removed from their housings, cleaned and reassembled.
