Ledbury Surveys Ltd

Refurbishment/Demolition Survey

All Saints Church
Worcester
WR1 2HN

Ledbury Surveys Ltd has undertaken a Targeted Refurbishment / Demolition survey at All Saints Church, Worcester, WR1 2HN

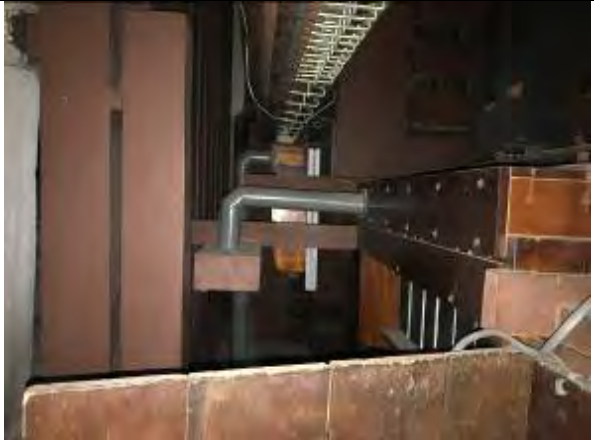
Worksheet Number	1

Floor/Room	Ground					
Room /Area	Organ					
Description	Insulation Board to Blower Box					
Sample No	Presumed					
Asbestos Type	Crocidolite					
Lab Reference	-					
Date of Next Inspection	13 th January 2020					
Priority Risk Assessment						
Normal occupant activity/ Likelihood of disturbance						
Normal occupant activity	0 1 2 3	Rare disturbance Low disturbance activities Periodic disturbance High levels of disturbance)	Accessibility	0 1 2 3	Usually inaccessible or unlikely to be disturbed Occasionally likely to be disturbed Easily disturbed Routinely disturbed	
Likelihood of disturbance	0 1 2 3	Outdoors Large rooms or well ventilated areas Rooms up to 10m ² Confined spaces	Extent/ Amount	0 1 2 3	Small amounts or items (e.g. strings gaskets) Less than 10m ² or 10lin/m pipe run Between 10m ² & 50m ² or 10lin/m or 50 lin/m pipe run More than 50m ² or 50lin/m of pipe run

Management Score						
MRA + PRA	SCORE		For management purposes a RISK RATING (MRA + PRA) of less than 9 presents a VERY LOW RISK, between 10 and 13 a LOW RISK and from 14 to 17 a MEDIUM RISK 18 + HIGH RISK			
6 + 3	9 Very Low					
Recommendations:	Remove and dispose of whole as hazardous waste prior to refurbishment works. If left for more then 3 months, Label and monitor in accordance with CAR2012

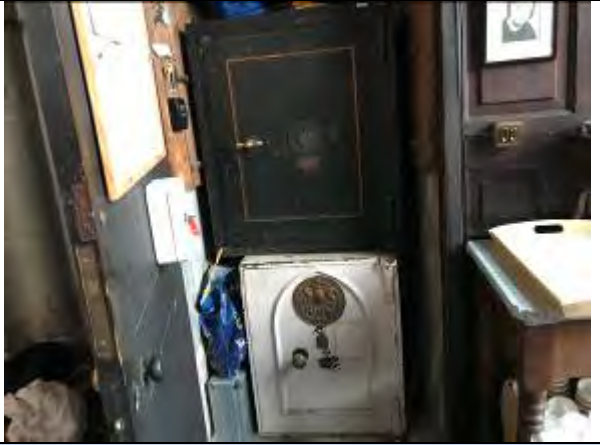
Worksheet Number	2

Floor/Room	Ground						
Room /Area	Tower Store						
Description	Insulation Board Laminate to Safes						
Sample No	Presumed						
Asbestos Type	Crocidolite						
Lab Reference	-						
Date of Next Inspection	13th January 2020						
Priority Risk Assessment							
Normal occupant activity/ Likelihood of disturbance							
Normal occupant activity	0 1 2 3	Rare disturbance Low disturbance activities Periodic disturbance High levels of disturbance)	Accessibility	0 1 2 3	Usually inaccessible or unlikely to be disturbed Occasionally likely to be disturbed Easily disturbed Routinely disturbed	0 1	
Likelihood of disturbance	0 1 2 3	Outdoors Large rooms or well ventilated areas Rooms up to 10m ² Confined spaces	Extent/ Amount	0 1 2 3	Small amounts or items (e.g. strings gaskets) Less than 10m ² or 10lin/m pipe run Between 10m ² & 50m ² or 10lin/m or 50 lin/m pipe run More than 50m ² or 50lin/m of pipe run	1 2 3

Management Score							
MRA + PRA	SCORE		For management purposes a RISK RATING (MRA + PRA) of less than 9 presents a VERY LOW RISK, between 10 and 13 a LOW RISK and from 14 to 17 a MEDIUM RISK 18 + HIGH RISK				
6 + 3	9 Very Low						
Recommendations:	Remove and dispose of whole as hazardous waste prior to refurbishment works. If left for more then 3 months, Label and monitor in accordance with CAR2012

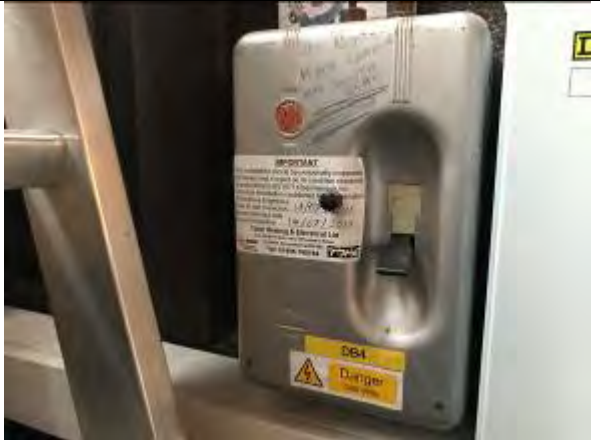
Worksheet Number	3

Floor/Room	Ground						
Room /Area	Garage Office/ Store						
Description	Flashguards, Ropes and Seals to Electrics						
Sample No	Presumed						
Asbestos Type	Chrysotile						
Lab Reference	-						
Date of Next Inspection	13th January 2020						
Priority Risk Assessment							
Normal occupant activity/ Likelihood of disturbance							
Normal occupant activity	0 1 2 3	Rare disturbance Low disturbance activities Periodic disturbance High levels of disturbance)	Accessibility	0 1 2 3	Usually inaccessible or unlikely to be disturbed Occasionally likely to be disturbed Easily disturbed Routinely disturbed	0 1	
Likelihood of disturbance	0 1 2 3	Outdoors Large rooms or well ventilated areas Rooms up to 10m ² Confined spaces	Extent/ Amount	0 1 2 3	Small amounts or items (e.g. strings gaskets) Less than 10m ² or 10lin/m pipe run Between 10m ² & 50m ² or 10lin/m or 50 lin/m pipe run More than 50m ² or 50lin/m of pipe run	1 2 3

Management Score							
MRA + PRA	SCORE	For management purposes a RISK RATING (MRA + PRA) of less than 9 presents a VERY LOW RISK, between 10 and 13 a LOW RISK and from 14 to 17 a MEDIUM RISK 18 + HIGH RISK					
4 + 3	7 Very Low						
Recommendations:	Remove and dispose of whole as hazardous waste prior to refurbishment works. If left for more then 3 months, Label and monitor in accordance with CAR2012

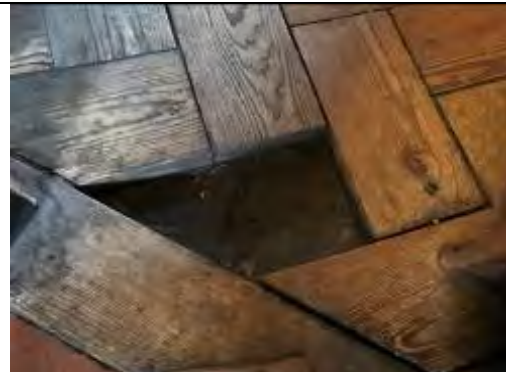
Debris to floor
ASC/1
NADIS

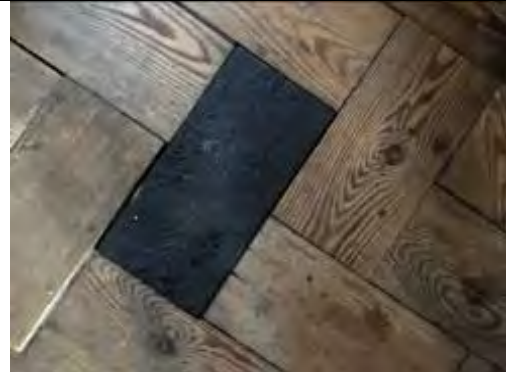
Bitumen adhesive to parquet flooring
ASC/2
NADIS

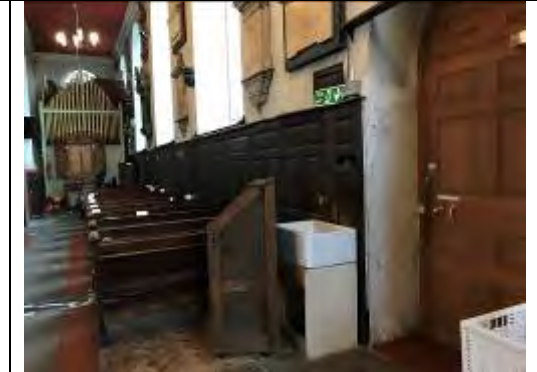
Slipped panels to be re fixed

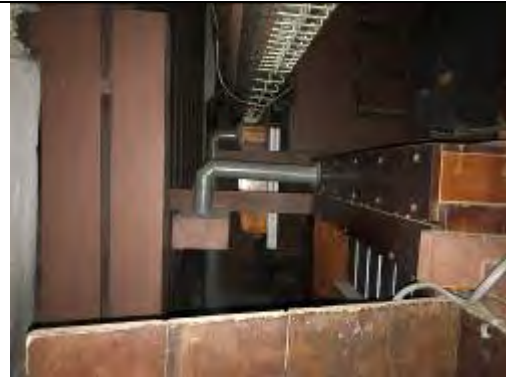
Presumed asbestos insulation board to organ
blower box
Crocidolite
