McNEILAGE CONSERVATION

St James Church, Dursley, Gloucestershire (Diocese of Gloucester)

Internal wall monuments

Conservation Report

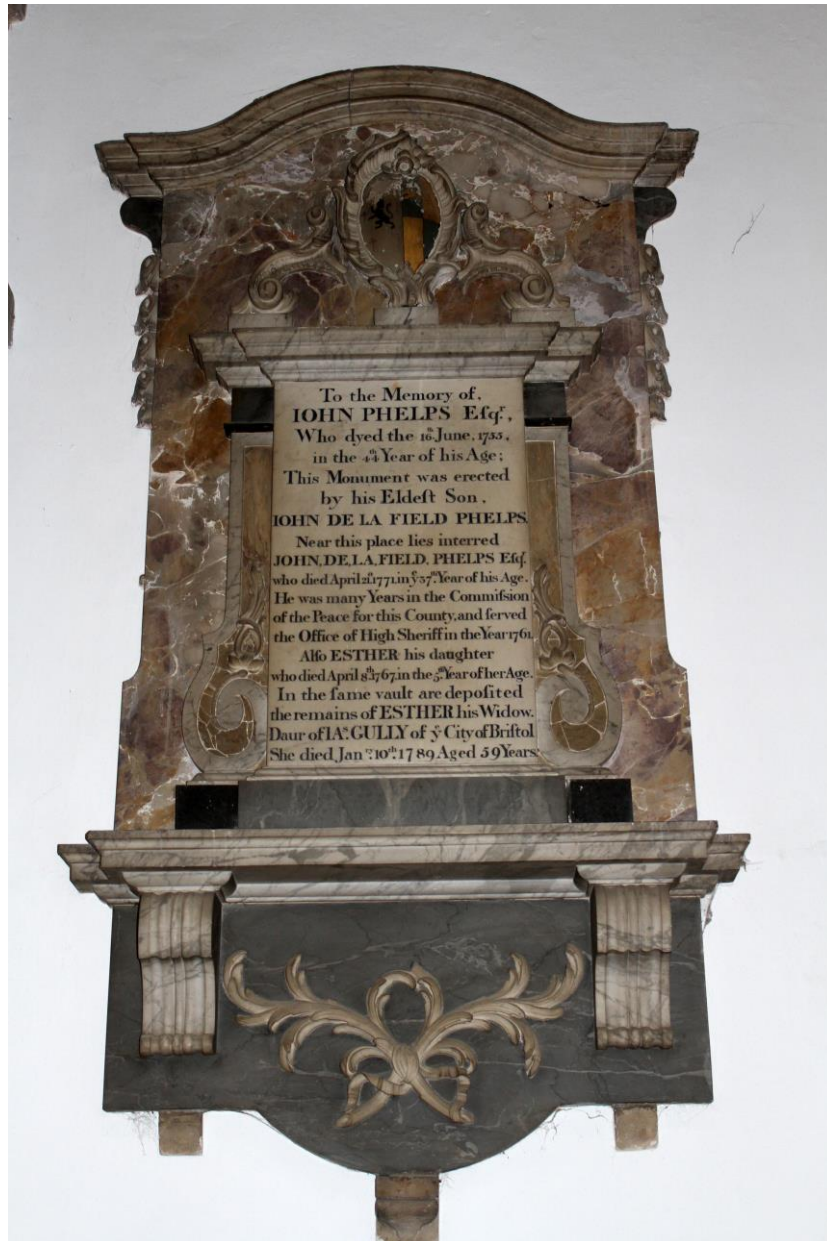
The monument was showing signs of disruption caused by failing and rusting fixings – open joints, displaced elements and a large crack in the topmost cornice. The lower parts of the monument appeared stable, with no open joints or signs of disruption. Surfaces were soiled but generally the stone was sound; polychrome on the cartouche was being lost.

The Phelps family monument before work

A secure and load-bearing scaffold tower was erected to permit work, and the monument was photographed and drawn to assist in dismantling work. The upper parts of the monument were then dismantled and all ferrous fixings found within were removed. Some of these were severely corroded, but others appeared still generally sound.

Old mortars were removed from monument stones and fixings stubs were drilled out of the supporting wall as necessary. All surfaces were cleaned with Synperonic A7 non-ionic detergent in water, sometimes with a little added pumice to assist the cleaning. Flaking polychrome was fixed with Primal B60a acrylic dispersion (10%) Areas of the backing plate were friable and these were filled and buttressed with lime mortars. The fractured cornice was repaired with an 8 mm threaded internal dowel and two surface cramps, all in 316L grade stainless steel, set in polyester resin. The monument was then re-erected, using 316L grade stainless steel cramps and resin for wall anchors, lime mortars and plaster for bedding joints, as appropriate.

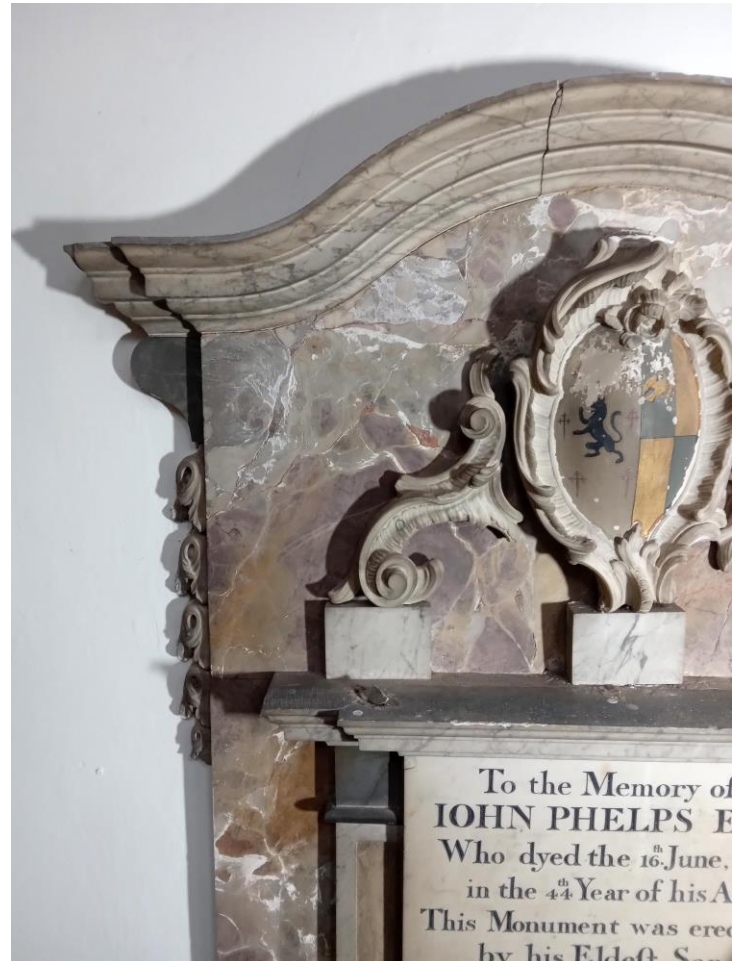
Right: crack in the cornice moulding caused by expanding ferrous cramp

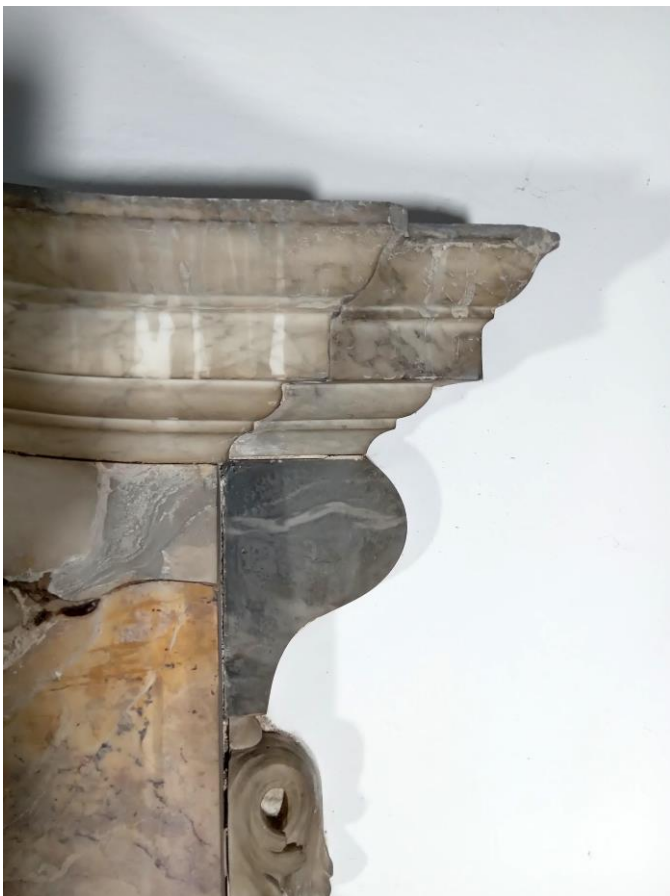
Below left open joints showing effects of iron expansion

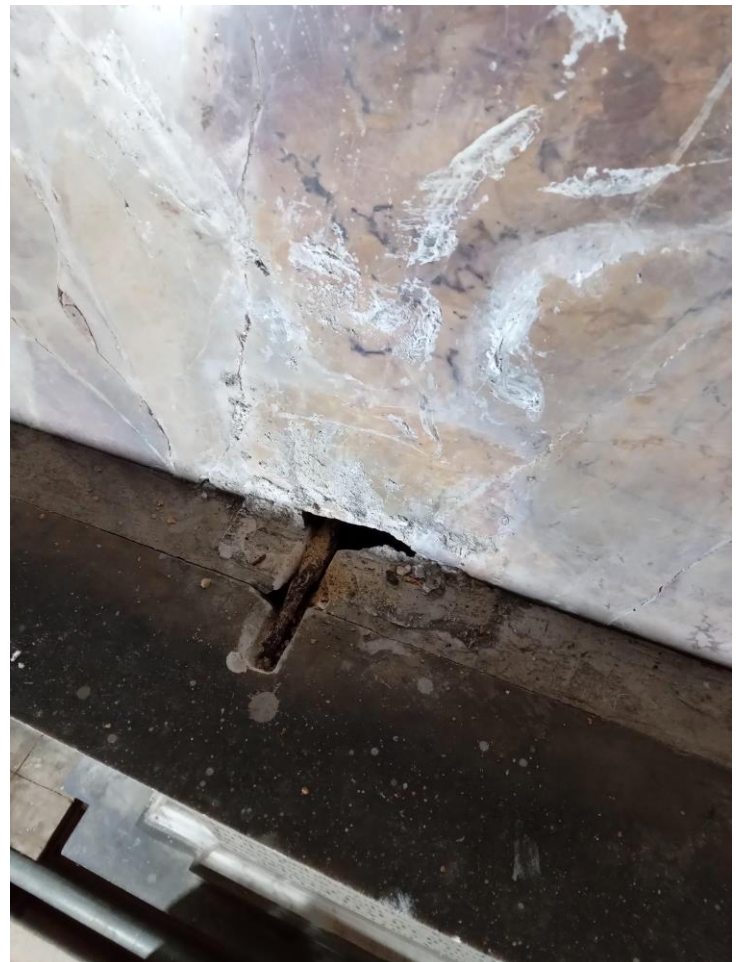
Below right: iron cramp exposed during dismantling

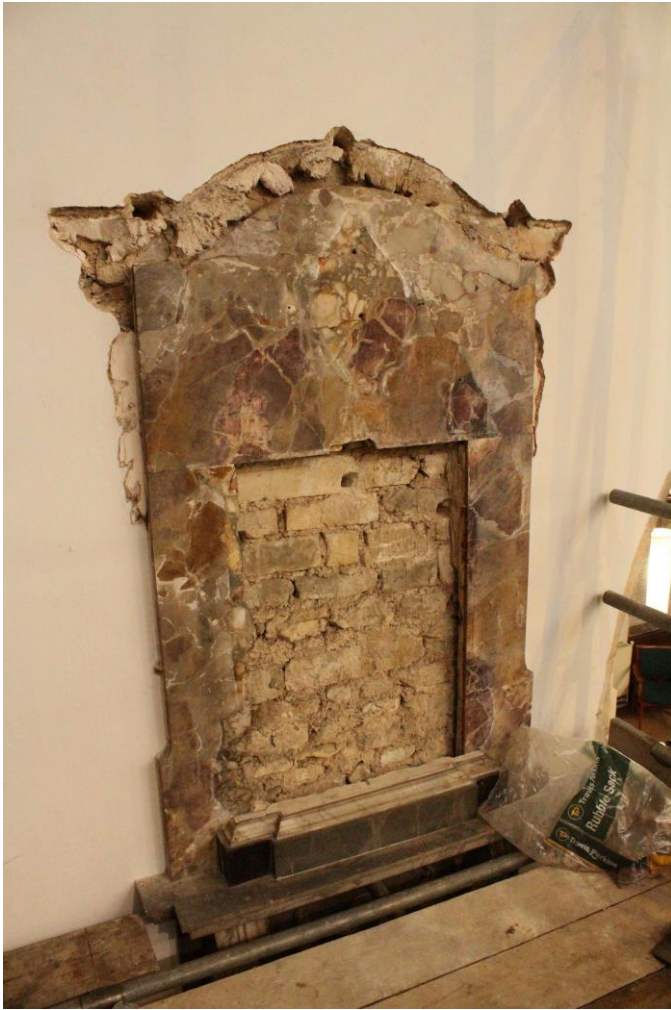
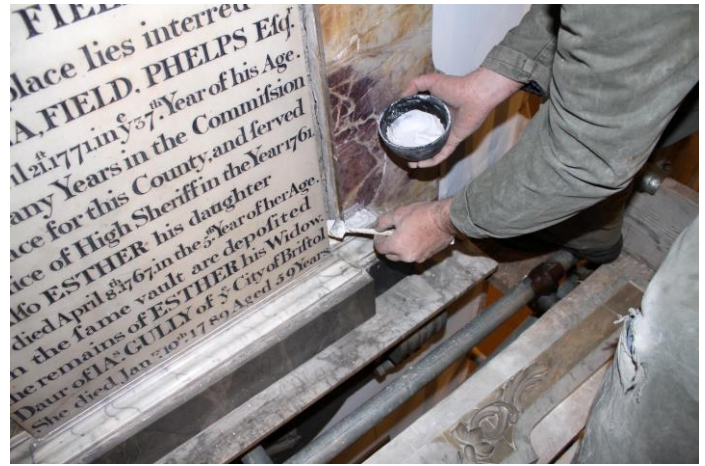
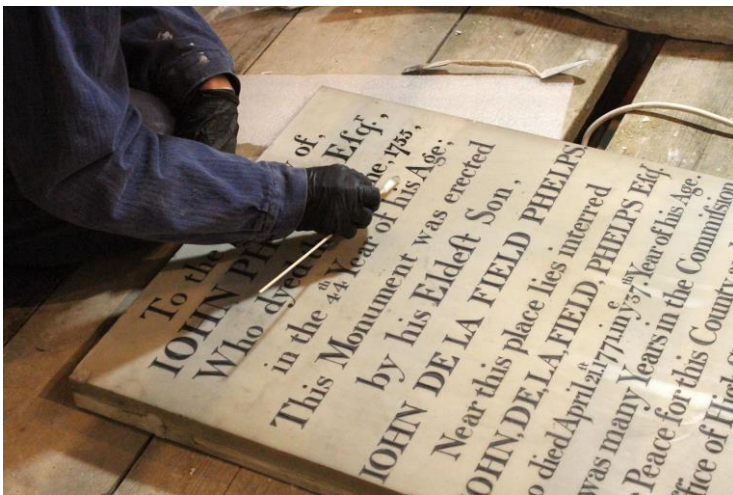
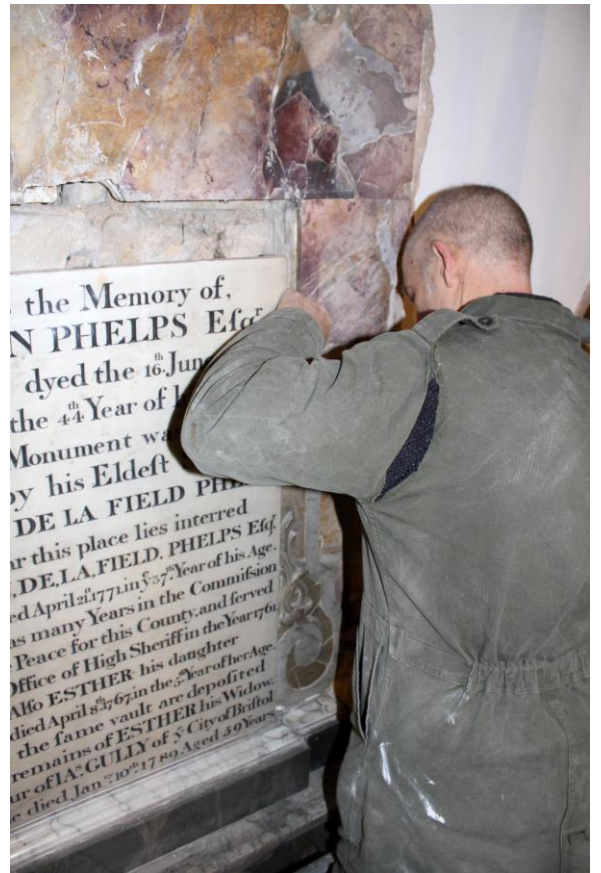
Work in progress, clockwise from left: the monument at fullest extent of dismantling; mixing and laying plaster for refixing; fixing a bracket into place; cleaning with cotton wool swabs

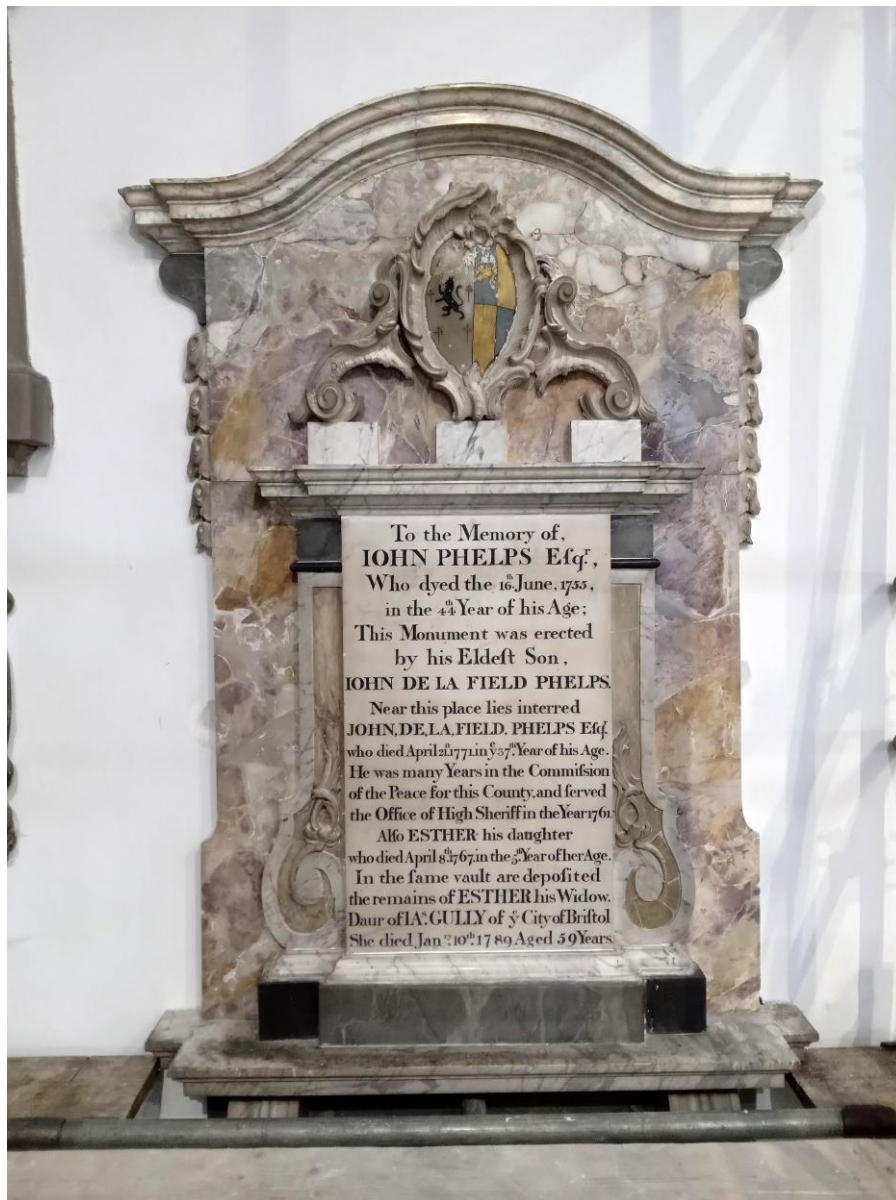
The Phelps monument after work

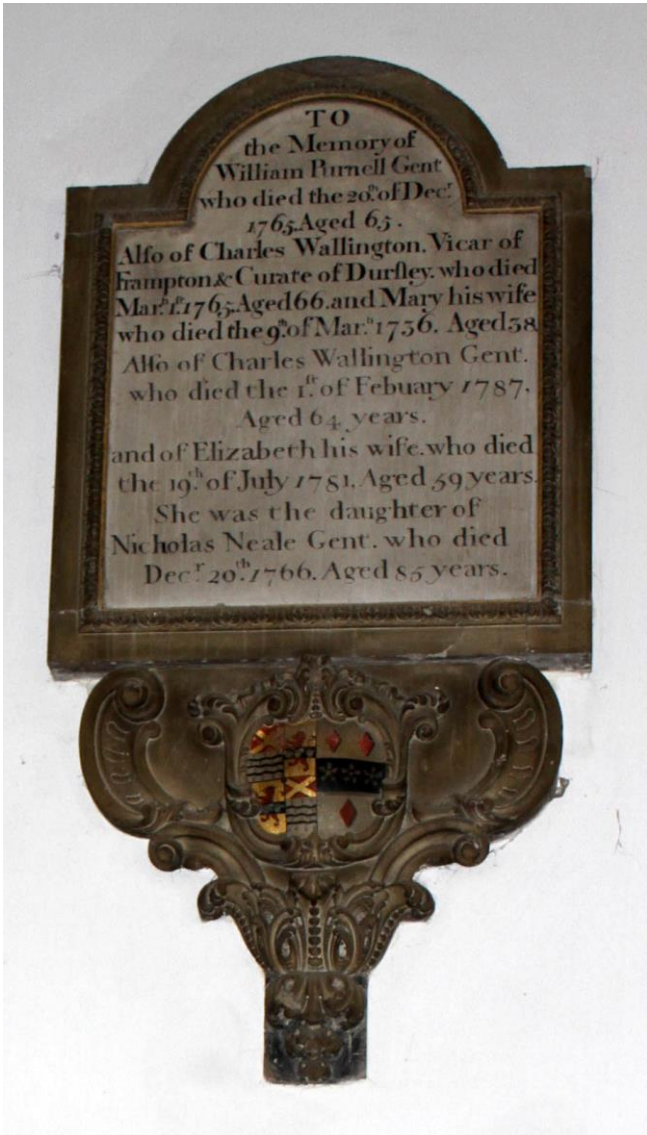
The monument had a number of open joints and one large failure, where the lower eastern section of the frame had been spalled away by the expansion of an internal dowel. Its stability could not be guaranteed. Surfaces were lightly soiled but sound.

Above, the Purnell monument before work; above right: large iron dowel causing damage to frame. Right: re-plastering above the re-erected monument in progress

A secure and load-bearing scaffold tower was set up to give access. The monument was recorded with digital images and drawings to assist with re-erection work. The monument was then dismantled down to the lowest point with ferrous fixings – the apron. All ferrous elements and old mortars were removed and the cracked section of frame was repaired with stainless steel dowels and polyester resin. The monument was then re-erected using lime mortars for bedding joints and stainless steel cramps, set in polyester resin for wall anchors. A large area of wall plaster had to be cut out above the monument to allow dismantling – this was made good with hot-mixed lime plaster, and limewashed to blend with the surrounding wall.

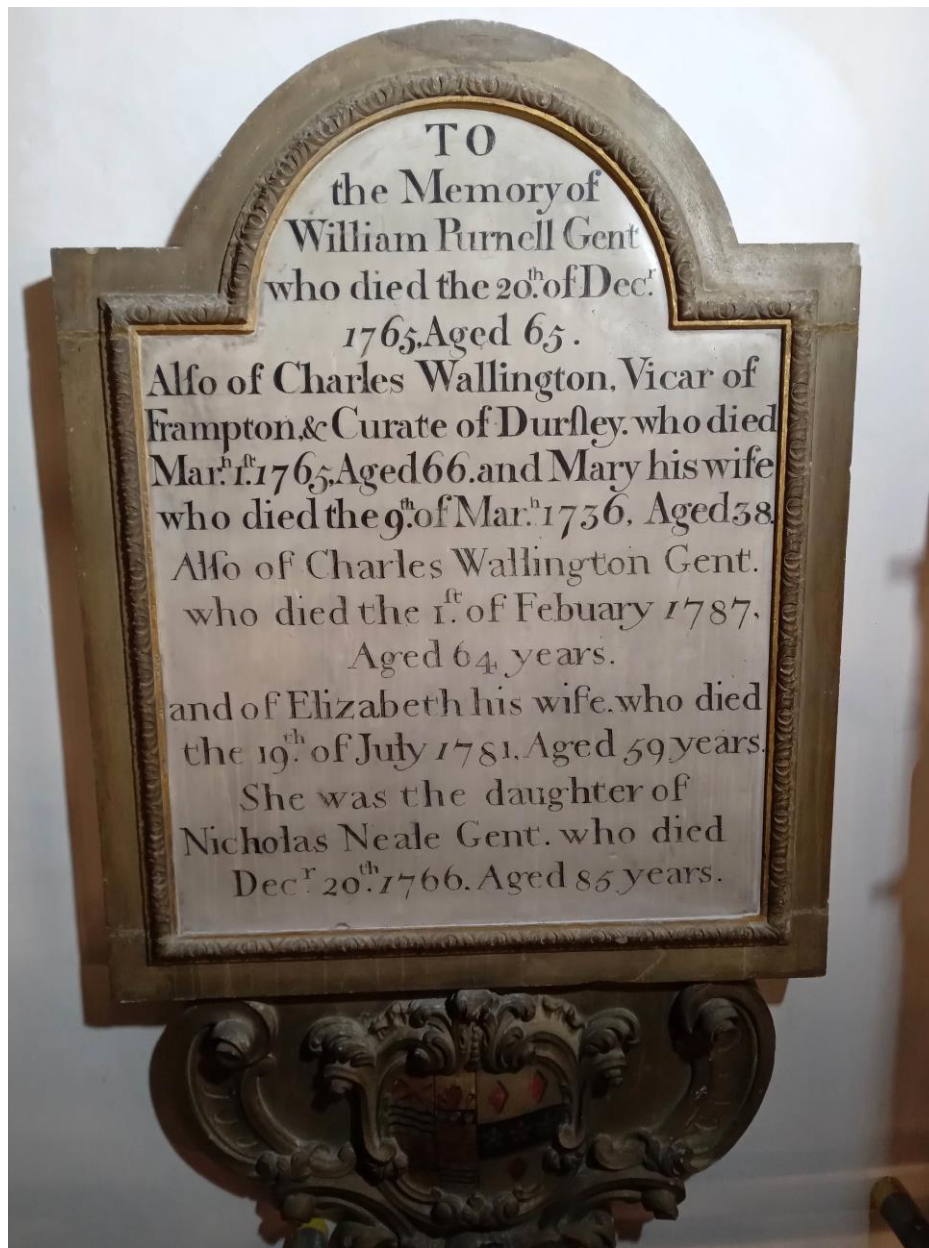
Purnell monument after work

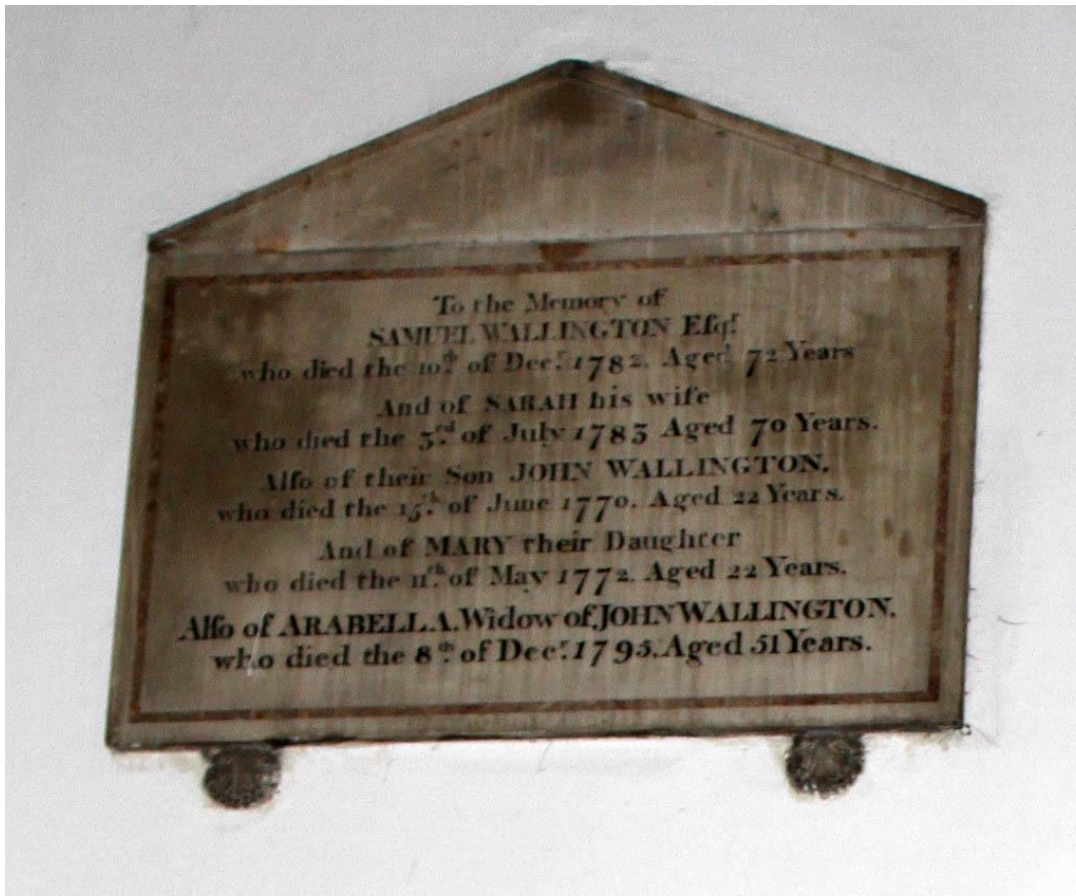
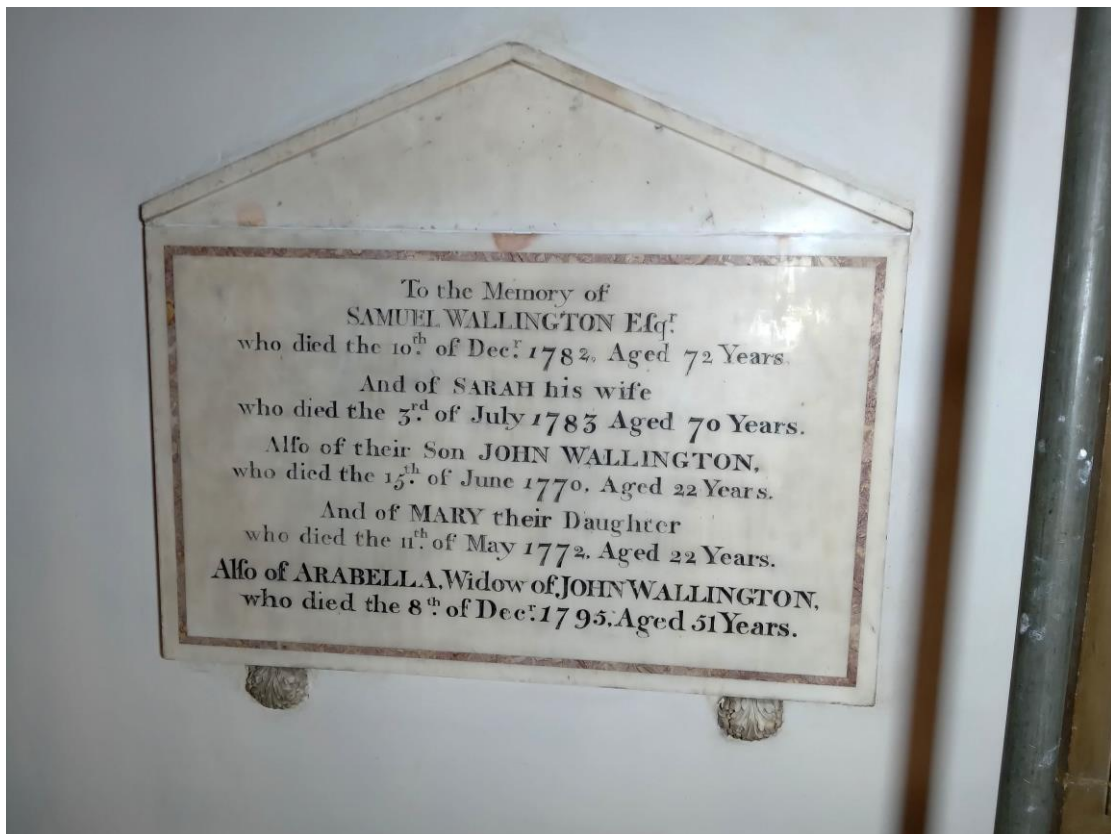
The ferrous fixings had begun to corrode, creating stains in the marble and an open joint between inscription and pediment, and its stability was uncertain. Surfaces were very heavily soiled and streaked with dirt and condensation runs.

The Wallington monument before and (below) after work

A secure scaffold was erected to give access and the monument recorded with photos and drawing. The pediment was removed, exposing the corroded cramps; a metal survey confirmed that no other metal elements existed within the structure. The cramps were replaced one by one with stainless steel set in resin and the pediment reinstated. Surfaces were successfully cleaned with Synperonic A7 non-ionic detergent with the addition of pumice. A pre-existing gap behind the inscription was retained to permit good ventilation.

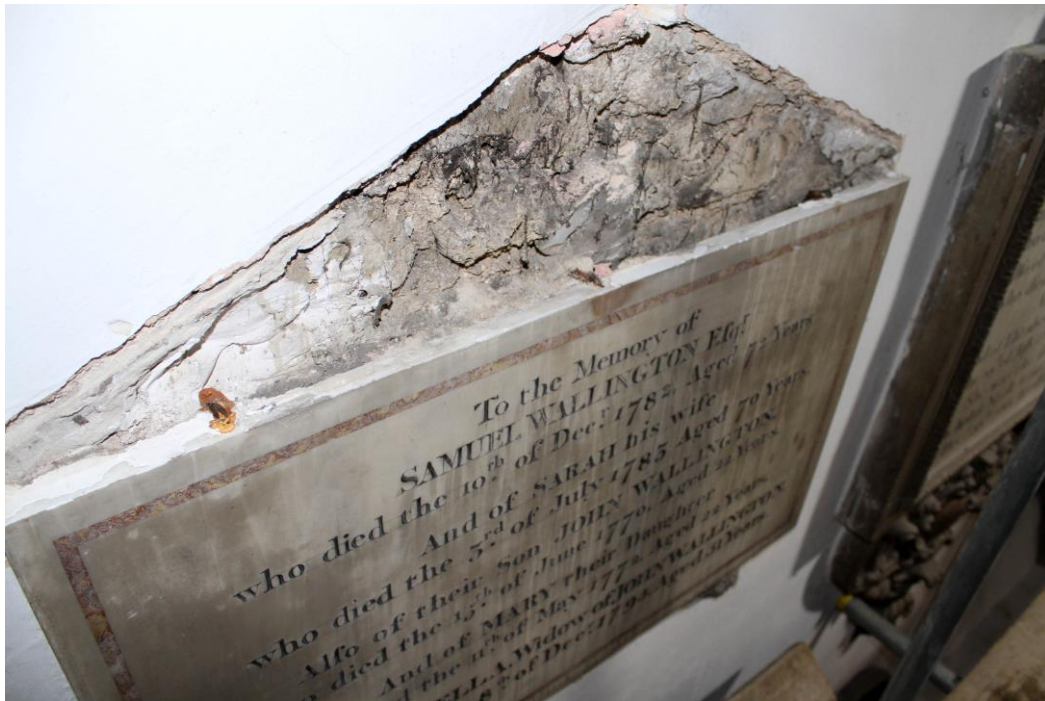
Above: cramps revealed in the top of the inscription

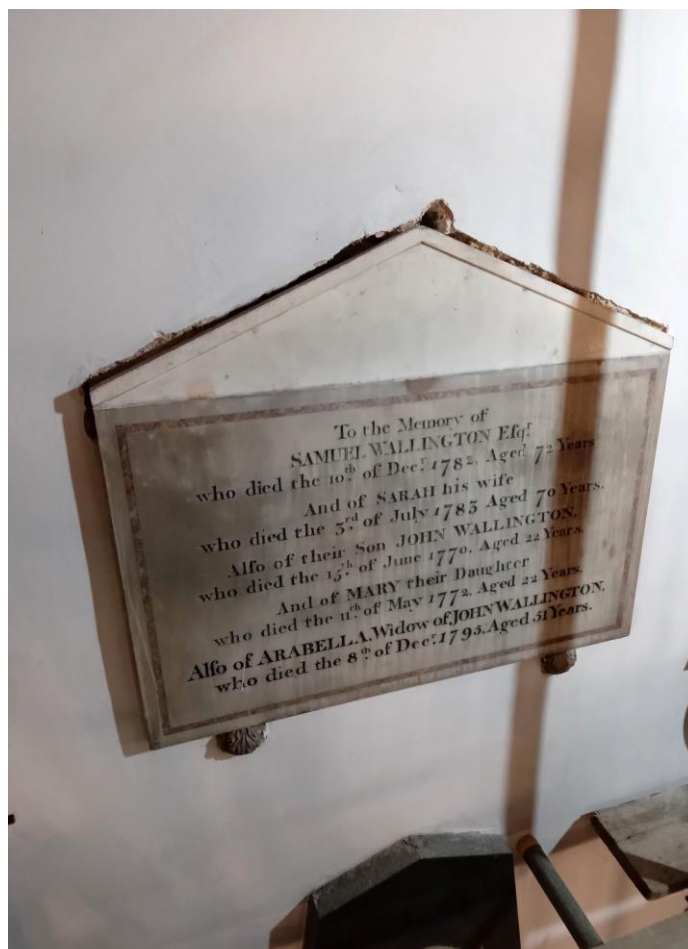
Left: reassembly in progress; note cleaned and uncleaned surfaces

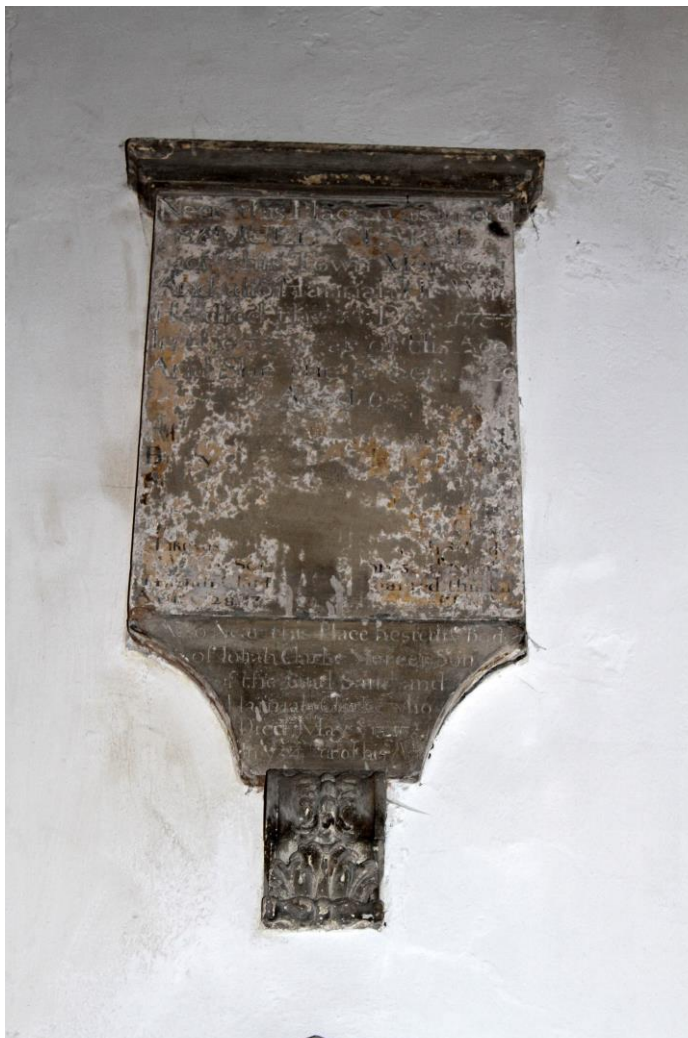
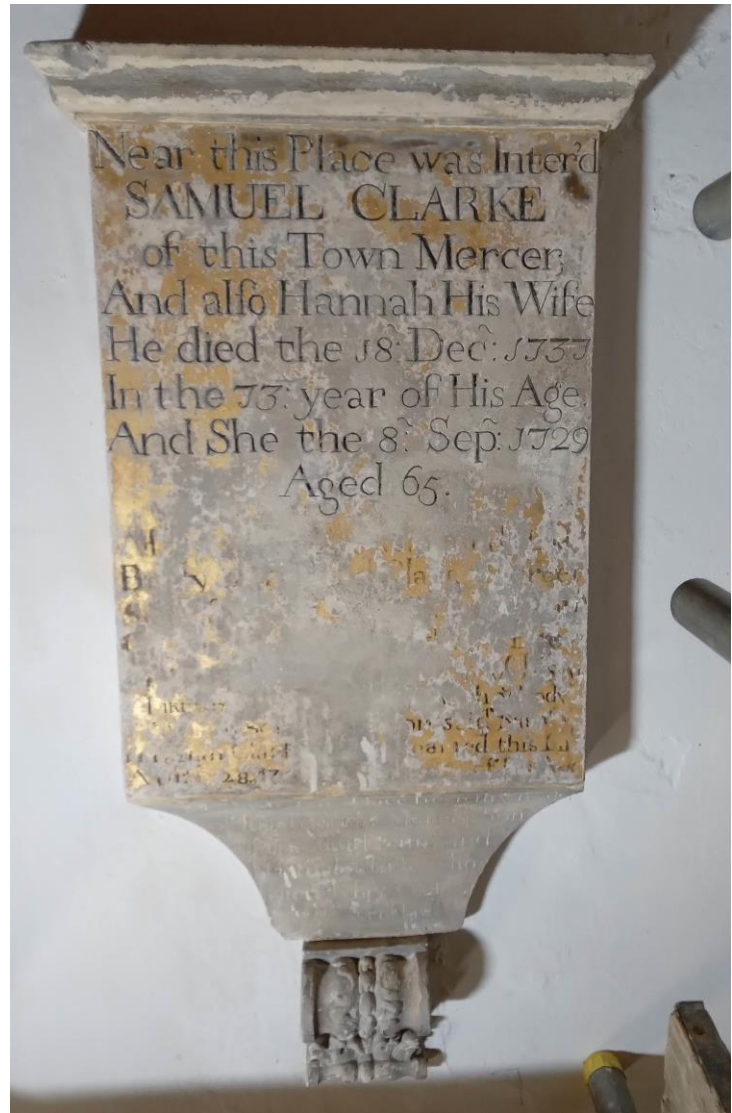
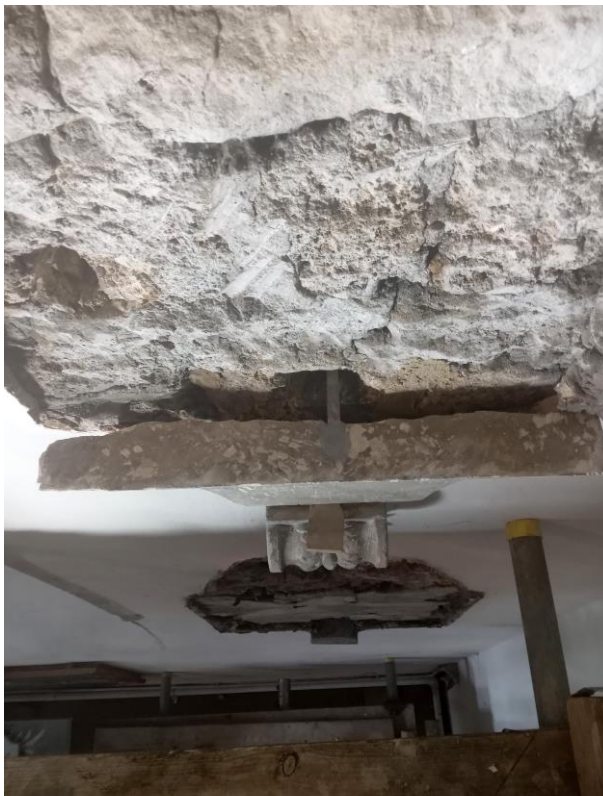
The monument was suffering from the failure of some of its ferrous fixings, and a large crack had developed between the monument and the supporting wall. Surface layers were fragile and flaking, and an unsightly later grey paint had been applied over the original surface.

The Samuel Clarke monument before (left) and after work (below); below left: a new stainless steel fixing set in resin

A secure scaffold tower was erected for good access and the monument recorded with photographs and sketch drawings to assist with re-erection work. The monument was then faced up with Japanese tissue, applied with Tylose MH 300, to ensure no surface layers were lost or damaged during dismantling. It was then dismantled down to the corbel (which was stable and therefore left in situ). Ferrous elements were removed and discarded. Areas of flaking applied layers were fixed with Primal B760a acrylic dispersion applied through the tissue and surfaces were cleaned with water and cotton swabs. In the process, it was revealed that the background to the lettering was gilded and the V-cut lettering painted black. The lower part of the inscription, which was simply painted and not inscribed, was partially lost. However, the upper inscription could still be discerned, and to allow it to be read from the floor, the lettering was retouched with Gamblin Retouching Colours. The monument was then re-erected with stainless steel cramps set in resin and lime mortar joints. The area around the monument was replastered with lime plaster as necessary.

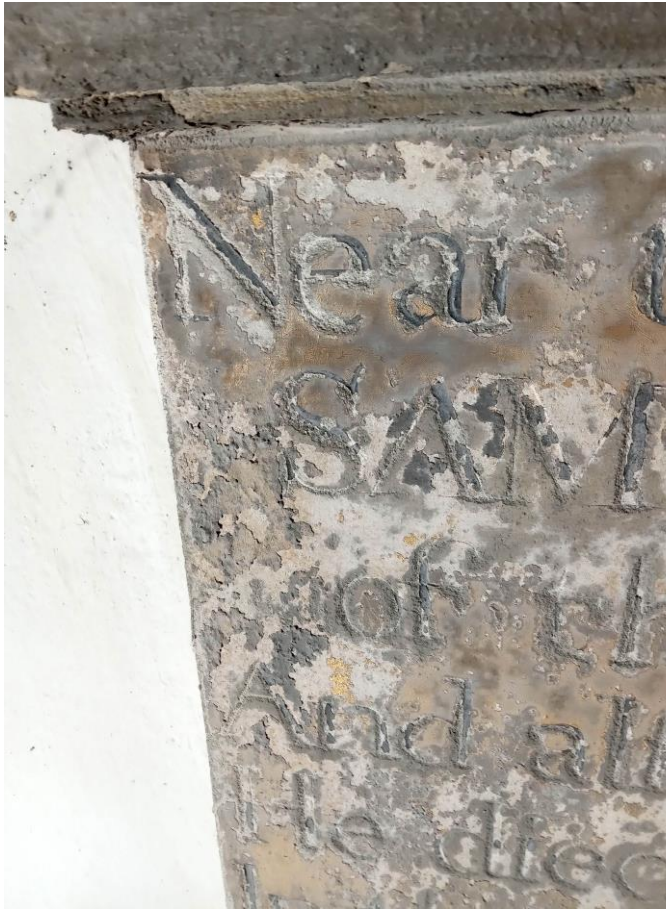
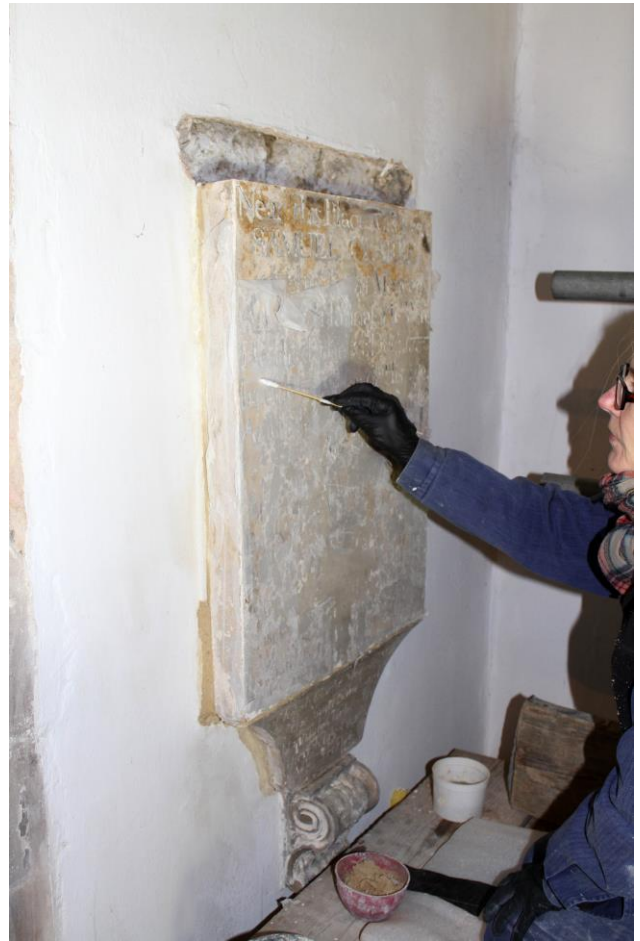
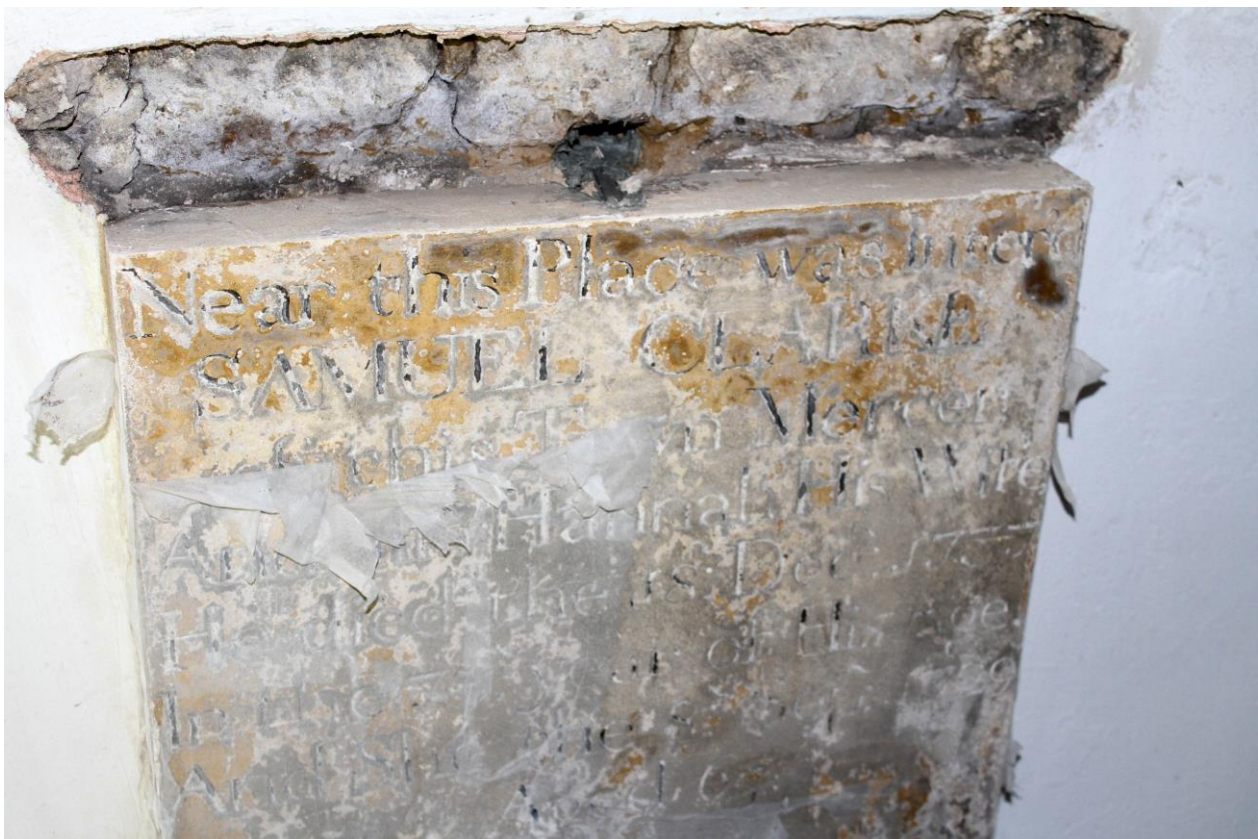
Above: flaking paint in the letters of the inscription; above right: cleaning in progress; below partially dismantled, note iron fixing and gilding emerging from under overpaint

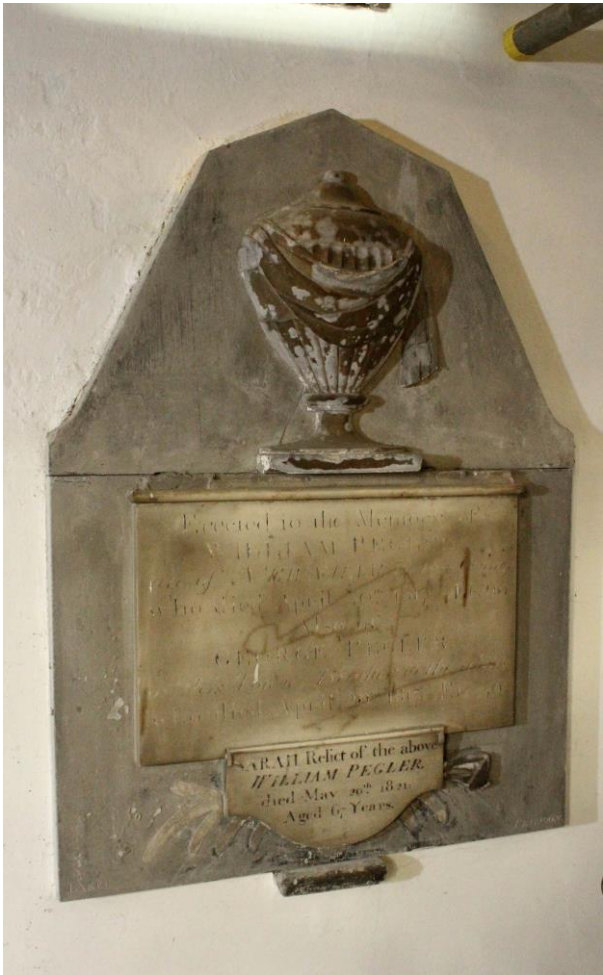
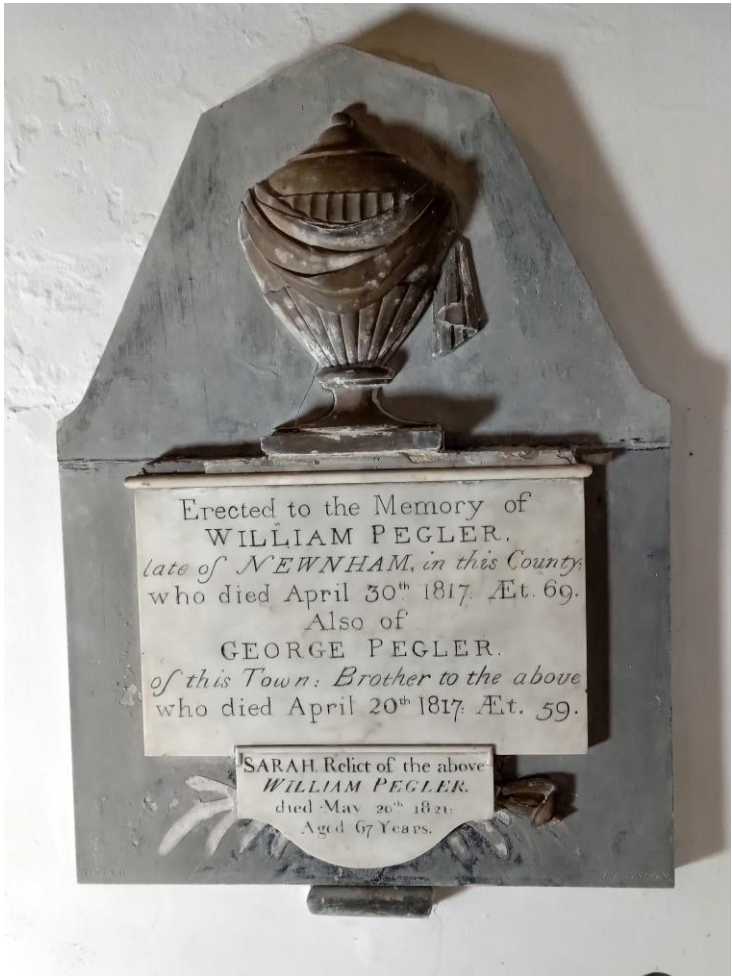
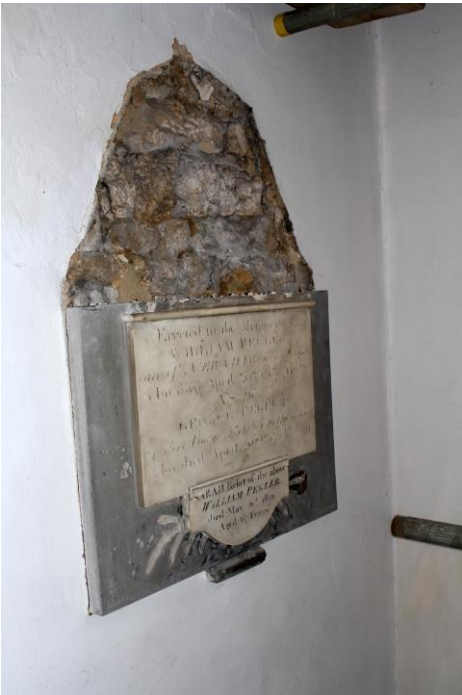
The monument has some structural disruption and a crack between its stonework and the wall, and its stability could not be guaranteed. The upper backing plate was cracked. Surfaces were heavily soiled and the inscription had faded and become illegible.

Monument of William Pegler, left: before and below: after work

Below left: dismantling in progress

A secure scaffold tower was erected to give good access. The monument was recorded with photographs and sketch drawings to assist with re-erection work. It was then carefully removed from the wall and laid on the scaffold. Old ferrous fixings were removed from both the monument and supporting wall. Surfaces were cleaned with suitable materials and the crack in the backing plate was repaired with a cramp of 316L grade stainless steel set into a chase in the rear face of the stone with resin. The monument was then re-erected with new stainless cramps set in resin and plaster joints. And the surrounding plaster was made good with lime-based materials. The inscriptions were retouched with Gamblin retouching colours to enable them to be read from the ground.

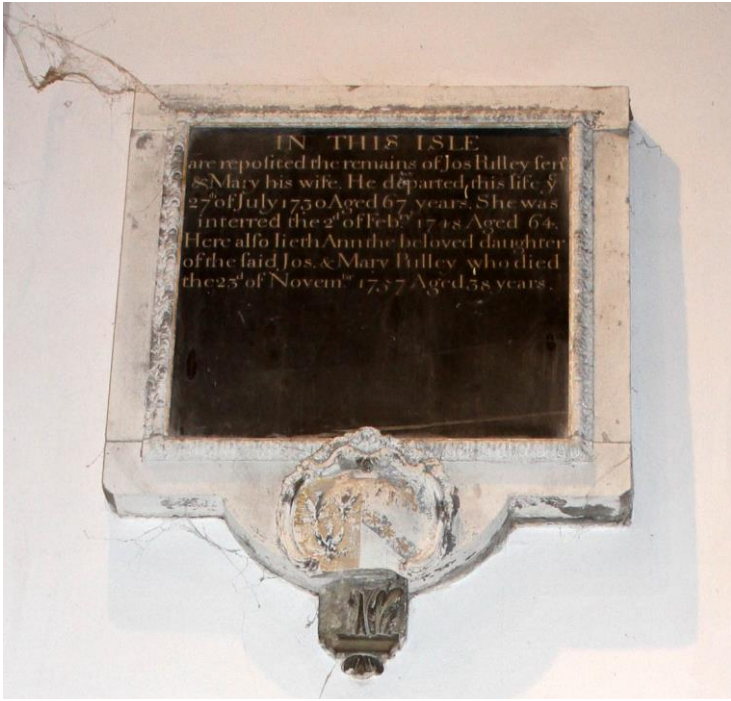
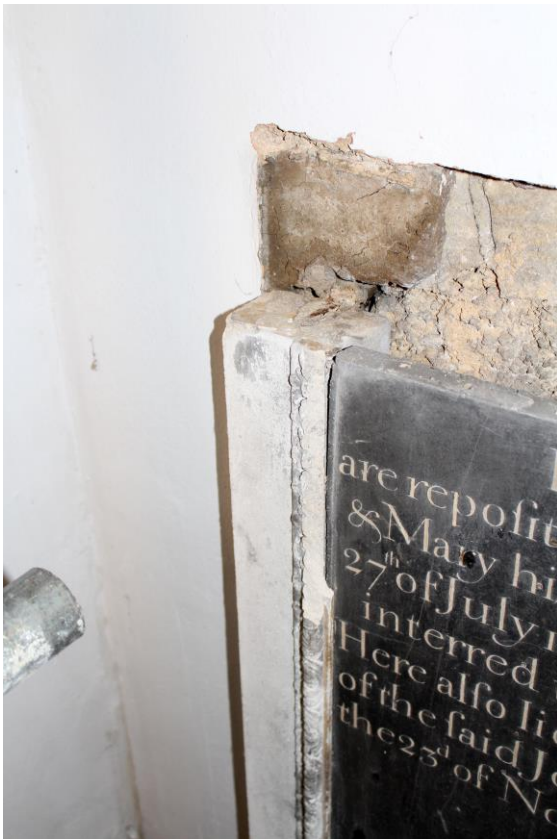
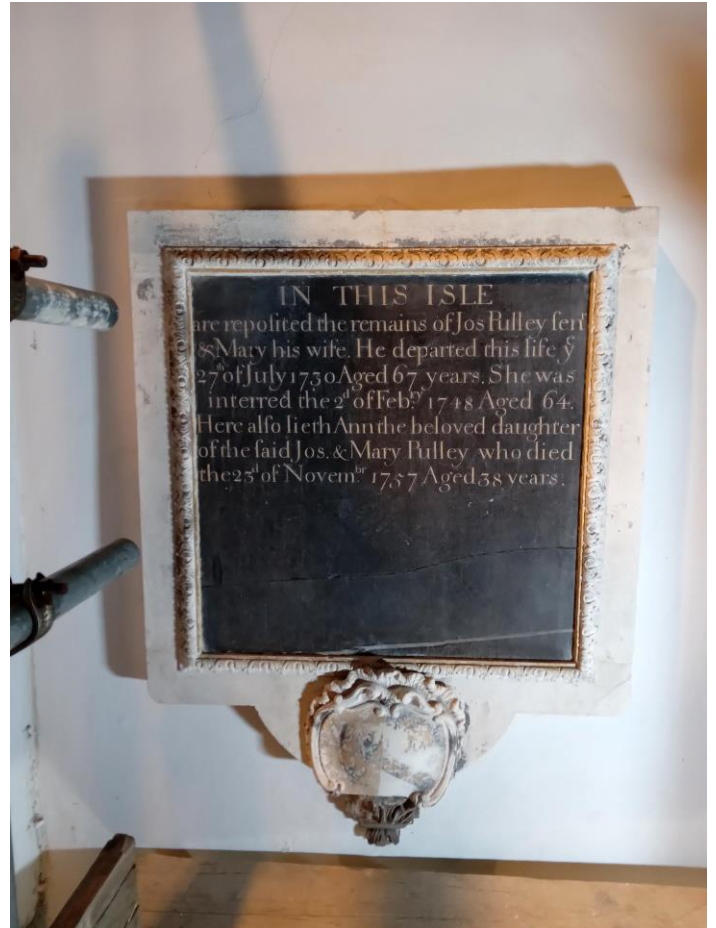
The monument had a large crack up the joint with the supporting wall and the topmost rail of the inscription frame was cracked where its central cramp had expanded and damaged the stone. The inscription panel was also cracked across just below the centre. The armorial achievement was held on a single corbel, and a metal survey confirmed that this was not made of metal. Surfaces of the stone were powdering somewhat, possibly as a result of historic water penetration in the wall behind.

Monument of Jos and Mary Pulley left: before work and below: after work

Below left: dismantling in progress

A secure scaffold tower was erected to give good access to the monument, which was recorded with photographs and working drawings to assist with re-erection work. The monument was then carefully dismantled; old fixings were removed from both monument and wall. The top section of frame was repaired with a stainless steel dowel set in polyester resin and gaps were filled with lime mortars. The cracked inscription was repaired with two 6mm dowels and a single flat stainless steel cramp set in to a chase in the rear face with resin. Surfaces were cleaned with cotton swabs and clean water to remove dust and any possible salt efflorescence. Remnants of the heraldic design were stabilised and consolidated with Primal B60a acrylic dispersion. The monument was then re-erected, using stainless steel cramps and resin for wall anchors and lime mortars for bedding joints. The plaster surrounding the monument was made good with lime plaster.

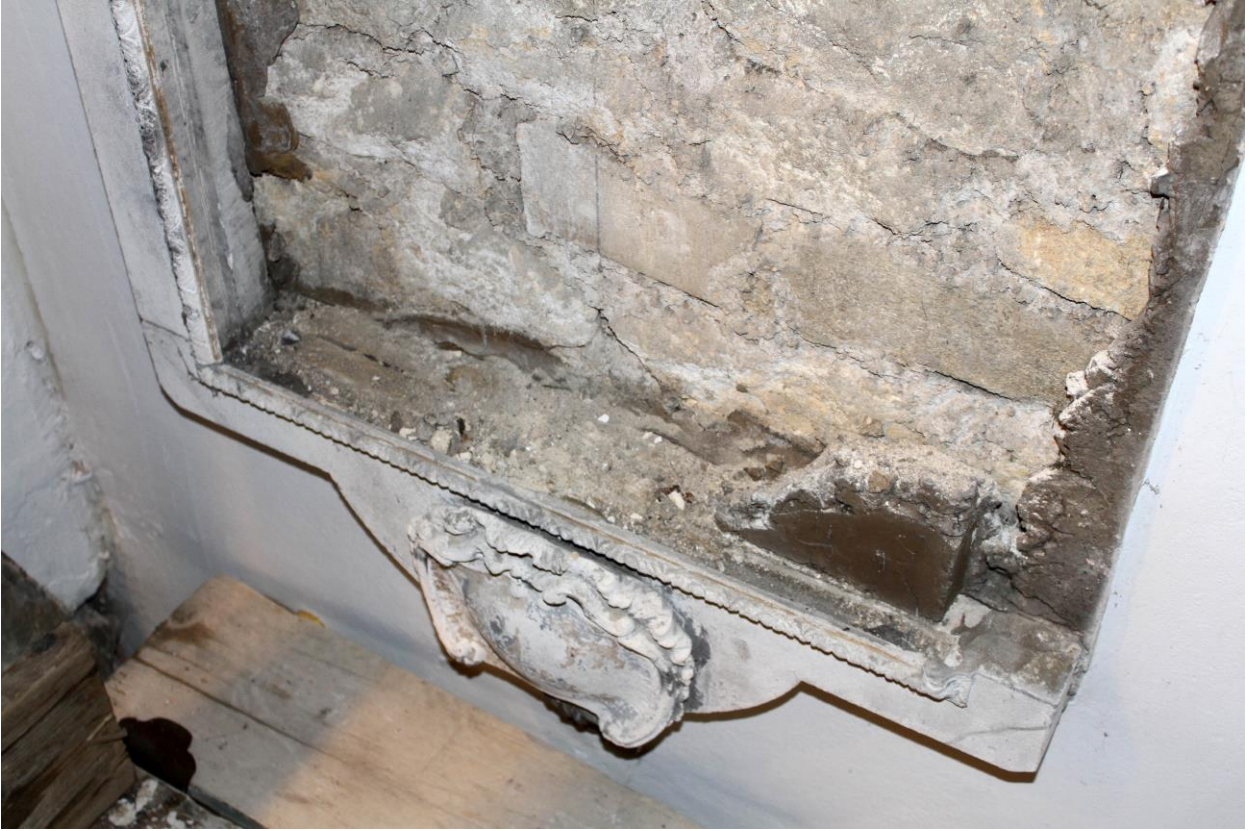
Pulley monument: dismantling in progress
