McNEILAGE CONSERVATION

St James Church, Dursley, Gloucestershire (Diocese of Gloucester)

Internal wall monuments

Conservation Report

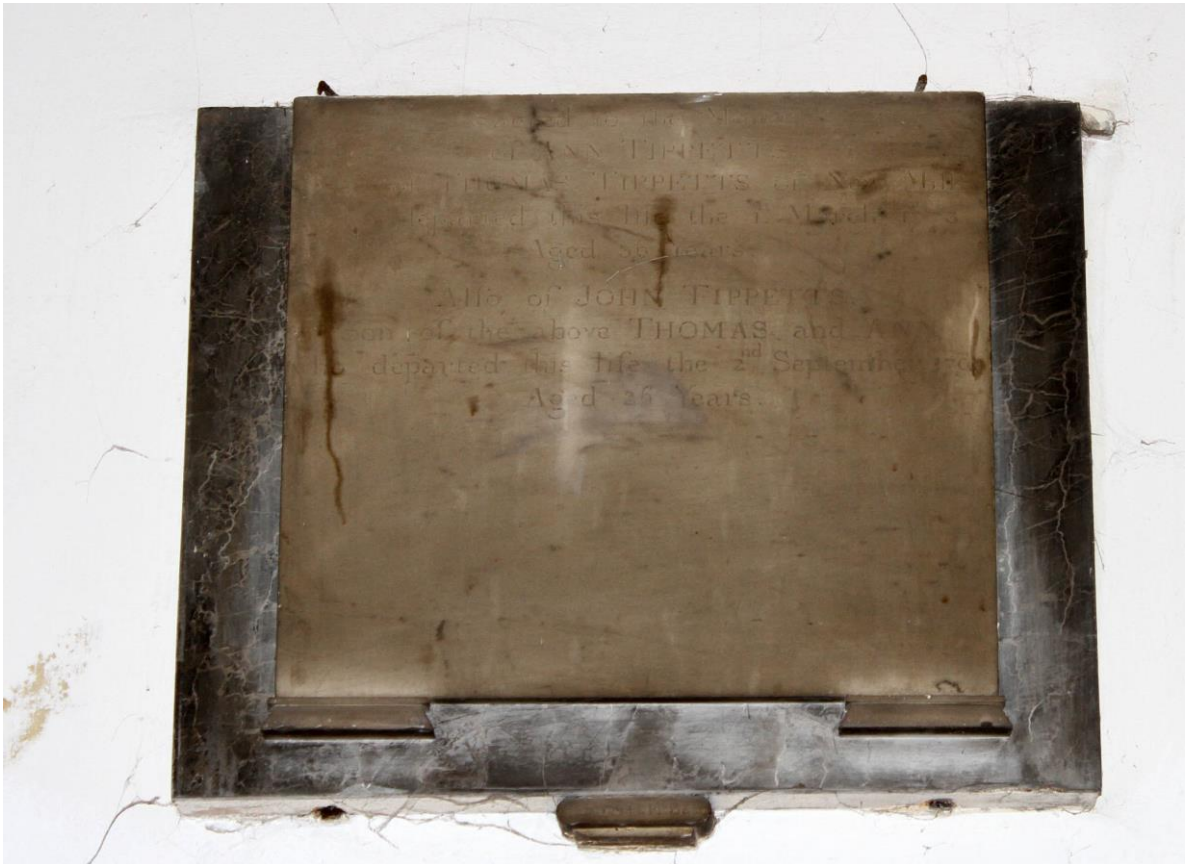
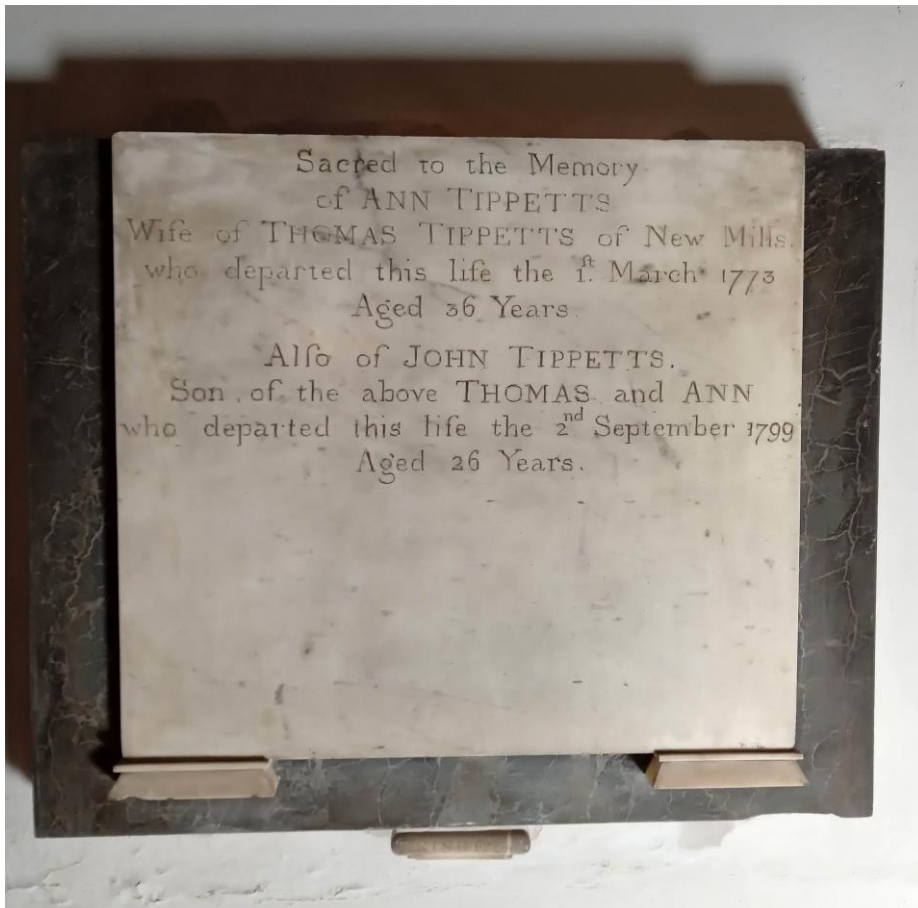
The monument was beginning to become unstable. It had already lost its upper sections in the past, evidently because of the rusting of cramps at the top of the inscription. There was a crack up the joint with the wall and the base cramps were visibly corroded.

Surfaces were heavily soiled and stained and the inscription had faded and become illegible.

Monument of Ann Tippetts,
above: before and left: after
work

A secure scaffold tower was erected to give good access. The monument was carefully released from its base cramps and removed from the wall to a work bench. Surfaces were cleaned with Synperonic A7 non-ionic detergent and pumice, and stains removed with appropriate solvents. Ferrous elements were removed from both wall and monument. New base cramps of stainless steel 316L grade were installed in the wall with resin and capped with lime mortar. The central stone corbel, which was loose, was rebedded in lime mortar. The monument was then re-erected and fixed with top cramps of stainless steel. The faded inscription was retouched so it could be read from the ground.

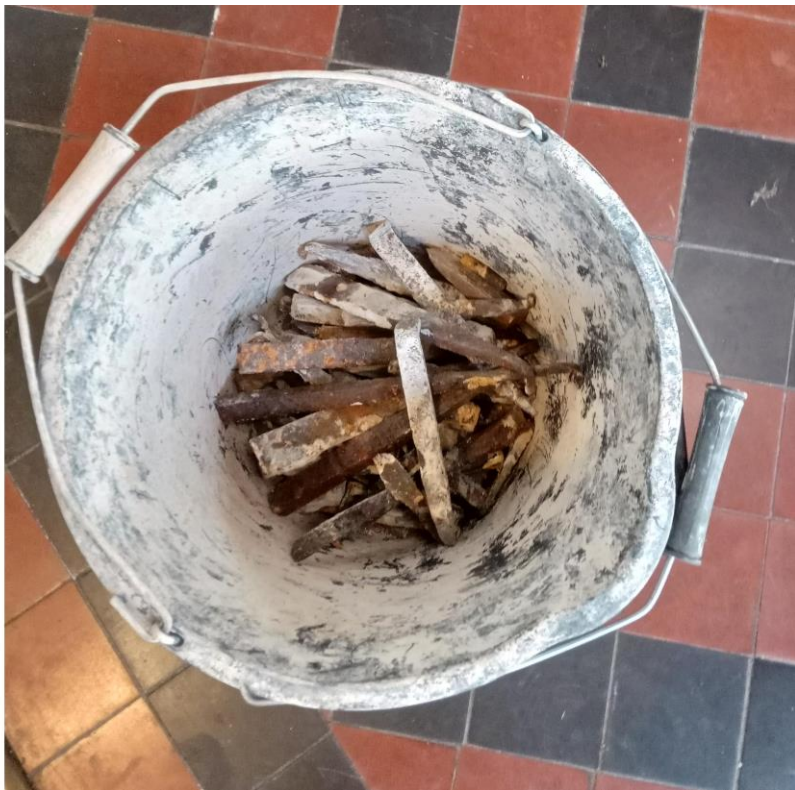
Left: Rusted ferrous fixings removed from the monuments

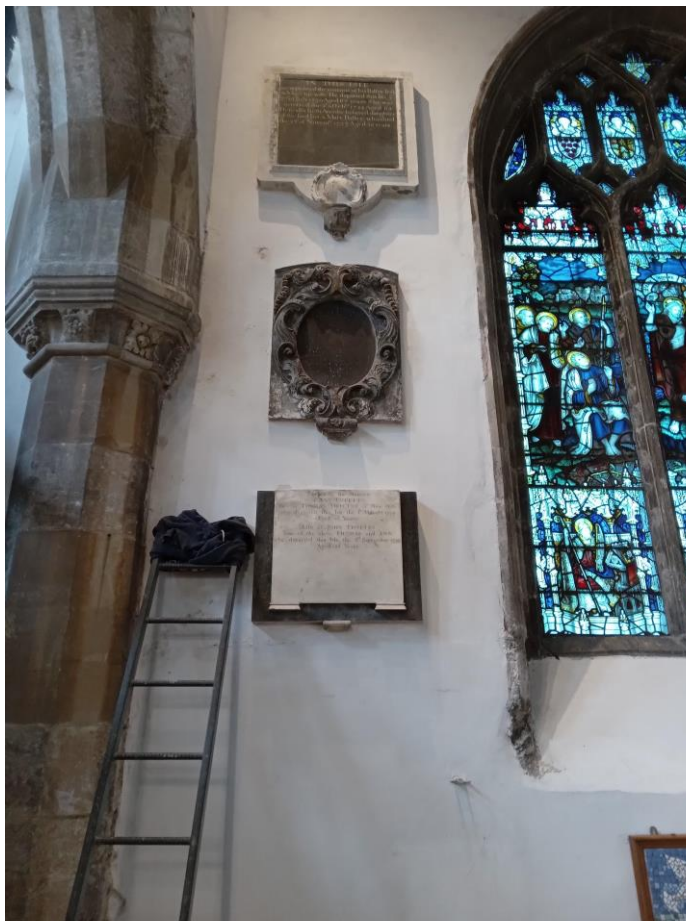
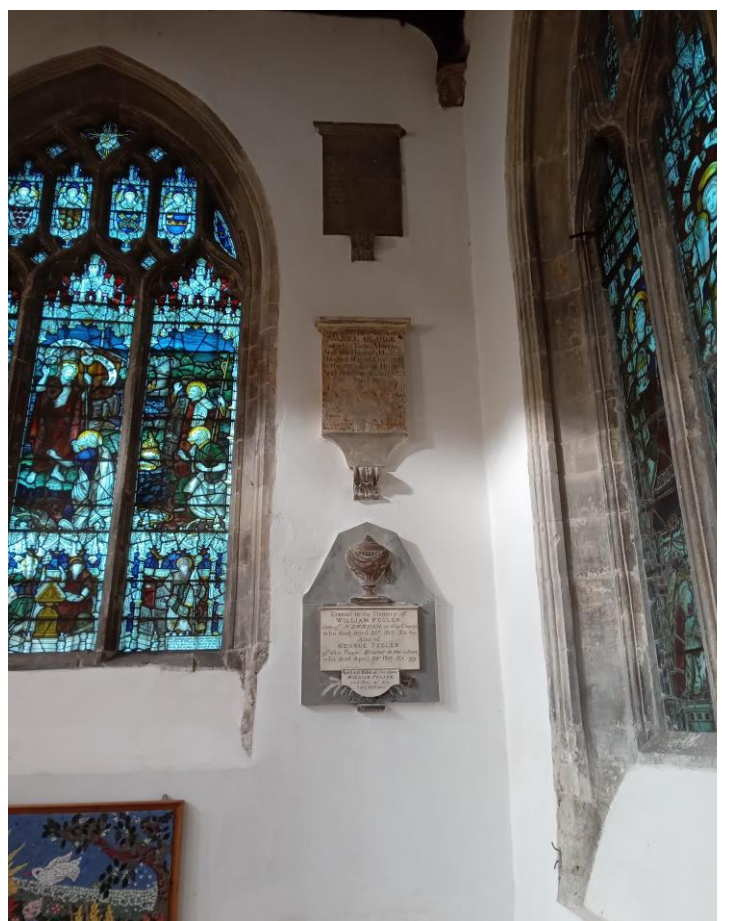
Below: the monuments of the west wall after work
