Grants for Programmes of Major Works Round 2: 2021/22

Table of photographs showing the completed project

Name of the site	St Andrews Church Rockbourne
Address of the site	4 New Road, Rockbourne, Hampshire, SP6 3NN

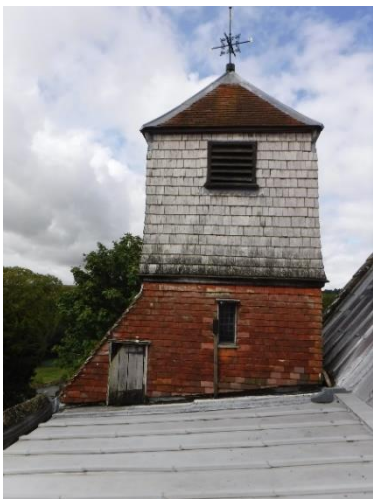
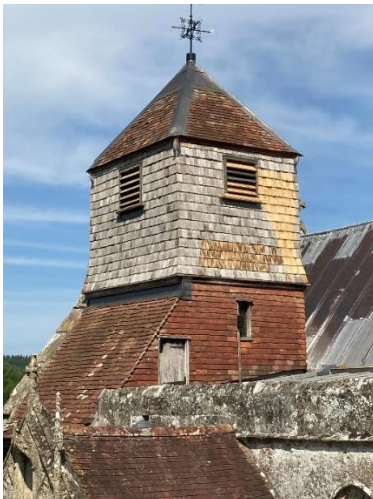
<p>Location on building: Tower from south aisle roof</p> <p>Short description of the repair need: Timber frame tower repair, remove shingles & roof tiles to access & improve previous details.</p>	<p>Short description of work that was carried out to address the repair need: Shingles refitted over new s.w. sarking boards. Tiles refitted on new Type 1F felt over sarking boards, bat slates added, secret eaves venting detail added, new leadwork details.</p>

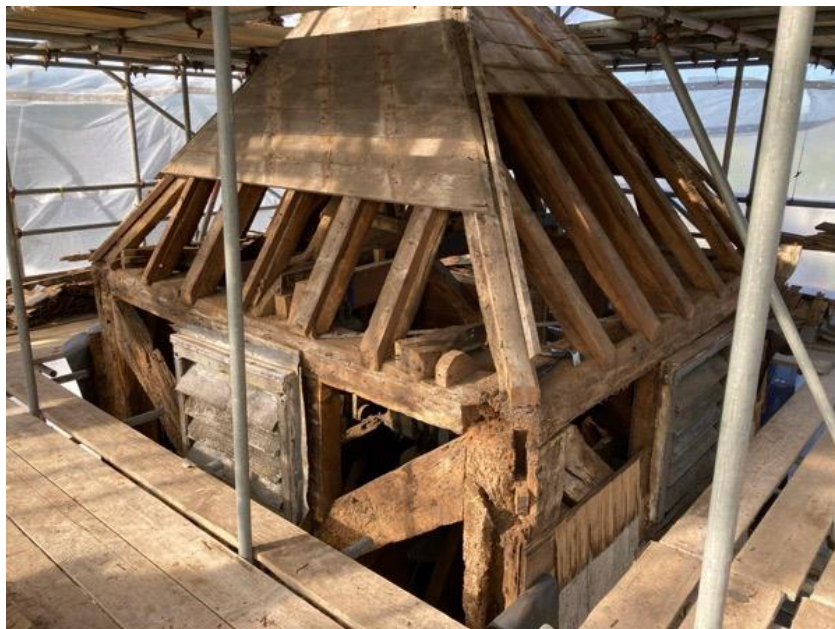
Image taken before the repair work

Short description of repair need: Structurally compromised timber frame to be repaired, retaining all sound timbers, piecing in where possible, treating beetle by paste & spray. Roof tiles, shingles & timber sarking removed for access.

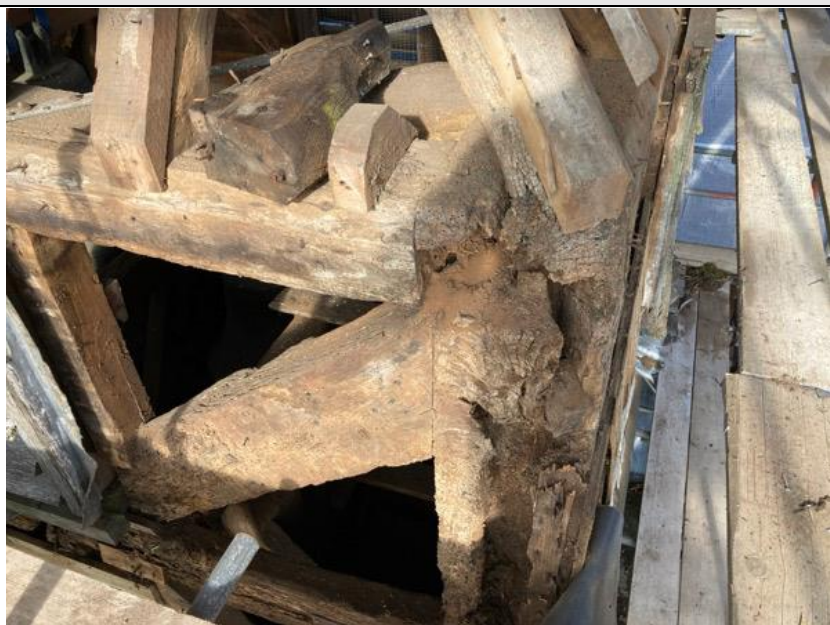
Image taken before the repair work

Short description of repair need: Death watch beetle & water damage / wet rot had structurally compromised the timber frame. Localised repairs to oak frame & replacement where necessary.

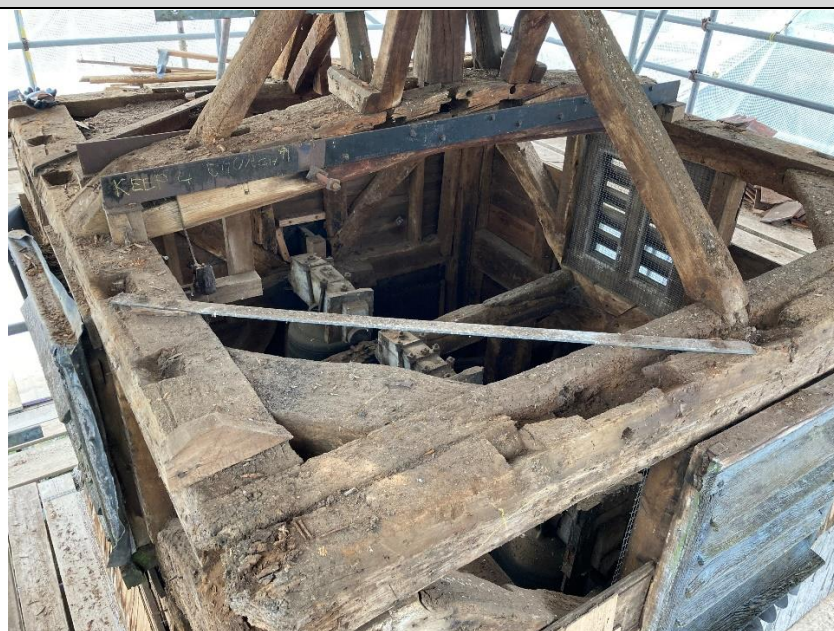
Image taken before the repair work

Location on building: Top frame with roof removed

Short description of repair need: Replacement of main beam & top frame beams to east & west where not structurally sound due to death watch beetle & wet rot decay.
