Grants for Programmes of Major Works Round 2: 2021/22

Table of photographs showing the completed project

| Name of the site | St Stephen the Martyr church |
| Address of the site | St Stephen's hill, St Stephens, Launceston, Cornwall. |

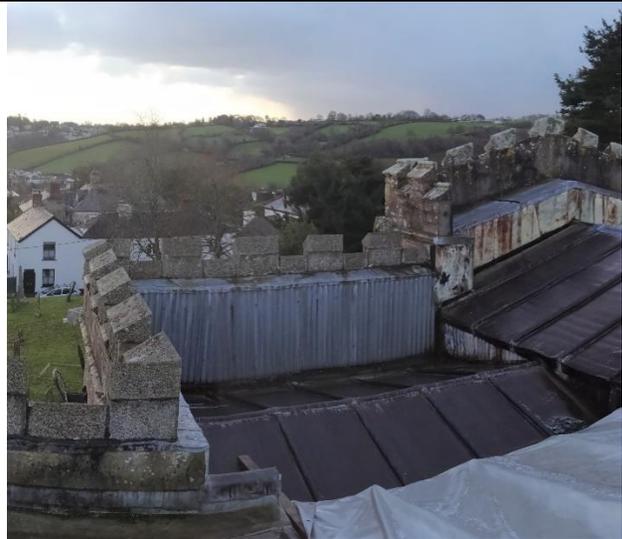
| Image taken before the repair work Date image taken: 11.12.19 | Image taken after the repair work Date image taken: 26.07.22 |
|---|---|
| <p>Location on building: Organ roof, South east corner.</p> <p>Short description of the repair needed: Insufficient gutter depth, failed lead parapet capping; failed rainscreen sheeting, failed lead.</p> | <p>Short description of work that was carried out to address the repair needed: New lead parapet capping including removal and replacement of merlons, parapet consolidation, new lead shallower roof pitch to allow deeper gutter profile, vertical lead to replace corrugated tin, larger areas of exposed parapet wall has been prepared for harling rendering in lime.</p> |

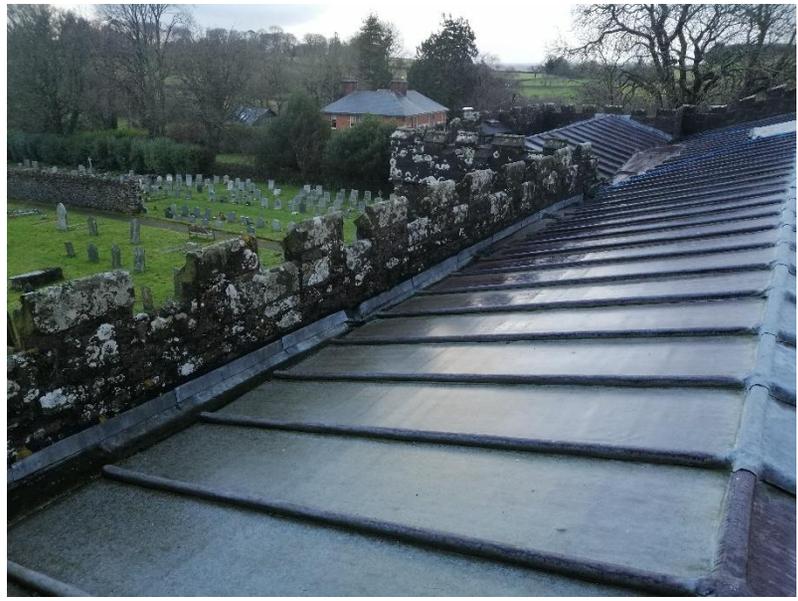
| <p>Image taken before the repair work Date image taken: 11.12.19</p> | <p>Image taken after the repair work Date image taken: 26.07.22</p> |
|---|--|
| <p>Location on building: North parapet wall, nave west end. Short description of repair needed: Rotten roof timbers, split flashings, poorly maintained and unstable parapet.</p> | <p>Short description of work that was carried out to address the repair needed: Parapet depointed, consolidated and repointed in a lime mortar. Preparation for final dressing and completion to repair works outside of the grant works. The same works undertaken on the southern parapets including lifting merlons and reintroducing lead DPCs.</p> |

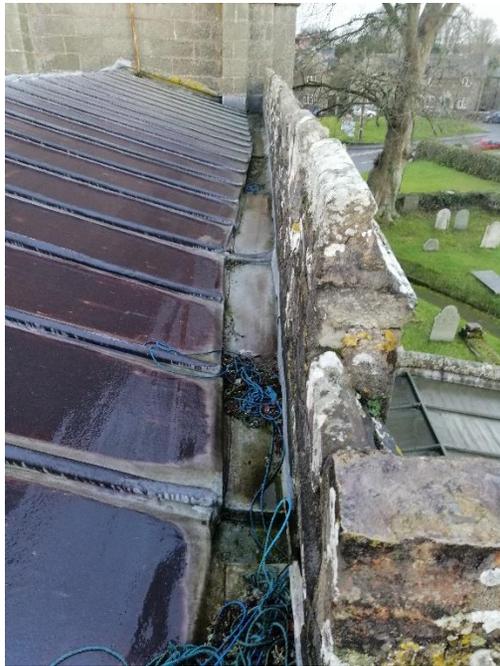
| <p>Image taken before the repair work Date image taken: 11.12.19</p> | <p>Image taken after the repair work Date image taken: 26.07.22</p> |
|--|--|
| <p>Location on building: Northern parapet gutter and nave slope. Short description of repair needed: Failed and slipping lead sheeting, insufficient fall on gutter causing roof timber decay.</p> | <p>Short description of work that was carried out to address the repair needed: New shallower lead pitch to north slope of nave to allow for a deeper gutter profile and improved falls, timber repairs, new code 8 cast lead roof. Exactly the same work was undertaken on the South parapet gutter.</p> |

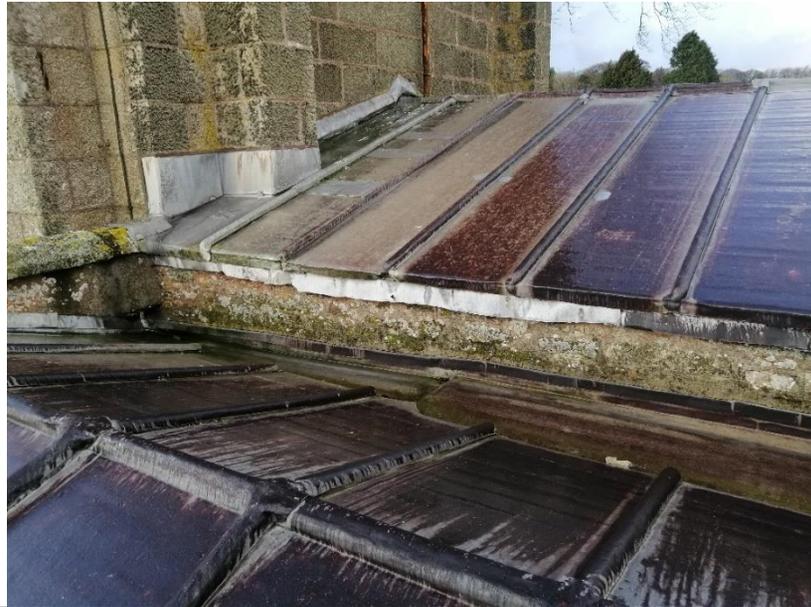
| <p>Image taken before the repair work Date image taken: 11.12.19</p> | <p>Image taken after the repair work Date image taken: 26.07.22</p> |
|---|---|
| <p>Location on building: Roof slopes of the Nave and south aisle and valley gutter. Short description of repair needed: Overlength failed lead sheeting, insufficient falls to the valley gutter and exposed masonry leading to timber decay.</p> | <p>Short description of work that was carried out to address the repair needed: New lead roof with shortened sheet lengths with staggered laps, vertical timber cladding and lead sheeting to cover the exposed walls, new lead gutter profile and increased number and height of steps.</p> |
