# St. Andrews church, Cold

## Aston

Treatment Report

## Giles Carter Memorial

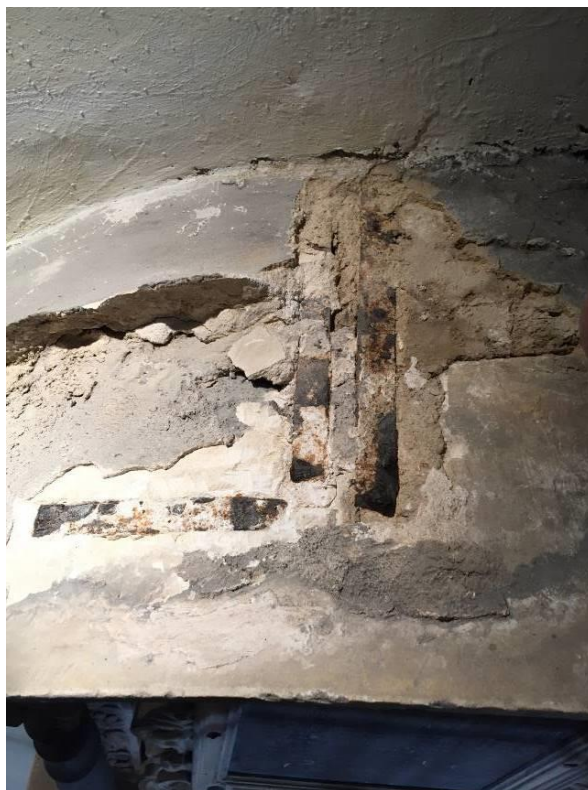
*Exposed cramps to west side of pediment*

The cherubs on the monument were removed to expose ferrous cramps retaining the pediment back to the supporting wall behind; one on the east side and two to the west side. A further cramp had been set over a calcite vein on the west side stone. The cramps were removed and replaced with stainless steel flat bar, but only one cramp was used to retain the west side stone since we could see no reason why two had been used previously.

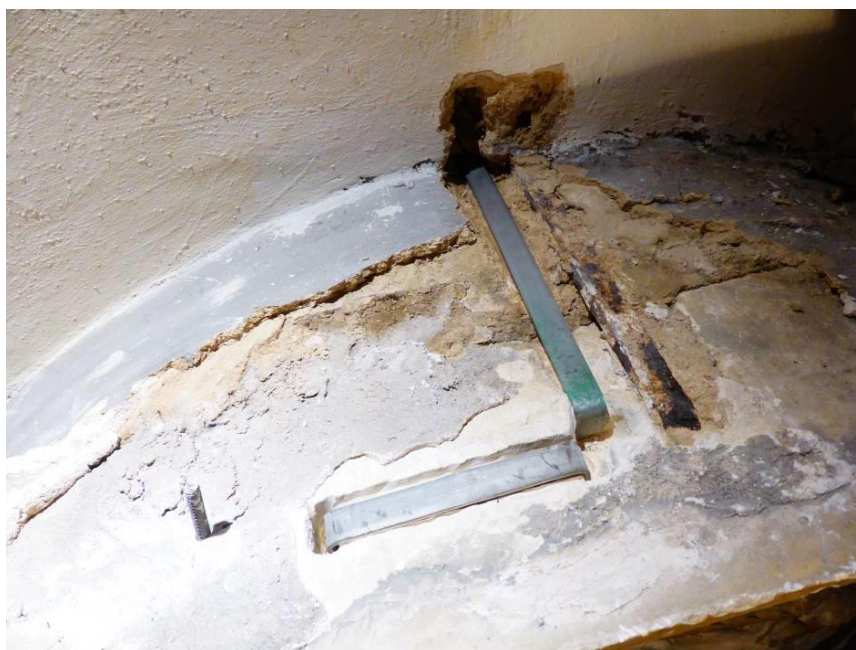
*During fitting of replacement cramps and locating dowel for west cherub*

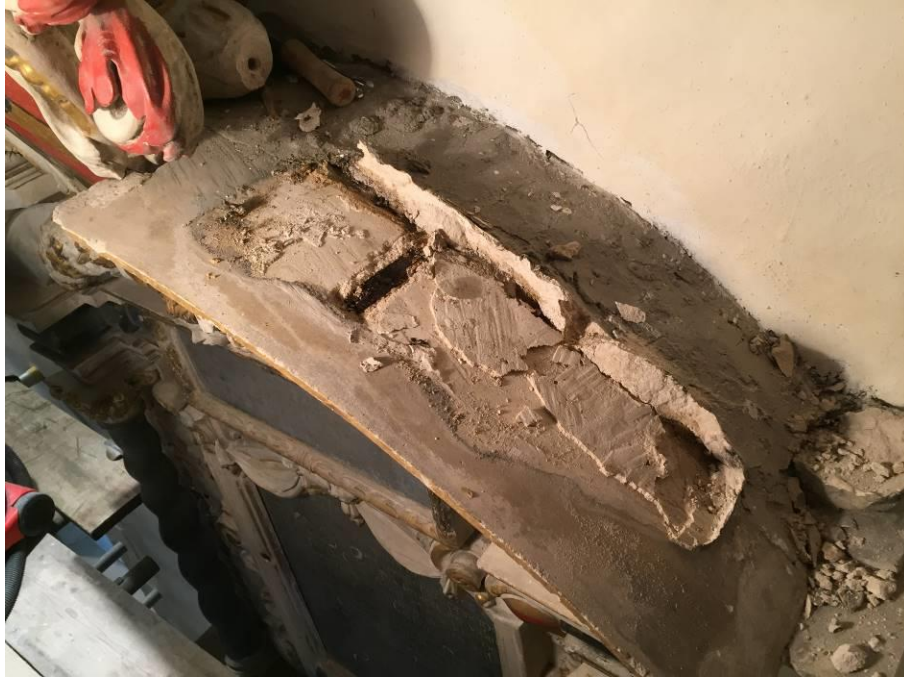
*Exposed cramps to east side of pediment*

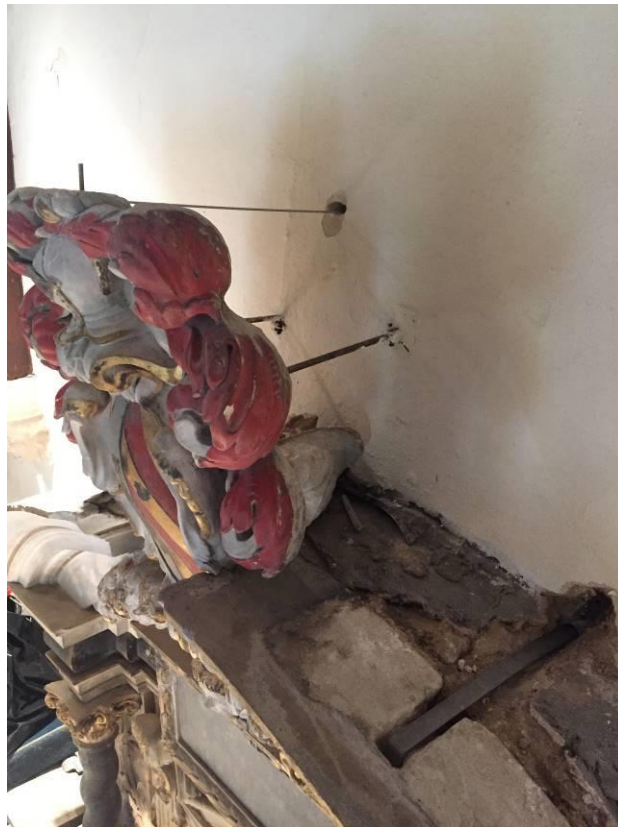
*During fitting of east side replacement cramp, shield strap and dowel for crest finial*

The flame finial crest surmounting the coat of arms was found to be loose and was removed. The timber peg holding it in place was replaced with a stainless steel dowel. The existing straps supporting the shield were supplemented with a new stainless steel strap cramped into the top of the crest alongside the new finial dowel.

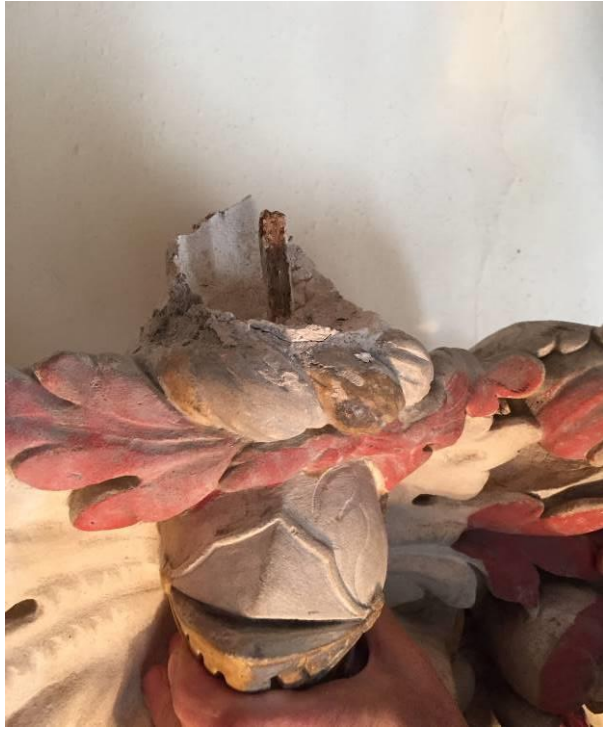
*Decayed timber peg for crest finial*

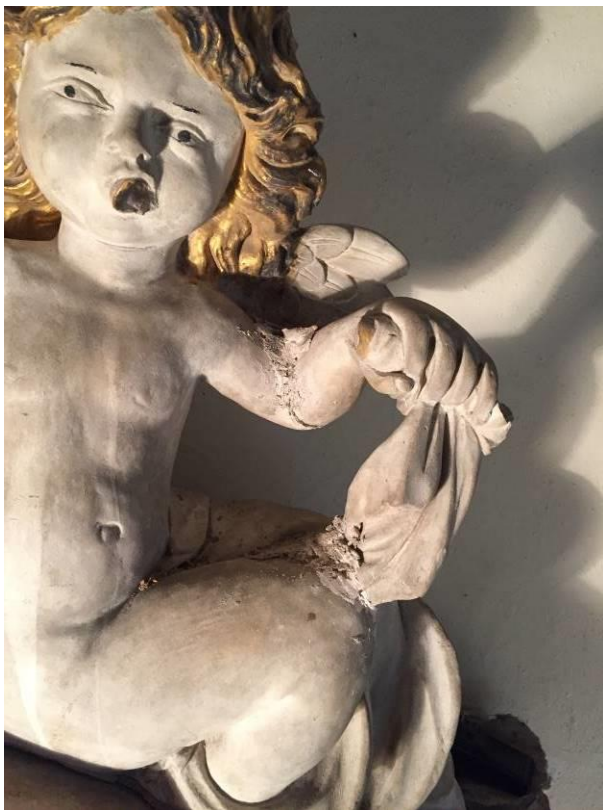
*East side cherub before refitting arm*

Exposed ferrous cramps over a calcite vein were removed from the front and back of the west side cherub and replaced with stainless steel flat bar. The poorly refixed sinister side arm to the east side cherub was removed and the ferrous dowels used to hold it in place replaced with stainless steel studding.

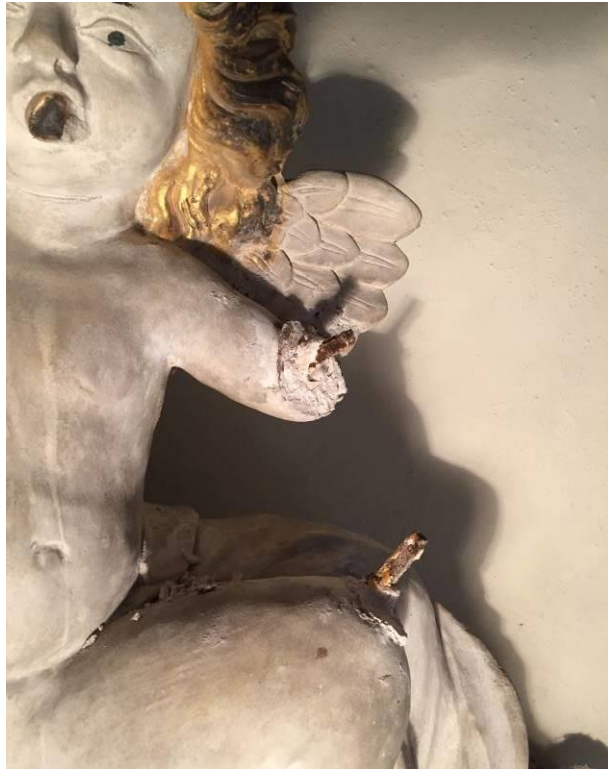
*East side cherub arm removed*

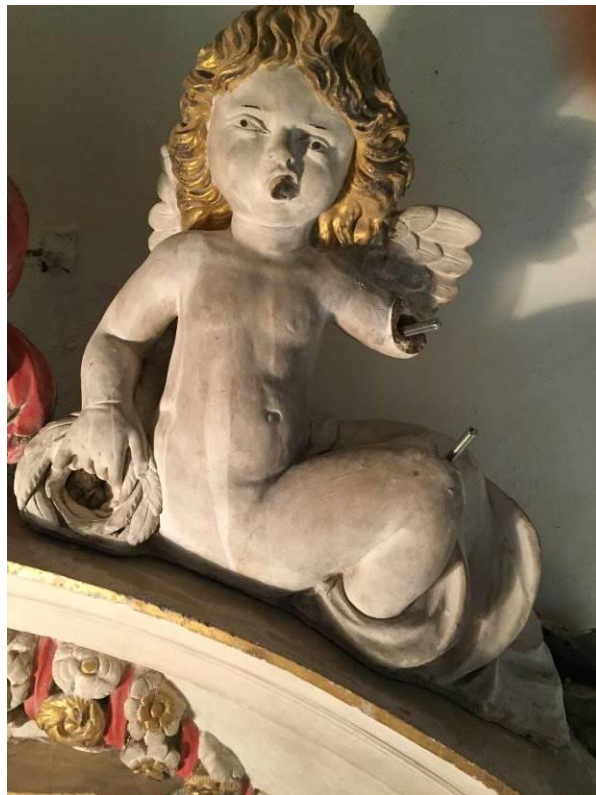
*East side cherub with new dowels*

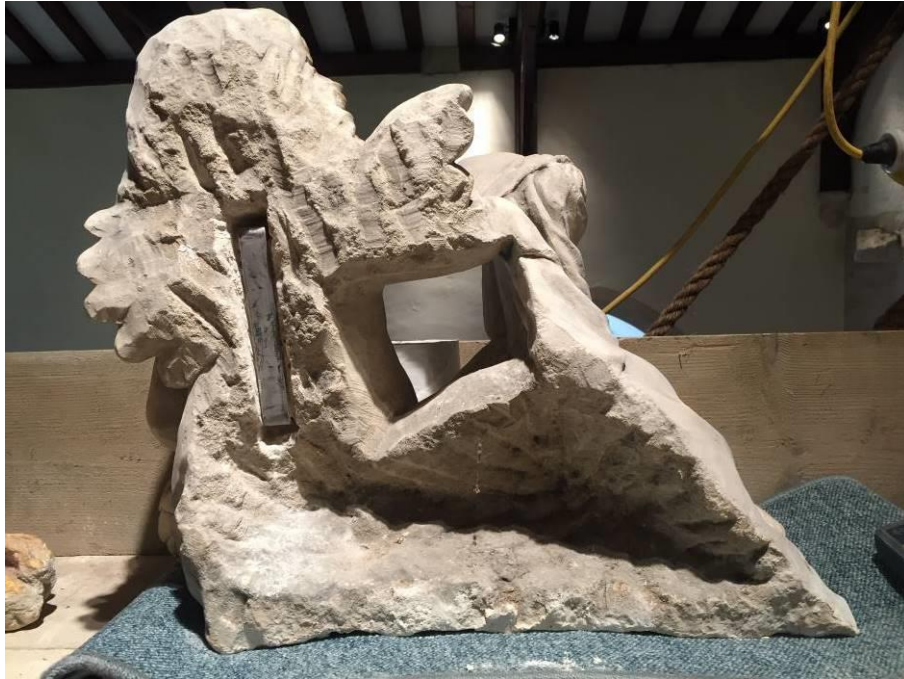
*Rear of west side cherub with replacement cramp*

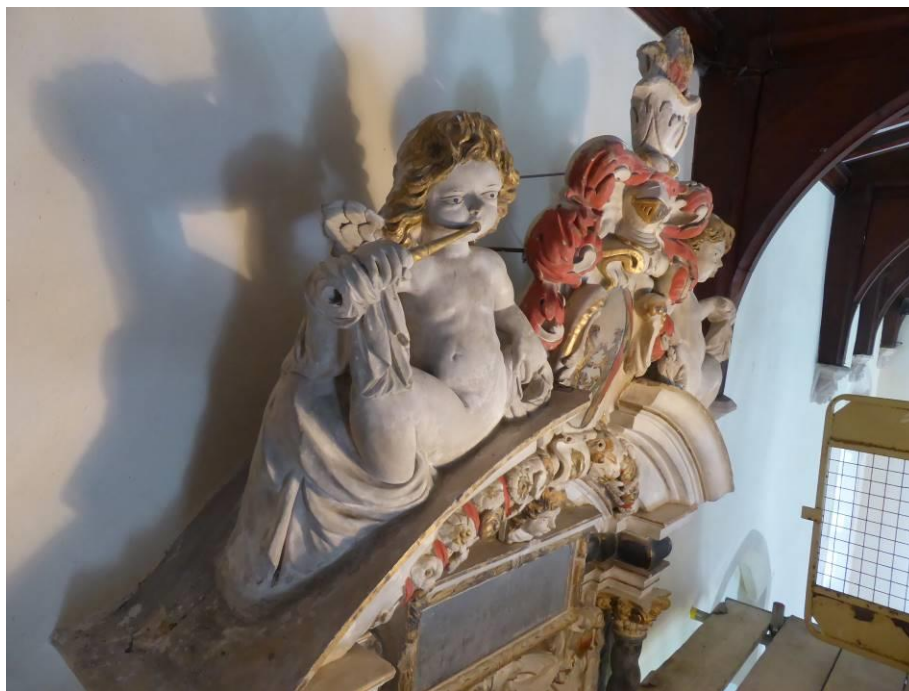
*Works to pediment completed*

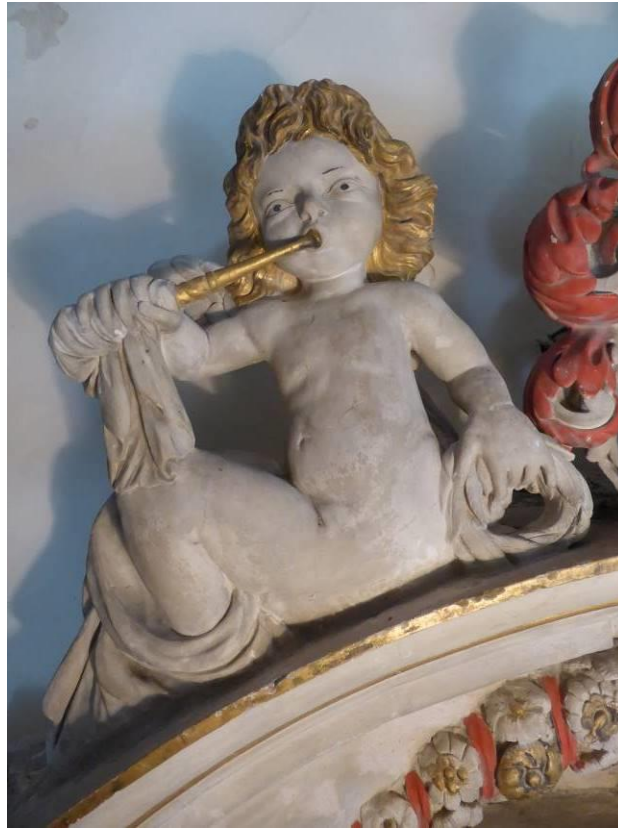
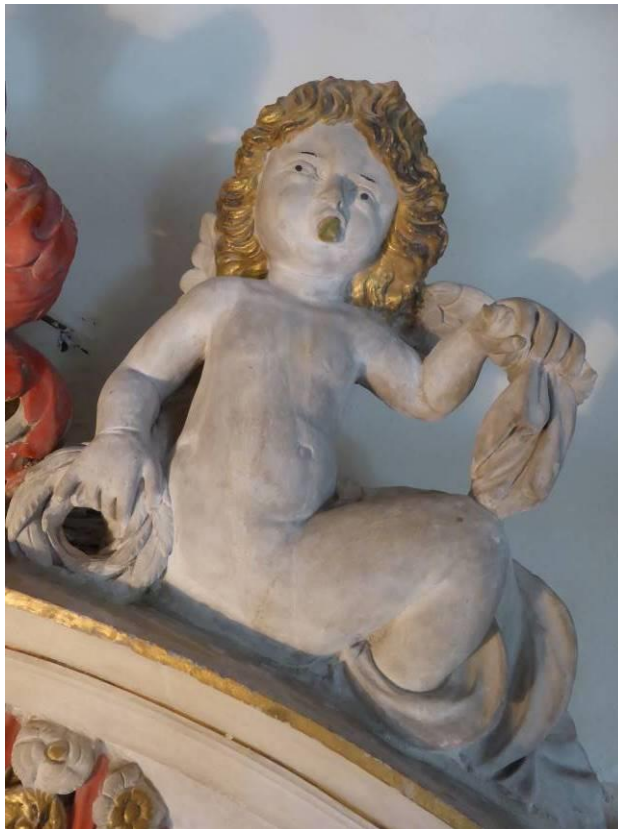
*West and east side cherubs after treatment*

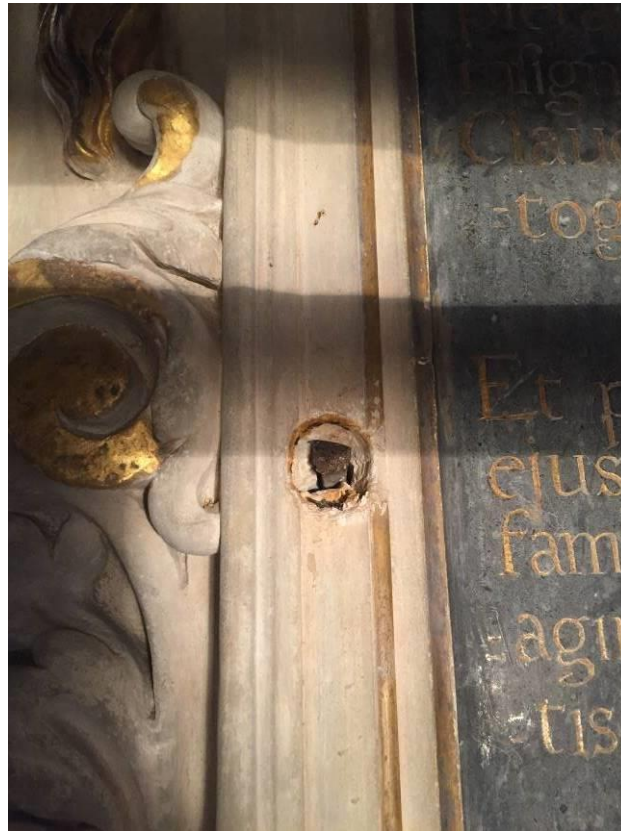
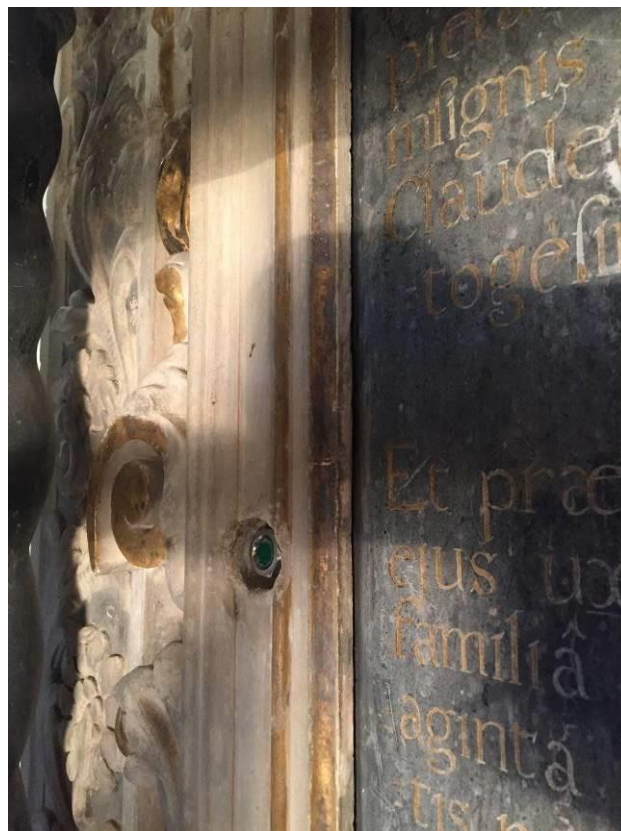
*Fixing to west side of inscription tablet before and after replacing with stainless*

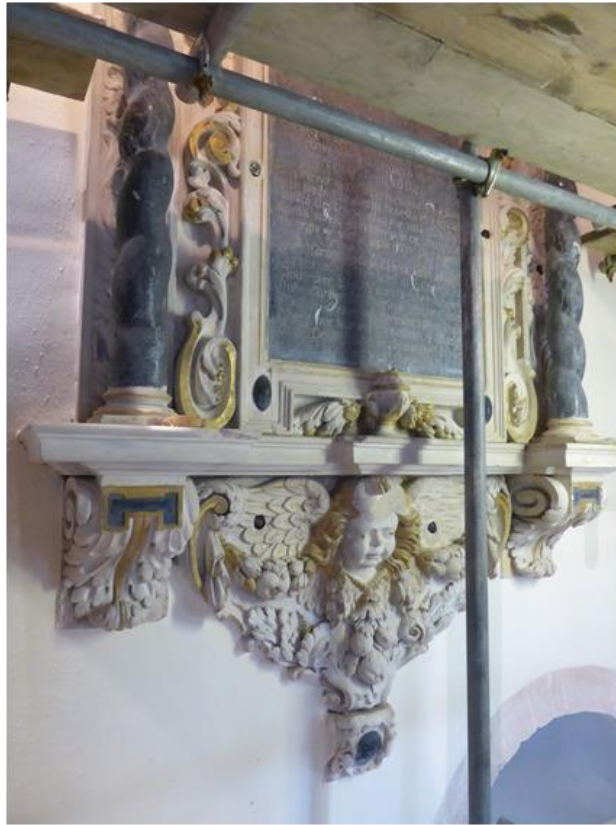
*Lower half of monument with exposed ferrous fixings treated*

The exposed heads of the fixings at lower level; to either side of the central inscription panel, behind the adjacent columns and to either side of the cherubs head on the apron below had loose rust removed, were treated with two coats of Kurust (a proprietary rust treatment) and then painted with Leyland Trade direct to metal paint tinted with earth pigments to match the colour of the stone. One of the fixing heads was found to be sufficiently decayed that it appeared to be no longer effectively restraining the stonework. The fixing was removed with a core drill and replaced with a length of stainless steel studding fitted with a hex nut.

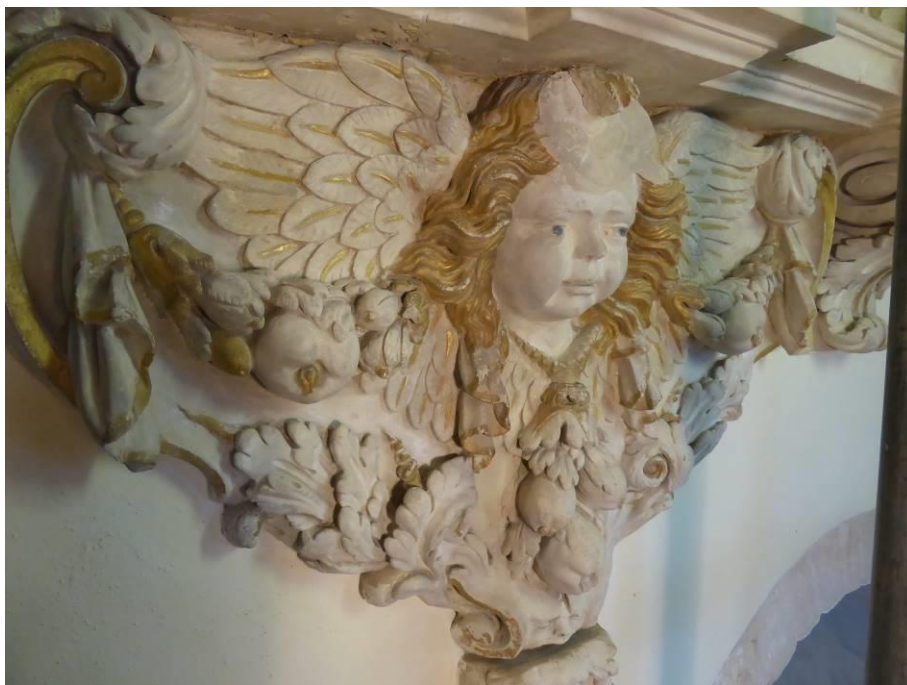
*Capping repairs over apron fixings and removal of fixing to cherub head*

Capping fills were made over each of the fixings with the following mortar:

The exposed ferrous dowel in the top of the cherubs head of the monument apron was removed and the fragment of stone it supported reset with a new internal stainless steel dowel support fixed with polyester resin (General).

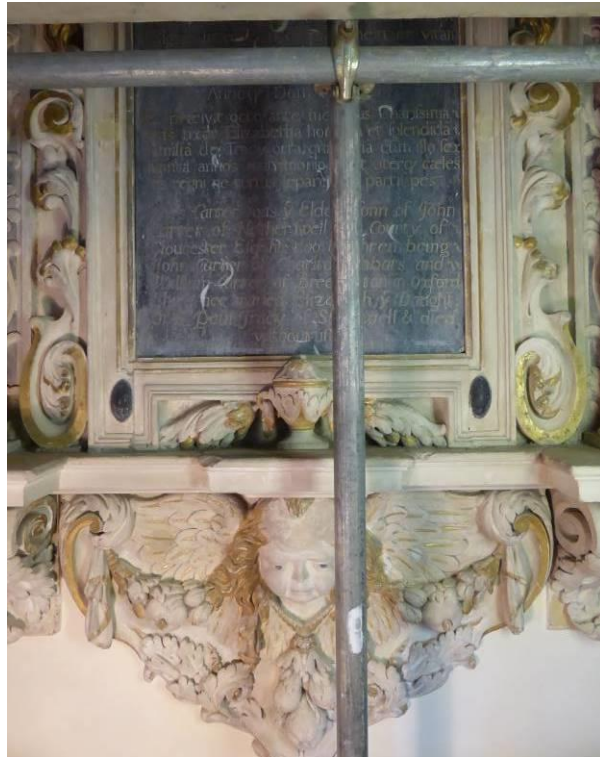
*Lower half of monument after treatment*

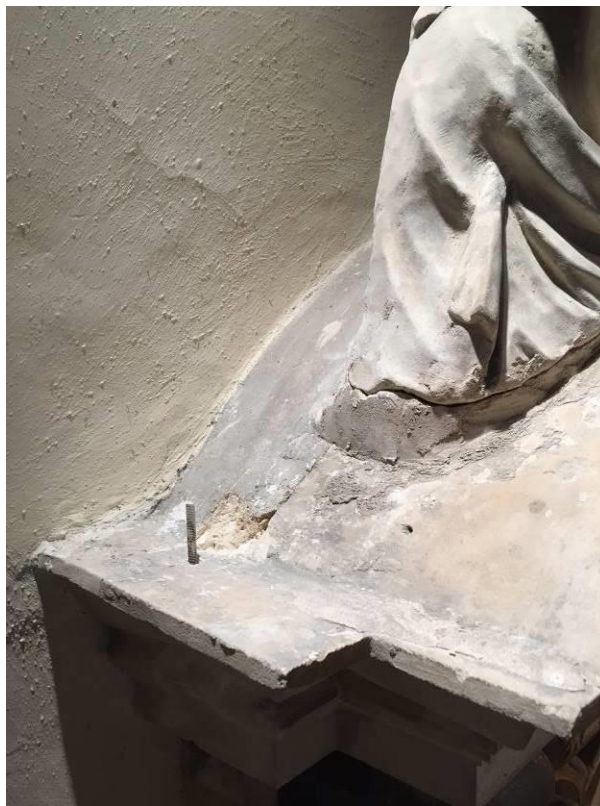
*Fixing for west side flame finial*

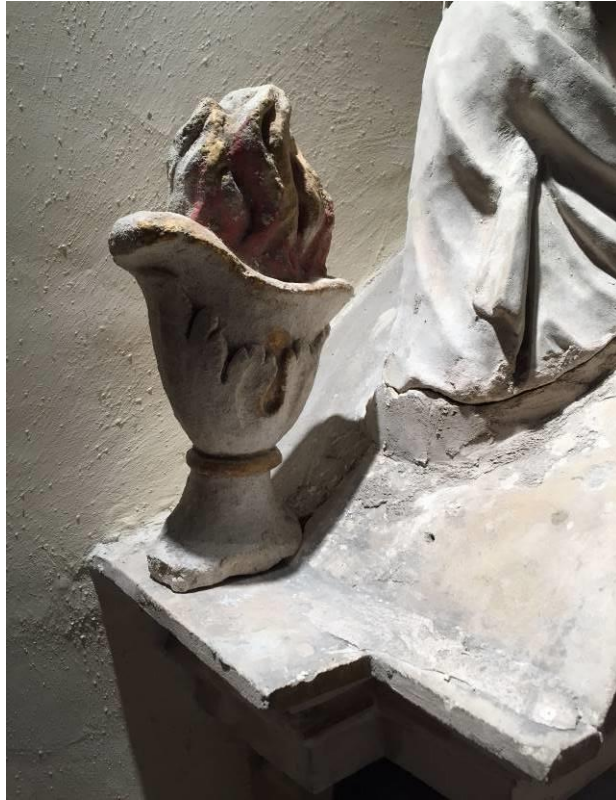
*West side flame finial*

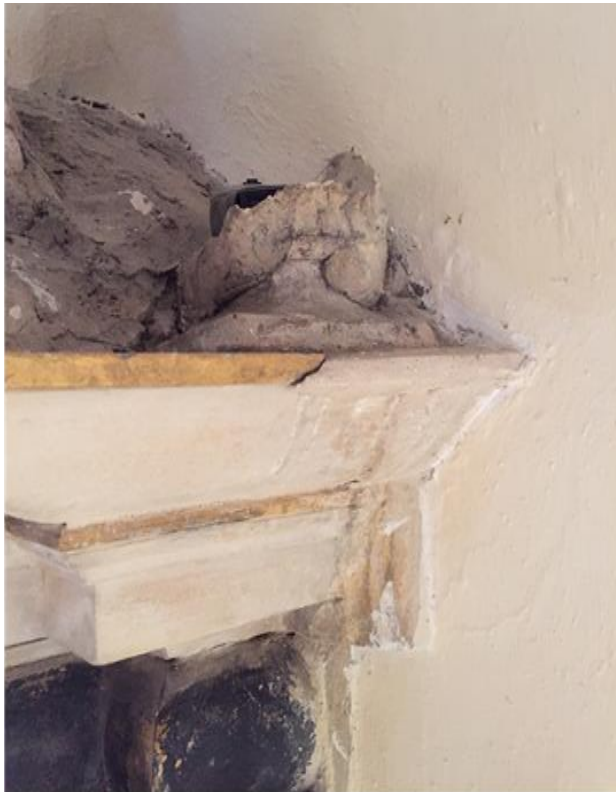
*East side finial socle before treatment*

Following enquiries through the College of Arms and discussion with the client about how to set about relocating the flame finial in possession of the church the decision was taken to locate it on the west side of the monument and carve a new flame/urn to sit on top of the in situ socle on the east side of the pediment. The socle on this die is somewhat smaller than its counterpart and so it was bedded up to give a similar finish level. Both urns were set on dry stainless steel dowels.

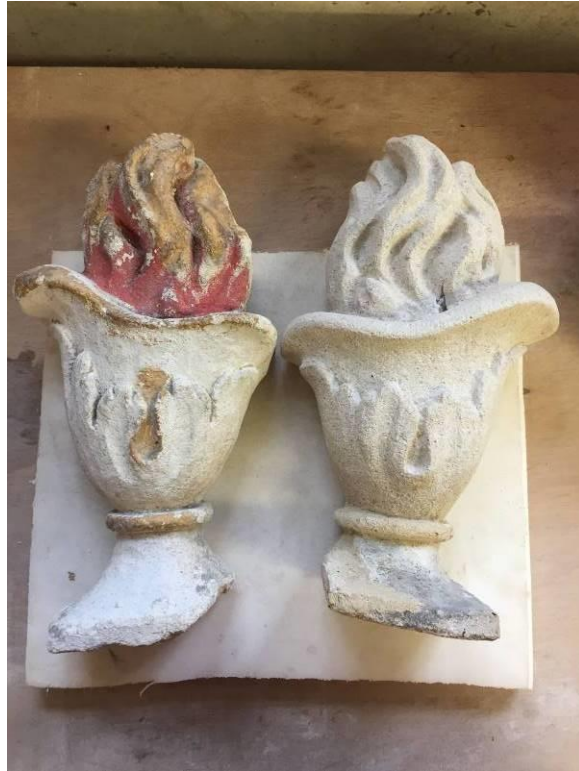
*West side urn and newly carved east side urn on original socle, prior to retouching to match*

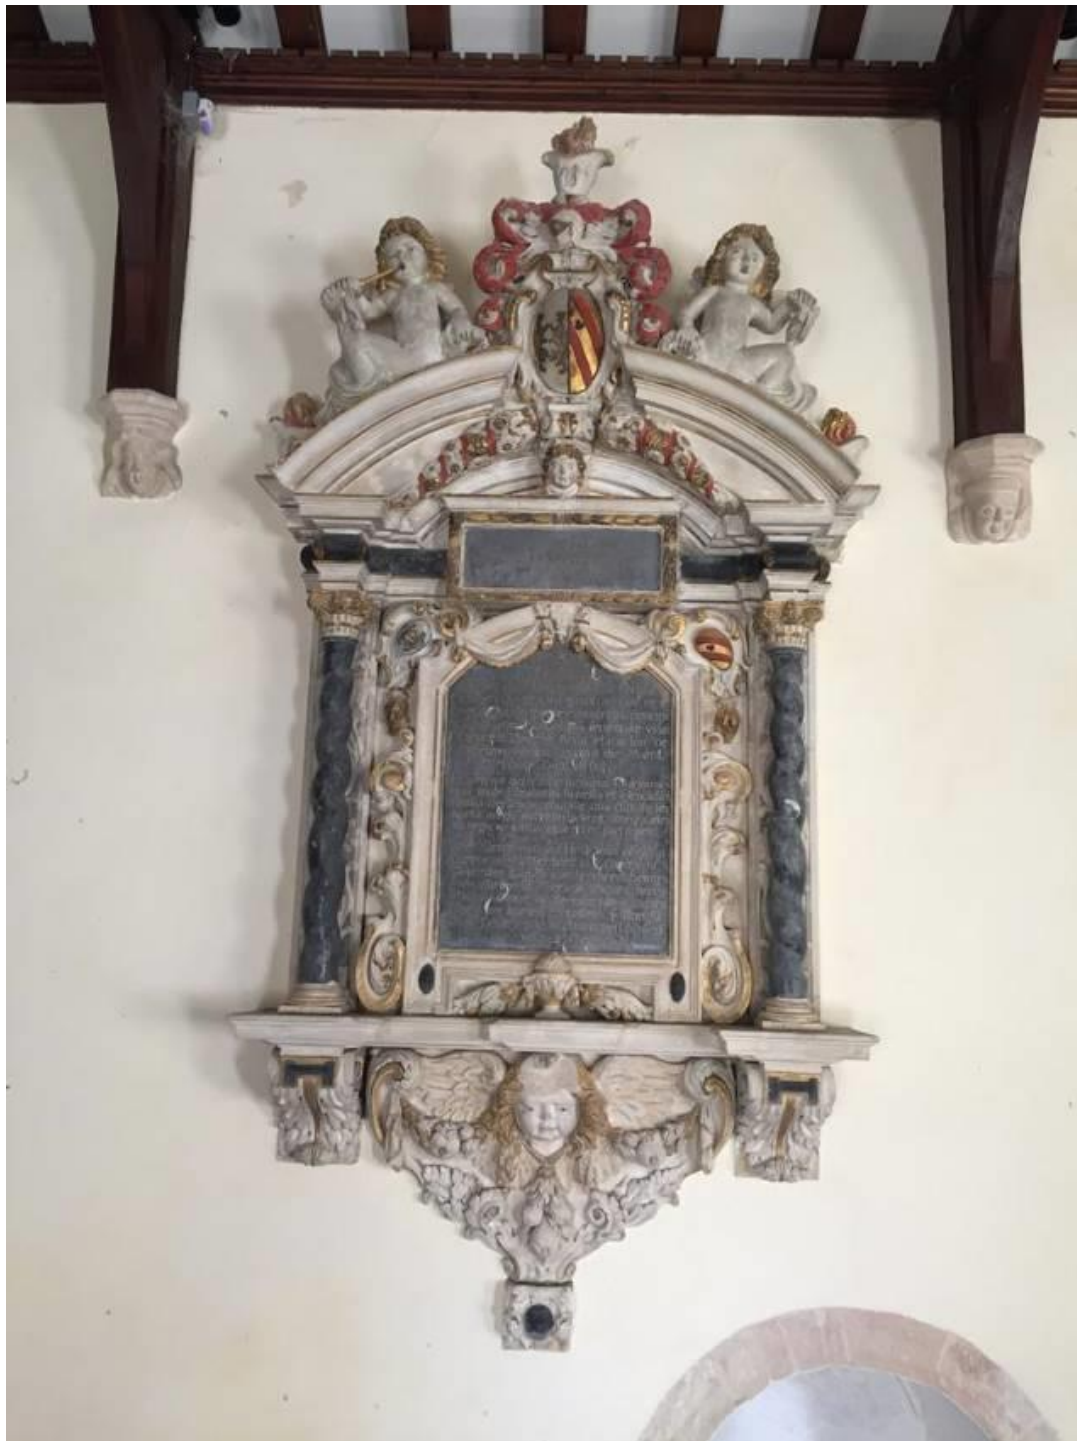
*Monument after treatment*
