**THE BLESSED VIRGIN MARY CHURCH, CLOFORD SOMERSET**

**Post Treatment Report for  
The Conservation of The Horner monument  
The Blessed Virgin Mary Church, Cloford, Somerset**

**Job No. 2601**

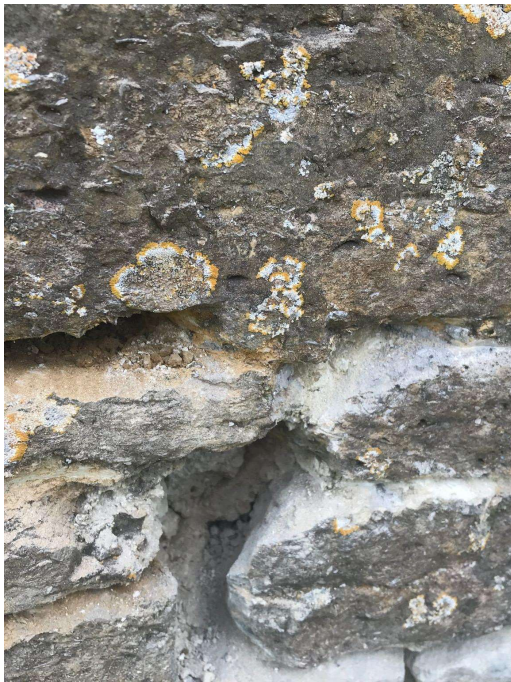
Figure 2 Image to show hard cementitious mortar to the right and softer lime mortar to the left.

Following the removal of the historic mortars, the walls were prepared for the application of a lime mortar, any fragmented or damaged stones were replaced, and the chapel was repointed with a 1:3 lime/sand mix and tended accordingly.

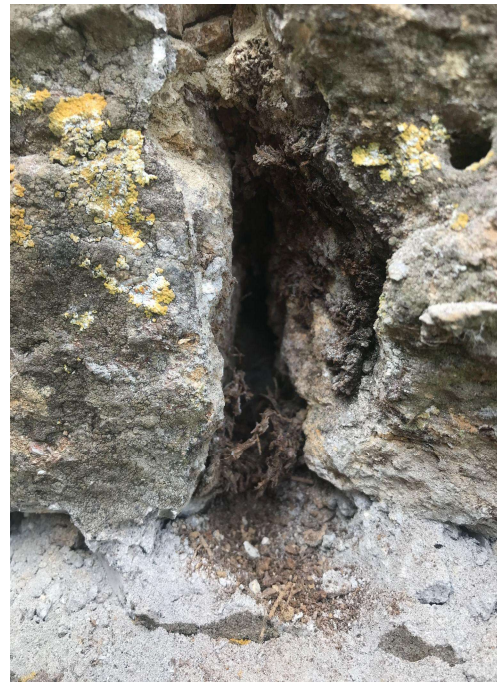
Figure 3 Image to show soil and root matter.

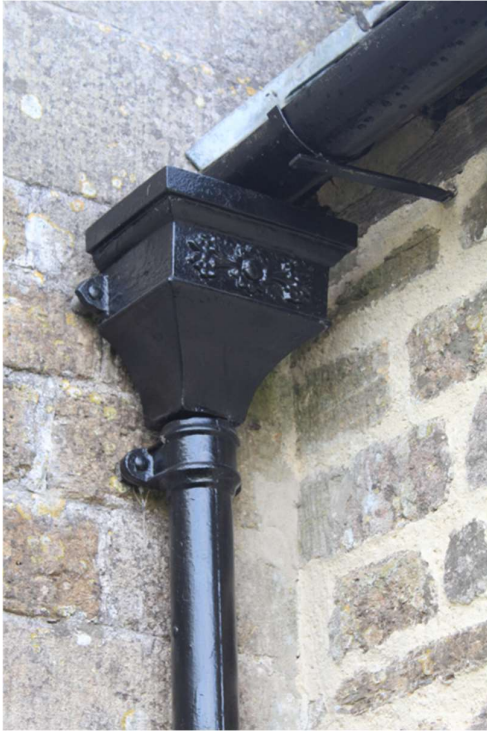
Figure 12 Painted rainwater goods

All the water goods connected to the Horner Chapel were redecorated. The existing paint was sanded down and cleaned before two coats of black metal paint were applied (specialised paint which was designed to be a primer/undercoat and topcoat in one. Brand – Rust-Oleum Industrial).

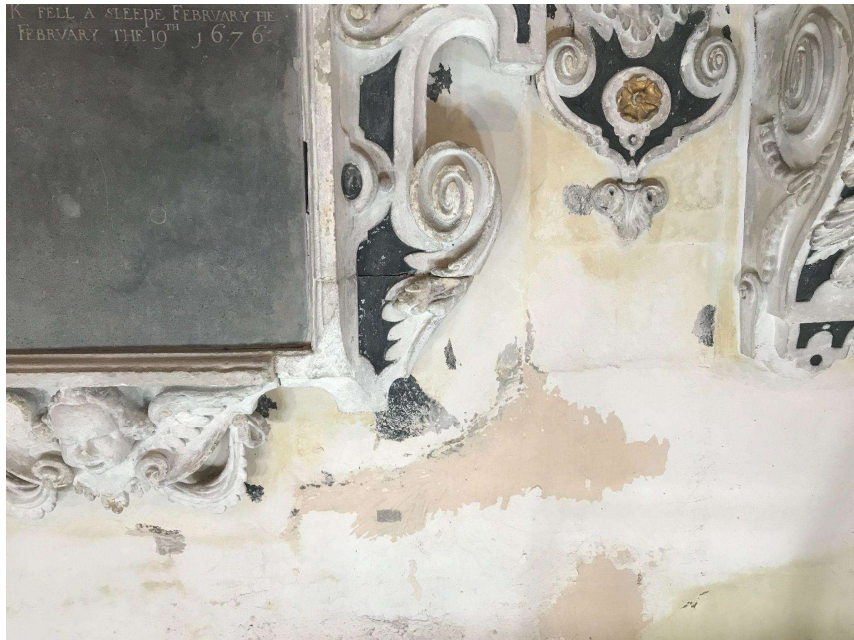
bands to the lower edges of the Sir George and Lady Anne Horner monument; these were of historic significance and therefore, to be retained. This retention of historic plaster now made the original recommendation to install an air gap around the monument moot.

Figure 3 Image to show evidence of mourning bands around the lower section of the monument.

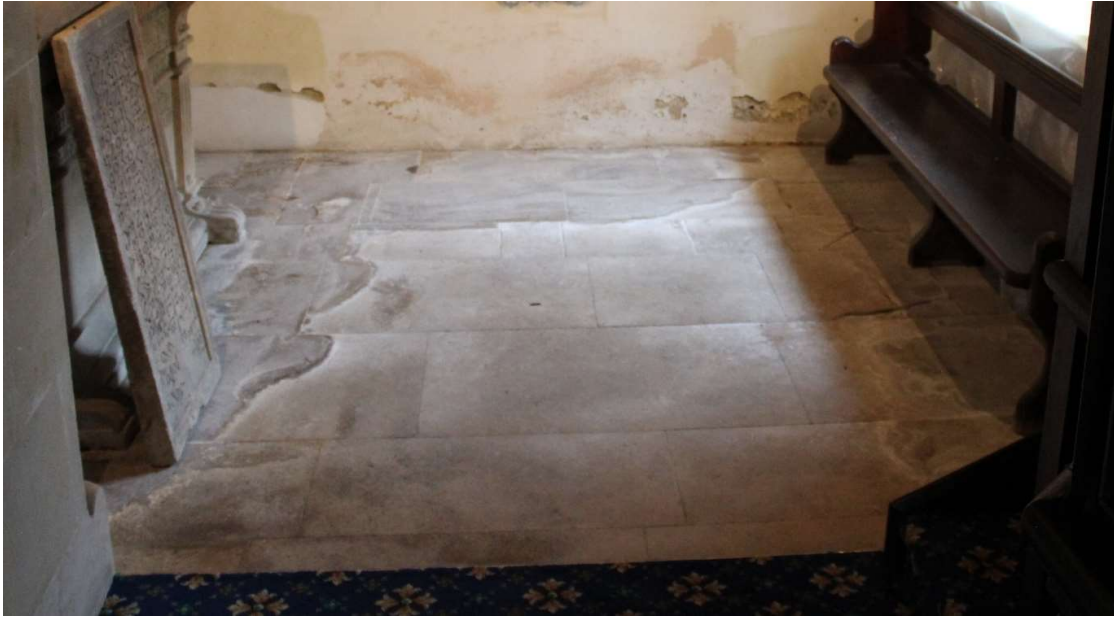
Note, the initial white bloom of salts on the floor is a reaction to both the carpet being lifted and the cleaning. Over time the bloom will fade. The dark stains contained in the surface should also subside in time as the chapel dries out, they will not disappear fully but should reduce in intensity.

Figure 15 Horner Chapel floor before cleaning

The stone floor was cleaned, and two flagstones beneath the window had the cement removed from their cracks and replaced with colour matched lime mortar.

The cleaning solution was 50% Acetone, 25% Clear spirit and 25% Deionized water.

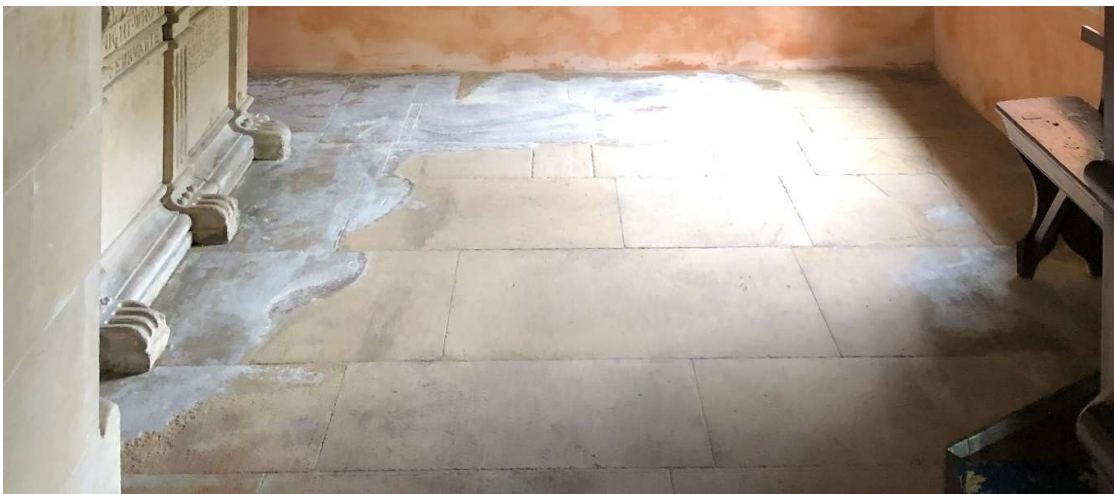
Figure 16 Horner Chapel floor after cleaning

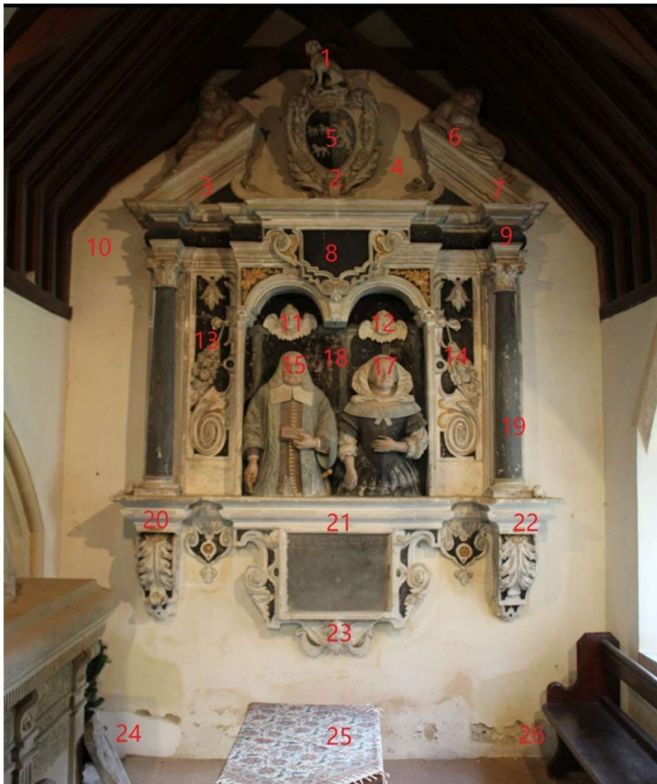
Figure 17 Surface Moisture readings on North Chapel Wall & Monument

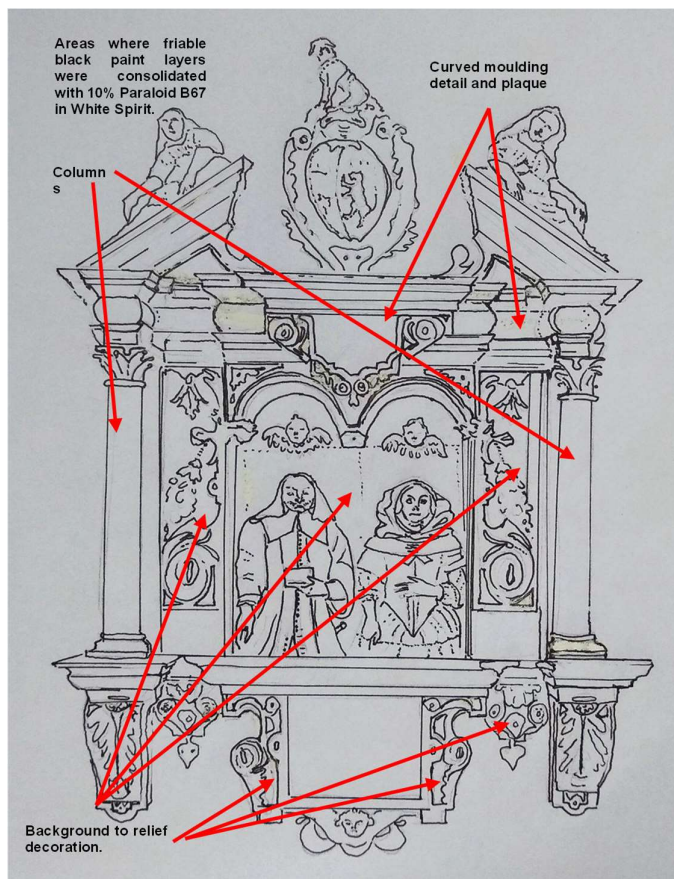
Figure 18 Diagram to show where friable black paint layers were consolidated.

Initial trials for paint consolidation as documented in 'The 2022 SSHC Evaluation of Trials and Proposed Treatment programme, The Horner Monument Cloford Church', Section 3: Consolidation and Touching In Trials, recommended the application of a solution of Tri-Funori in deionised water, unfortunately, these trials were found to be inadequate when re-visited. It was therefore determined a stronger approach was required to ensure a longer lasting finish. The original binding material within the black paint had dissipated, leaving the black pigment powdery, detached, and fragile. It was concluded that a new binder needed to be introduced, this would minimise the loss of original pigments and in turn reduce the need to introduce another paint layer to any areas of loss. Paint analysis indicated that this black paint layer could be original, (The C940 Paint Analysis report by C. Hassall, May 2022). Further consolidation trials using Paraloid B67 in white spirit proved effective, this medium provided a stronger binder for the original pigments and could be readily adjusted to achieve the desired surface finish, whilst also being quick drying and reversible. The application of 10% Paraloid B67 in White Spirit was successfully applied by a brush, gentle sweeping motions helped to work the loose pigments into the new binder thus helping to unify the overall colour and finish. This method was used on all the black surfaces as these were considered the most friable.

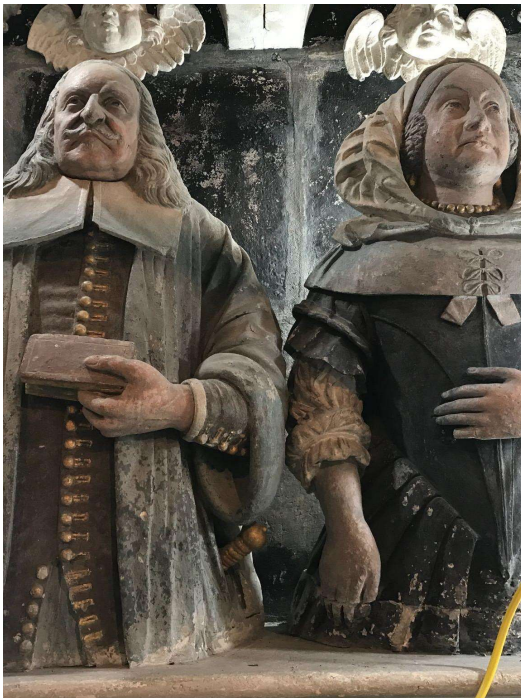
When assessing the overall appearance of The Sir George and Lady Horner Monument, it was concluded that the flaky heavy grey overpaint detracted from the softer more refined painted details seen on the monument and due to its instability, there were extensive areas of loss which in turn lead to a disparity in the readability of the monument. It was however part of the monument's history and therefore, it was established that some areas would be removed whilst other areas consolidated to regain a sense of balance. Having established a compatible consolidation treatment method for the areas of black paint a similar approach was also trialled for the other painted surfaces. This involved the use of a 10% solution of Paraloid B67 in White Spirit with the addition of a sympathetic pigmented tint that was applied to the scheme being treated to both stabilise and enhance the painted surface.

Figure 21 Figures & background before Consolidation.

The figures were addressed first, the approach taken was as described above, areas of loose heavy overpainting such as the Brown on Sir George's Bible were removed carefully by mechanical means to reveal a red and gilded version, whilst other painted surfaces were consolidated with an appropriately pigment tinted solution of 10% Paraloid B67 in White Spirit, this was particularly effective at unifying the overall appearance of the various green tones seen on Sir George's jacket.

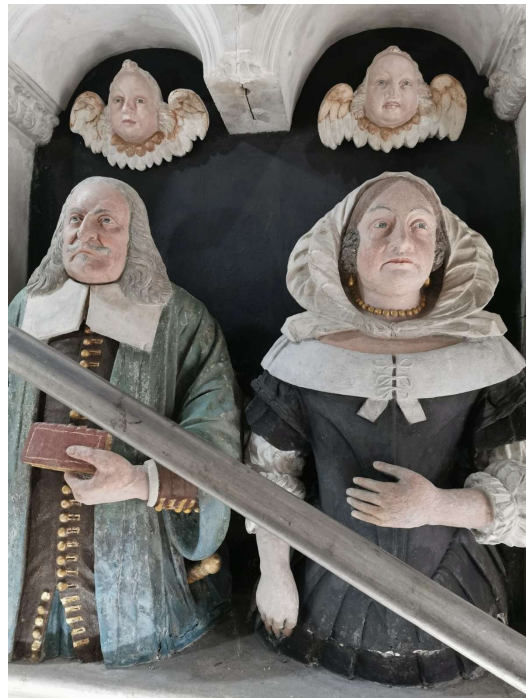
Figure 22 Figures and background after Consolidation.

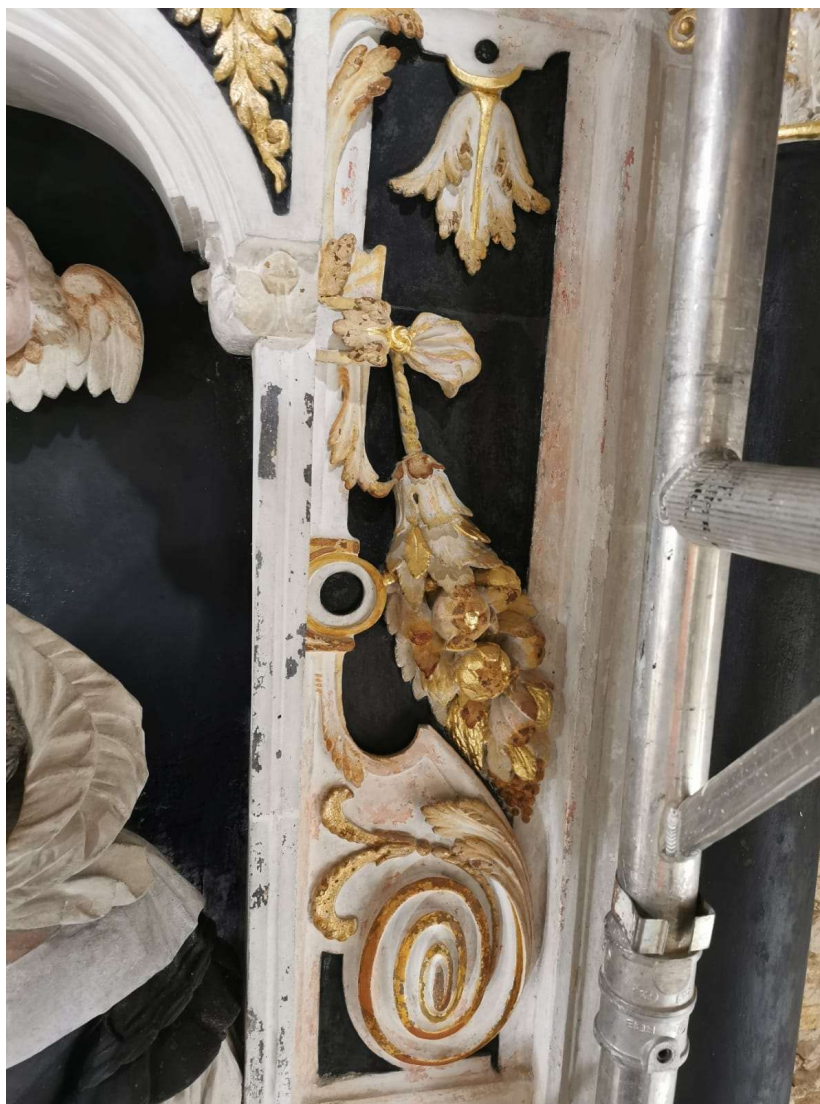
The gilded elements to the monument were key to improving the monuments readability. Unfortunately close inspection revealed that these decorative surfaces were also very fragile and would require a stronger consolidation treatment. Trials proved a solution of 20% Paraloid B67 in white spirit to be effective. Selective areas of decorative detail, mostly to the high relief panels to either side of the main figures, were re-coloured using earth pigments or gilded to honour two different historic paint schemes.

Figure 30 Image to show where a selective approach of re-gilding and in-painting was applied to improve the readability of the decorative elements

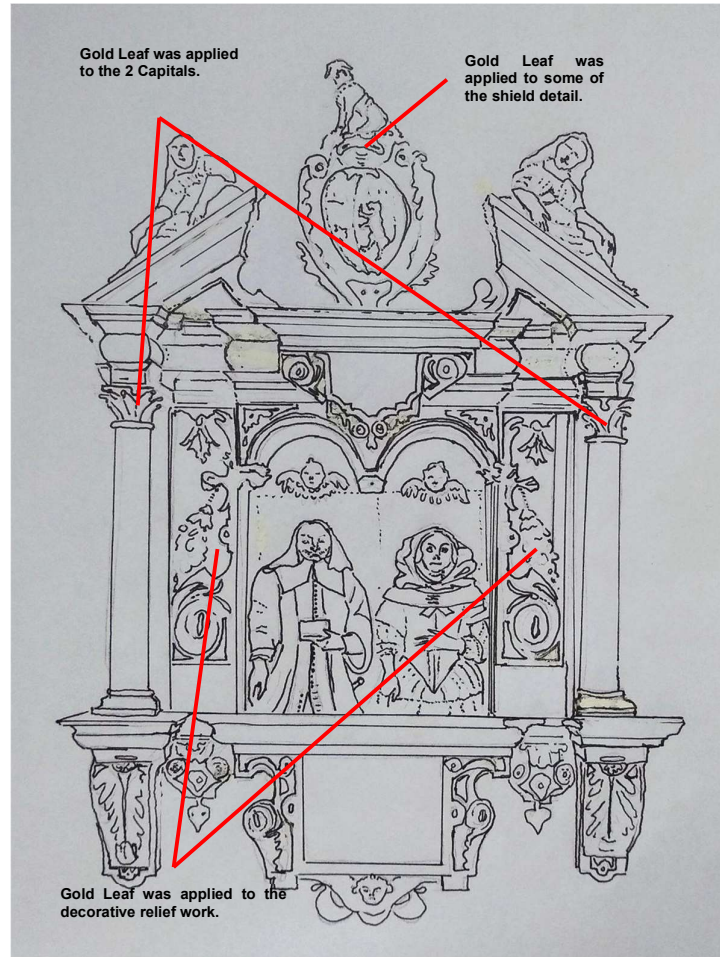
Figure 31 Image to show where the new gold leaf was applied

Paint analysis (The C940 Paint Analysis report by C. Hassall, May 2022) revealed that Silver gilt was present in samples 4.1, 4.2, 4.7 and 4.10. Here silver leaf was laid directly on top of the buff-coloured undercoat (In the 17<sup>th</sup> and 18<sup>th</sup> centuries oil gilding involved laying the metal foils onto oil paint that was tacky, rather than the use of size) and a glaze or varnish was then applied over the silver to enhance its colour and even mimic gold. Where there was evidence of silver gilt the decorative elements were dark in appearance and could only be seen where there were areas of loss to the grey overpaint. Where the grey overpaint was sound, pigments bound in Paraloid B67 and white spirit were applied on top of the paint to emulate the appearance of the silver gilt to enhance the overall readability of the monument, (see figure 11).

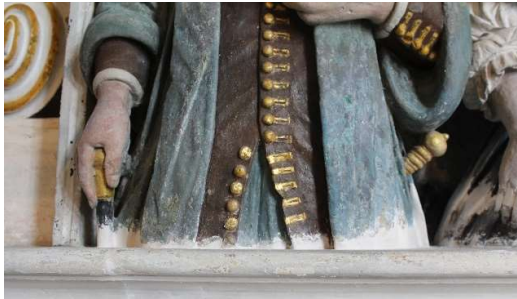
Figure 34 The base of Lord Horner's coat and walking cane during repairs

- Lord Horner Repairs:  
Where missing, extending both coat and walking-cane to join the main mantle; making good some previous repairs also along this join.
- Lady Anne Repairs:  
The repairs were carried out to both the base join with the mantle and to the join in the carved figure (running at the same height as her lower hand). This involved moving the upper part of the figure to align the hand and dress as near as possible. Old repairs had been carried out to both dress and hand join. The new repairs married up these discrepancies.  
Lady Anne's little finger on her righthand was refixed and the missing end remodelled.

All the repairs to the cornices, figures, and open joints were made with plaster of Paris. The sinister main mantle corner had stainless-steel armatures inserted; with a colour matched lime mortar repair mix the repair was built up in two coats to full profile. The new sinister corbel leaf was carved out of Bath stone.

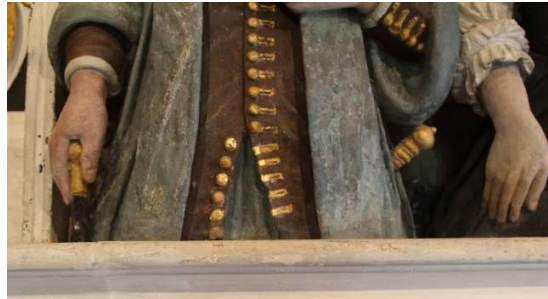
Figure 35 The base of Lord Horner's coat and walking cane after repairs

The repairs to the figures were painted to match its corresponding setting. The cornice, new pointing and some previous repairs were then toned in. The new leaf carving was given two washes of white limewash.

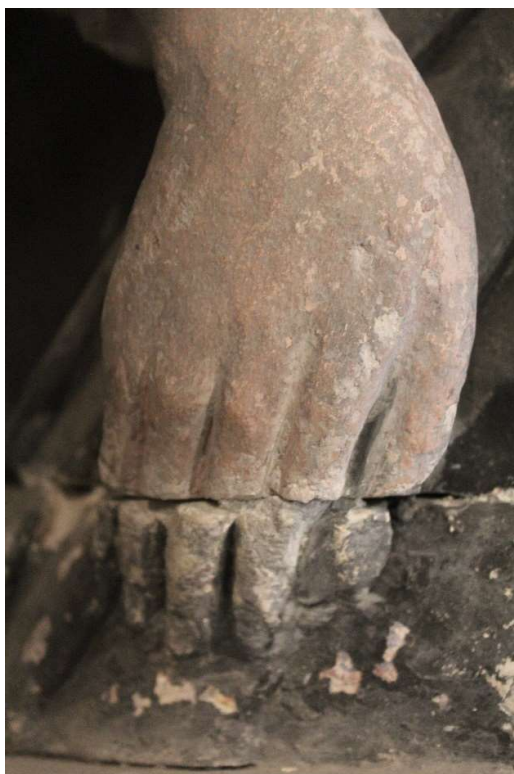
Figure 36 Lady Anne's right hand before conservation work

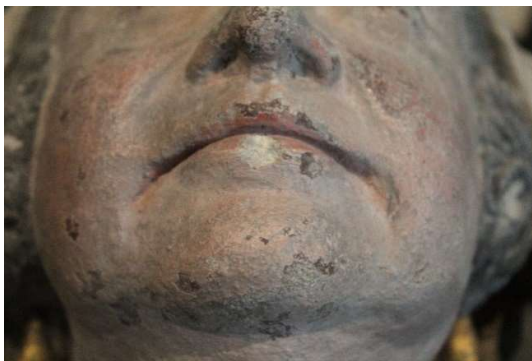
Figure 39 Lady Anne's Lip before repair and painting

- A single small repair was carried out to Lady Anne's bottom lip
- Various open joints and tidying up of previous repairs across the whole monument.
  - The cornice was damaged along the top edge and corners, these were repaired and toned in, (illustrations for these can be found in the 'Additional Works' section)
  - Sinister corbel leaf, the leaf on this corbel was missing and no longer on site. A decision was made to hand carve a new leaf as this section was noticeably missing as works progressed. The new leaf was made from stone as it is in a vulnerable position.
  - Sinister main mantle and far sinister mantle damaged corners

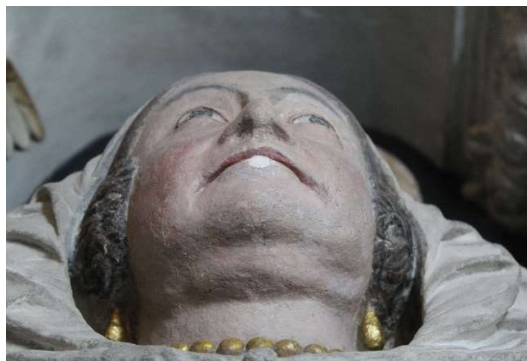
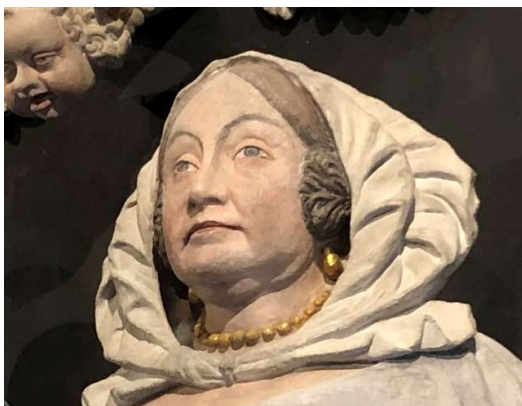
Figure 40 Lady Anne's Lip during repair and painting

Figure 41 Lady Anne's Lip after repair and painting

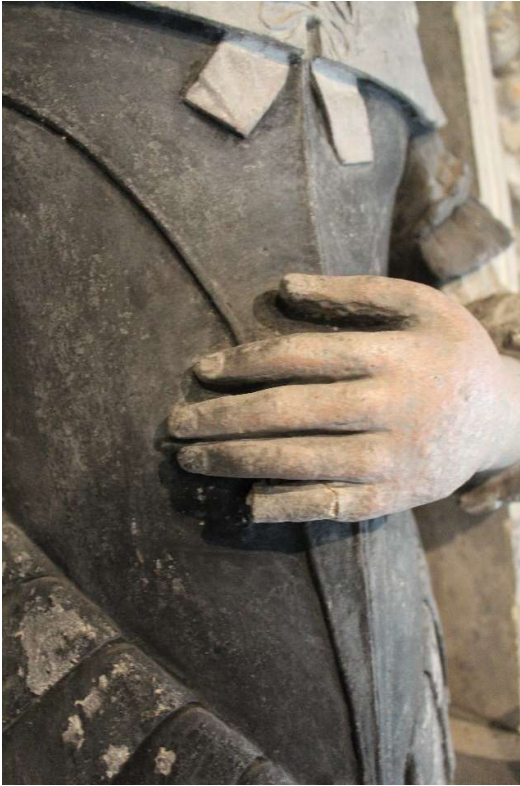
Figure 42 Lady Anne's little finger before repairs

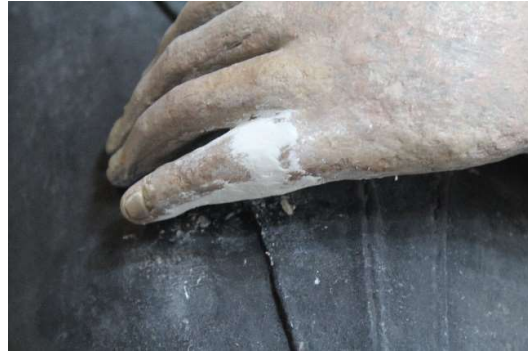
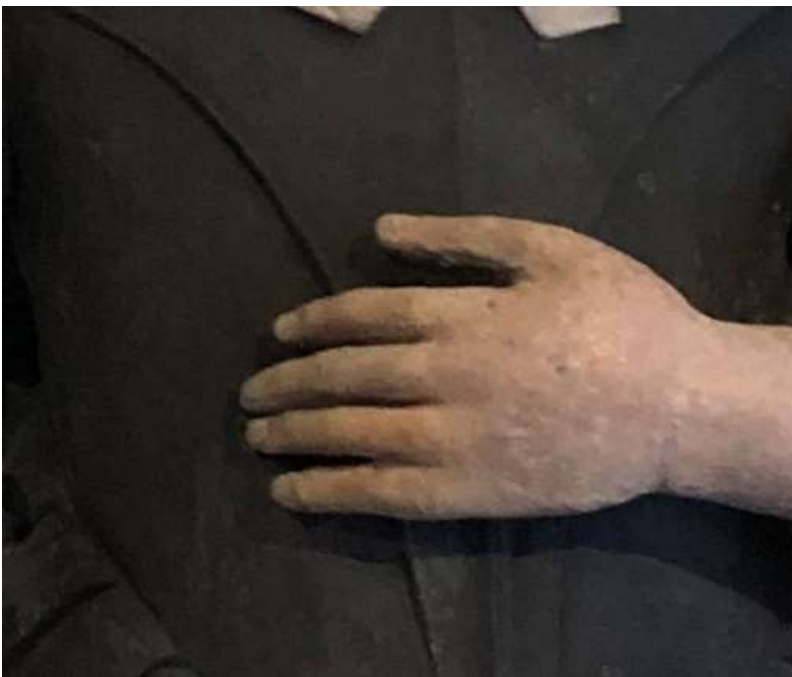
Figure 43 Lady Anne's little finger during repairs

Figure 44 Lady Anne's little finger after repairs and painting

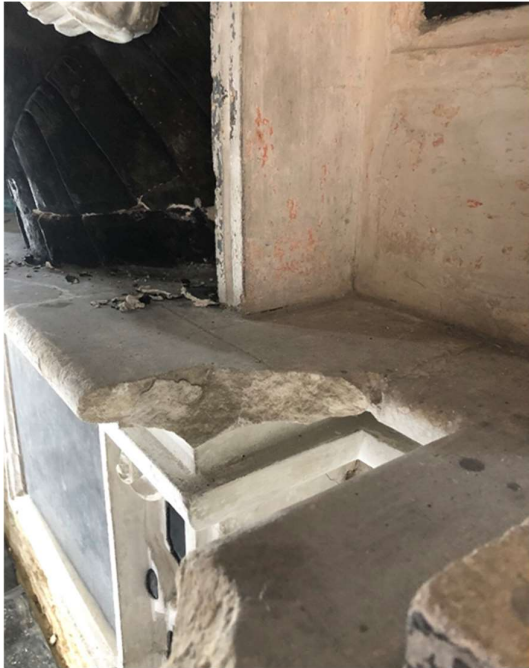
Figure 45 Missing sinister section of main mantle

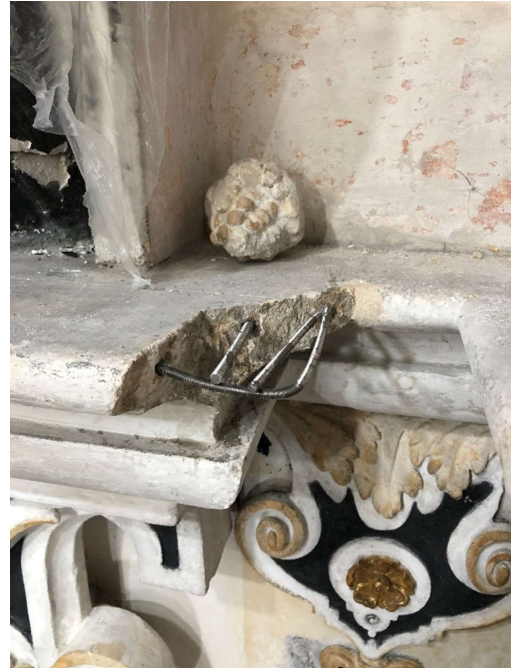
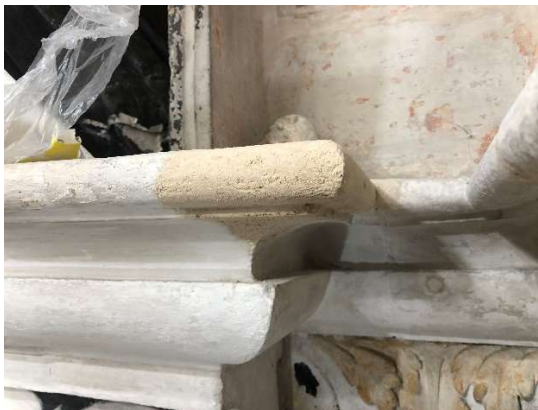
Figure 46 The stainless-steel armatures being installed to the sinister main mantle

Figure 47 Completed repair to the sinister main mantle

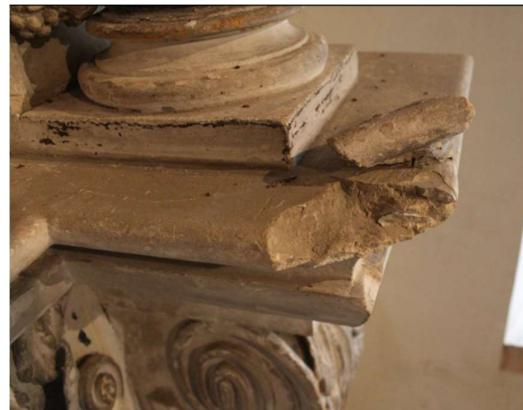
Figure 48 Missing section before repair to the far sinister mantle

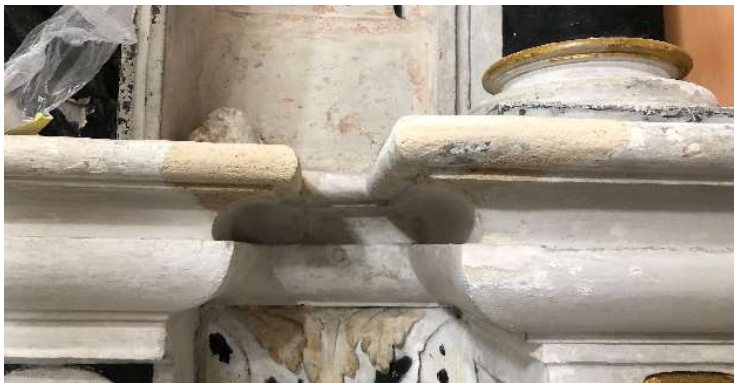
Figure 49 Completed repairs to the mantle

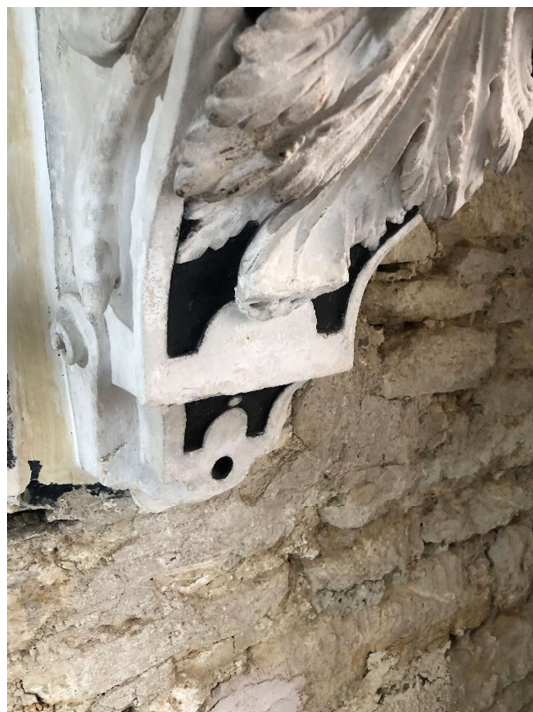
Figure 51 Missing leaf on sinister corbel

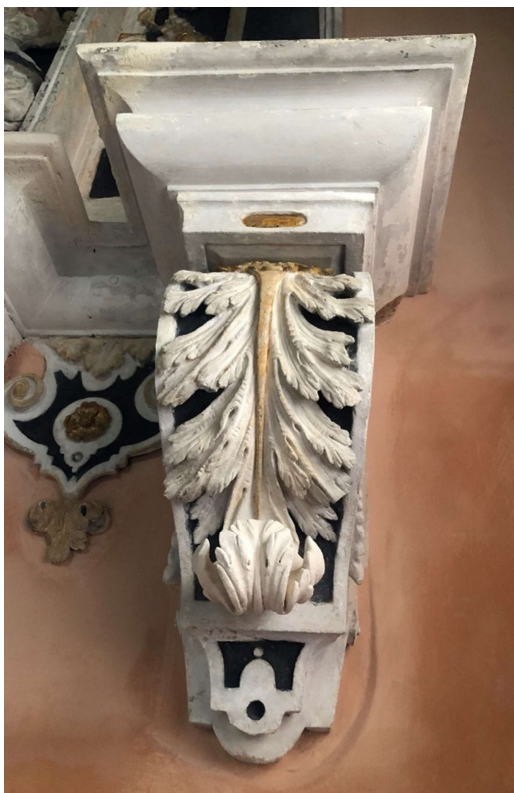
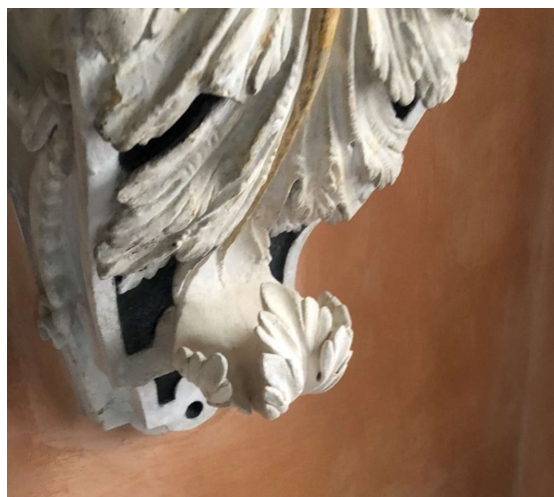
Figure 52 New carved leaf on the sinister corbel (face on)

Figure 53 New carved leaf on the sinister corbel (looking north-west)

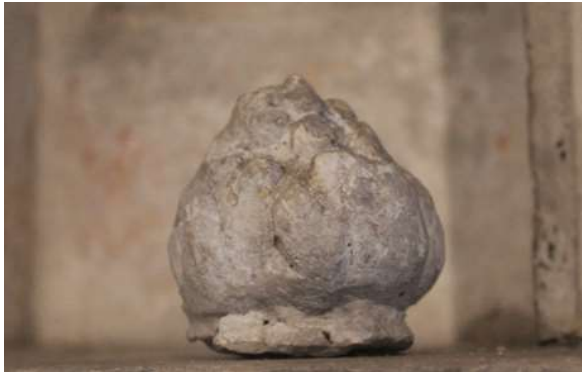
Figure 54 First grape and leaf embellishment loose on monument

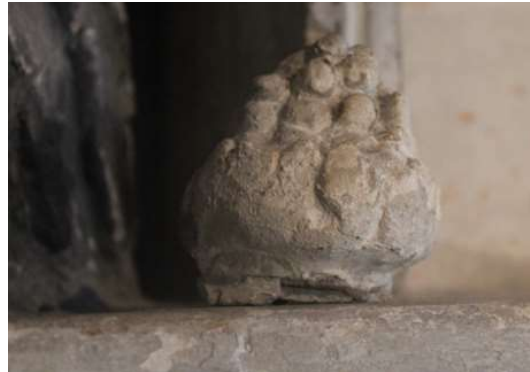
Figure 55 Second grape and leaf embellishment loose on monument

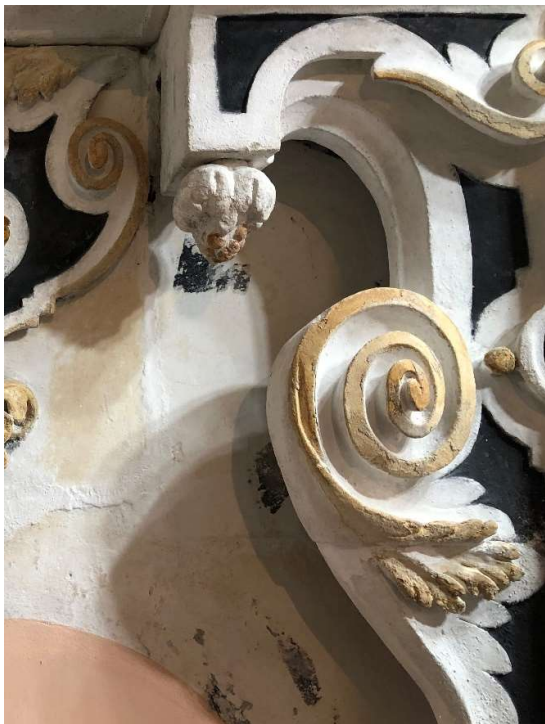
Figure 56 Dexter grape and leaf embellishment fixed in place

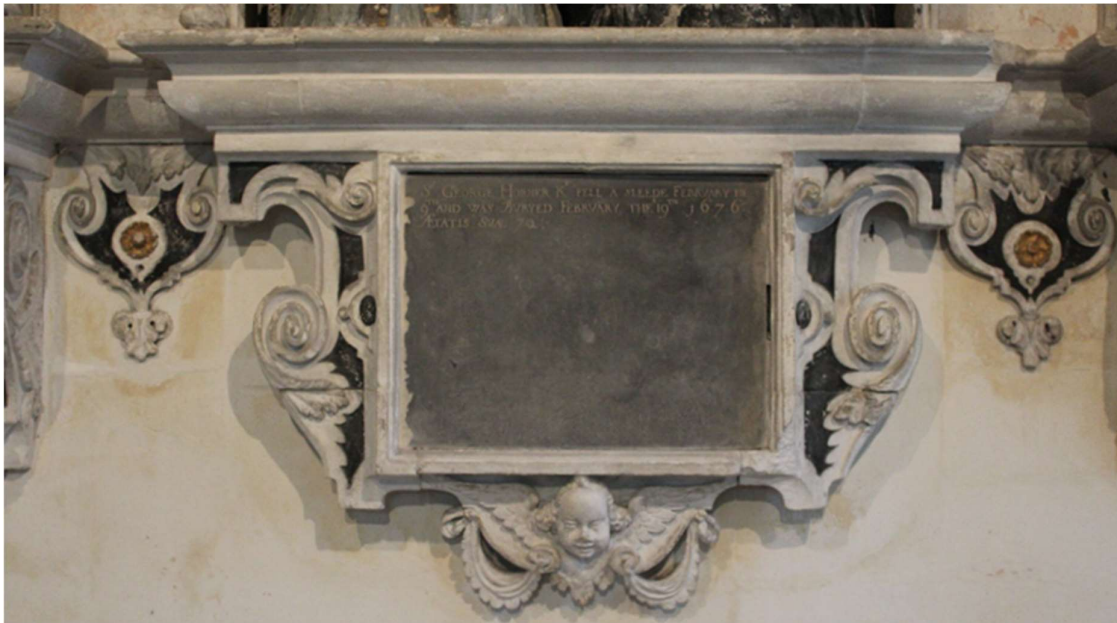
Figure 58 Monument with the missing grape and leaf embellishments

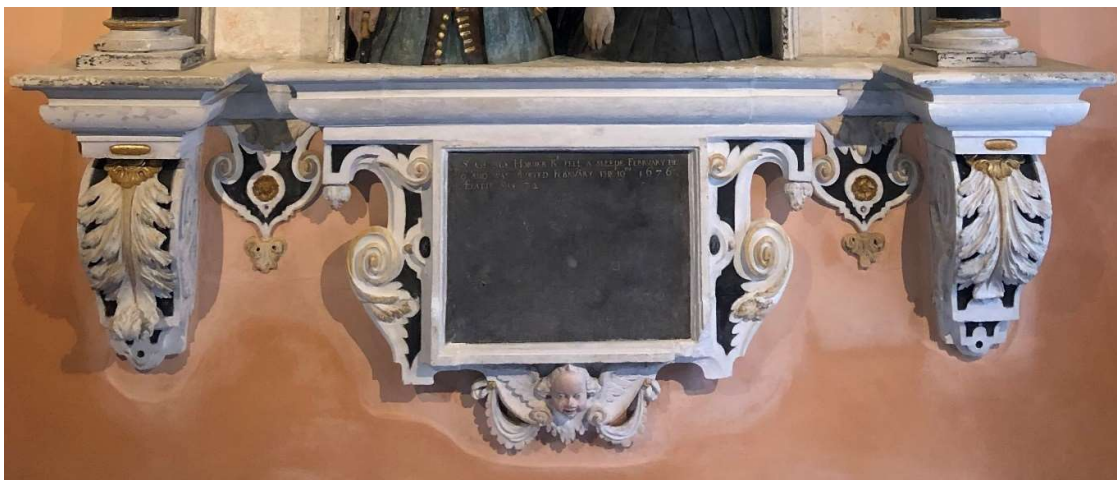
Figure 59 Finished monument with the grape and leaf embellishments in place

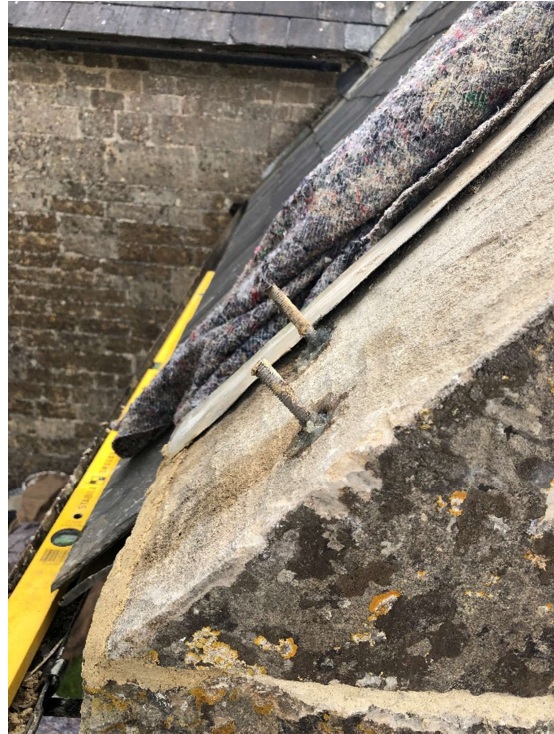
Figure 72 The new stainless-steel pins fitted

As an alternative to replacing the current kneeler coping with a longer stone - costs, lead time for cutting and looking out of balance with the north-west kneeler were considered. The need to replace the mortar bed and iron fixings to the coping necessitated it being lifted. This would then allow a lead tray to be fitted to the underside bottom edge of the coping. Two more copings above the kneeler were found not to have a sufficient mortar bed. They were taken off and re-bedded after first installing stainless-steel pins and a new mortar bed to the kneeler/coping.

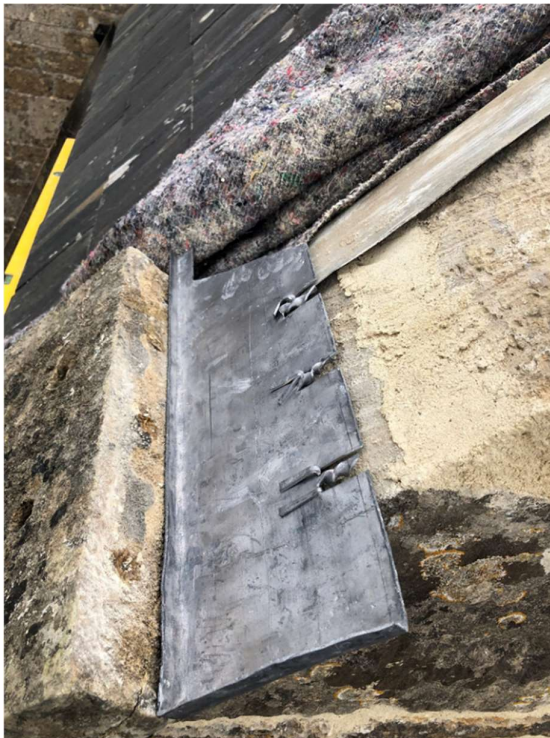
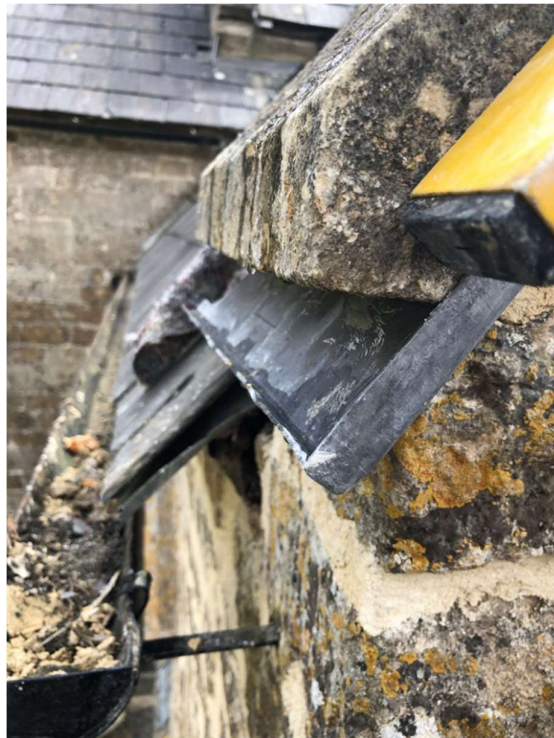
Figure 73 The lead tray before fitting

Figure 74 Lead tray fitted and being tested

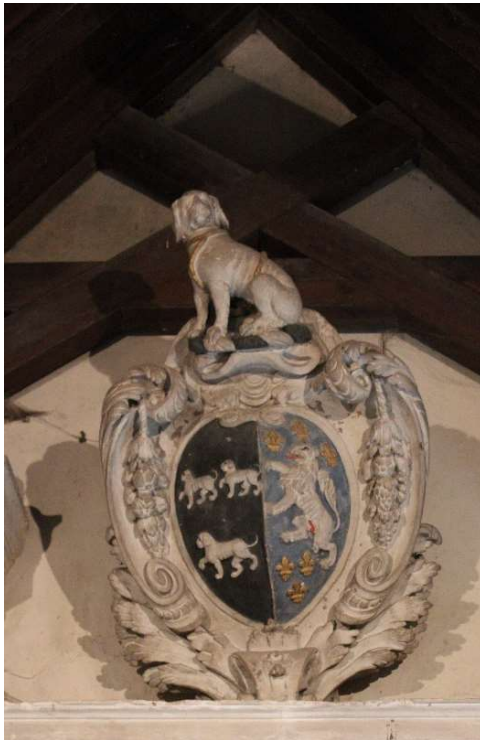
The crest at the top of the monument was not aligned with the monument beneath. This was because when it was rebuilt, the iron stay holding the crest was fixed into the rafters and was set to be central to the roof. The foot of the crest however was set to the middle of the monument, hence the disparity. To rectify this the iron stay was removed and replaced with two stainless-steel threaded bars; the crest was then aligned to the monument only.

Figure 75 Crest (before straightening)

The crest had two new holes made and then stainless-steel fixings were set in plaster of Paris. The wall also had two new holes drilled, the threaded bar inserted and fixed with anchor resin. All the fixings were designed to be hidden from the viewer at ground level.

Stainless-steel was marine grade 316, diameter of 6mm.

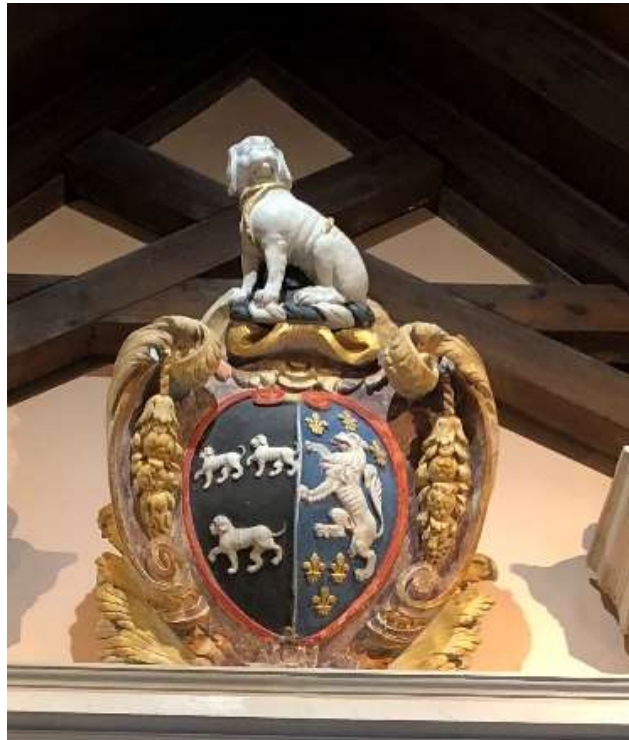
Figure 76 Crest (after straightening)

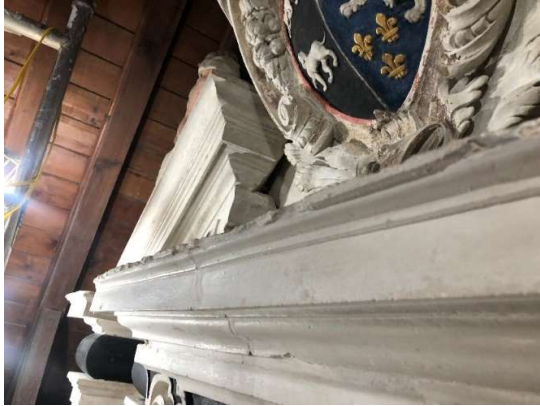
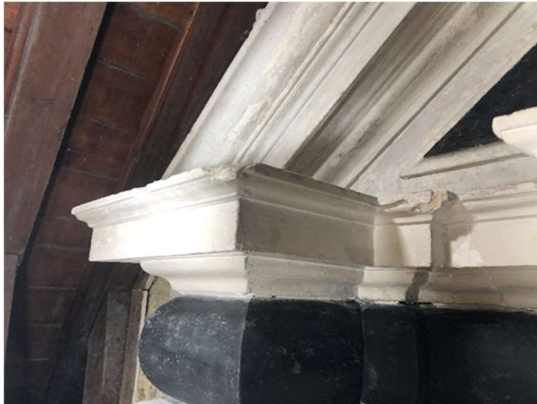
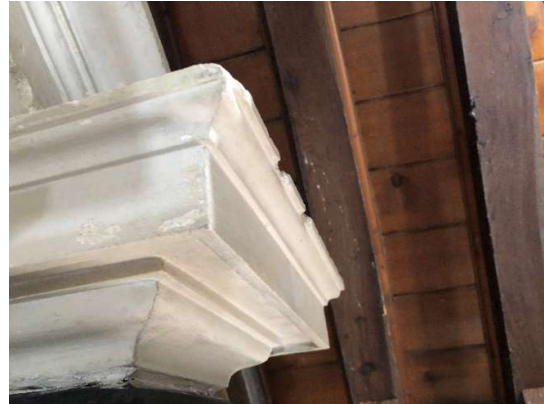
Over time the cornice has succumbed to damage, through rebuilding or ladders being put up against the monument along this edge. The repairs were only small, so armatures were not needed. They were carried out in plaster of Paris.

Figure 77 Central cornice (before repair)

Figure 78 Dexter cornice (before repair)

Figure 79 Sinister cornice (before repair)

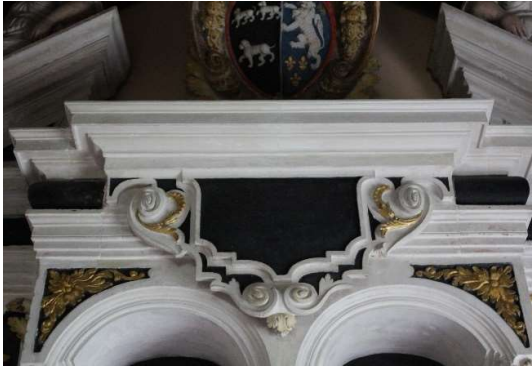
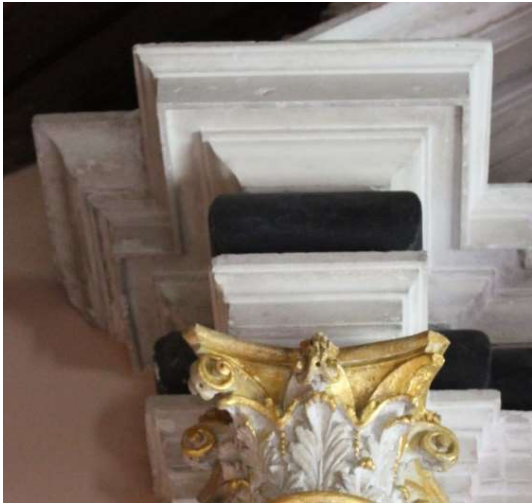
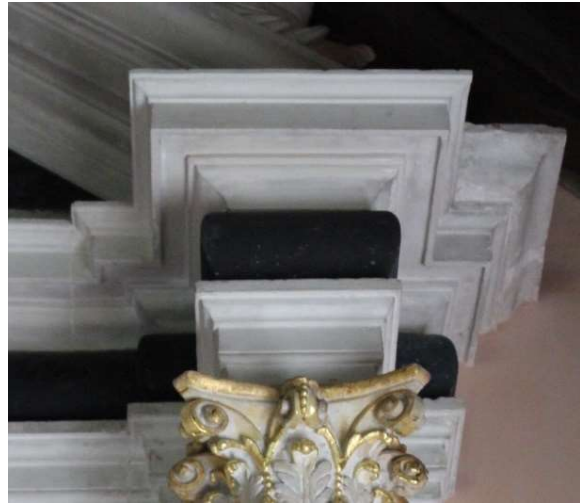
Figure 80 Central cornice (after repair)

Figure 81 Dexter cornice (after repair)

Figure 82 Sinister cornice (after repair)

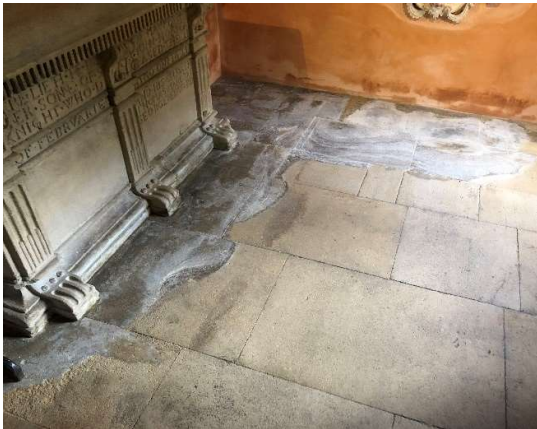
- Moisture levels should be monitored across the interior of the chapel over the coming year, with careful inspection for evidence of further salt efflorescence on all surfaces, including the monuments.
- Currently the salts are moving faster to the surface on both floor and walls; this should calm down and disappear with both regular vacuuming and as the chapel dries out.
- At the end of a one-year period of monitoring, an assessment should be made regarding the condition of the floor and base of the walls.

If the salts and elevated levels of moisture remain, then the ground drainage is not sufficient and further intervention is needed.

Figure 83 Salt formation on the stone floor in the north-west corner; September 2022

As in 'The Condition Survey & Recommendations report 2020,' carried out by SSHC; a French drain was recommended to alleviate this problem, this solution would be recommended again.
