**FINAL ASSESSMENT ON THE DISMATTLEMING OF A
TABLE TOMB WITHIN THE CHURCHYARD OF
ST MARY & ALL SAINTS CHURCH,
HAMPTON LOVETT, WORCESTERSHIRE**

October 2019

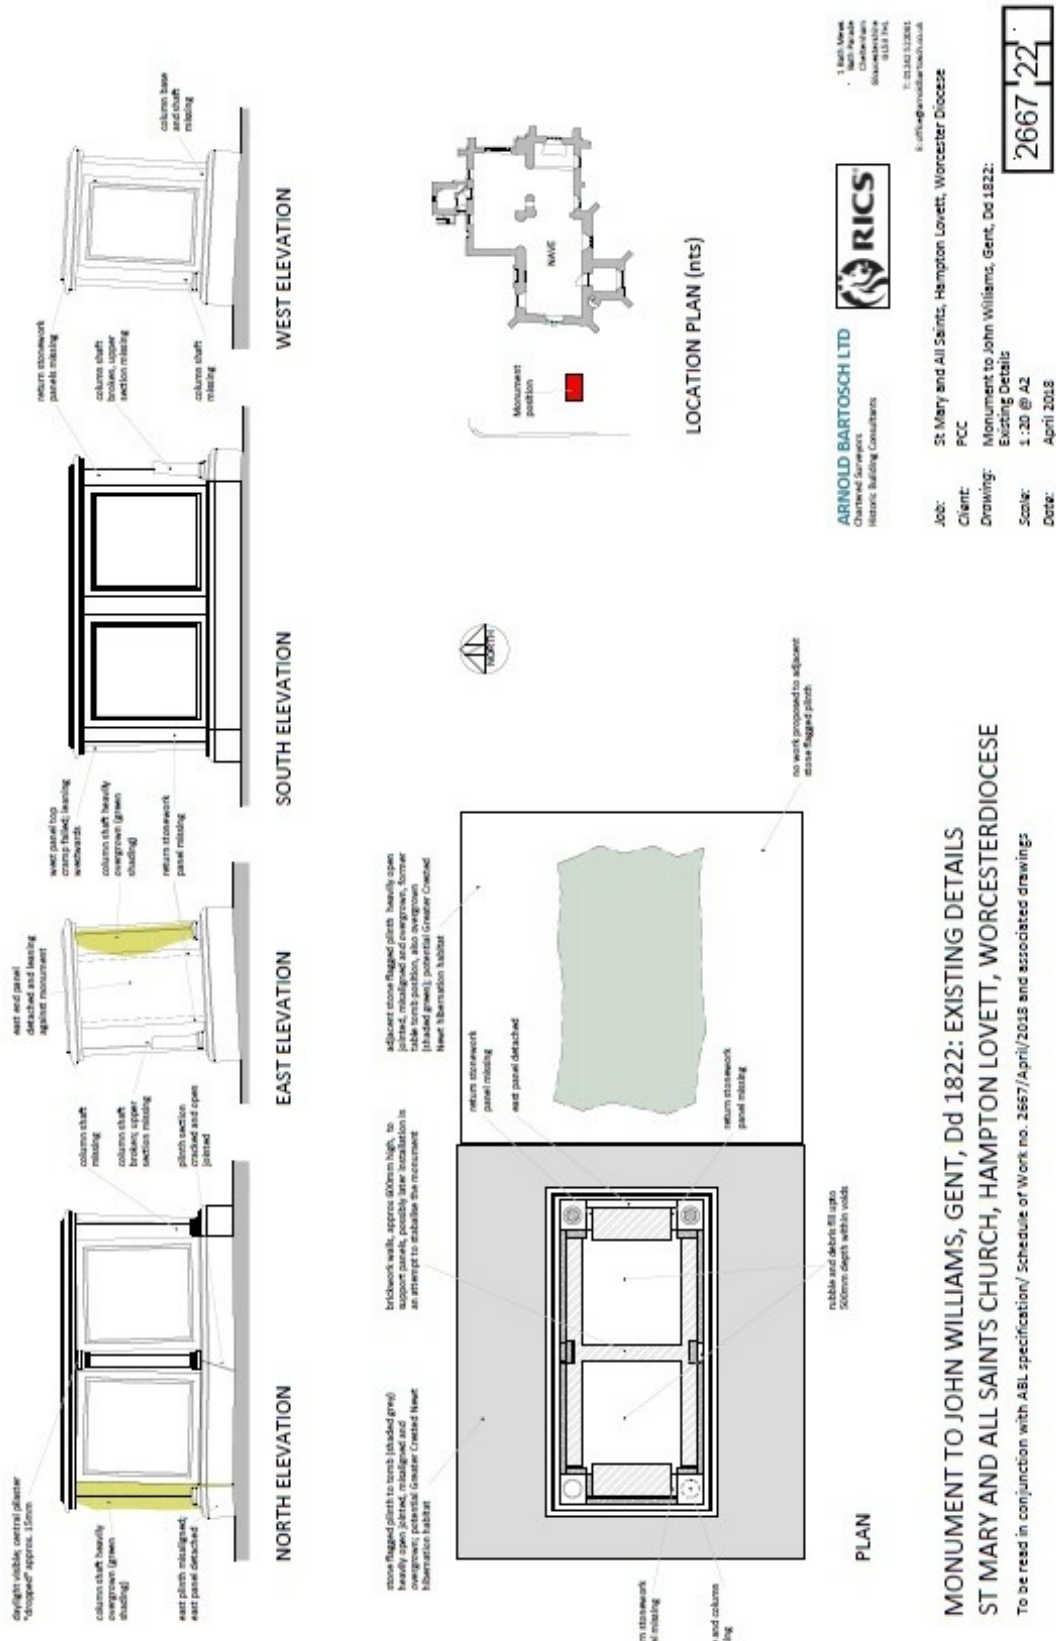
2667_22

Inspection of the table tomb reveals that the monument was in a poor state of repair (see **Figure 3**). The dismantling programme was organised in four stages:

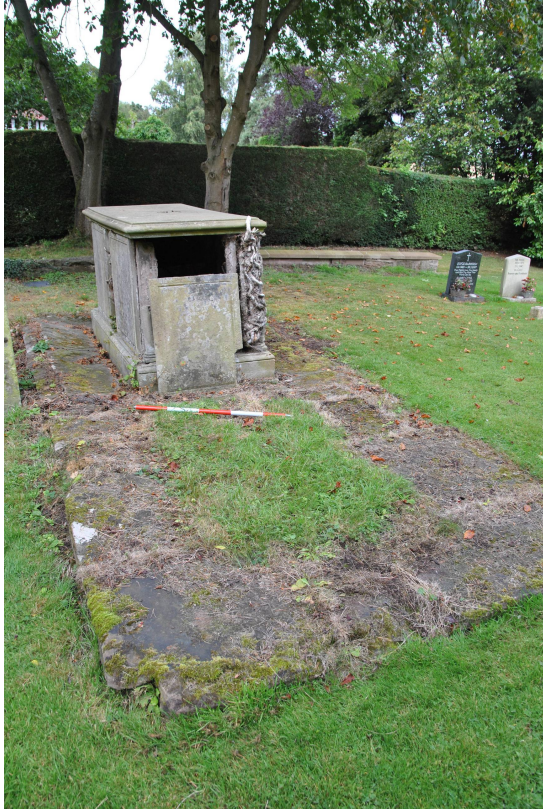
The John Williams monument was dismantled in one day and under strict archaeological monitoring. Prior to dismantling the tomb was photographed and its location-context (e.g. **Plate 1**). **Plate 1** shows that the monument stands over a large broken stone slab which probably covers a [brick-lined] crypt. According to an assessment by Sally Strachey Historic Conservation (January 2019) and Arnold Bartosch Ltd., the monument was in a poor state of preservation (**Plates 2 to 6**). The textual dedication to John Williams and his wife are engraved on two squared panels on the southern side of the monument (**Plates 7 & 8**). Despite the rigours of time and (200 years) sustained weathering the engraved text is in a reasonable state of preservation; however, these and other upright panels were loose and liable for collapse (e.g. see **Plate 2**).

Plate 1. General view of the eastern side of the tomb before dismantling
Plate 2. View of the eastern side of the tomb before dismantling

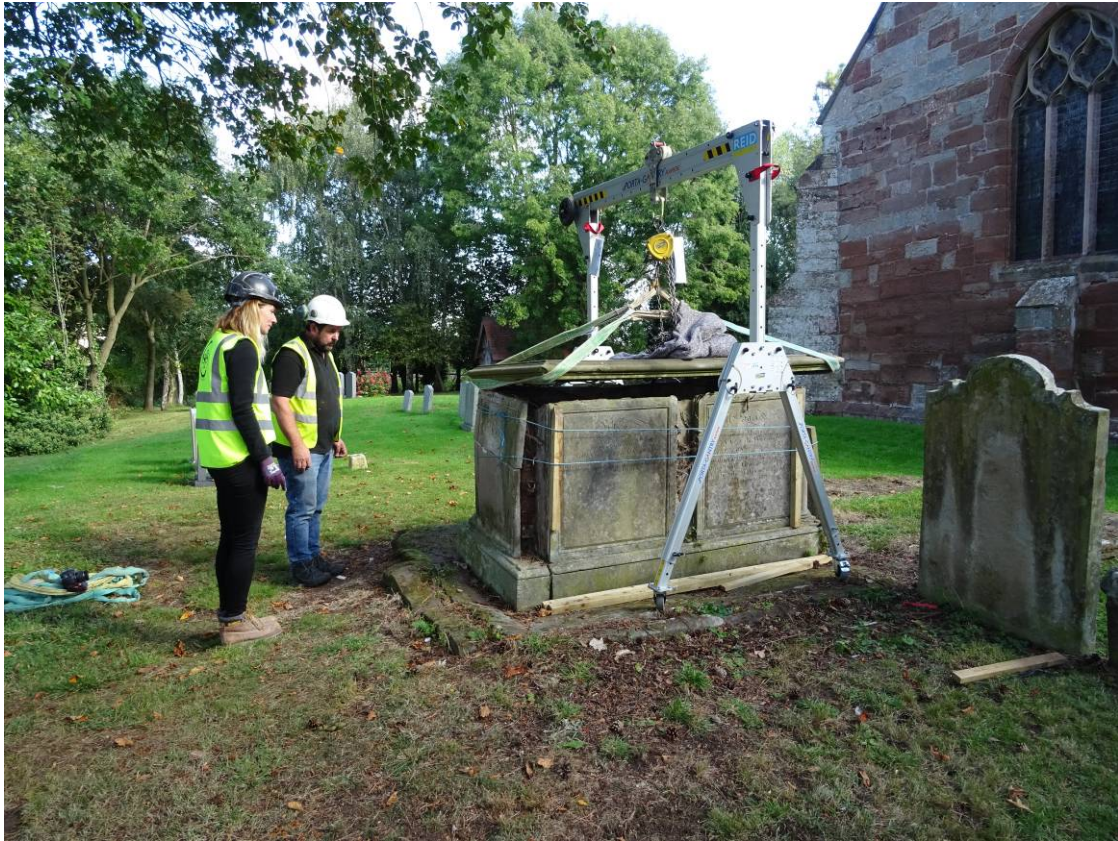
Plate 9. The lifting of the capstone and the steadying of the side panels

Before the upright panels were removed, the enormous capstone was lifted using a gantry hoist (**Plates 9-10**). The capstone remained suspended whilst the Sally Strachey Historic Conservation team assessed the structurability of the panels and the potential ease of their careful removal (**Plate 11**).

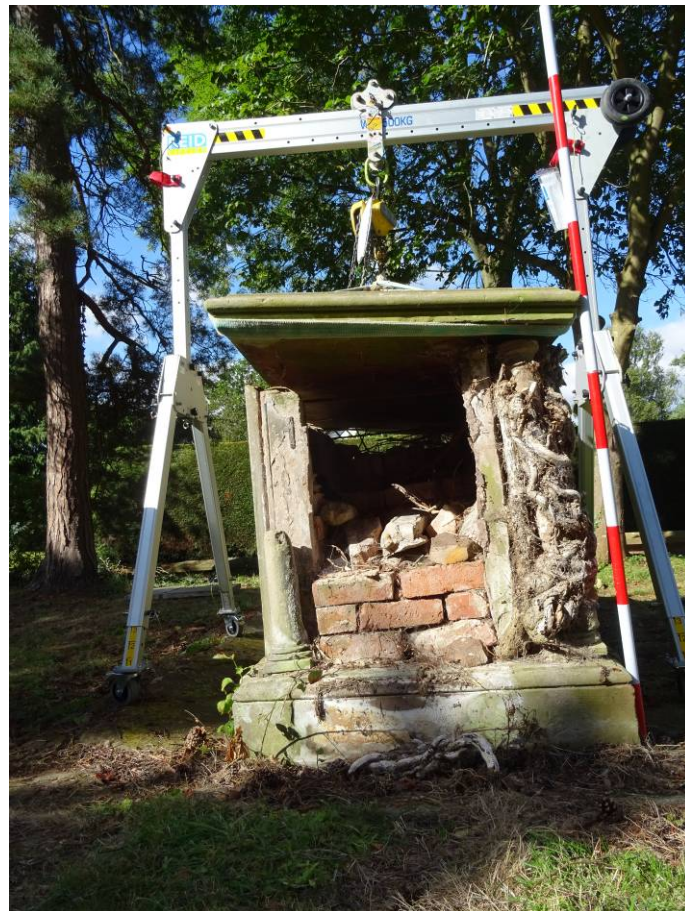
Plate 10. Dismantling of the tomb with the capstone suspended

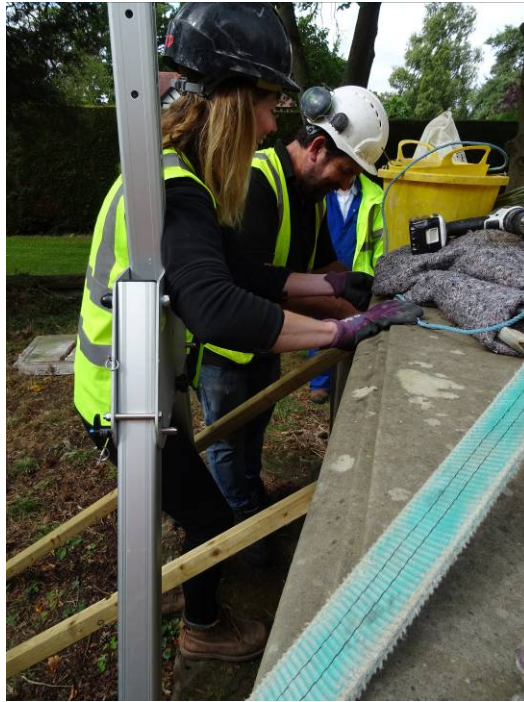
Plate 11. Steadying the capstone following the removal of the side panels

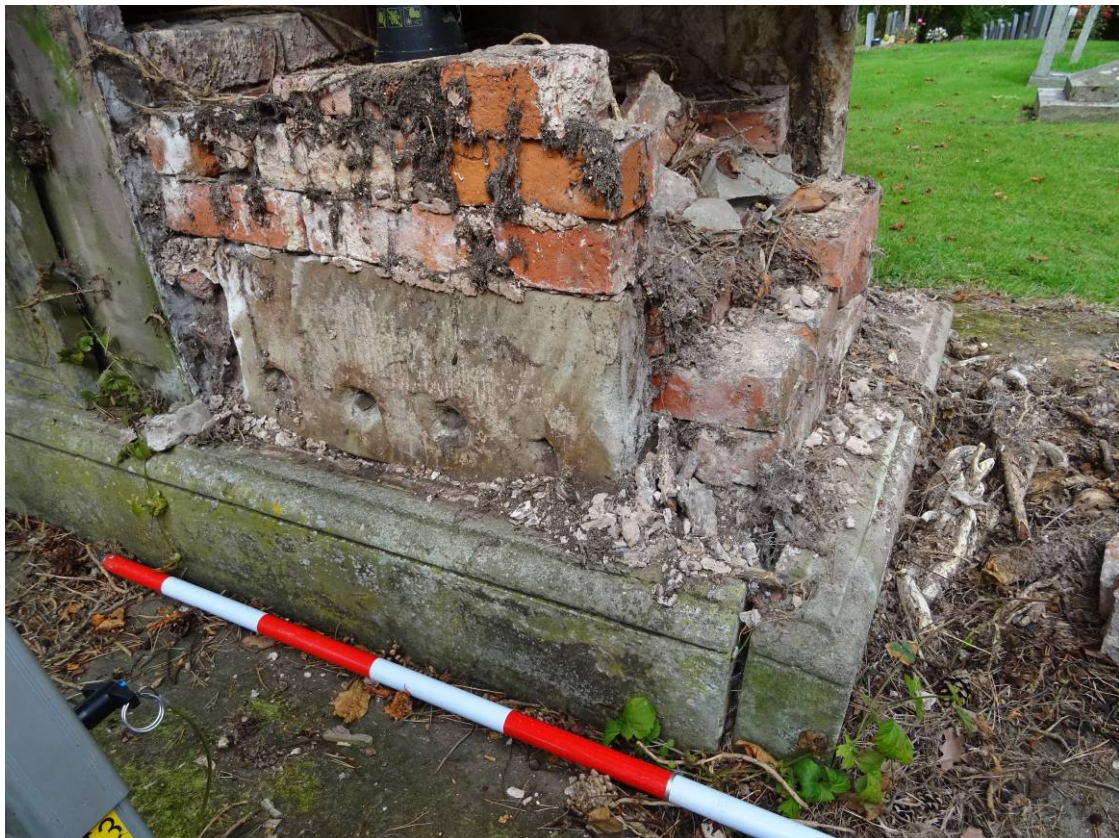
Revealed, following the removal of all of the side panels was a coarsely-laid brick and stone superstructure; much of which was un-mortared (**Plate 12**).

Plate 12. The inner core revealed, following the removal of the stone panels

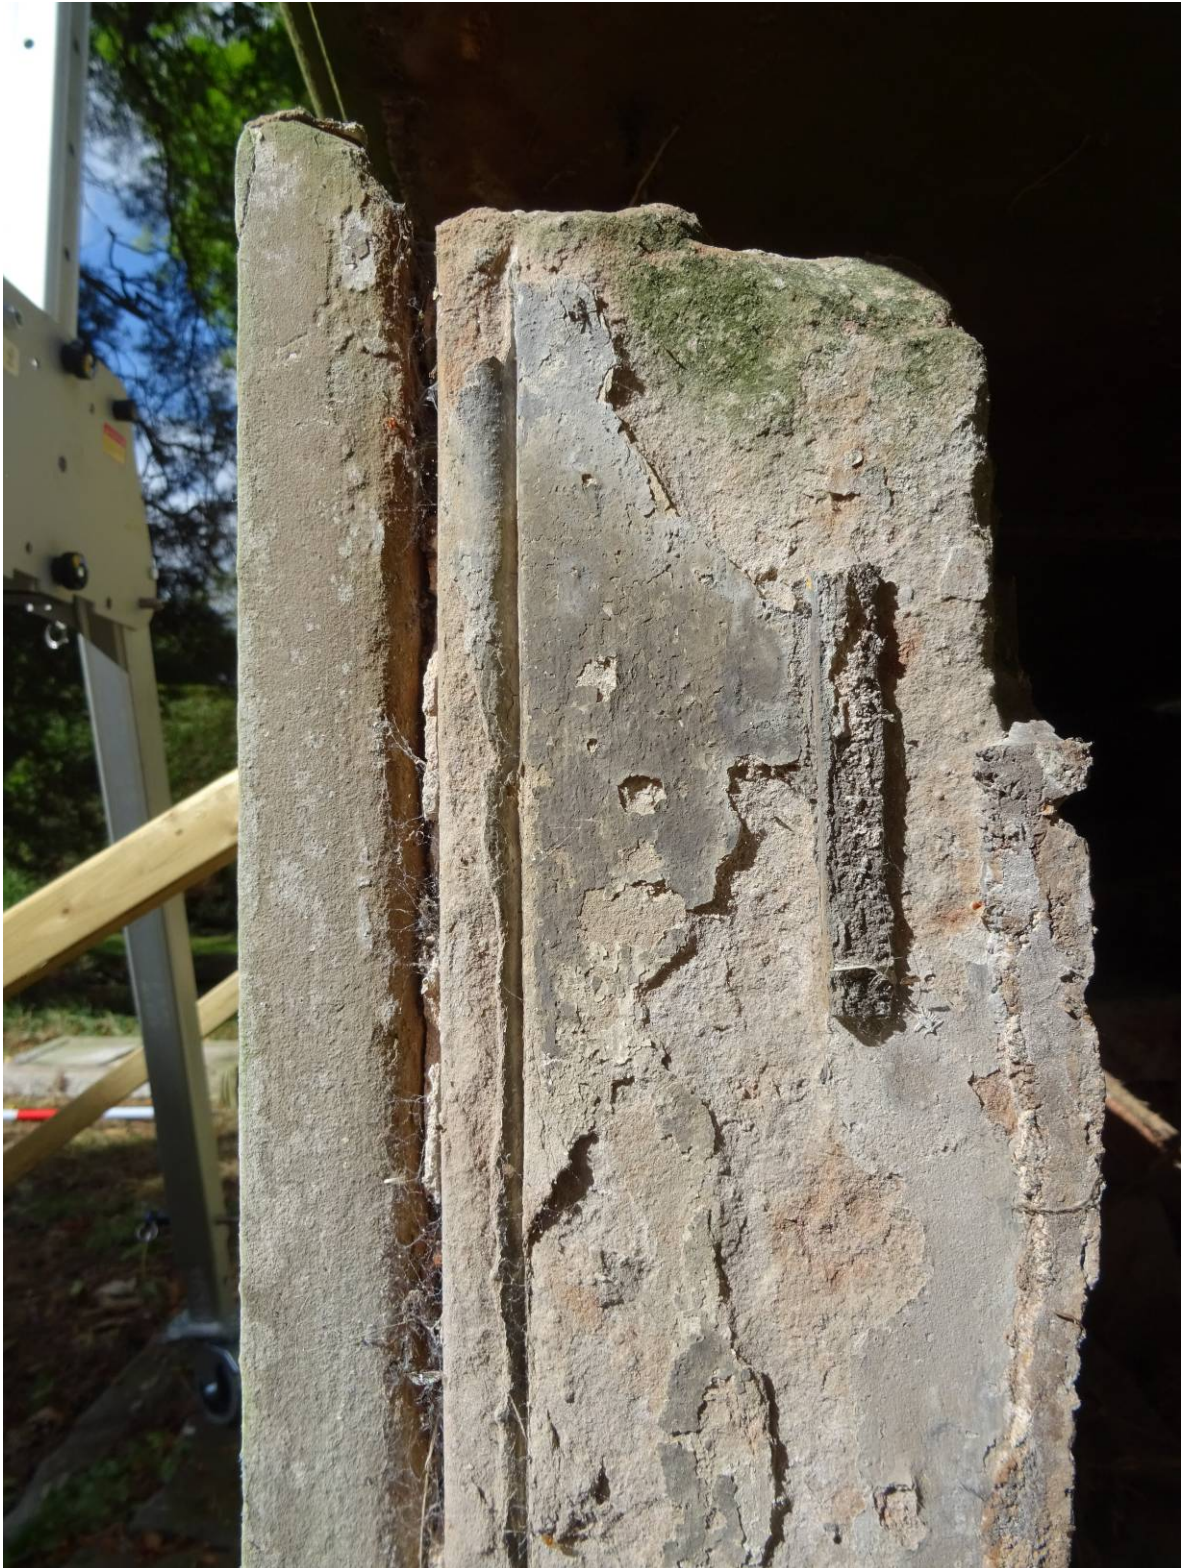
Plate 13. Stone column with the trace of an iron fitting and a later cement regime

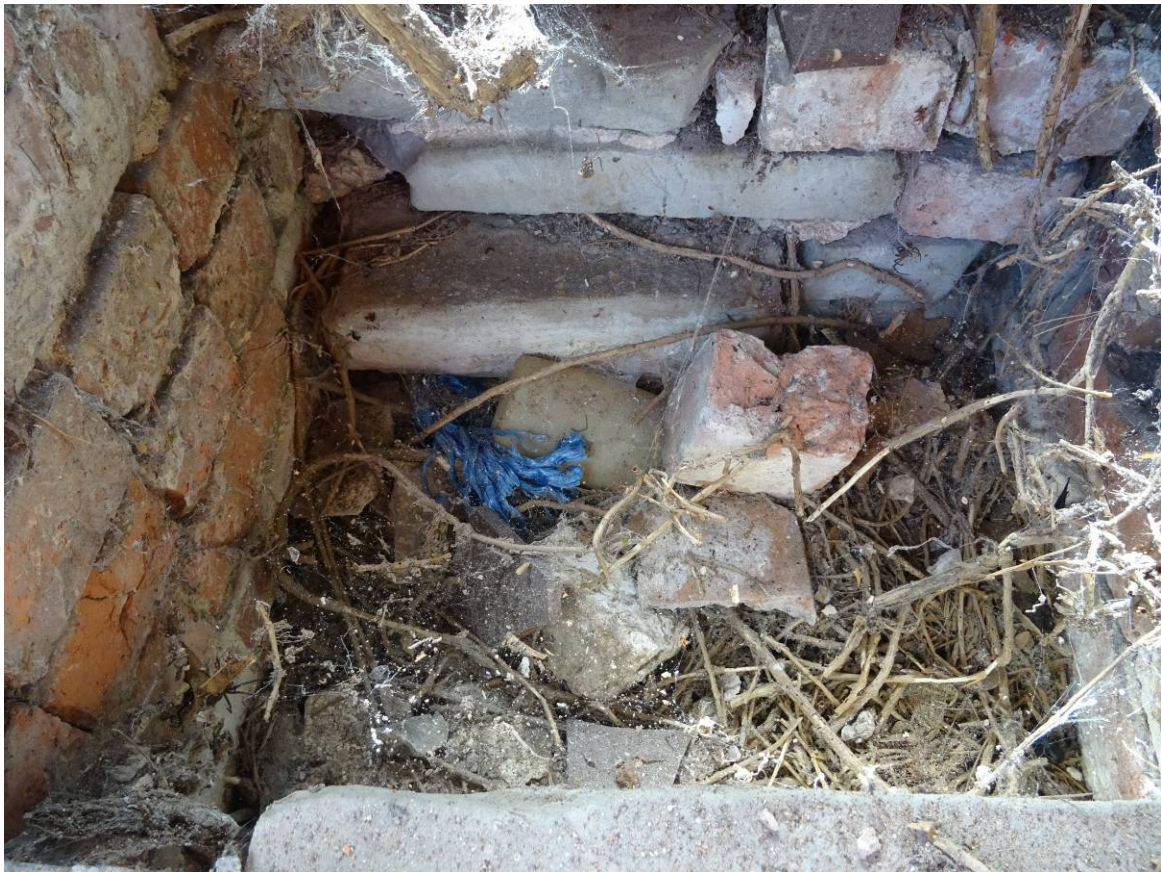
The watching of the four stages revealed no additional archaeological material. The removal of the side panels revealed a series of iron clasps and griping bars which held the panels in place. Dismantling revealed evidence of the monument's construction methodology, including a secondary (later) rebuild of the internal space. Clearly, much of the structural fabric is made of brick including the foundations that directly sit over the top of a large rectangular slab. This slab covers an early 19th century crypt. The secondary phase of construction, probably occurring during the 20th century includes the reuse of dressed stone, with railed kerbstone sections being used to partly [re]construct two chambers within the chest tomb.

Plate 17. One of two rebuilt chambers within the core of the tomb

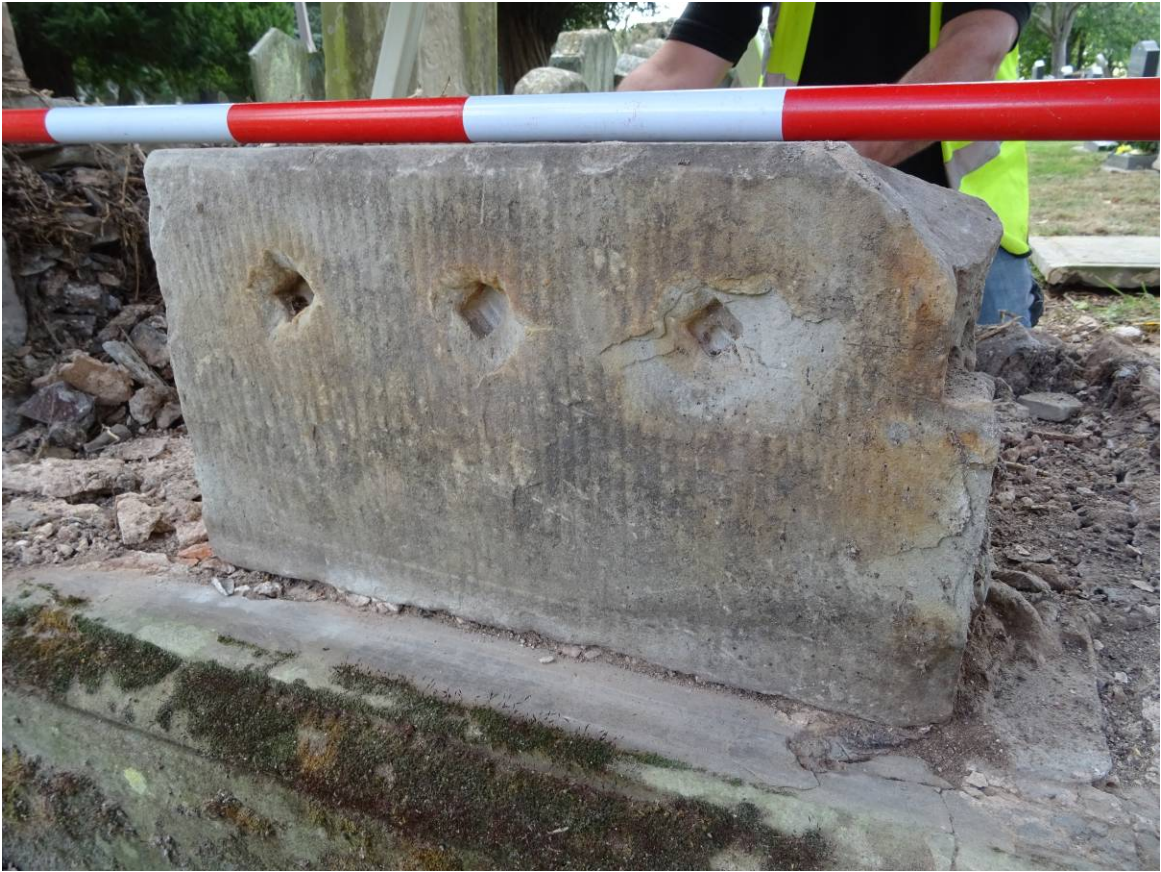
Plate 18. Reused railing kerb used to support the panels of the tomb

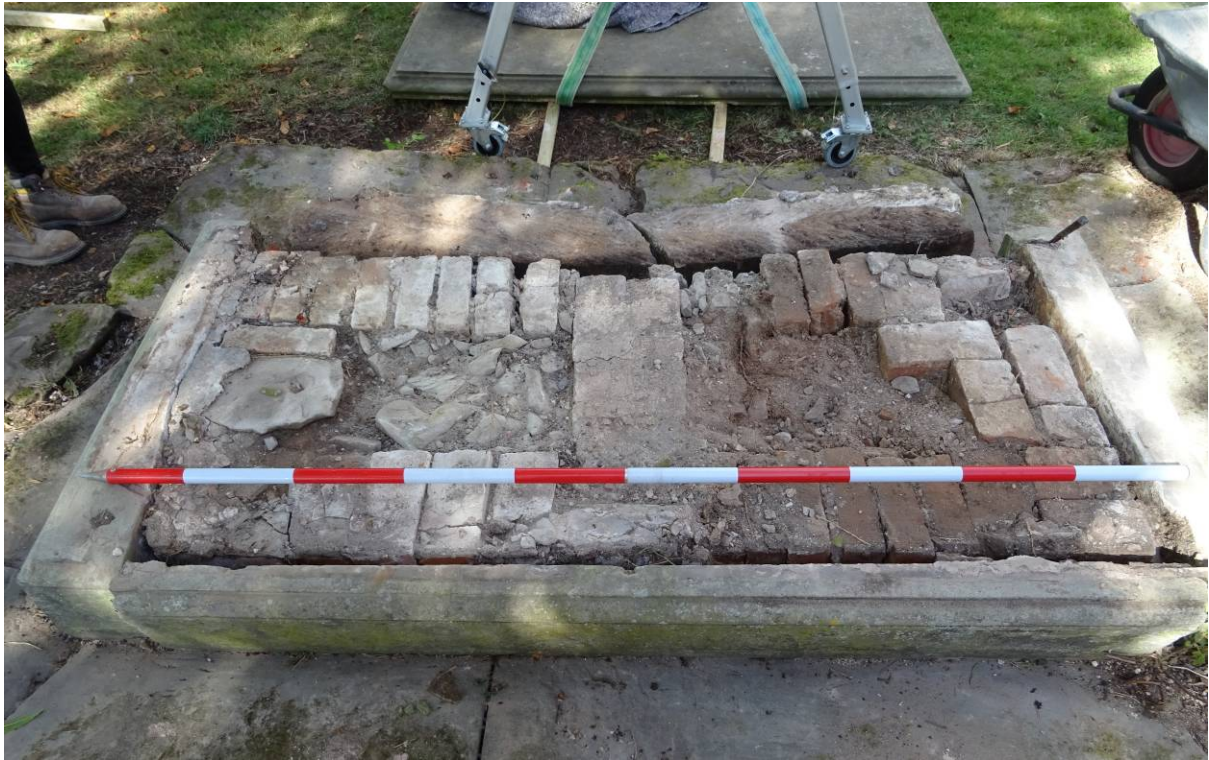
Plate 20. The base of the monument showing a re-set floor using building debris, enclosed by a moulded plinth

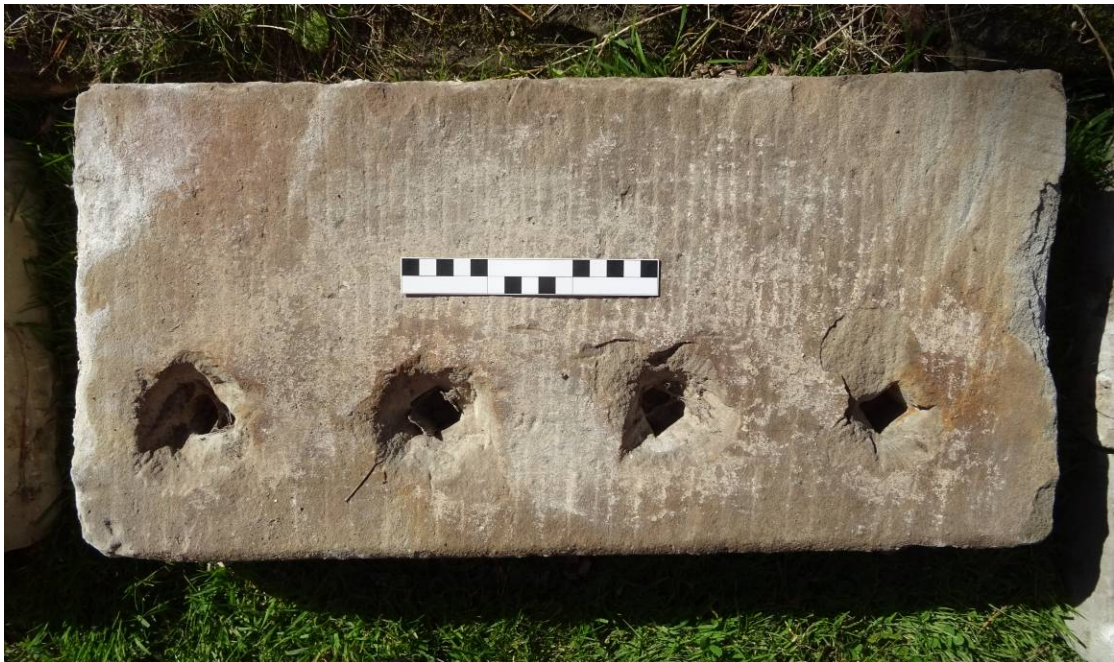
Plate 23. A broken section of a kerb (plinth) with railing footings

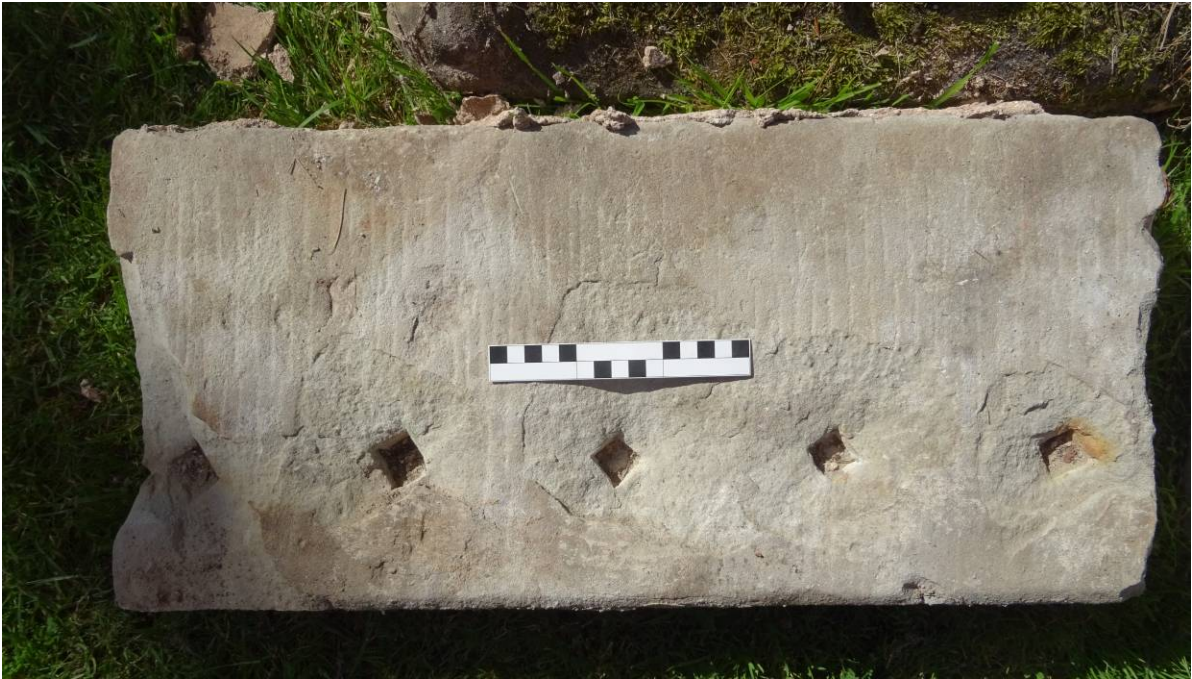
Plate 24. A broken section of a kerb (plinth) with railing footings

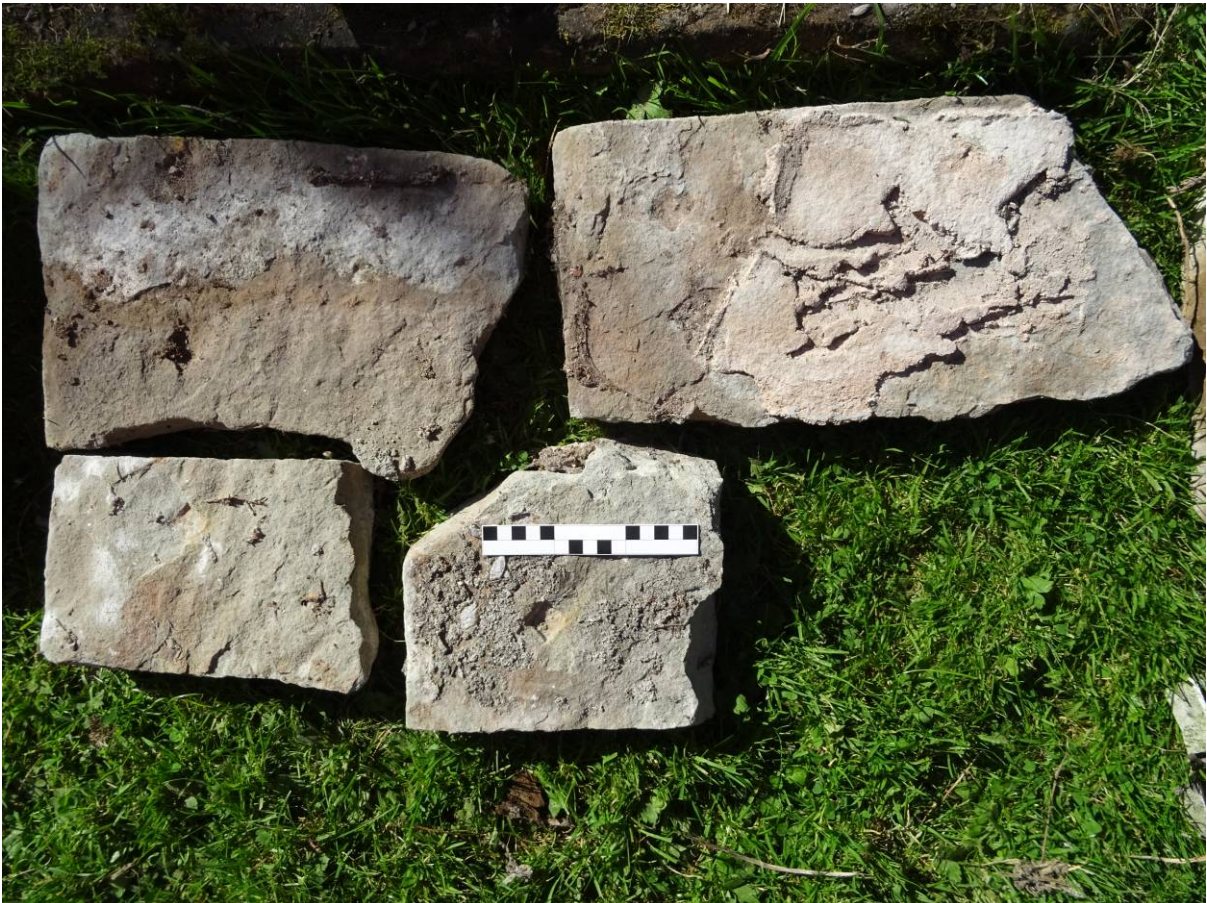
Plate 25. A selection of the rubble infill from the core of the monument
