# CHURCH OF ST. ANDREW CHEDWORTH

# CONSERVATION NOTES ON ELEVEN LISTED CHURCHYARD MEMORIALS

Work Completed following Report October 2020 Conservation Notes and Findings August 2022

CENTRELINE ARCHITECTURAL SCULPTURE FAIRFAX HOUSE, VICARAGE STREET, PAINSWICK, GL6 6XS

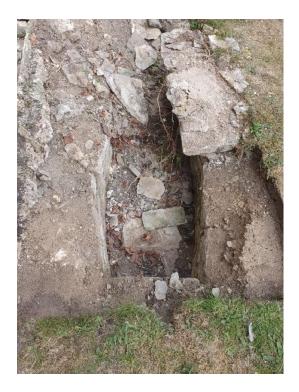
Monument completely dismantled and the vault was found to be filled with soil.

Void beneath the tomb

Tops of vault walls repaired, the east end of the vault was missing which supports the theory in the Report that there were steps down to the vault form the east.

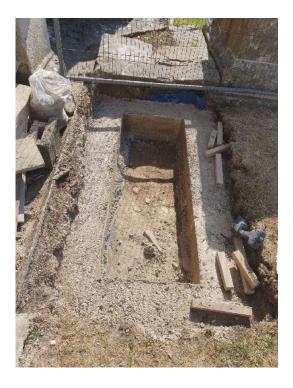
Ring beam in place ready for the lintels

Ring beam inserted on which Supreme Prestressed Textured concrete lintels were laid to support the monument.

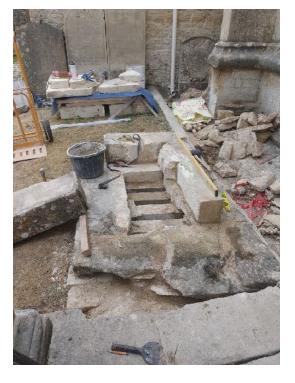
Concrete lintels set on the ring beam

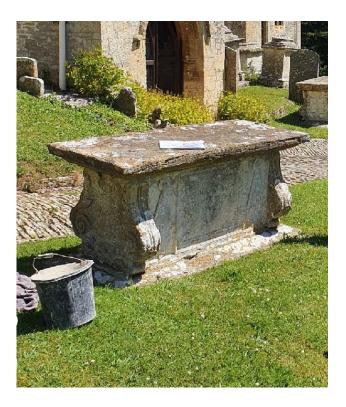
Mortar filling the spall in W lyre end

Mortar filled spall in W lyre end and repointed open and cracked joints with lime mortar.

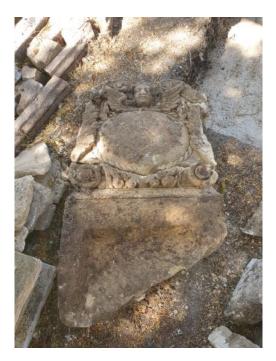
Monument dismantled to plinth level. It was found that part of the underground base was made up using a broken headstone. The part that would have been below ground has the date 1697 carved on it but it is uncertain whether the headstone was ever used or whether the 18thC masons were simply using an abandoned commission.

Uncovered 17thC headstone

Limecrete base installed and 17thC headstone laid back face down in original orientation and position which is under the E half of the monument.

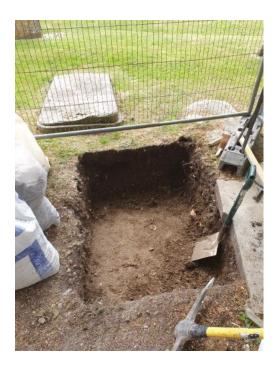
Area dug for Limecrete foundation
