ST. MARY'S CHURCH, THORNBURY, GLOS.

CONSERVATION TREATMENT REPORT OF THE WALL PAINTING  
FRAGMENT

ON THE SOUTH WALL OF THE NAVE.

JANUARY 2023

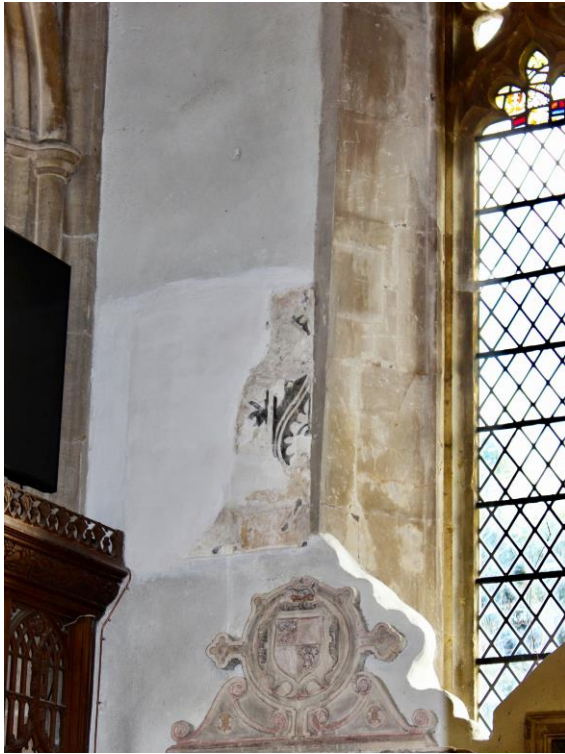
*Fig. 1*

*View showing the fragment of wall painting adjacent to the window reveal.*

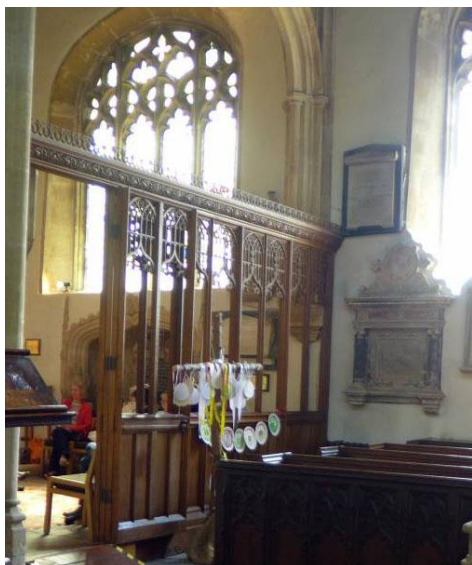
***Fig. 1***

*View showing the area before the monument was taken down*

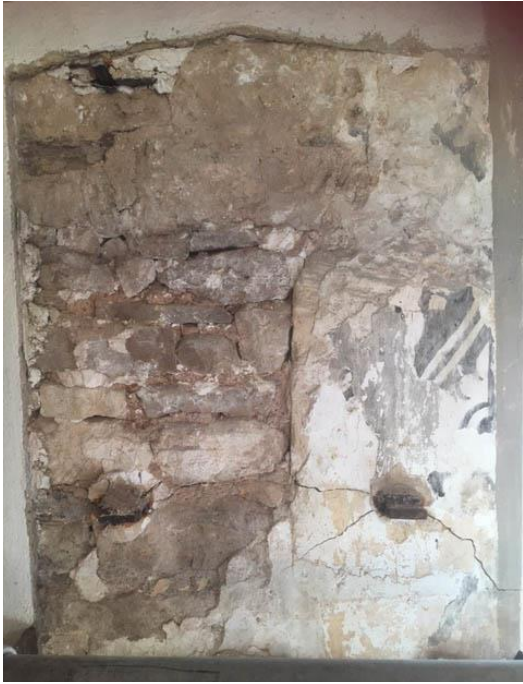
**Fig. 2**

*View showing the wall after the monument was removed and the painting was first revealed*

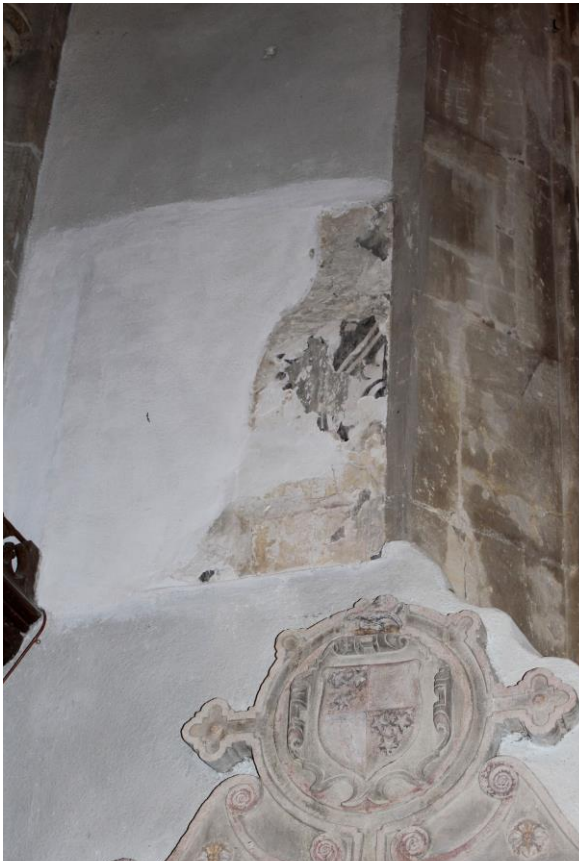
**Fig 3**

*View showing the wall painting prior to conservation, after the builder had filled the adjacent area of loss.*

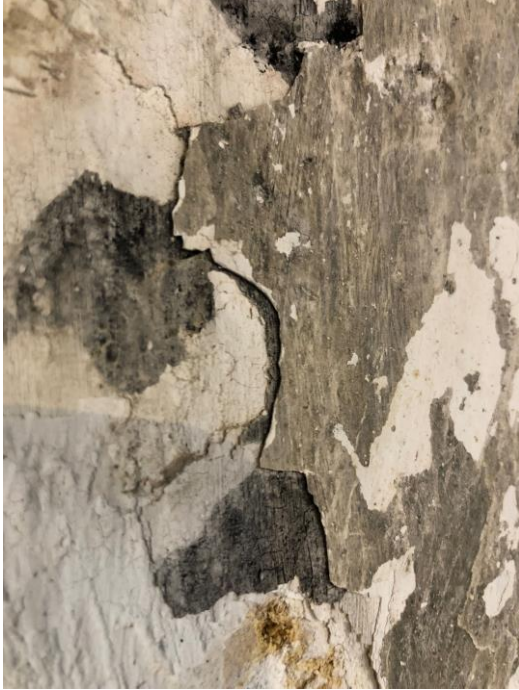
**Fig. 5.**

Delaminating fragments were pre-wetted with denatured alcohol. A fine grout of sieved dispersed lime was injected behind lifting paint layers. In some areas grout was applied from a fine brush and encouraged to flow behind the flakes.

*Detail showing the two painted schemes with fragile edges of painting that are lifting away from the surface.*

A fine lime mortar made up of lime putty, fine sand and stone dust was applied to vulnerable edges of the wall painting and small lacunae in the surface of the painting to add support.

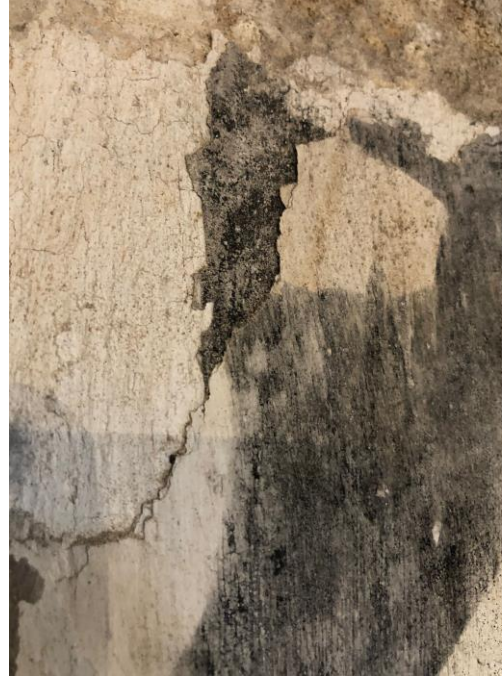
**Fig. 6.**

*Detail showing the Japanese tissue applied to protect the painting during grouting.*

Prior to undertaking consolidation of the paint layers, areas to be treated were protected with a layer of Japanese tissue applied with a 2% solution of Tylose MH300.

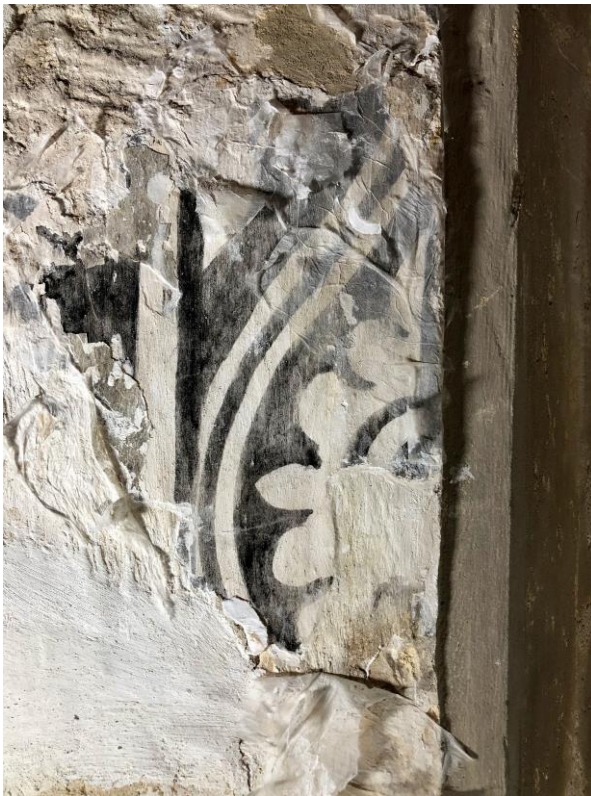
**Fig 7**

*Detail showing the lower area of painting after conservation.*

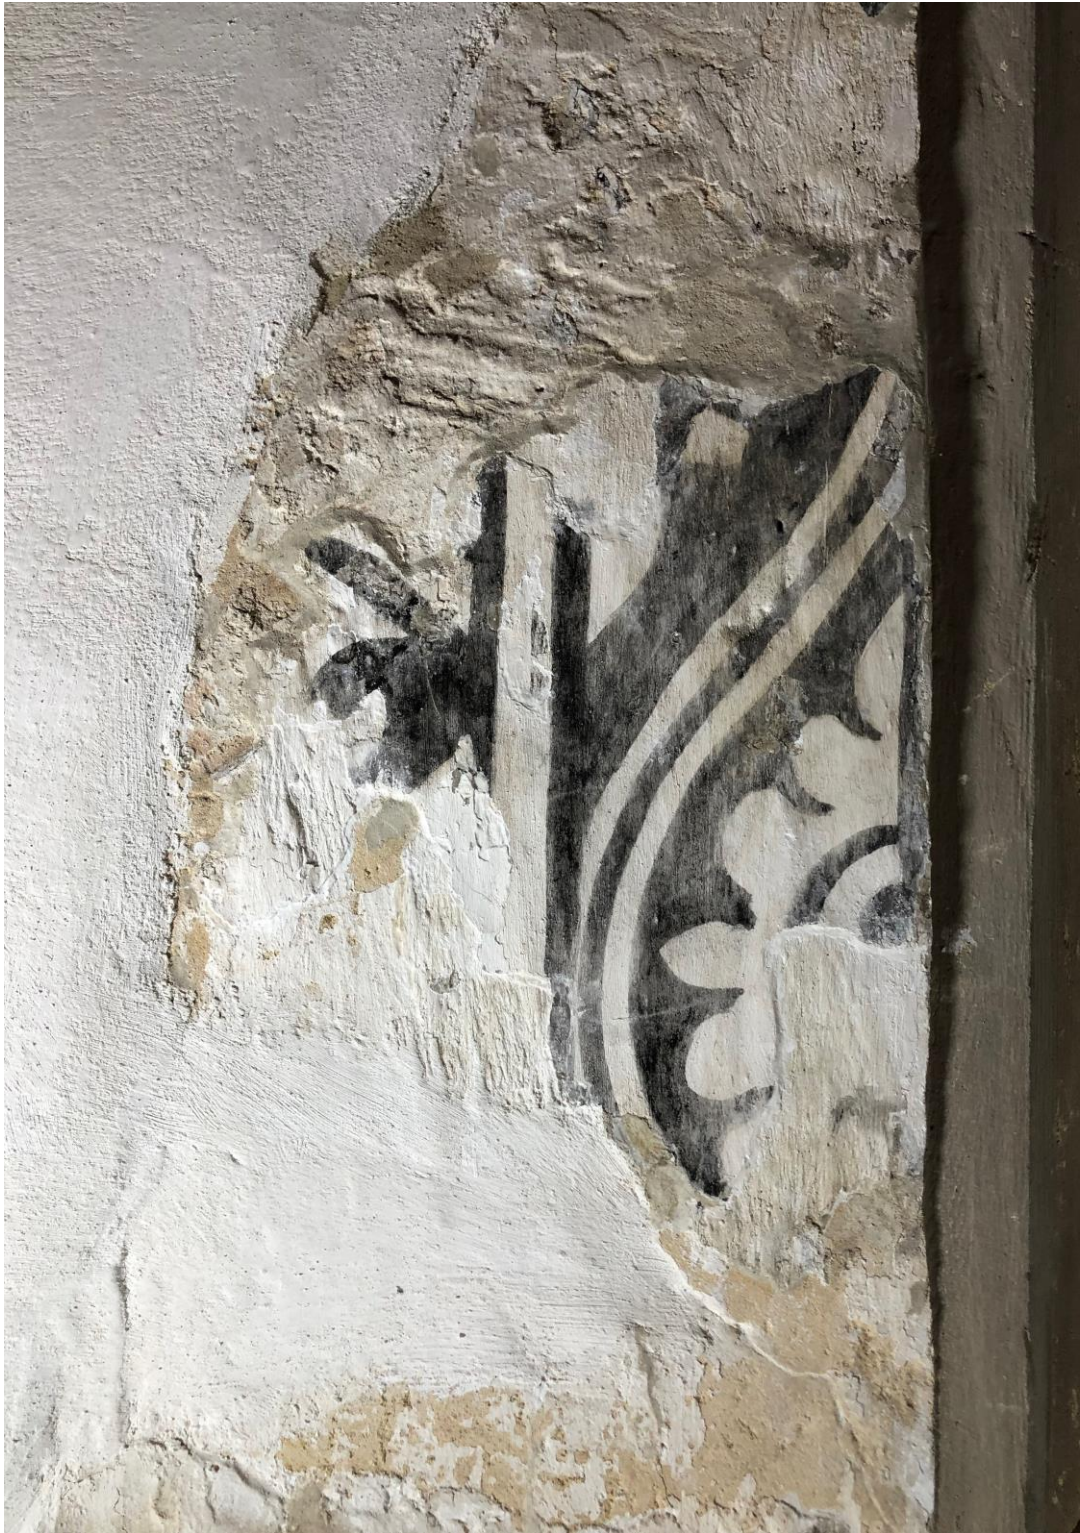
**Fig. 8**

*View showing the whole area after conservation*
