## A timber survey of

### CHRIST CHURCH, WOODHOUSE, HILL, HUDDERSFIELD

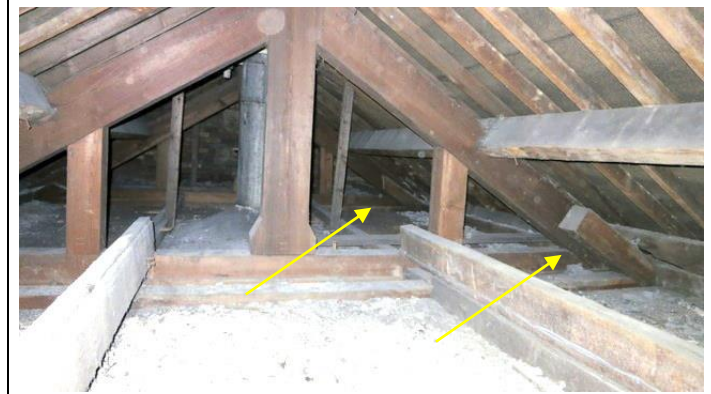
1

Photo 036 looking into the chancel. The ceiling has no secondary support (from ceiling joists for example) and hence no weight was placed on the ceiling.

Many of the common rafters have been replaced here (and throughout all the roofs).

Note - arrowed in the RHS of the picture the tops of the second principle rafters which give the impression of a double truss arrangement - seen from below.

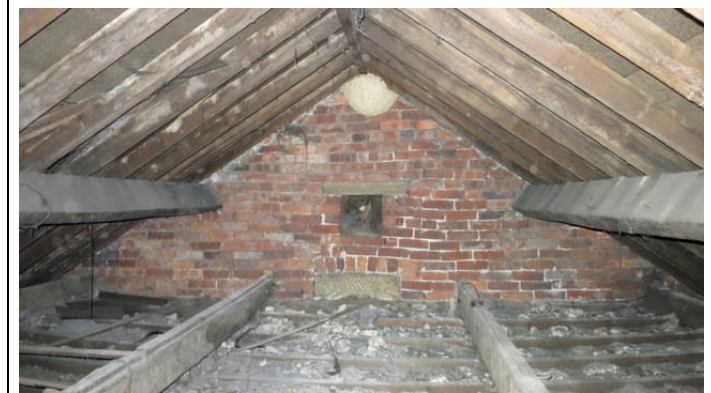
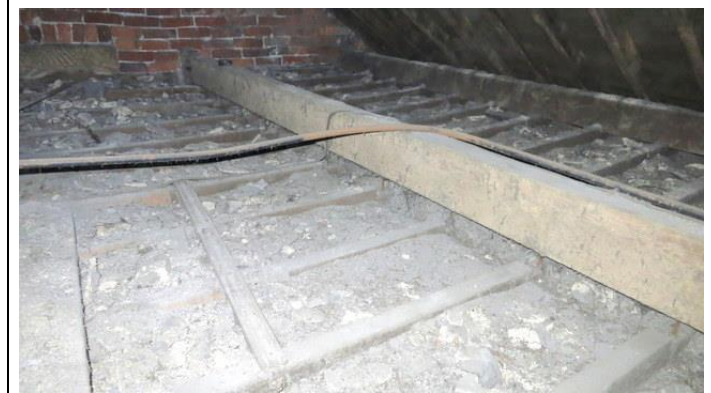
2

Photo 038 looking in to the S transept. Access was not possible to the S wall, although the bearings of the purlins and ceiling beams appear sound – see below.

The common ceiling joists have bowed away from the beam. It seems as if the nails through the common rafters have pulled out of the underside of the ceiling beam. Consequently, the ceiling cannot take any amount of weight.

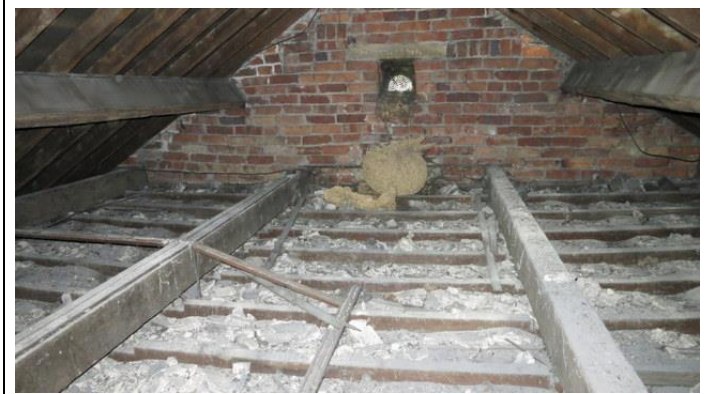
3  
Photo 042 looking into the N transept. Again the ceiling structure seems to have pulled away from the ceiling beam and again no access was attempted. The purlin and ceiling beam bearings appear sound.

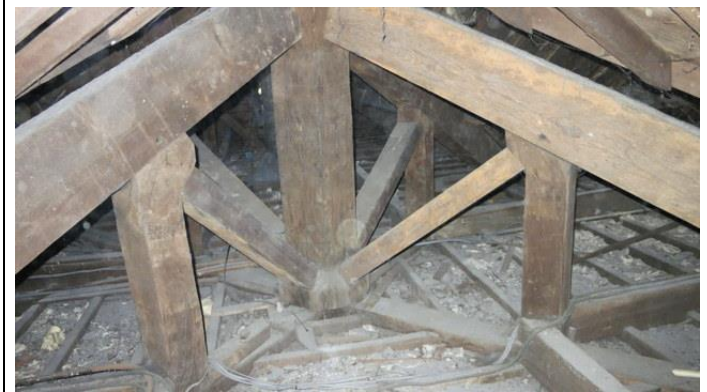
4  
Photo 041 showing the structural arrangement at the crossing point of the transepts with the main body of the church.

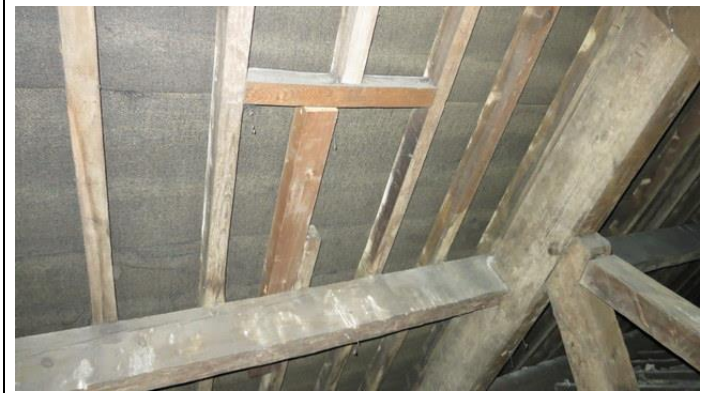
5  
Photo 044 shows what is presumably one of the original access hatches – now roofed over. (There was one on the N and S pitches).

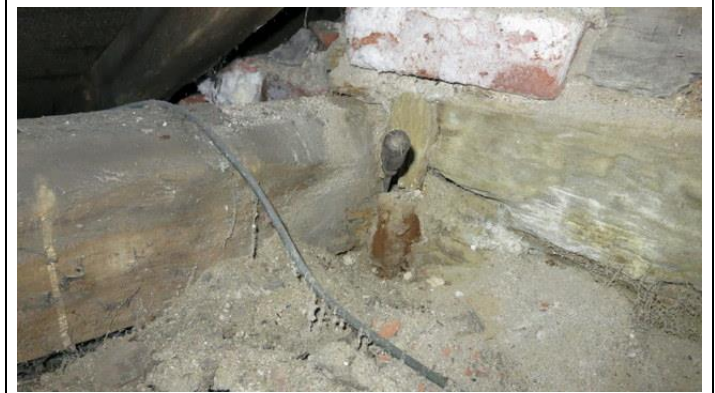
6  
Photo 048 shows the purlin bearing adjacent to an area of water penetration (ob 17 below). The softwood purlin bearing has lost its outer (probably sapwood) edges within the wall.

Although there is almost certainly a fork of sound heartwood in the wall, this bearing will require additional support to stabilise it. As the detail is clearly difficult to keep dry it may be considered prudent to provide additional support to this purlin which isolates it entirely from the masonry. This could be in the form of wrapping the embedded repaired end or even cutting the purlin where it enters the wall and supporting it with a bracket or similar.

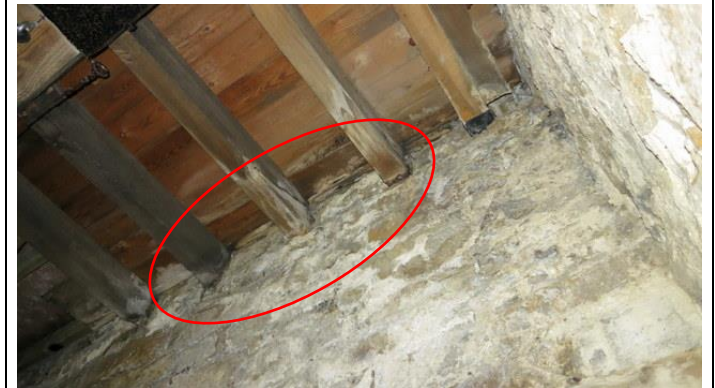
7  
Photo 051 shows the underside of the SW corner of the floor of the Bell chamber. The first joist is wrapped. The next 3 joist ends are decayed in their bearings and require additional support.

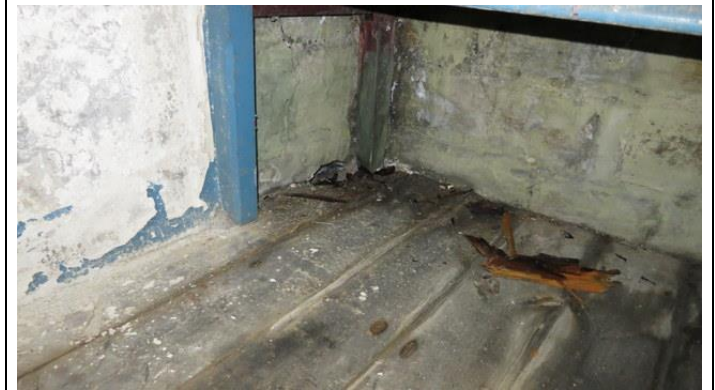
8  
Photo 045 shows the floor in the SW corner at Gallery level (below the Clock chamber). The embedded joist bearing in the SW corner and floor boards are wet and decayed in this corner. See below.

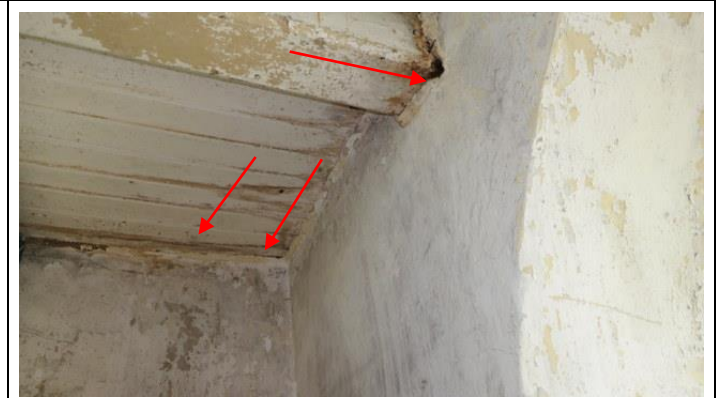
Photos 046 shows the underside of the floor at this point. It is likely at least 2 or 3 common joist bearings are decayed in the S wall and the principle floor beam (arrowed opposite) has lost most of its sapwood to wet rot decay within the wall and will therefore require additional support.

**Recommendations are as those of ob 6 above.**

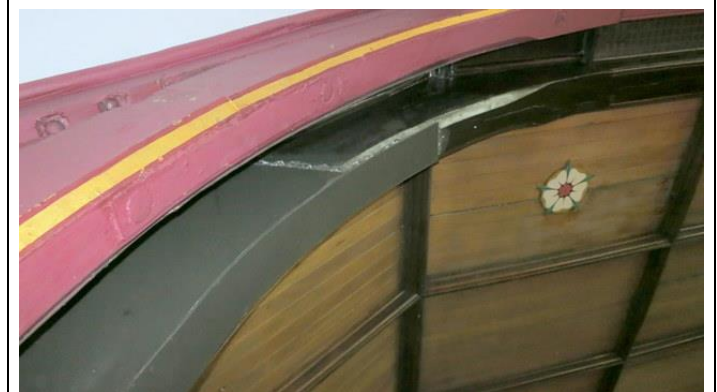
9

Photo 064 shows a previously repaired truss end. It is not clear how the repair has been carried out due to the boxing. (Close access was not possible to this beam end due to the positioning of the pews below).

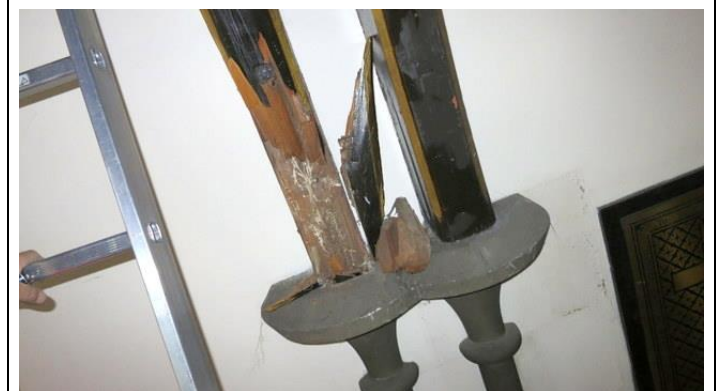
10

Photo 052 shows historic decay (probably dry rot) to the foot of the arched brace and post of the truss. The timber is now dry and the decay is historic. This detail (where the truss post/brace bears onto the corbel) changes from truss to truss and it is not clear whether this is the original detail or a previous repair. The damage is local to the post and arched brace. There are no signs of any decay at cornice level or to the foot of the principle rafter, although it is concealed by the roof structure. It is probable this happened at the same time as the damage which caused the decay to the adjacent truss and may not have been noticed.

**The base of the post and arched brace will require repair.**

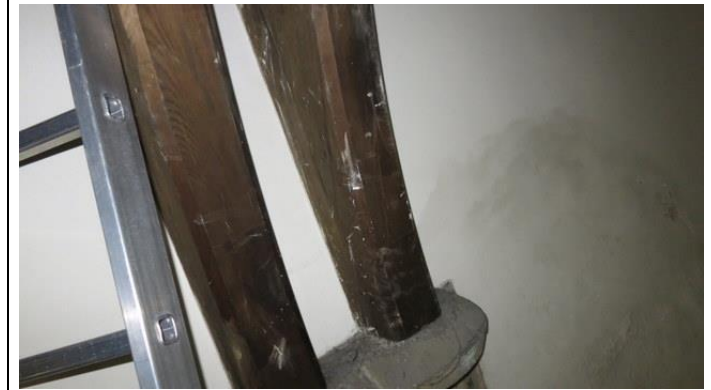
11  
Photo 056 shows the feet of the arched braces adjacent to a large damp patch in the wall caused by defective rainwater goods externally. These are both later repairs and are sound.

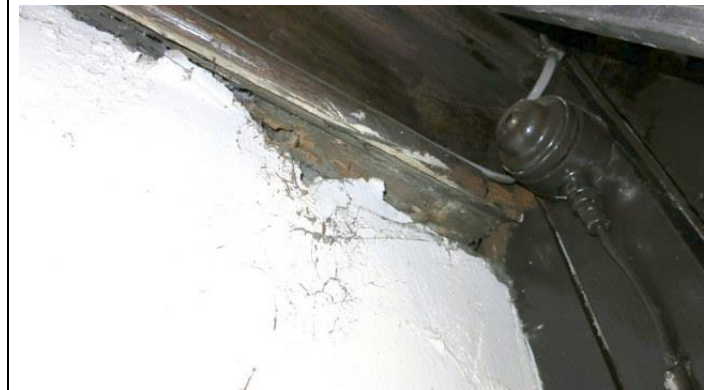
12  
Photo 058 shows decay to the edge of the plate behind the cornice. The decay is historic and the timber in this area is now dry.

**However, it would be worth checking the integrity of this principle rafter over the wall head when the opportunity arises. See external detail below.**

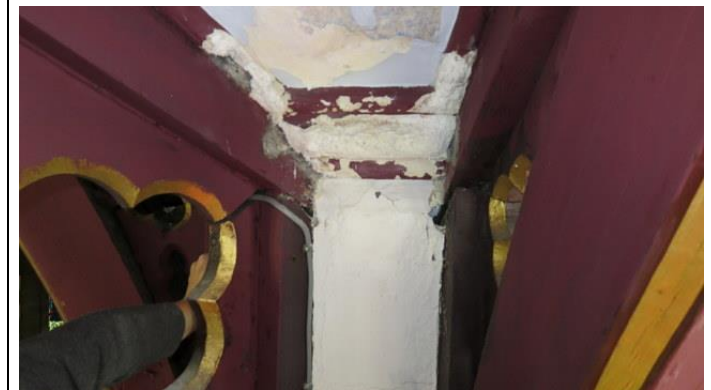
13  
Photo 063 shows some decorative damage at the foot of the valley formed with the S transept. All of the timber is dry and was not damaged as far as access was possible.

**Again it would be prudent to check the condition of these elements over the wall head when access allows.**

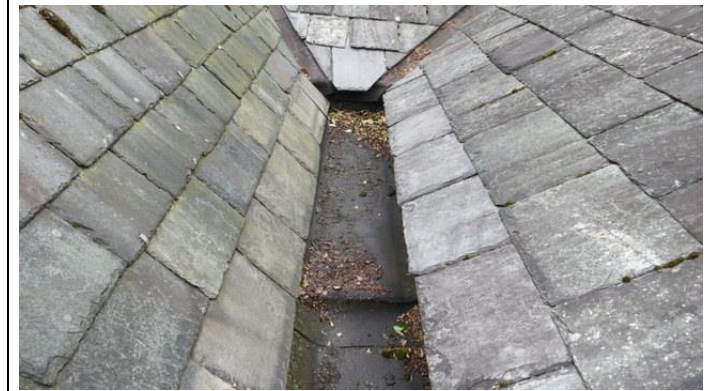
Photo 085 shows the external detail above obs 12 and 13 which is prone to blockage and was holding some detritus and standing water at the time of survey.

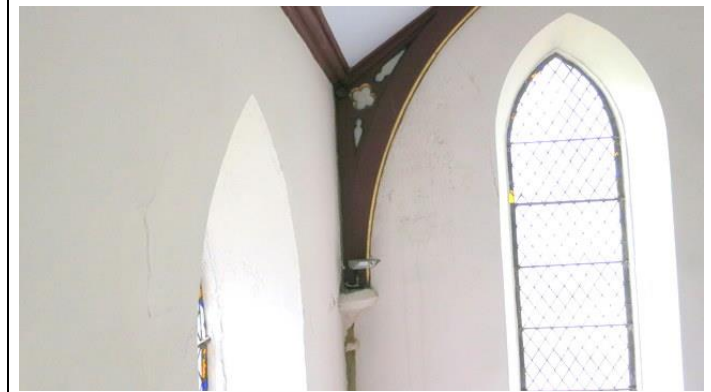
14  
Photo 067 shows water damage to the hard cementitious plaster (which hasn't disassociated from the substrate as yet). The adjacent rafter foot which is more of a cover strip, is undamaged and currently dry.

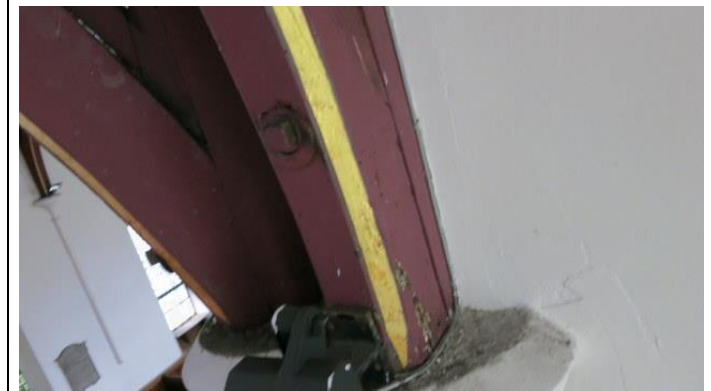
15  
Photo 068 shows the foot of the W valley made between the N transept and nave. There are signs of seasoning shakes and possibly historic water ingress although the detail is now sound and dry.

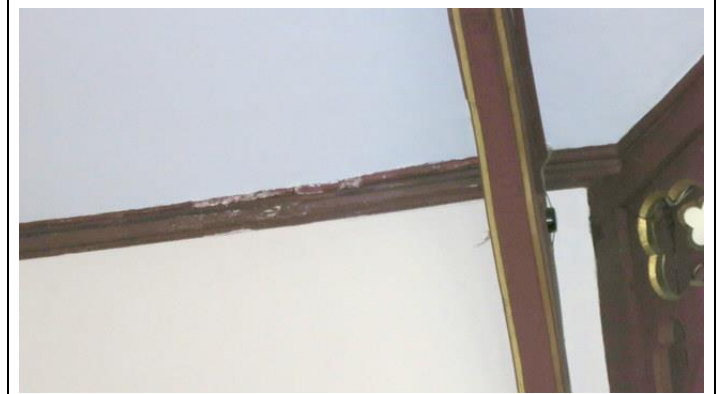
16

Photo 069 shows some damage to the cornice. Access was not possible as a result of the pews, however the damage is not thought to be structurally significant.

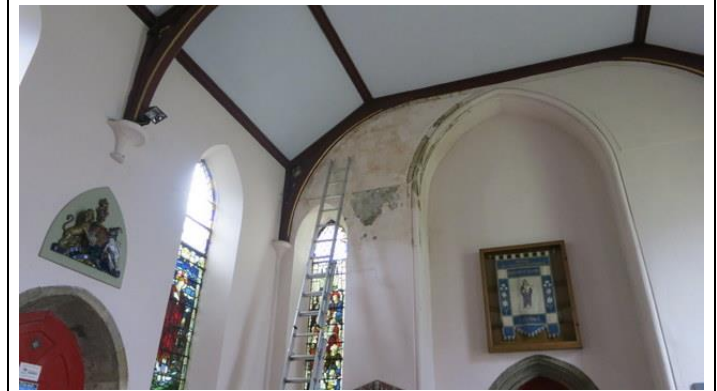
17

Photo 071 - the arched brace and ceiling joinery were inspected at the point of water damage in the SW corner of the nave. The timber is sound although the plaster-most of which seems to be relatively recent cementitious one-has disassociated from the masonry substrate – although is not as yet being actively shed off the wall.

There is some minor, superficial and historic damage to the arched brace on the W wall of the nave.

Much of the internal plaster work is cement-based and some has lost adhesion to the walls locally below the transept valleys and at the wall heads, but most noticeably in the SW corner of the nave. As mentioned above, it is not currently in a state of collapse, but its condition will deteriorate relatively rapidly from this point forward.

**Various areas of plaster around the church will require replacement. See discussion.**

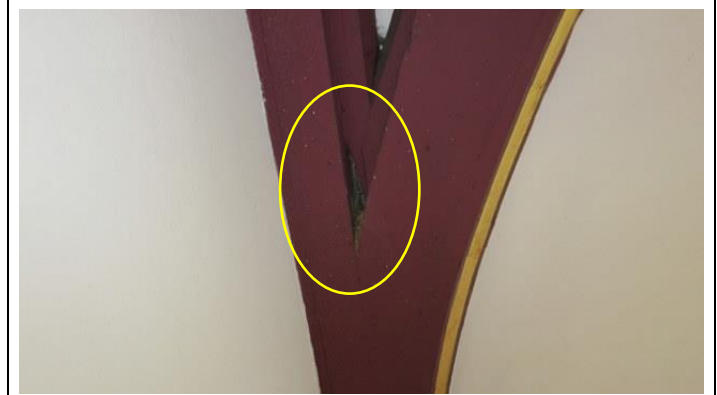
18

Photo 070 shows some historic and superficial decay to the back of the inner detailing of the arched brace and post. The damage is not structurally significant.

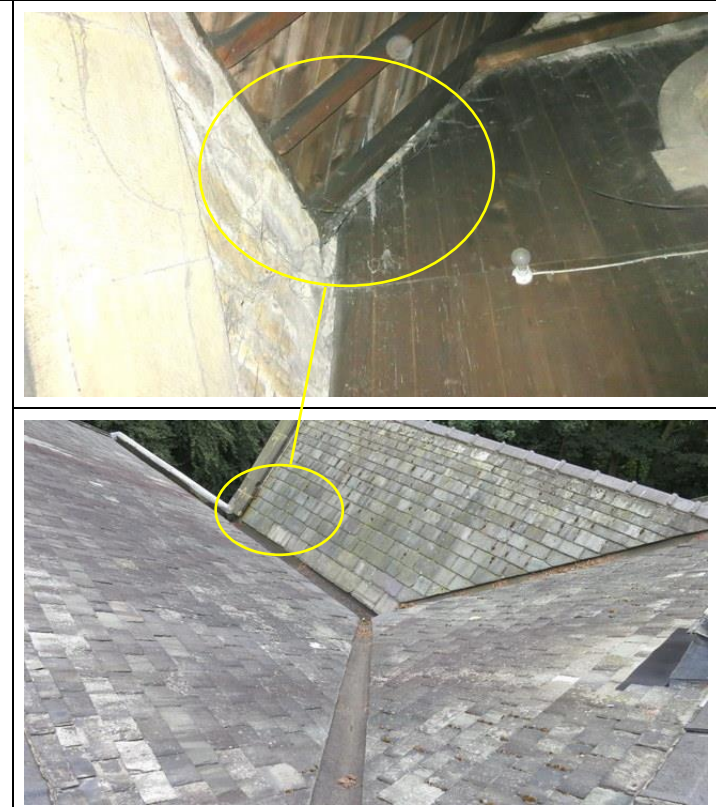
19

Access to the roof above the organ was difficult. However, it is possible there may be some damage to the roof structure below the same valley mentioned in obs 12 – 13 above.

**Again further inspection would be prudent if the opportunity arises.**

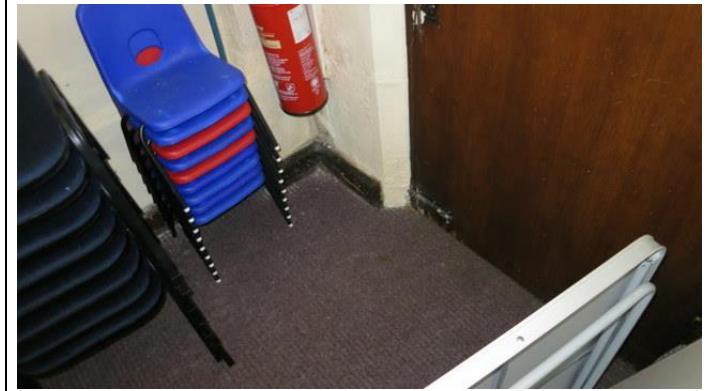
20

Photo 075 shows decayed skirting board (oak) for approximately 1 metre away from the N wall behind the chairs. There is also some movement in the floor which suggests some or all of the floor is suspended.

**Further exposure is required at this point which may well reveal further decay to the joists of the subfloor.**

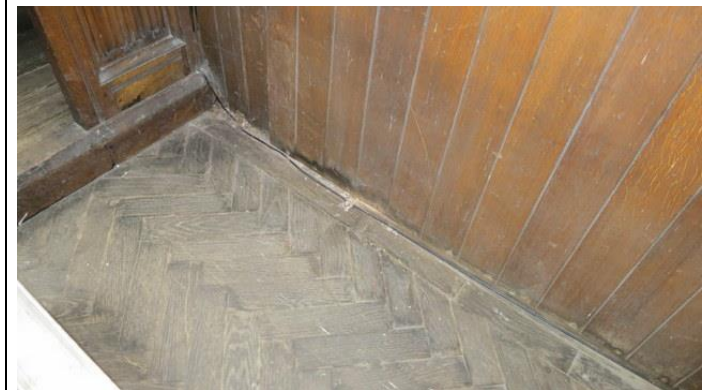
21

Photo 076 shows some decay to the ends of the wainscoting and presumably the grounds to which it was attached. This has resulted in approximately 1-2 m of the wainscoting which can be moved at its base at the W end of the N transept.

**The stability of the wainscoting will slowly deteriorate – even in the absence of water – and should be repaired relatively soon.**

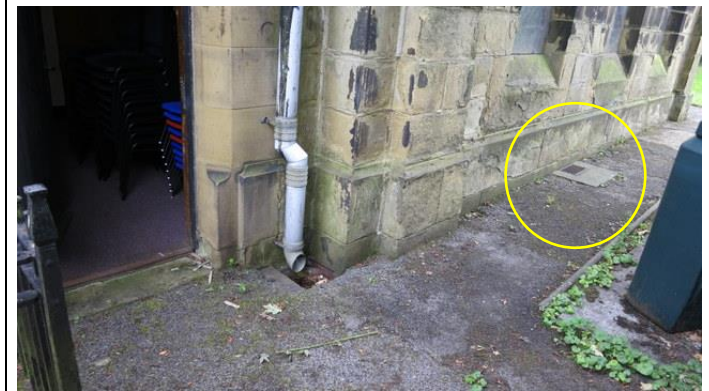
22

The damage shown in obs 19 and 20 above, is presumably due to the external perimeter conditions-namely the drain and the external perimeter (which seems to fall into the N elevation of the N transept), shown opposite.

**One of the air vents is circled opposite – see discussion. It is probable each of these floor vents has its own drain which may well be blocked. If it hasn't already been carried out, a drainage survey would be beneficial – to include all the external perimeter grates.**

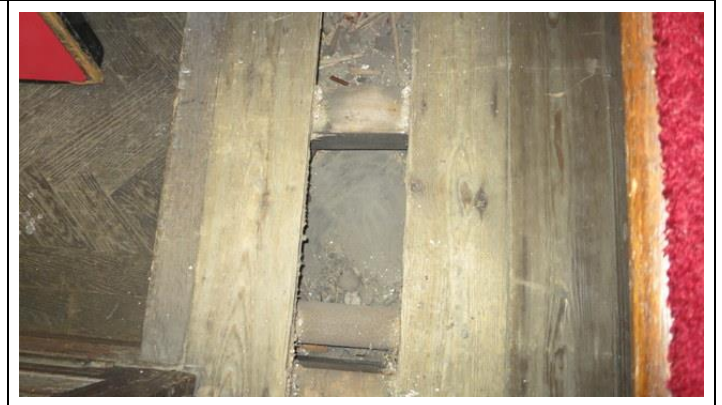
23  
Elsewhere the timber pew platforms are in good condition. Photo 078 shows where they were built straight across the existing wood block floor which presumably is still intact below all of the other platforms.
