ARCHITECT'S REPORT – Clock Refurbishment

St. Bartholomew's Church, Arkendale

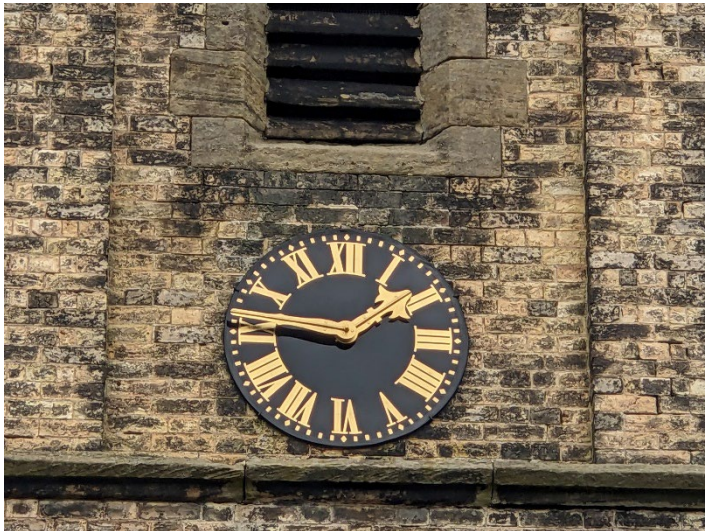
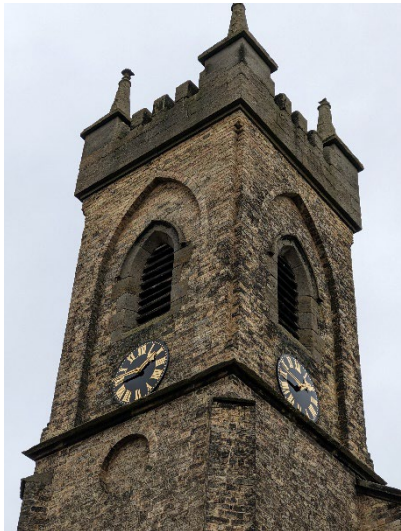
The clock has had new faces manufactured, to replace the existing, which were found to be simply sheets of steel. The original hands have been re-used and re-gilded.

I was unable to attend on the day of reinstallation, however, I visited shortly afterwards to inspect the clock faces, which have been reinstalled successfully and look wonderful.

The open joints in the masonry, specifically the stone plinth remain and have not yet been fully addressed, however. There is a need to carry out some fairly urgent repointing of the open brickwork joints to the tower, so this should all be addressed in the near future under a separate programme of works.
