**St. Andrew's church
WINGFIELD
Suffolk
(Diocese of St Edmundsbury and Ipswich)**

**Record of conservation works carried out to the monument to
Michael de la Pole (d.1415) and his wife Katherine**

June 2023

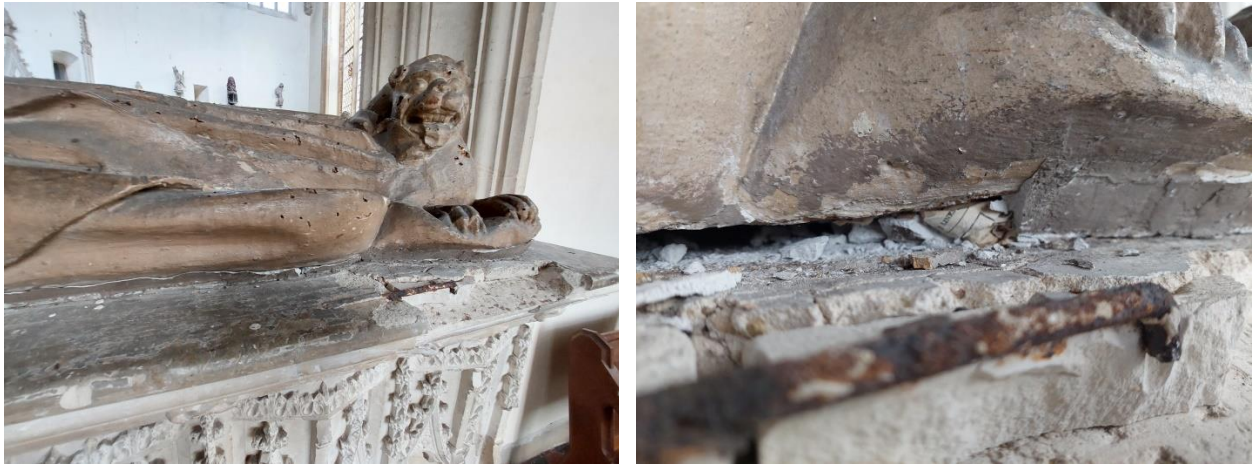
Before any works commenced the monument was thoroughly documented with detailed photographs and datums to accurately record its current condition and position. The plaster fill surrounding the south side of the effigy of Katherine de la Pole was carefully removed with hand tools, to reveal that Katherine was being supported with old newspaper at the head and feet with nothing in the middle.

Plates 2 and 3: Plaster fill before and after removal, with view of newspaper padding for the feet of Katherine de la Pole.

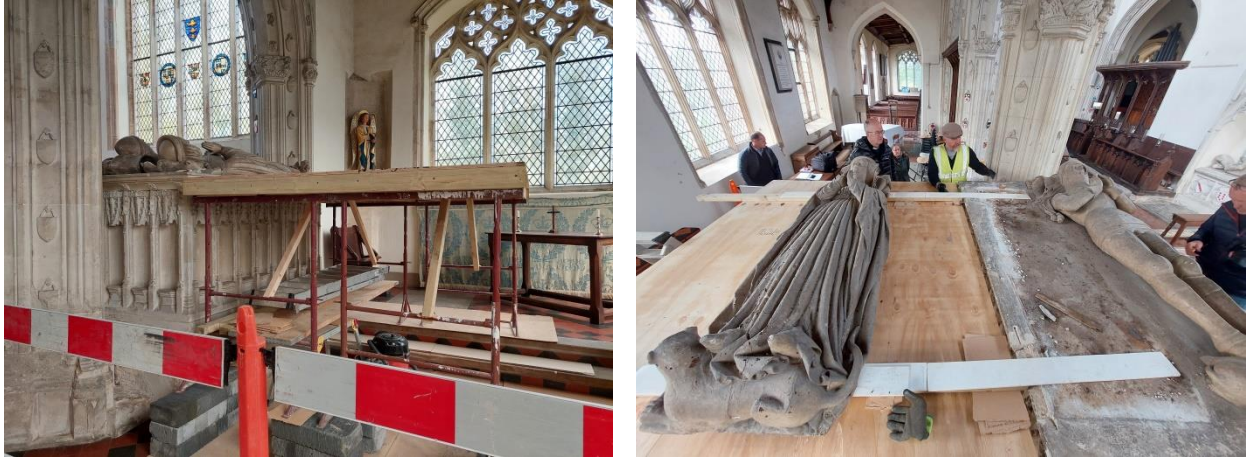
Plates 4 and 5: Temporary platform and Katherine de la Pole being moved by Teflon skids

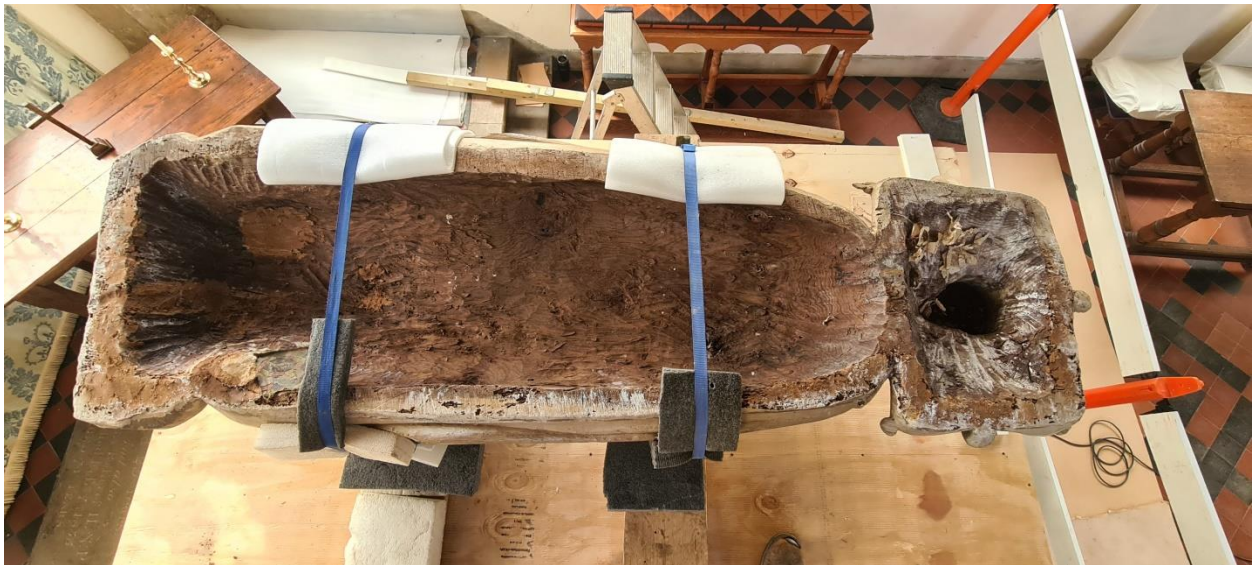
Underneath there was evidence of historic insect damage, fortunately not too much, and she was still structurally secure. However cloth and resin repairs had been used to fill historic insect damage, so it was not possible to see the entirety of the historic insect damage to the woodwork. It is worth noting that very little frass was found underneath the two effigies.

Plate 6: Underside of Katherine de la Pole

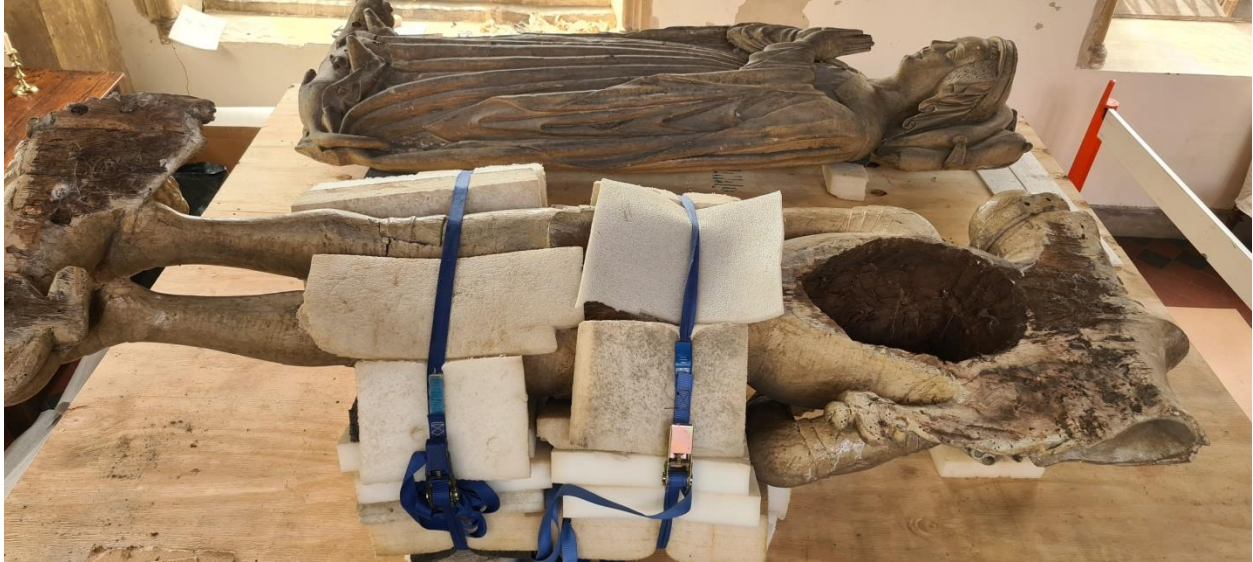
Wooden runners and Teflon skids were then placed underneath Michael's effigy, before sliding him on to the platform alongside Katherine. Again several large foam pads were attached to Michael's effigy before turning him over to inspect the condition of the underside of the effigy. Michael was also structurally sound and there was far less insect damage to his effigy.

Plate 7: Underside of Michael de la Pole

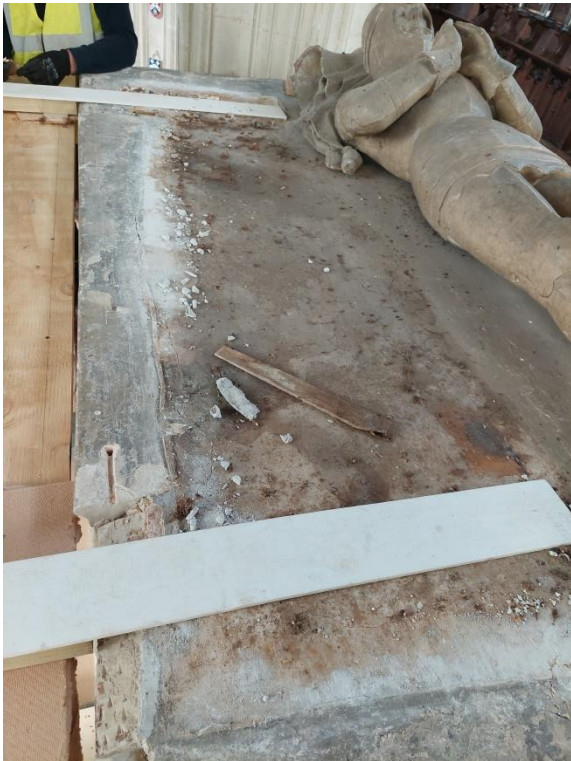
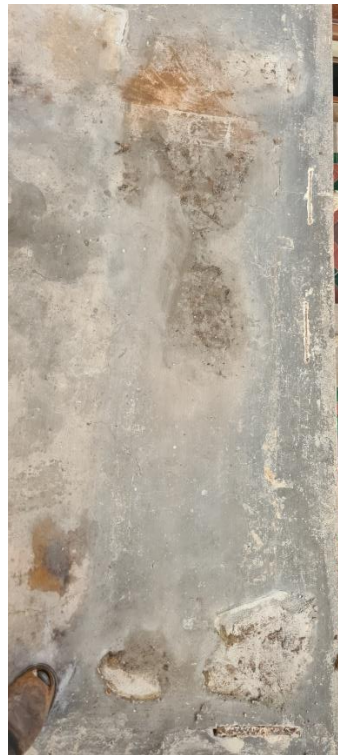
Both effigies had hollowed out areas, in Katherine's main body and head, and in Michael's head.

Plates 8 and 9: The exposed tomb chest below the effigy of Katherine de la Pole (left plate) and underside of Michael de la Pole (right plate)

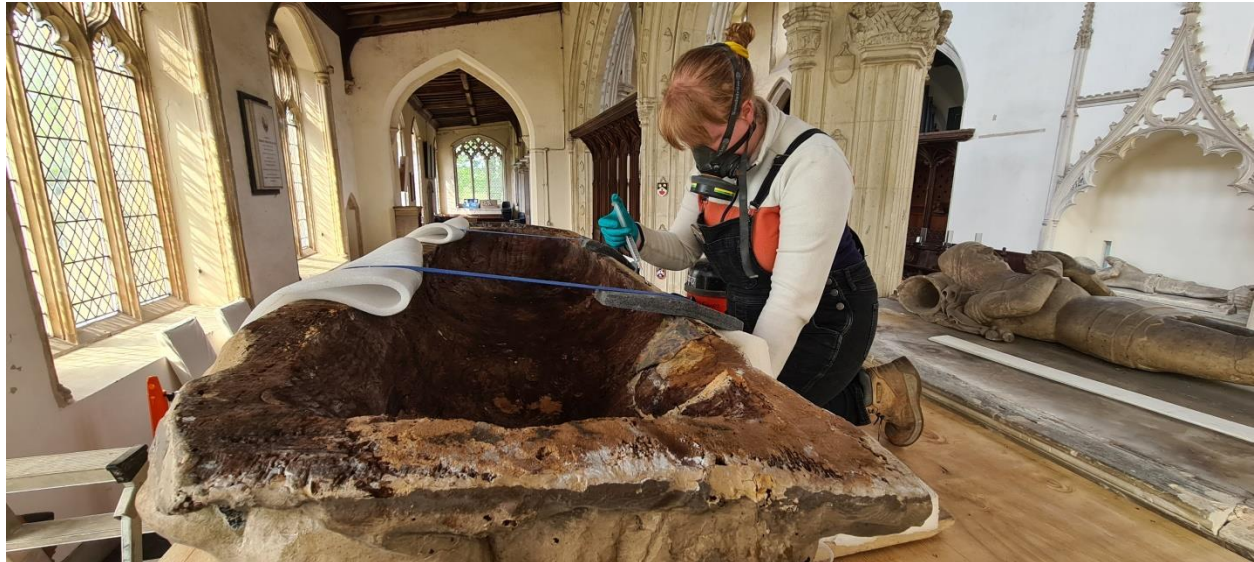
Plate 10: Katherine de la Pole being injected with Constrain.

Both sides of each effigy were treated with *Constrain*, a water-based insecticide with a neutral pH. All surfaces were sprayed before all of the flight holes and cracks in the wood were injected.

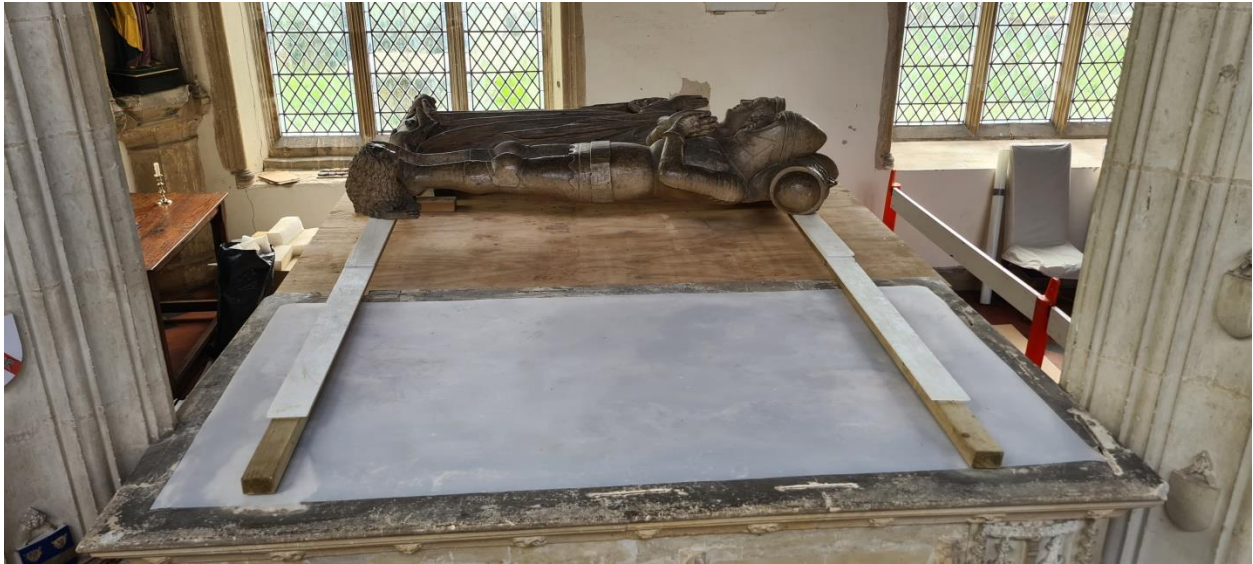
Plate 11: Re-instatement of Michael de la Pole on to tomb chest

After inspecting and recording the top of the tomb chest for evidence of insect damage, the residual debris was removed using a soft bristle brush and vacuum cleaner. A sheet of clear rigid plastic (usually used as a stone templating material) was placed on top of the tomb chest to collect and record future debris between treatment cycles. The effigies were then reinstated back onto the tomb chest using the same method used to lift the effigies off the tomb chest, see above.

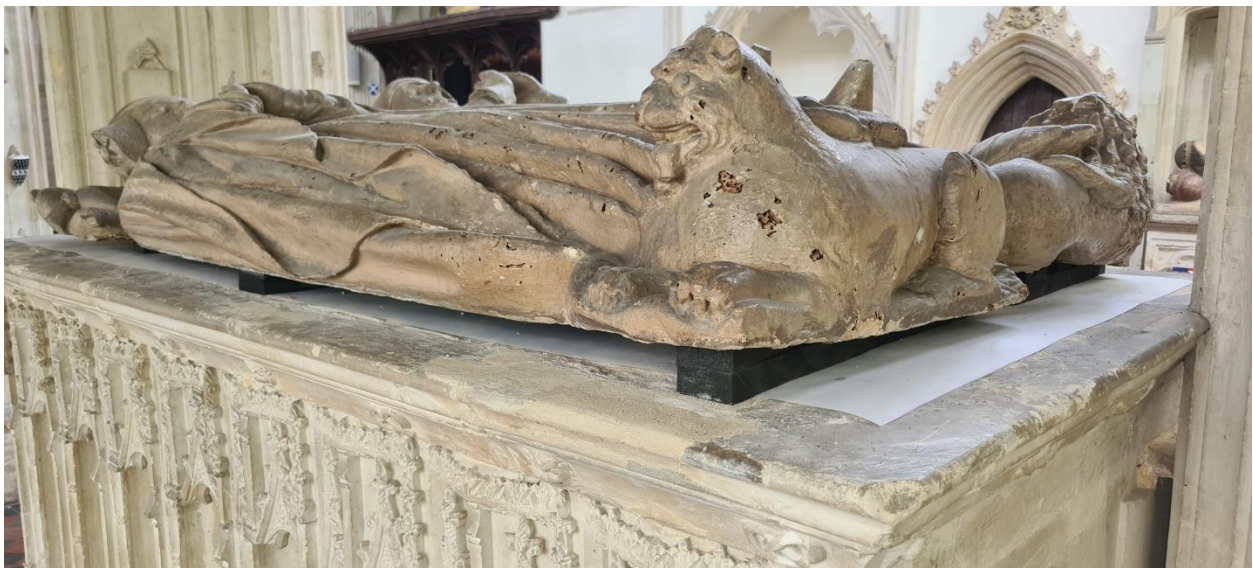
Plate 12: Effigies being supported by Plastazote foam on top of a sheet of Mylar.

Both effigies were placed on *Plastazote*, a museum grade inert high-density foam, supports on top of the plastic sheet. The temporary platform was then dismantled to give access to work on the tomb chest and lower stonework.

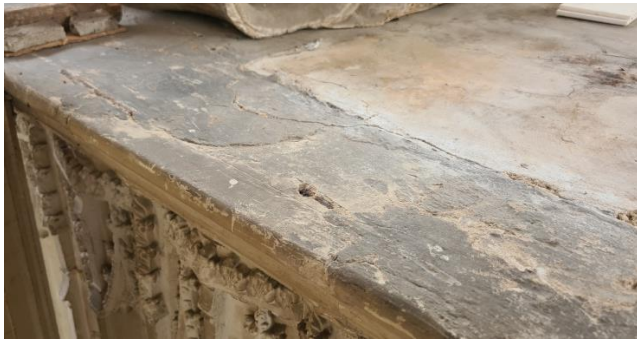
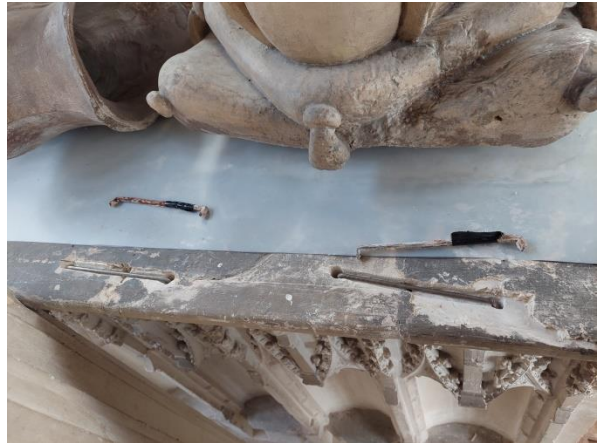
On further inspection all of the cramps around the perimeter of the top of the tomb chest were rusting and needed to be removed and replaced. The iron cramps on top of the tomb chest were carefully removed and replaced with 316 grade stainless steel 6mm threaded dowel set in polyester resin.

Plate 13 and 14: Rusting cramps on top of the tomb chest being replaced with stainless steel

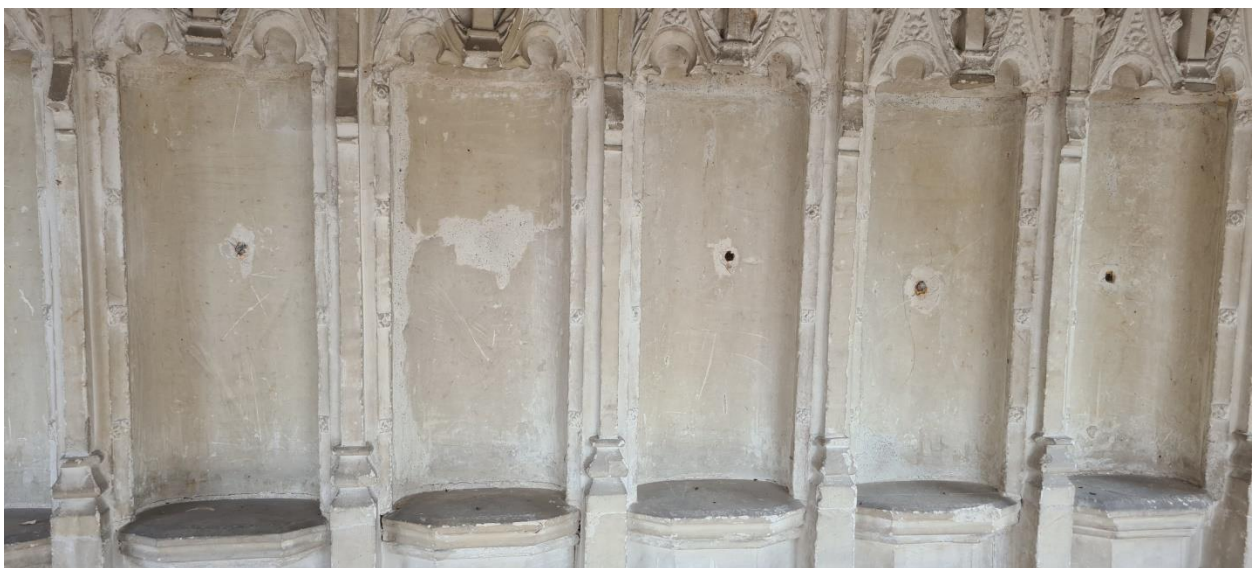
Historic iron fixings which had been causing stresses to the stone due to their corrosion and expansion were carefully removed from the back of the recesses and made good with a lime putty mortar repair mix, see below.

Plate 15: Historic iron fixings before removal

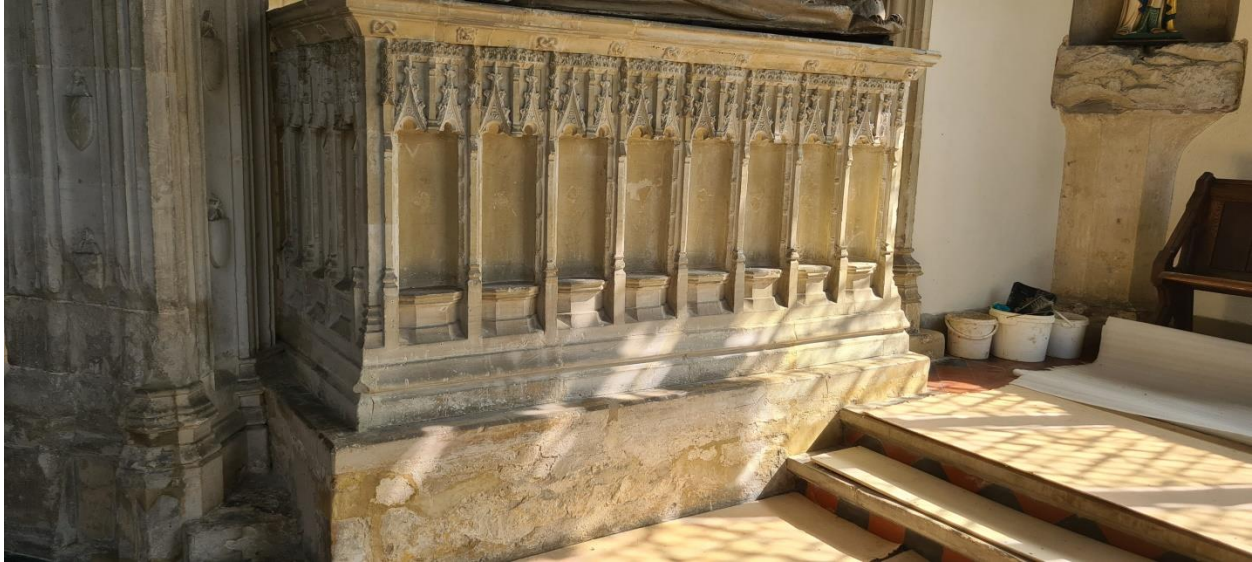
Plate 16: Mortar repair after removing historic iron fixings

The warm limestone repair mortar mix was used to repair over the cramps on top of the tomb chest, and to make good holes left by the removal of historic iron fixings in the recesses of the tomb chest.

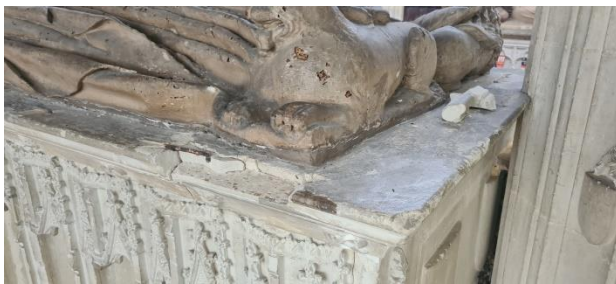
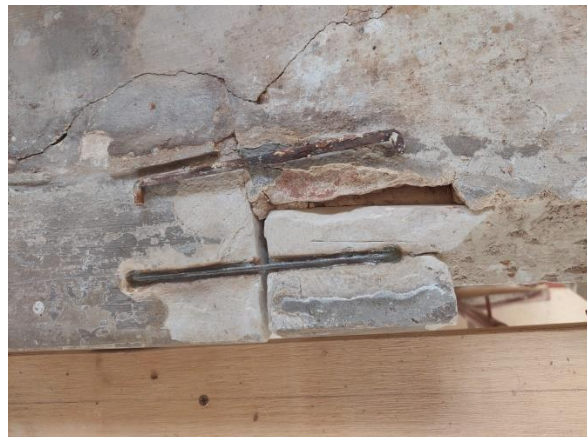
Plates 17 and 18: Before and after the re-attachment of loose indent

The loose indent on the south side of the cornice was re-attached with a 316 grade stainless steel 6mm threaded dowel pin set in polyester resin, when the adjoining iron cramp was removed.

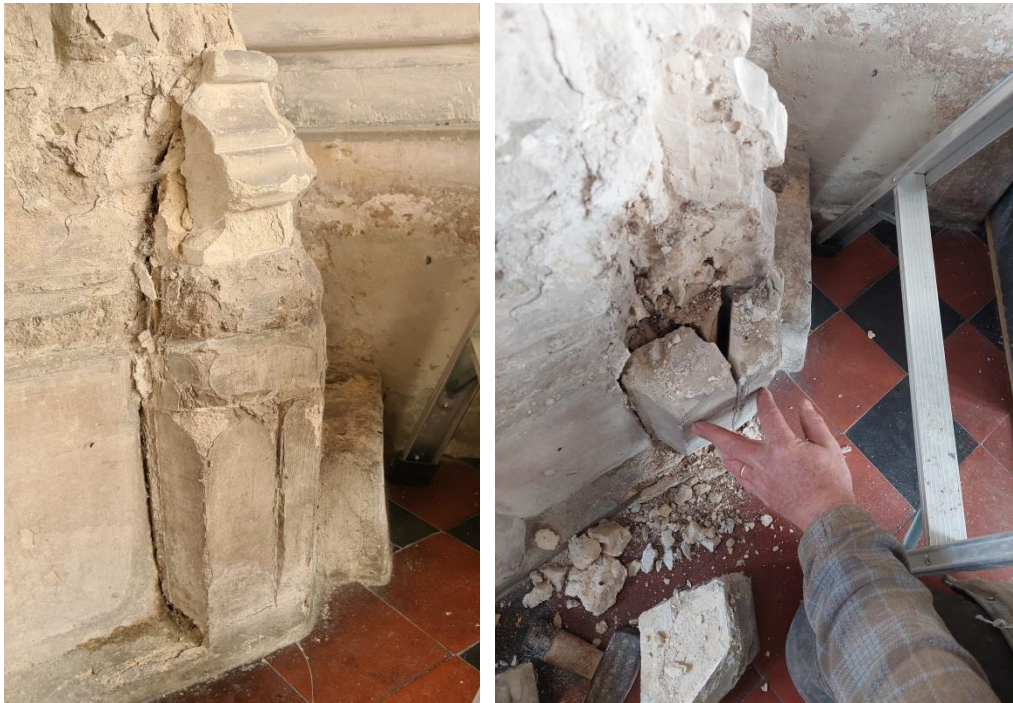
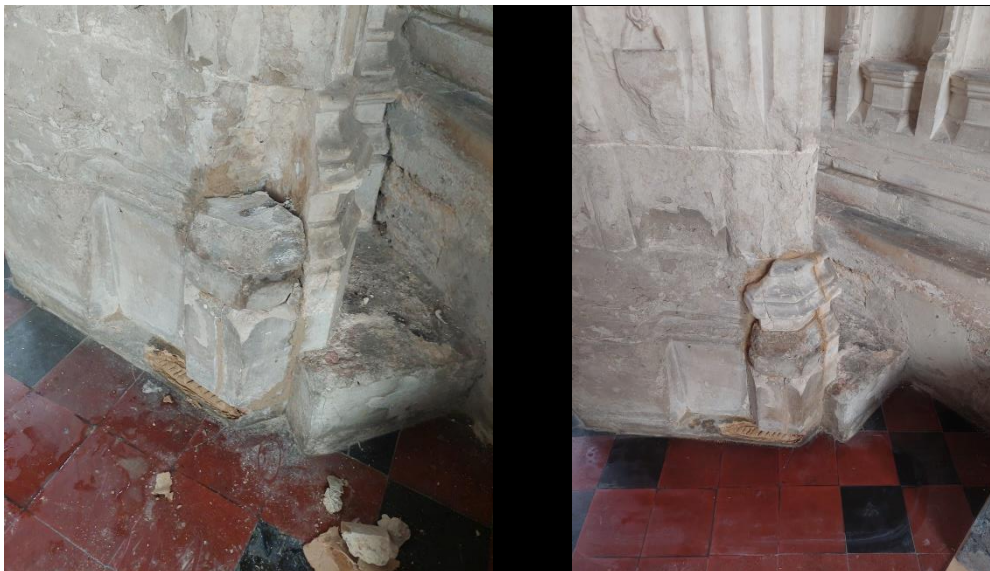
Plates 19, 20, 21 and 22: Column section before removing, and during reconstruction including found section from top of tomb chest

It was noted while repairing the loose column base section that the bottom of the column had been pieced together with small elements.

The loose section of the column base, to the west of the monument, was removed and fractured into several sections. These sections and an additional section found at the feet of the Katherine de la Pole effigy were re-attached with three 316 grade stainless steel 8mm threaded dowel pins set in Hilti HY polyester resin, before being made good with a lime putty mortar repair mix, see below.

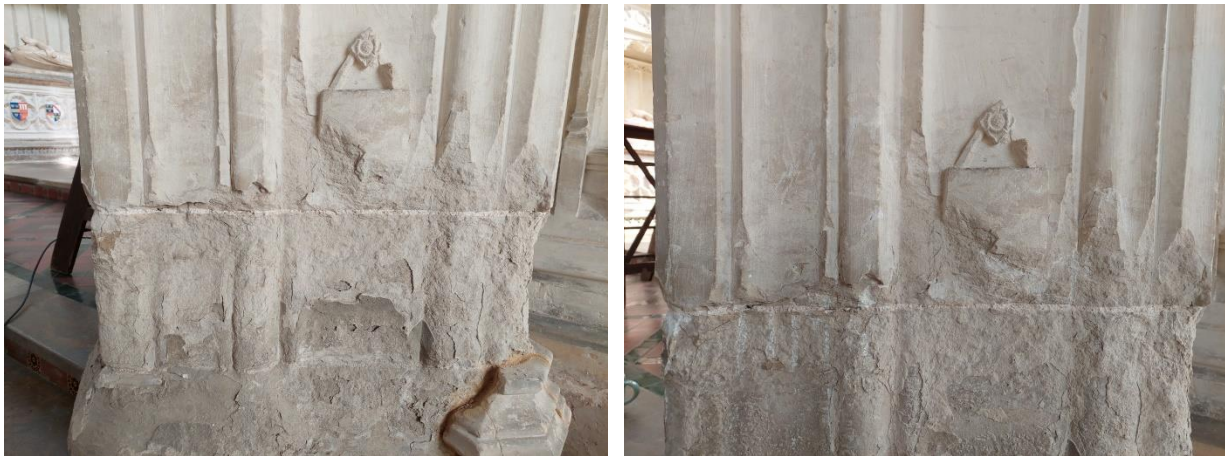
After the section was re-attached, to the column west of the monument, all loose material around the rest of the base of the column was carefully brushed off. The carving details along the salt evaporation line, however, were in danger of being lost and had several cracks underneath them. These cracks were grouted with a lime putty mix before being repaired with the clunch grey colour matched lime putty repair mortar fillet.

Plates 23 and 24: Carving details before and after being grouted on column west of monument

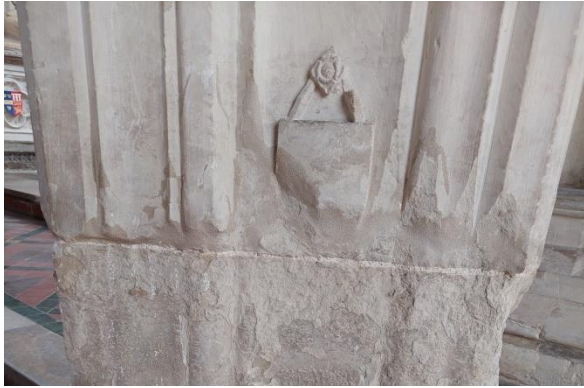
Plate 25: Mortar fillet to carved details on column

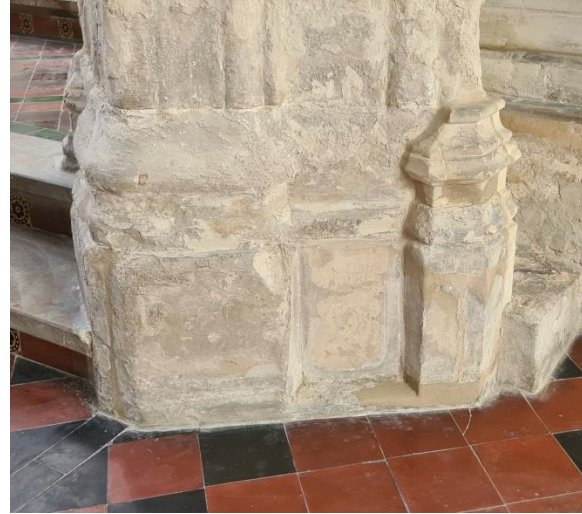
Plate 26: Mortar repairs to re-attached section

After the loose column section was repaired and re-attached to the column, carved details were also repaired with the clunch grey colour matched lime putty repair mortar mix, see plate 26.

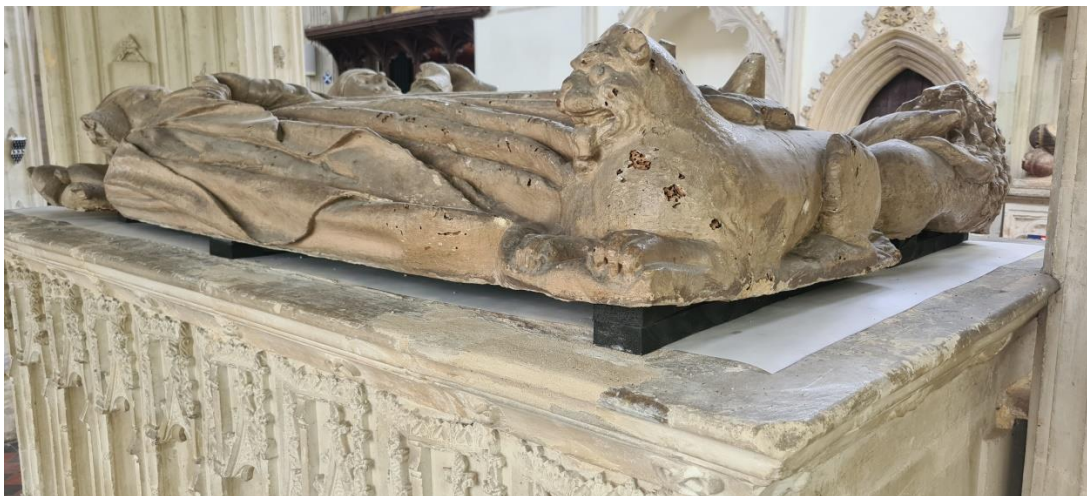
Plate 27: Repair to south side of cornice and replaced cramps

A mortar repair, using the warm limestone repair mortar mix built up in several layers, was made to the missing section of cornice on the south side of the tomb chest. All open joints and cracks on the tomb chest were also filled with the warm limestone repair mortar mix.

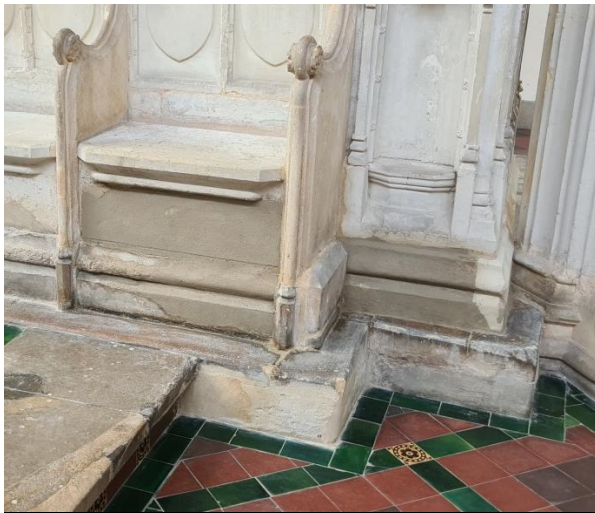
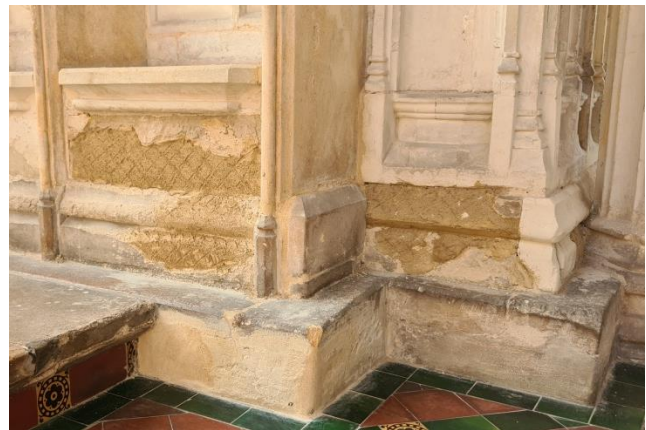
The base of the tomb chest had, like the base of the column to the west of the monument, been damaged by salts. The damaged areas had their loose material carefully brushed away including several loose cement repairs and lost areas were consolidated with the warm limestone repair mortar mix. Some areas on the base of the tomb chest had the original profile rebuilt in several layers in the warm limestone repair mortar mix.

Plates 28 and 29: During and after lime putty repairs to base of monument (north side)

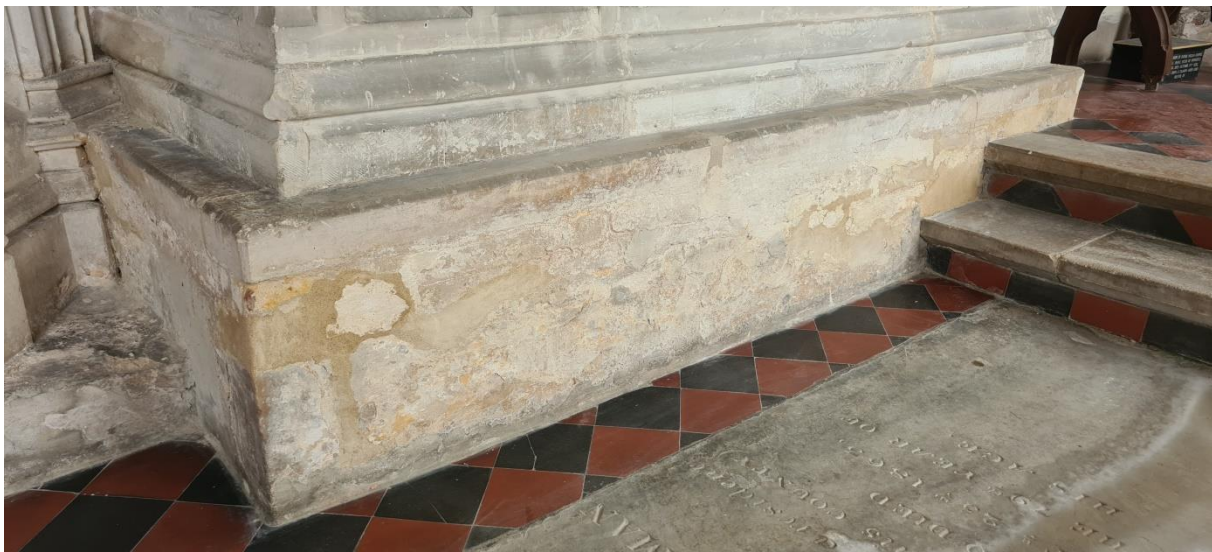
Plate 30: Base of tomb chest (south side) consolidated with lime putty repair mortar mix

All loose joints and cracks on the tomb chest were raked out and repaired with the warm limestone lime putty repair mix.

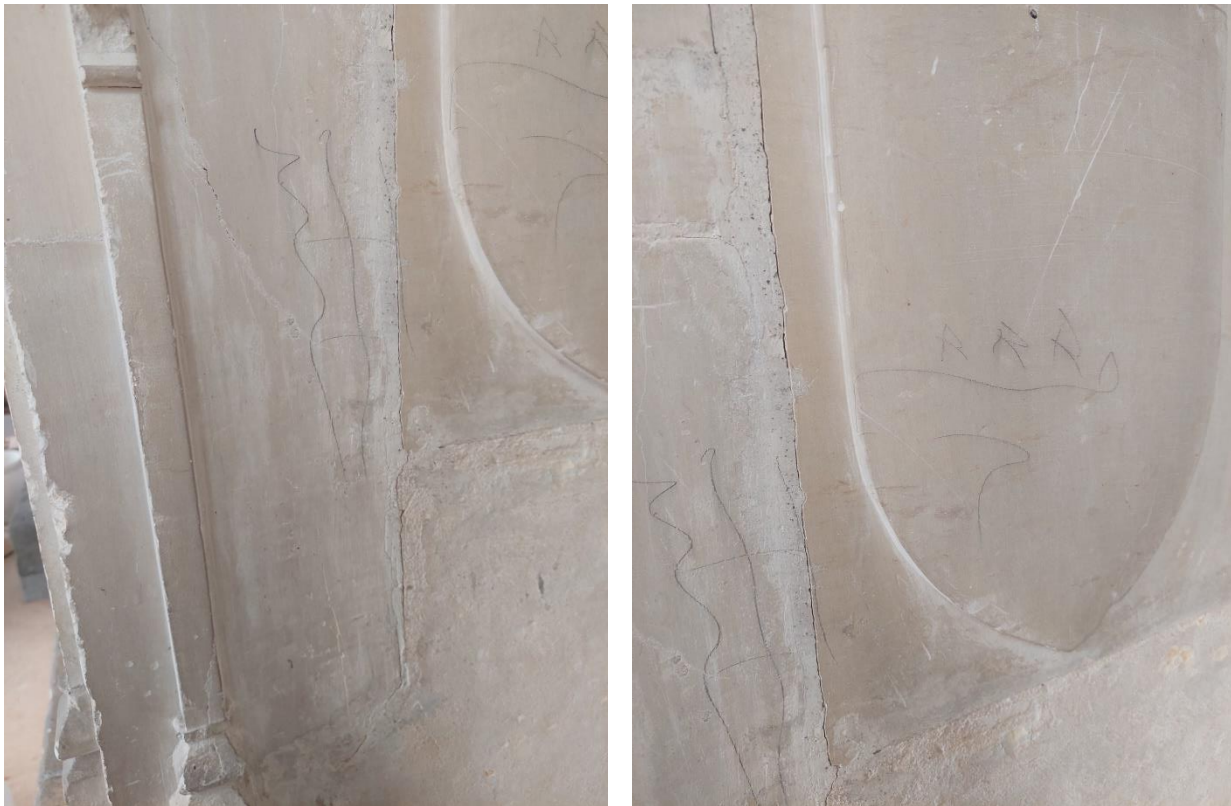
Plates 31 and 32: Graffiti in pencil (?) on East side of tomb chest

Graffiti on the east side of the tomb chest was removed using de-ionised water and melamine sponges, another piece of potentially historic graffiti of an arch was left.

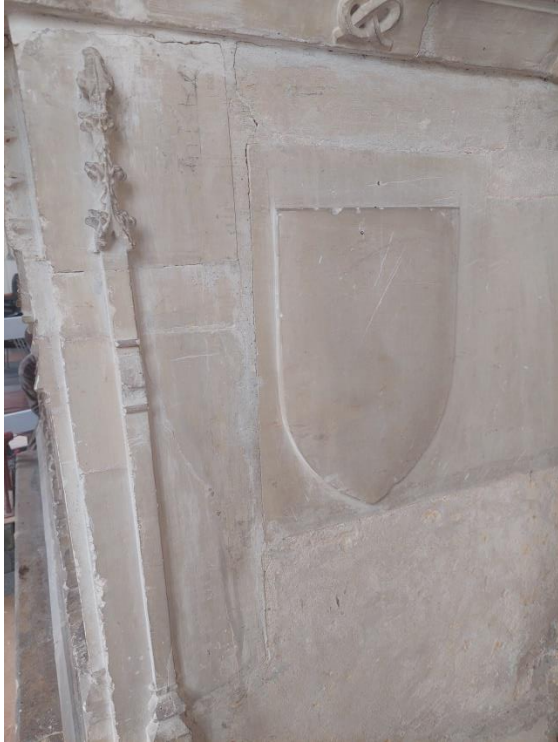
*Plate 33: Graffiti removed with
historic graffiti arch still remaining*

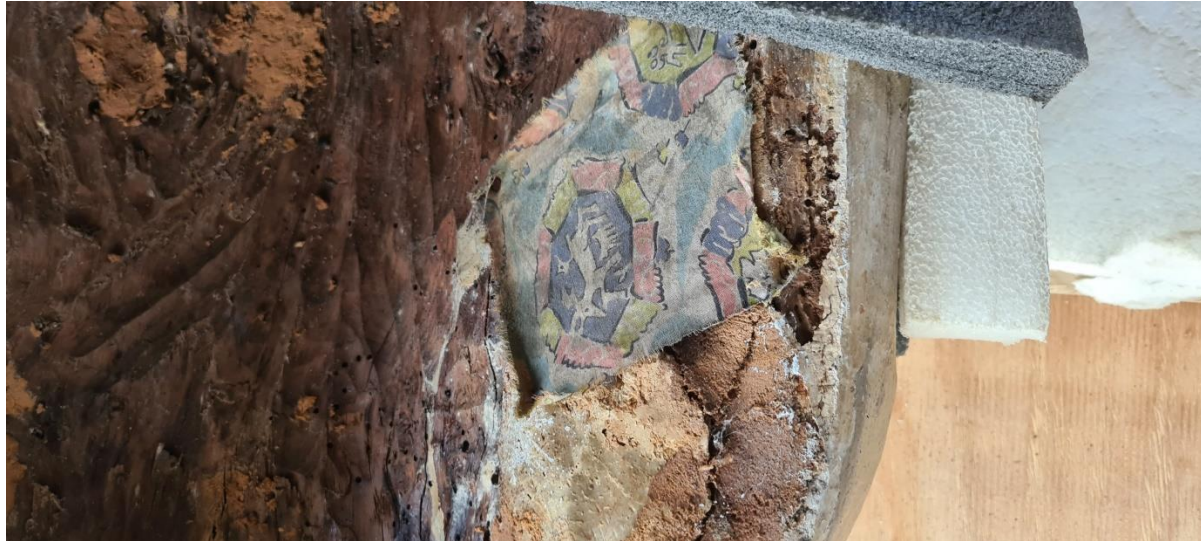
The material used to repair the insect damage on the under side of the Katherine de la Pole effigy has a pattern that looks very much of the 1950s, which would correspond the date of previous roof repairs.

Plate 34: Material used to repair insect damage underneath Katherine de la Pole effigy

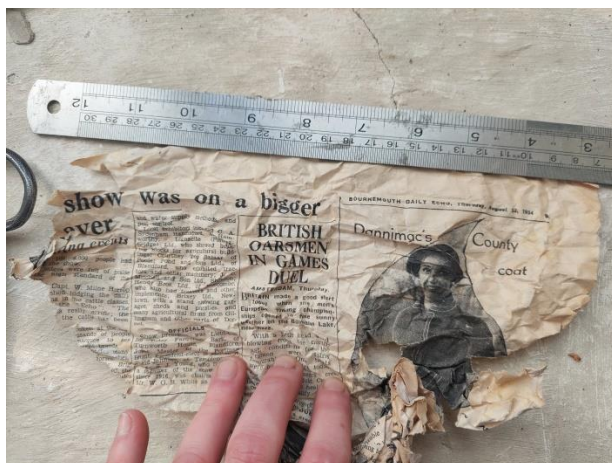
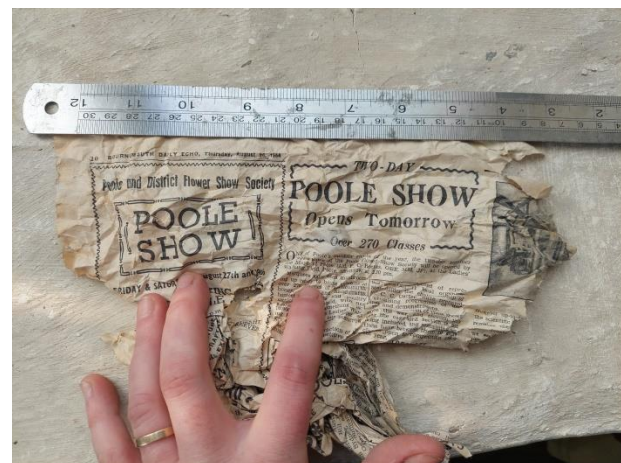
The newspaper found underneath the Katherine de la Pole effigy was from the *Bournemouth Daily Echo* with a date of Thursday 26th August 1954. Further research, beyond the scope of the present record, might identify who carried out this last repair work.

Plates 35 and 36: Two examples of the newspaper found underneath Katherine de la Pole effigy
