OLVESTON St Mary

Tower report

Project No 0639

Rev /
1st June 2017

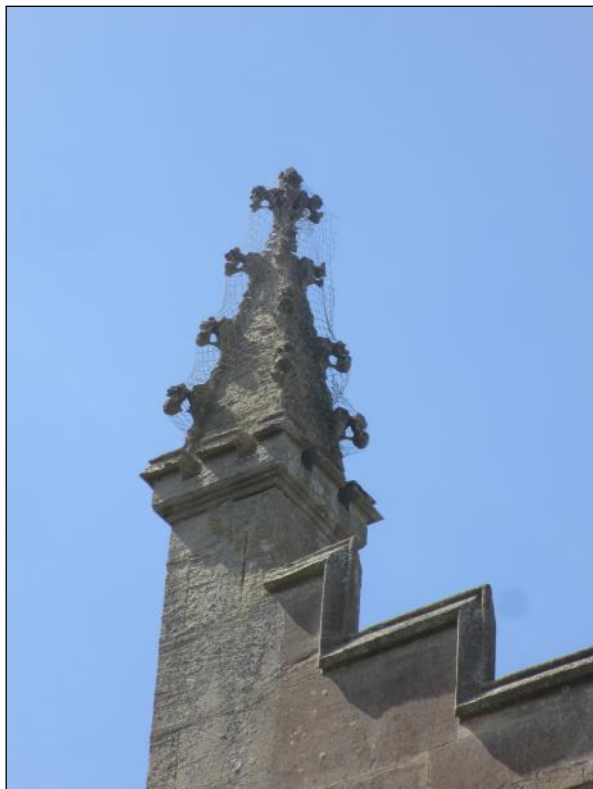
Top left : All four of the pinnacles are currently netted.

- 1.3.14 All the pinnacles have been temporarily netted to assist with catching any stone that becomes loose. One detached section from a finial was noted as being trapped by the netting. The condition of the netting is poor and its replacement is required in the near future.

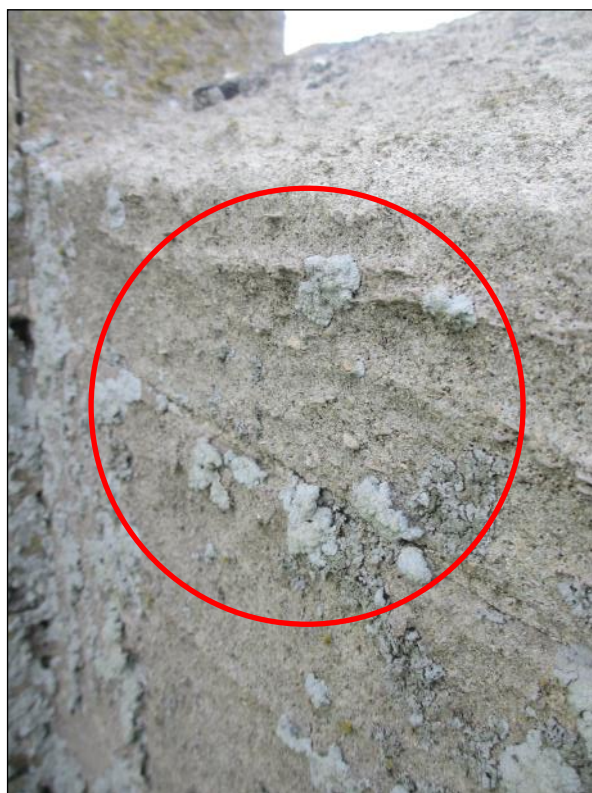
Lower right : The proud shells in the oolitic limestone.

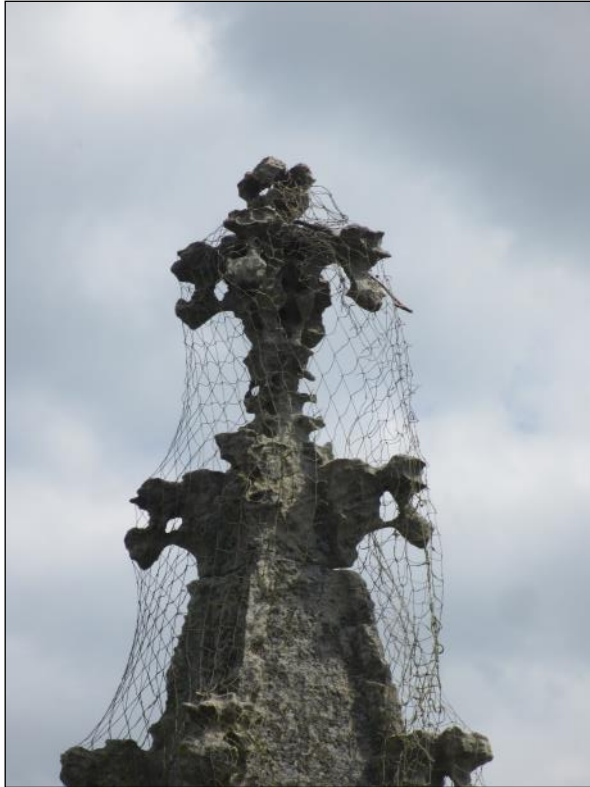
Top left : The neck of the finial has thinned.

- 1.3.16 It is proposed that 4no new pinnacles are carved and installed.

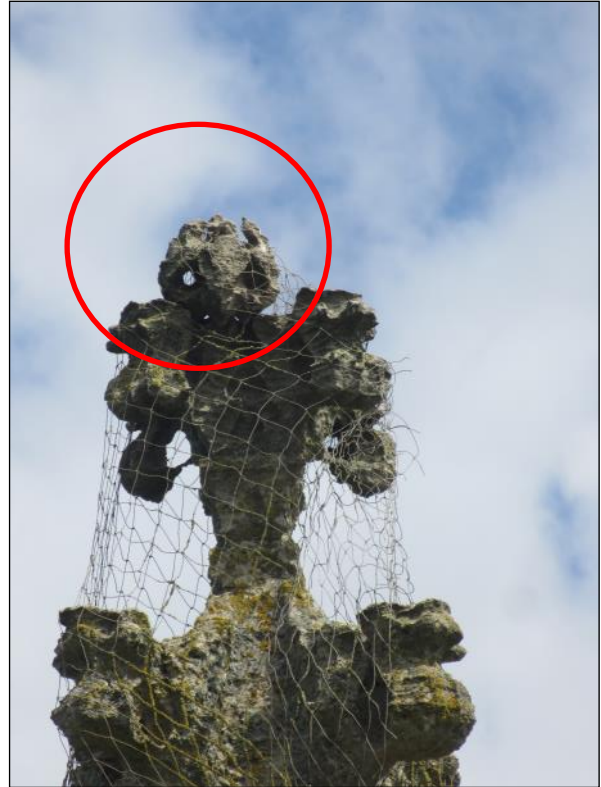
Lower left : Extensive erosion to the crockets and loss of detail.

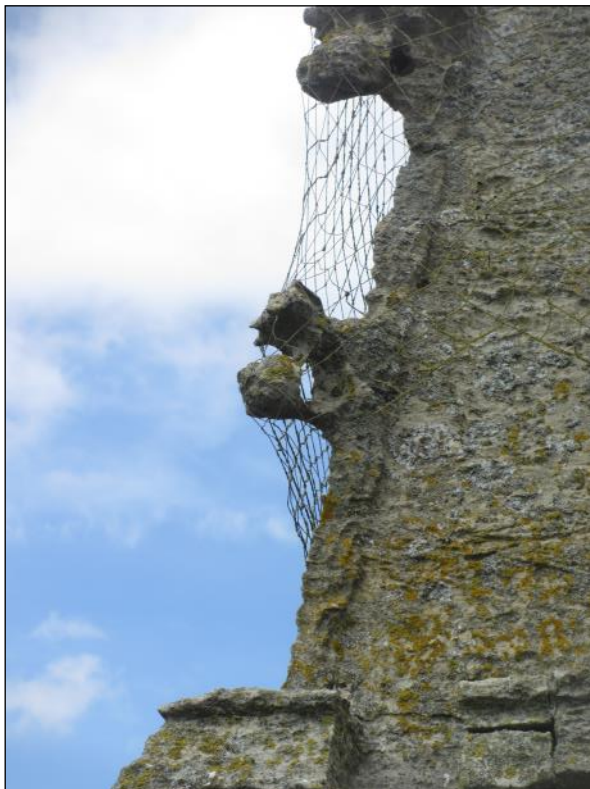
Top right : The ball on this finial has now broken off.

- To this northeast pinnacle, the condition of the lower crockets is fair and the upper crockets poor. The finial is in exceptionally poor condition with the upper section loose and trapped by the netting.

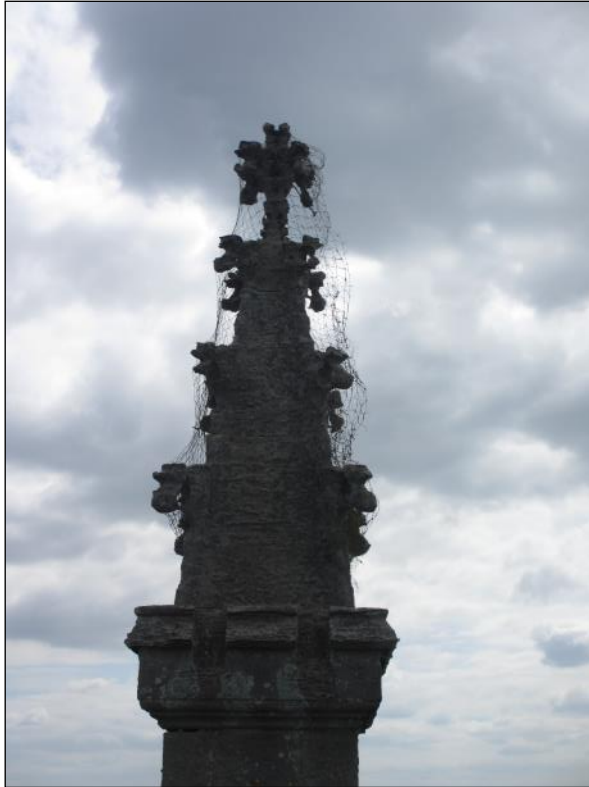
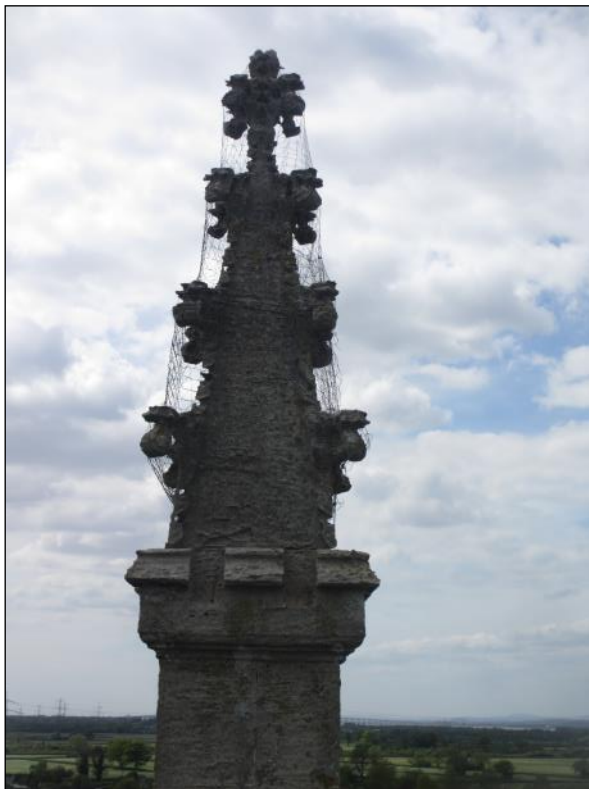
Top left : The southeast pinnacle - viewed looking south.

Top right : The southeast pinnacle - viewed looking east.

- The southeast pinnacle finial neck is badly eroded. All the crockets are in very poor condition with stone loss having already occurred. Further stone loss can be reasonably anticipated at any point.

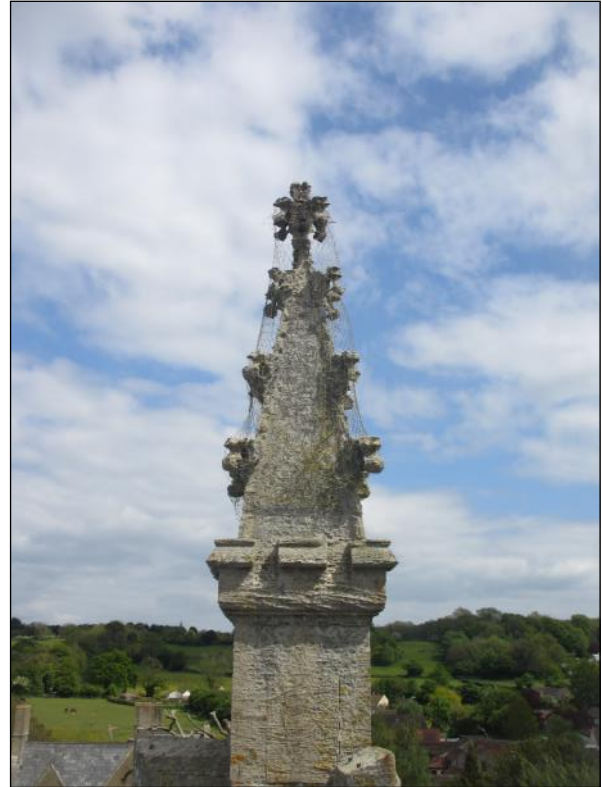
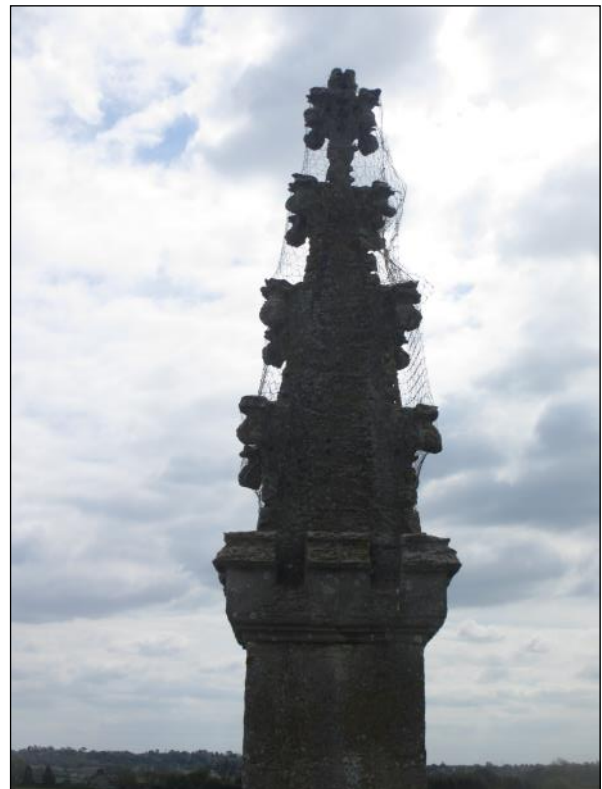
Lower left : The southwest pinnacle - viewed looking west.

Lower right : The southwest pinnacle - viewed looking south.

- To the southwest pinnacle, the neck of the upper finial is significantly reduced in dimension and all the crockets are in poor condition. Stone loss is likely in the near term.

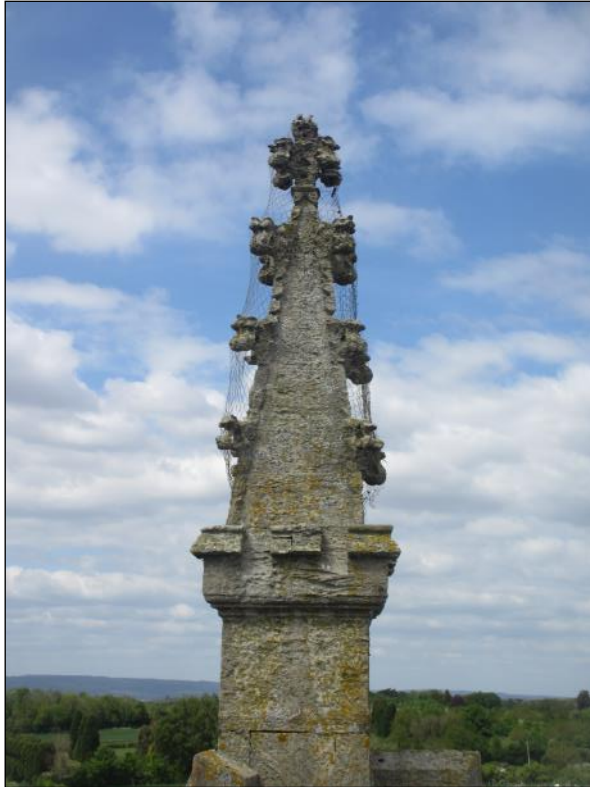
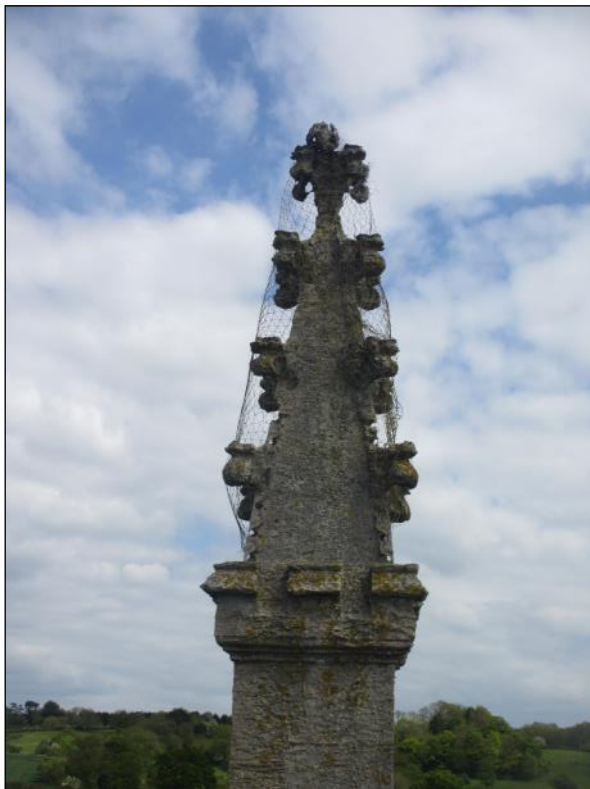
Top left : The northwest pinnacle - viewed looking north.
Lower left : The northeast pinnacle - viewed looking east.
Top right : The northwest pinnacle - viewed looking west.
Lower right : The northeast pinnacle - viewed looking north.

- To the northwest pinnacle, the condition of the upper crockets is better than found elsewhere but the condition of the lower sections is poor. The upper section indicates the extent of stone loss/erosion that has taken place to all pinnacles.

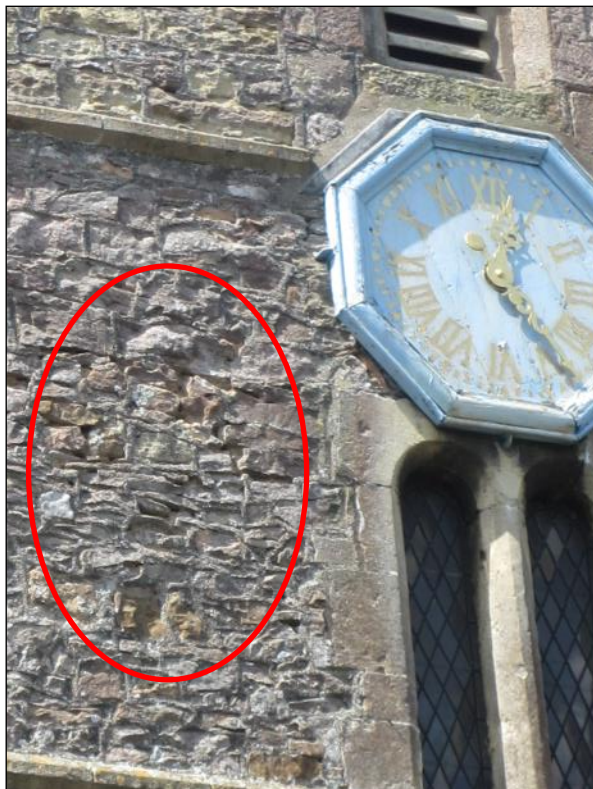
Top left : Extensive mortar loss from the stonework to the east face for of the tower.
Lower left : Damaged and missing stone louvres on the south side.
Top right : Two section of string course on the north side are in poor condition.
Lower right : Loose masonry along the former roof line.

areas, deep voids are visible and approximately 10% of the area requires deep pack pointing. 100% repointing is required.

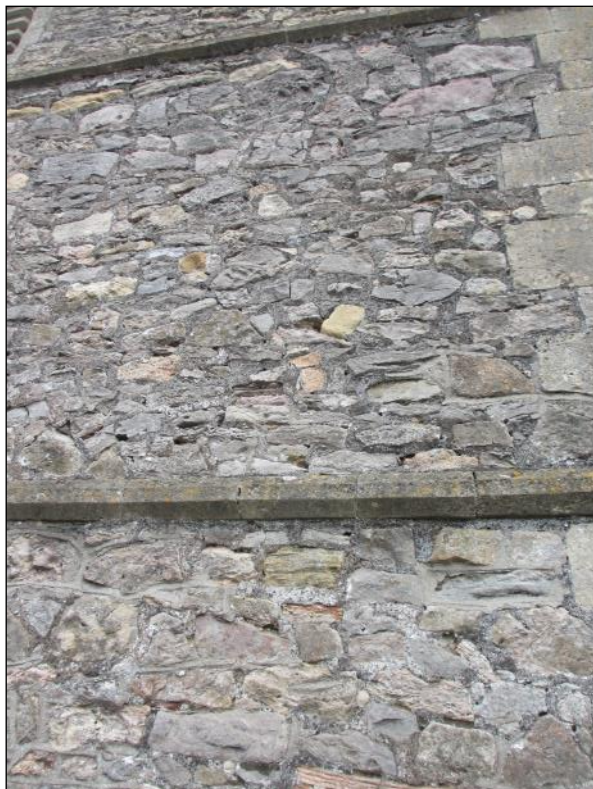
Top left : The typical condition of the stonework and failing pointing to the middle stage (west).

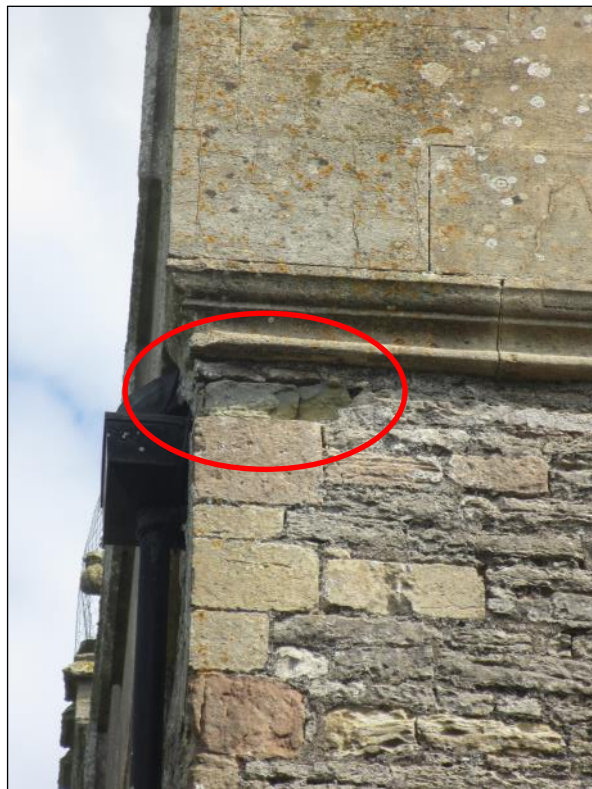
- 1.3.26 To the parapet, washed out joints exist and to the string courses, open perpend joints exist with one small plant noted. 75% repointing should be assumed.

Lower left : Vegetation growing from the string course on the south side.

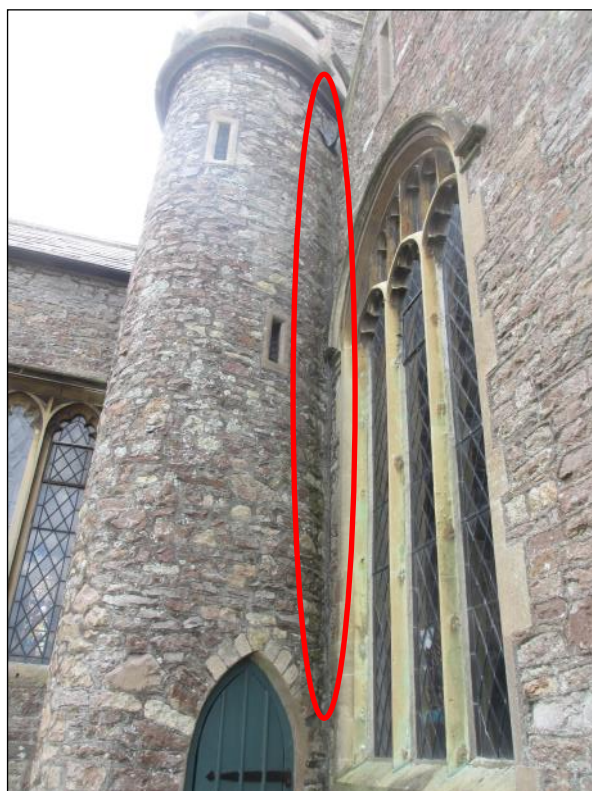
Lower right : Cracking to the detaching vice turret stair.

- 1.3.43 The vice turret is cement pointed full height and there is a significant vertical crack at the junction with the north aisle and the chancel. The stair appears to be not bonded to either wall and the cracking is long-standing. The cracking was assessed by MRM Engineers in 1993 but the presence of daylight through the crack on the south side,

coupled with further movement supports the argument that a new inspection is now required together with proposals to arrest further detachment. An assessment by a Structural Engineer is being sought and a copy of the original report is attached in Appendix I.

- 1.3.44 To the north aisle crack, silicone has been used to re-seal the gap. Following the assessment by a Structural Engineer and the implementation of proposals, it is recommended that all of the cement mortar and silicone is removed and the crack repointed full height. Consideration should be given to repointing the whole of the outer face of the stair enclosure.
- 1.3.45 The 3no vice turret windows are infilled with chicken wire and these would benefit from being replaced with powder coated stainless steel guards to provide permanent bird protection.
- 1.3.46 Internally, cracking is also very evident at the top of the stair. Following the Structural Engineer's assessment and implementation of proposals, approximately 5m² of repointing is required.
