**ST MICHAEL'S CHURCH, ALNWICK,
NORTHUMBERLAND**

**ARCHAEOLOGICAL OBSERVATIONS ON THE
INTERNAL STRUCTURE OF THE UPPER TOWER**

JB Archaeology Ltd

September 2020
Revised October 2020

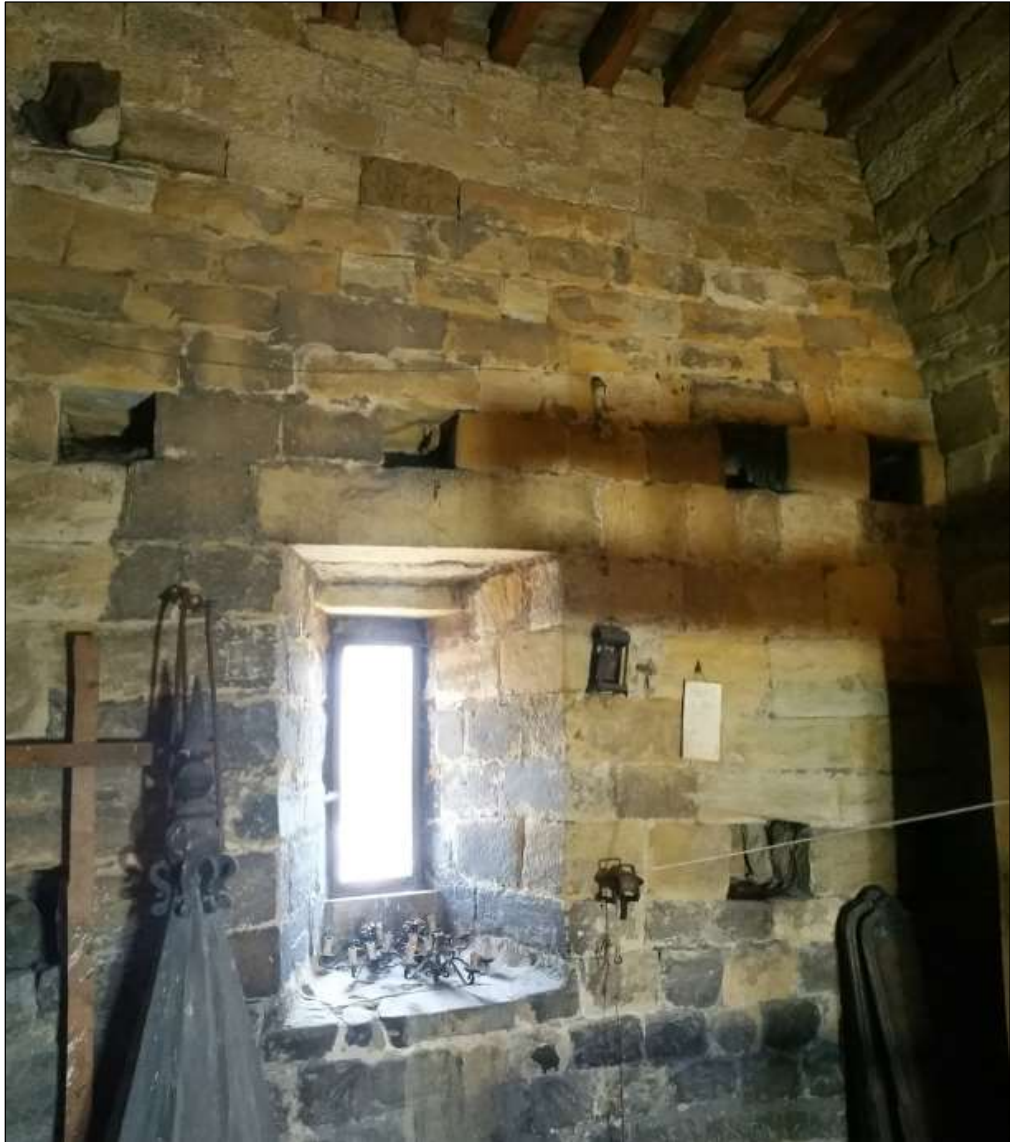
Plate 1. Eastern elevation

- 2.4 Directly above where the remains of the timber baulk there is a noticeable change, in all four internal elevations, in the form of the stonework. This is *c.* 1m below the floor level of the belfry (Plates 1, 2, 4 & 5). This, along with the holes described above, strongly suggest a rebuild or at least a re-configuration of the upper portion of the tower – i.e. the ringing chamber and belfry.

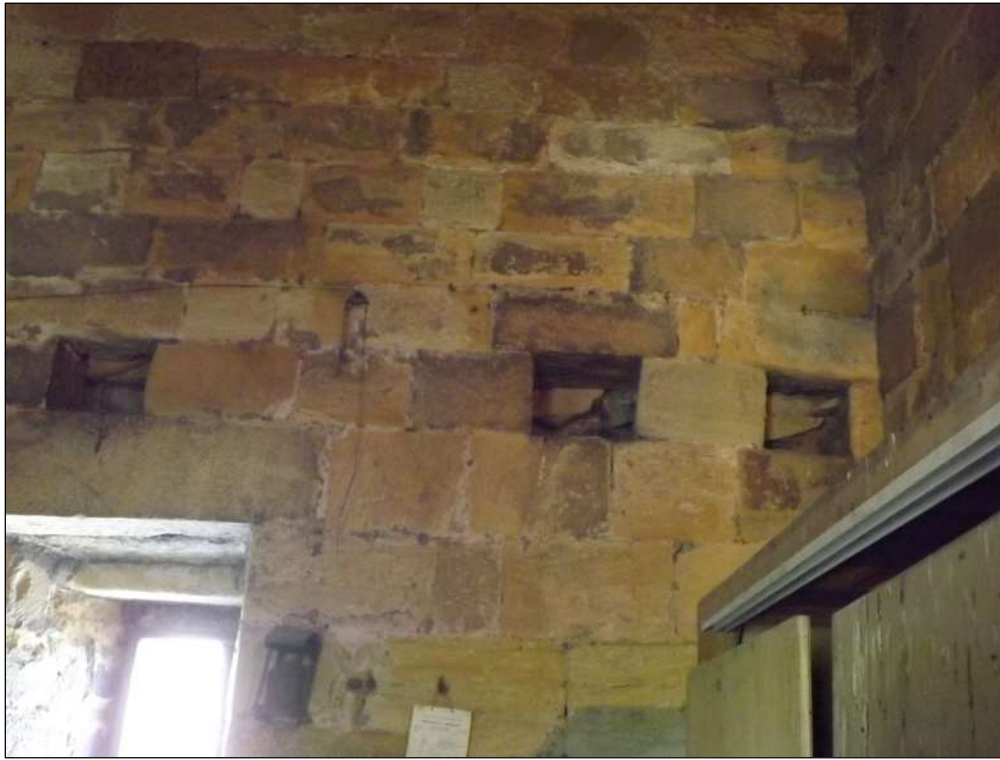
- 2.2 One of these possible joist holes in the eastern elevation could be seen to contain a finely worked architectural stone at the rear of the recess, suggesting a reconfiguration of the wall, in at least this area, using salvaged stonework (Plate 3).

Plate 3. Joist holes in east elevation, note worked stone in 2nd from right and slope of the right hand socket

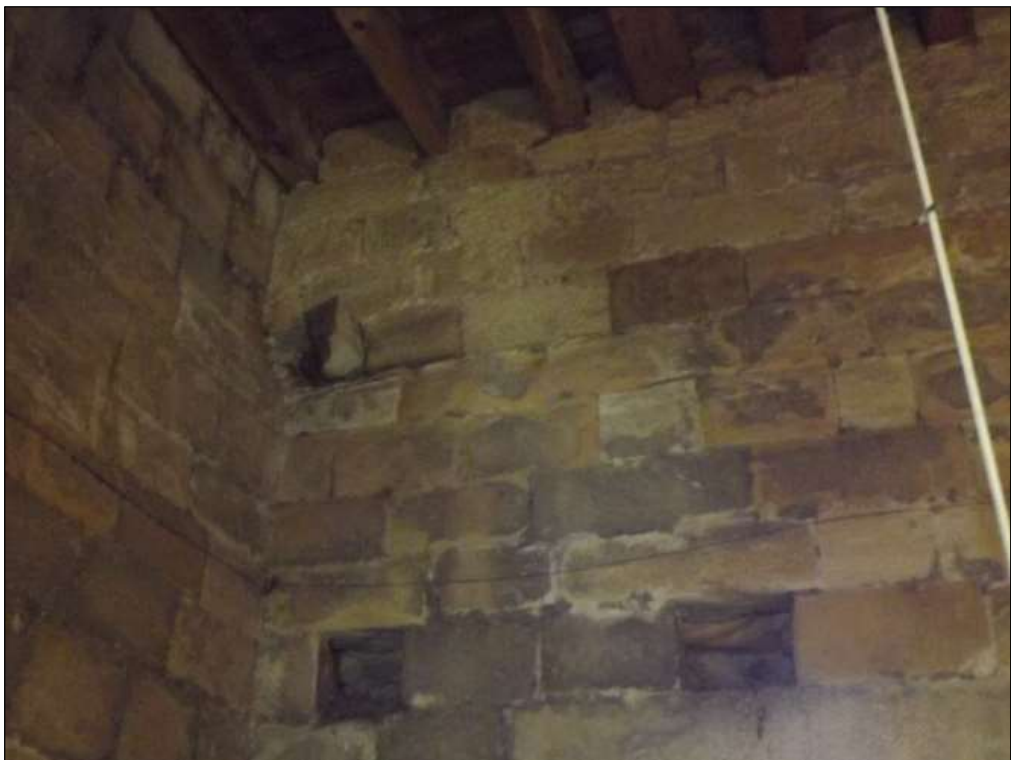
- 2.3 In addition to the lines of possible joist holes the remains of a timber baulk (?joist) towards the north side of the western elevation with a corresponding stub in the south side of the eastern elevation is also possibly indicative of an earlier floor (Plates 4&5). It is interesting to note that the remains of the baulk

Plate 4. Timber baulk in east elevation, note change in stonework above baulk

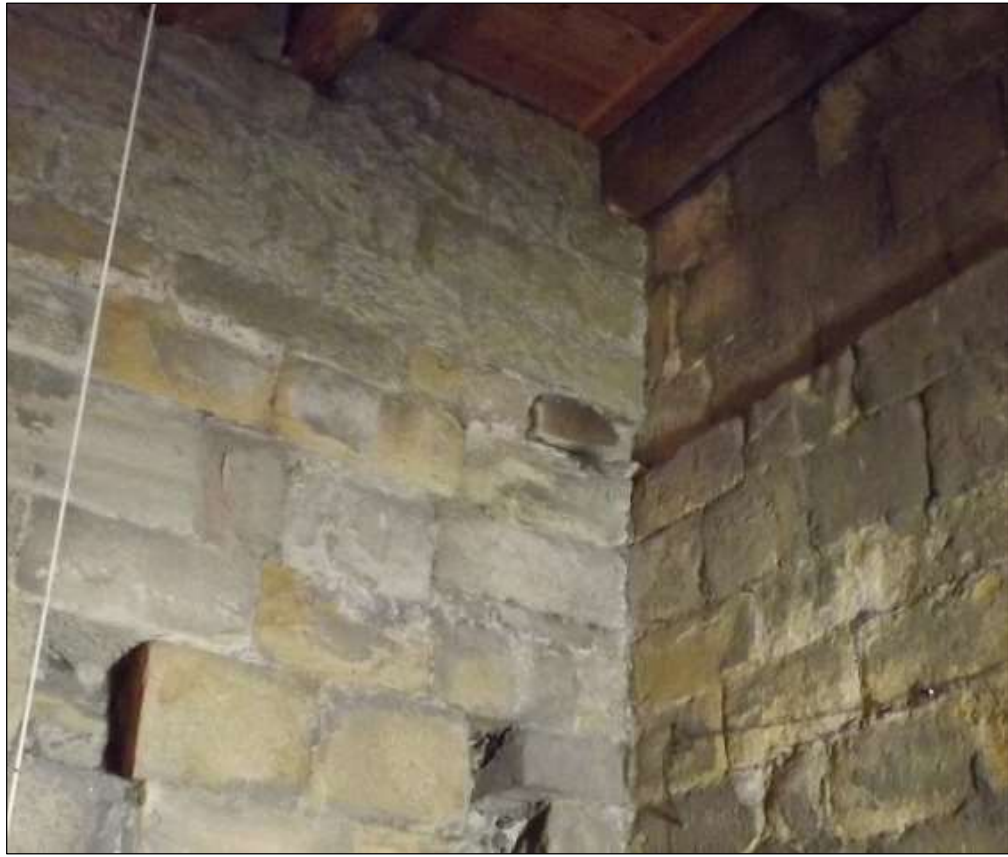
appear to have a potential relationship with the step in the stonework of the north wall (Plate 5).

Plate 5. Timber baulk in west elevation and note change in stonework

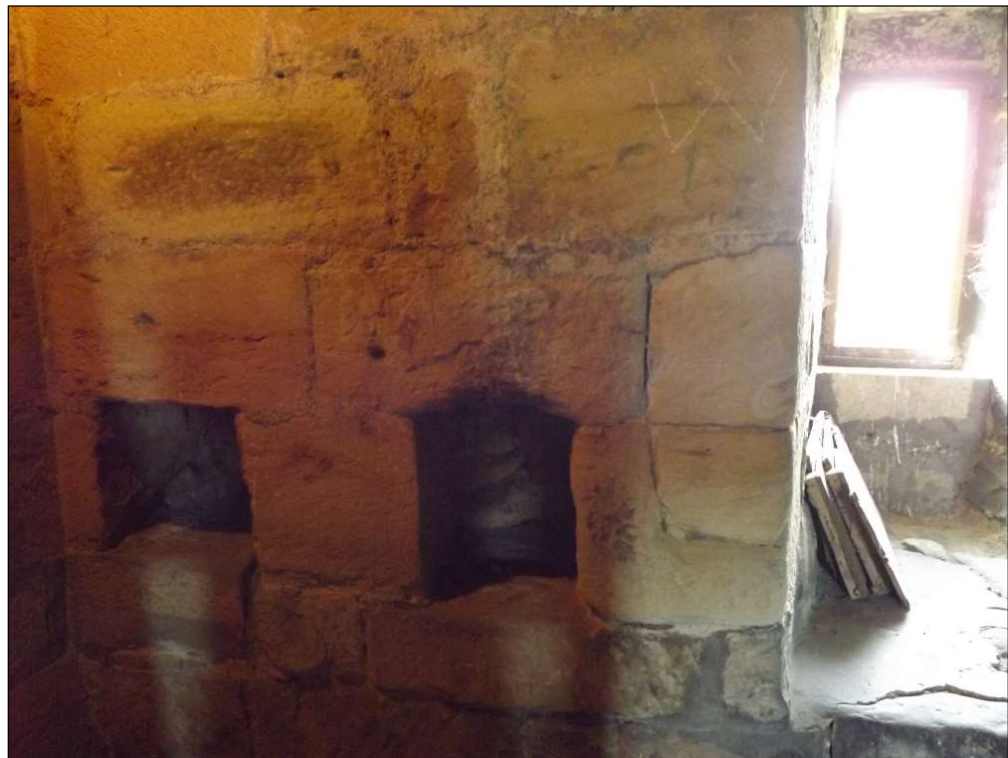
- 2.5 Although there currently seems to be strong evidence for changes in floor levels within the ringing chamber there is also much evidence for current floor having been established for a long time. The main evidence for this is the fact that the current floor level is the same as the one that survives on all existing plans of the church and that it seems to relate well to the level of the sills of the current windows. Though the sill of the two windows are formed differently in each elevation which could suggest past alterations. Further evidence is the presence

of at least two lantern niches in the western elevation with sooting on the upper stonework (Plate 6).

Plate 6. Lantern niche & irregular stonework in window reveal in W elevation

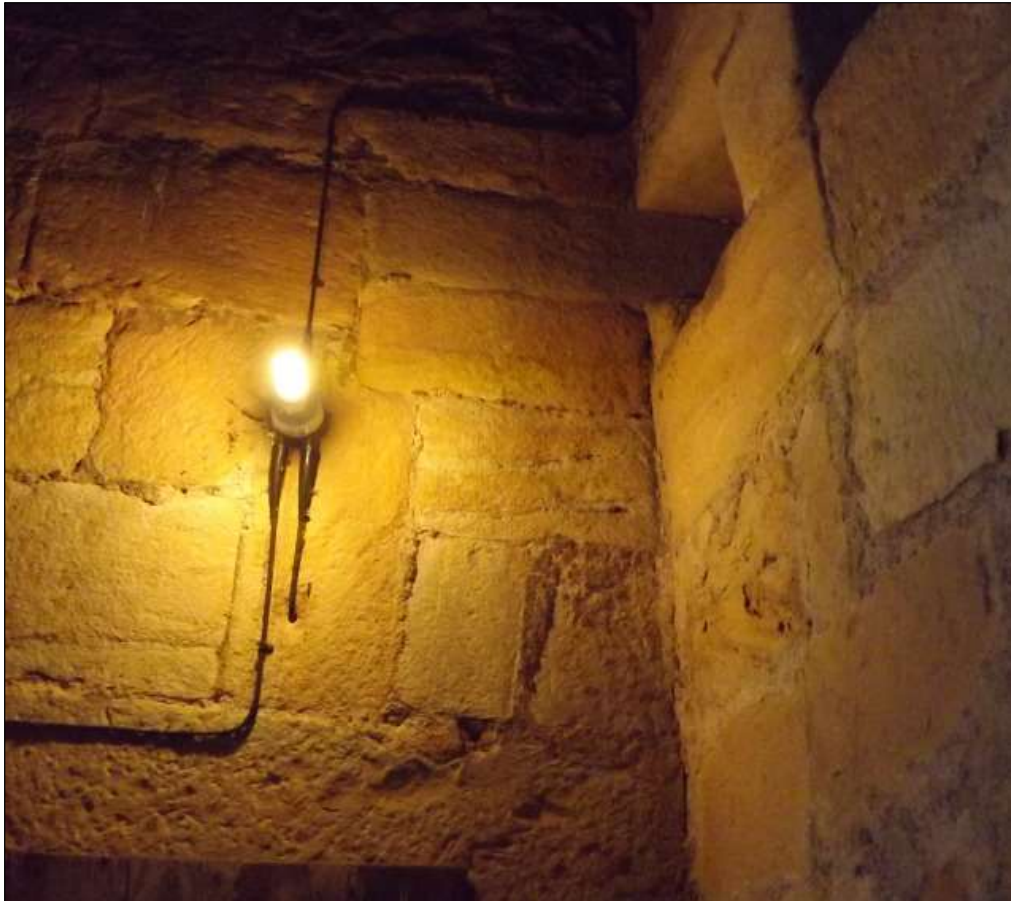
- 2.6 A closer inspection of the stone work around the doorway into the ringing chamber and the on the southern side of the window in the western elevation noted some marked discontinuities in the stone coursing (Plates 7&8). Changes in the coursing such as that seen here is not readily obvious anywhere else in the ringing chamber and may also indicate some form of rebuild in this portion of the tower. This could well be related to the features noted at the top of the spiral stairs, on the other side of the door to the ringing chamber, which are discussed below.

Plate 7. Irregular stone work over door in south elevation

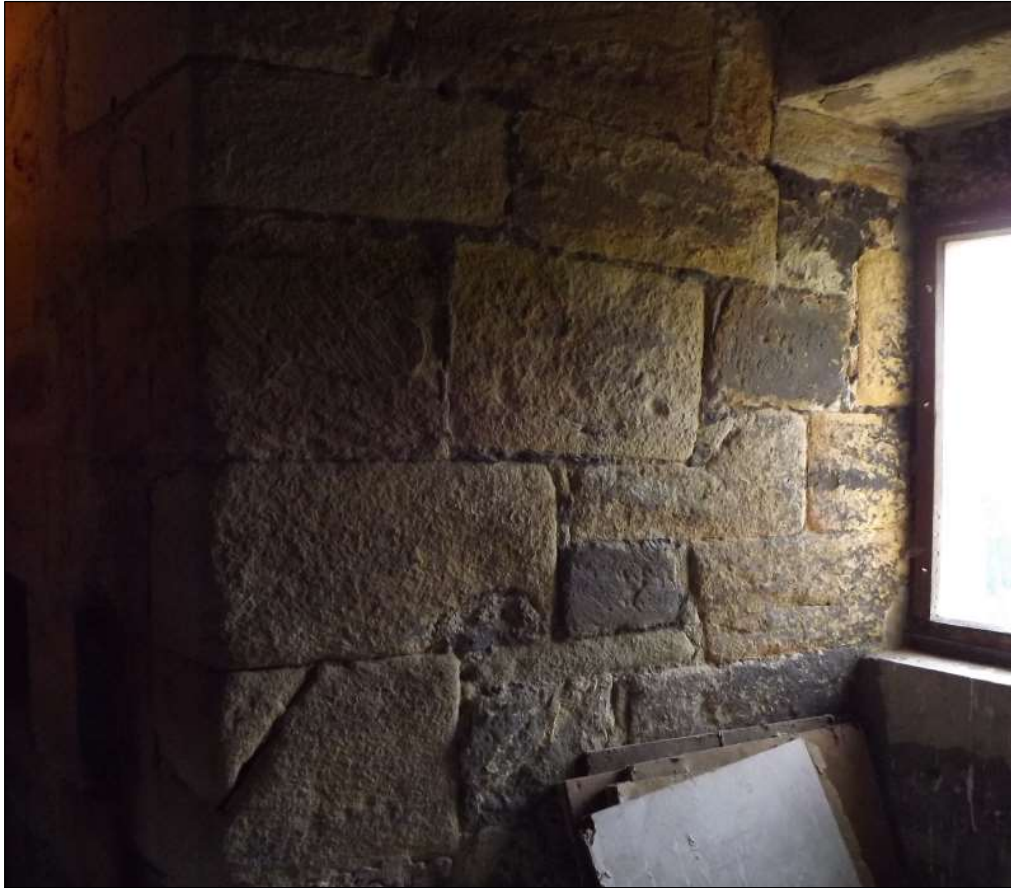
Plate 8. Irregular stone work in window reveal

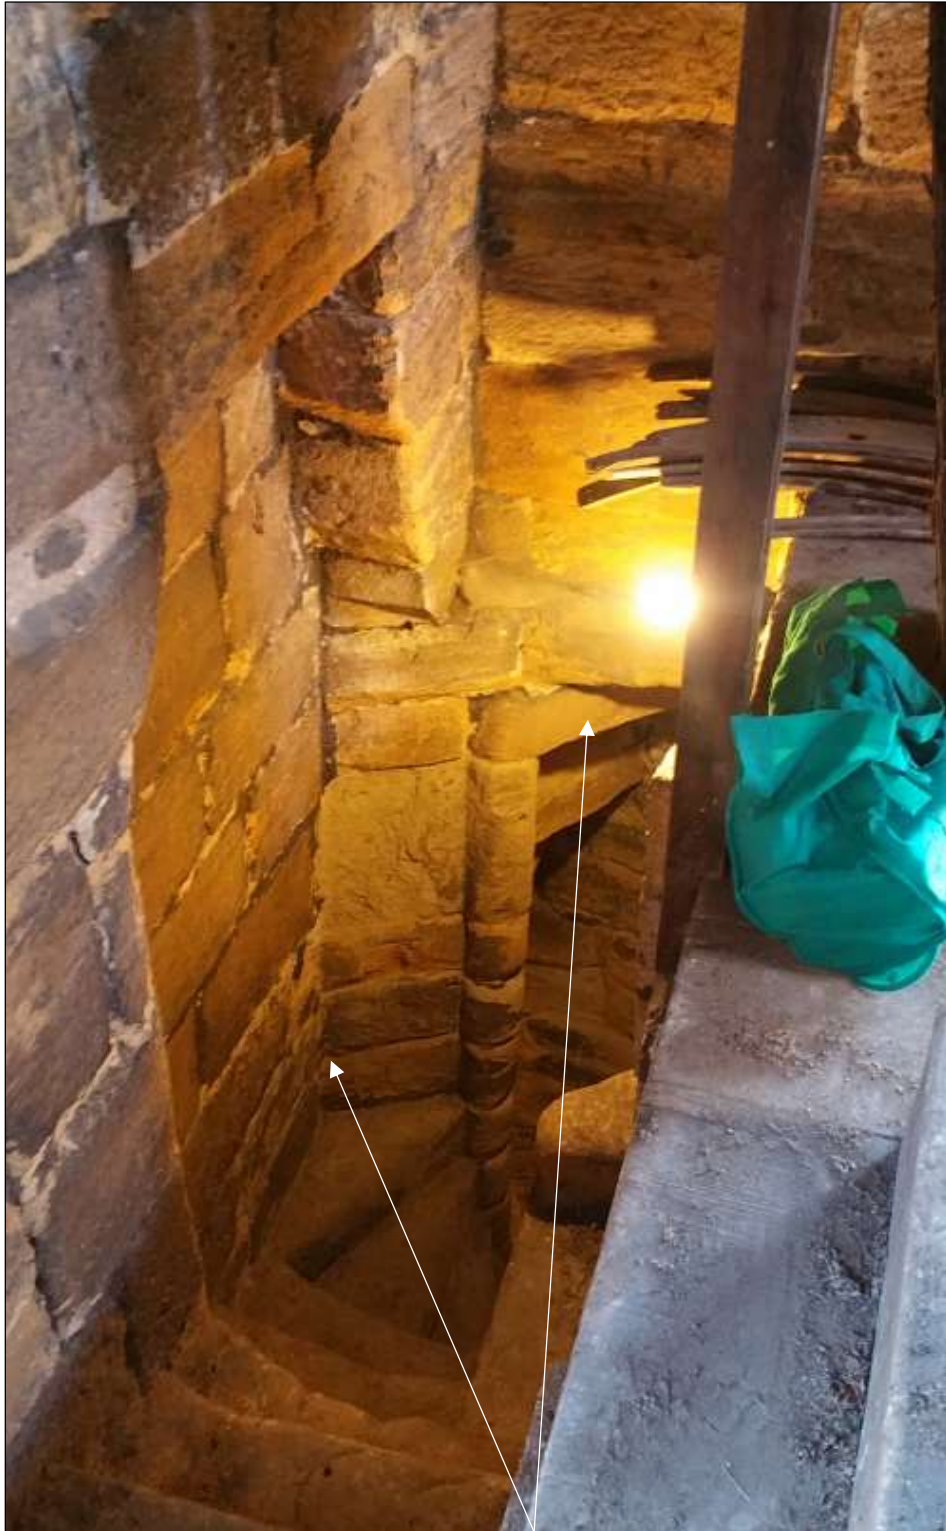
- 2.7 Probably the most obvious feature in the upper part of the tower, and one that has been commented on before (Ryder, ND, 8, and Ryder, 2018, 2), is the abrupt change from the spiral stone stairs to the straight run which enters the belfry. At the point of change there is also the access to the ringing chamber. It can be clearly seen that the spiral stairs originally (or at least in an earlier configuration) continued upwards and have been blocked off (Plate 9). This is visible in both the stonework constructed across the steps and the underside of the continuing spiral. Where the spiral has been blocked off the stone work has all the appearances of being a blocked opening – a window or more likely a door as it extends down to the step of the stairs. The head and jambs of the opening can be seen to have carefully chamfered stonework suggesting a well formed, intended to be permanent, opening (Plate 10). As this opening would, currently, be straight out into the southern elevation it does not appear to be leading anywhere, so potentially a window here is a more logical explanation. However, there are no other windows at this height in the tower and no obvious signs of blocked openings in any of the external elevations. One possible option is that there may have been a second ‘turret’ to mirror the one in south-eastern corner of the main body of the church and that later works have removed much of the evidence for this.

- 2.8 From the evidence of the remains of the continuation of the spiral stairs it would seem that it originally (or in a different phase) continued up for at least another floor. If this were the case it would seem possible that it may have provided

access to a now missing floor represented by the upper row of possible joist holes seen in the ringing chamber as described above.

Plate 9. Top of spiral stairs showing continuation of now blocked of spiral (D Beaumont)

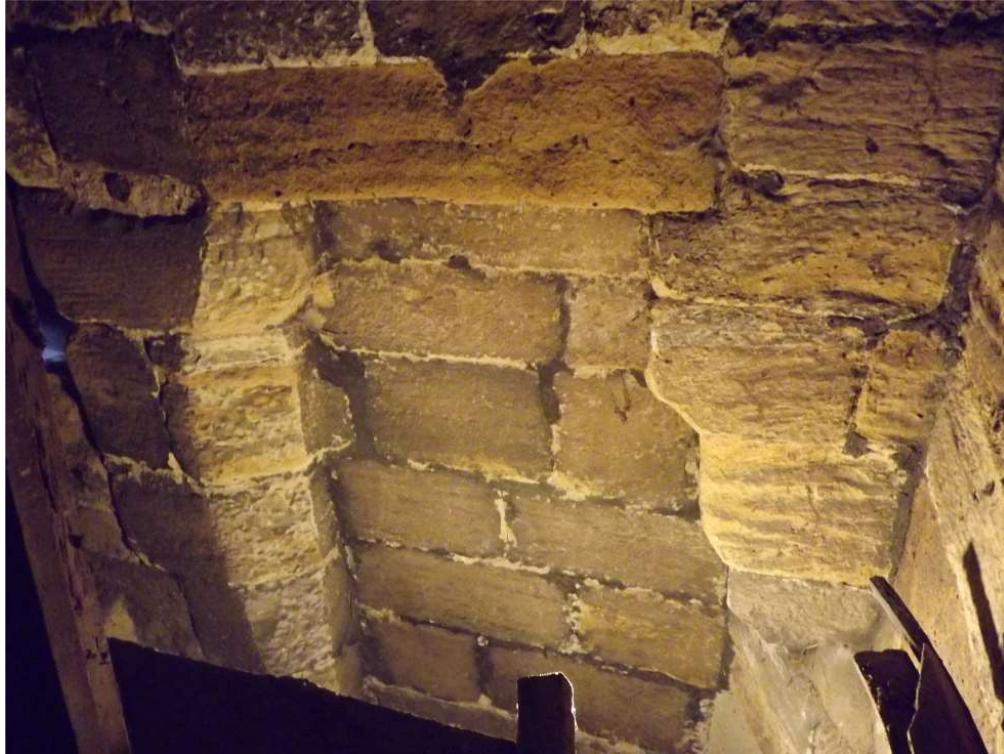
Plate 10. Probable blocked opening in south elevation

- 3.5 In conclusion from the brief examination of the interior of the ringing chamber and top of the spiral stairs it would appear that an earlier form of the tower had the spiral stairs continuing up to at least another floor. In this form the stairs would have also provided access to a floor which was slightly higher than the one currently seen in the ringing chamber. At some point the now blocked opening in the southern elevation was inserted through the turn of the spiral stairs thus potentially isolating the earlier upper floor. What this opening was for is uncertain but it would either be a window or doorway. If it was a window then it would normally be assumed that there would be others in the tower to provide some form of symmetry, which there do not seem to be. For it to be a doorway then it would need to lead to a room or space of some form. Currently

it would have opened into 'fresh air' but, as mentioned above, if a matching turret had been built on this corner it would have provided access to that.

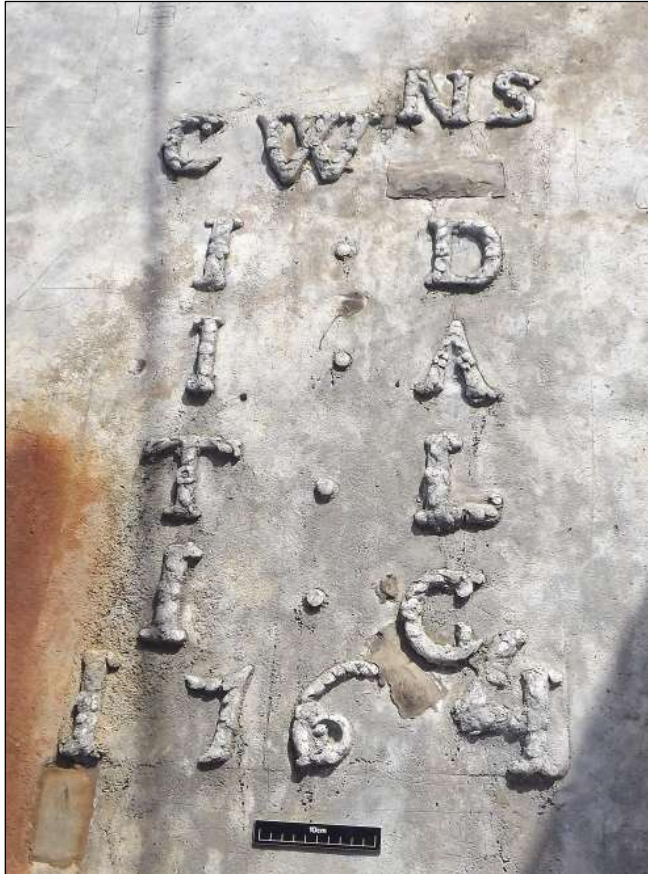
no evidence for when this happened but the initial results of the graffiti survey on the roof of the tower has recorded a large lead plaque on the roof with a series of initials and the date 1764 (Plate 11). So far this is the earliest date identified in the graffiti on the roof and could suggest a *terminus post quem* for the current configuration of the roof.

Plate 11. Lead plaque of 1764
