## Stained Glass Record of Works Undertaken

<b>Site: St John's Church, Howsham</b>	
<b>Works undertaken by: Keith Barley, Alison Gilchrist, Aurélie Haugeard, Anne-Catherine Perreau, Helen Whittaker and Daniel Thomas</b>	<b>Completion date: 27 January 2020</b>
<b>Barley Studio, York YO19 5LH Tel: 01904 489093 Web: www.barleystudio.co.uk</b>	<b>Owner / client: PCC St John's Church</b>
<b>General description: Repair, maintenance and restoration of eight stained glass windows</b>	
<b>This record should be read in conjunction with the Proposal of Works by Keith Barley, 27 August 2018. All works recommended to windows I, sII, sIV, sV, nII, nIV, nV and wI have been undertaken, as detailed below.</b>

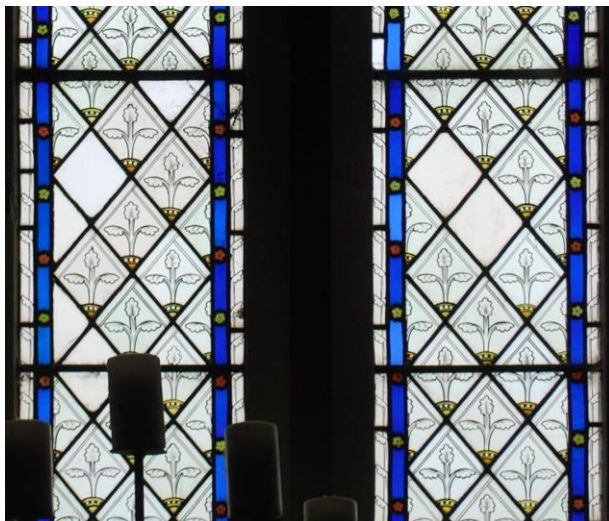
*Detail: window nIV lights b and c before restoration showing previous unpainted repairs*

- Eleven previous repair pieces (unpainted) replaced with new pieces, painted to match original with Reusche pigment and Rockingham silver stain, fired, on antique glass of matching tint to original
- Support bars rubbed down and painted with Hammerite Metal Paint (Smooth Black)
- The external surface of the leadwork re-sealed with linseed oil glazing cement
- All loose mortar pointing raked out and the window re-pointed using hydraulic lime mortar
- Glass cleaned in situ using deionised water on microfibre cloths.

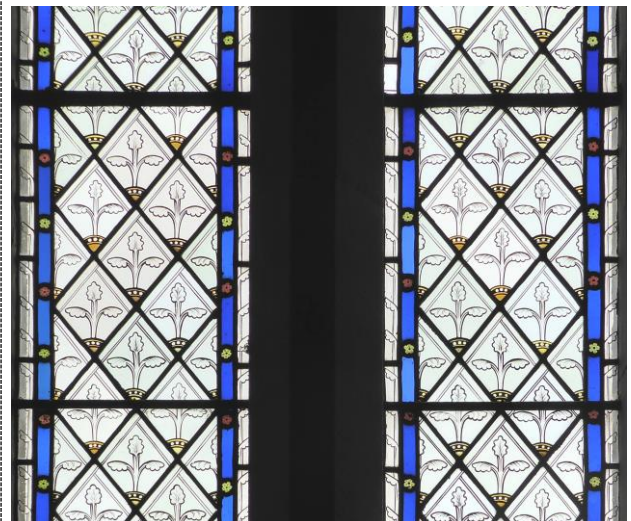
*Detail: window nIV lights b and c after restoration with new painted pieces*

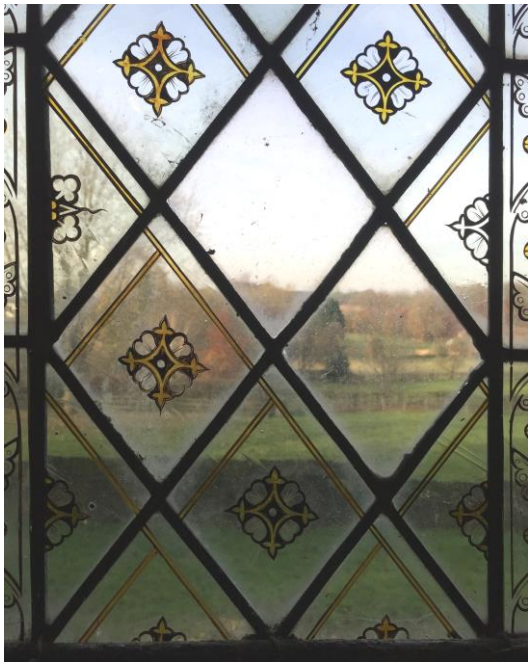
*Detail: window nV light b before restoration showing previous unpainted repairs*

- Two previous repair pieces (unpainted) replaced with new pieces, painted to match original with Reusche pigment and Rockingham silver stain, fired, on antique glass of matching tint to original
- Support bars rubbed down and painted with Hammerite Metal Paint (Smooth Black)
- The external surface of the leadwork re-sealed with linseed oil glazing cement
- All loose mortar pointing raked out and the window re-pointed using hydraulic lime mortar
- Glass cleaned in situ using deionised water on microfibre cloths.

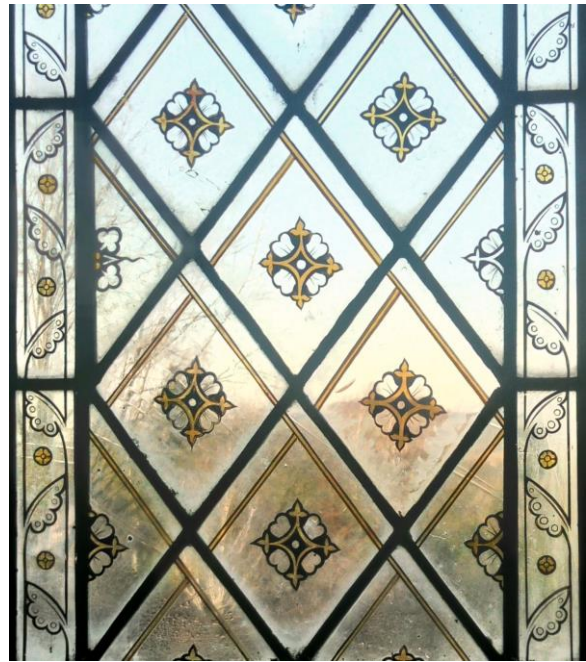
*Detail: window nV light b after restoration with new painted pieces*

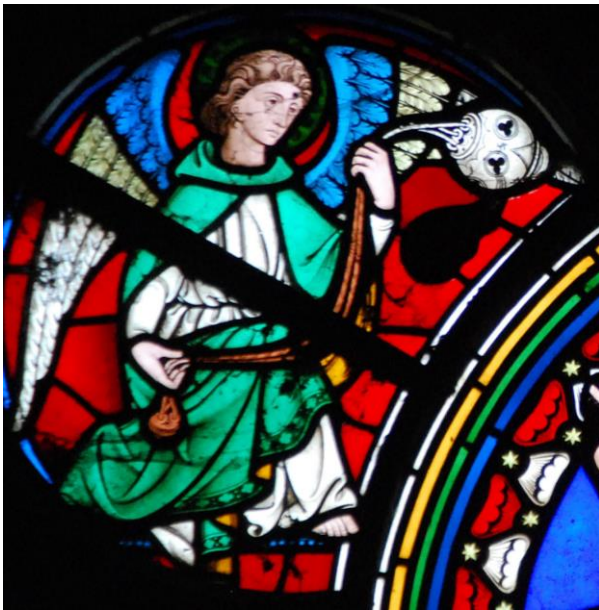
*Detail: window w1, top left lobe, before restoration showing crizzled piece*

- Two eyelet panels screw fixed through copper fixing clips into drilled and plugged holes into stonework
- Two crizzled purple pieces (one completed lost and holed) replaced with new pieces, painted to match original with Reusche pigment, fired, on antique glass of matching tint to original, signed with studio mark and dated on reverse with diamond pencil
- Support bars rubbed down and painted with Hammerite Metal Paint (Smooth Black)
- The external surface of the leadwork re-sealed with linseed oil glazing cement
- All loose mortar pointing raked out and the window re-pointed using hydraulic lime mortar
- Glass cleaned in situ by dusting down with soft hair brush.

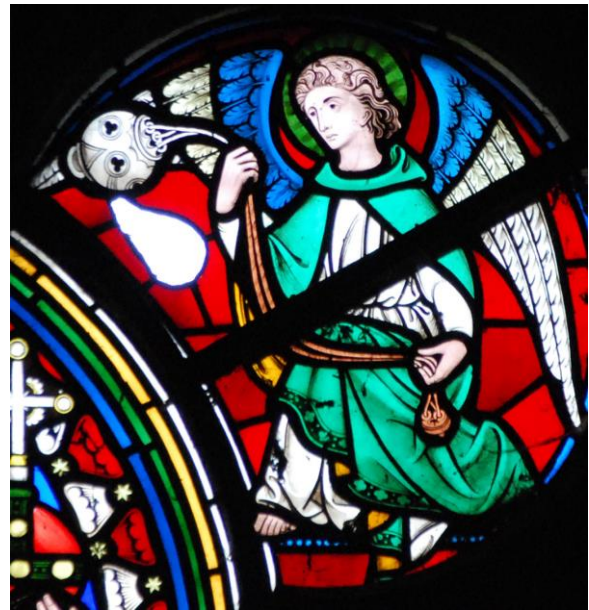
*Detail: window w1, top right lobe, before restoration showing lost (crizzled) piece*

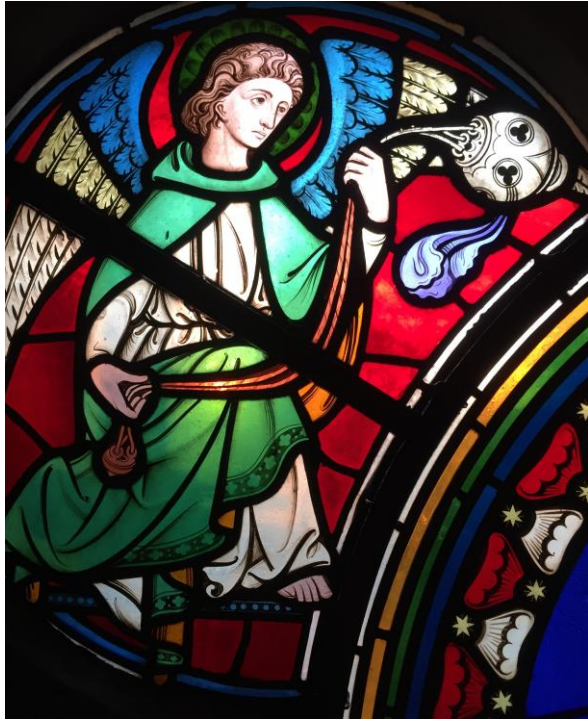
*Detail: window w1, top left lobe, after restoration showing new painted piece*

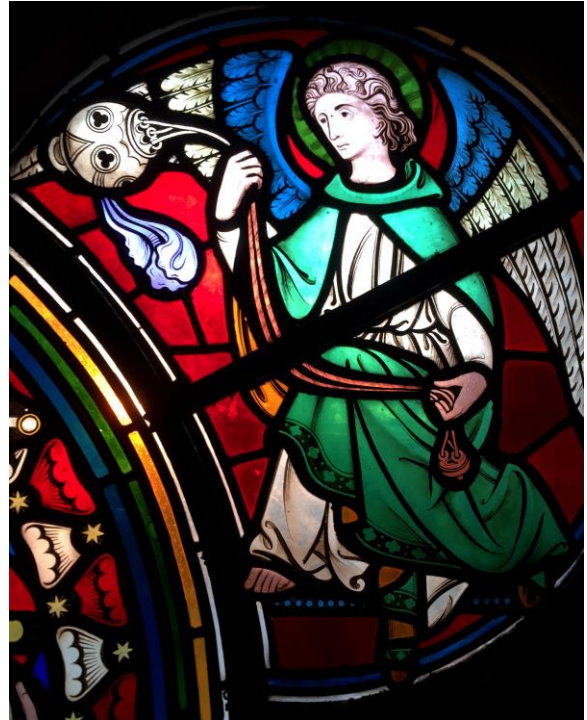
*Detail: window w1, top right lobe, after restoration showing new painted piece*

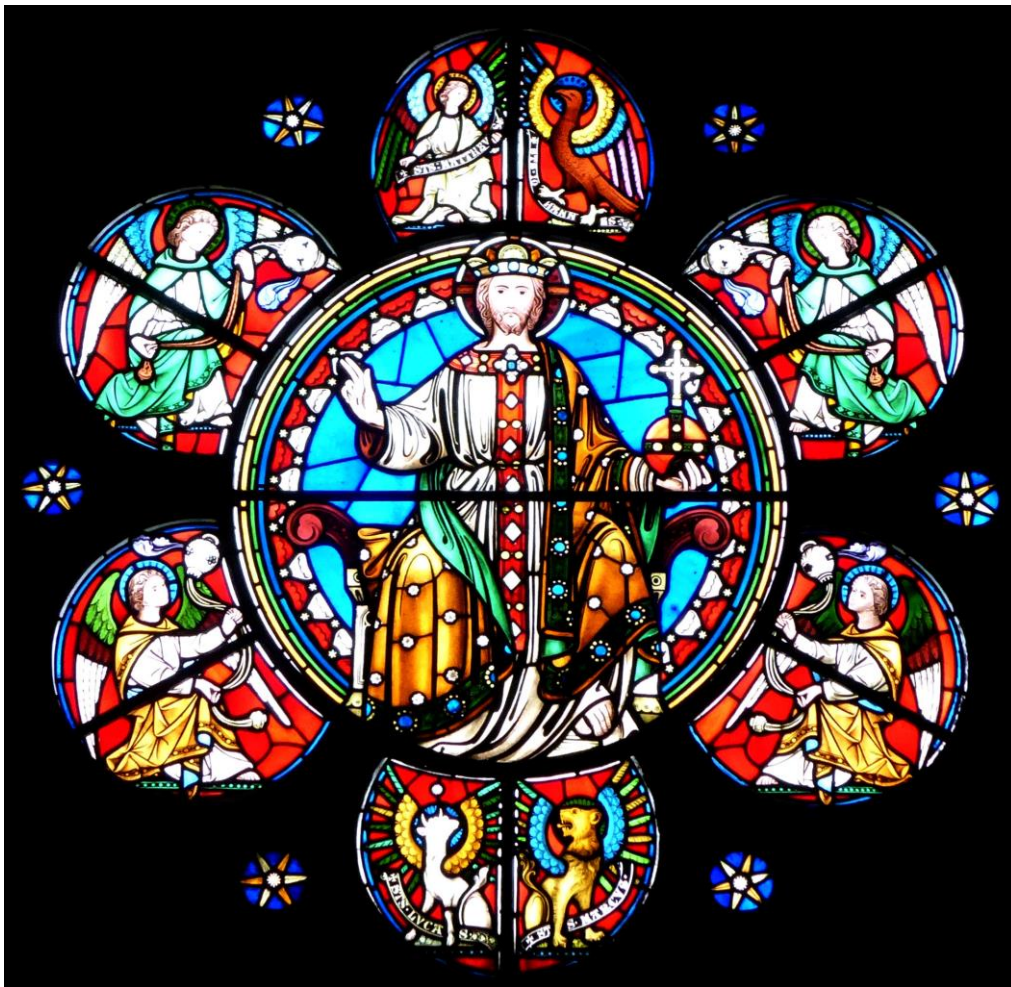
*West window, complete, after restoration*

- One loose 'star' eyelet panel removed to studio
- Box polycarbonate installed as temporary window covering

- New 'star' eyelet panel created to replace panel
- Painted to match original with Reusche pigment, fired, on antique glass of matching tint to original, signed with studio mark and dated on reverse with diamond pencil
- Leaded using extruded lead of matching size and profile to original (Heaps, Arnold and Heaps)
- Sealed with linseed oil glazing cement
- Copper fixing clips soldered to perimeter lead of both new and original eyelet panels
