## Stained Glass Record of Works Undertaken

<b>Site: St John's Church, Howsham</b>	
<b>Works undertaken by: Keith Barley, Alison Gilchrist, Aurélie Haugeard, Anne-Catherine Perreau, Charlotte Roden and Daniel Thomas</b>	<b>Completion date: 1 July 2019</b>
<b>Barley Studio, York YO19 5LH Tel: 01904 489093 Web: www.barleystudio.co.uk</b>	<b>Owner / client: PCC St John's Church</b>
<b>General description: Repair, maintenance and restoration of three stained glass windows</b>	
<b>This record should be read in conjunction with the Proposal of Works by Keith Barley, 27 August 2018. All works recommended to windows sIII, sVI and nIII have been undertaken, as detailed below.</b>

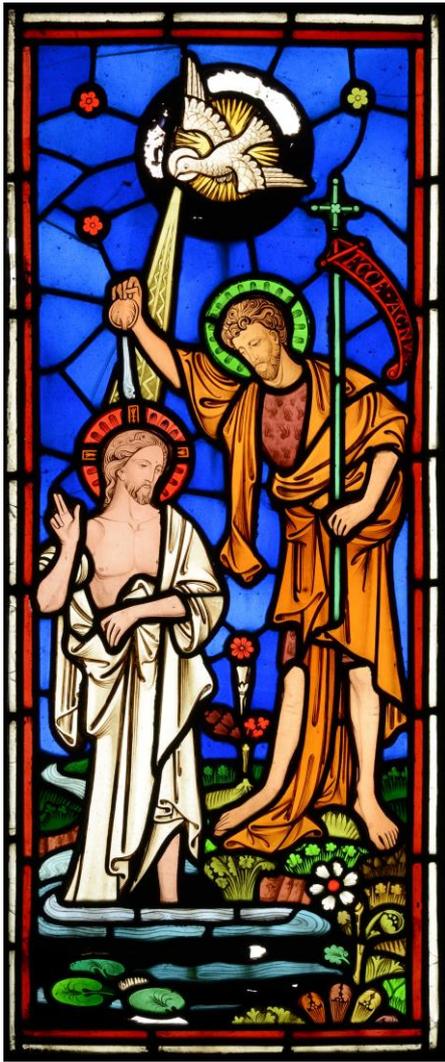
*window sVI panel 2a before conservation*

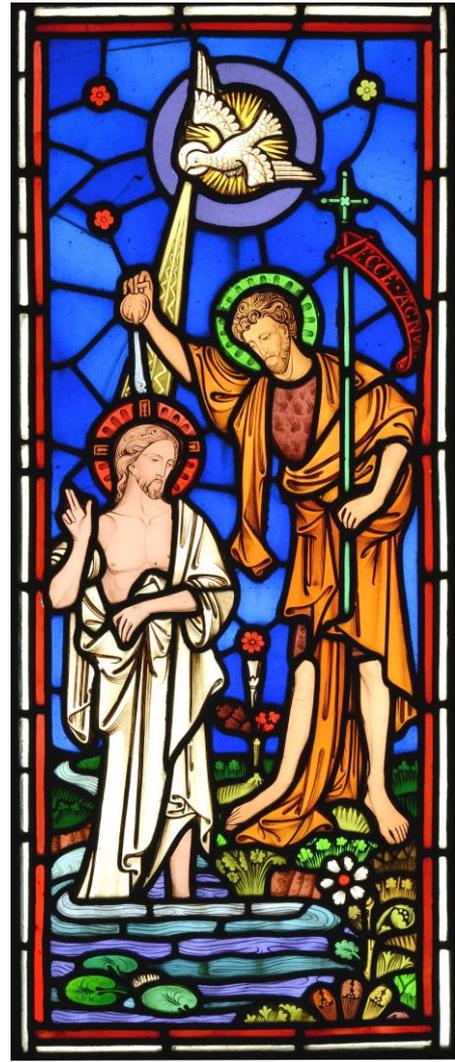
*window sVI panel 2a after conservation*

- Border glass and lead to all 3 panels replaced where badly broken, using antique glass of matching tint and texture to original (Tatra) and extruded lead of matching size and profile to original (Heaps, Arnold and Heaps)

- Panels re-sealed with black putty to the inside (painted) surface and linseed oil glazing cement to the outside surface
- Panels cleaned using deionised water on cotton wool swabs

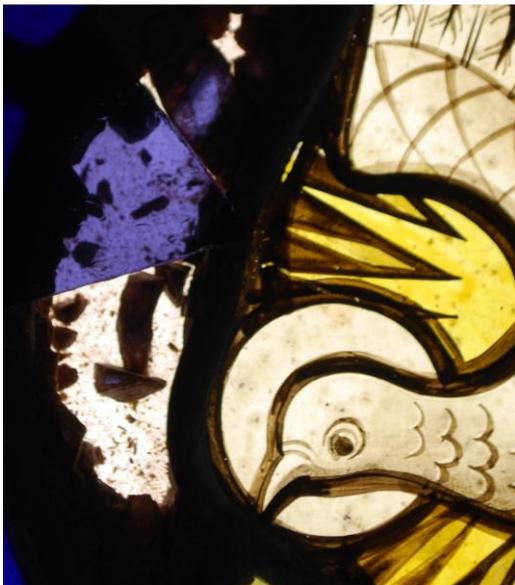
*detail: matching glass colour to surviving piece in halo (top)*

- Crizzled pieces in panel 2 replaced with new pieces, painted on antique glass with purple colour matched to small surviving piece in halo of dove [see image below]

- New pieces painted with Reusche pigments, matching design and shading of surrounding pieces and discernible surviving paint on crizzled pieces for water, stipple texture to tone down pieces in halo of dove, fired, signed with studio mark and dated on reverse with diamond pencil

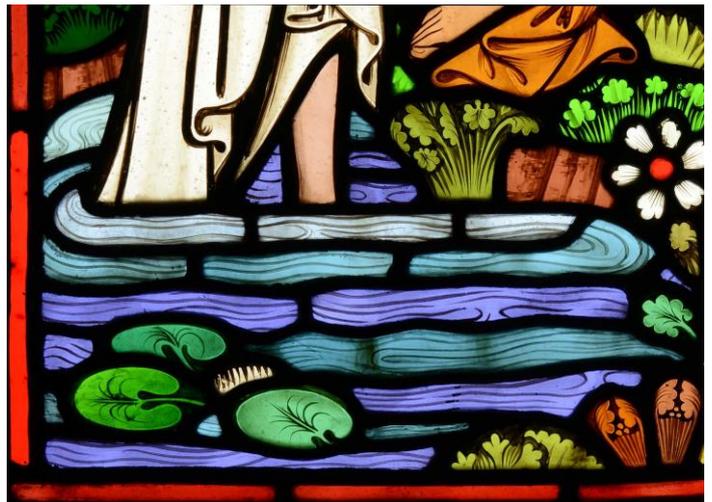
*detail: new pieces completing water around Christ's feet*

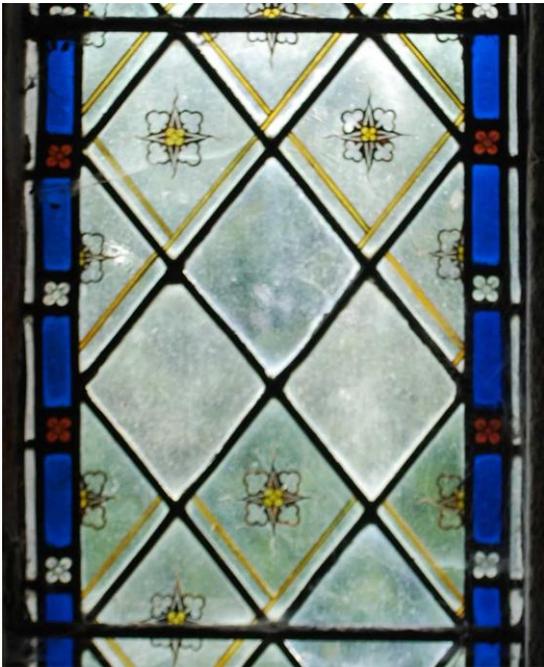
*Detail: window nIII light a before restoration showing previous unpainted repairs*

- Six previous repair pieces (unpainted) replaced with new pieces, painted to match original with Reusche pigment and Rockingham silver stain, fired, on antique glass of matching tint to original, signed with studio mark and dated on reverse with diamond pencil
- Support bars rubbed down and painted with Hammerite Metal Paint (Smooth Black)
- The external surface of the leadwork re-sealed with linseed oil glazing cement
- All loose mortar pointing raked out and the window re-pointed using hydraulic lime mortar
- Glass cleaned in situ using deionised water on cotton wool swabs for the inside (painted surface) and deionised water on microfibre cloths for the outside surface.

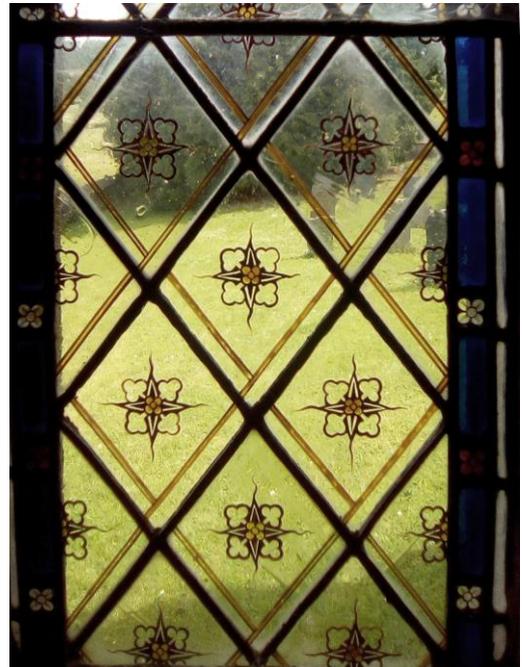
*Detail: window nIII light a after restoration with new painted pieces*
