## St Michael the Archangel, Mere

Diocese of Salisbury

Preliminary inspection of medieval wall painting in trefoil niche, nave, south wall

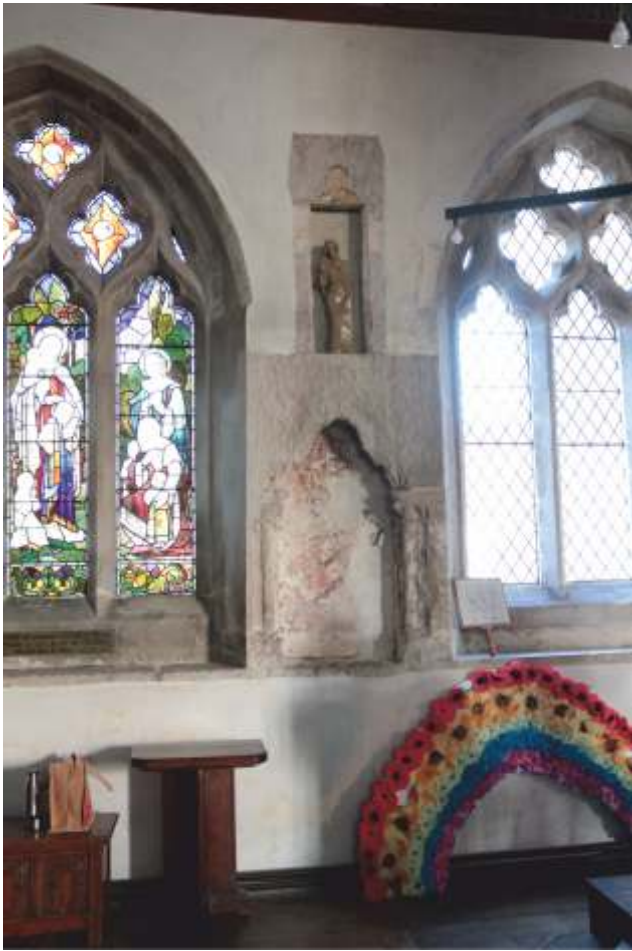
The poor condition of the painted plaster in the back of the lower niche of the shrine had been known about for some time. The author first inspected it in July 2018. The reason for the deterioration was due to a faulty rainwater downpipe corresponding to the position of the shrine which had been repaired. Photos 1 & 2.

1 - Above - The shrine in 2018.

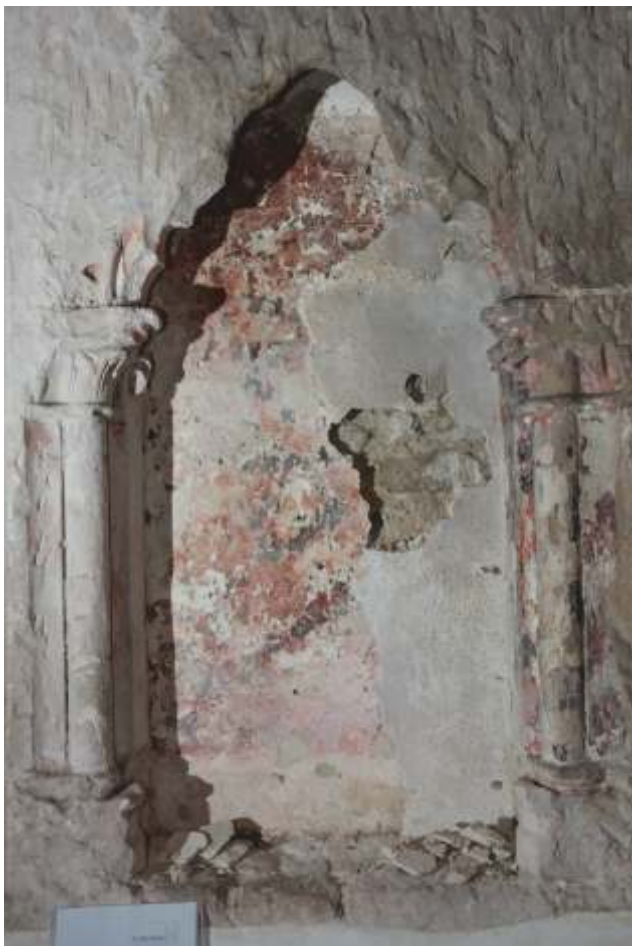
In the spring of 2022, as a result of some unfortunate further damage by a young boy with learning difficulties, a second inspection was made. Photos 3 & 4. The results of that inspection were documented in an illustrated report dated 13 April 2022. That report put forward proposals for the conservation of the painted plaster, and suggested that a paint sample be taken for analysis. Subsequent to the submission of the report, practical measures to conserve the painted plaster were commissioned in two phases, the first in July 2022 and the second in September 2023.

3 - Below - The detached plaster 2022.

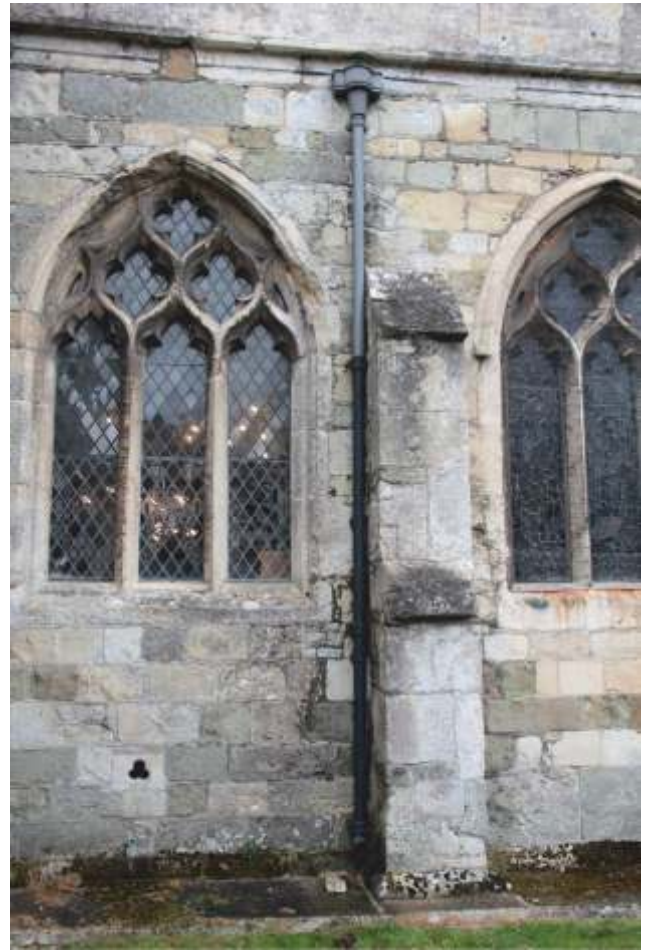
2 - Above - Exterior fabric 2022 with repaired downpipe.

It is important to maintain the good condition of the rainwater goods corresponding to the location of the shrine to prevent deterioration in the future.

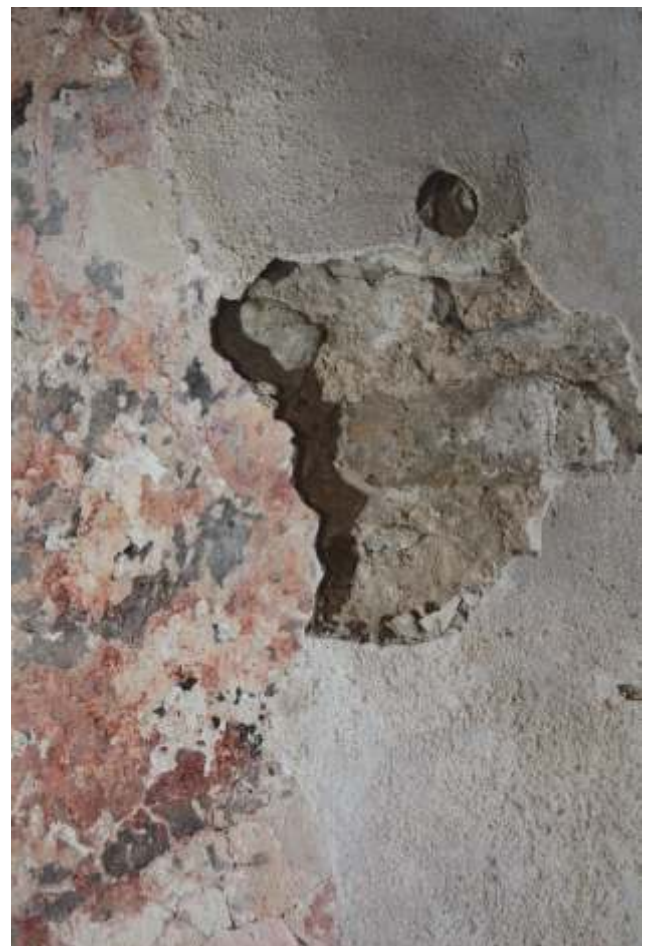
4 - Below - Detail from 3 showing the detached painted.

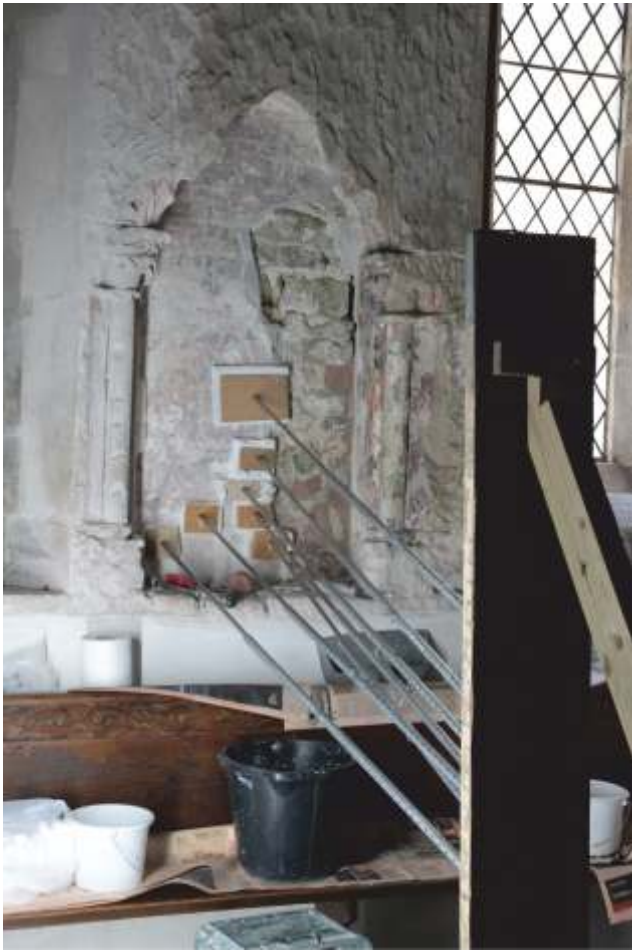
5 - Above - Securing detached plaster, 2023.

The detached painted plaster in the back of the lower niche was secured using a lime grout<sup>2</sup>. The lime grout was administered via syringe following minimal pre-wetting using a mixture of ethanol and water (again via syringe). The detached plaster was gradually eased back into position using gentle pressure, working from areas of least detachment to greatest. Once

detached passages were eased back into position, they were held in that position overnight using spring loaded presses<sup>3</sup> whilst the grout set. Photos 5 & 6.

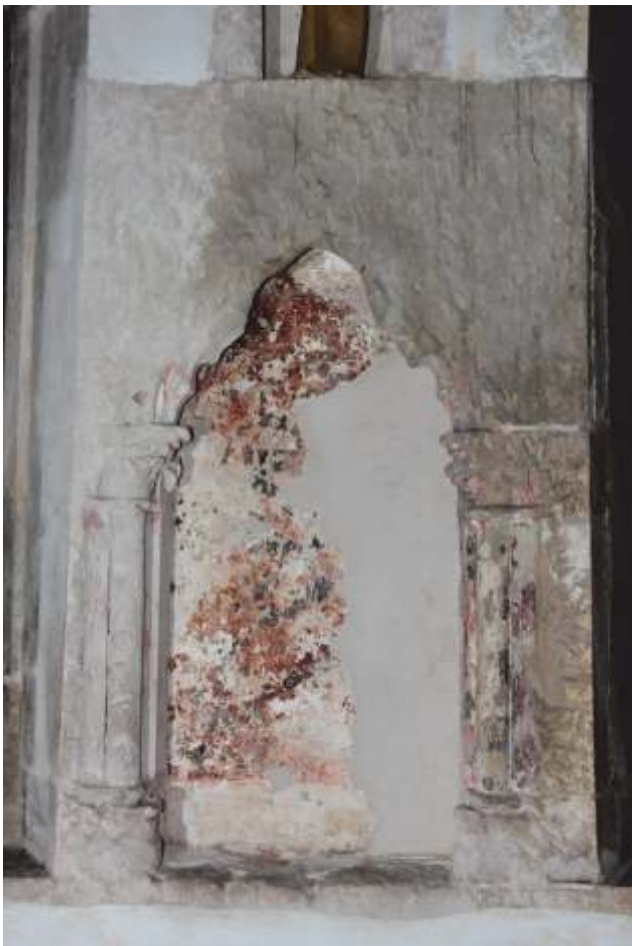
7 - Below - The niche following conservation and plaster repair, 2023.

There were numerous cracks in the detached plaster. These were filled with a fine lime mortar. This both supported the painted plaster and improved its appearance.

Previous repair plaster was removed and replaced with lime plaster comprising a base coat and skim coat. The ratio of lime to sand was 3 : 1. Photos 7 & 8.

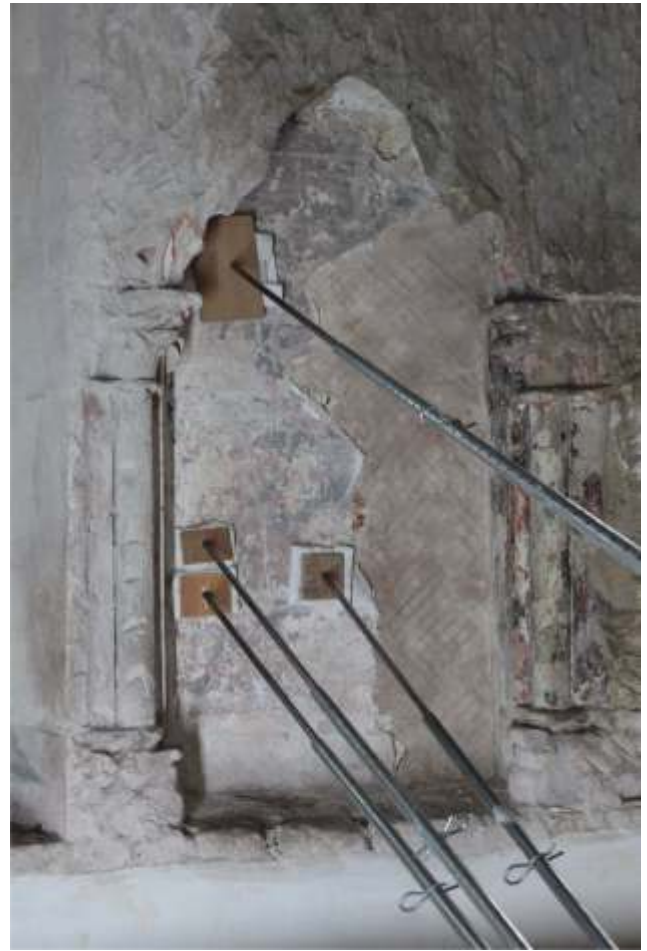
6 - Above - Base coat plaster on RHS as well as further securing detached plaster.

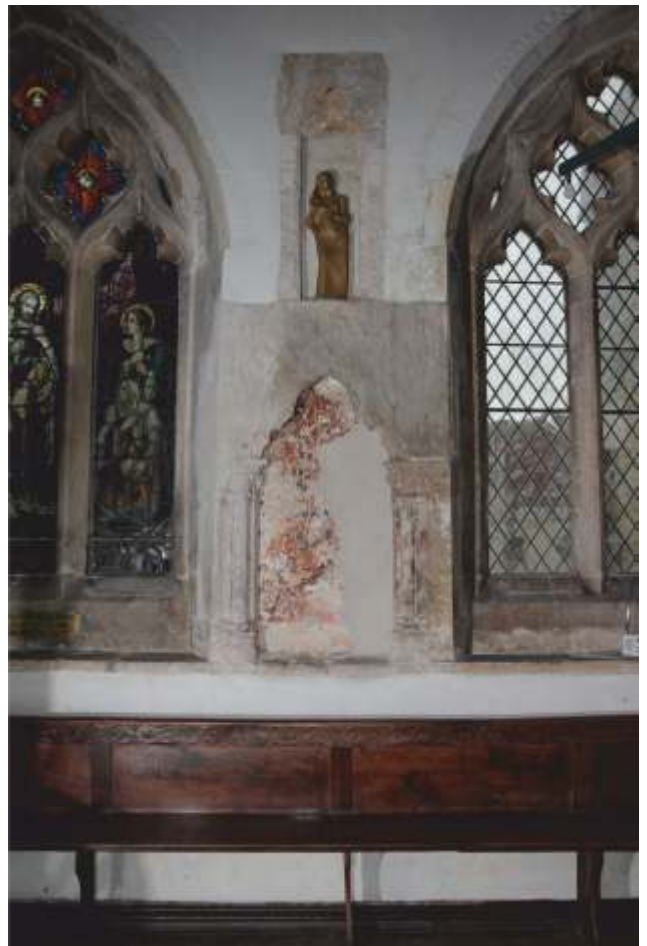
8 - Below - Overall view of the shrine after conservation.

The condition of the painted plaster in the niche should be inspected by a trained and competent wall paintings conservator in ten years, autumn 2033.

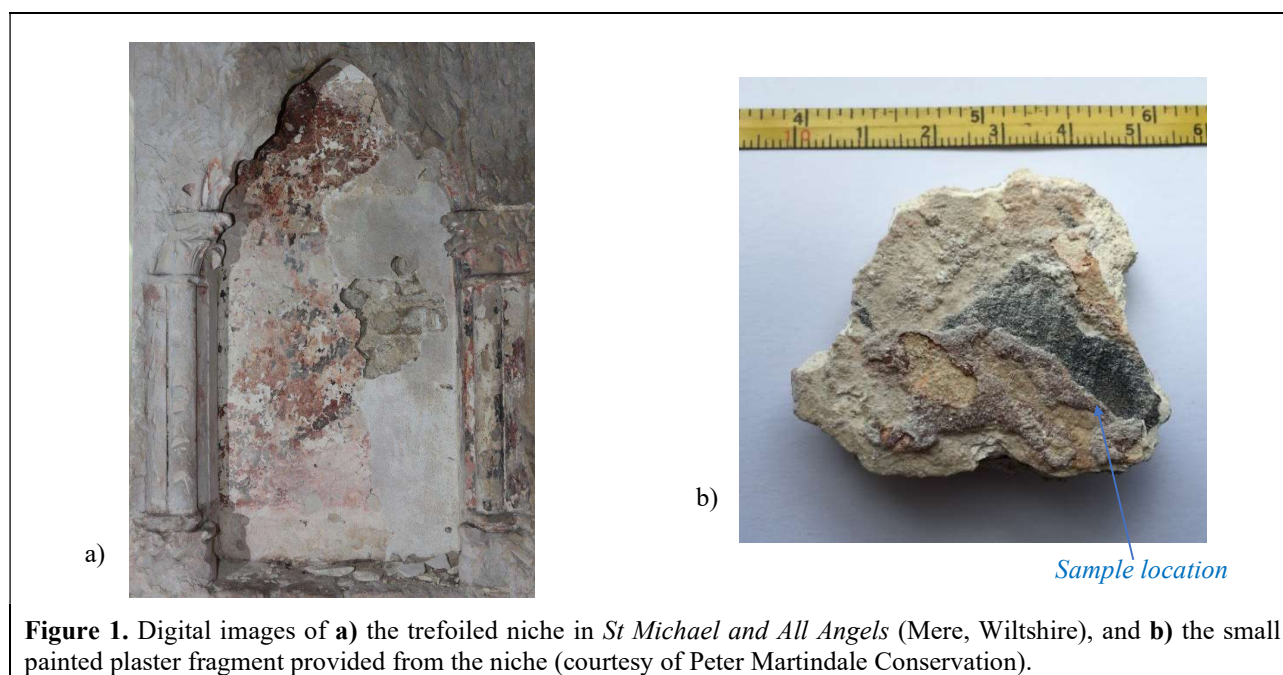
**Figure 1.** Digital images of **a)** the trefoiled niche in *St Michael and All Angels* (Mere, Wiltshire), and **b)** the small painted plaster fragment provided from the niche (courtesy of Peter Martindale Conservation).

The black paint visible on the sample fragment appears to have been applied as a primary layer over the white plaster in some areas, with the edges of the pale yellow-brown paint observed to overlap this opaque paint (see Figure 1b). It is not clear whether the gypsum component identified in each decorative layer is original plaster material used in the fresco painting technique or whether it has developed from the degradation of a lime plaster more typically used for fresco layers.<sup>7,8</sup>

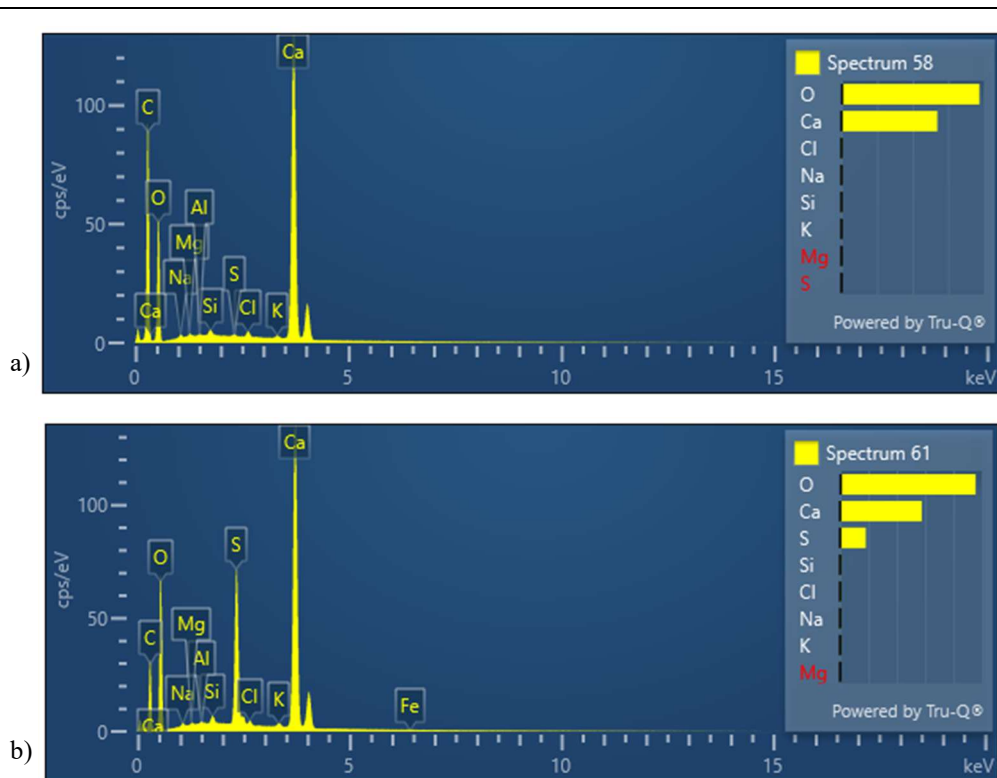
**Figure A1.** EDX spectra obtained for selected layers in the sample from the painted plaster fragment, showing the spectrum for **a)** the white plaster base layers (*Spectrum 58*), dominated by peaks for calcium (Ca) most likely associated with calcium carbonate ( $\text{CaCO}_3$ )/carbonated lime plaster; the weak peaks for sodium (Na), magnesium (Mg), aluminium (Al), silicon (Si), sulphur (S), chlorine (Cl) and potassium (K) may be attributable to natural impurities or silicate minerals added to the plaster; **b)** the off-white/pale brown layer (*Spectrum 61*), with strong peaks for calcium (Ca) and sulphur (S) most likely associated with *gypsum* ( $\text{CaSO}_4 \cdot 2\text{H}_2\text{O}$ ), with the calcium also possibly associated with calcium carbonate ( $\text{CaCO}_3$ ); the weak peaks for sodium (Na), magnesium (Mg), aluminium (Al), silicon (Si), chlorine (Cl), potassium (K) and iron (Fe) may be attributable to the mineral content of an *ochre* as well as to other soluble salts and impurities.

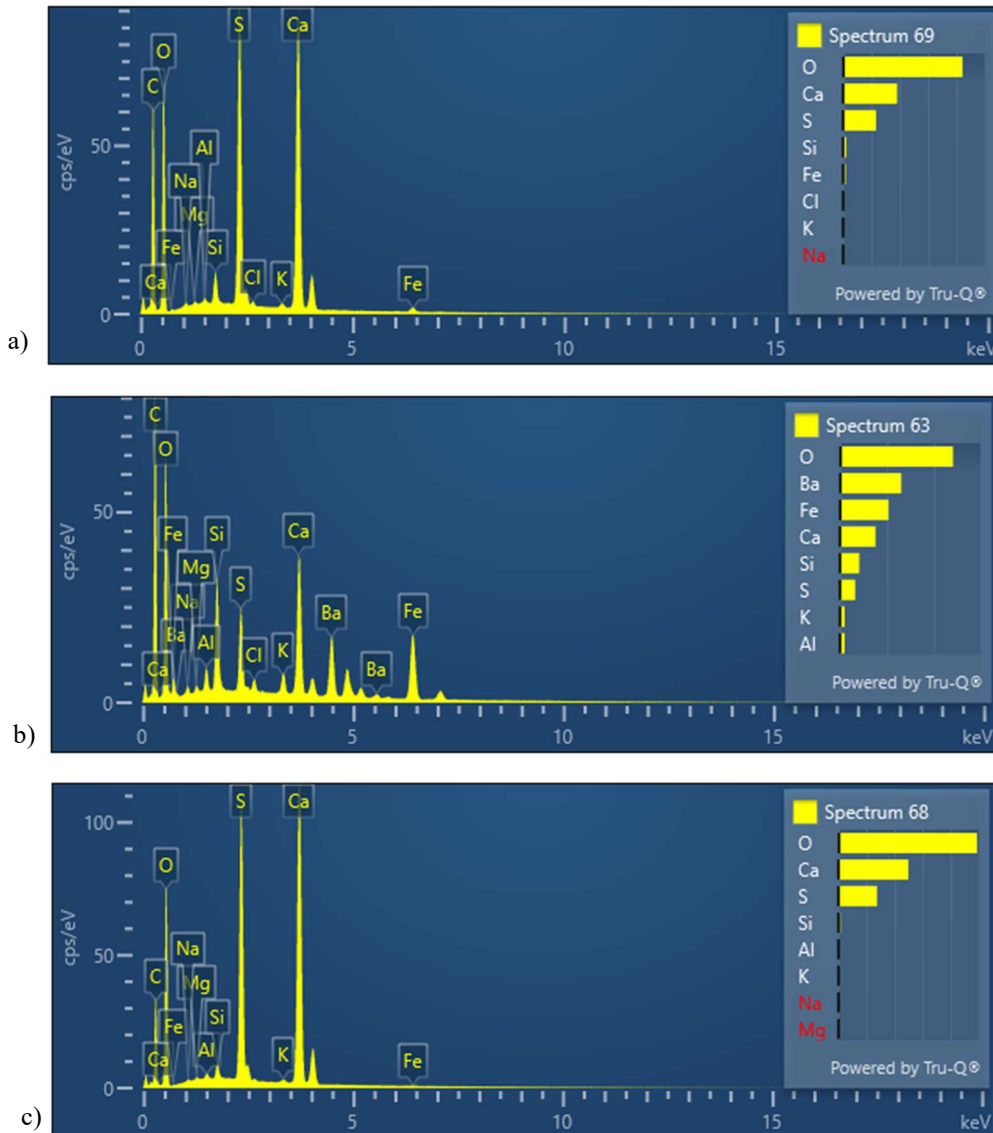
**Figure A2.** Further EDX spectra obtained for selected layers in the sample from the painted plaster fragment, showing the spectrum for **a)** the lower red layer (*Spectrum 69*), with strong peaks for calcium (Ca) and sulphur (S) most likely associated with *gypsum* ( $\text{CaSO}_4 \cdot 2\text{H}_2\text{O}$ ), with the peak for calcium also possibly attributable to calcium carbonate ( $\text{CaCO}_3$ ); the peaks for sodium (Na), magnesium (Mg), aluminium (Al), silicon (Si), chlorine (Cl), potassium (K) and iron (Fe) are likely to be associated with the mineral content of *red ochre* as well as other soluble salts; **b)** the darker red paint layer (*Spectrum 63*), with strong peaks for silicon (Si), aluminium (Al) and iron (Fe), and weaker peaks for sodium (Na), magnesium (Mg), chlorine (Cl) and potassium associated with *red ochre*; the peaks for calcium (Ca) may be attributable to calcium carbonate ( $\text{CaCO}_3$ )/lime plaster or in conjunction with the peak for sulphur (S), to *gypsum* ( $\text{CaSO}_4 \cdot 2\text{H}_2\text{O}$ ); the peaks for barium (Ba) and sulphur (S) are likely to be due to the presence of barium sulphate/*barium white* ( $\text{BaSO}_4$ ); and **c)** the surface off-white layer (*Spectrum 68*), with strong peaks for calcium (Ca) and sulphur (S) most likely associated with *gypsum* ( $\text{CaSO}_4 \cdot 2\text{H}_2\text{O}$ ), with the peak for calcium also possibly associated with calcium carbonate ( $\text{CaCO}_3$ ); the weak peaks for sodium (Na), magnesium (Mg), aluminium (Al), silicon (Si), potassium (K) and iron (Fe) may be attributable to the mineral content of an *ochre* and/or to the typical silicate/oxide particles found in accumulated dirt layers.
