**Project Number A-02386 (7485)**

**Targeted Refurbishment and  
Demolition**

**Asbestos Survey Report**

**St Peter's Church  
Stoke Road  
PL8 1DY**

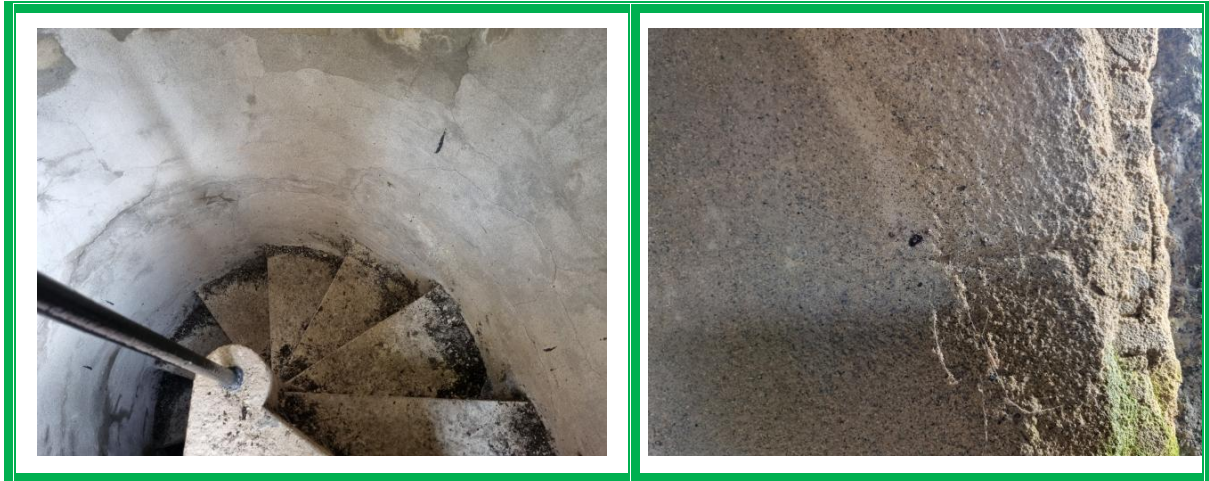
<b>Item No:</b>	<b>1</b>	<b>Sample No:</b>	<b>PT/01</b>
<b>Location:</b>	Ground Floor - Stairs 001

<b>Material Description:</b>	Walls -	
<b>Identification:</b>	Sampled - No Asbestos Found	
<b>Approx. quantity:</b>	N/A	
<b>Accessibility</b>	N/A	<i>Assessment Score</i>
<b>Product type:</b>	N/A	N/A
<b>Extent of Damage:</b>	N/A	N/A
<b>Surface Treatment:</b>	N/A	N/A
<b>Asbestos type:</b>	N/A	N/A
<b>Material Assessment Score:</b>		N/A
<b>Risk Assessment Score:</b>		N/A
<b>Action:</b>	N/A	
<b>Comments:</b>	Render to walls throughout stairs, ground floor to roof, concrete ceiling block rendered walls, concrete stairs floor, lead and glass windows, timber doors, and frames.

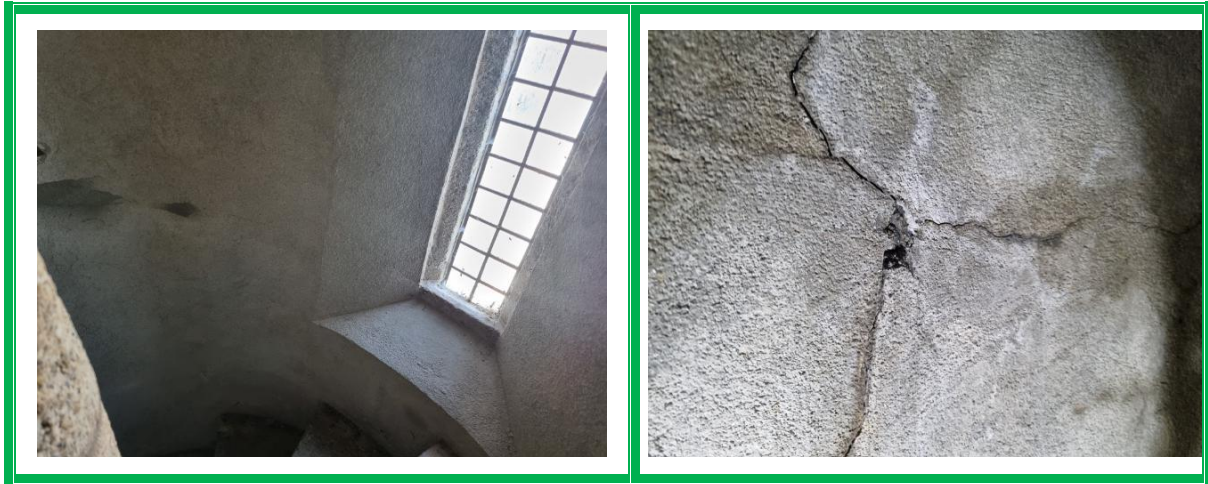
<b>Item No:</b>	<b>2</b>	<b>Sample No:</b>	<b>PT/02</b>
<b>Location:</b>	Ground Floor - Stairs 002

<b>Material Description:</b>	Walls -	
<b>Identification:</b>	Sampled - No Asbestos Found	
<b>Approx. quantity:</b>	N/A	
<b>Accessibility</b>	N/A	<i>Assessment Score</i>
<b>Product type:</b>	N/A	N/A
<b>Extent of Damage:</b>	N/A	N/A
<b>Surface Treatment:</b>	N/A	N/A
<b>Asbestos type:</b>	N/A	N/A
<b>Material Assessment Score:</b>		N/A
<b>Risk Assessment Score:</b>		N/A
<b>Action:</b>	N/A	
<b>Comments:</b>	Render to walls throughout stairs, ground floor to roof, concrete ceiling, block rendered walls, concrete stairs floor, lead and glass windows, timber doors, and frames.

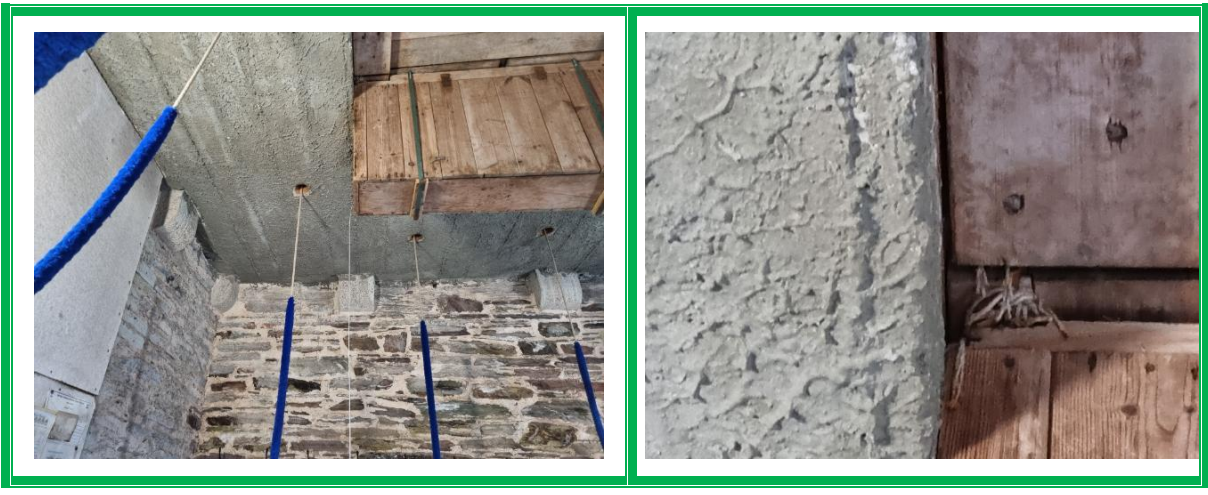
<b>Item No:</b>	<b>3</b>	<b>Sample No:</b>	<b>PT/03</b>
<b>Location:</b>	First Floor - Ringing Chambers 003

<b>Material Description:</b>	Ceiling -	
<b>Identification:</b>	Sampled - No Asbestos Found	
<b>Approx. quantity:</b>	N/A	
<b>Accessibility</b>	N/A	<i>Assessment Score</i>
<b>Product type:</b>	N/A	N/A
<b>Extent of Damage:</b>	N/A	N/A
<b>Surface Treatment:</b>	N/A	N/A
<b>Asbestos type:</b>	N/A	N/A
<b>Material Assessment Score:</b>		N/A
<b>Risk Assessment Score:</b>		N/A
<b>Action:</b>	N/A	
<b>Comments:</b>	Render to ceiling and stone walls, concrete floor with timber hatch, leaded windows, timber door and frame, electric heater present.

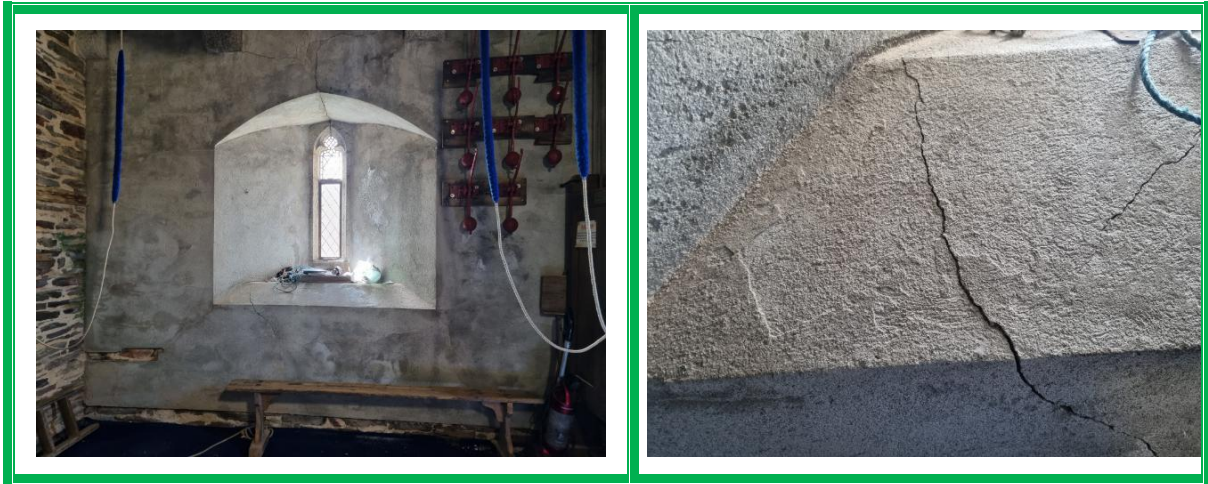
<b>Item No:</b>	<b>4</b>	<b>Sample No:</b>	<b>PT/04</b>
<b>Location:</b>	First Floor - Ringing Chambers 004

<b>Material Description:</b>	Walls	
<b>Identification:</b>	Sampled - No Asbestos Found	
<b>Approx. quantity:</b>	N/A	
<b>Accessibility</b>	N/A	<i>Assessment Score</i>
<b>Product type:</b>	N/A	N/A
<b>Extent of Damage:</b>	N/A	N/A
<b>Surface Treatment:</b>	N/A	N/A
<b>Asbestos type:</b>	N/A	N/A
<b>Material Assessment Score:</b>		N/A
<b>Risk Assessment Score:</b>		N/A
<b>Action:</b>	N/A	
<b>Comments:</b>	Render to ceiling and stone walls, concrete floor with timber hatch, leaded windows, timber door and frame, electric heater present.

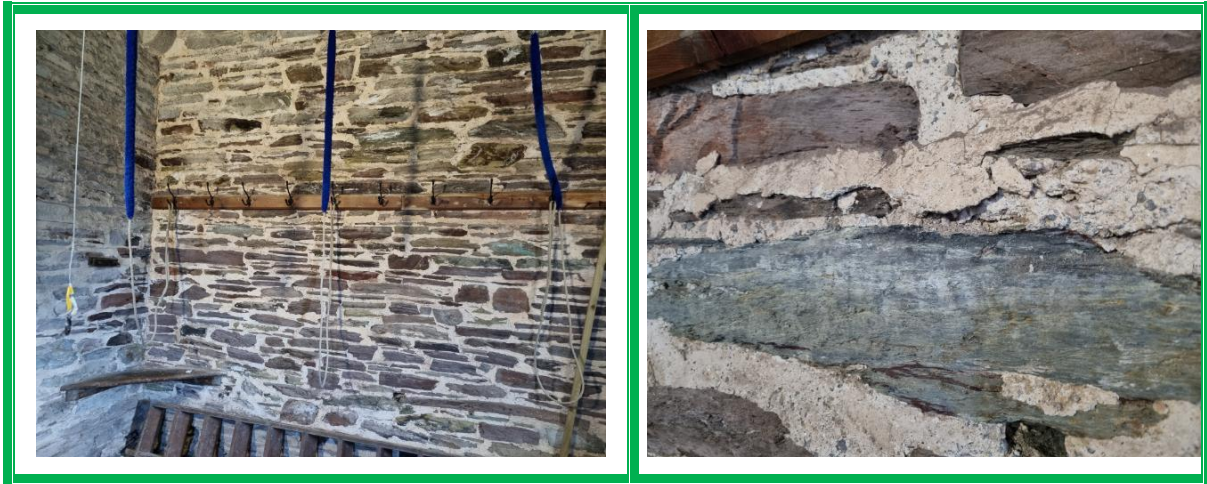
<b>Item No:</b>	<b>5</b>	<b>Sample No:</b>	<b>PT/05</b>
<b>Location:</b>	First Floor - Ringing Chambers 005

<b>Material Description:</b>	Walls -	
<b>Identification:</b>	Sampled - No Asbestos Found	
<b>Approx. quantity:</b>	N/A	
<b>Accessibility</b>	N/A	<i>Assessment Score</i>
<b>Product type:</b>	N/A	N/A
<b>Extent of Damage:</b>	N/A	N/A
<b>Surface Treatment:</b>	N/A	N/A
<b>Asbestos type:</b>	N/A	N/A
<b>Material Assessment Score:</b>		N/A
<b>Risk Assessment Score:</b>		N/A
<b>Action:</b>	N/A	
<b>Comments:</b>	Render to ceiling and stone walls, plaster to walls, concrete floor with timber hatch, leaded windows, timber door and frame, electric heater present.

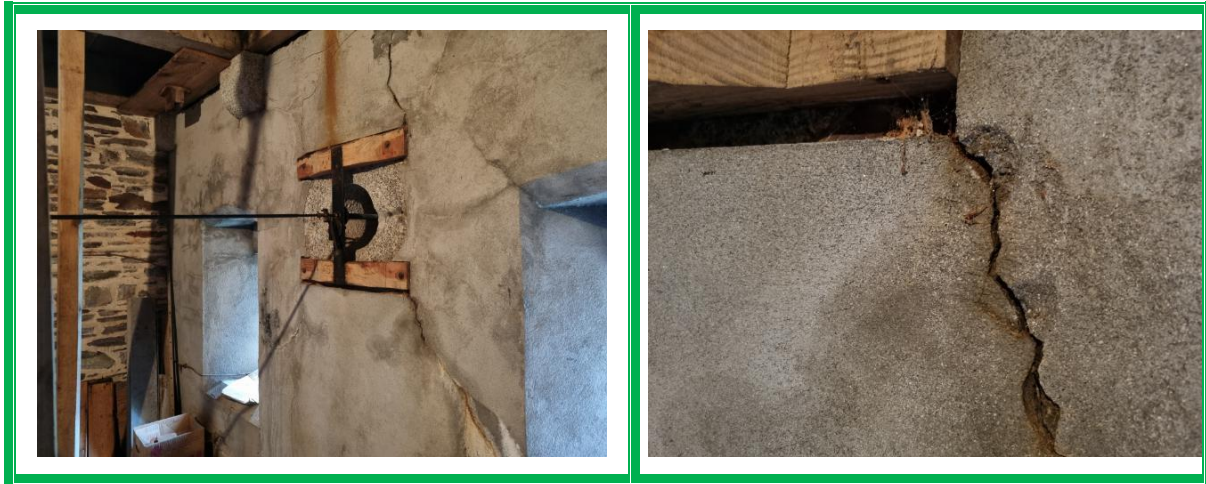
<b>Item No:</b>	<b>6</b>	<b>Sample No:</b>	<b>PT/06</b>
<b>Location:</b>	Second Floor - Clock Room 006

<b>Material Description:</b>	Walls -	
<b>Identification:</b>	Sampled - No Asbestos Found	
<b>Approx. quantity:</b>	N/A	
<b>Accessibility</b>	N/A	<i>Assessment Score</i>
<b>Product type:</b>	N/A	N/A
<b>Extent of Damage:</b>	N/A	N/A
<b>Surface Treatment:</b>	N/A	N/A
<b>Asbestos type:</b>	N/A	N/A
<b>Material Assessment Score:</b>		N/A
<b>Risk Assessment Score:</b>		N/A
<b>Action:</b>	N/A	
<b>Comments:</b>	Render to walls of clock room, timber ceiling, block rendered walls, concrete floor, lead and glass windows, timber door, and frame.

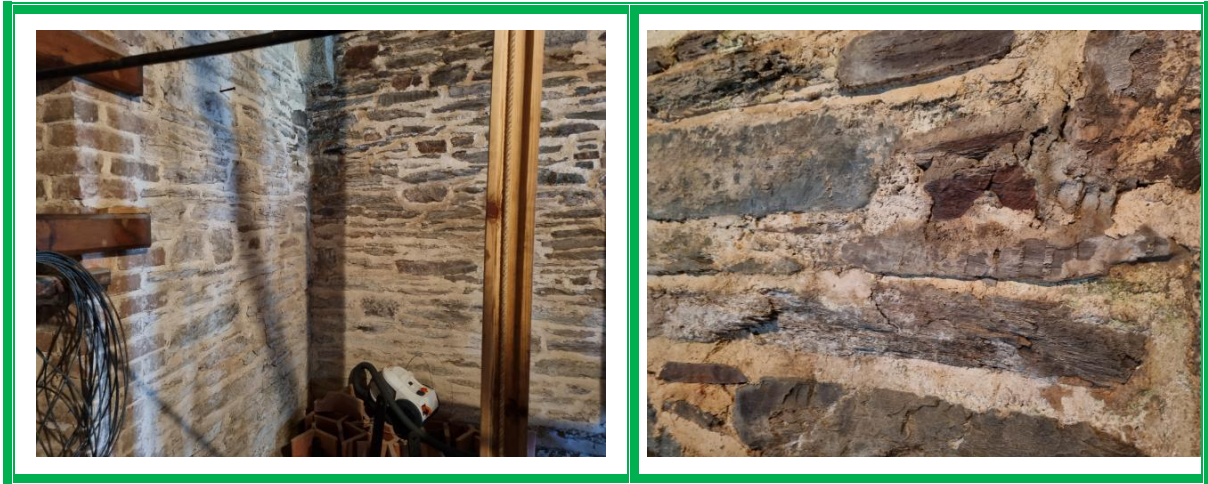
<b>Item No:</b>	<b>7</b>	<b>Sample No:</b>	<b>PT/07</b>
<b>Location:</b>	Second Floor - Clock Room 007

<b>Material Description:</b>	Walls -	
<b>Identification:</b>	Sampled - No Asbestos Found	
<b>Approx. quantity:</b>	N/A	
<b>Accessibility</b>	N/A	<i>Assessment Score</i>
<b>Product type:</b>	N/A	N/A
<b>Extent of Damage:</b>	N/A	N/A
<b>Surface Treatment:</b>	N/A	N/A
<b>Asbestos type:</b>	N/A	N/A
<b>Material Assessment Score:</b>		N/A
<b>Risk Assessment Score:</b>		N/A
<b>Action:</b>	N/A	
<b>Comments:</b>	Render to ceiling and stone walls, plaster to walls, concrete floor with timber hatch, leaded windows, timber door and frame, electric heater present.
