CHURCH OF ST PETER  
DORCHESTER, DORSET  
GORDON MONUMENT

CONDITION ASSESSMENT  
&  
RELOCATION REPORT

MAY 2023

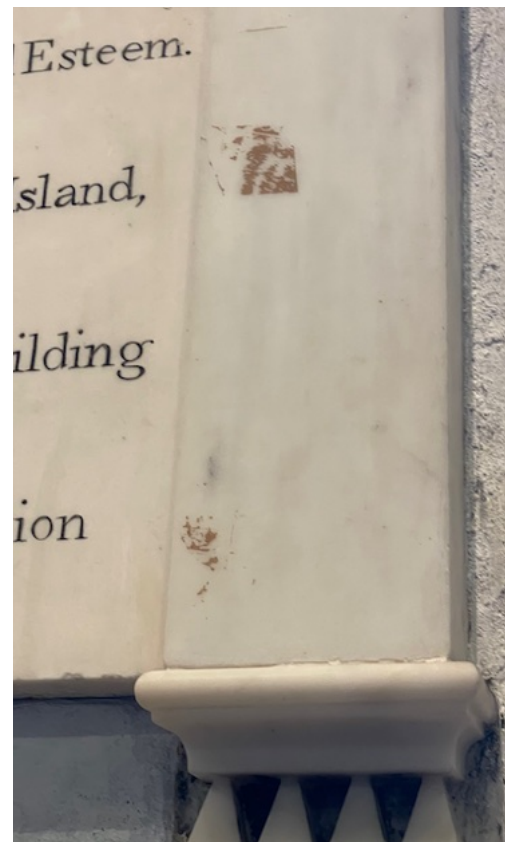
Figure 7 ~ Parcel tape marks on sinister side shaft.

SOILING ~ all areas are lightly soiled to varying degrees. Marks from parcel tape remain on the side shafts. An iron stain to the base of the urn, also mentioned in 1998, remains.

- Tape marks were removed using acetone. Light cleaning undertaken to remove any grit or dust from the dismantling.
- The north elevation early polychromy, recorded in 2000 ~ An isolating layer was applied to this area prior to application of limewash or plaster.

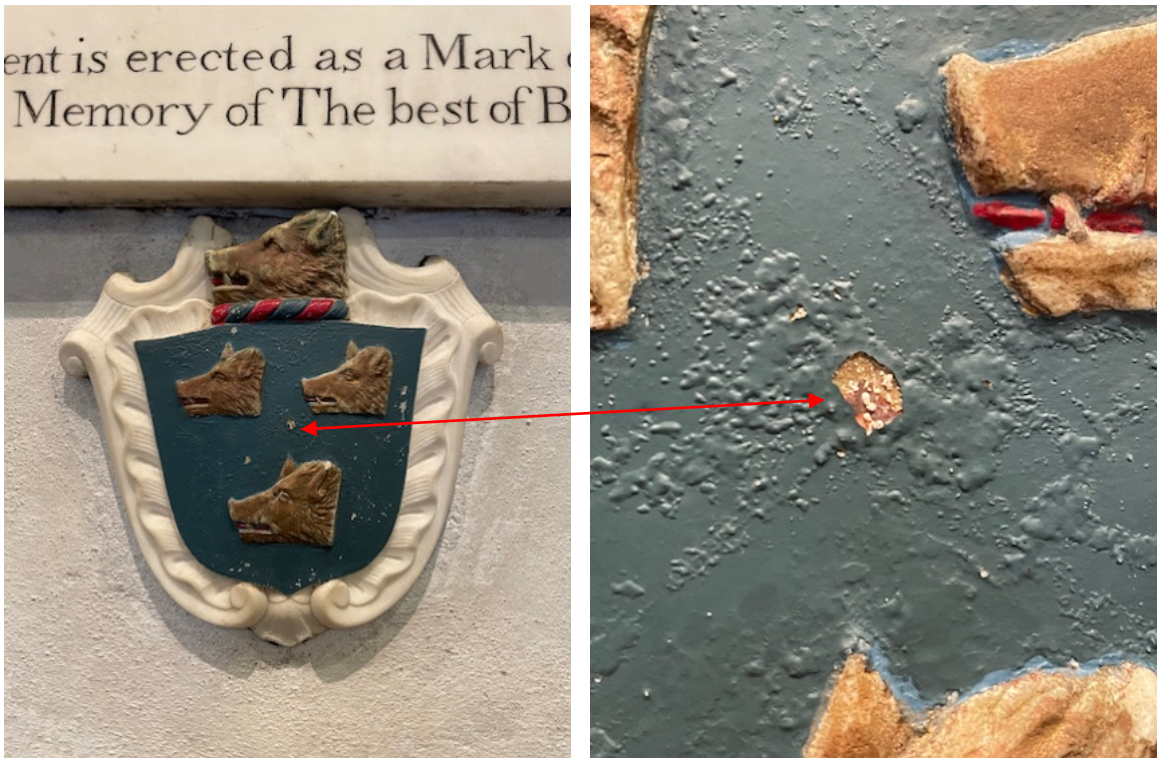
POLYCHROMY ~ The lettering on the inscription and urn are legible. The blue polychromy of the shield is blistered and flaking due to salt damage, with some areas of loss. An earlier scheme of red and gold leaf may be noted beneath the existing. See figure 7.

Figure 8 ~ Details of the lower shield, illustrating the blistering of the polychrome and losses, plus an underlying decorative scheme.

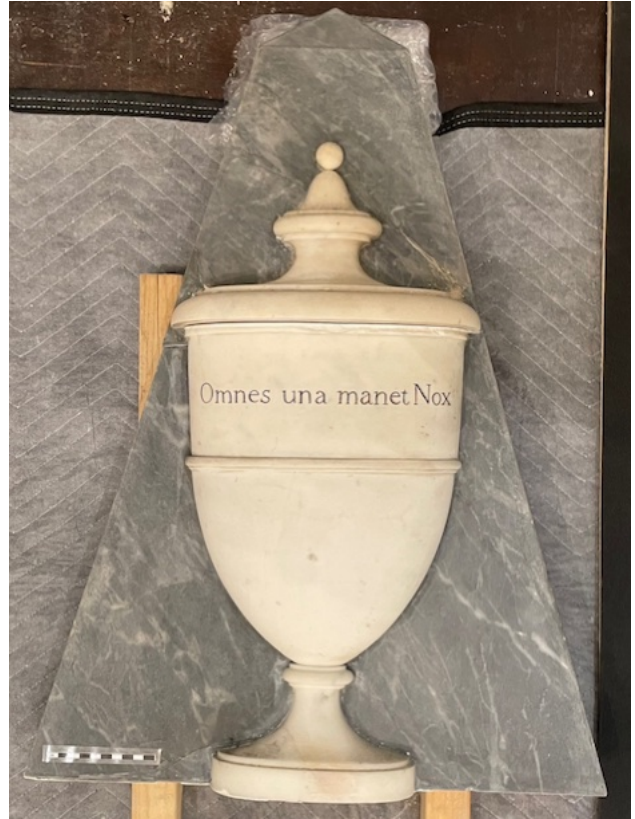
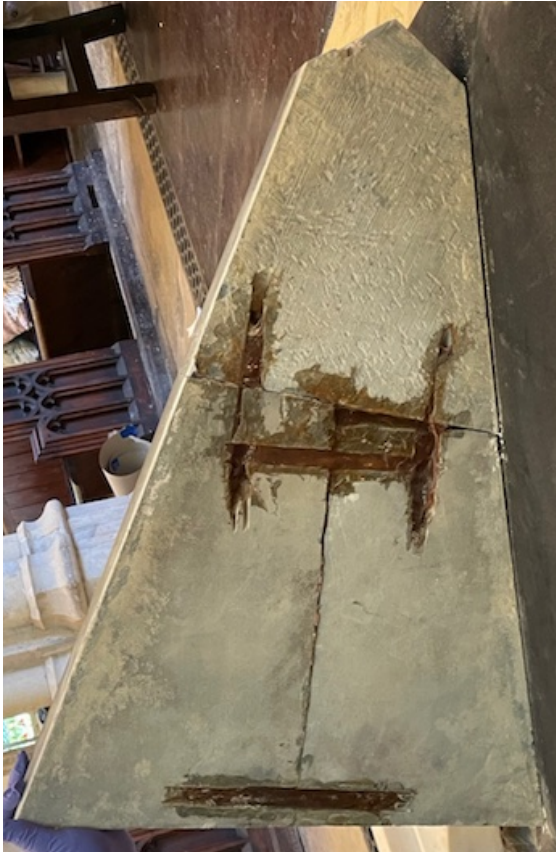
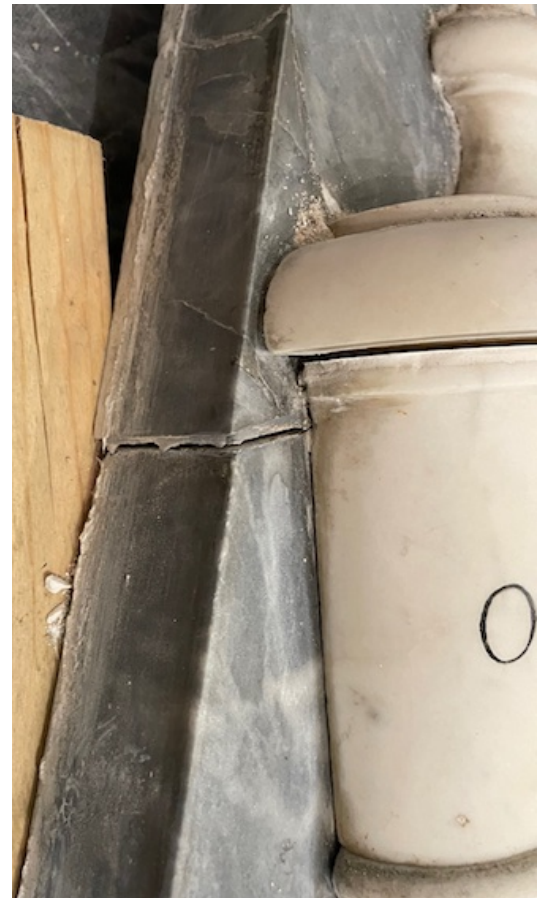
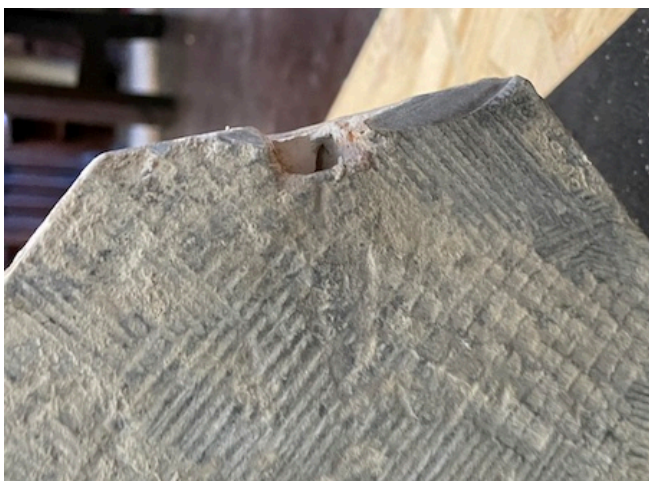
1~ URN & GROUND

Slight movement in joints noted and epoxy cracked on rear, but relatively secure.

Figure 11 ~ Details or Urn and Ground. Lower left image illustrates retaining cramp location.

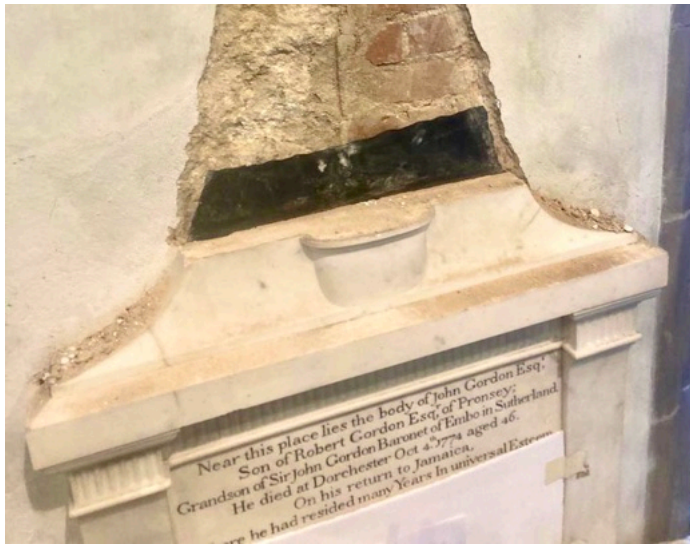
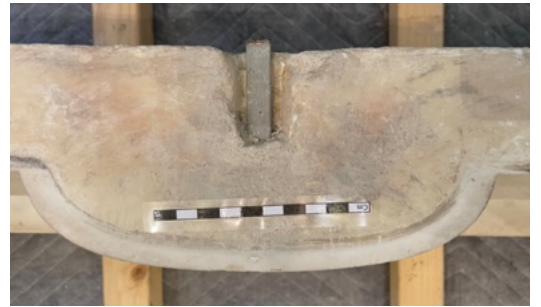
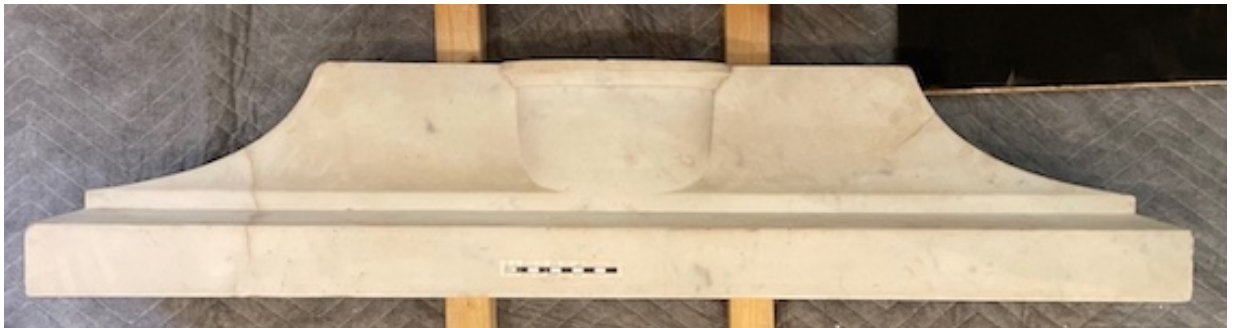
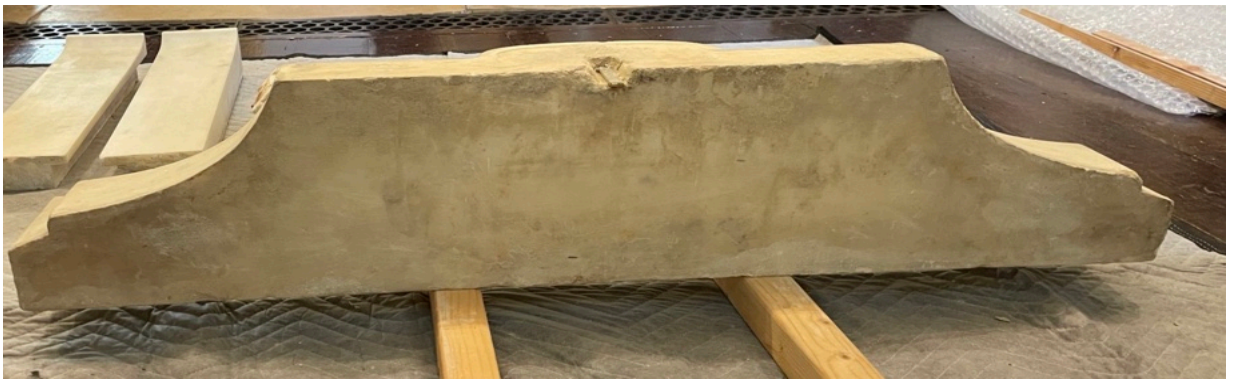
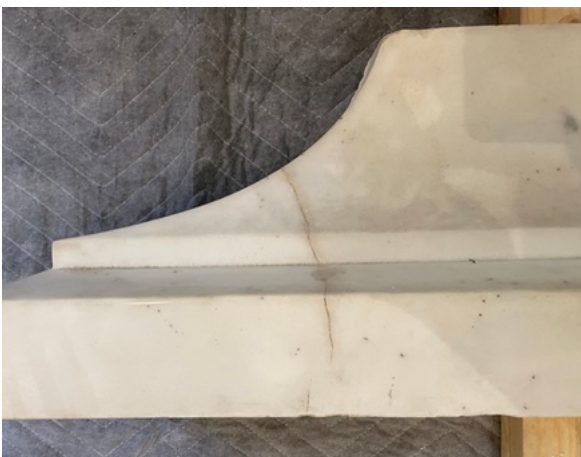
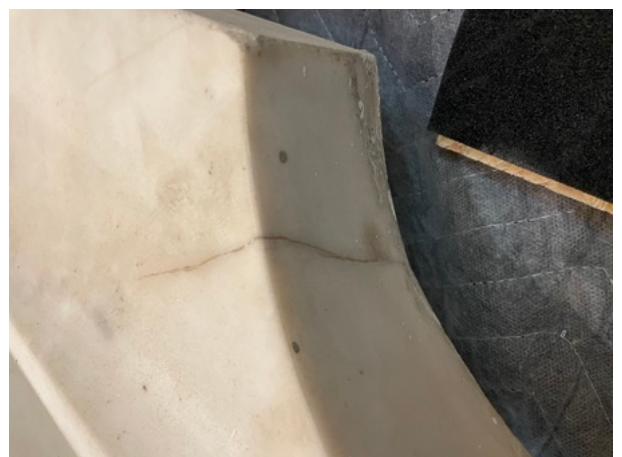
2 ~ SHELF or Mantel

STABILITY ~ The marble and monument are structurally sound and no movement was noted to the joints or perimeter. However, cracking/fractures of the 'shoulder' sections as noted in the Kelland report.

Figure 12 ~ Image of mantel, in situ, of retaining cramp location, front face, rear face, historic cracks to left and right shoulders.

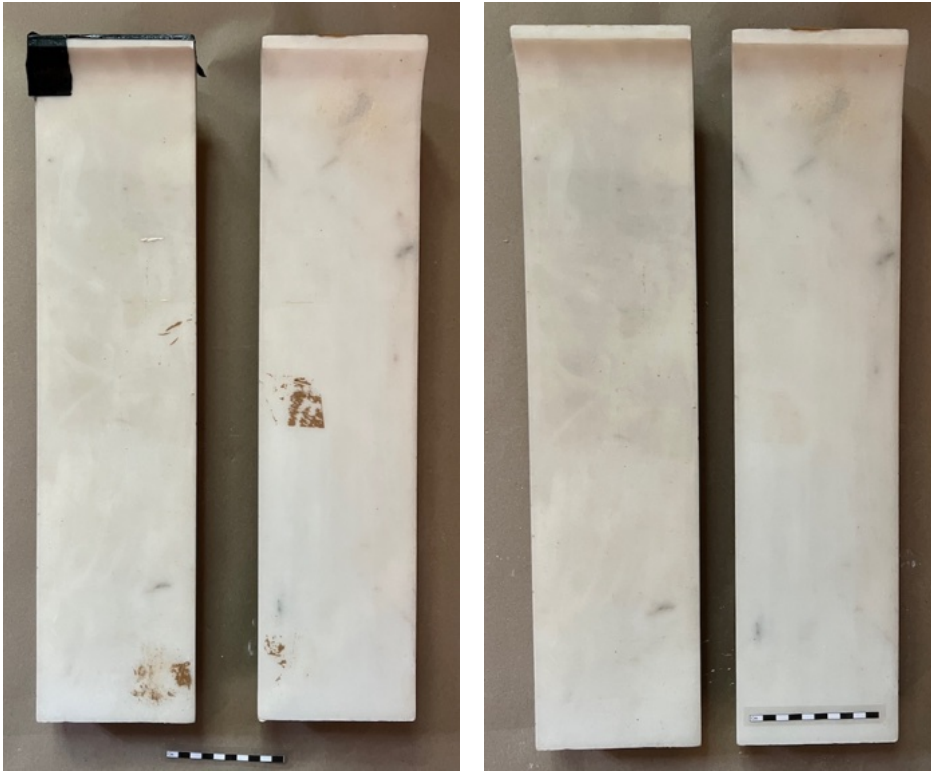
Figure 18 ~ Details of pilasters ex-situ. Upper image illustrates front face prior to removal of tape marks, upper left after removal.

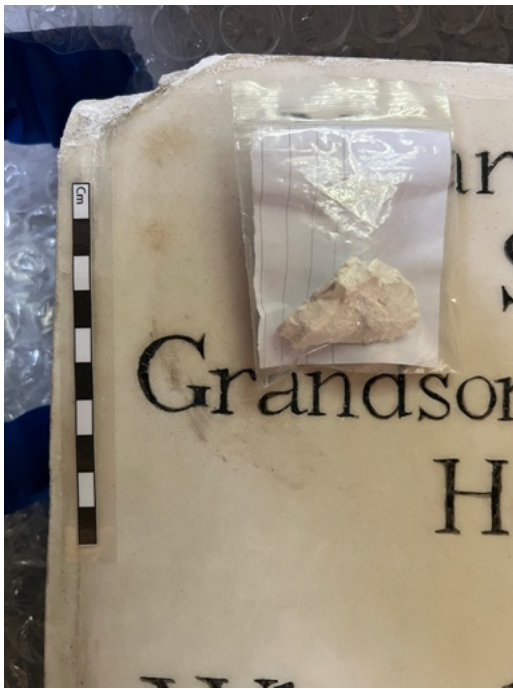
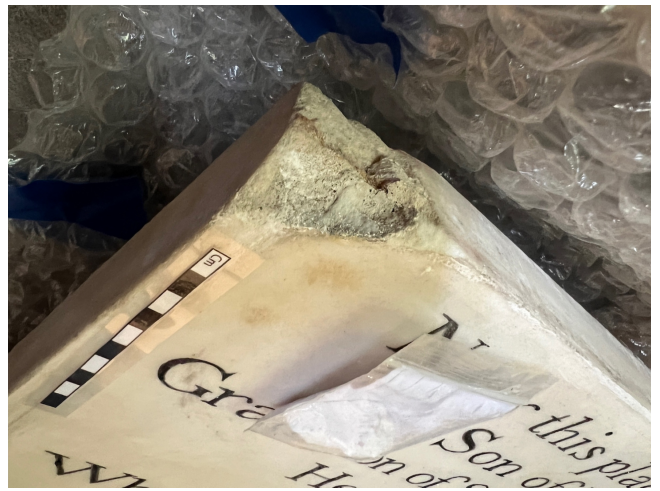
LOSSES ~ Past plaster repairs undertaken to missing upper /left dexter corner of inscription stone. No recent losses were noted.

Figure 21 ~ Details of historic repairs to upper corners of inscription panel.

Above ~ upper left / dexter plaster repair detached and bagged.

Below ~ upper right / sinister corner repair.

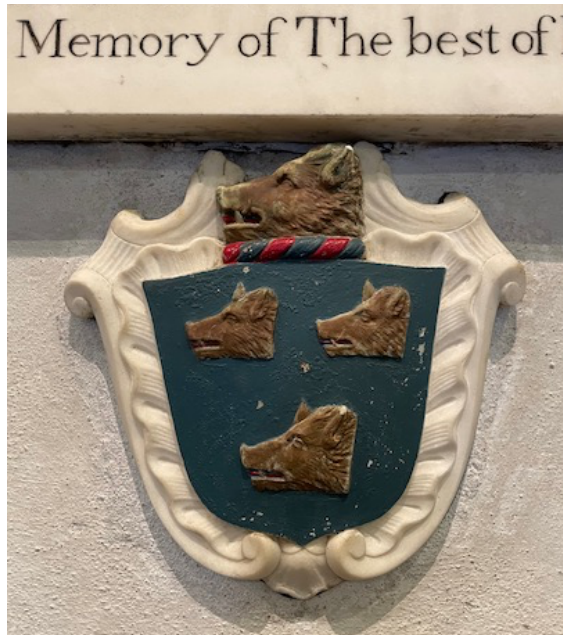
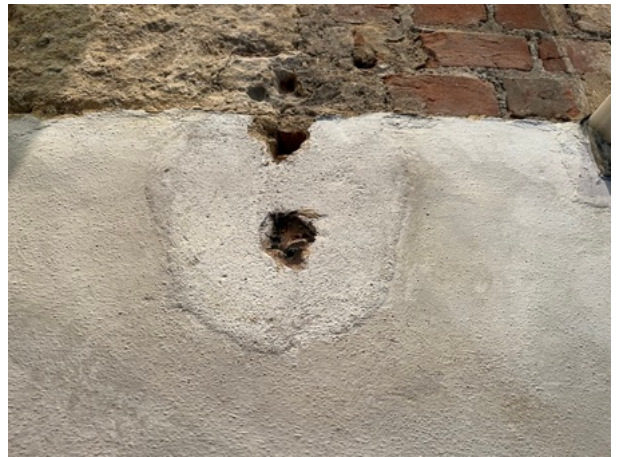
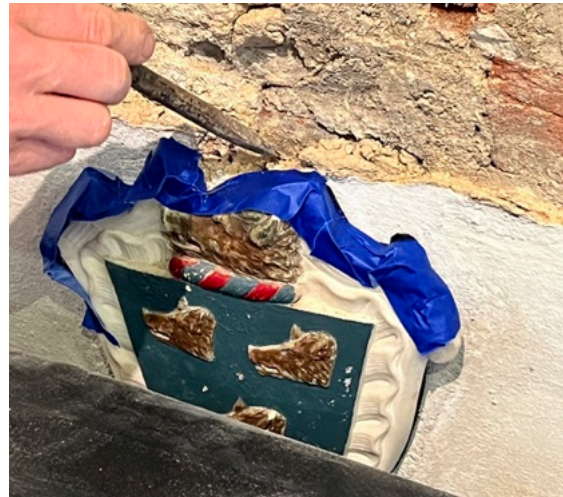
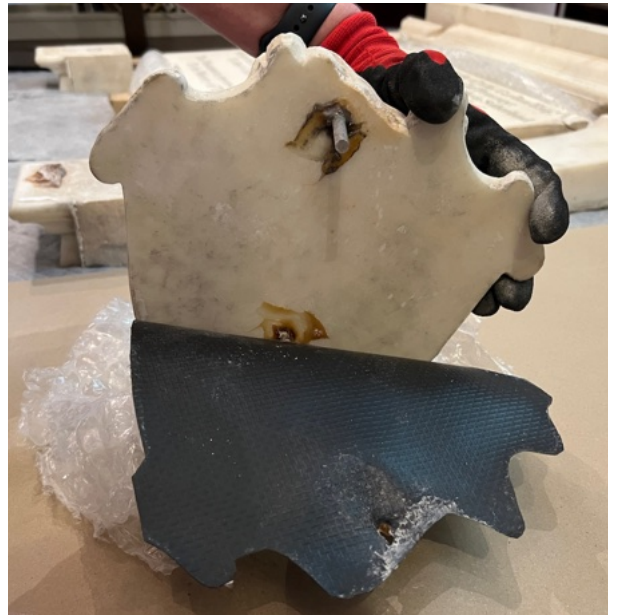
8 ~ COAT OF ARMS

Figure 23 ~ Details of cartouche with painted coat of arms. clockwise from top left: in-situ, dowels after removal; rear face; ex-situ; detail of painted surface and minor loss; locating cramp.

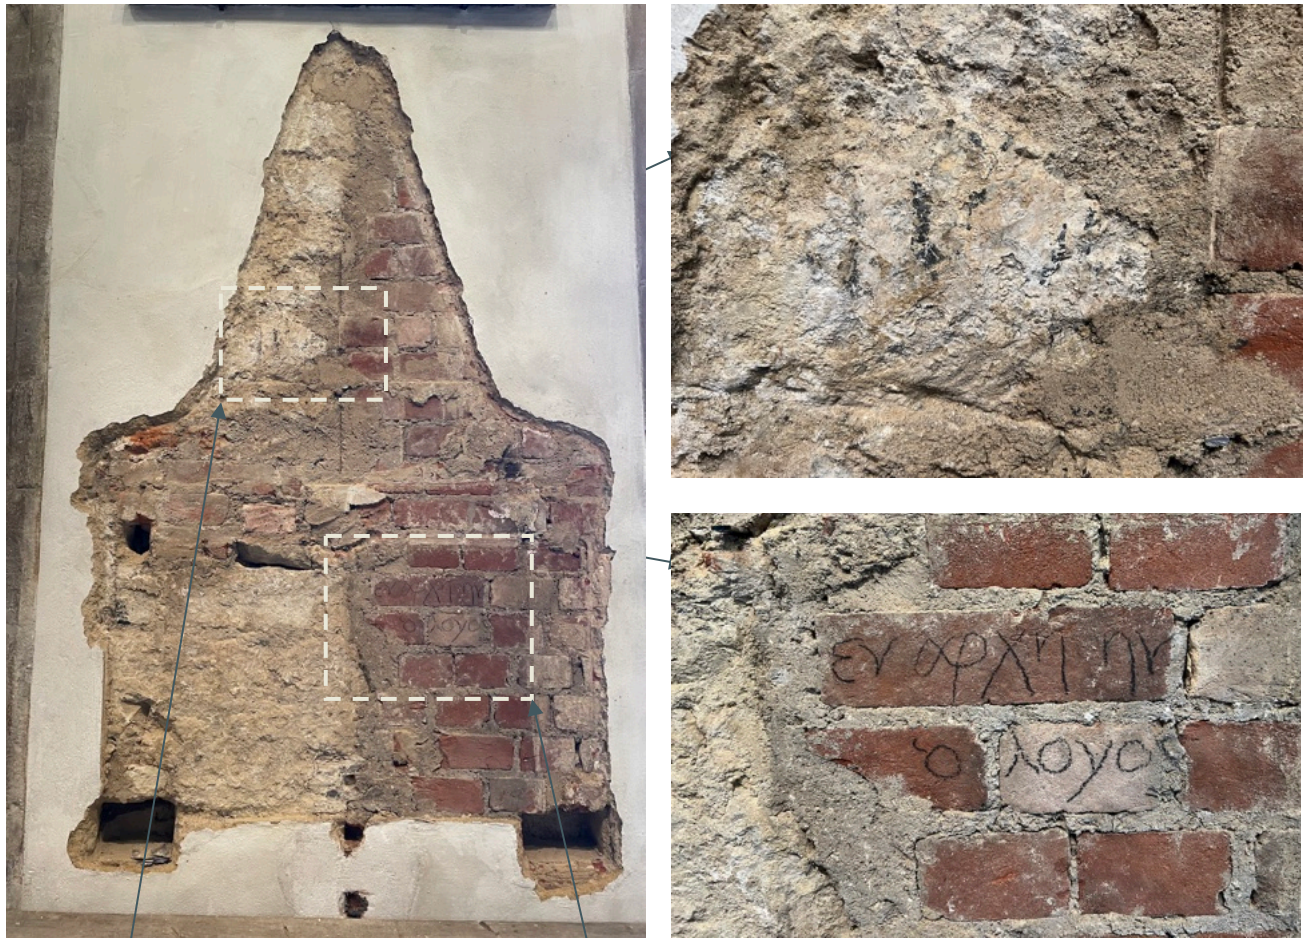
Figure 26 ~ North elevation after removal of Gordon Monument, illustrating location of historic painted inscription, A, and more recent, 2000, inscription, B.

The exposed wall where the monument was removed, is to be replastered and redecorated in lime plaster and lime wash by others.  
An isolating layer was applied to the historic inscription paint traces as well as the 2000 inscription in Greek.

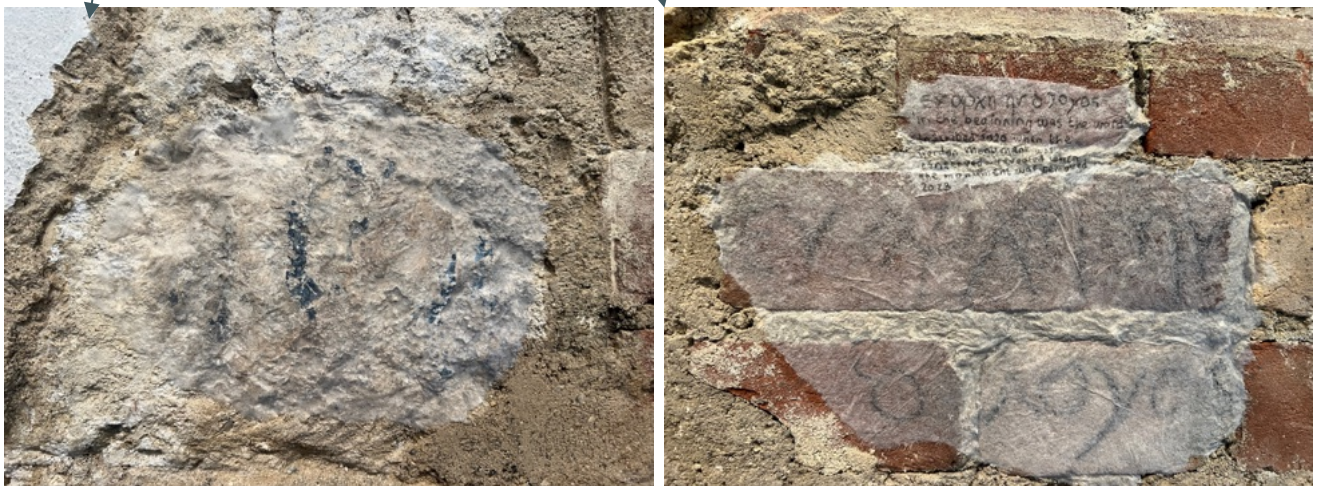
Figure 27 ~ North elevation after monument to John Gordon dismantled. Areas of historic painting and greek inscription are faced up with tissue as protective isolating prior to replastering.
