THE CHURCH OF ST FRANCIS OF ASSISI BOURNVILLE

THE NICHOLSON PIPE ORGAN

REPORT AND PROPOSALS

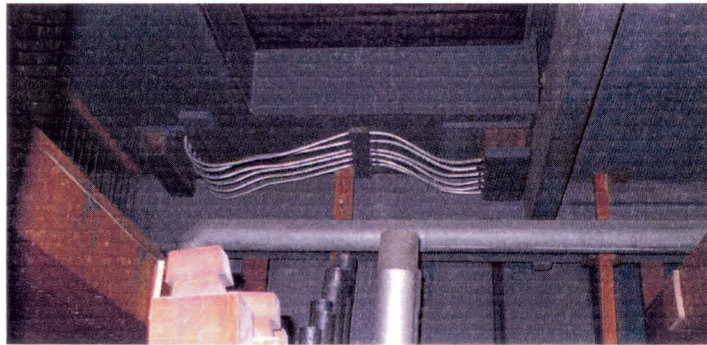
We noted that the Great soundboard has pallet boxes at the front and back, linked by pneumatic tubing. Hence two sets of motors and pallets in the bass will need releathering.

Great soundboard pallet linkages

The soundboards will be taken apart to table and bars. All splits filled, plugged and table screwed. Windways flooded with glue and vented. New cloth fitted below the bars and impregnated with glue. Table and bars planed true and flat.

Pallets cleaned off and recovered with felt and leather. Springs cleaned, lubricated and reset. Upperboards planed true and flat, broken sliders repaired. Table and upperboards grouted and polished. Slides adjusted for free and smooth working on reassembly.

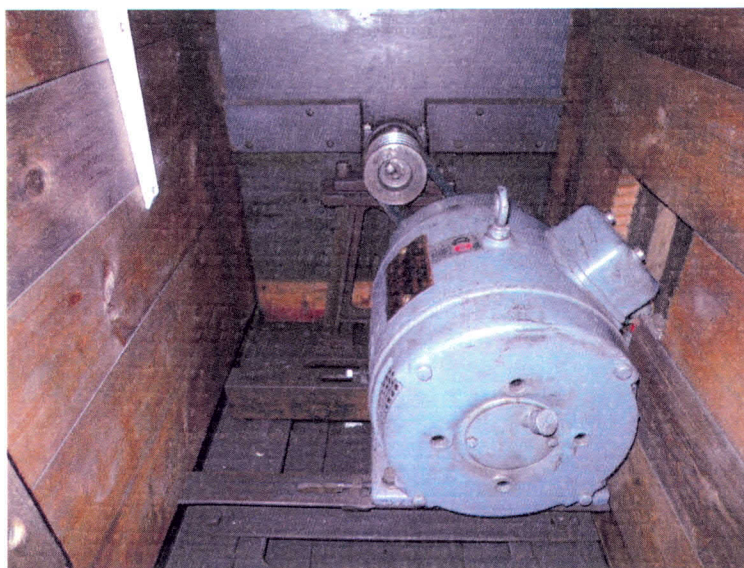
The blower failed recently due to lack of oil in one of the bearings. Fortunately, the burning smell due to the fan rubbing against the old wooden fan casing was noticed before it developed into something more serious. In these days of heightened awareness of health and safety obligations, a wooden fan housing is a risk that should be avoided.

Wooden blower housing

Furthermore, the blower 'plays out' easily on full organ which is very evident in the pitch of the two stops which work on the highest pressure, namely the Tromba and Clarion. Our recommendation is therefore to replace the old blower by a modern unit of increased capacity with a metal casing and long-life bearings with a generous oil reservoir and warning indication of low oil level. The existing belt drive and two of the four bearings will be eliminated. The whole unit will require far less maintenance.

The present blower will be discarded and replaced by one of larger capacity made by Laukhuff of Germany. The belt drive will be eliminated and four bearings will be replaced by two. The motor will be provided with long-life and silent running plain bearings with a generous oil reservoir that will considerably cut down on the amount of maintenance required. The reservoir will be provided with a float switch and warning light to militate against a repeat of the low oil level incident that led to the recent bearing failure.

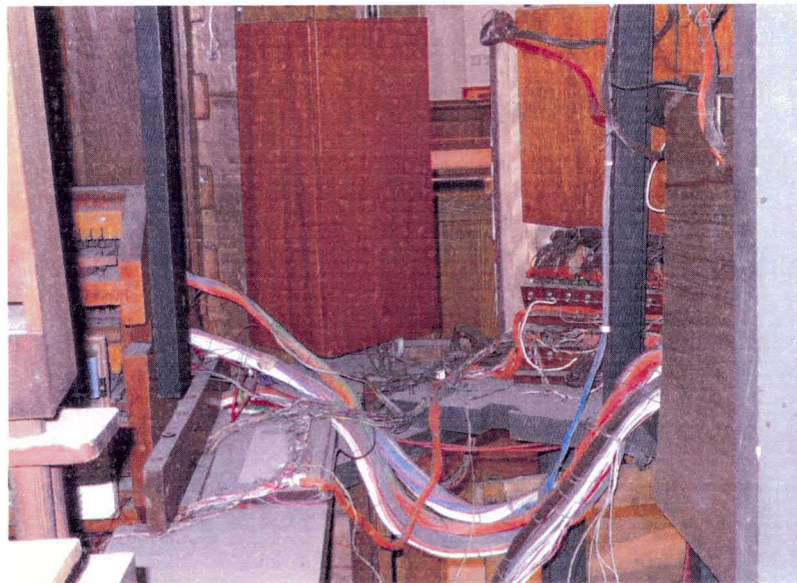
The low-voltage wiring was very poorly executed in 1989. Since the two ends of the wiring will need reconnecting to the key contacts and solid state control system respectively, we recommend that complete replacement of the cable looms would be the appropriate way forward to ensure longevity and ease of future maintenance.

1989 low-voltage wiring

New low voltage wiring will be installed throughout. All cables will have copper conductors with PVC covering. Main cable runs will be housed in PVC trunking for protection and neat appearance.
