200123-1267-CSW  
23<sup>rd</sup> January 2020

### **TRIAL HOLE & DRAINAGE INSPECTION AT ST NICHOLAS CHURCH, FYFIELD**

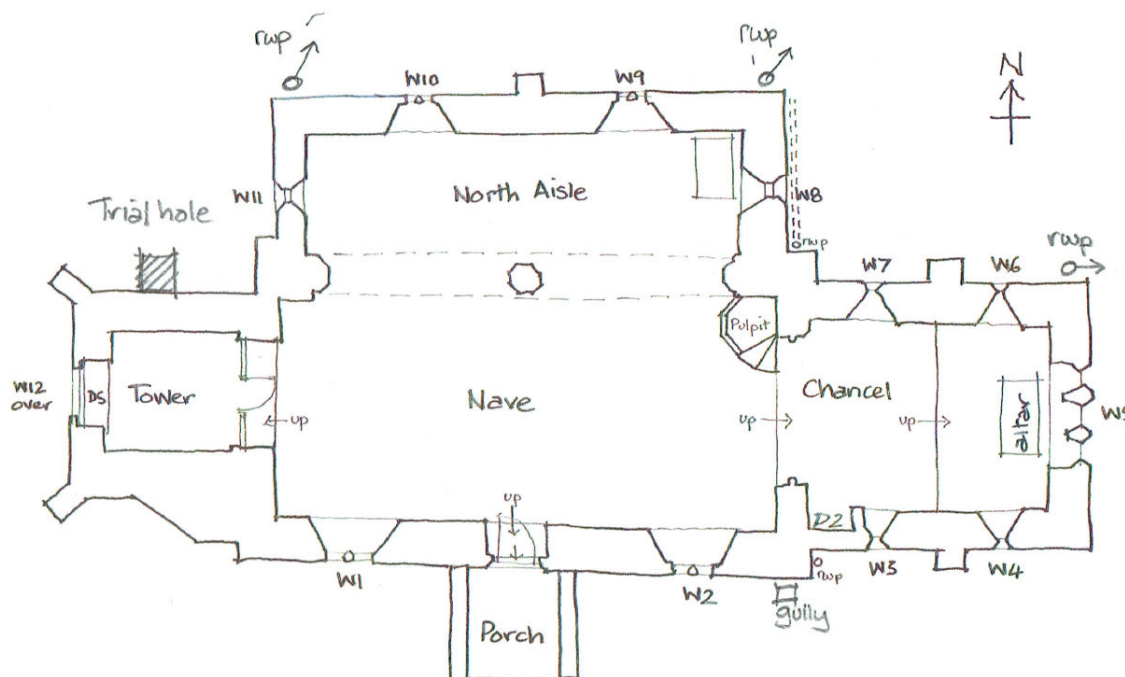
I met with Elliot and his operative at the Church on Tuesday 21<sup>st</sup> January 2020, at around 9.30am. A neat trial had been dug adjacent to the Tower on the North side, as indicated on the plan overleaf. At my request the hole was deepened a little further to an approximate depth of 1100mm. The trial hole uncovered soil that appeared well draining and not of a high clay content.

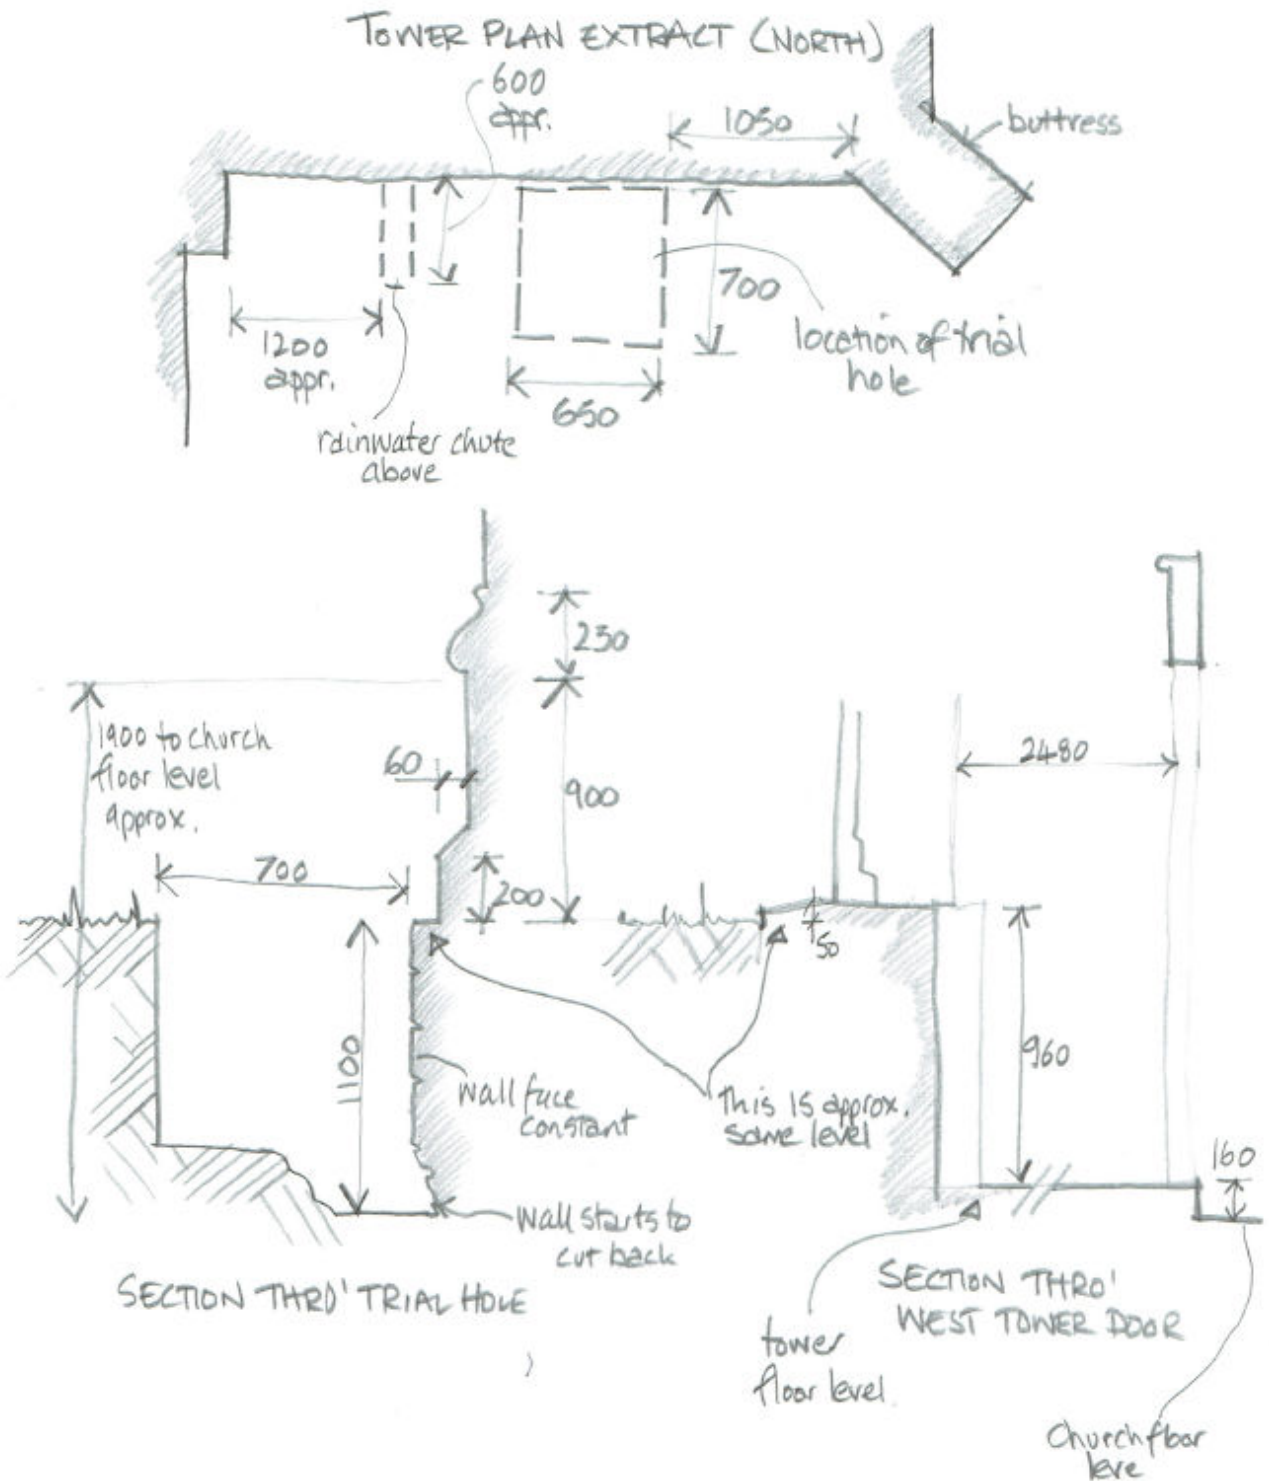
It appeared from the face of the tower wall, that the base of the trial hole may well have reached the base of the wall as the stonework appeared to 'cut back in'. At the rear of this short report is a sketch section through the trial hole and the approximate internal floor level of the tower and church.

The findings suggest that as a result of the high ground level in comparison to the low church / tower internal floor level, that ground water held in the soil, seeps slowly into the wall build up, and migrates eventually causing damp in the tower corners (where there are probably some voids between the larger stones). This is also exacerbated further with the discharge of the rainwater chute at high level from the tower roof.

All of this we already knew to some extent, however the hole has allowed us to appreciate how the tower wall was built below ground. Basically the wall continues down with only a minimal step out from the face above. Should we proceed with a French drain then this may be kept reasonably tight to the tower (apart from the buttress projections).
