St Buryan Churchyard Cross, Cornwall
Archaeological recording and watching brief during
repairs

Client	St Buryan PCC
Report Number	2016R050
Date	August 2016
Status	Final
Report author(s)	James Gossip and Ann Preston-Jones with Ryan Smith and Andrew Langdon
Checked by	Andy Jones
Approved by	Andrew Young

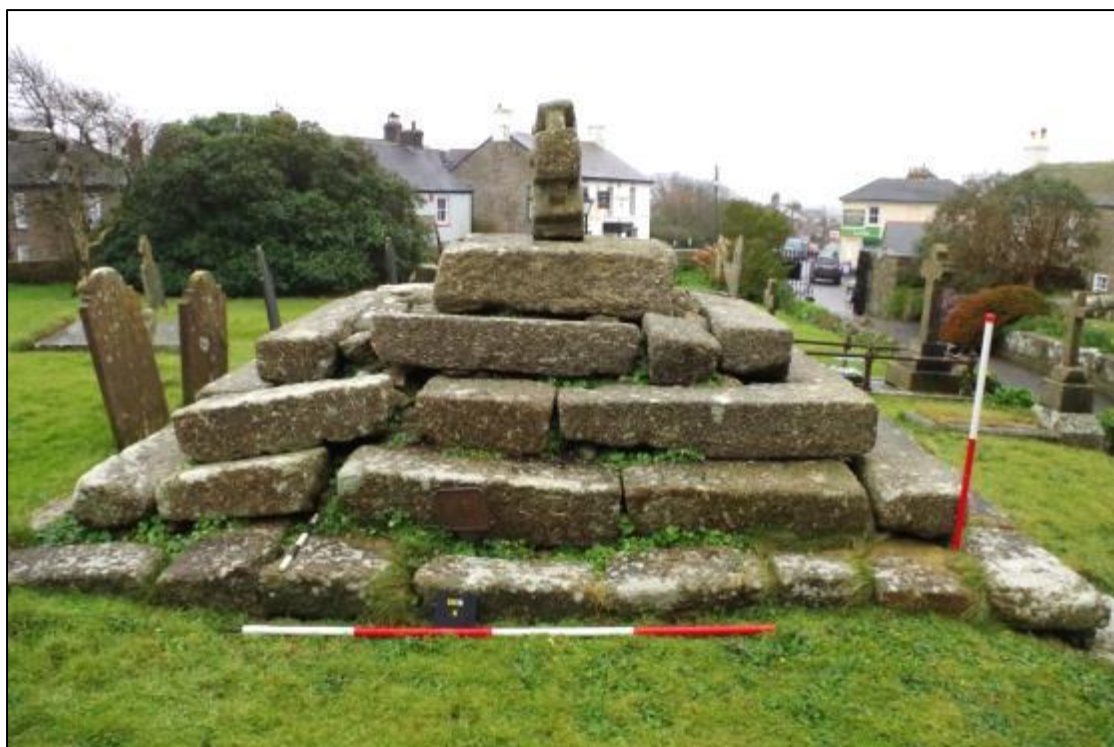
Fig 15 North elevation, showing slumping towards the east (left) (JG).

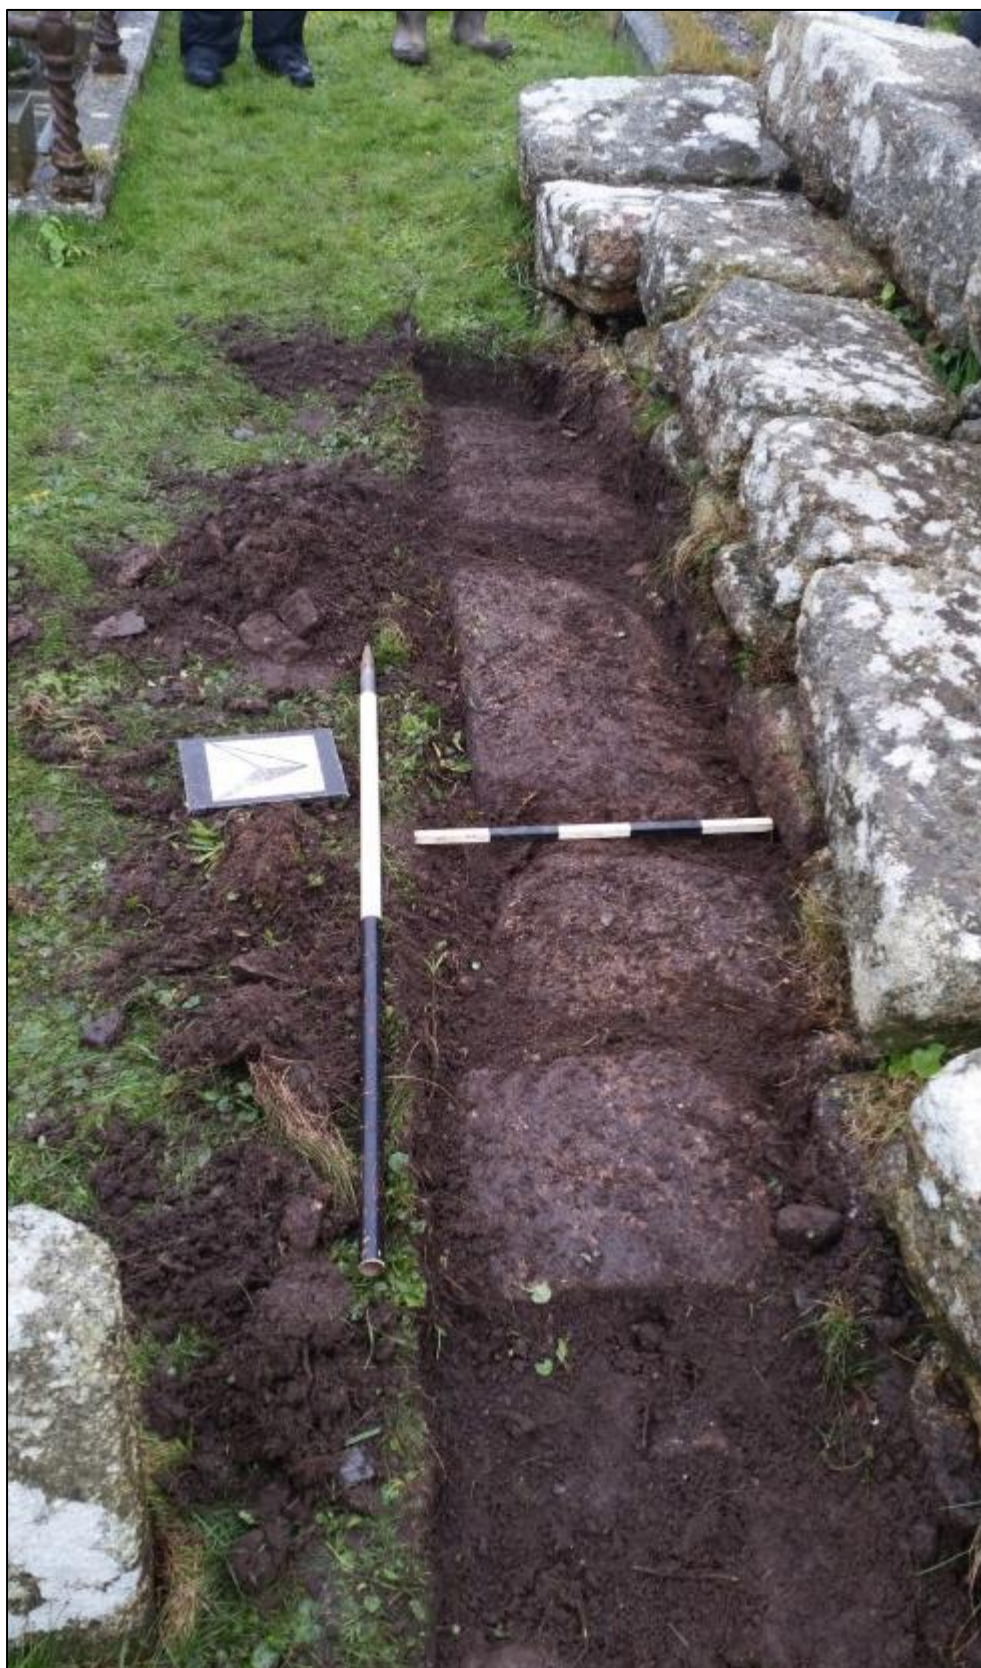
There was no solid core of material to provide a base or foundation for the first tier, as the ground beneath was part of the make-up for the raised graveyard. This soil was very wet and had caused the granite to degrade. This appeared to support the assumption made at the outset that the bottom tier of stone, which contains less massive blocks but includes one or two with drill marks, could have been added after the main rebuild; it might relate to the post-1840 work referred to in the churchwardens' accounts (above) or at the time of the church restoration. It might have been added to prevent movement of the new steps away from the core. An additional, lower, step which was found on the

Fig 20 The additional paving or steps found on the south side, after removal of turf (RS).

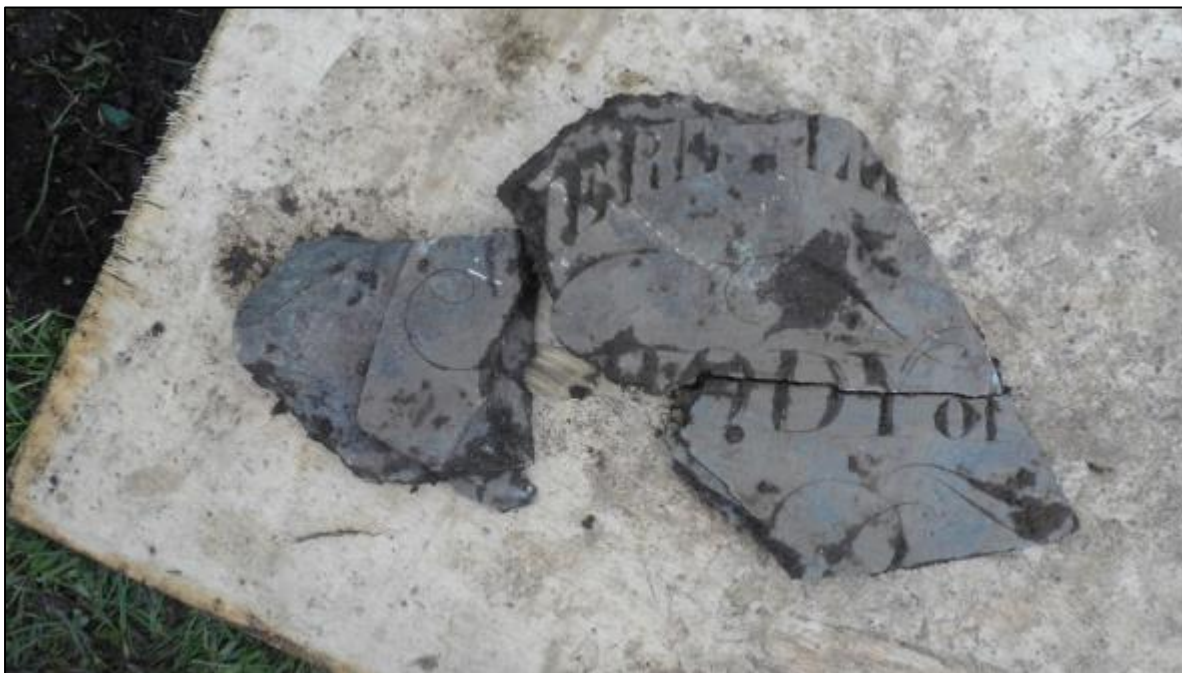
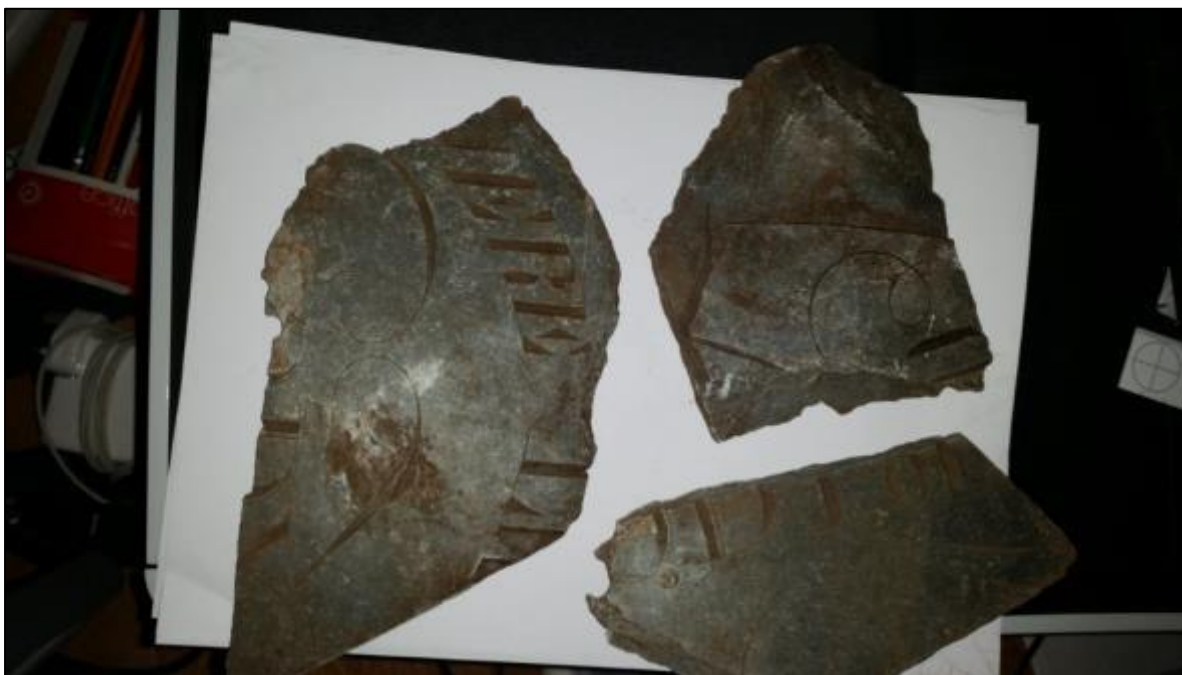
This is confirmed by the fact that when the ground beneath the south east corner of the pedestal was excavated to a depth of over 0.4m to enable a slab to be laid to provide a firm base, some modern pottery fragments and pieces of a nineteenth century slate headstone were found (Figs 21 and 25).

Fig 21 Fragments of headstone found under south-east corner of pedestal (RS).

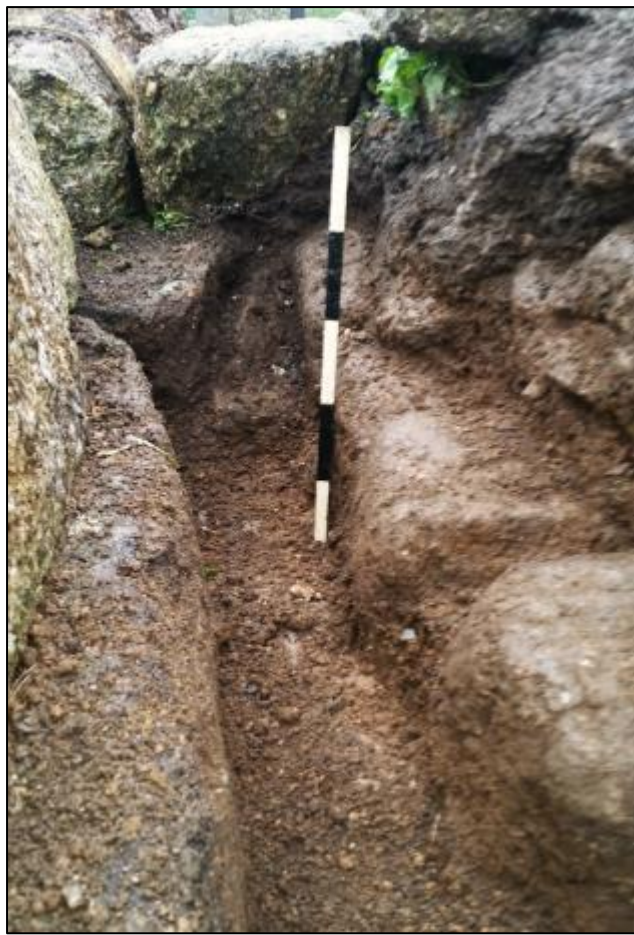
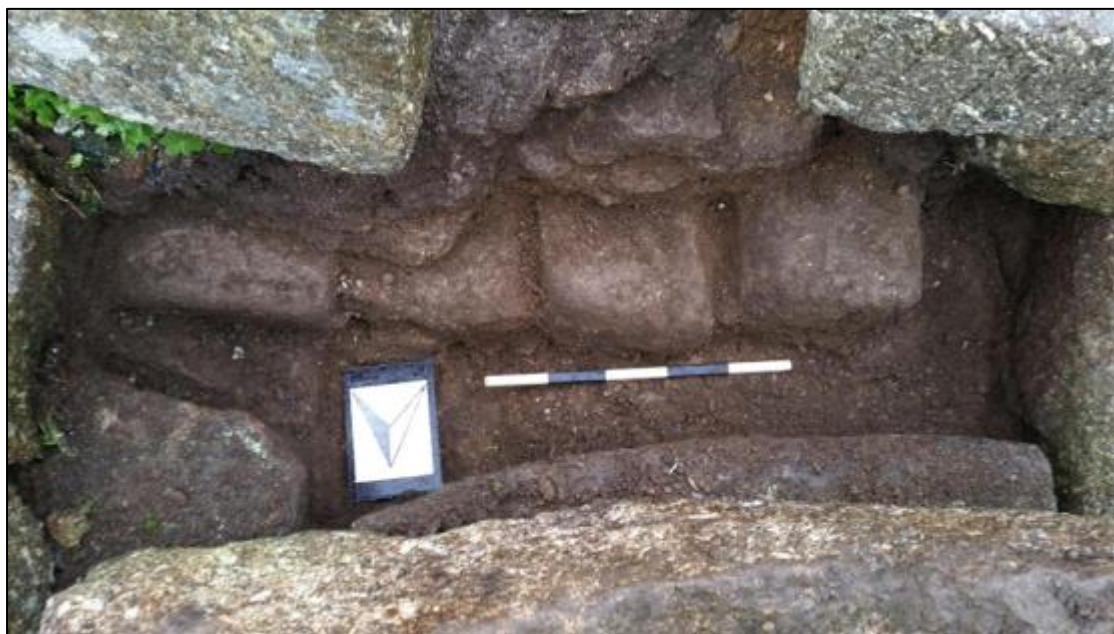
Behind the outer facing was an earlier, possibly original flight of steps which appears to be *in situ*, but in a poor state of repair. This was built of very much smaller stones (Fig 27), without any drill marks evident (although none of these stones were removed). Various spots were probed to determine the foundation of the wall, but these were never confirmed due to the limited excavation. From this it appears very likely that the nineteenth century refurbishment referred to in the churchwardens' accounts, deduced from the illustrations and confirmed by excavation, had involved building a new stone face or shell over and around the entire original stepped base of the cross, the latter forming the foundation for the new work. From the small glimpses allowed by the work methods, it is likely that this original monument survives in its entirety as a core within the nineteenth century steps. This helps to explain the way in which the plinth had deteriorated - slipping away from the core especially on the east side where grave subsidence may have contributed to the effect - while leaving the cross head apparently firmly set at its apex.

The partial collapse of the outer 'shell' of the monument was due to a rebuild in the nineteenth century that involved insufficiently stable core material and poor bonding (there is no evidence that it was repointed). The presence of two graves close to the eastern side of the monument may have caused some slumping as grave backfill settled. The condition of the monument prior to the nineteenth century rebuild is illustrated by JS Prout's engraving (Fig 6) – clearly it was decided to invest in the structure at this time, creating a larger and more impressive monument. However, the Churchwardens' Accounts show that this was in fact only one part of a massive programme of works in the churchyard at the time: a programme which included the churchyard walls and culminated with the full restoration of the church in the 1870s.

Fig 27 Wall or face of older step hidden within the nineteenth century 'shell', north-west corner (RS).

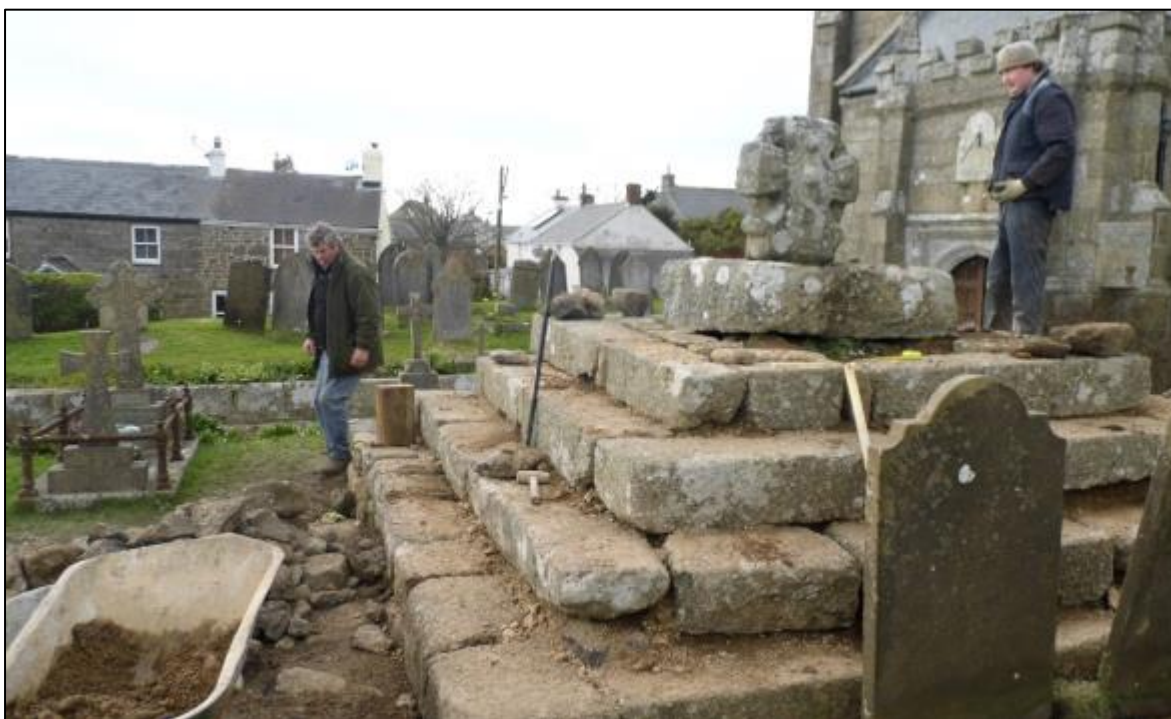
Fig 31 Conservation work in progress: the use of rab (local orangey-brown granitic subsoil) to level the stones can be seen in this picture (in the stonework joints and in the wheelbarrow) (AGL).

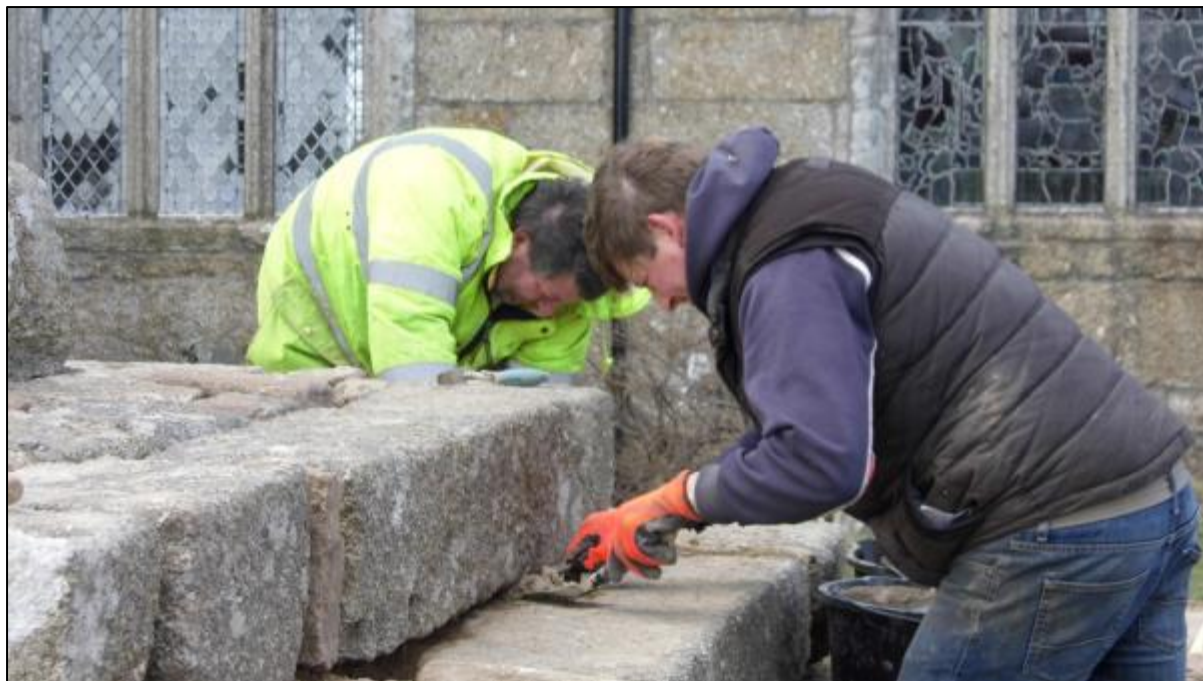
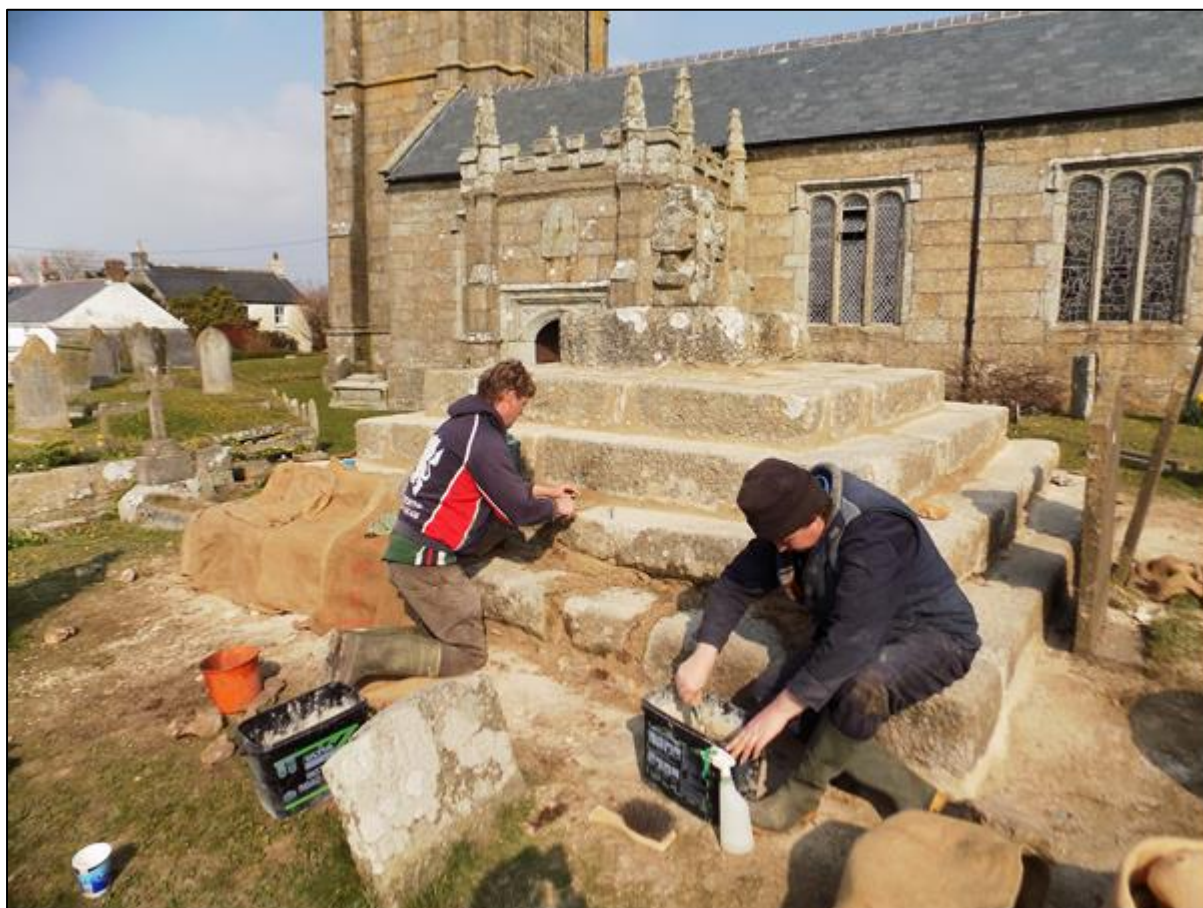
Fig 32 Conservation work in progress: deep pointing of the joints of the cross pedestal in a lime-based mortar (AGL, APJ).
