St Mary the Virgin Church in Great Milton

Treatment Report

March 2024

Condition works of Dormer Monument

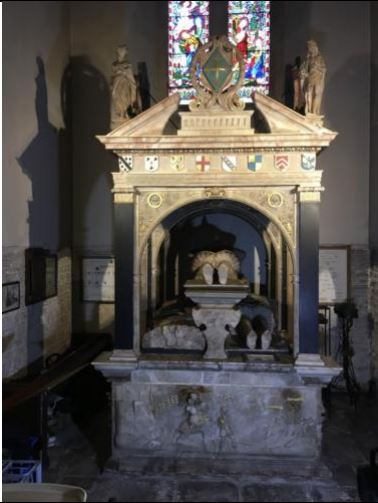
<p>Fig. 1: general view of Dormer monument before conservation works</p>	<p>Fig. 2: monument after completion of the treatment</p>

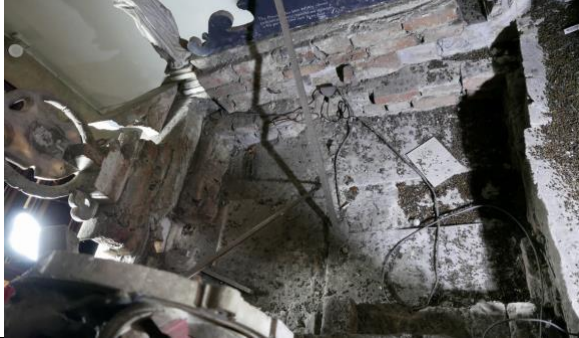
<p>Fig. 3: large amount of dirt, dust and dead insects on the top of the monument canopy</p>	<p>Fig. 4: dirt and cobwebs on the window sill above the monument</p>

The first stage of the works was **dry cleaning**. This operation was done with the use of vacuum cleaners equipped with HEPA filters. More stubborn dirt was gently brushed towards the vacuum hose with small paint brushes. Most of the dust, dirt, cobwebs and dead insects were located on the top of the canopy of the monument. During this process, conservators also vacuumed the window sill and lower part of the mullion of the western window, located above the monument.

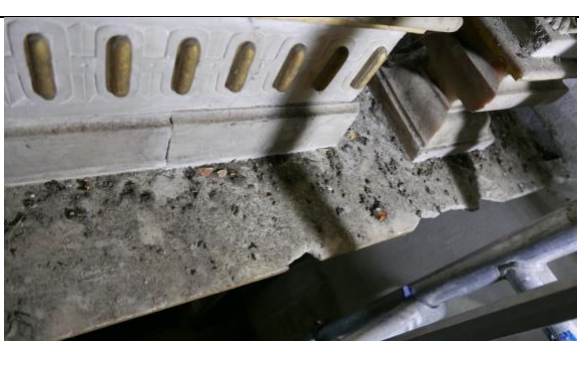
<p>Fig. 5: sky facing surfaces before dry cleaning</p>	<p>Fig. 6: dirt and cobwebs on decorative elements of the monument</p>

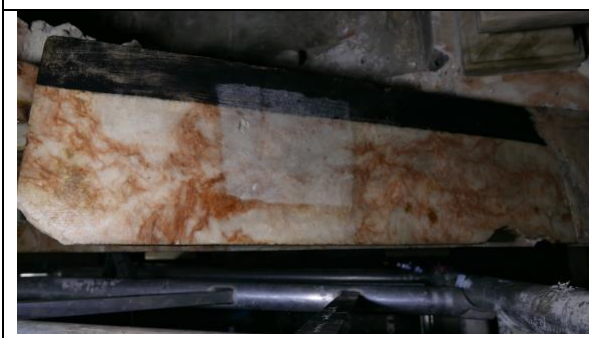
Fig. 11: square section of alabaster before wet cleaning; noticeable difference between cleaned and non cleaned stone surface

- V&A mix (white spirit mixed with deionised water in ratio 1 : 1, with a small addition of non-ionised detergent Synperonic A7) was used for cleaning the alabaster surface. The mix was applied on small areas of the stone surface with soft paint brushes, worked and removed with cotton swabs. After cleaning of

each small section (approximately 5cm x 5cm) the treated surface was neutralised with deionised water (mist sprayed) and dried with a clean cotton wool swab. This very time-consuming technique allowed the use of a minimal amount of solvent solution and water that potentially could affect the alabaster surface (alabaster is a water soluble limestone). Due to the presence of resistant dirt, wet cleaning with V&A mix was repeated on most sky facing sections of the monument.

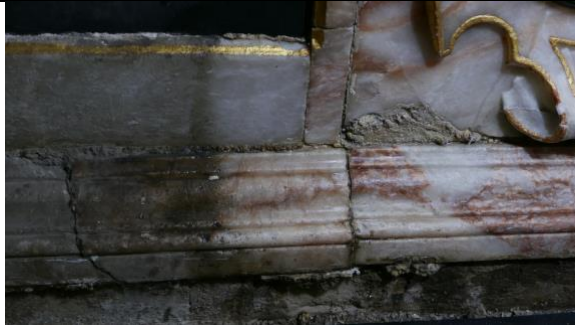
The largest fill and reconstruction repairs were located at the lowest part of the monument, by the floor. The original stone in that area was significantly deteriorated and some areas of the moulding were missing. The main reason for this type of deterioration and damage was ingress of capillary water and salt efflorescence within the soft limestone. In this case, it was decided to provide large fill repairs made of two layers of mix. The deeper layer was made of 'mortar' based on plaster of Paris mixed with chalk dust and granules (up to 4mm diameter) in ratio 1:1. This mixture was very light, porous and due to presence of chalk dust had great adhesion to the deteriorated limestone. The top, levelling layer (1-3mm thickness) was made of plaster of Paris

Fig. 13: lowest section of alabaster moulding before and after cleaning

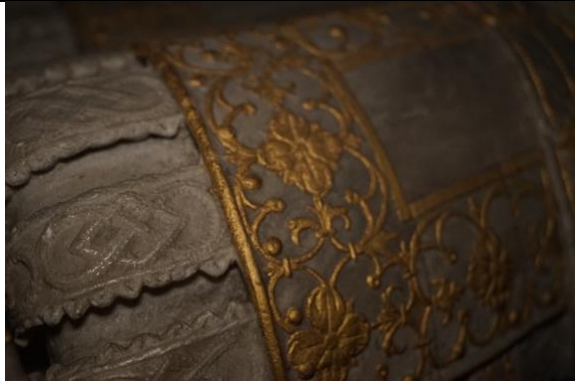
Fig. 17: alabaster and gilding before cleaning

- Gilding was cleaned with a solution of tri-ammonium citrate (TAC) in deionised water (2.5% TAC in water). The solution was applied on the cleaned surface with cotton swabs on wooden skewers. After cleaning, the gilded surface was neutralised with deionised water and dried with cotton swabs.
- Deionised water with a small addition of non-ionised detergent Synperonic A7 was used for cleaning the black marble/limestone columns. Again, after cleaning the stone surface was neutralised with deionised water and dried with cotton swabs.

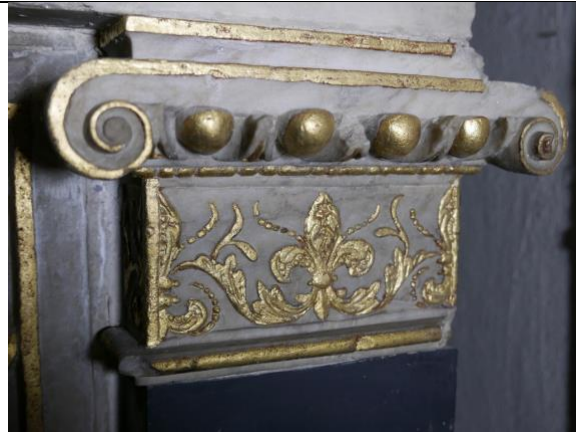
Fig. 21: capital of the column before wet cleaning

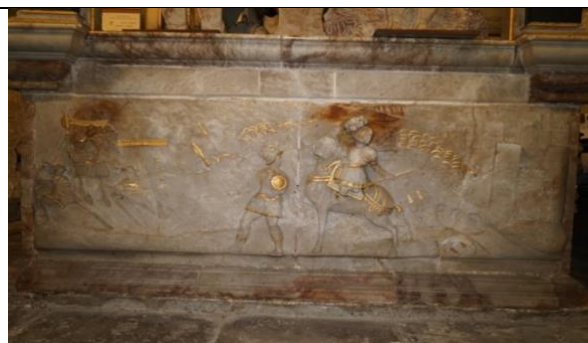
Fig. 23: battle scene panel with visible open joints, cracks, deterioration of stone in lowest part, discolorations

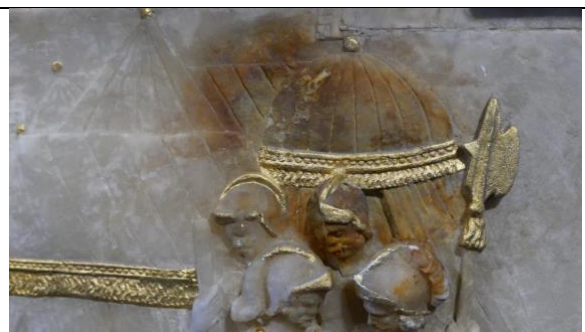
Cleaning also included trials of removal of red stains located on the carved decorative alabaster panel (battle scene at the front of the monument) and on the right hand side of the monument. This red staining has been caused by the slow corrosion of ferrous fixings used for connecting the monument elements (probably during moving the monument from the southern aisle to the tower in 1860). Trials included application of poultices containing a solution of 5% and 8% TAC in water. Poultices in the form of cotton swabs pre-dampened in TAC solution were applied to the treated stone surface for 0.5, 1, 2, 4 and 8 hours. After these different periods of time there were no visible changes in the red discoloration. After 8 hrs of poulticing, small areas with salt efflorescence around the poultice were observed. This fact clearly indicated that poulticing was not successful in this case.

Fig. 24: ferrous stains in top right corner of the panel

After discussion with the architect and PCC representatives, it was decided that two large areas of alabaster covered with red iron staining should be retouched (they were located at the front of the monument on an elaborate carved battle scene). As mentioned earlier, it was not possible to remove the stains with the use of poulticing techniques. Retouching was completed with acrylic paints diluted in water and applied to the alabaster surface with sponges. This method was successful and the retouched areas blended with the surrounding stone surface very well.

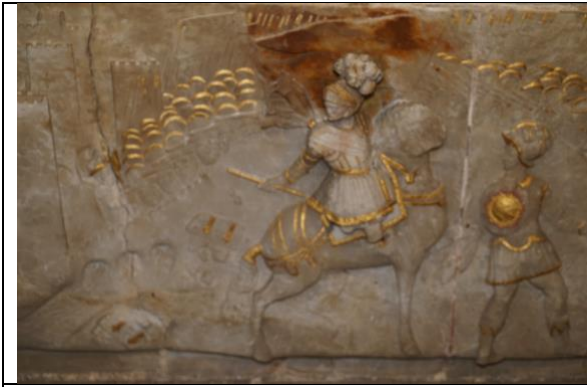
Fig. 25: ferrous discolorations of stone

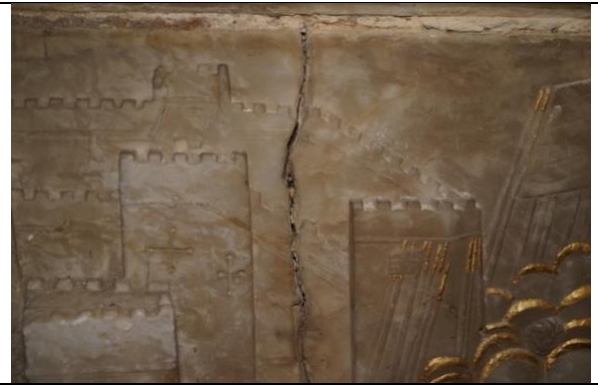
Fig. 26: open crack on alabaster panel

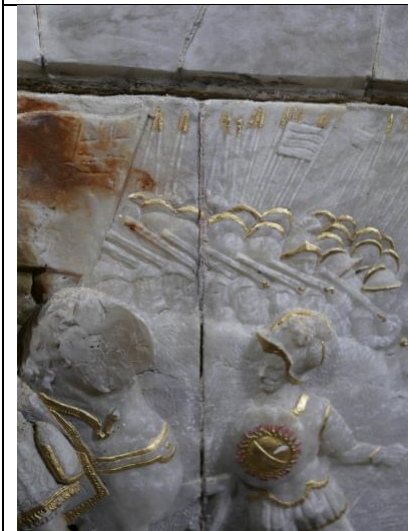
Fig. 27: wide open joints with partly or fully missing original pointing

It must be highlighted that the amount and level of reconstruction repairs had been discussed with the architect and PCC representatives prior to conservation works. The aim of the fill and reconstruction repairs was to unify the general appearance of the object (repointing of all open joints and cracks) rather than to provide full reconstruction of all missing details.

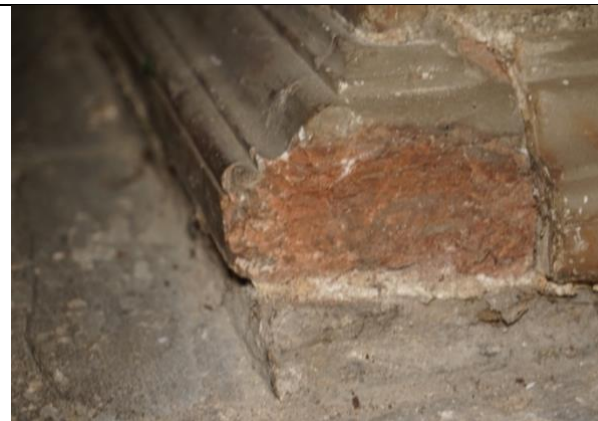
Fig. 28: missing stone corner (alabaster) in the left hand side of the panel

only. The shape of the missing moulded alabaster section in the left corner of the front elevation of the monument was reconstructed in the same manner. Application of these large fills significantly improved the appearance of the monument.

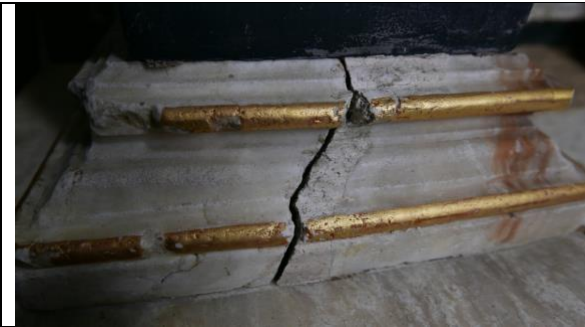
Fig. 31: open crack previously repaired with plaster

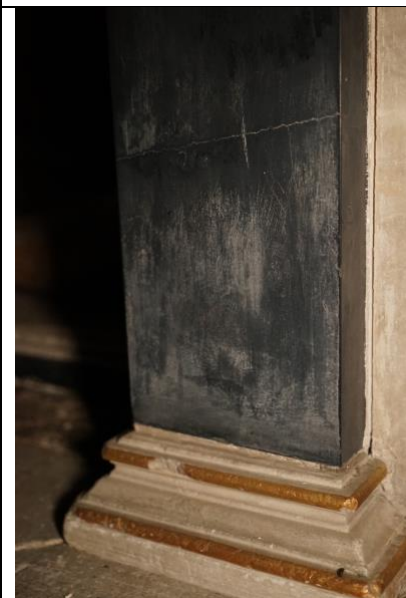
Fig. 35: discoloration of the black marble column shaft

The shafts of the columns (carved in black marble) were treated with microcrystalline wax mixed with ivory black pigment. This allowed unification of faded colours on the black stone surface.

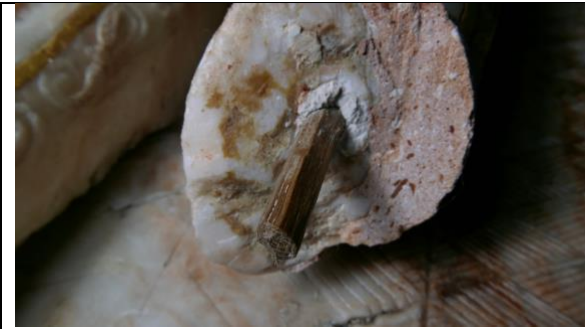
- The left foot of the central effigy (Ambrose Dormer) was found to be loose in two sections. After dismantling the loose elements, it was found that they were connected with oak pegs and wide open joints filled with pigmented plaster. The wooden pegs were replaced with stainless steel dowels (6mm diameter) set on polyester resin. Missing fragments of stone in the wide open joints were filled with plaster of Paris.

Fig. 37: dismantled, fractured section of the leg of the effigy of Ambrose Dormer; visible previous mortar repair and wooden dowel

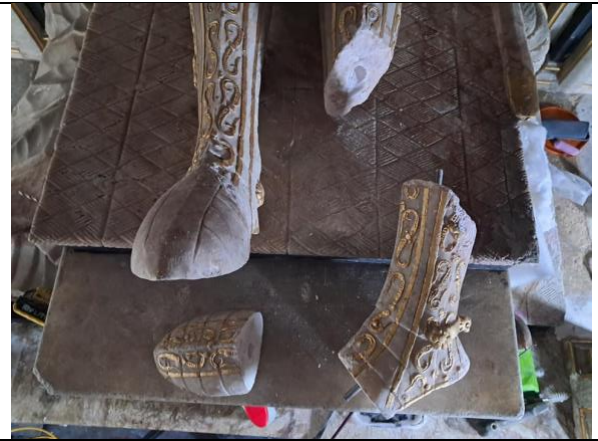
Fig. 38: detached elements of the leg before reinstallation

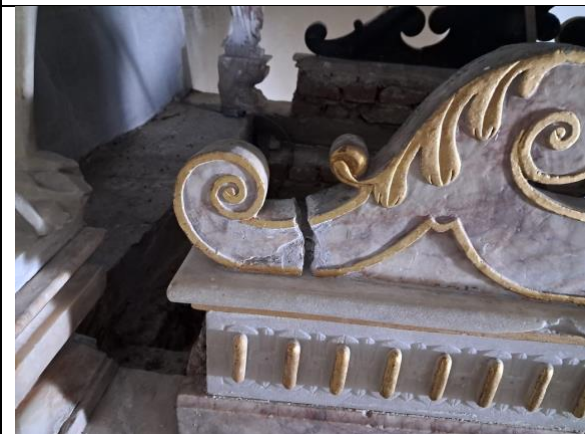
- Two decorative ornaments on the top of the canopy (left hand side of the monument) were found to be loose. An old plaster joint was carefully removed

Fig. 41: detached decorative ornament

and small threaded stainless steel dowels (A4 marine grade; 4mm diameter) were provided as connection between the two detached sections of stone. The dowels were anchored with polyester resin and the joint was grouted with plaster of Paris.

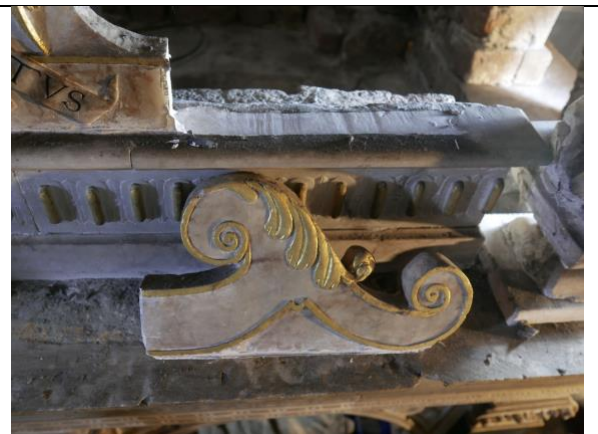
Fig. 42: another ornament carved in alabaster, before re-setting

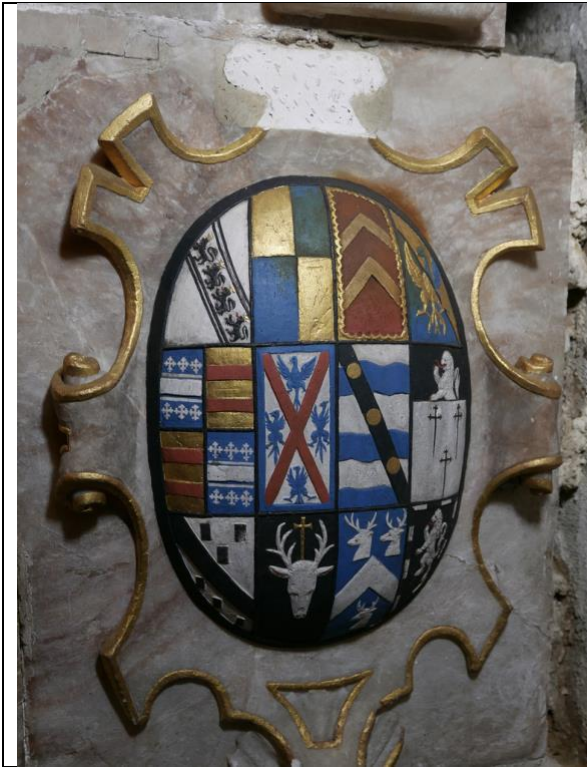
Fig. 43: detached volute above the heraldic shield

- A section of the detached carved volute above one of heraldic shields (far right hand side of the tomb pedestal) was re-adhered with a small amount of polyester resin and plaster.

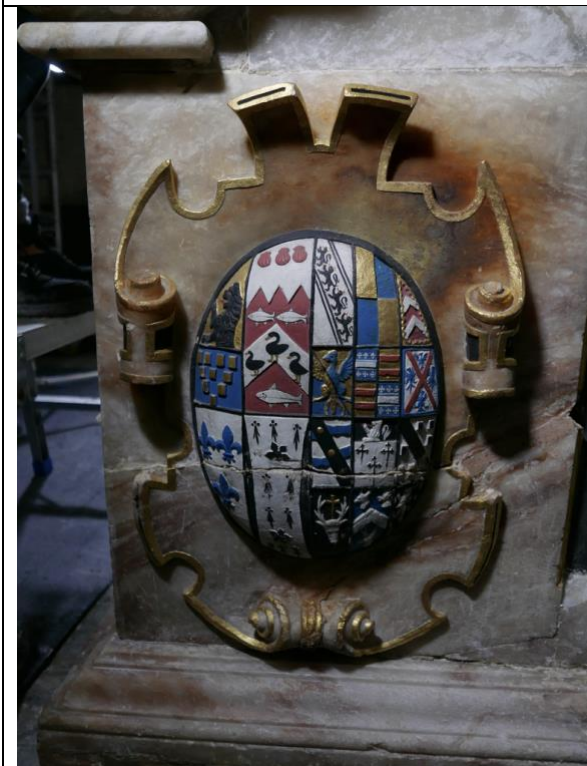
Fig. 45: coat of arms with horizontal fracture across the shield; noticeable ferrous staining of the alabaster

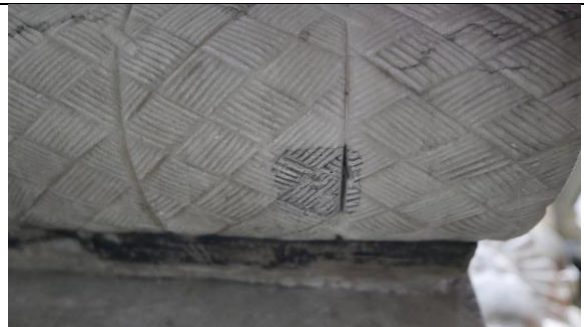
Fig. 54: another fixing hole repaired with plaster, presumably in 1956
