**St. Peter's Church
Clayworth
Nottinghamshire
(Diocese of Southwell)**

**A Record of Conservation Works Carried out to the Monument
of Humphrey Fitzwilliam (d.1556)**

July 2024

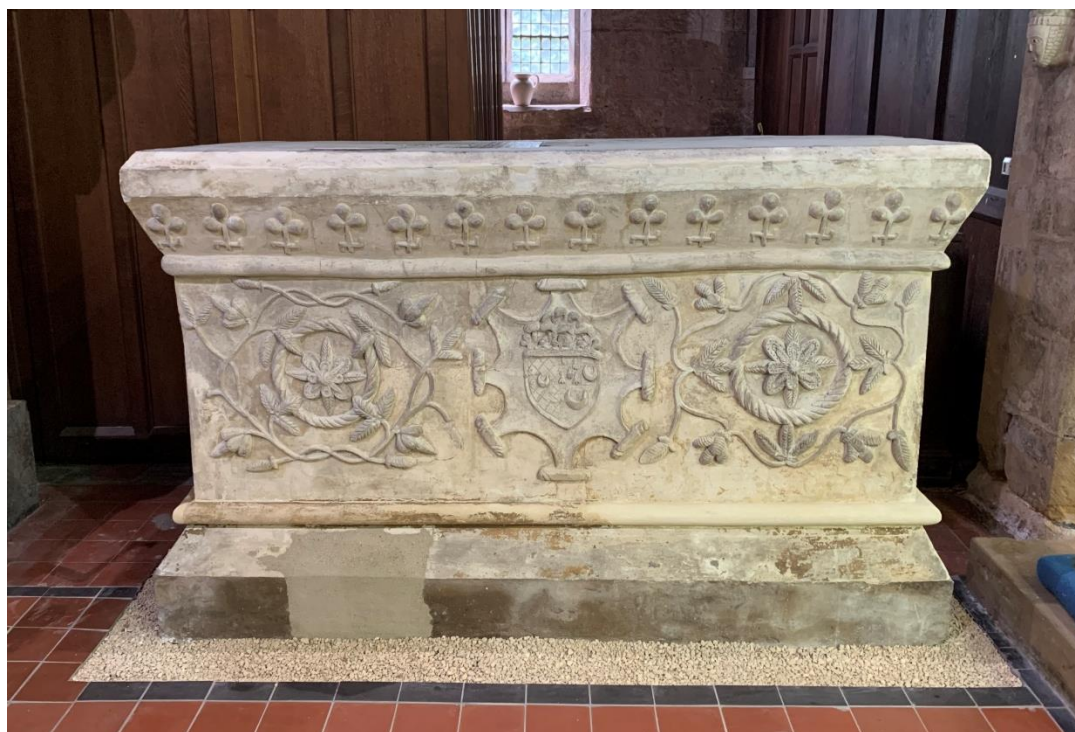
Plate 1: The monument after conservation

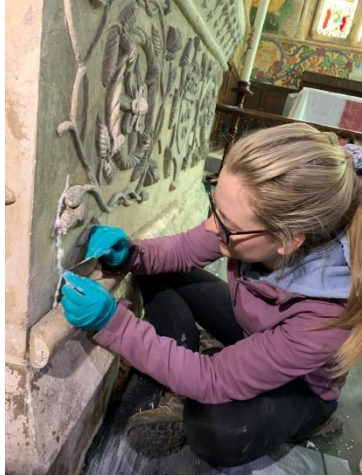
Plate 2 (left): The south face during consolidation

1. The area was secured from visitor access with cones to provide a suitable safe working area. The floor was protected before works began by laying sheets of Correx taped together. Record photographs and notes were taken throughout the process.
2. Consolidation of the plasterwork was carried out before cleaning to preserve the original surface. Historical cracks allowed access to the back of the delaminated plaster for a small needle to be inserted. The area was flushed with IDA (Industrial Denatured Alcohol) used as a wetting agent to improve travel of the grout. Then *CaLoSiL E50* (a nanolime dispersion) was injected into the area to consolidate any powdered surfaces behind the plaster. The area was then grouted using *Deffner & Johann CalXNova* Lime Injection Mortar (A dispersed hydrated lime mixed with minerals and water).

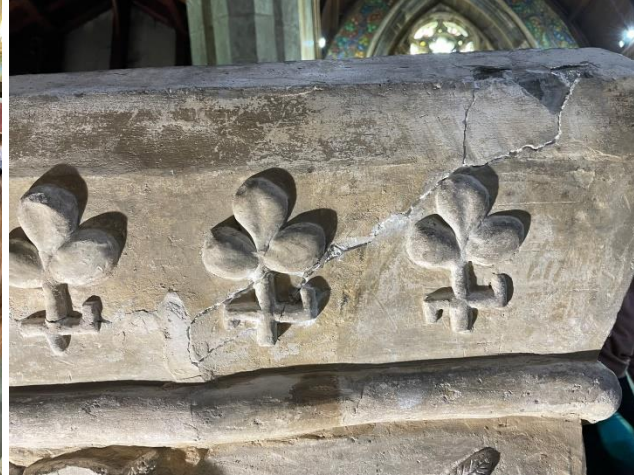
Plate 3 (right): The west face after consolidation

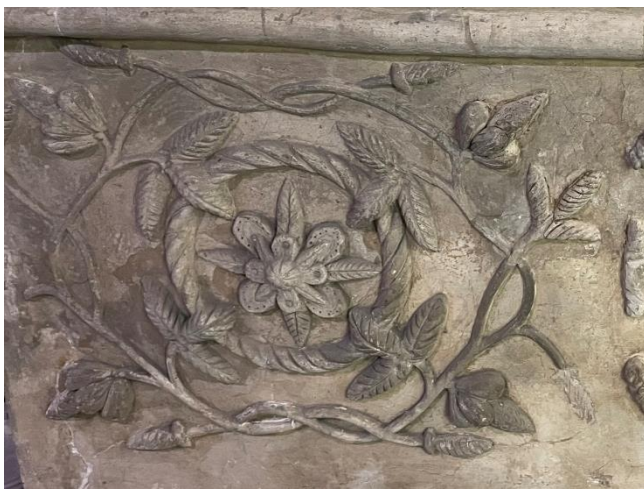
Plate 4: Before cleaning.

2. The south facing elevation had significantly more discolouration, from what appeared to be soot. This is presumably from candles being situated close to the monument.

5. Surfaces were consolidated using *Primal SF-016* (a deep penetrating acrylic solidifier) diluted to 5% in de-ionised water.
6. The whole surface of the monument was cleaned with smoke sponges and in areas that required further cleaning a cotton wool swab with a small amount of de-ionised water and *Synperonic A7* (non-ionic detergent) was used ensuring not to flood the surface.

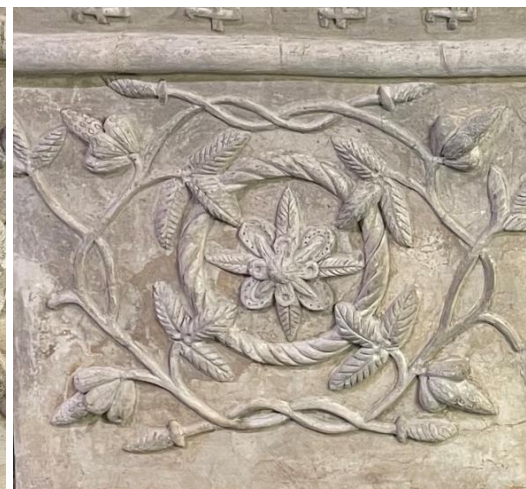
Plate 5: After cleaning.

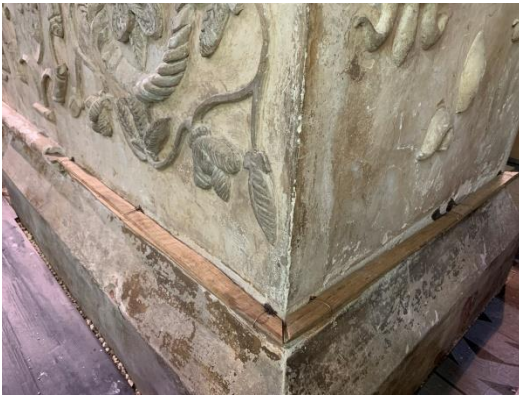
Plate 6: The lath fixed in place.

7. The missing section of bull nose moulding was reconstructed using sections of riven oak lath doubled up and secured together using stainless steel wire. This wire was fishtailed at the end and inserted into small holes drilled into the plaster and adhered with *Hilti HY* polyester resin. The new moulding was roughed out with a first layer of plaster made from 1 part lime putty, 2.5 parts Baston plastering sand with the addition of hair. This was left to firm before the finishing layer of plaster was applied replicating the shape of the bullnose and blending with previous repairs. The mix consisted of 1 part lime putty, 1.5 parts Clipsham stone dust and 1 part Portland stone dust.

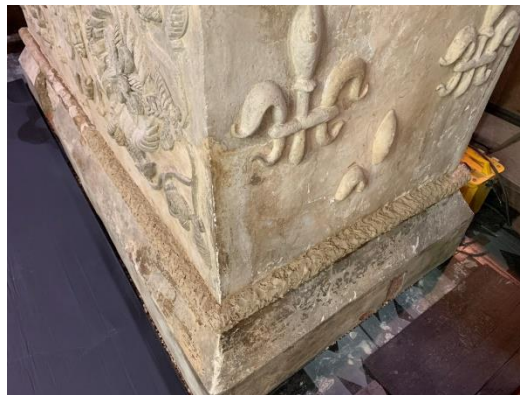
Plate 7: The backing coat for the moulding.

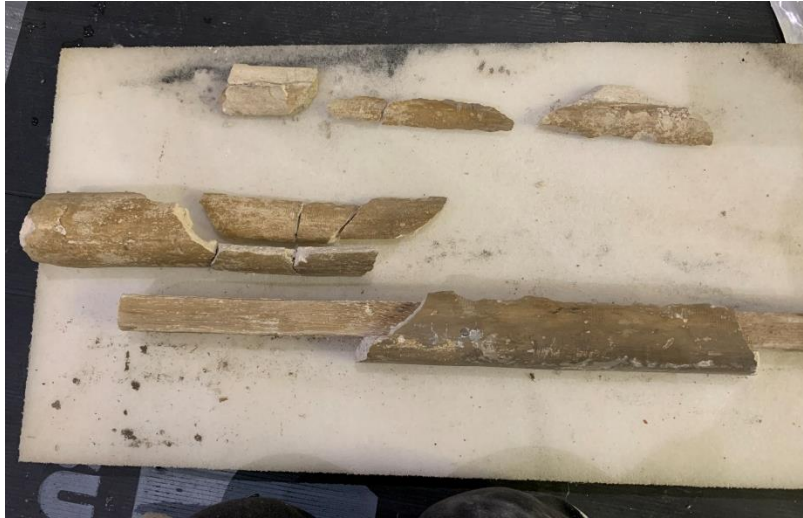
8. The most extensive repair to the bullnose was on the west end. The structure was still in place, however it was very loose and was easily removed. Removal allowed the remaining plaster which was also loose to be secured. This was done using *CalXNova*. The remaining plaster meant a different method of attaching the wood had to be used to enable it to sit flush. This was done by drilling small holes into the wood of the moulding and into corresponding places on the monument. Twisted stainless steel wire was used as a dowel, this was fixed into the monument with *Hilti HY* polyester resin and into the wood with *General* polyester resin. Once secured the loss to the north end of the moulding was reconstructed in the same way as on the other sides.

Plate 8: The loose bullnose moulding and plaster sections from the west face.

4. The bullnose has been repaired previously and at least two different methods had been used.
5. When drilling for the bullnose brick or stone was found behind the plaster on the east and south side however the west side had a void immediately behind the plaster suggesting with some damp brick dust suggesting deterioration of the substrate.

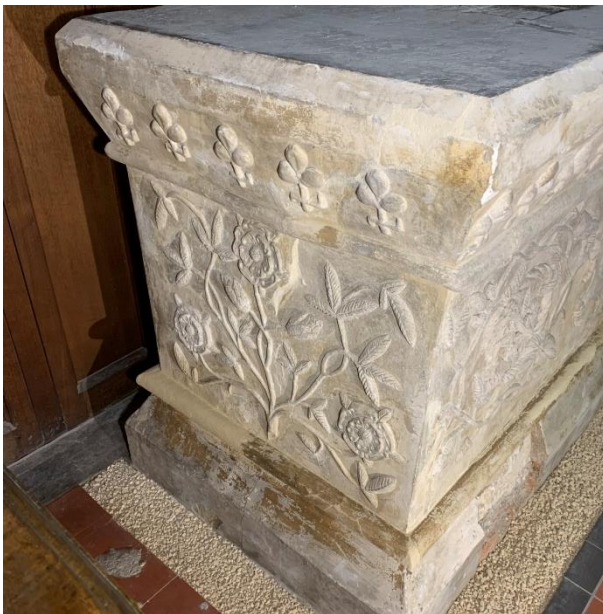
Plate 9: The west face after mortar repairs and reinstating moulding.

9. The losses in the plaster were filled using a mortar mix consisting of 1 part Singleton Birch lime putty, 1.5 parts Clipsham stone dust and 1 part Portland stone dust. Losses to the decoration were not re-constructed but surfaces were left flush to the surrounding area.

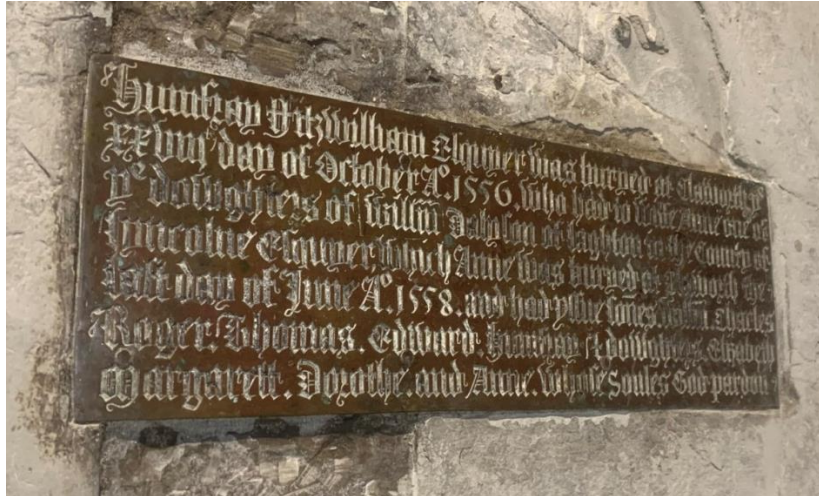
Plate 10: The brass plaque after cleaning and waxing.

10. The brass plaque on the top of the monument was cleaned using a small amount of IDA on a cotton wool swab. *Renaissance* microcrystalline wax was applied to the surface with consideration to not leave excessive residue in the lettering and then carefully buffed to a uniform finish.

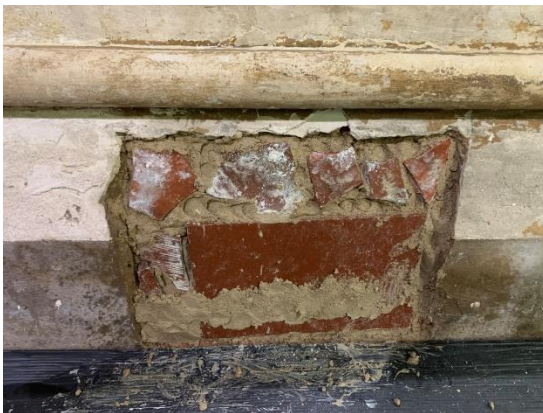
11. Investigation of the suspected cement render on the plinth of the tomb chest revealed the cement to be more extensive than first thought. An investigation window was opened to assess the depth of the cement. This was covered in Dr David Carrington's letter dated 2 July 2024. It was decided that it would be potentially too destructive to remove the render fully. Instead the cracks and losses were filled and the investigation window was repaired. The cracks were grouted with a mix of 1 part *St. Astier* NHL2, 1 part Portland stone dust. The investigation window was built up in layers with a mix of 1 part NHL 2, 2.5 parts Baston plastering sand with sections of tile. A top coat of 1 part NHL 2, 1.25 parts Portland stone dust, 0.5 parts Clipsham stone dust and 0.25 parts Delabole slate dust was applied to the cracks and losses.

Plate 11: Building up the backing coats.

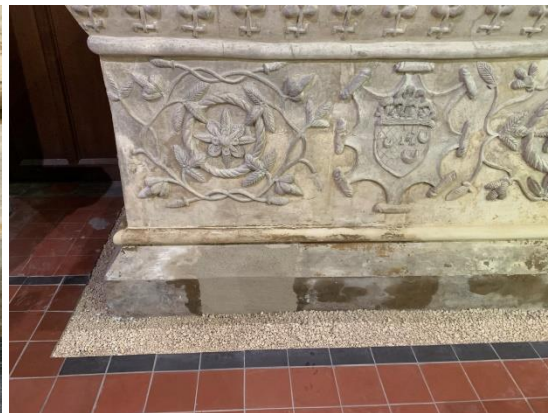
Plate 12: The top coat applied.

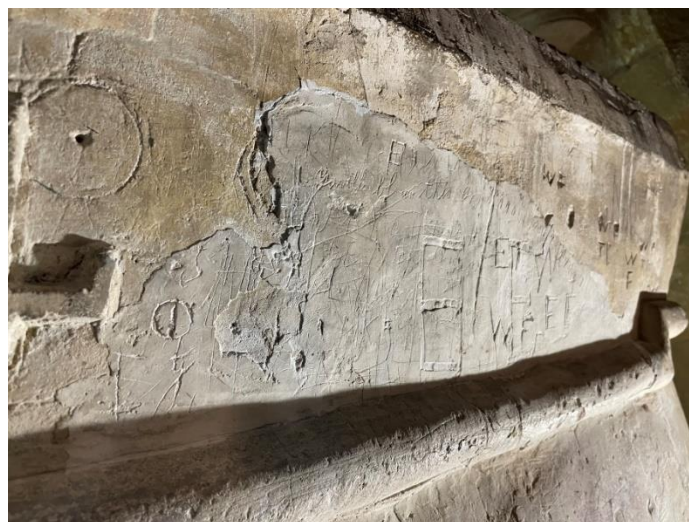
6. There are sections of graffiti on the back of the monument (north side) which are mainly prevalent on old sections of repair. Various initials, names and dates can be seen.

Plate 13: Graffiti to the north side of the tomb chest.
