**St. Michael & All Angels church
RAVENSTONE
Leicestershire
(Diocese of Leicester)**

**Conservation report on the churchyard monument to
Reverend David Thomas (d.1810)**

April 2024

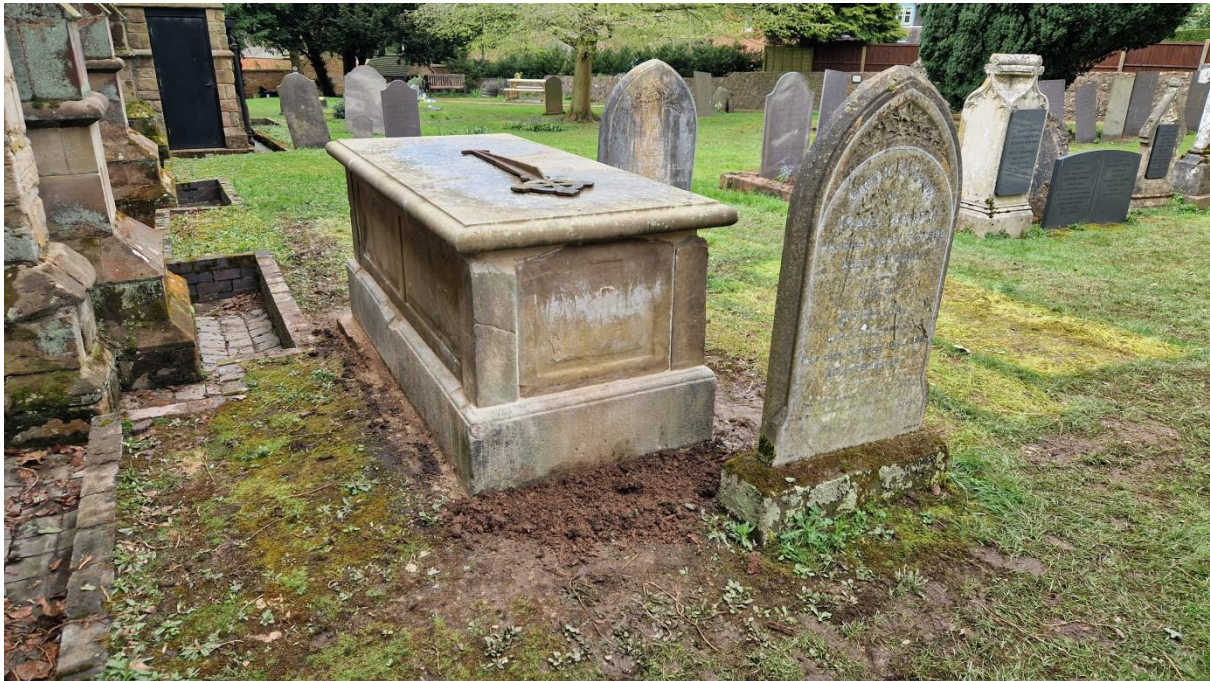
Plate 1: the completed tomb chest

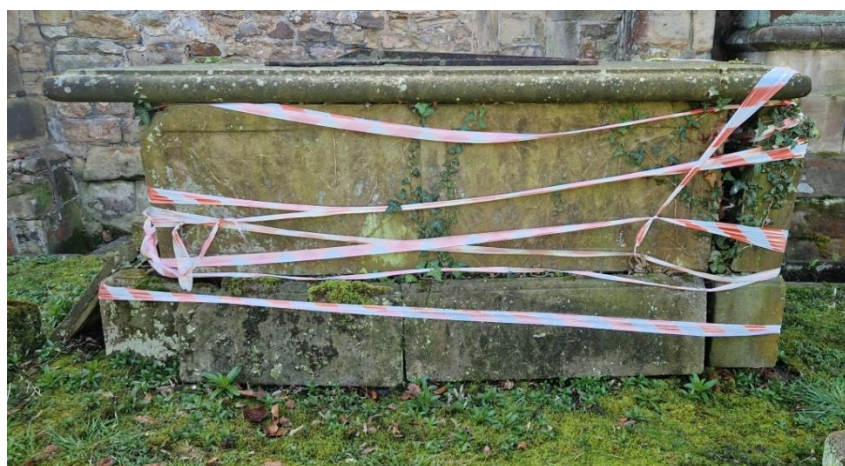
Plate 2: showing the tomb chest prior to conservation work.

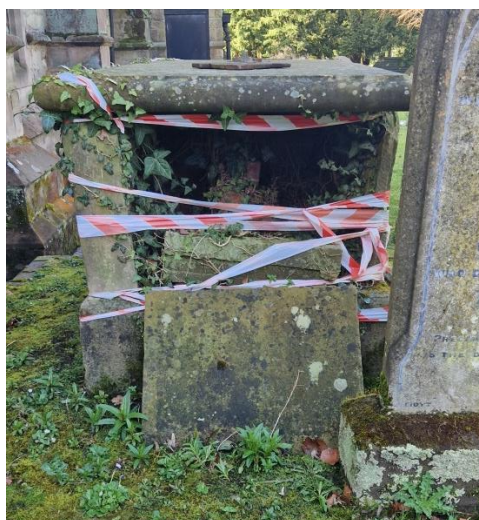
Plate 3: the east end of the tomb chest displaying extensive disruption.

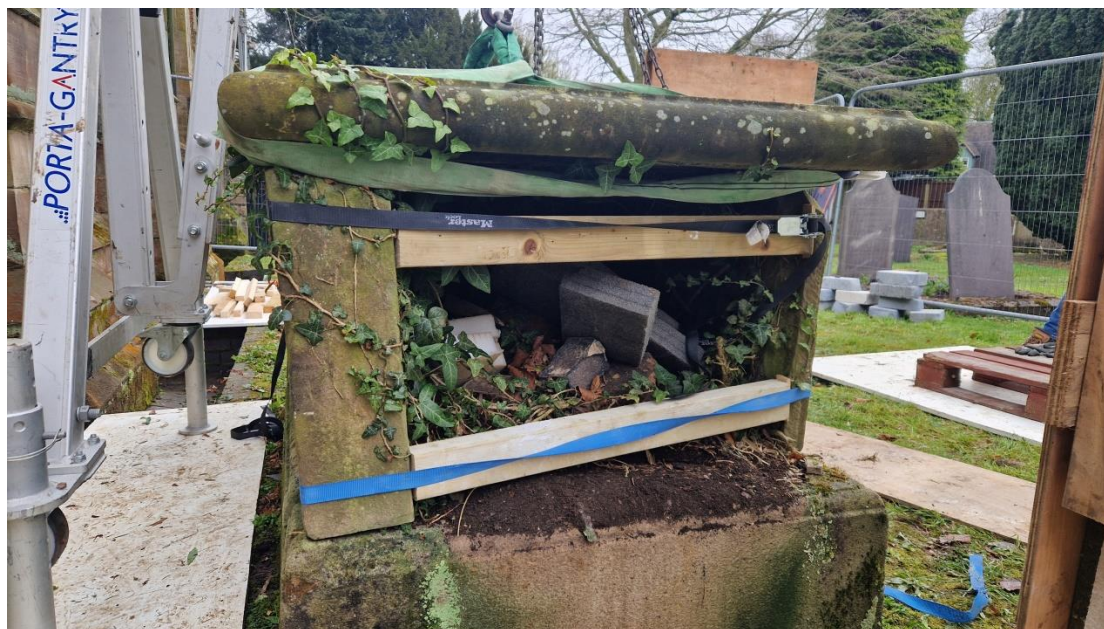
Plate 4: here we can see the east end of the tomb and the timber shoring with ratchet straps securing the stone panels. This method of shoring was also carried out to the west end also.

An A-frame gantry was erected over the tomb in readiness to lift the stone lid off and away. Prior to lifting the top off of the monument the side panels required shoring up. This was carried out to prevent the panels from toppling over and also to create a sound platform for when the large stone lid was levered up ready for lifting.

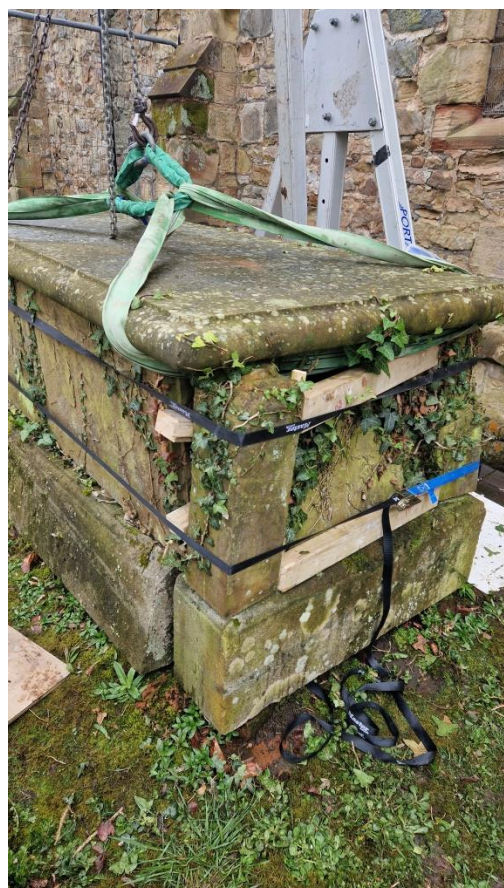
Plate 5: showing the stone lid ready to be lifted away.

The tomb lid was gently levered up, one side at a time and two timber bearers were place underneath. Lifting straps were then fed underneath the stone lid and hooked onto a block and tackle. The lid was then lifted away and placed onto timber bearers on the ground to one side.

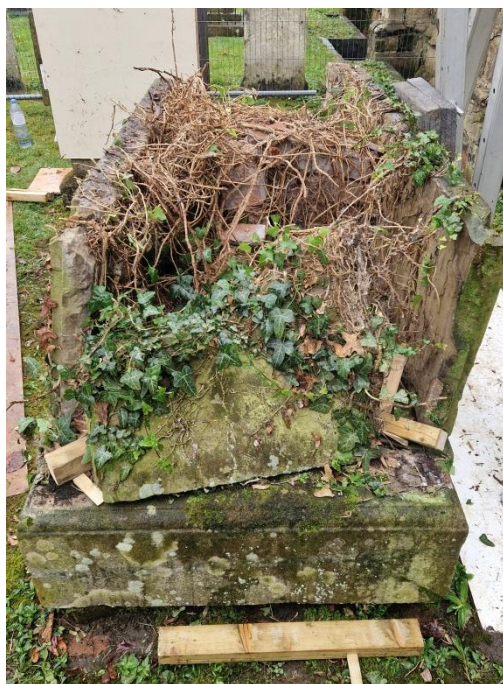
Plate 6: (left) here we can see the extensive ivy network inside of the tomb.

With the lid removed a core was revealed and extensive root networks of ivy. The ivy was cut away and disposed of. The eight stones that comprise the side panels of the tomb were now numbered and removed from the plinth stones. The core comprised of mainly bricks and a handful of broken floor tiles. The bricks contained within the core, where complete, are $4\frac{3}{4}'' \times 9\frac{3}{4}'' \times 3\frac{3}{4}''$ and are a deep red colour and hand made. The Tiles were incomplete, but looked to be $4\frac{3}{4}''$ square and 1'' thick and again a deep red colour. The brick core rises from the foundation inside of the north and south plinth stones and in a cross formation up to the top of the panel stones. The lime mortar that was used for the core appears to be the same mortar as for bedding and pointing of the six large panel stones. The core came apart with ease as the mortars had largely failed and broken down. The plinth stones were then removed from the brick foundation and also given an identifying number.

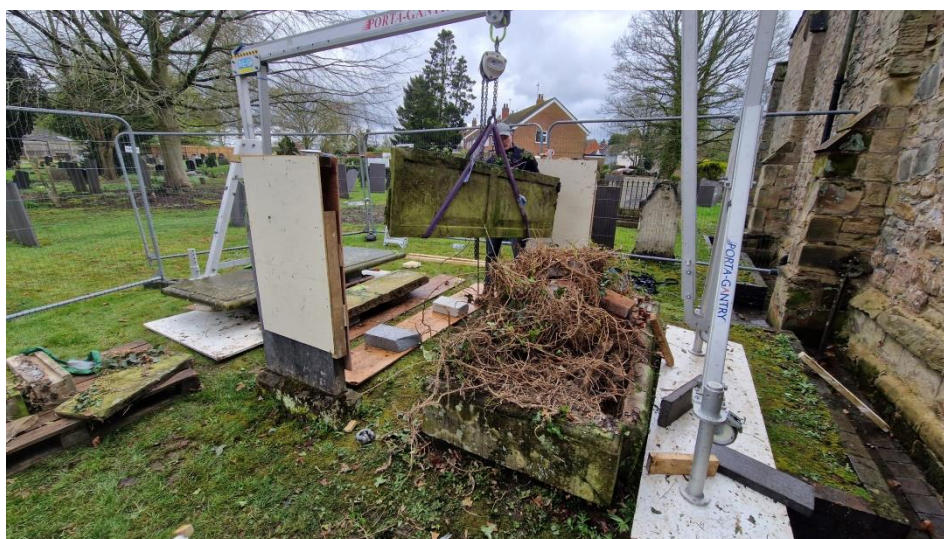
Plate 7: (below) using the A-frame gantry the side panels are removed from the tomb.

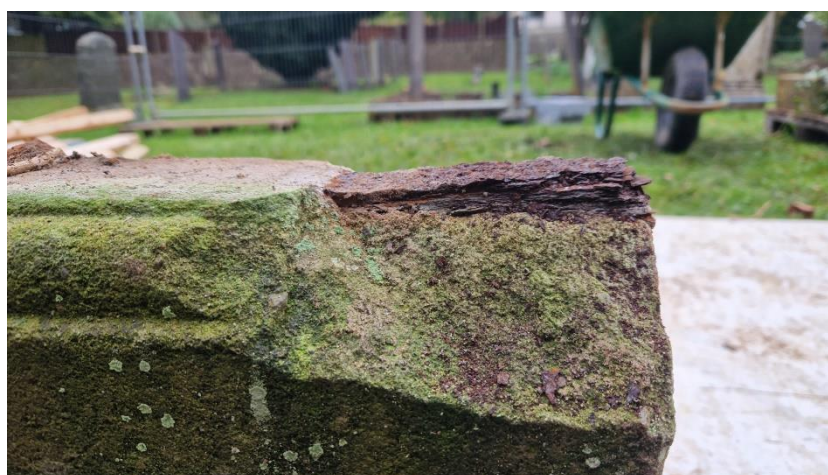
There were numerous stones to pin back together. These mainly comprised the plinth stones where corroding iron cramps had rusted and laminated causing the stone to fracture. Also the west end panel required fixing together using steel armatures. All of the steel used for repairs was 316 grade stainless steel. The steel used for pinning stones together was threaded rod with a diameter of 8mm. the steel used to repair the west end panel was, again, threaded rod with a diameter of 10mm. all of the steels were set into Hilti H170 resin.

Plate 8: here we can see the level of delamination to one of the plinth stones iron cramps. This delamination has caused the surrounding stone to fracture and break away.

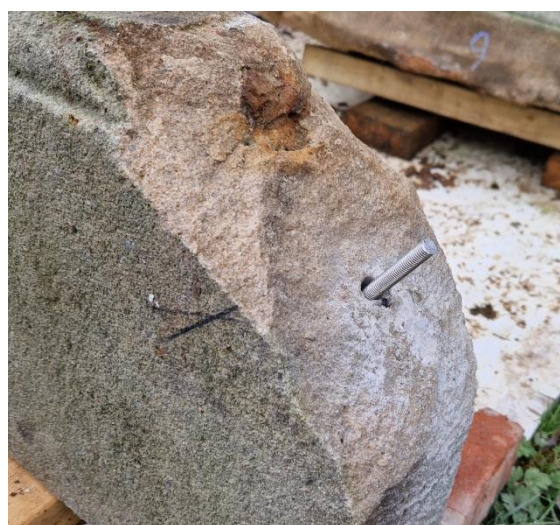
Plate 9: one of the hidden pins ready to be fixed into position along with the fractured stone.

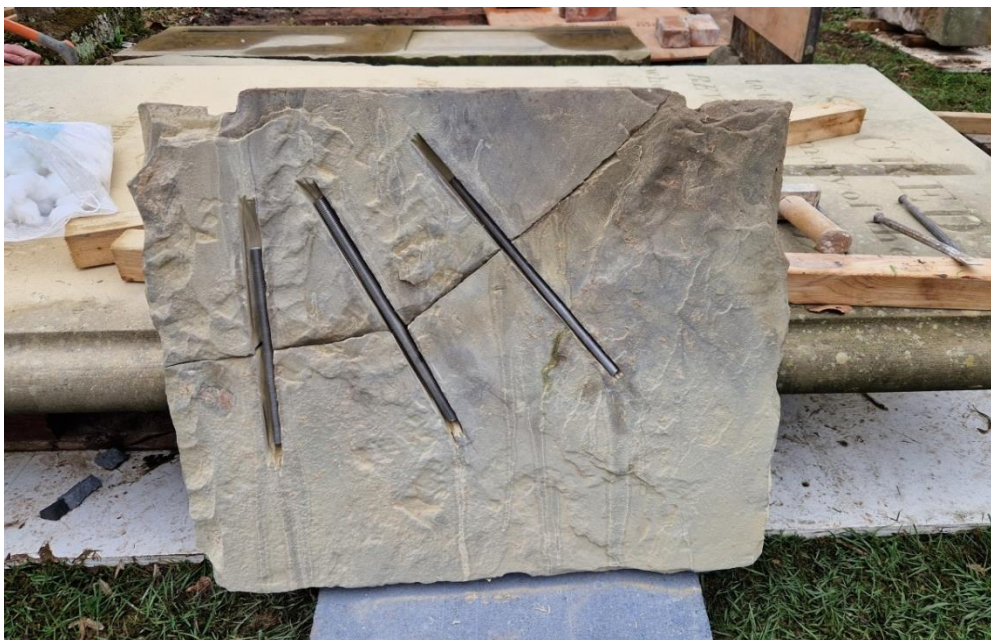
Plate 10: this is the rear of the west end panel. The stainless steel dowels are set into pre-cut grooves.

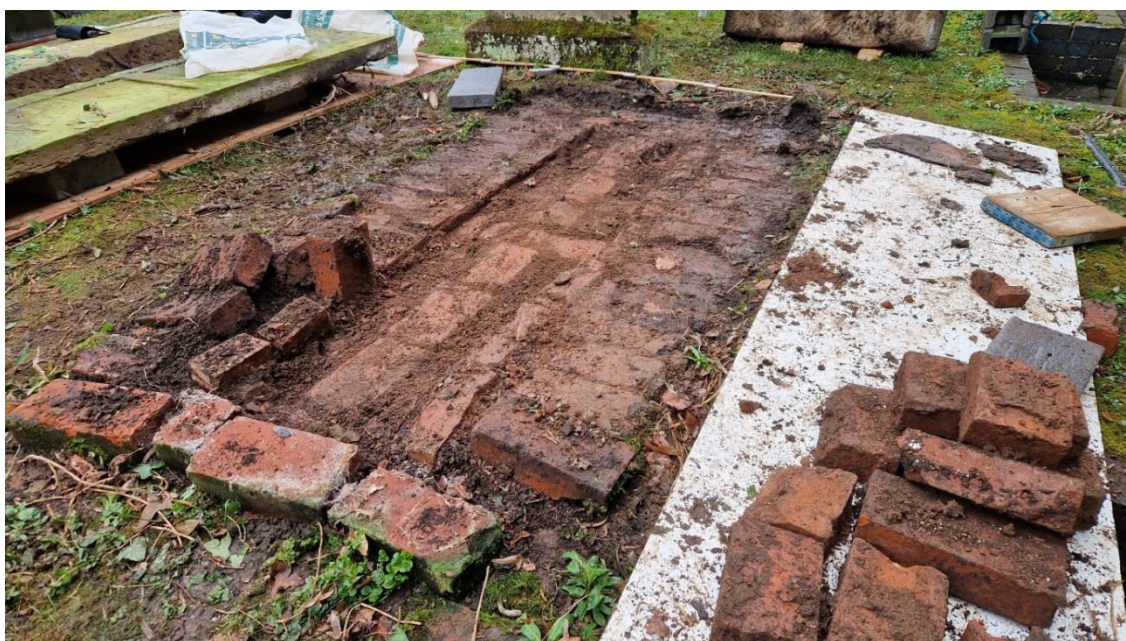
Plate 11: showing the disruption to the brick foundation.

The foundation for the monument consists of bricks and mortar, the same bricks as the core of the tomb. To the west side of the foundation the bricks were displaced and loose, these were lifted and re bedded into position. The lime mortar mix for this process is given later when discussing the building of the brick core. What remained of the ivy roots was treated with Roundup root and stump killer, following the manufacturer's instructions.

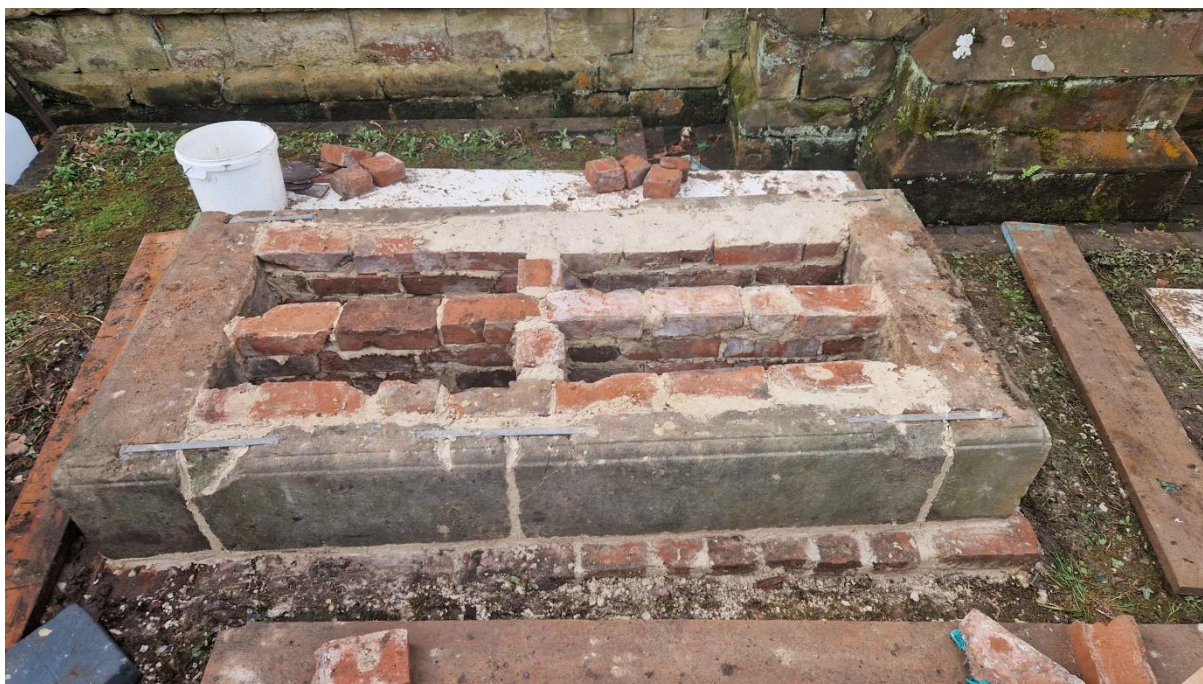
Plate 12: here we can see the plinth stones in position and cramped together. Also the brick core was built up in the same arrangement as the original.

Once the foundation had been completed the plinth stones were moved into position and bedded down. The bedding and pointing mix is given below. We fabricated, on site, 316

stainless steel strap into legged cramps. The stainless steel strap was 20mm x 3mm and at various lengths. The turned down legs were 40mm long each. These would be set within pre-prepared holes drilled into the tops of the stones. A channel was then chiseled away linking the drilled holes allowing the new cramps to be set recessed below the upper surface of the stone. The cramps were set into Hilti H170 resin. Once the plinth stones had been completed, including cramping them together, the brick core could be built up to plinth course height.

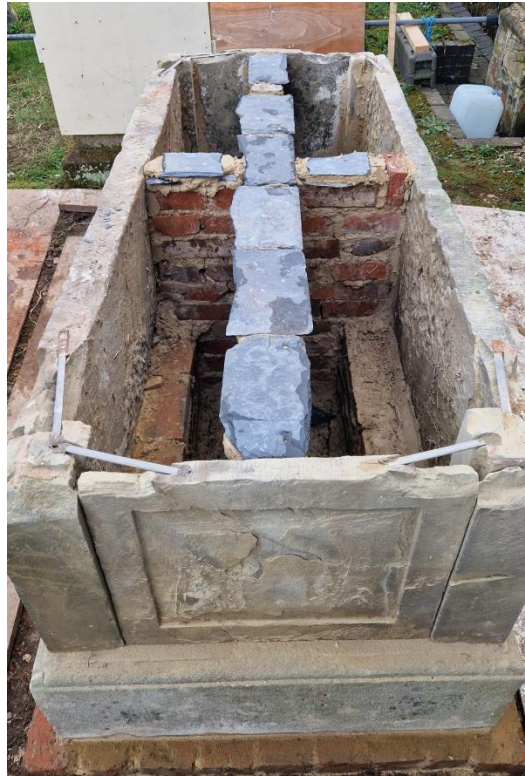
Plate 13: the panels are now bedded down and cramped together. The brick core was built up with slate packers to bring the core level with the outer panels. Although all of the good core material was used up it was necessary to include 25 new bricks. The new bricks were supplied by Bulmer Brick and Tile company, Sudbury.

The panel stones were then set out on the top of the plinth stones dry to achieve the correct setting out and spacing. Once this process had been completed the stones were set onto a lime mortar bed. When all had been set correctly they were cramped together as above.

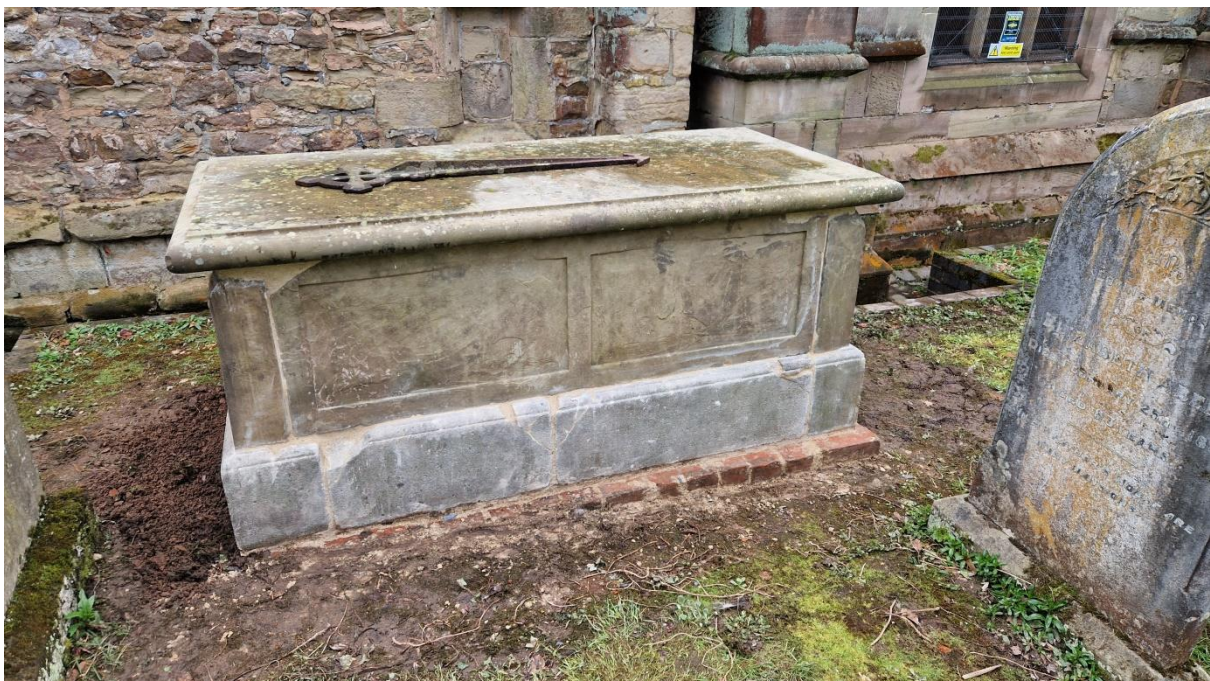
Plate 14: the stone top to the memorial was then maneuvered into position utilizing an A-frame and lifting equipment. The lid was placed onto the same bedding mix as the rest of the tomb stones.
