## Conservation Records

**Location:** St Mary's Church, Stalisfield, Kent

**Panel:** 3 (inner)

**Window:** North window of the chancel, nII

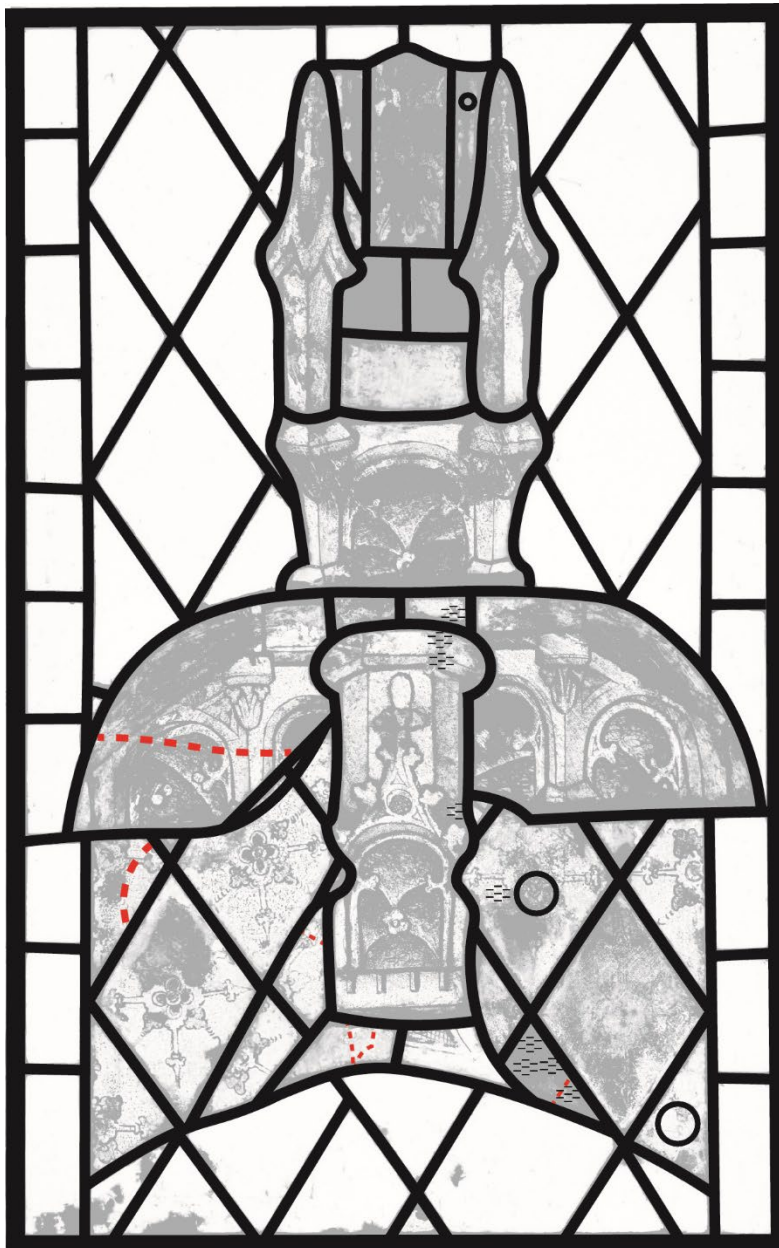
Before Conservation Internal

**Damage (Cause, if known):** A few fractures in the medieval glass. All stable. See diagram.

**Internal:** The glass has suffered much paint loss. Remaining paint is mostly stable with a few very small areas of loose paint. See diagram.

**Repairs:** Most of the glass fractures have been bonded with a silicone-based adhesive, probably at the time of re-leading in 1986. Excess adhesive has been left on the surface in places. See diagram.

Paint to the outside

Unstable paint

Previously bonded break

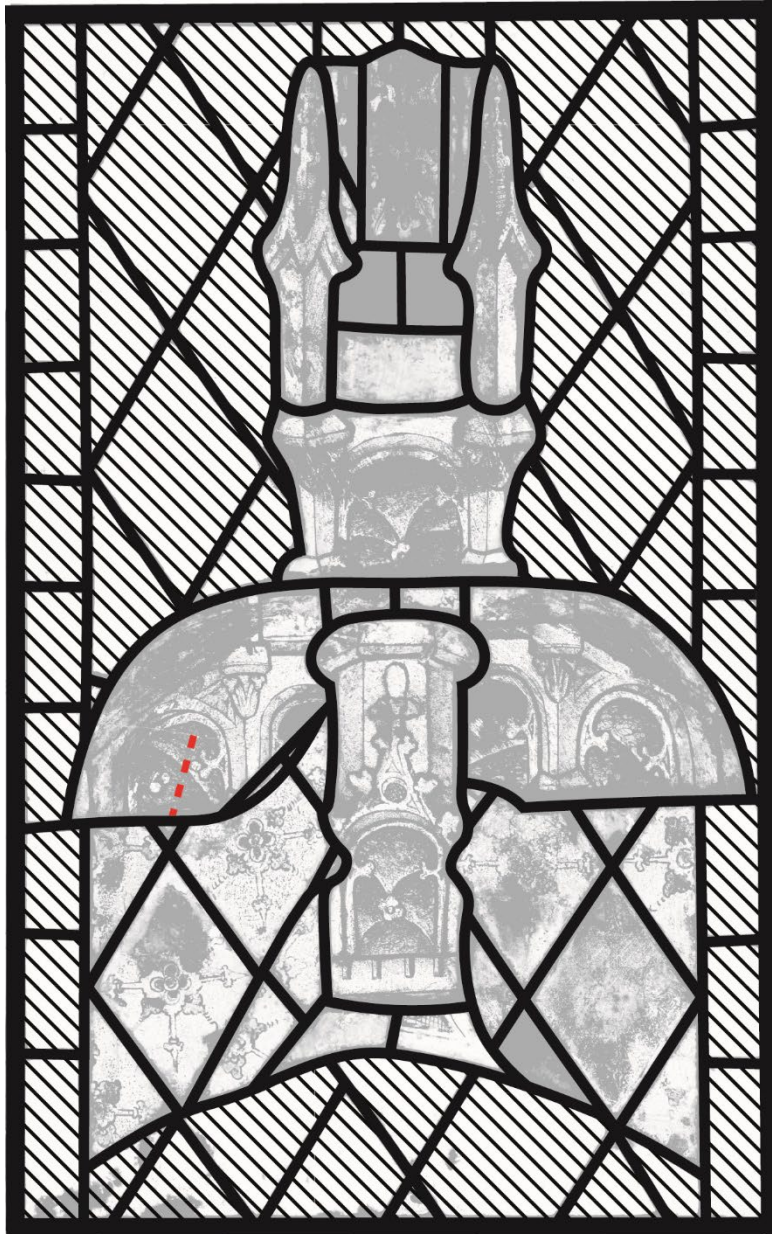
Before Conservation Internal

**Later Additions:** The panel is made up of 15<sup>th</sup> century glass that may have come from the same window originally. The pieces have been arranged in a decorative way that looks cohesive, though probably not in their original positions in relation to each other. They have been set into a rectangular panel by the addition of clear quarries. See diagram.

Unbonded break

**Adhesives used for Edgebonding:** Paraloid® B72 acrylic resin dissolved in acetone was dropped from the reverse side into one crack that did not appear to have been previously silicone bonded. See diagram.

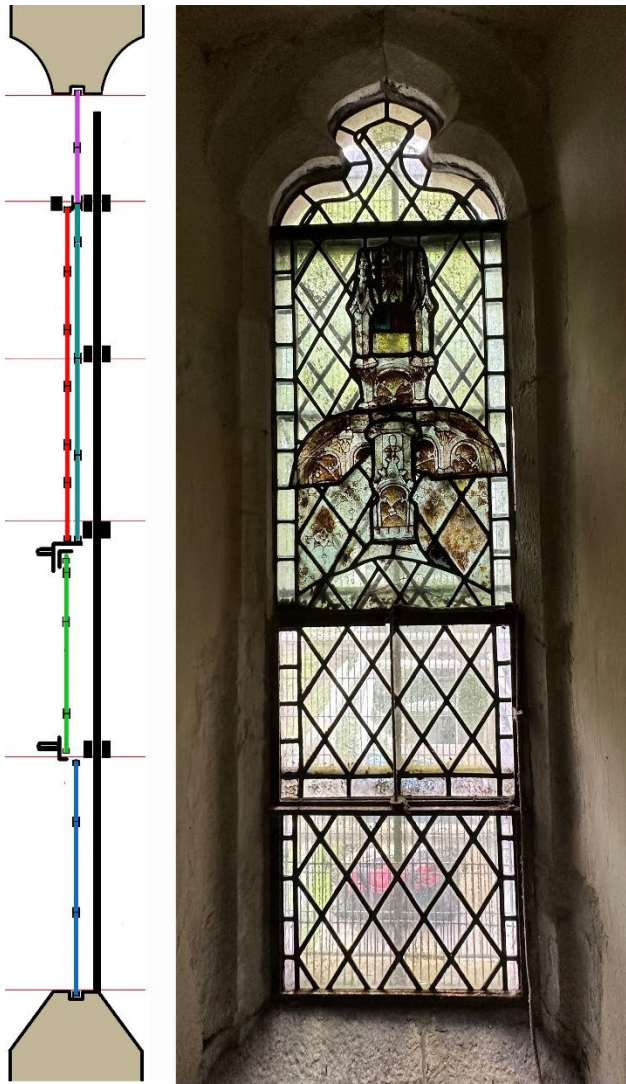
The panel sits closely in front of the external window, which not only impedes the visual legibility of the medieval glass, but the lack of ventilation between the two layers has allowed dirt to build up and condensation to form on its surfaces, accelerating the corrosion process.

Before conservation, showing previous glazing arrangement

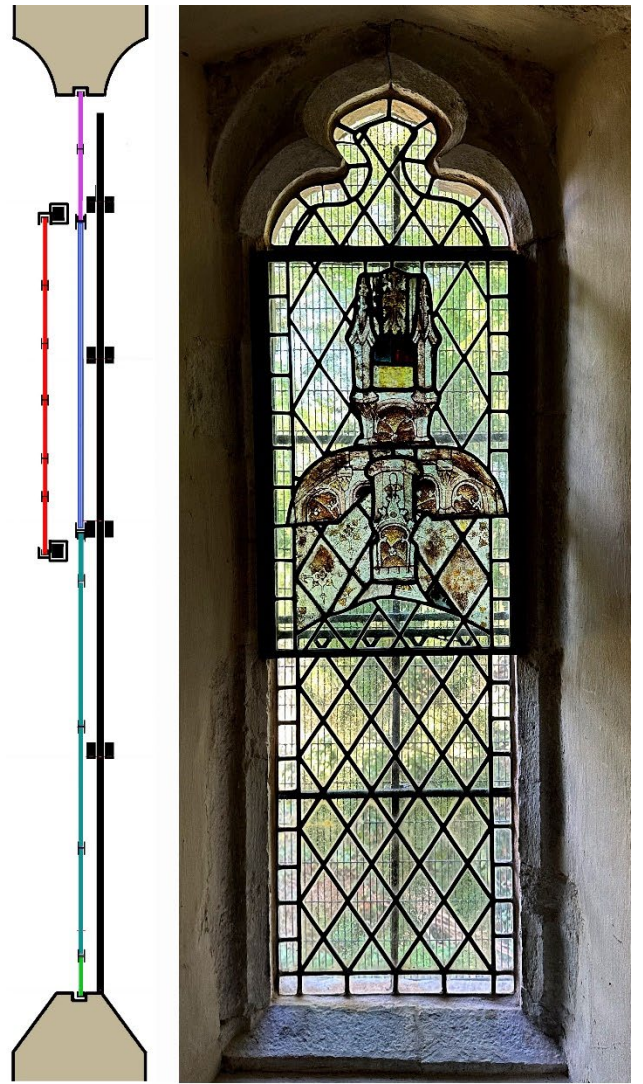
After conservation, showing new glazing arrangement

The panel was framed with 12mm wide bronze channelling and suspended from two 12mm diameter, round horizontal bronze bars set into the surrounding stonework. It was hung in front of the window nll again with a gap for air flow, which will prevent condensation forming on the medieval glass, thus significantly reducing the rate of further corrosion.

The part of the window that is situated directly behind the medieval glass (panel 3 outer) has been replaced by a sheet of clear laminate glass edged in lead came, which will improve the visual legibility of the medieval glass in front of it, as well as protecting it from outside impact damage.

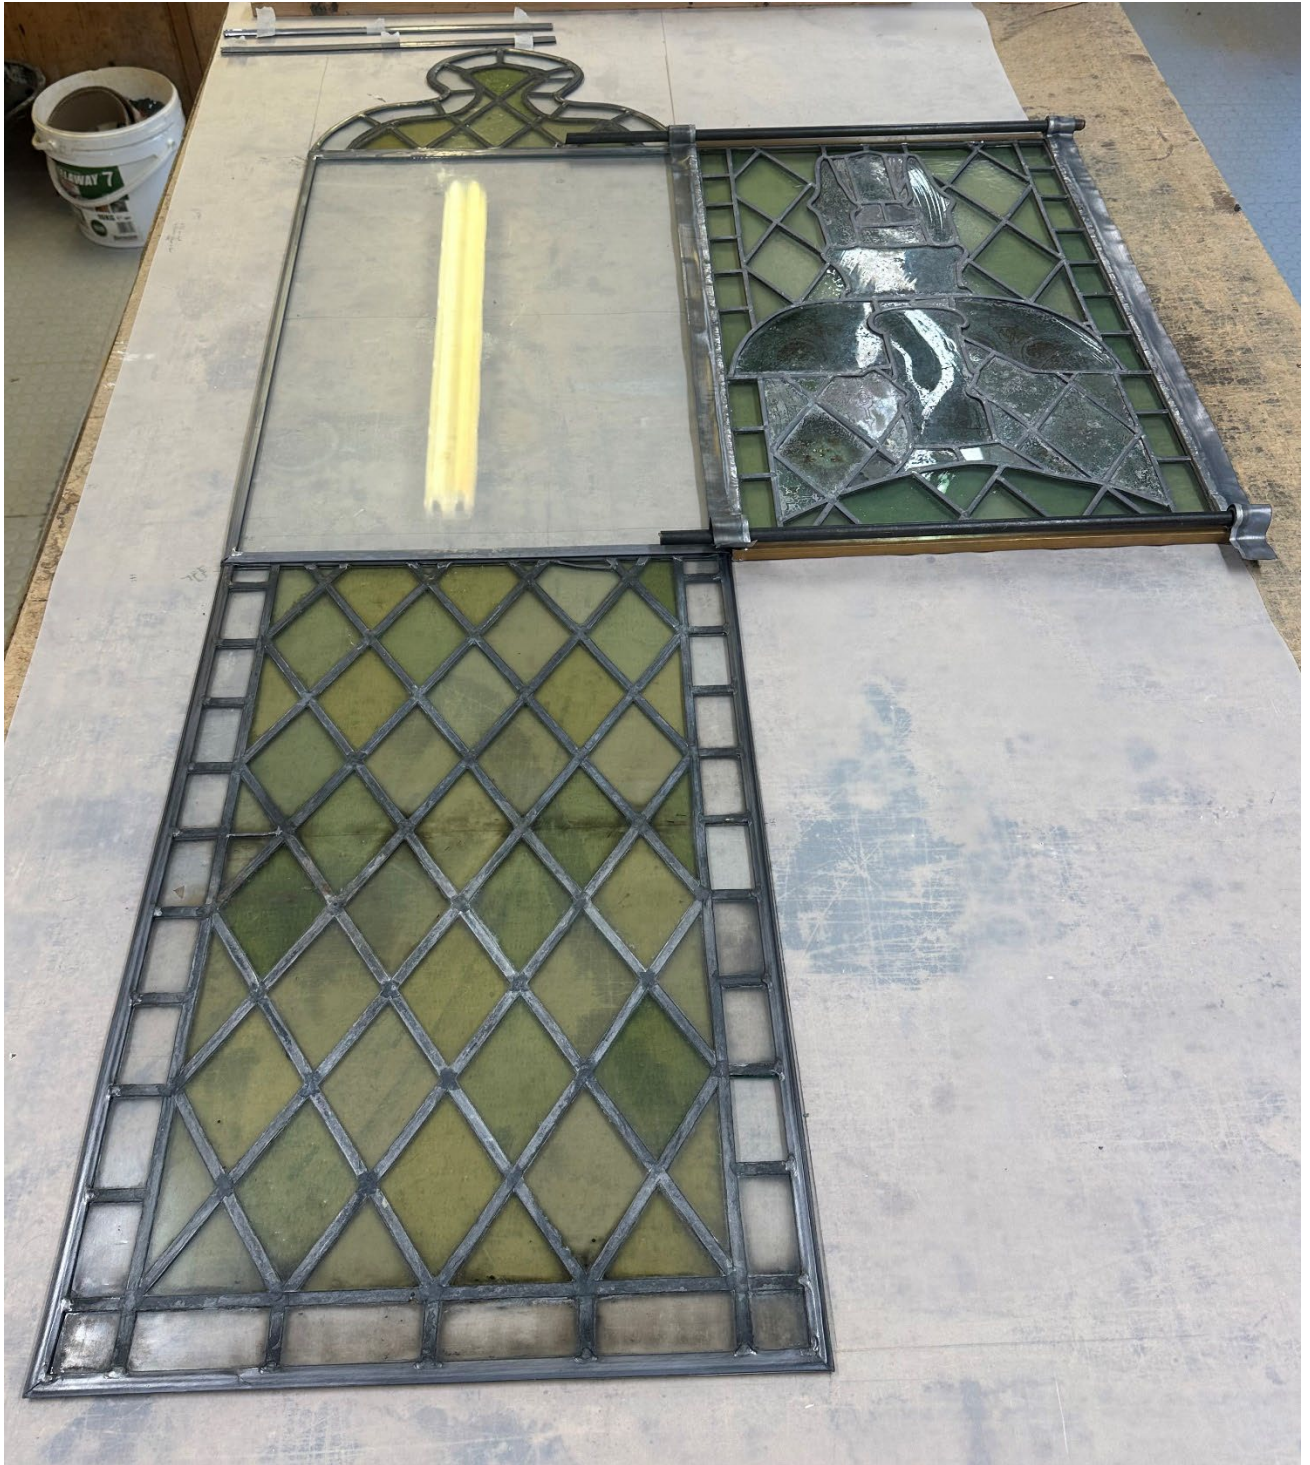
Above: the outer layer of glazing, with 19<sup>th</sup> century diamond quarries in head and bottom panel, and a new laminate sheet of glass in the middle; the inner layer of glazing containing the medieval stained glass is now framed with a bronze U-channel and suspended with steel hoops on bronze bars set into the jambs. A strip of lead flashing prevents light creeping around the edges of the frame.
