**COUNTRYSIDE CONSULTANTS**  
**Townhead, Alston, Cumbria, CA9 3SL**

Job no: 23/09  
Client: Cockfield Church PCC  
Project: Roof repairs following lead theft  
Date: 21<sup>st</sup> June 2023  
Present: Adam Rhodes, Contracts Manager, Wensley Roofing Ltd.  
Ian Wells, Conservation Architect, Countryside Consultants.

**SITE VISIT:** revised notes dated 3<sup>rd</sup> July 2021

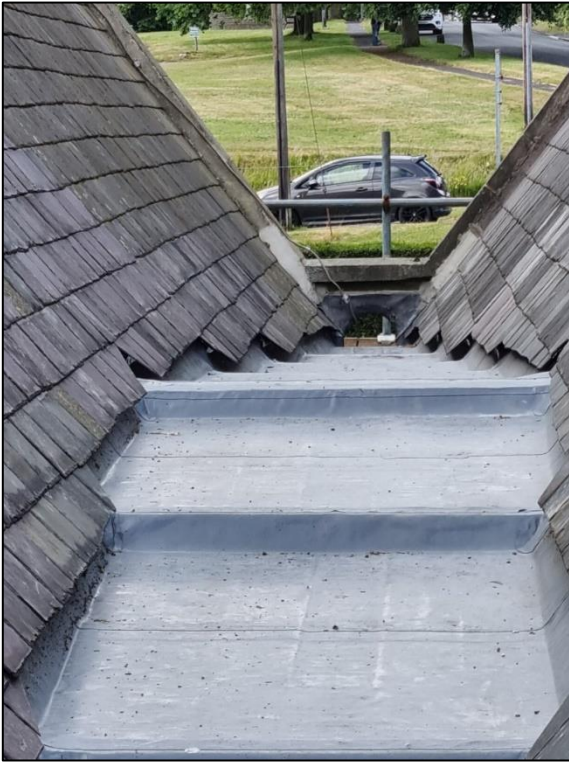
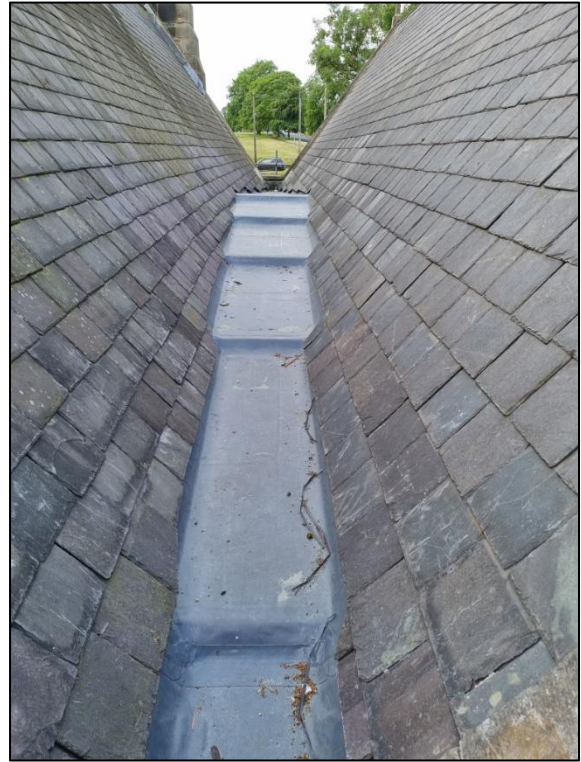
*Looking West, Nave on left and North Aisle on right.*

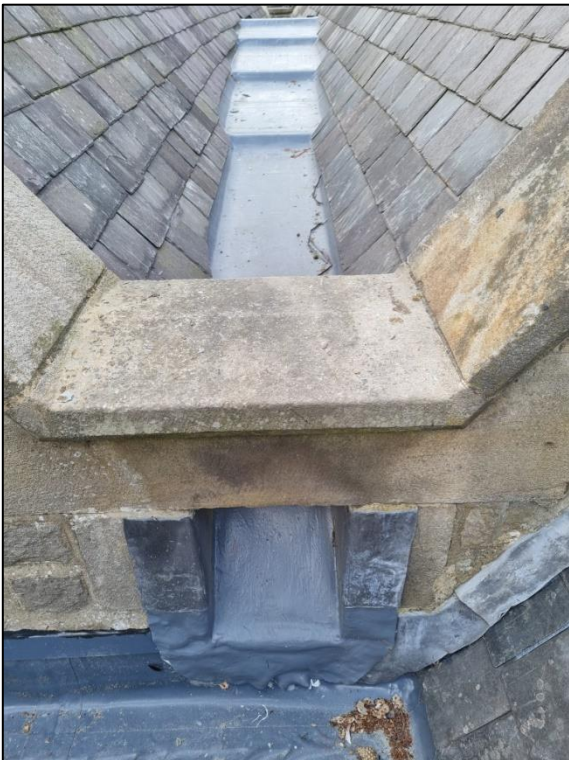
Where lead has been kept it has been painted in grey membrane material to disguise it.

*Shute at the chancel arch.*

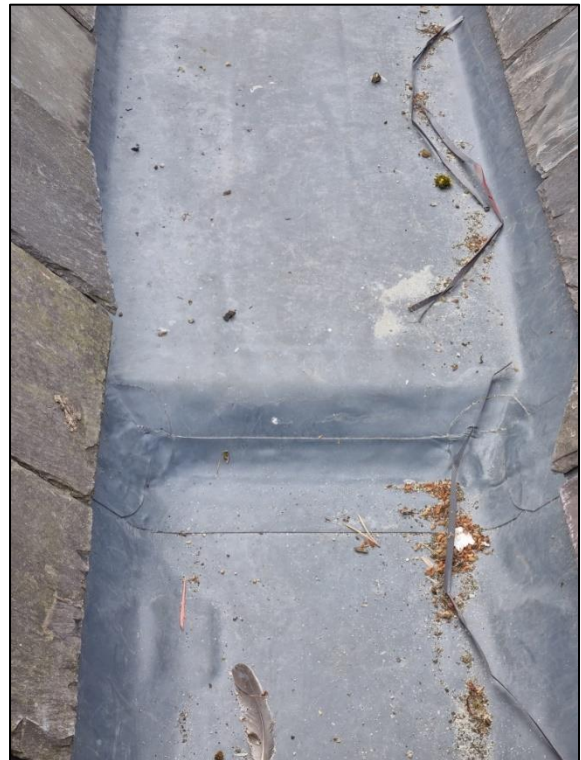
There is a certain amount of builders' debris and old detritus from before the theft. Adam assures me that this will all be carefully removed before the scaffold is struck.

*Package straps left in the gutter to be removed.*

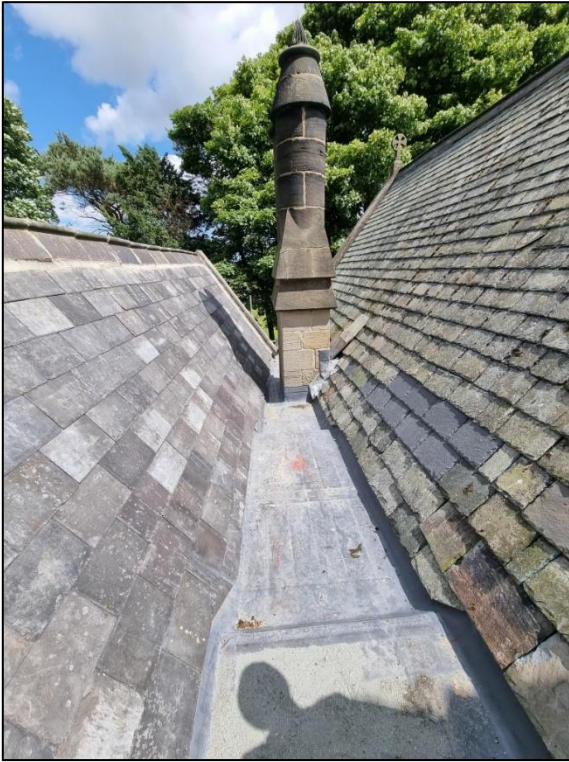
The narrow valley next to the chimney and the associated lead flashings have been left in place. The debris needs to be removed.

*Original lead flashings around the chimney, and in the adjacent section of gutter have been kept.*

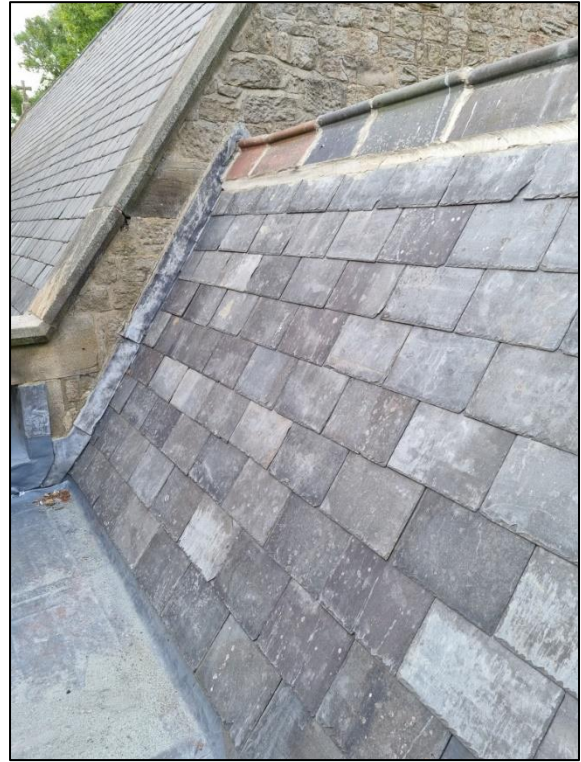
*Looking east at north pitch of the vestry roof. Imported Welsh Slate has replaced the Westmoreland which was in poor condition.*

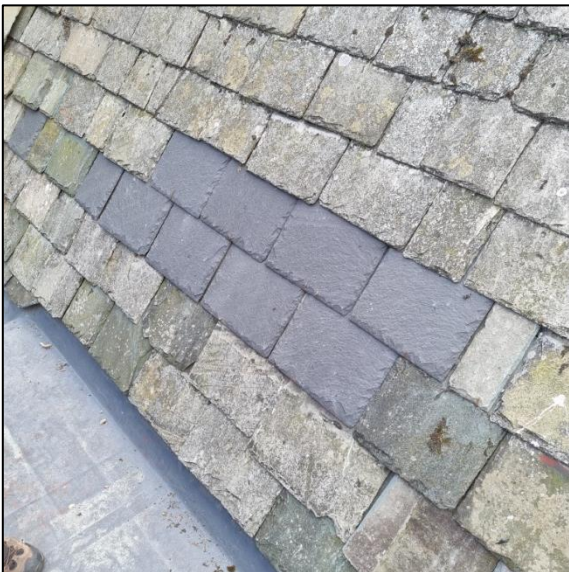
Minimal damage and all in acceptable condition. The ridge pointing is poor, and light can be seen through it. The small patch repairs have been done with new blue Westmoreland because new green would have been double the cost.

*North pitch of chancel.  
Patch repair in new blue Westmoreland.*

IW requested a quote for patch repointing the ridge this will be done when the cleaning is done.

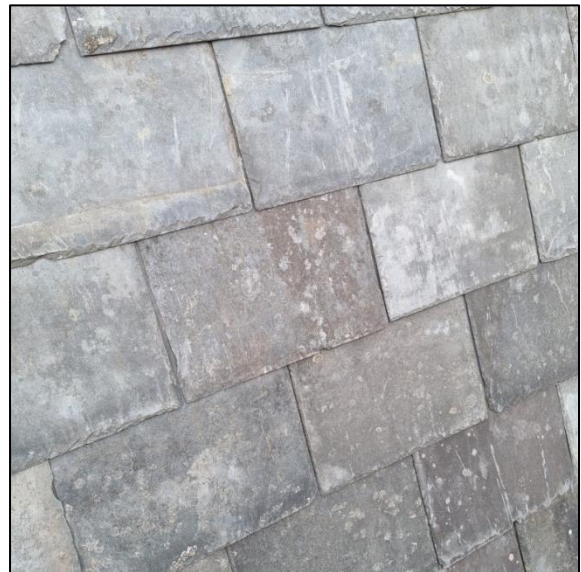
This pitch has been re-laid on new breathing sarking and battens. In second hand Welsh slate. It looks particularly good work.

*Detail of second-hand Welsh slate used for the South pitch of the Vestry.*

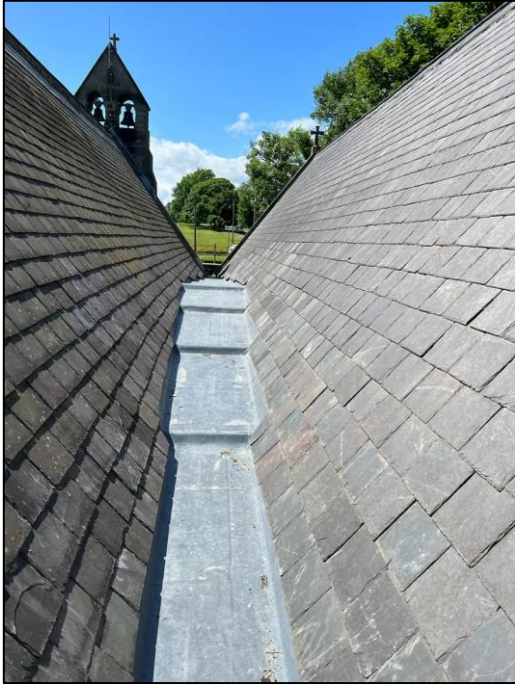
*Central gutter cleaned of debris*

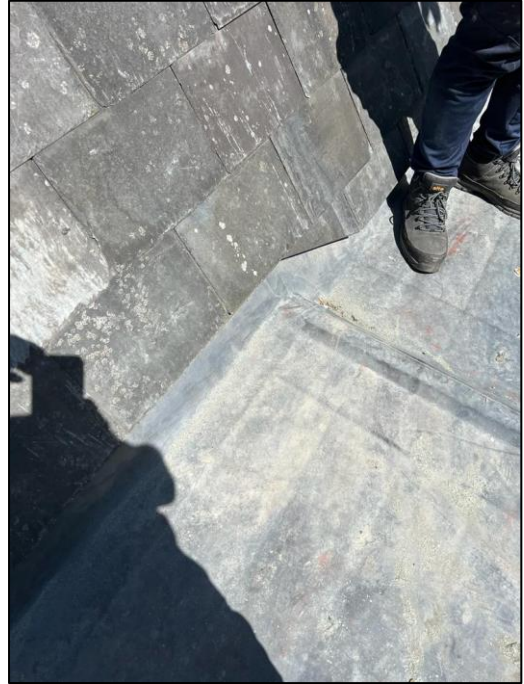
*Detail of gutter*

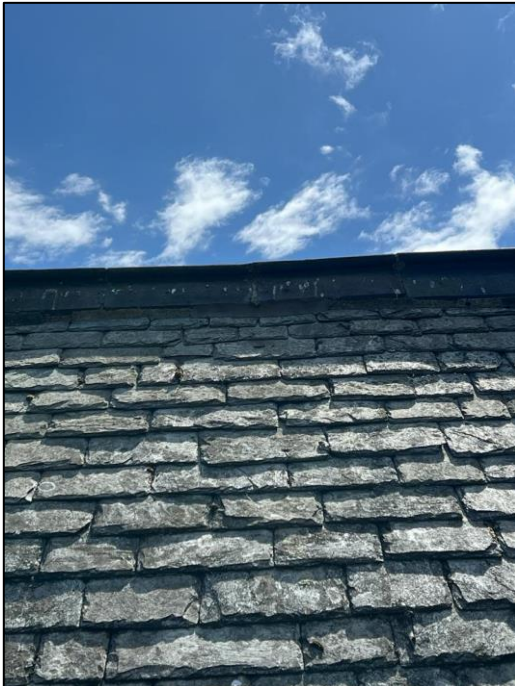
*Ridge over chancel pointed*

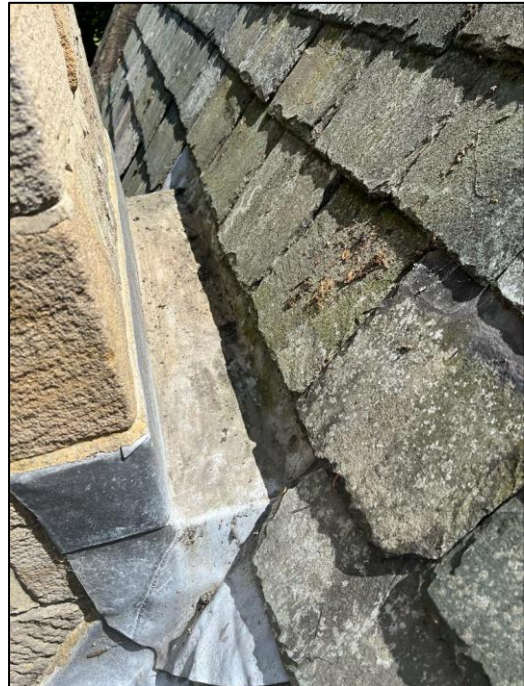
*Flashing behind chimney cleaned*
