STRUCTURAL REPORT
St Andrews Church
Wollescote

The consultants were appointed by Rev. David Nichol, Rector of St Andrews Church, Wollescote on behalf of the PCC of St Andrews Church, Oakfield Road, Wollescote to carry out a report on the Church.

The report is to specifically comment on the current condition of the Church following the demolition of the Church Hall after this had suffered from significant subsidence. This Practice had previously prepared a report issued on 6th May 2019 and this records the details of the Church Hall and also the resultant cracking within the Church.

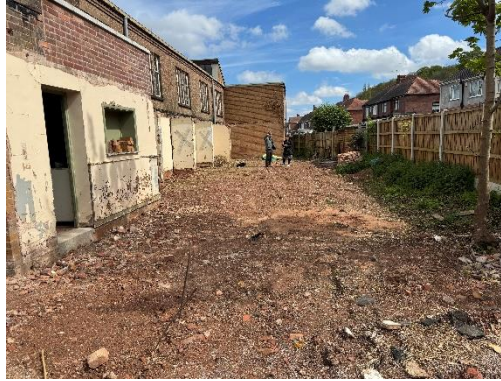
Photograph No.1

The Church Hall has been demolished and the area where this was previously present, which is to the south of the Church, (actually south-east but the references will be as per the original report), and this is shown on photograph No.1.

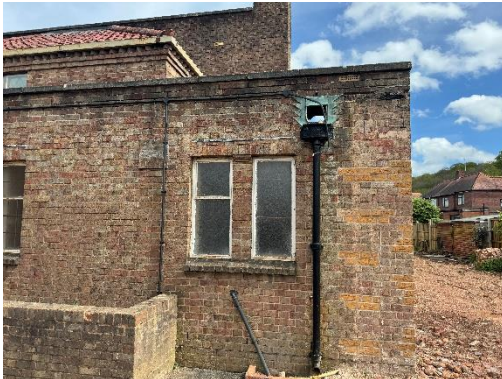
Photograph No.2

Starting with the western section, as shown on photograph No.2, this showed no signs of any cracking and the main work is where the previous toilet block was present. There is a minor amount of repointing where the flashing was let into the brickwork, as shown on photograph No.3.

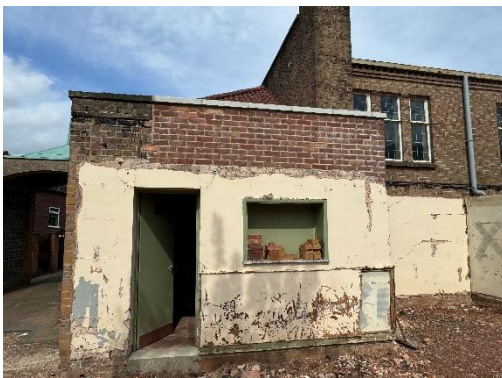
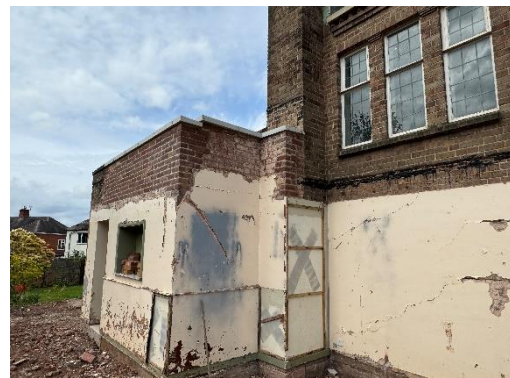
Moving around to the southern elevation and the western part, this was in a reasonable condition with the plaster remaining to the walls and some very localised making good required to the top western corner. This also applies to the return back to the main Church, where again there was no signs of any structural distress and this can all be seen on photograph Nos.4 and 5.

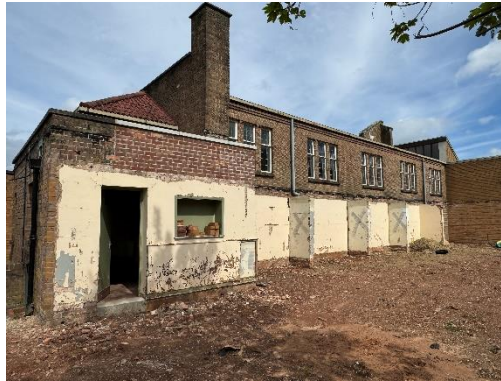
Photograph No.6

The main area where the Church Hall abutted the Church can now be separated into five bays delineated by cross walls and this is shown on a general view, photograph No.6.

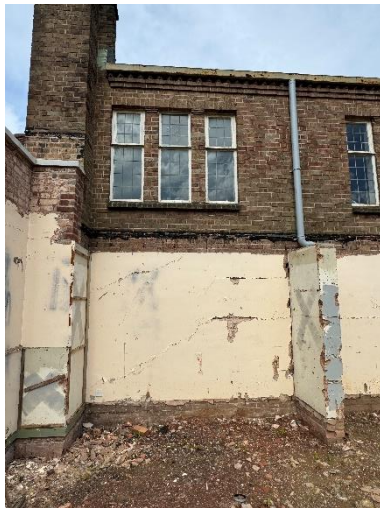
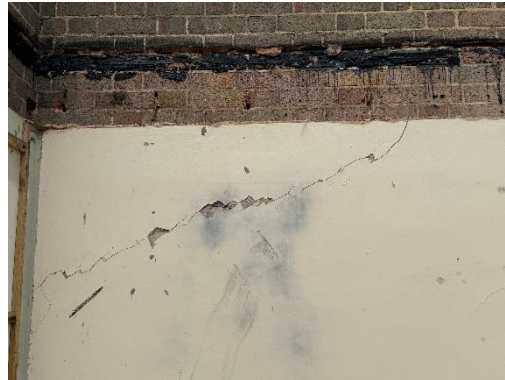
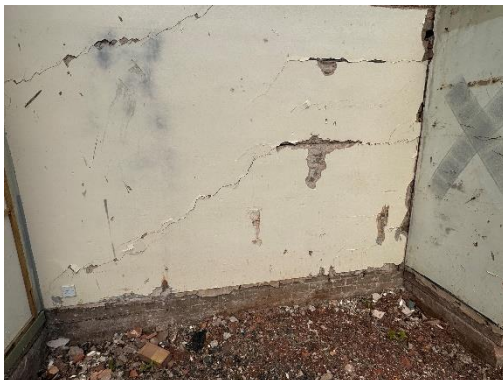
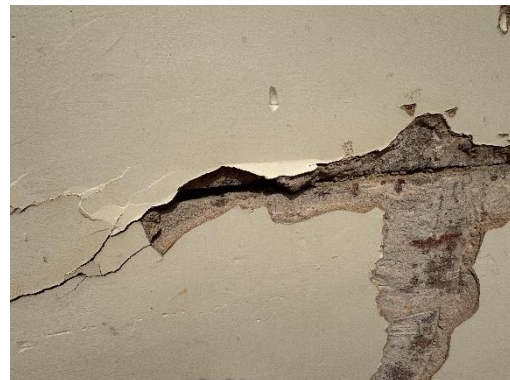
This is shown on photograph No.7, and there is a series of cracks within the plaster. However, these are not of a width which are of significant concern and are shown on photograph Nos.8 to 10 inclusive.

The longer term works required will be to cut out and repair the cracking, which is as a result of the previous movement. The cracks internally and externally can all be cut out and repointed, and as they would appear to extend through the full thickness of the brick wall, installing helical remedial ties such as Helibar would be prudent to ensure that the bond is re-established in the brickwork prior to repointing. The plaster and decorations can then all be made good.

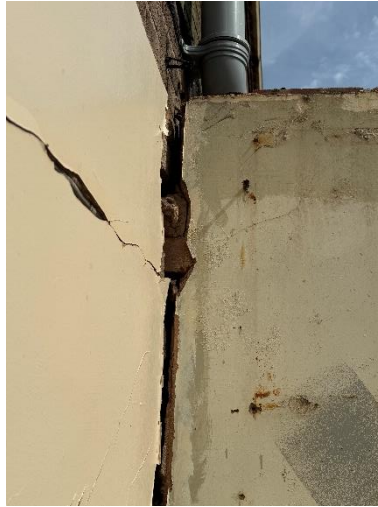
Photograph No.11

At the cross wall position, this is in fact not bonded into the main wall and can be taken down, as can be seen on photograph No.11.

The fact that these walls are not bonded into the Church wall is indicative that they are not providing a buttress. They are on a shallow foundation and therefore there is no issue with these being removed and this will not affect the structural stability of the main Church.

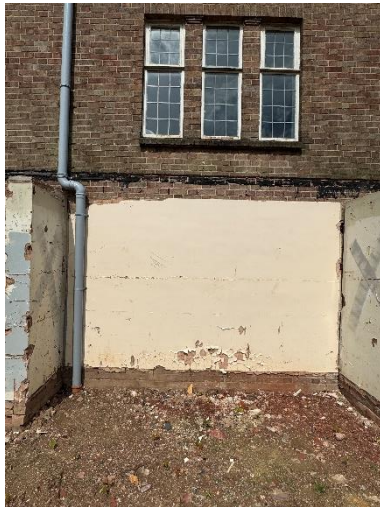
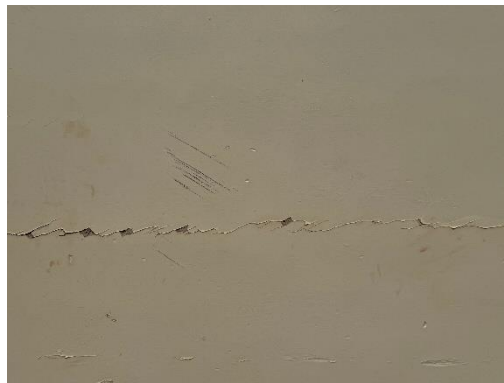
A general view is shown on photograph No.12. The brickwork is in a reasonable condition with the plaster showing little cracking and there is one horizontal crack which is shown in detail on photograph No.13.

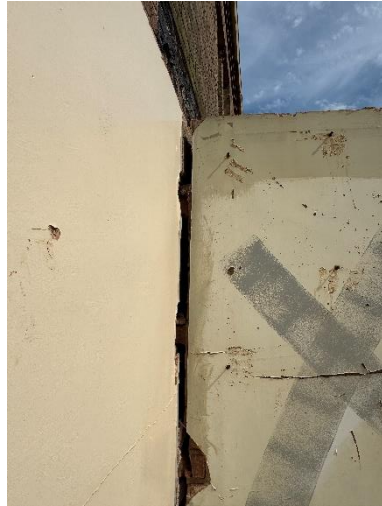
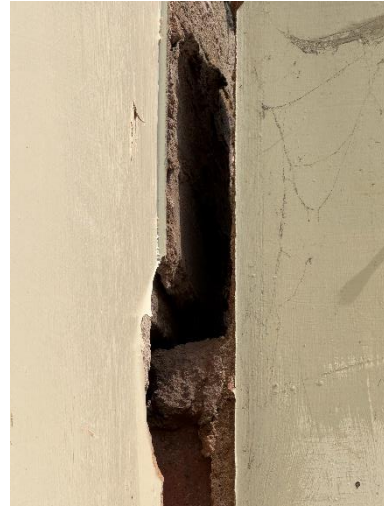
At the cross wall position this has detached completely but again, there was no indication this was bonded, as shown in general on photograph No.14 and in detail on photograph No.15.

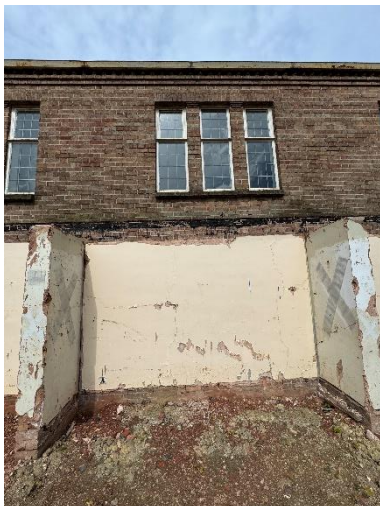
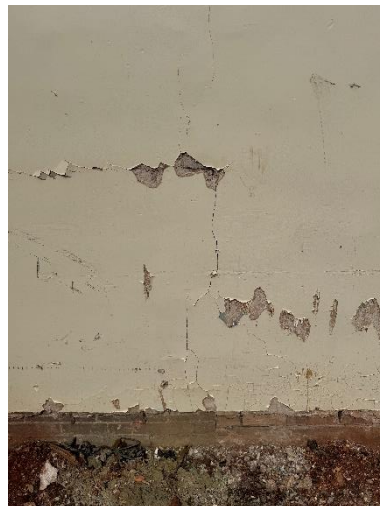
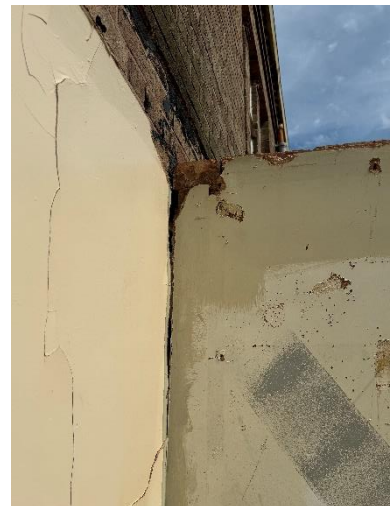
A general view is shown on photograph No.16. This is in a reasonable condition with only minor hairline to 1mm cracking and again there is an open joint with the cross wall, these points being shown on photograph Nos.17 and 18.

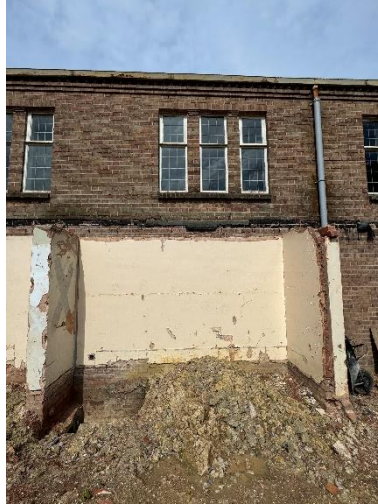
Photograph No.19

A general view is shown on photograph No.19.

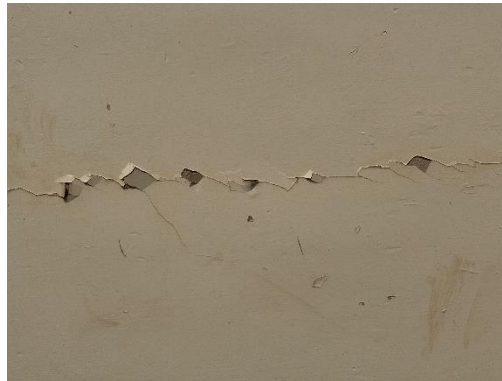
Photograph No.20

Mid-height there is a slight horizontal crack, as can be seen on photograph No.20.

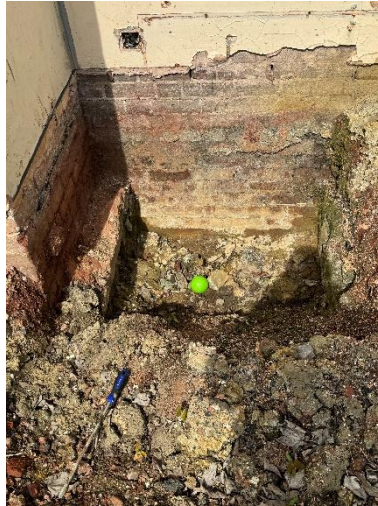
Photograph No.21

In this bay, a trial hole has been excavated and it is apparent that the foundation to the cross wall is 530mm below the damp proof course and this protrudes by 150mm, going down a further 100mm. The main foundation extends down to 920mm below ground level and protrudes by 250mm.

Although the bottom was not fully exposed, it was felt that there was an additional depth of 150mm when probed with a screwdriver.

At the time of the inspection the soil was quite desiccated and a general view of the hole can be seen on photograph No.21.

Externally, the trial hole should be infilled and it is thought that with the Leylandii now not being present, that the ground will begin to rehydrate. What should be noted is that there has been no further movement since the Church Hall has been demolished and therefore there is not a concern with the overall stability. It should also be noted that the worst cracking was in bay 2, but this is only 1.5mm wide and the vertical cracking at bay 3, 1mm wide, as can be appreciated on photograph Nos.50 and 51 respectively.

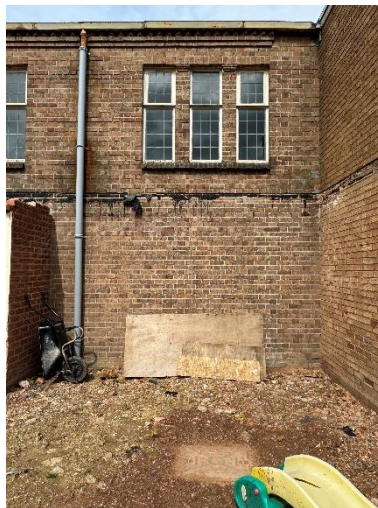
Photograph No.22

This is shown on photograph No.22 and this is exposed brickwork and shows no signs of any significant cracking.

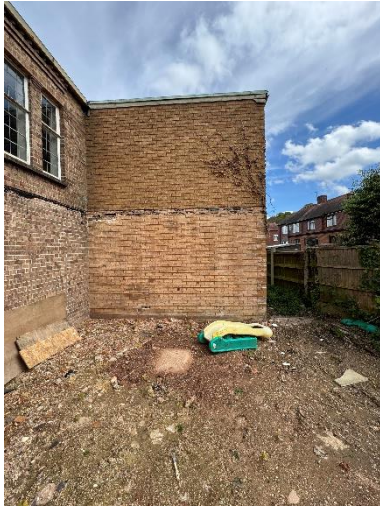
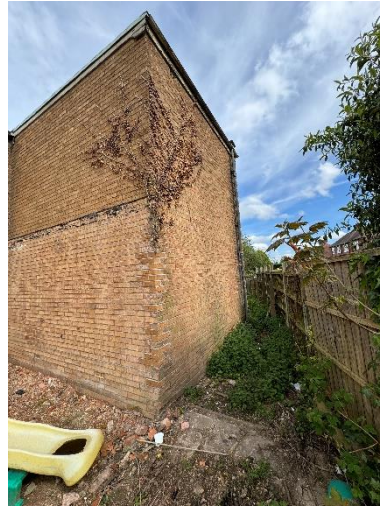
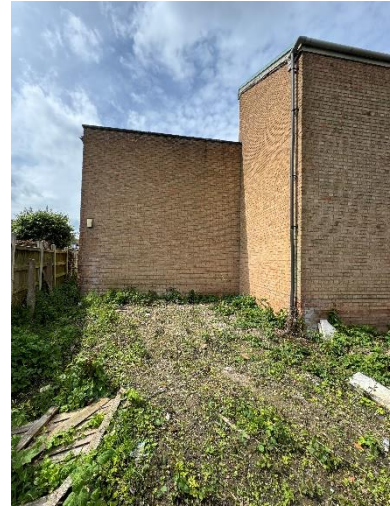
The building then returns to the south, as shown on photograph No.23, then to the east and then returns back round to the north and these last two elevations are shown on photograph Nos.24 and 25. There was no cracking to these elevations and the main item to notice is that there has been ivy cut off, which should be fully removed and the vegetation at the base of the wall should be cleared.

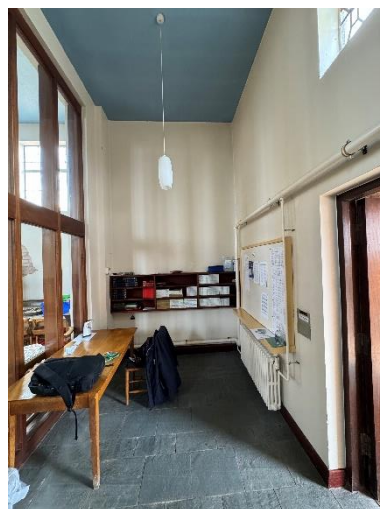
Photograph No.27

The first section of wall is within the western entrance, is shown on photograph No.27, and this was free from structural cracking.

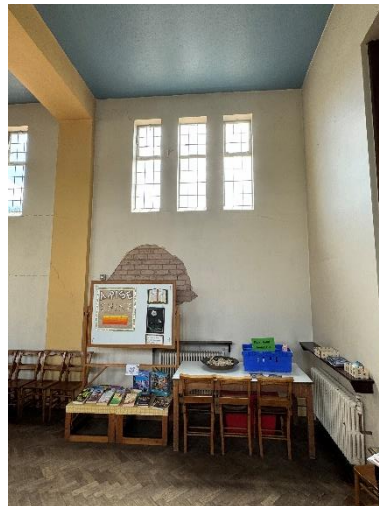
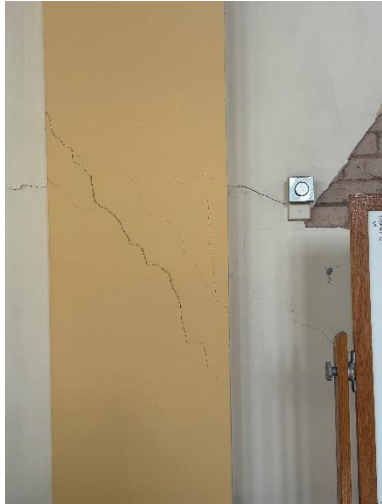
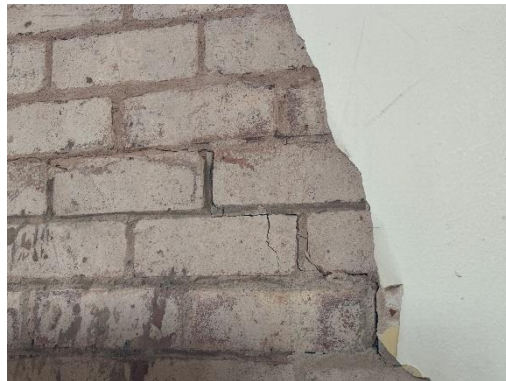
It is noticeable that the plaster is partially off the wall. There is a degree of cracking to the casing to the frame, as well as a slight diagonal crack where the plaster has come away, all as recorded on photograph Nos.30 and 31.

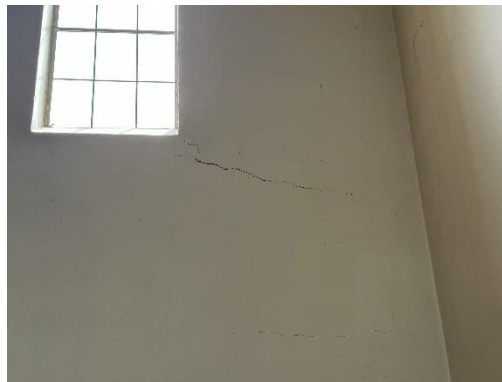
Photograph No.32

From the bottom right-hand corner of the window there is again minor cracking, as can be seen on photograph No.32.

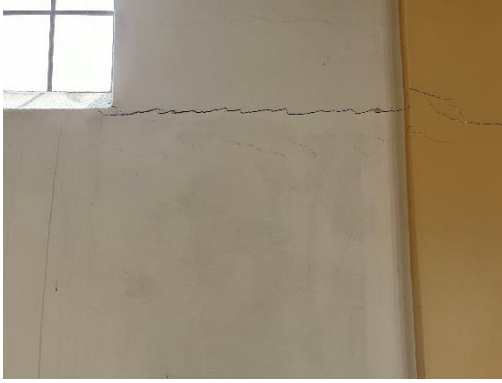
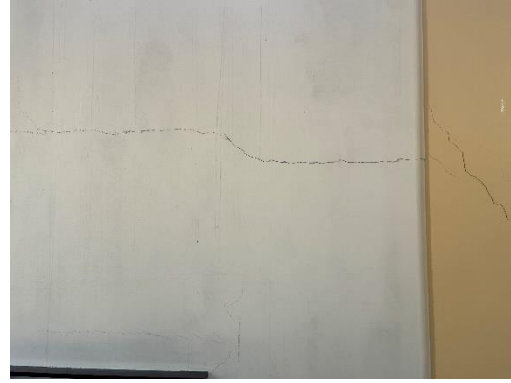
The main items to note is there is a horizontal crack from the bottom right-hand corner of the window and also one below here, all as can be seen on photograph Nos.34 and 35.

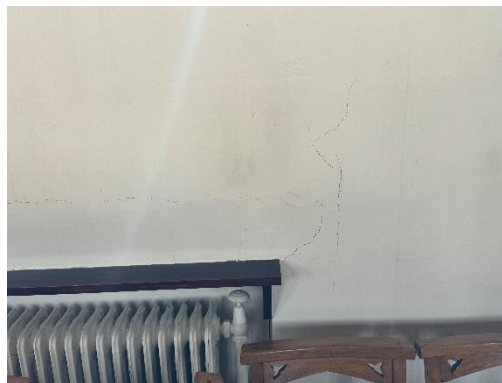
Photograph No.36

There is also minor cracking from the radiator, as shown on photograph No.36.

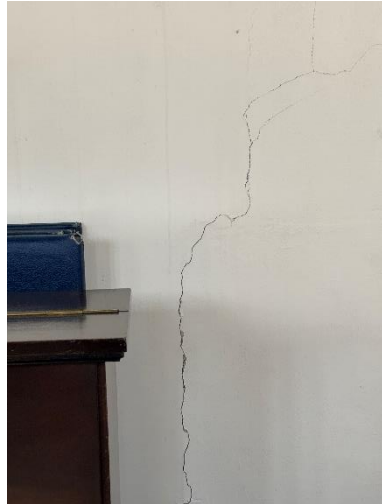
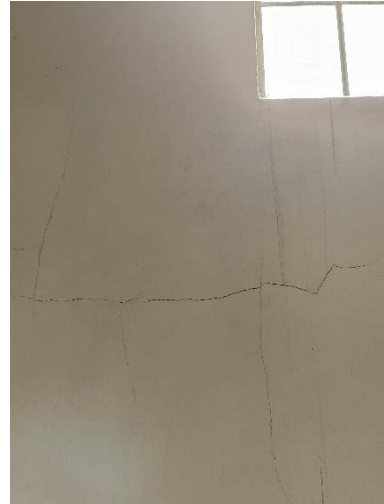
There is a vertical crack which extends up towards the window and then a horizontal crack towards the bottom left-hand corner of the window, all as shown on photograph Nos.38 and 39.

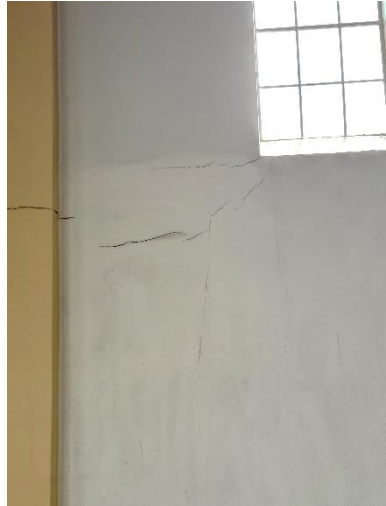
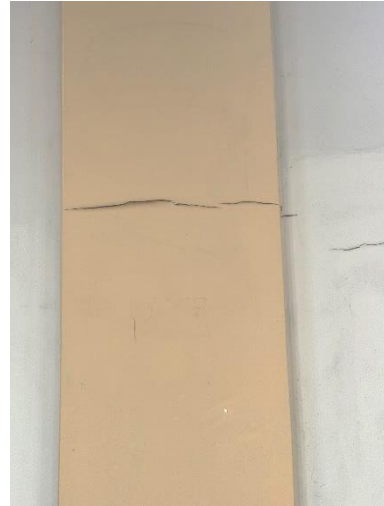
There is again slight horizontal cracking from the bottom corner of the window which then extends across to the pier, and this is shown on photograph Nos.41 and 42.

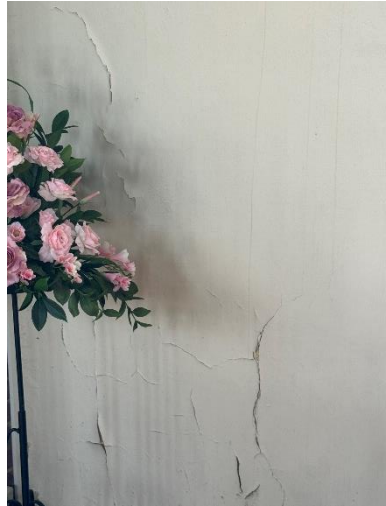
Photograph No.44

There is no major cracking, but there is a disturbance to the decorations where the paint is peeling slightly, as shown on photograph No.44. Where the building then returns as noted externally, this houses the organ, as shown on photograph No.45 and from what could be seen there was no indication of any significant movement.

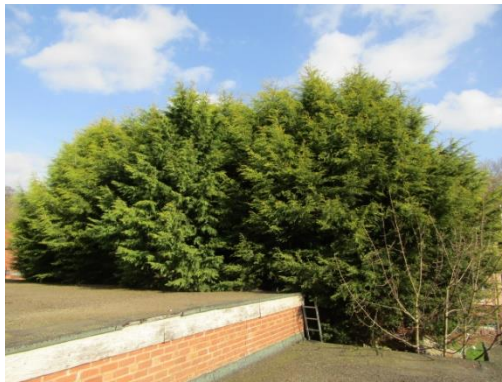
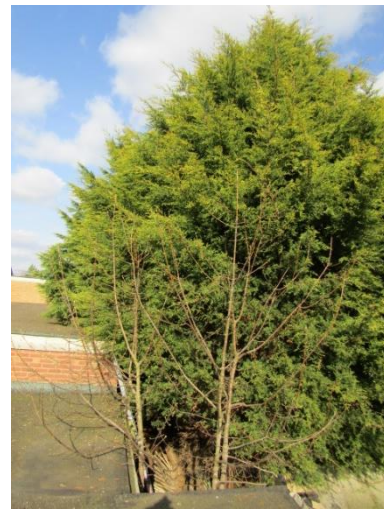
Originally, the Church Hall had moved significantly which was considered to be due to clay shrinkage accentuated by the water demands of a row of Leylandii tree immediately adjacent to the Church land, as can be appreciated on photograph Nos.46 and 47, which are from the original report.

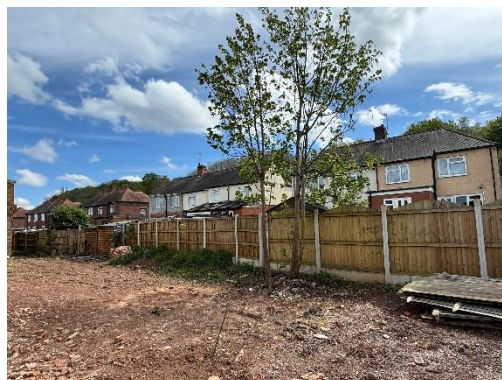
Photograph No.48

It is clear that the trees have been removed which will be very beneficial for the Church and this can be appreciated on photograph No.48.

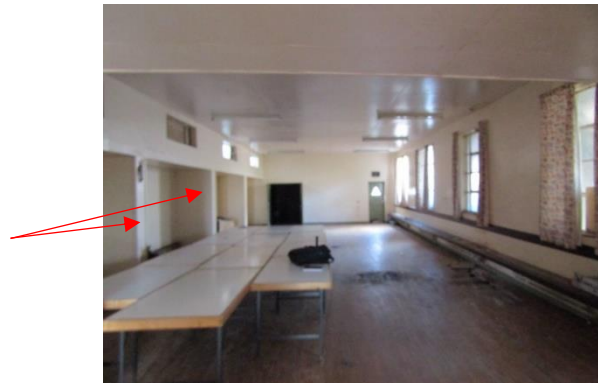
Photograph No.49

Externally, there are a series of five brick piers which originally were internal to support the upper part of the Church Hall wall where it stepped in, as can be seen on photograph No.49.

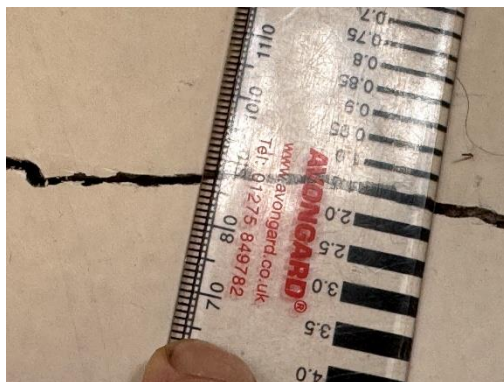
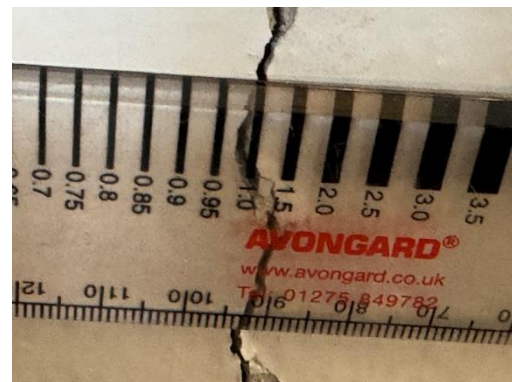
This width of cracking on a building of this nature and age is not of concern and therefore can be repaired as noted above.
