The Church of The Holy Cross, Middlezoy, Somerset. 6th October 2024.

A report on the bell installation with proposals and recommendations for restoration.

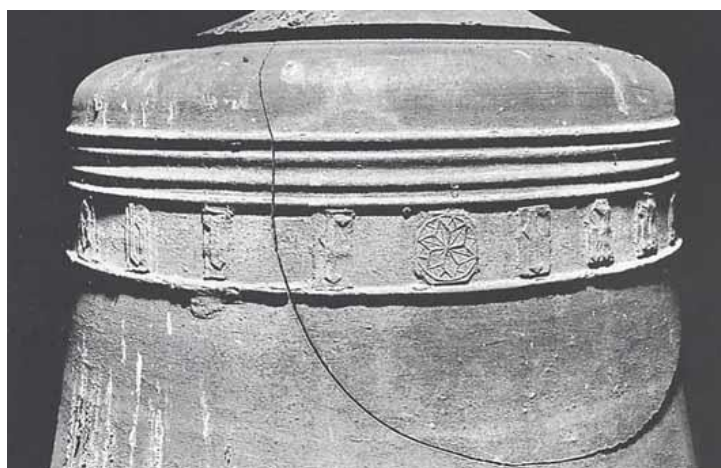
As far as can be seen and heard as they hang in the tower, the bells appear to be in sound and resonant condition. My only concern as far as the bells themselves are concerned is that the roots of the cast-in crown staples remain embedded in the five older bells. As the name describes, a "cast-in" crown staple is a loop made of wrought iron, from which the clapper is hung. This would have been cast into place as part of the bell manufacture and being made of a ferrous material, the staple corrodes, delaminates could potentially expand to up to 7 times its original size, building up huge pressure on the surrounding bell metal. Corroded cast in crown staples are the most common cause of cracks in bells, and any remains of these should be carefully extracted as part of any planned restoration.

A typical crack caused by corroded cast-in crown staple. (*Sparkford, Somerset – © Christopher J N Dalton*).

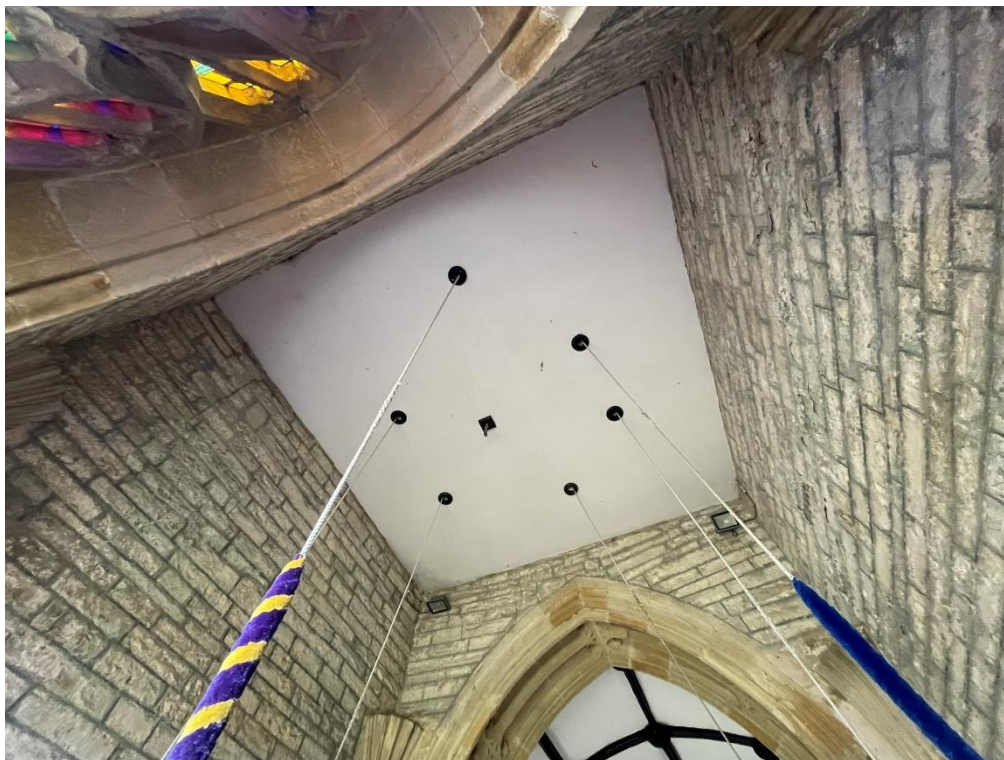
There is a serviceable trap door for the hoisting of bells and materials in the first floor. There is no permanent trap door in the second floor, and I was informed that two steel beams incorporated into the structure of the second floor, restrict the available space, although it is believed there is sufficient room for the largest bell to pass between the beams, if turned onto its side. The 3rd floor includes boards which can be removed to allow the bells and associated equipment to pass through.

Looking up at the second floor – showing lack of trap door for the hoisting of bells and associated materials.

Liaise with a local joiner with regard to the creation of a trap-door in the second floor.

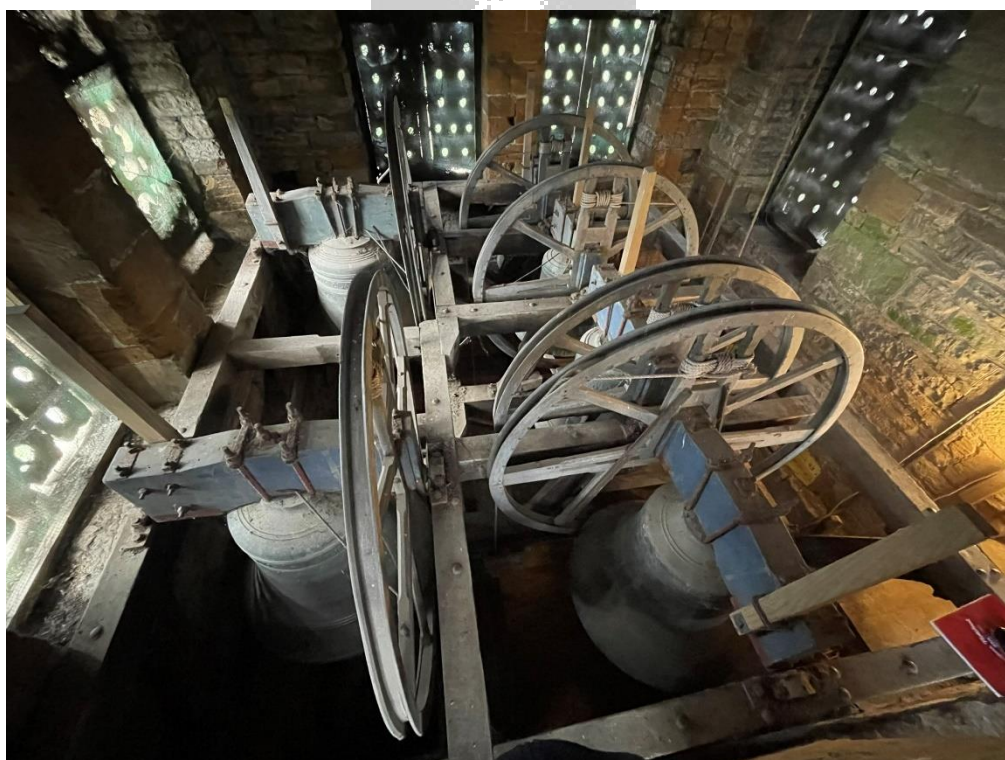
A general view of the bell installation from the east side.

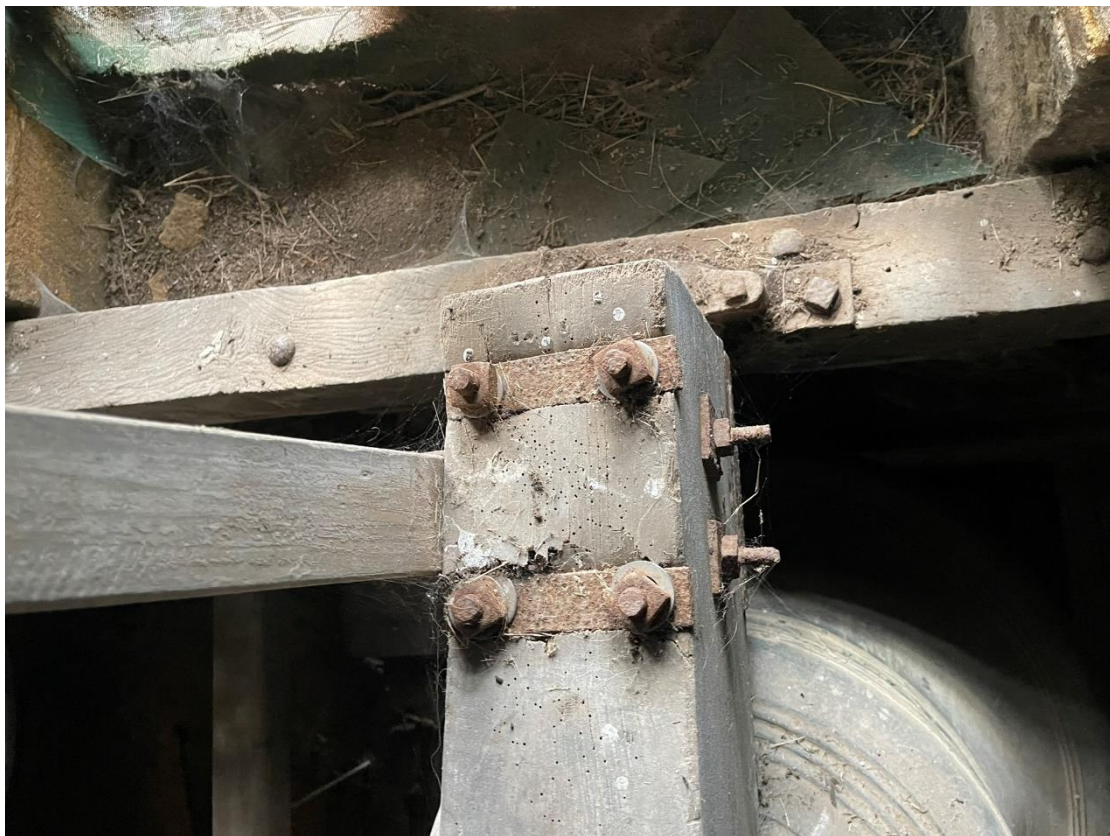
The headstocks are made of hardwood and date from 1907. They are fitted with cast iron plate type gudgeons. The bells are supported by iron straps and dogs, which pass through the canons, around the headstocks and are secured with nuts on top of each headstock. The headstocks of the three larger bells (4, 5 and 6) are becoming decayed due to exposure to the elements, and also attack by wood boring insect. The ironwork is beginning to sink into the timberwork and it is certain that the gudgeon plates are no longer accurately aligned as a result.

The poor state of the headstock of bell 6.

- A fabricated steel, hollow box section headstock, with turned steel gudgeons, steel wheel cleats and clapper adjustment screws for the setting and subsequent maintenance of even striking.
- A pair of double-row self-aligning ball bearings, housed in sealed, cast iron, plumber block type housings.
- Independent clapper staple of steel, fitted with a high tensile steel hinge pin.

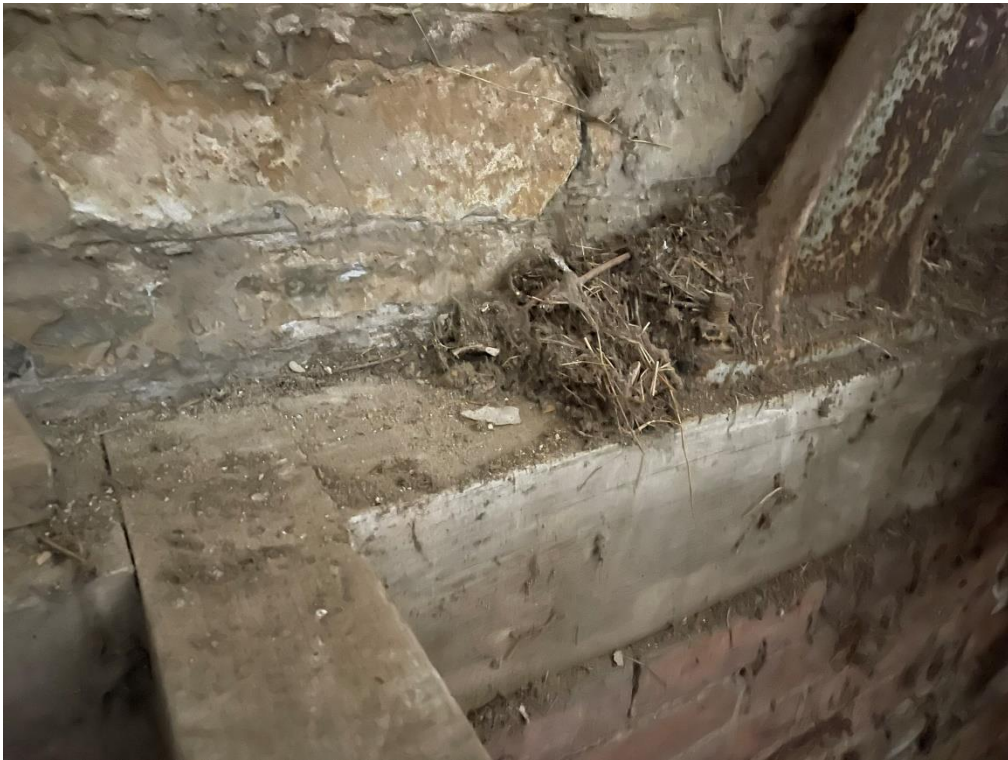
The outer edges of the frame also rest on a ledge (or offset) in the east, south, and north tower walls. The gap between the bottom sills and the tower walls has become filled with dirt and nesting materials. The small amount I removed during my inspection was damp, which suggests that moisture is likely accumulating more widely, potentially damaging the timberwork.

The accumulated dirt and nesting material, between the bellframe and the tower walls.

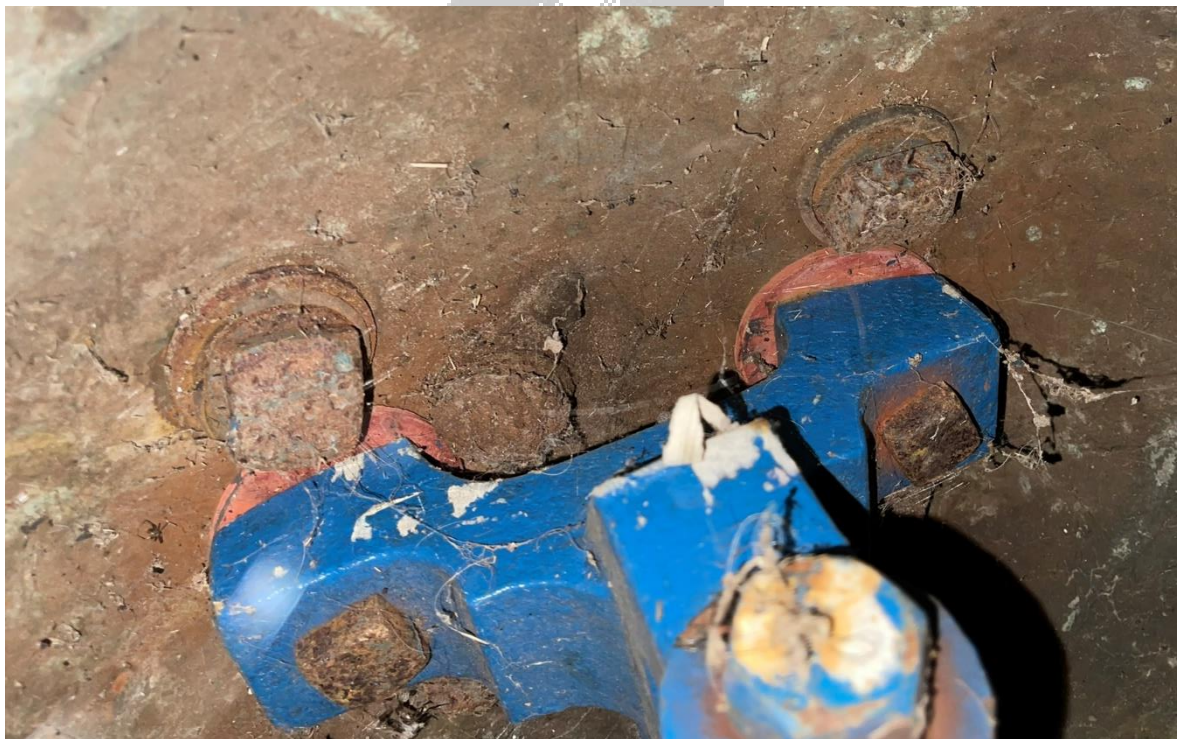
Bell no 5 was cast with a flat top. The remaining bells were cast with canons and cast-in crown staples. The canons have subsequently been removed (probably in 1907) and the cast-in crown staples have been cut-off flush with this inside surface of the bells. Bells 1-5 have had central holes drilled though the centre of their crowns to enable independent crown staples to be fitted, secured with a vertical central bolt on top of the headstock. Bell 6 has an independent crown staple secured by two bolts passing through holes in the crown, either side of the headstock. All 6 bells are supported by 4 bolts passing through holes in their crowns and around their headstocks.

The crown staple of bell 6, showing the roots of the original cast-in crown staple.

Carefully remove all remains of the cast in crown staple from each bell.

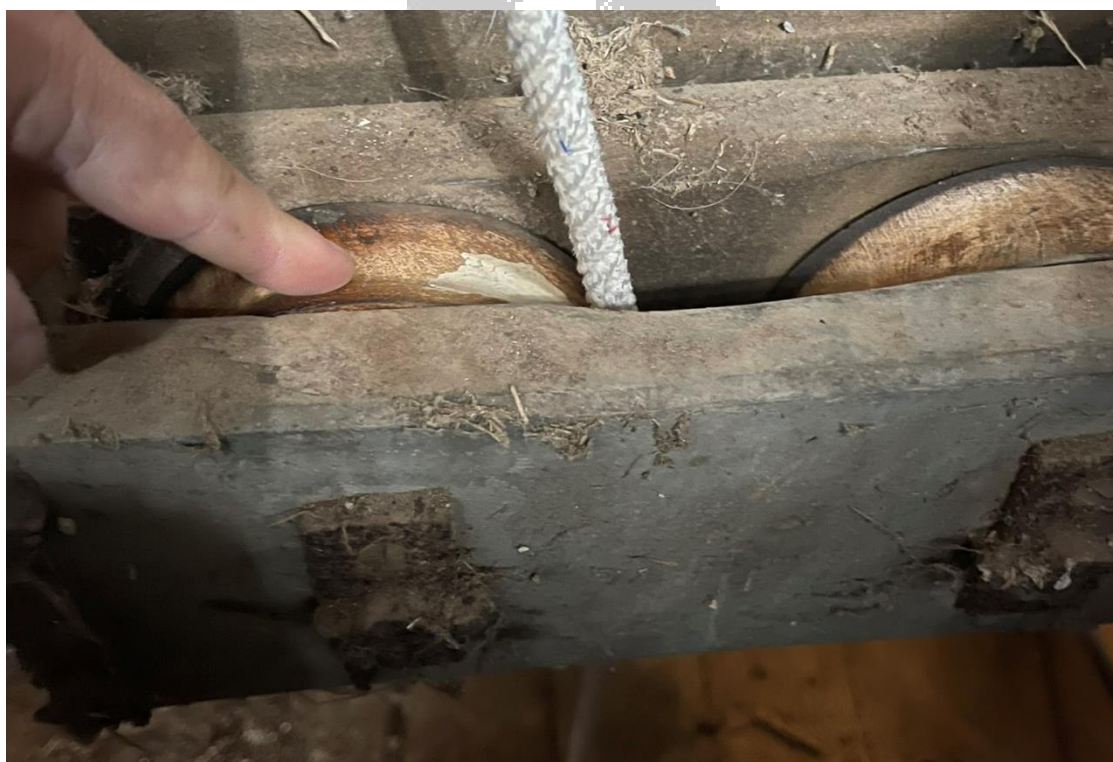
The roller boxes are formed of timber sheaves mounted on ball bearings. There does not appear to be any simple way of lubricating the bearings. Being made of timber, the cross grain is softer than the end grain, and the pulleys have worn unevenly. In general, the pulley sheaves are visibly worn, particularly that of bell 5.

Showing wear to the pulley sheaves.

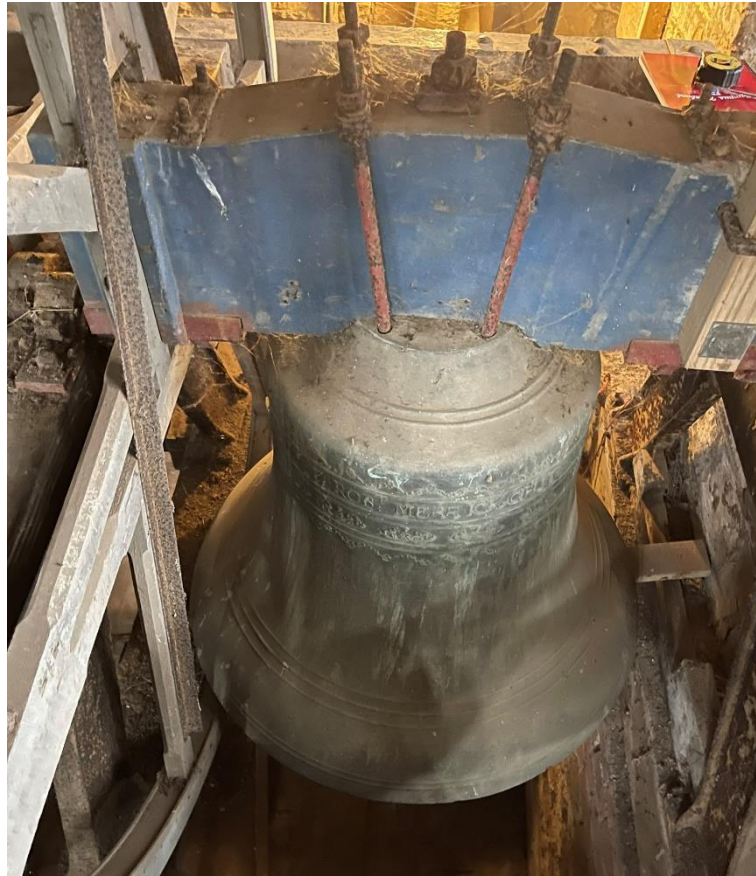
The fittings of bell 4.
