BATH ABBEY

**Conservation assessment on the monument to
Bishop James Montague (1618)**

1. Introduction

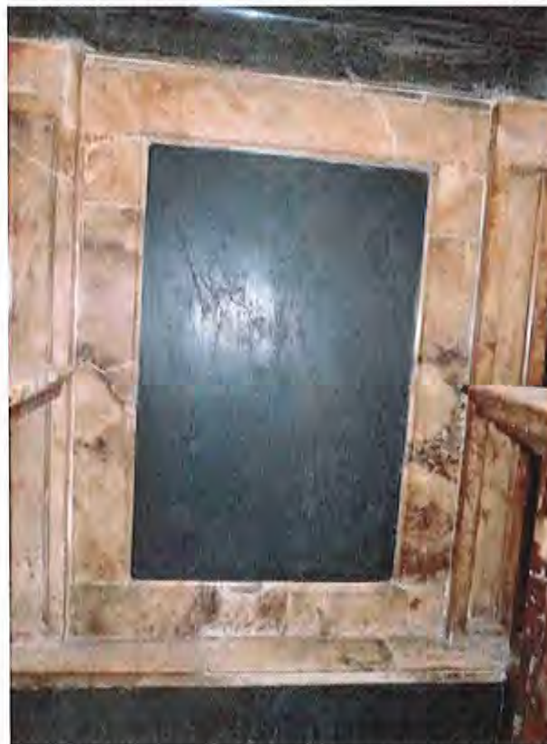
This is generally in good condition with no active decay. The chamfered section of base has been indented on to an original vertical face. There are a number of indents where damage has been repaired by the insertion of replacement sections of alabaster (for example in the NW corner on the upper moulding of the plinth). There is also plentiful evidence of repointing and repair; this appears to have been carried out in plaster of Paris and then toned in by the application of pigmented wax. There is a filled diagonal crack in the top of the frame; this continues above the moulding into the top slab. This may be due to slight structural and historical movement.

Fig 2: detail of west end panel with indents and repair visible on the frame

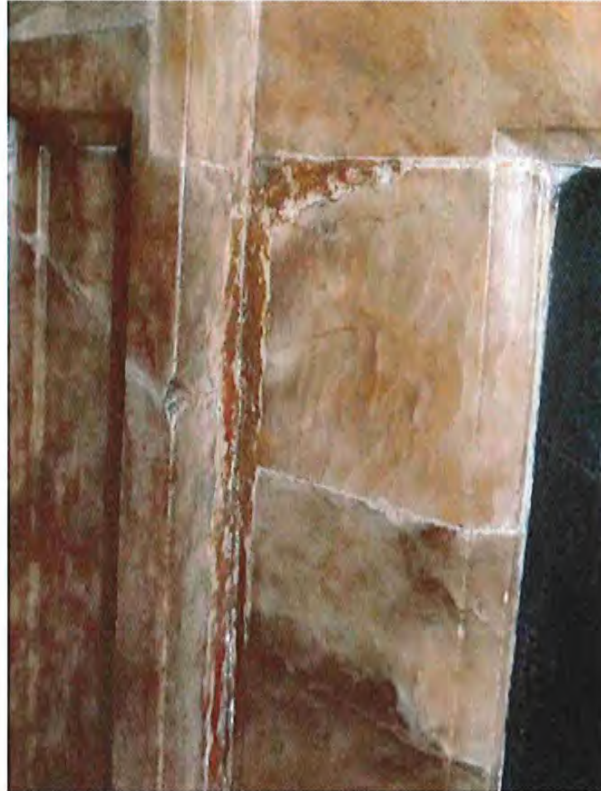
All surfaces have a sticky feel and appearance consistent with the application of a wax coating; this is easily seen under a x 15 magnifying lens. The vertical joint between the small flanking panel and the frame of the central panel is open with the pointing having become detached. A covermeter survey showed no metal fixings used in the construction of the chest on this side.

Fig 3: detail of west end panel showing pigmented wax applied to the surface of repair/pointing

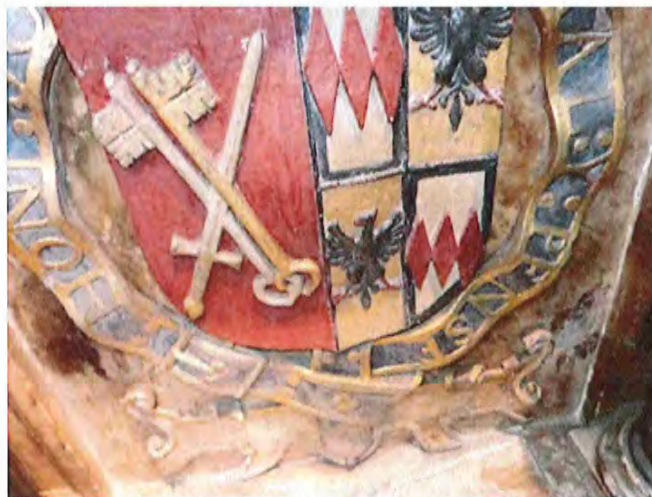
The SW section is in generally good condition although there is a crack across the top corner of the polychrome panel. Many of the joints appear to have been extensively repointed and all areas have been waxed. This has led to some sections (notably the red areas of the heraldry) appearing rather milky as moisture has got behind the wax.

Fig 4: detail of repainted polychromy showing milky appearance of red

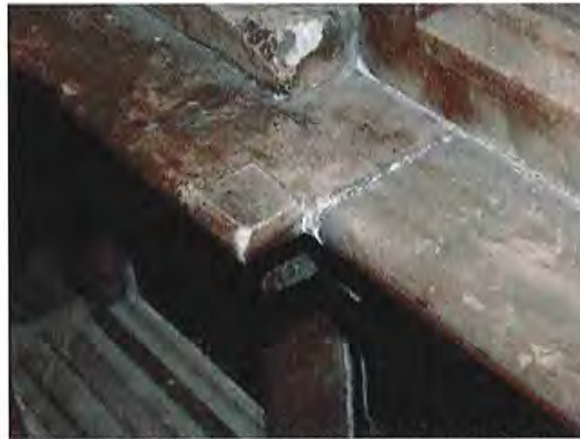
There are a number of indents and repairs, notably a large indent at the top of the plinth. Most of them are on the top surface of the plinth and on the base of the columns. These have been well executed and there is no further damage in the vicinity. The columns are in good condition with some streaking and a milky appearance where moisture may have got behind the applied wax. The covermeter survey shows that the columns are secured at the top with ferrous cramps.

Fig 5: detail of typical indent on the top moulding of the plinth

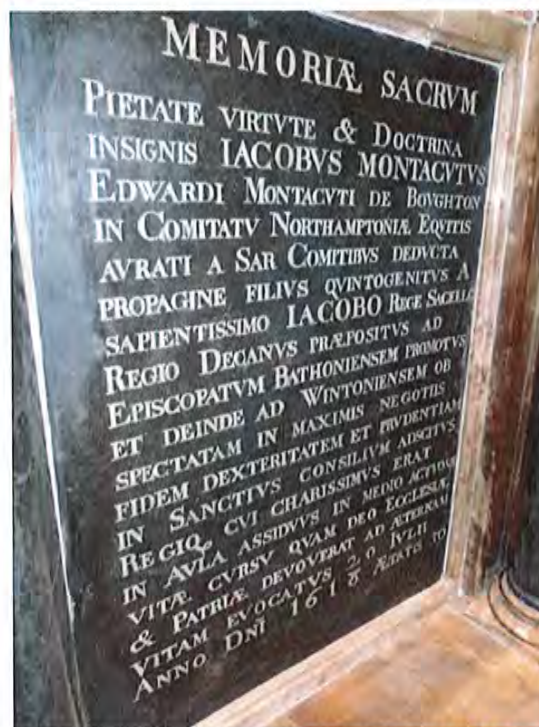
The central panel is also in good condition with the inscription remaining legible. It is interesting to note that the inscription is off centre with a large margin on the left side and almost no margin on the right side. There is a break across the top of the plinth and slight localised loss of pointing around the panel.

Fig 6: central panel showing wide margin on left and no margin on right

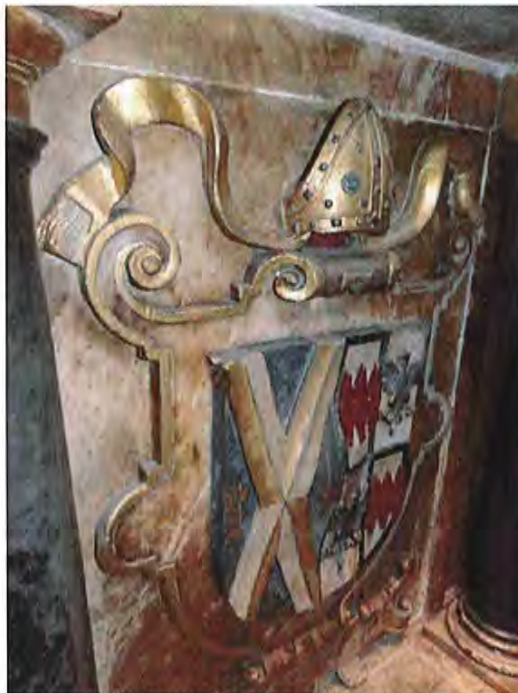
Fig 7: SE panel

The SE panel is physically in good condition but it has some defects in the appearance. As with other sections, there are multiple indents and repairs, notably to the top of the plinth. There is a small indent missing from the SW corner of the eastern column capital. Other areas show signs of repointing and repair; many of these have been well disguised by the application of pigmented wax.

As with all of the monument, there is plentiful evidence that all areas of polychrome have been repainted. This has not always been done with the greatest care and it appears that the gilding may be gold paint rather than gold leaf. There is a general milkiness from moisture getting beneath the wax and in places (for example the cross), it is possible to see the craquelure in the underlying paint layer. In some instances this has caused the most recent paint layer to crack as well. Towards the base, the alabaster has a patchy appearance due to the deterioration of wax coatings.

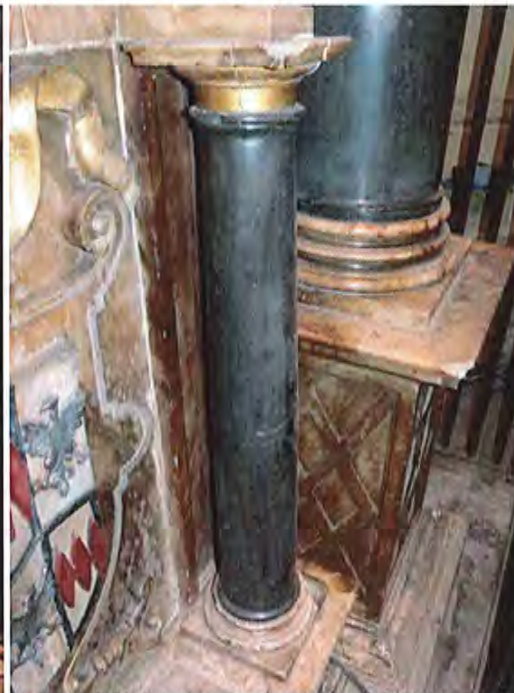
Fig 8: SE corner column showing some milkiness on the surface

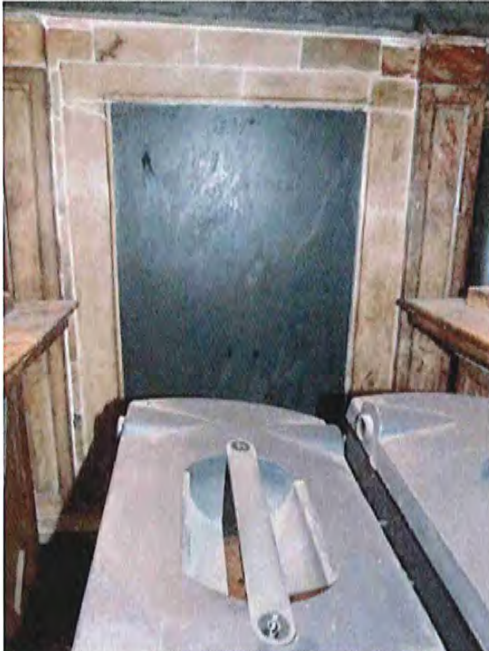
There are two speakers wedged against the east end of the chest tomb; these have the potential to cause damage to the alabaster.

Fig 9: east end panel (partially obscured by speakers)

- 5.1 Remove speakers from current storage against the monument at the east end.
- 5.2 Remove projector and dismantle timber support from east entablature.
- 5.3 On the north side railings, secure individual balusters to top rail to reinstate the rigidity of the railings.
- 5.4 Using a soft bristle brush and vacuum, remove dust from all surfaces.

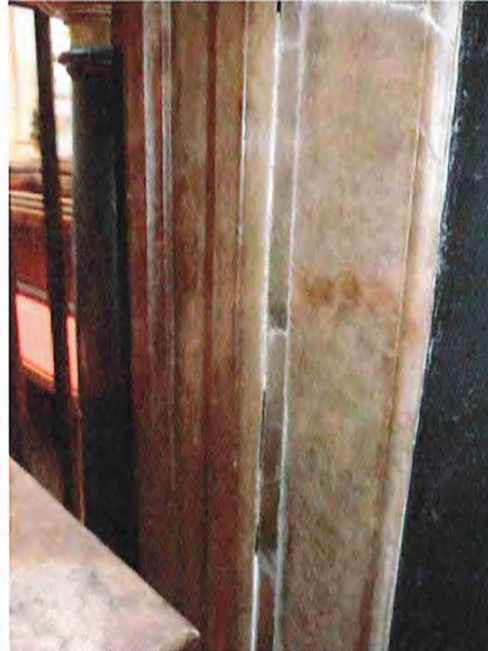
This is generally in good condition but it is extensively repaired and indented and there is also active loss of mortar from the vertical joint at the interface between the small sunken panel and the frame of the panel. The frame is broken into seven separate pieces which have been fixed together. The black marble panel itself has considerable condensation on the surface; this is causing some blanching around the irregularities in the marble but it was not possible to understand what the cause of the condensation might be.

Fig 10: detail of indents on frame

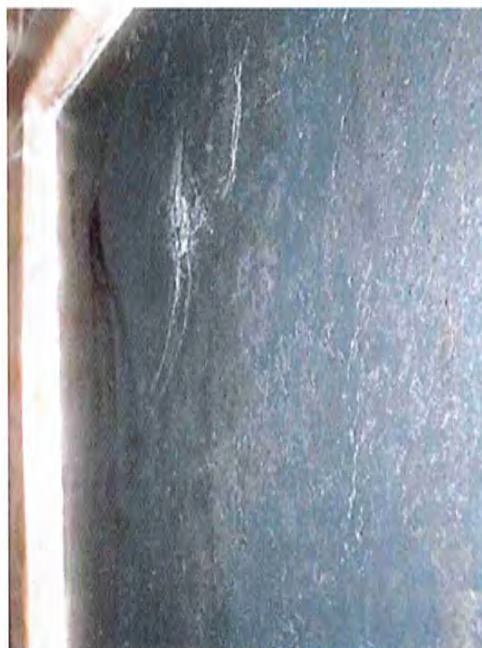
Fig 11: condensation on east end panel

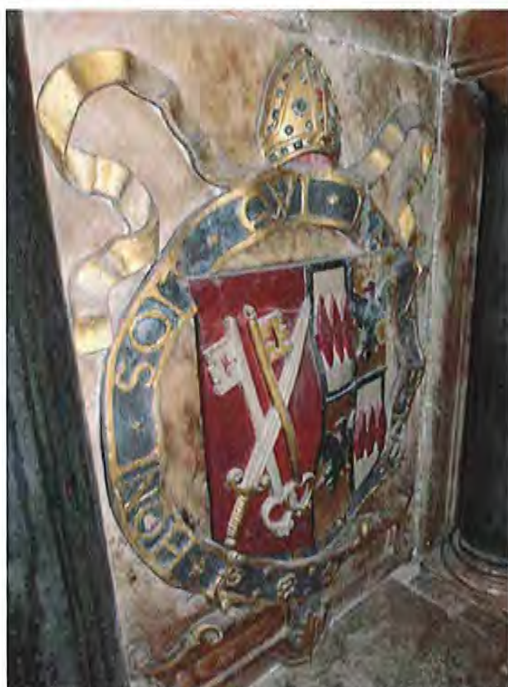
Fig 12: NE panel

The condition of the NE panel is generally good with less indents than on the south side but there are still some repairs. The most significant of these is a vertical crack that has signs of minor continuing deterioration. The pointing at the top of the panel also has slight decay. There is considerable evidence of pigmented wax applied over the repairs. Some of the polychrome has been rather crudely touched in and the columns have a somewhat milky appearance.

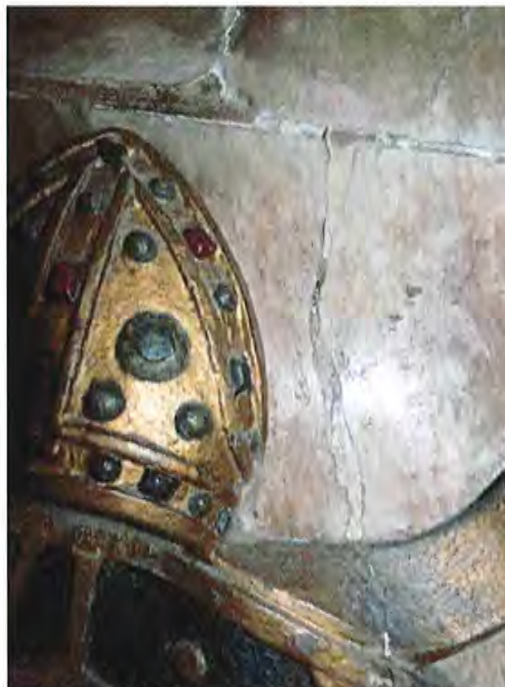
Fig 13: detail of crack with minor deterioration

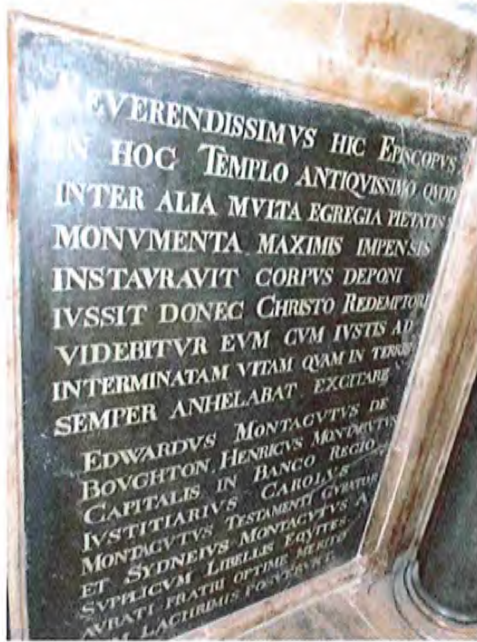
Fig 14: central panel

The central panel has a crack that has been repaired on the upper surface of the plinth. The inscription is legible having been repainted; as with the inscription on the south side, it is set off centre with a large margin on the left side and a very small margin on the right. The surface at the top west corner is roughened and there is some minor cracking on the lower west side.

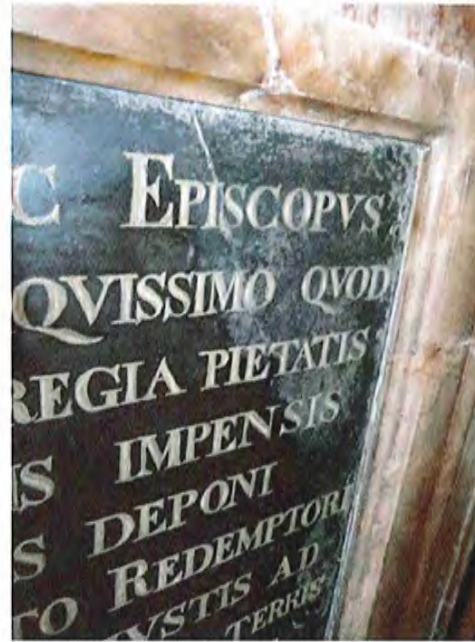
Fig 15: detail of rough texture at top corner of central panel

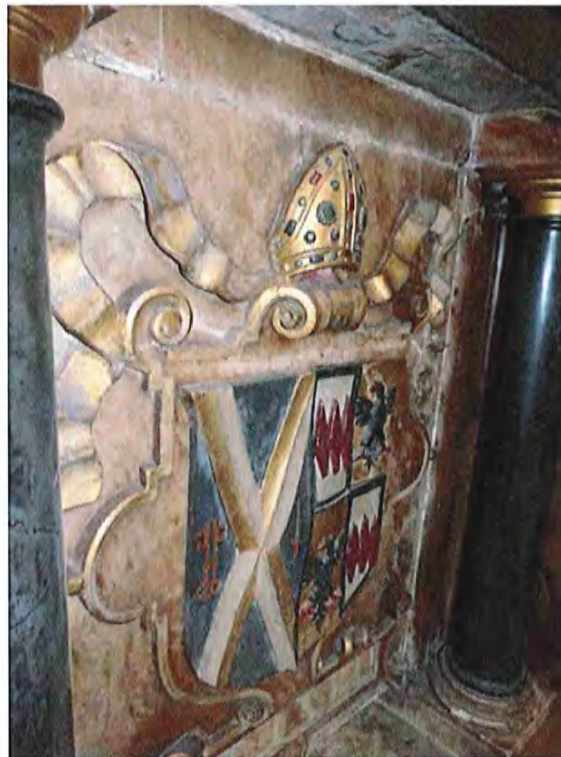
Fig 16: NW panel

The NW panel is in good condition. There are repairs to the pointing and cracks at the top and across the inscription; these have been well carried out. It appears however that repairs have been carried out at a number of different times as the nature of the fill material differs. The repainting of the polychrome is rather crude in places and there is some cloudiness in the colour due to moisture getting behind the wax. There is an indent missing from the top surface of the plinth.

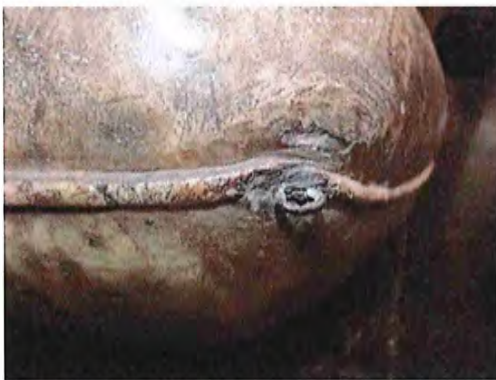
This is a very accomplished piece of carving and is in good condition. The decorative tassels from the top corner of the pillow are missing. On the face, there is slight damage to the nose but otherwise the detail is mostly intact. The

Fig 18: detail of missing element from cushion

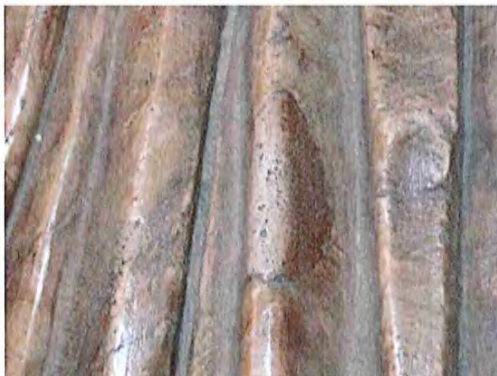
hands have been replaced or refixed but the tips of the fingers and half of one thumb are missing. Examination of the surface of the robe shows a very large number of repairs. Some of these run across the figure for a good length but they are not breaks. It is possible they are weak beds in what was a very substantial piece of alabaster. The surface has a very fine comb scratching in many areas and this seems to be as a result of the removal of plaster and polychromy. Small traces of polychromy are still visible in deep recesses of the carving particularly beneath the pillow and between the ear and the ruff of the cloak.

Fig 22: detail of repairs to effigy

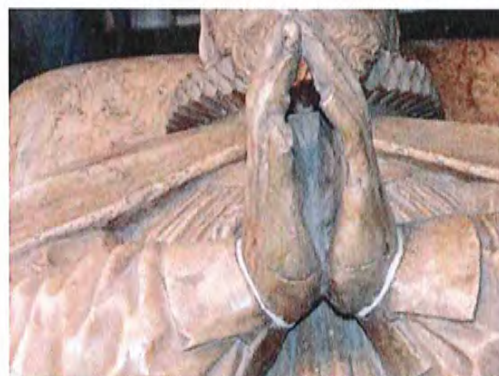
Fig 23: detail of replaced and damaged hands

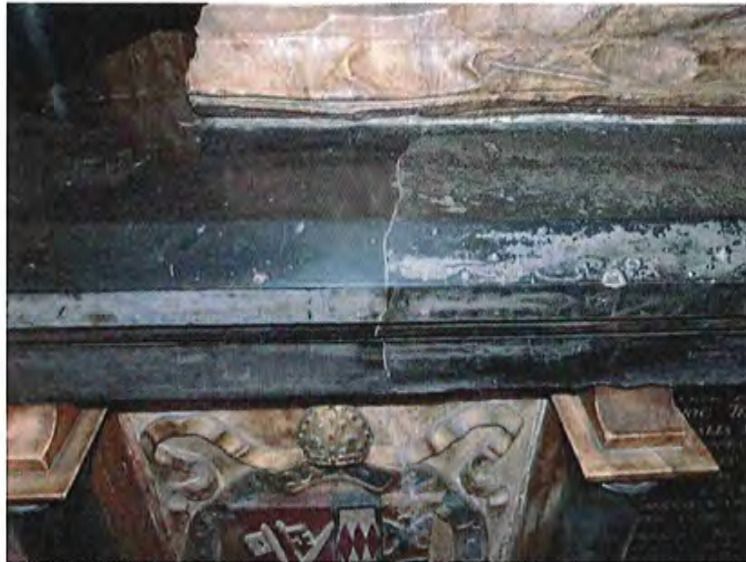
This is in good condition although here is some historic decay at the west end where there is a historic (but now stable) crack in the surface. There are a number of other faults running across the slab but these appear to be part of the geology of the stone as the roughness of the surface seems to change either side of the fault. On the north side, there is some decay to the arris on the underside of the moulding. The unpolished soffit of the stone has some localised flaking.

Fig 24: fault across slab with different surface effect on each side

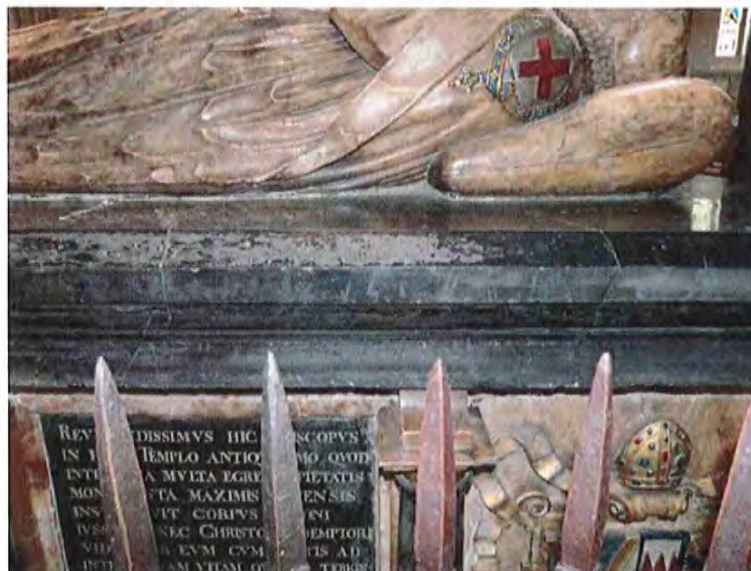
Fig 25: faults running across the slab

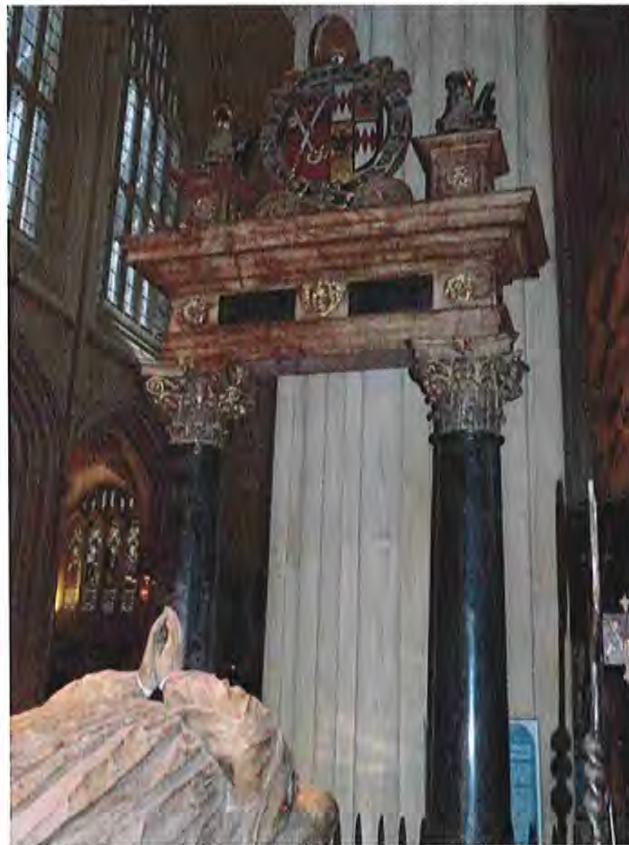
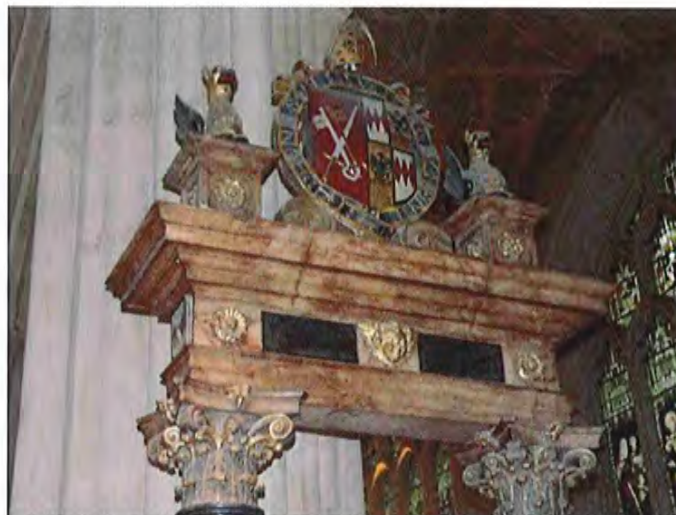
The west entablature has a brown appearance due to the discolouration of the wax; this rather detracts from the vibrant appearance of the alabaster. There are a number of indents of the moulding on the east side and one particularly wide but filled joint on the west side. Griffins and cartouche all appear to be sound; there is a minor chip from the NW corner of the southern griffin base. The entablature is held in place with two large cramps restrained into the adjacent column; there is a further cramp at the top of the cartouche. All surfaces are dusty.

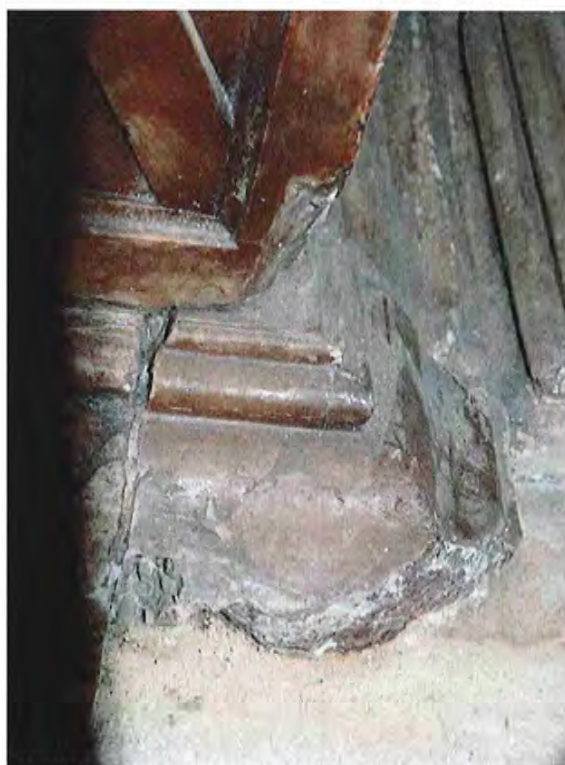
The NE column plinth has a new base stone and the alabaster plinth above has been extensively repaired especially at the NW corner. The NW corner of the lower moulding of the plinth is damaged and disrupted. All four corners of the plinth capital are indented. The column and capital are sound although the surface is dusty and there is some slight differential staining.

Fig 28: disrupted stone at base of plinth (NW corner)

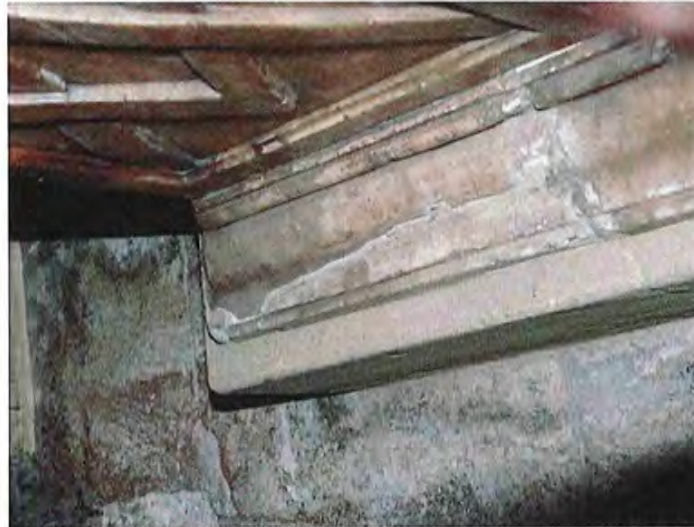
The upper moulding of the SE column plinth has indents on all four corners. The east side of the lower moulding is made up with plaster painted to resemble alabaster. The column and capital are in good condition with a dusty surface and some slight differential staining.

Fig 29: detail of lower moulding on SE corner showing section made up in plaster

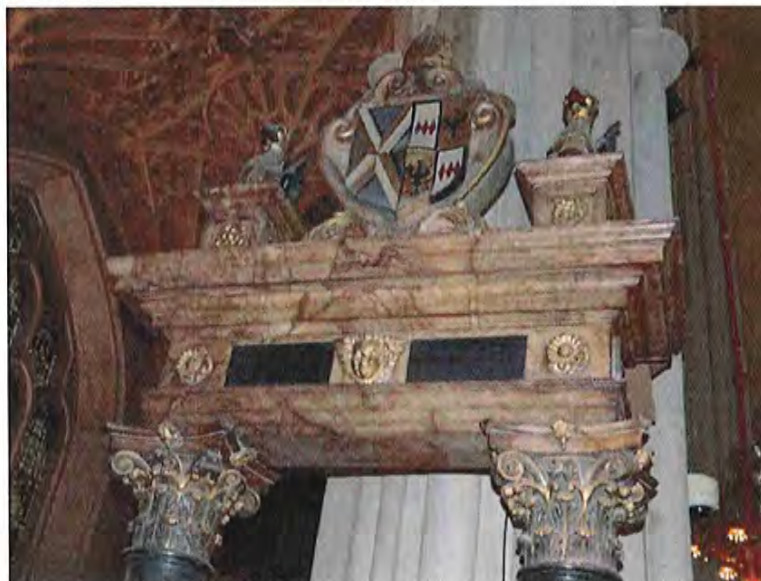
Fig 30: upper section of east entablature

The east entablature is sound but has a deep brown appearance from the discolouration of the wax. The polychromy appears to be in good condition. The cornice has a large indent on the east side. There is a wide (but filled) vertical joint on the west side. The griffins and cartouche seem in good condition but are generally dusty. The entablature, which is cramped in the same way as the corresponding west entablature is being used as a support for a projector.

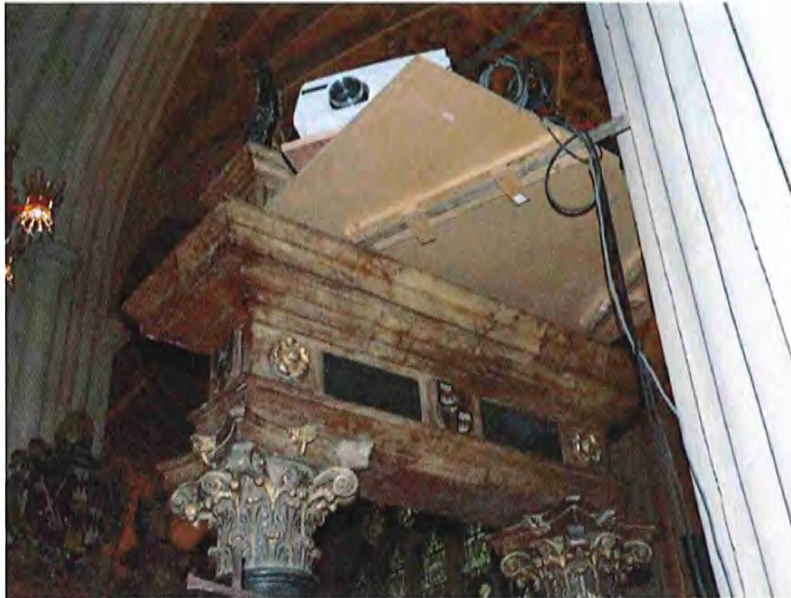
Fig 31: detail of east side of east entablature showing how it is being used as a projector stand

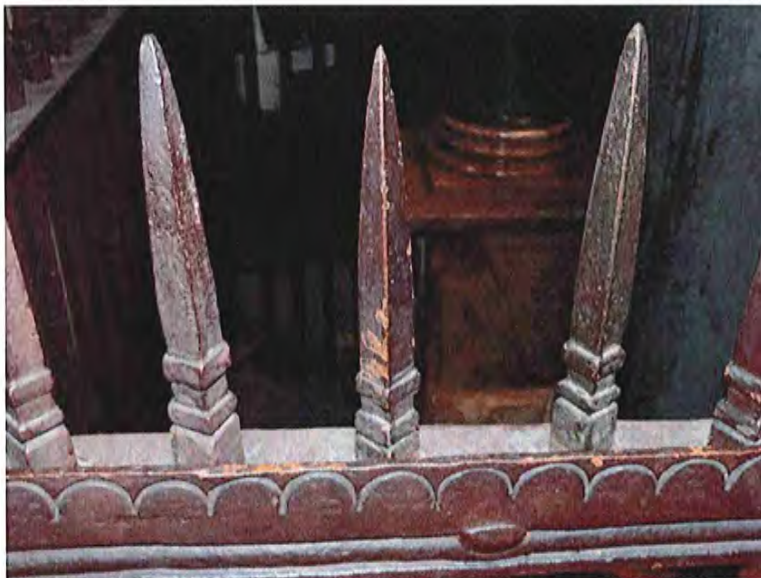
There are no obvious signs of current corrosion and there is evidence (which could only be confirmed by carrying out cross sectional paint analysis) that the railings have been stripped and painted with red oxide primer followed by the current red/brown top coat. There are some areas of paint abrasion, particularly on the north side. The balusters on the north side are all loose presumably as a result of this side of the railings being removed to allow floor works to be carried out in 2013. There are a few loose bits of solder remaining on the top rail. As a result, the whole railing wobbles and, as it is regularly touched by the passing public, this may be getting worse. In contrast, the south side railings are firm as the tops of each baluster are brazed onto the top rail.

Fig 34: detail of paint loss from railings showing red oxide beneath

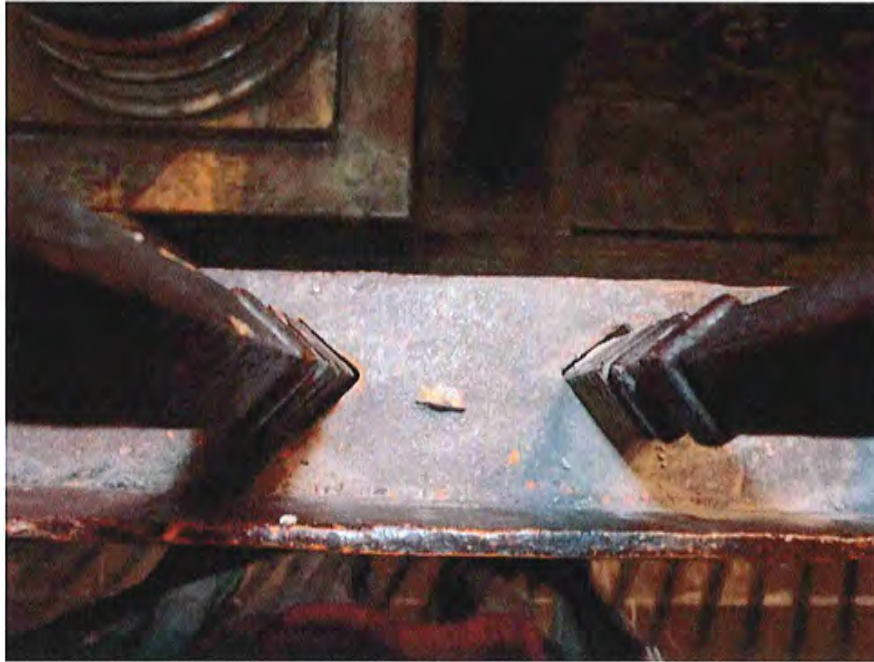
Fig 35: north side railings showing how balusters are not fixed to top rail

The railings themselves are in good condition although the north side is rather loose due to having been recently removed to allow works to the floor. Their presence also ensures that the many visitors to the Abbey are not able to touch or interfere with the monument which is therefore well protected.

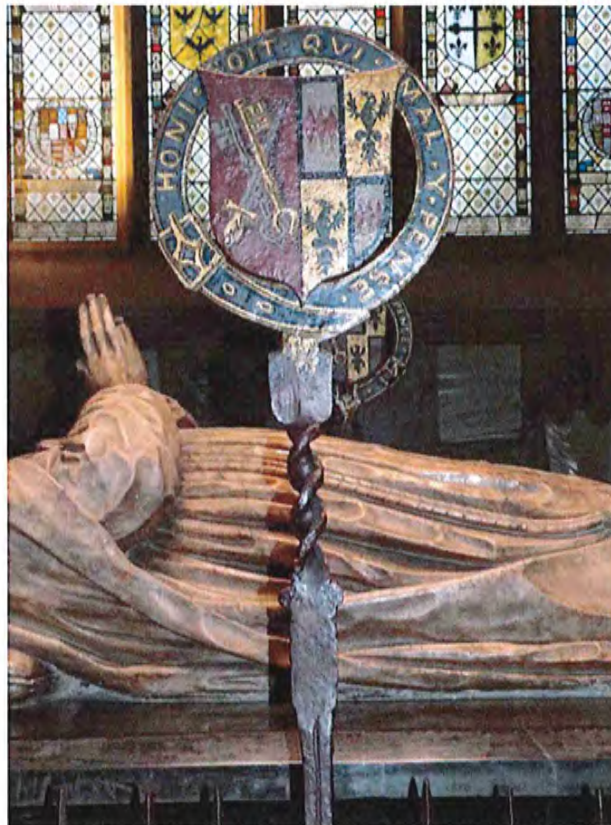
All of the polychrome shields and discs have been repainted.

Fig 36: example of polychrome disc set above railings

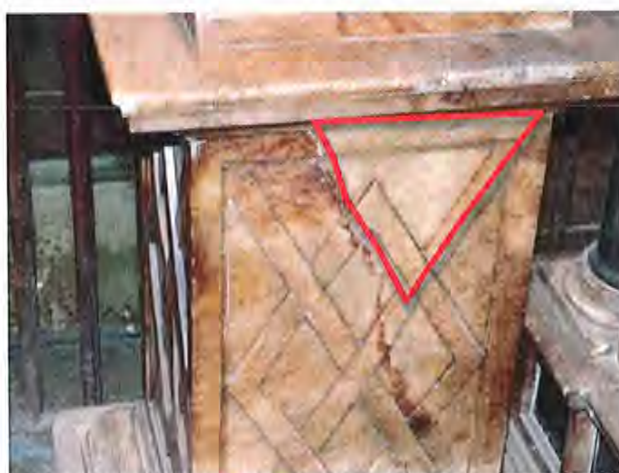
In terms of what work is essential, there is no absolute need for any intervention to the stone elements or the polychromy. A small-scale trial was undertaken using a melamine sponge to see if the surface wax could easily be removed; the result is shown in Fig 37.

Fig 37: area of plinth showing effect of light clean with melamine sponge

It might be thought desirable to remove the wax from all areas and, in so doing, to lighten the alabaster and remove the cloudy appearance from the polychrome and columns. Although this might be an option, it is an expensive and time-consuming process.
