Modbury church reordering

Site visit by Sue Spackman 25th September 2023

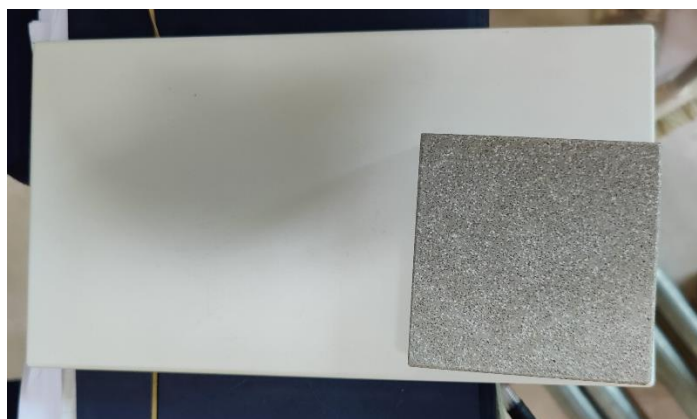
Warm white panel is for the kitchen doors/draw fronts.
The grey is the worktop and infill sections.

The layout has not changed in any meaningful way. However, the proposed door frontage colours and the worktops material have been reconsidered. The PCC wish that the kitchen does not form a distraction on entering the church and therefore wish it to be the colour of the walls, (which is a warm white). They also wish the warden pew backs (which form part of the kitchen frontal) to be lime waxed or painted a warm white. The aim is to lose the kitchen into the colour of the walls rather than have a dark varnished timber facing the south door, which will stand out.

The PCC wish the worktop to be a good quality reconstitute resin worktop to mimic a slate/granite. The taps will be drop down and the sinks will be covered with worktop inserts. The extractor fan is as approved.

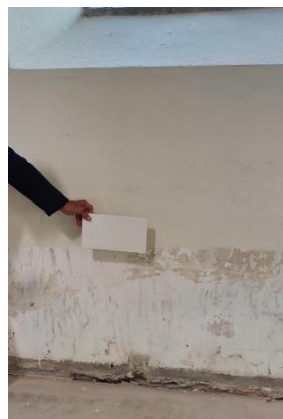
Door front comparison with wall colour.

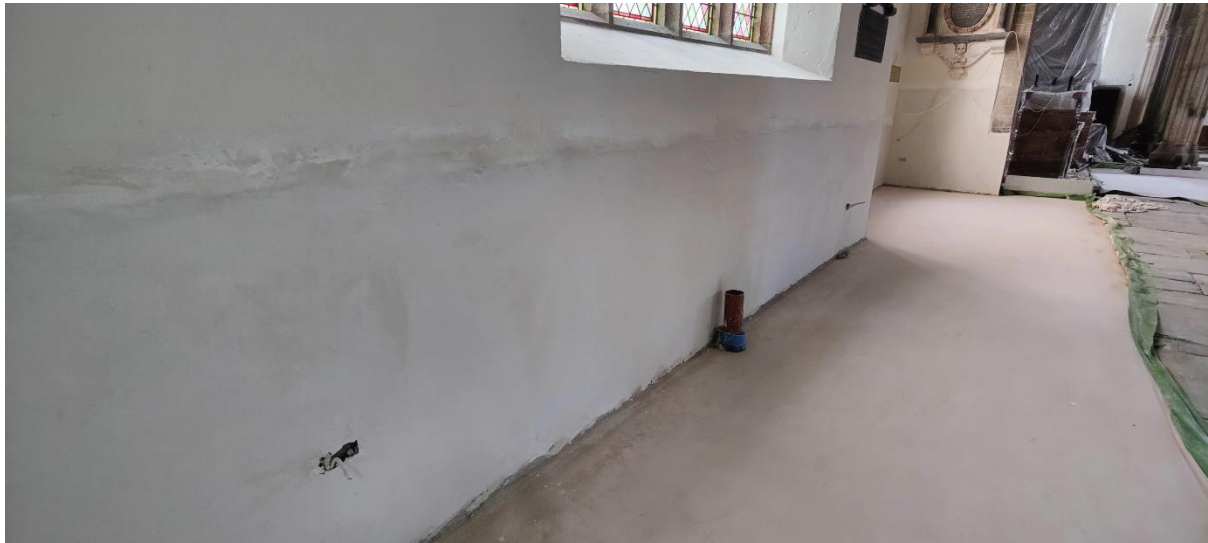
North aisle plaster repairs. Drying before painting.

The existing pew ends abutting the external walls and the panels between were removed as part of the approved works. The lime plaster was very poor and in places missing. It was agreed the church would reinstate a lime plaster along the north and south walls prior to the installation of the new wainscot. This is currently drying out. The PCC (following the principle of not visually re-cluttering the church) now feel that introducing a wainscot over the lime plaster would be unnecessary a) because the poor missing plaster has been replaced and no longer needs covering, b) the plain walls give the space a better quality interior and improved acoustics, c. there is no historic precedent as previously it was pew ends that abutted the wall with infill panels.

If a wainscot were insisted upon they would wish it to be painted the colour of the walls.

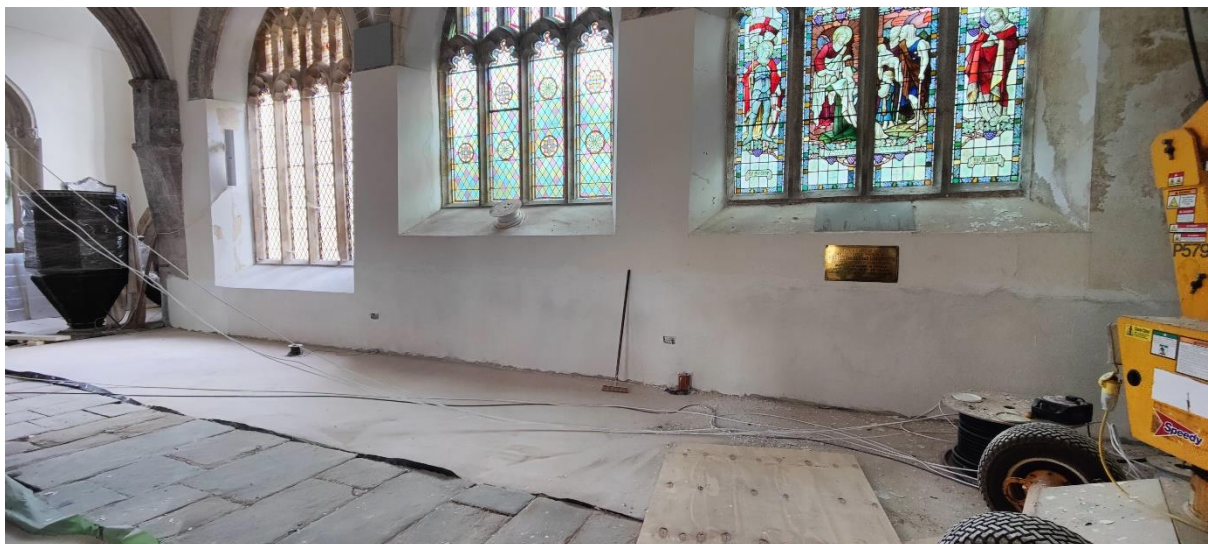
South aisle plaster repairs. Drying before painting.

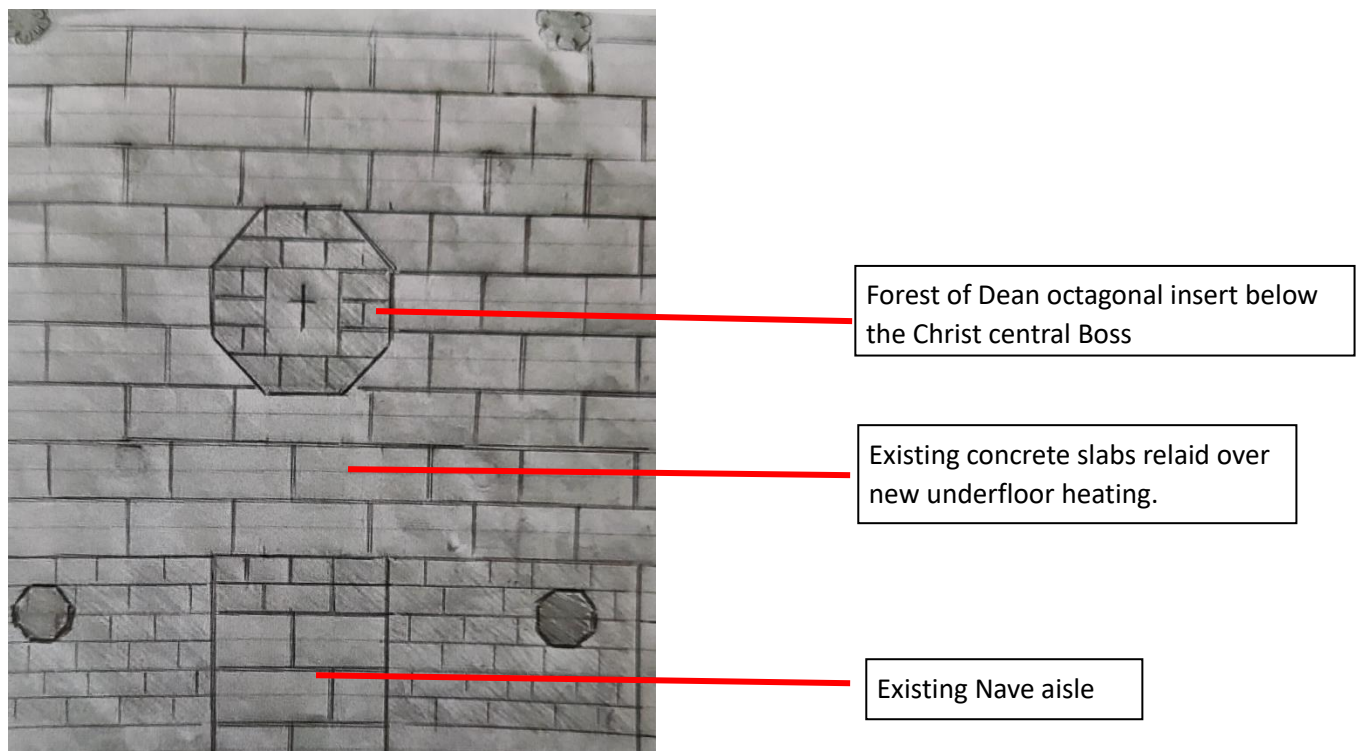
Sketch of transept crossing

The lifting of the transept floor slabs has been successful overall. This was to provide additional underfloor heating within this area. Some concrete slabs were broken in this process and the PCC were considering what to use as a replacement. New in situ concrete was considered but it was felt that using the new Forest of Dean floor finish in a pattern directly under the central crossing medieval boss of Christ would help centre the church and act as a focus for the nave altar. See the preferred sketch below. The octagonal shape echoes octagonal shapes that already exist elsewhere in the church – both the granite and the marble fonts are octagonal, as too are the granite columns in cross-section as well as the pulpit. The symbology of the octagon was also considered appropriate, associated with rebirth and resurrection.

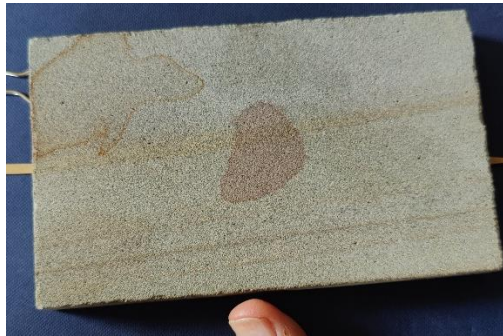
The church have identified that the stone easily stains with red wine, tea, coffee, cake (fat content) and other foods. The PCC wish to point out that, in this case, the floor does not breath and therefore the application of a sealant is not detrimental to the integrity of the floor; the use of the church with a servery provides additional staining outside the usual natural aging of the church and lastly the sealant does not alter the colour of the stone. The PCC is also concerned that footfall around the door will quickly show staining from outdoor shoes.

Stained Forest of Dean floor finish.

For these reasons they wish to amend the condition to allow a sealant on the stone. The sealant proposed is recognised by the stone industry as one of the better products and acceptable by the Forest of Dean quarry.

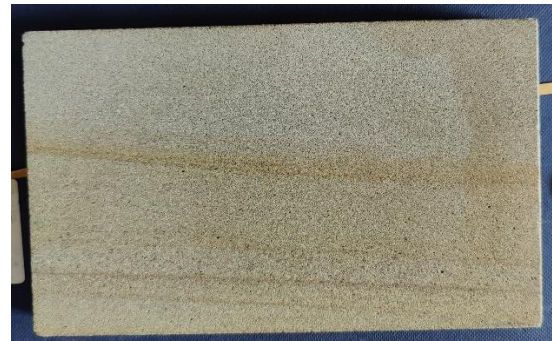
Forest of Dean sealed. No colour change

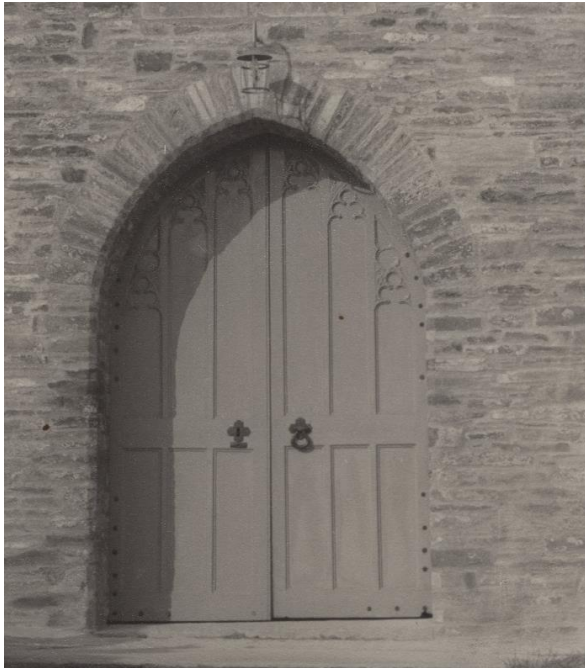
Currently the church outer porch doors are expected to be repaired and re-stained a dark brown. The church porch rebuild photos of the 1950's shows that the doors were painted a light colour. Peeling the paint off the ironmongery the base coat is a blue, similar to the organ pipe colour. Therefore, the current stripped and stained appearance was introduced post the 1950's. The PCC wish to repair and repaint the door a lighter colour to make the church more welcoming. They propose a blue to match the organ pipes.

Porch door after it was rebuilt in the 1950's, note the doors are painted and a light colour.

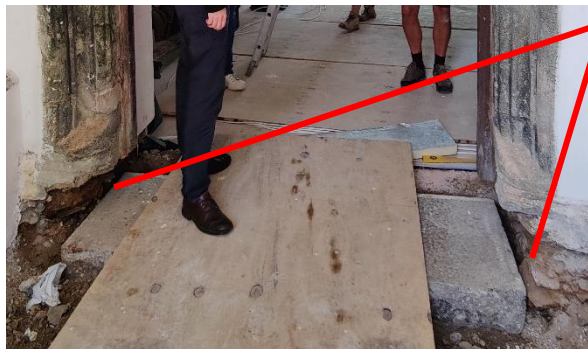
The floor within the porch is sloped into the church. To allow a flush threshold the old floor was lifted. The current base of the south door entrance arch had been poorly repaired using a cement infill. This has been removed to expose an earth and rubble stone packing. (This was done in the presence of the archaeologist). Re-rendering this area in a lime build up was not considered desirable and therefore it is proposed to introduce two Forest of Dean plinths with chamfer stop ends. The size has been cut to minimise the impact on the supporting rubble below. The Forest of Dean stone is one of the best matched for the polyphant gothic stone entrance surround and this is what the PCC propose to install.

These are the two arch base areas where the cement has been removed to expose a rubble base the walls. It is proposed to insert stone plinths with chamfered corners. These will be bedded into in lime mortar and onto the granite threshold step.
